MERCEDES-BENZ A-Klasse

A 250 e 8G-DCT

VIN NO W1K1770861J313903
Registration Number 861J313903

Inspection Report Summary

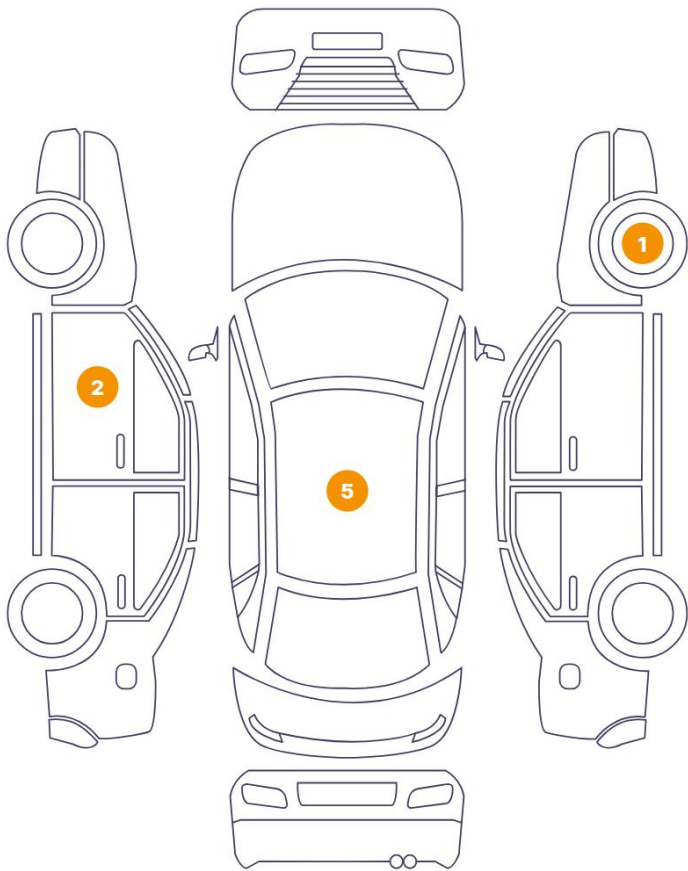
8 Damages

Component		Damage	Comments
1	Door / Front Left	Bodywork / Dent / Dent	
2	Door / Front Left	Paint / Scratch / Scuff	
3	Roof	Bodywork / Dent / Dent	
4	Roof	Bodywork / Dent / Dent	
5	Roof	Bodywork / Dent / Dent	
6	Roof	Bodywork / Dent / Dent	
7	Rim / Front Right	Out of Bodywork / Scratch	
8	Roof	Bodywork / Dent / Dent

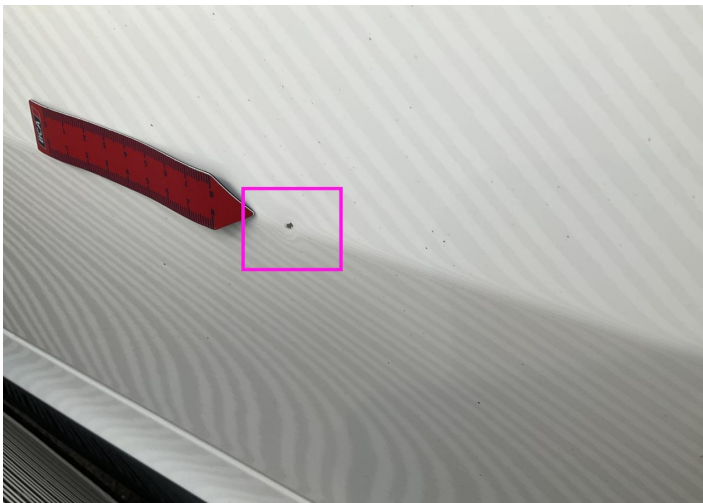
1. Door / Front Left
Bodywork / Dent / Dent -

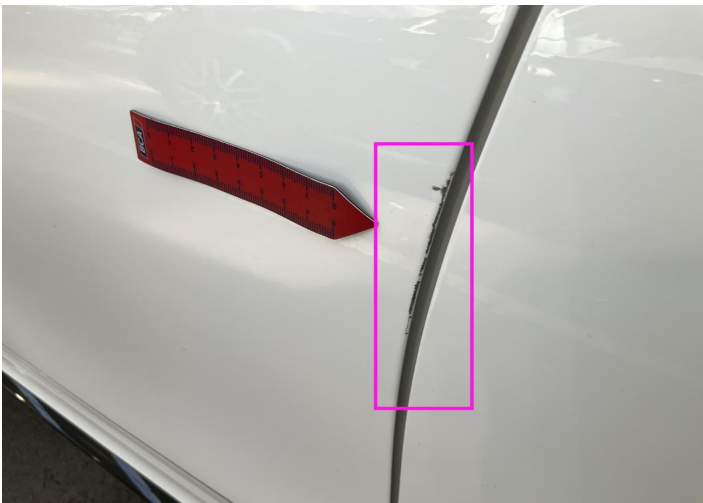
2. Door / Front Left
Paint / Scratch / Scuff -

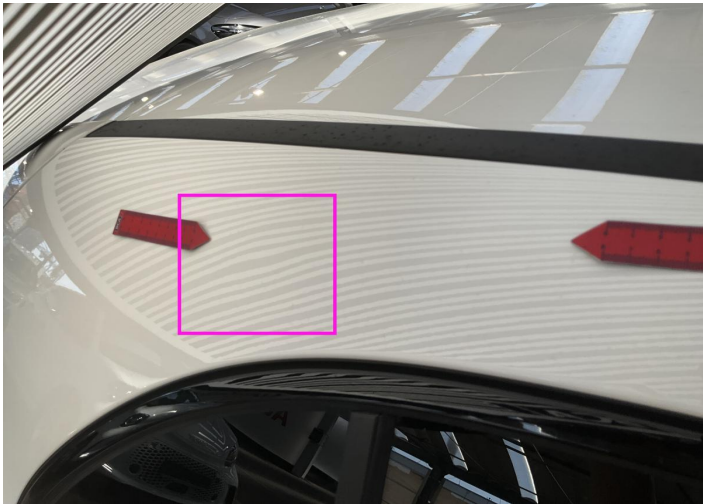
3. Roof
Bodywork / Dent / Dent -

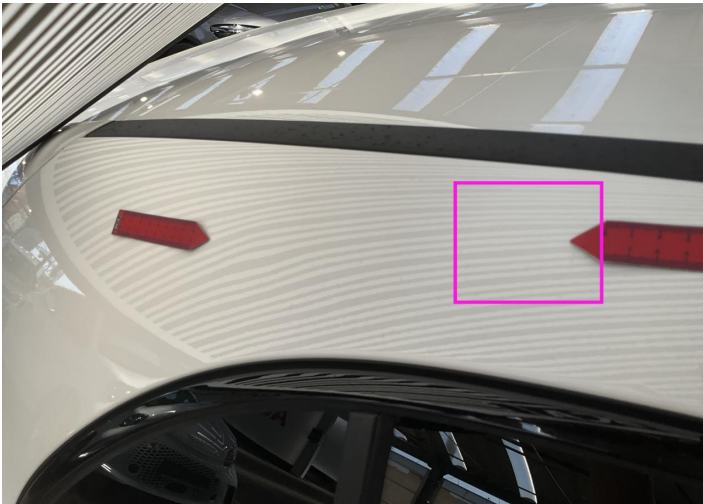
4. Roof
Bodywork / Dent / Dent -

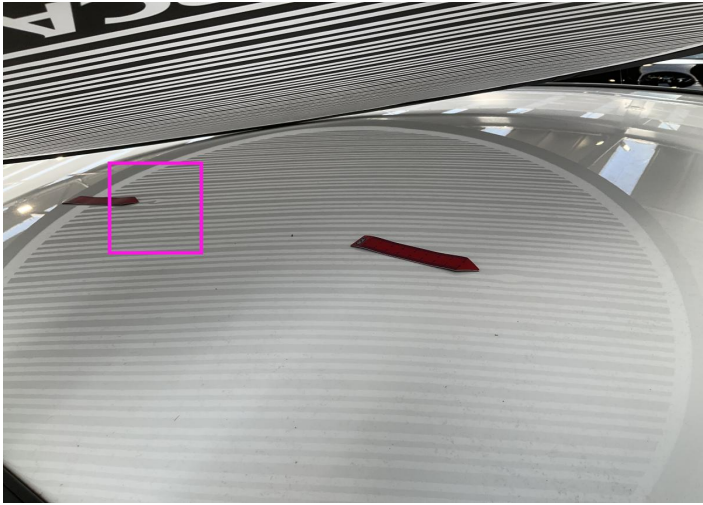
5. Roof
Bodywork / Dent / Dent -

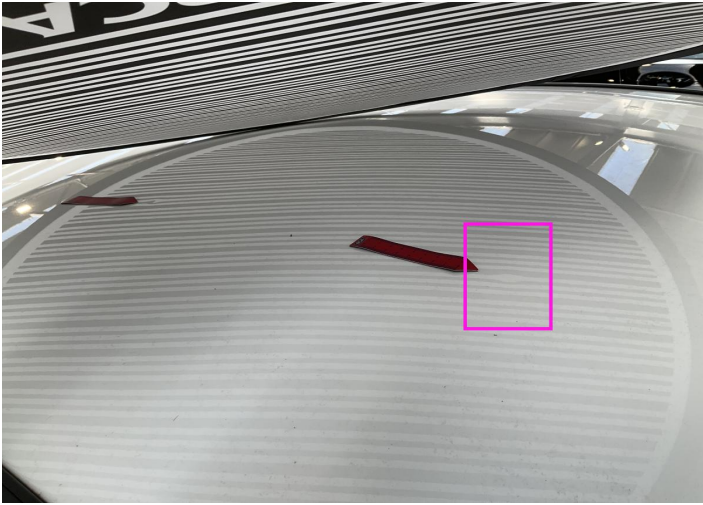
6. Roof
Bodywork / Dent / Dent -

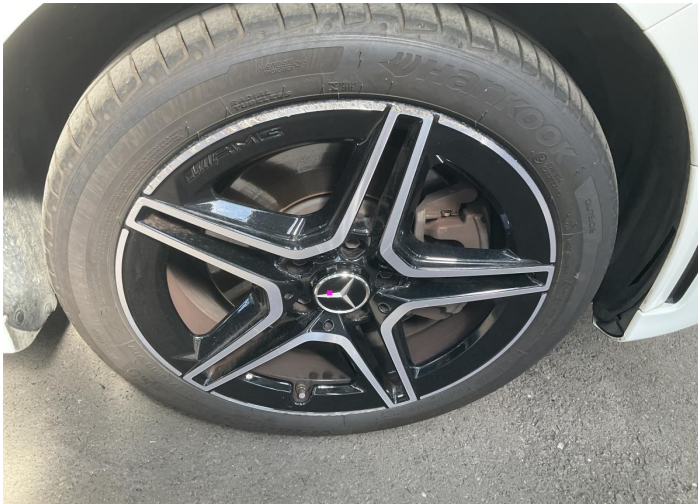
7. Rim / Front Right
Out of Bodywork / Scratch -

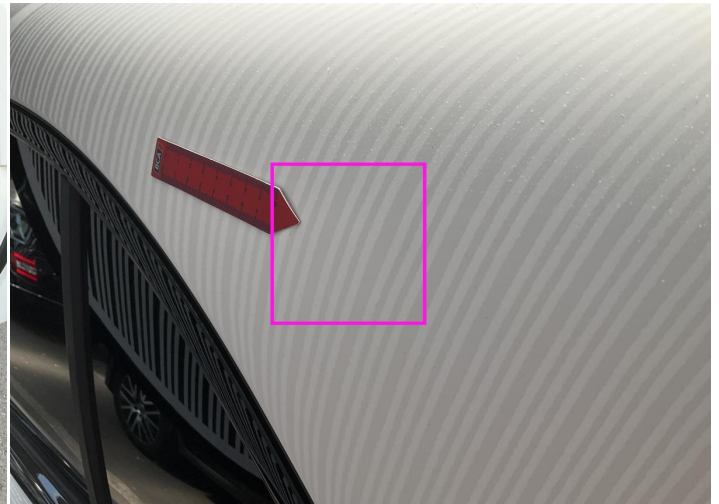
8. Roof
Bodywork / Dent / Dent -
