Expertise

Protocol number: 38870551  
Order No. / Reference: 24155659  
Inspection date: 12 Mar 2025

Manufacturer: Mercedes-Benz  
VIN: W1K2052131G052166

Model: C 300 de T 9G-TRONIC

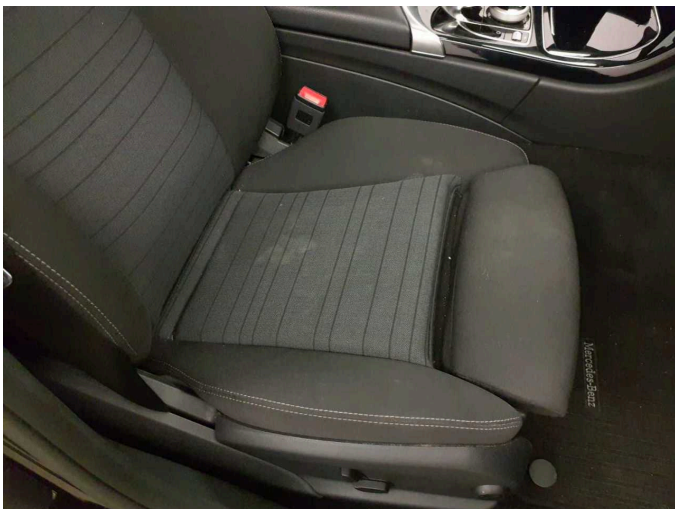
| No. | Component group | Description |
|---|---|---|
| 1 | Seat - front | Seat cover - left side - Soiled - Clean |

**Damage 1:** Seat - front: Seat cover - left side - Soiled - Clean

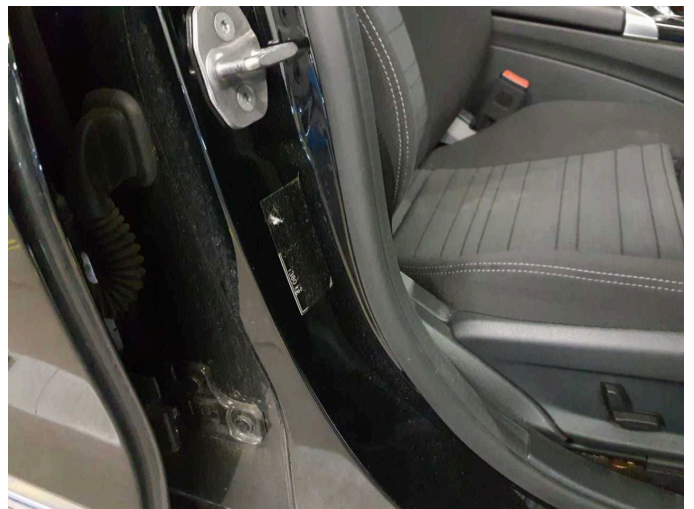
| No. | Component group | Description |
|---|---|---|
| 2 | Seat - front | Seat cover - right side - Soiled - Clean |

**Damage 2:** Seat - front: Seat cover - right side - Soiled - Clean

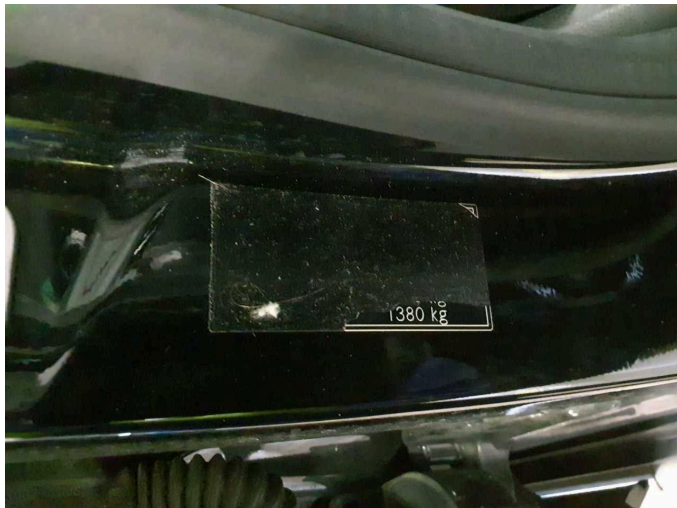
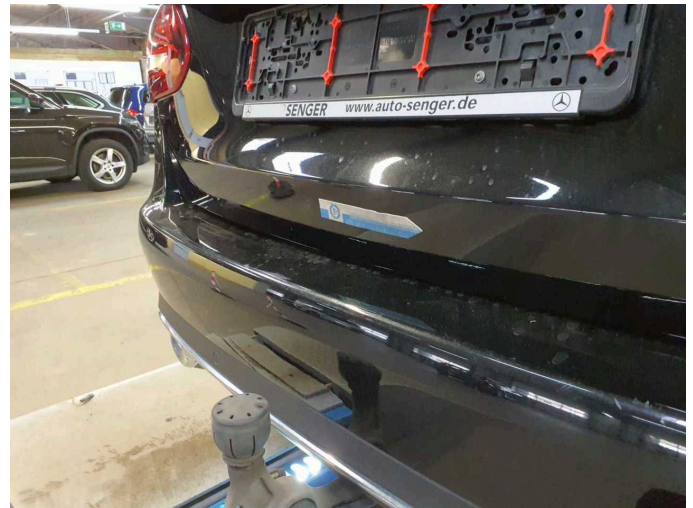
| No. | Component group | Description |
|---|---|---|
| 3 | Body | Identification plate - Missing - Replace |

**Damage 3:** Body: Identification plate - Missing - Replace

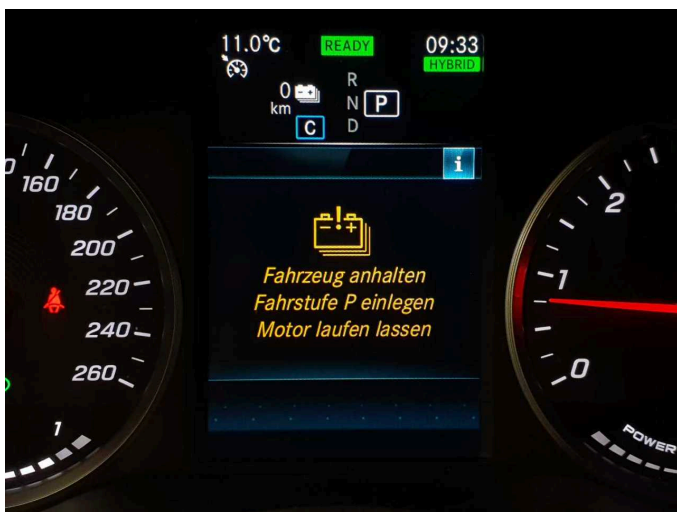
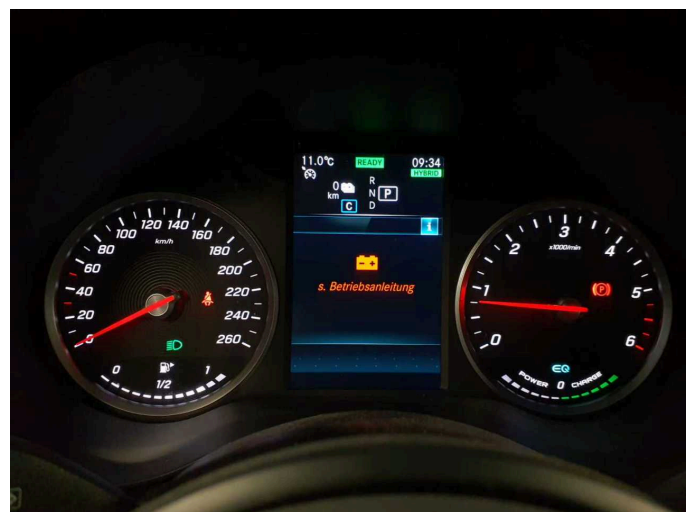
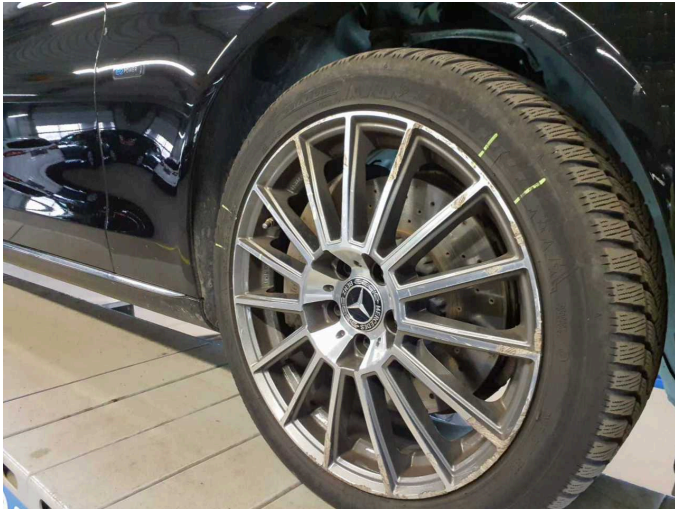
| No. | Component group | Description |
|---|---|---|
| 5 | Instrument panel | Indicator light (Batterie/Bordspannung vorhanden) - on - Perform diagnosis |

**Damage 5:** Instrument panel: Indicator light (Batterie/Bordspannung vorhanden) - on - Perform diagnosis

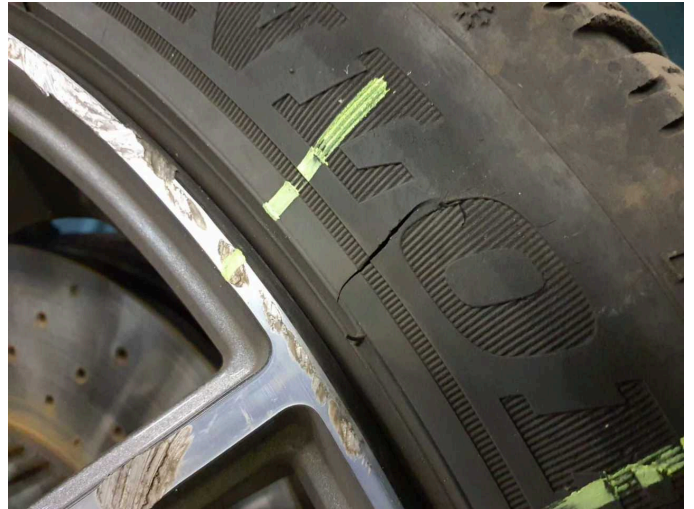
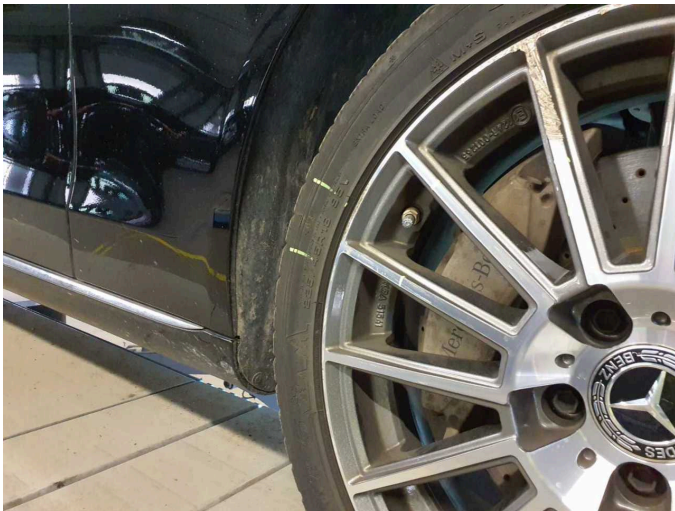
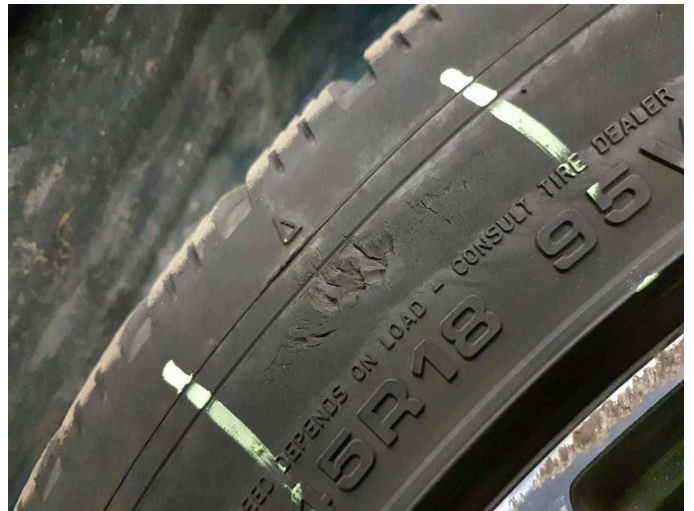
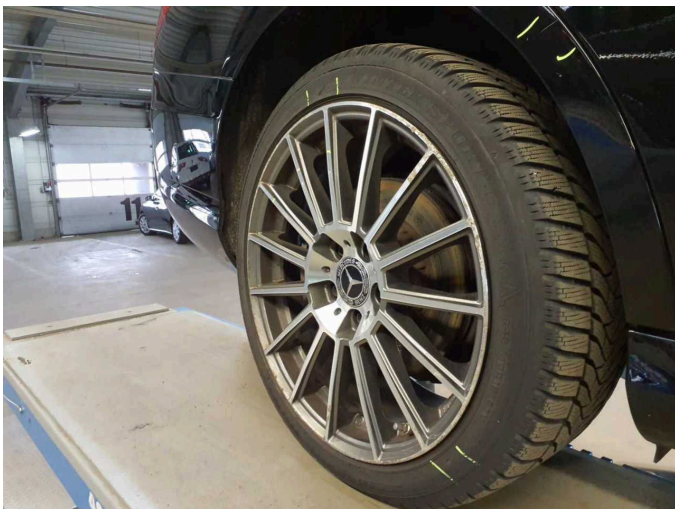
| No. | Component group | Description |
|---|---|---|
| 6 | Wheel / tyres | Tyre - front right side - Porous / cracked - Replace |

**Damage 6:** Wheel / tyres: Tyre - front right side - Porous / cracked - Replace

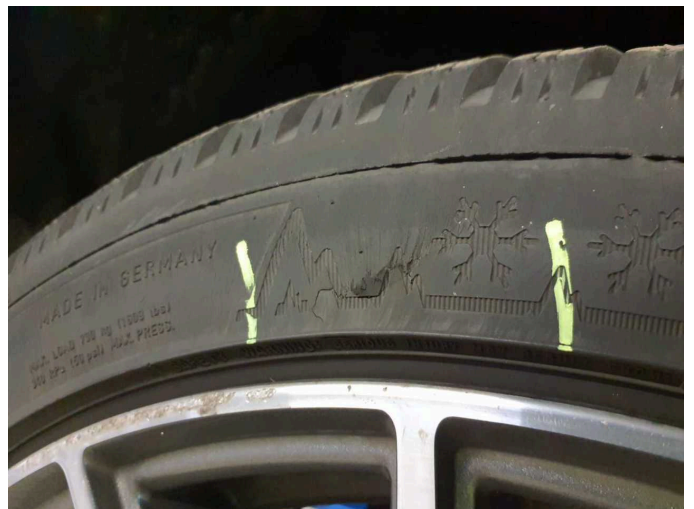
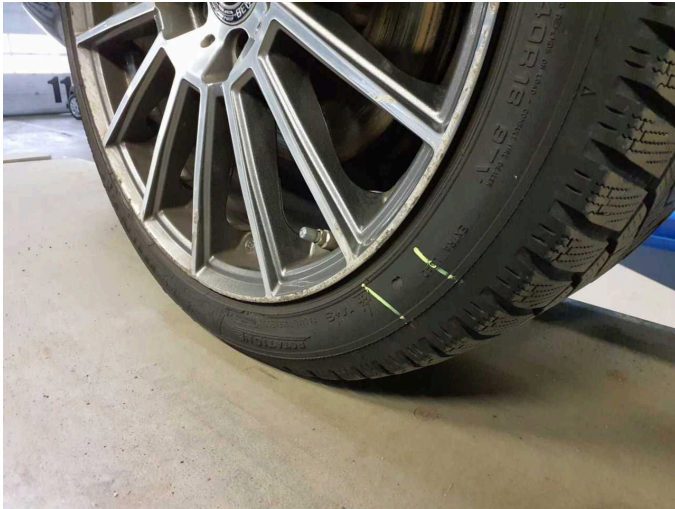
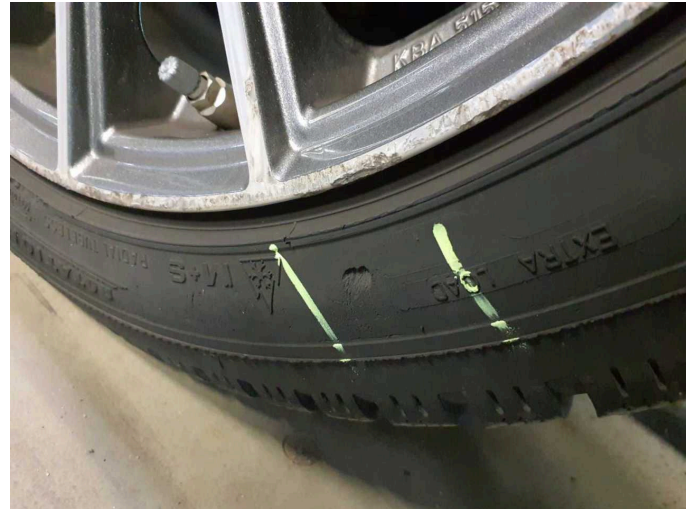
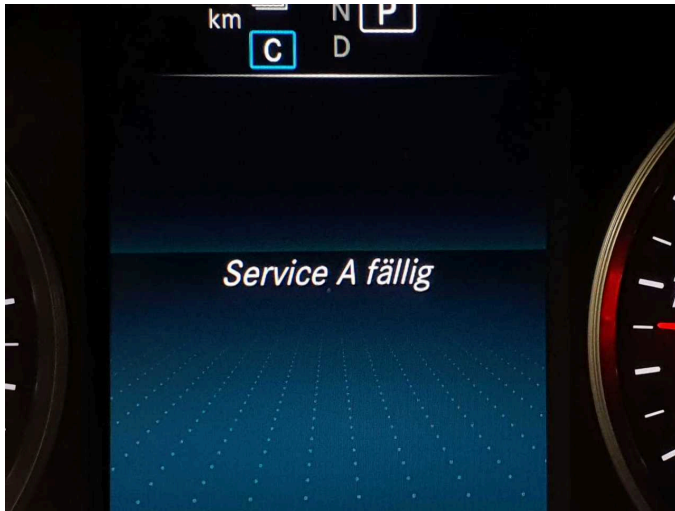
| No. | Component group | Description |
|---|---|---|
| 7 | Wheel / tyres | Tyre - rear right side - Porous / cracked - Replace |

**Damage 7:** Wheel / tyres: Tyre - rear right side - Porous / cracked - Replace

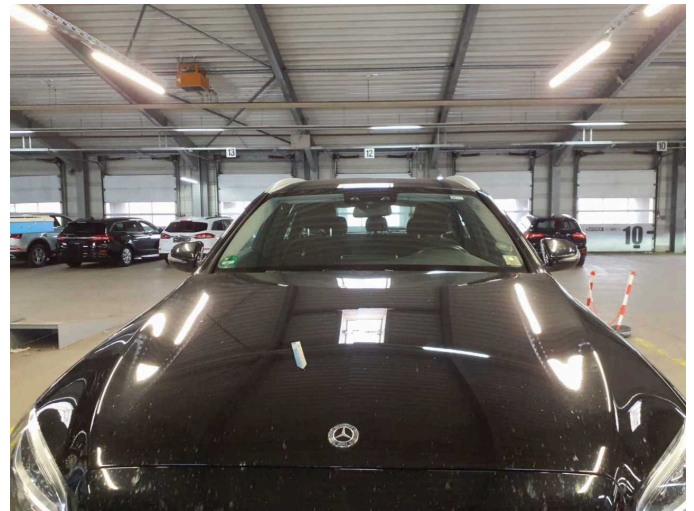
| No. | Component group | Description |
|---|---|---|
| 8 | Misc. | Inspection / maintenance - Due - Perform |

**Damage 8:** Misc.: Inspection / maintenance - Due - Perform

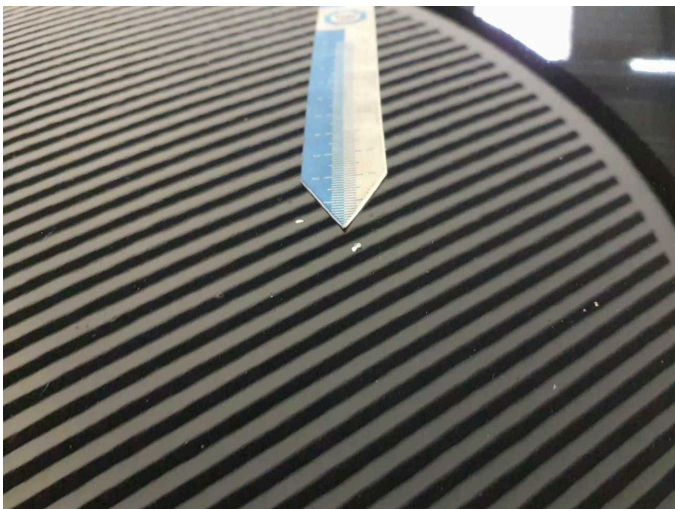
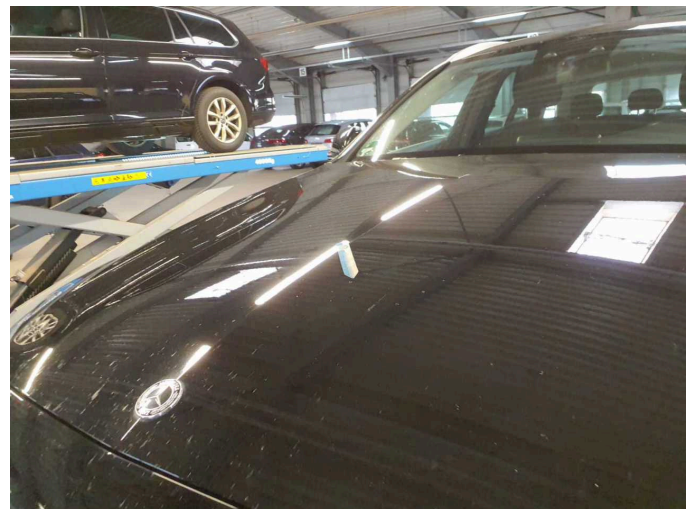
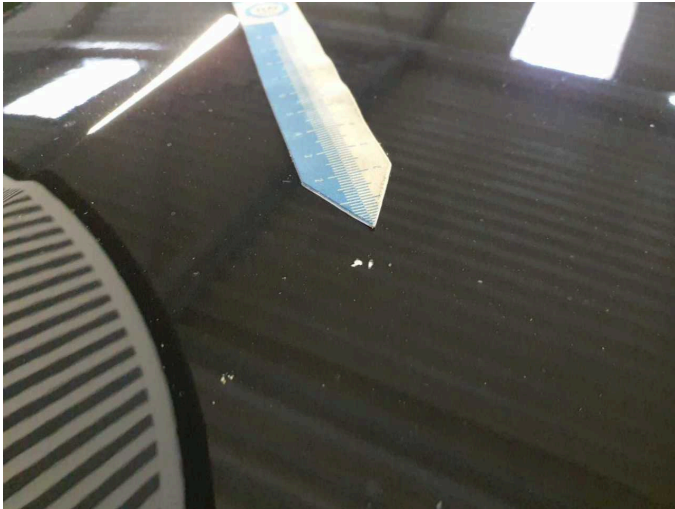
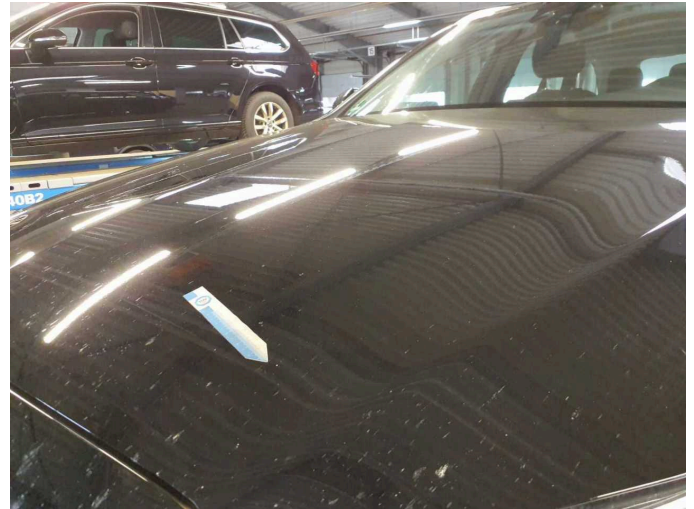
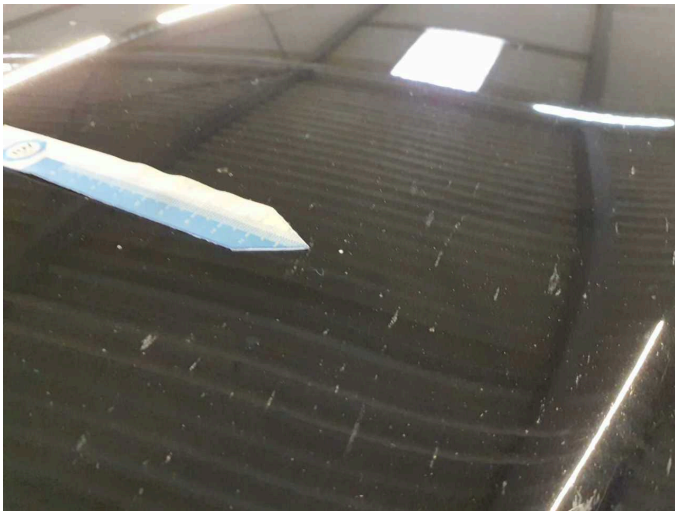
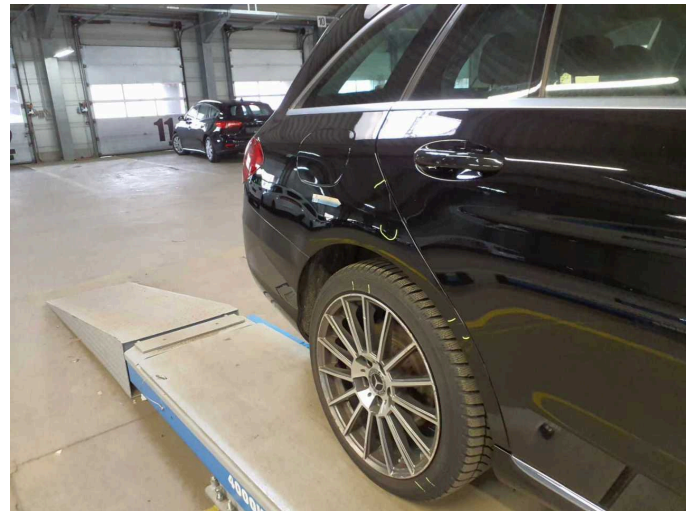
| No. | Component group | Description |
|---|---|---|
| 9 | Bonnet | Bonnet (Sandstrahleffekt) - Stone chips - Paint |

**Damage 9:** Bonnet: Bonnet (Sandstrahleffekt) - Stone chips - Paint

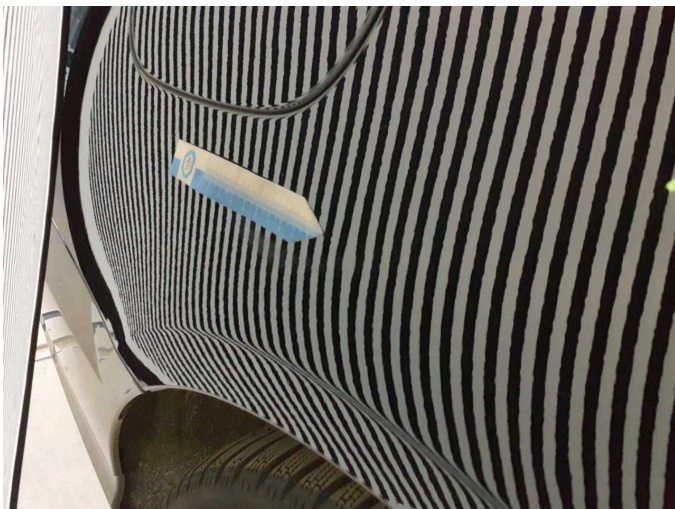
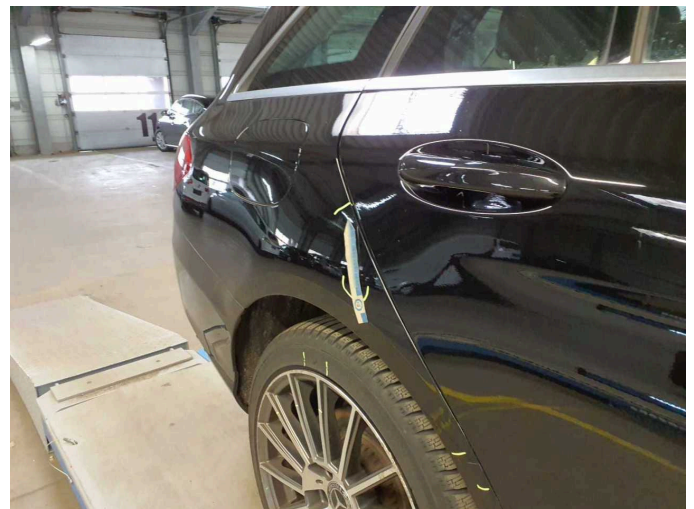
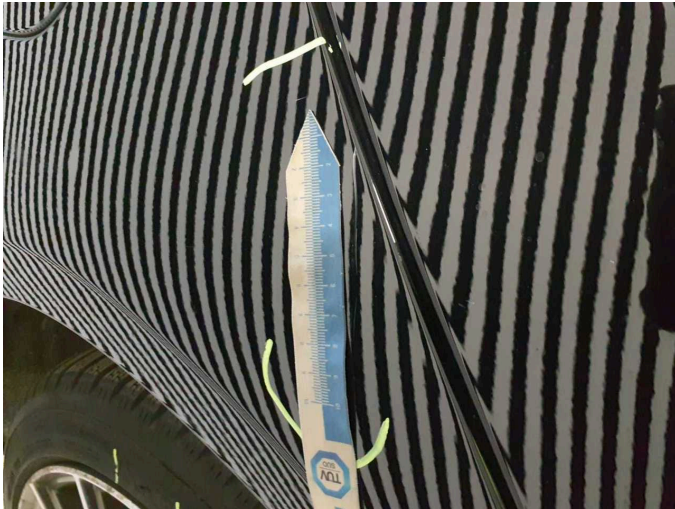
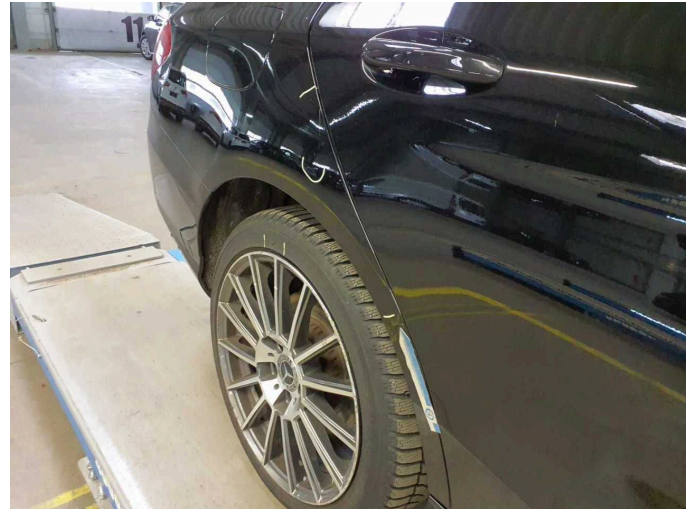
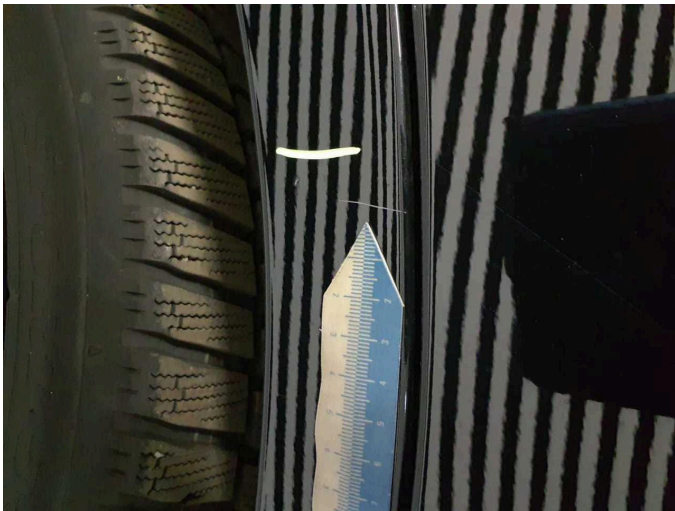
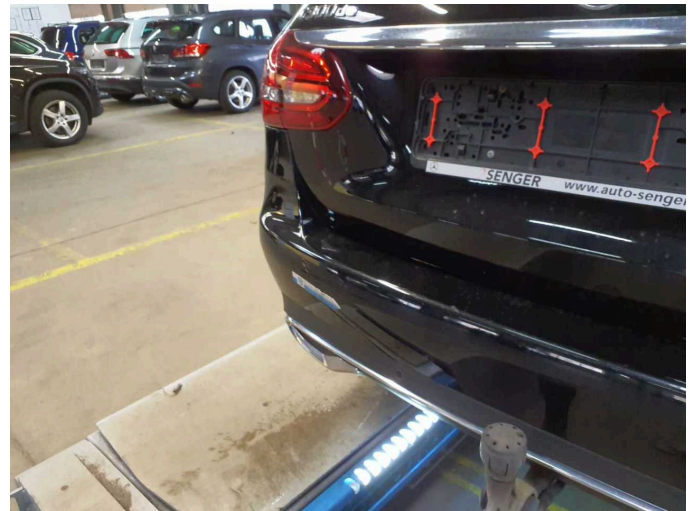
| No. | Component group | Description |
|---|---|---|
| 10 | Side panel - rear right side | Side panel (Kratzer) - dent(s) - Repair and paint |

**Damage 10:** Side panel - rear right side: Side panel (Kratzer) - dent(s) - Repair and paint

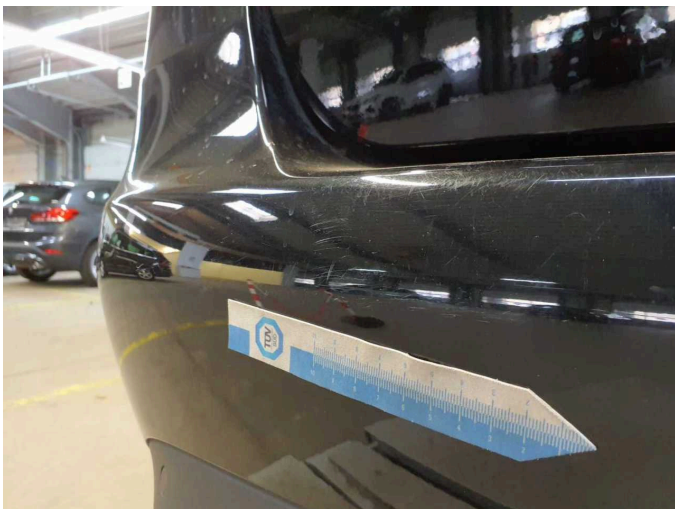
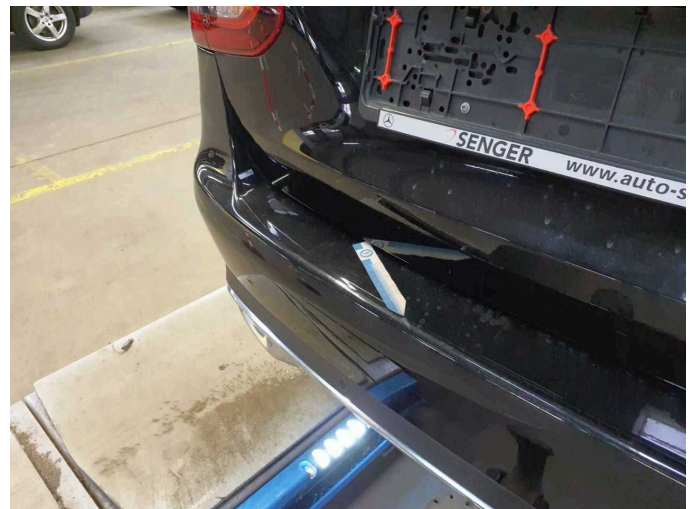
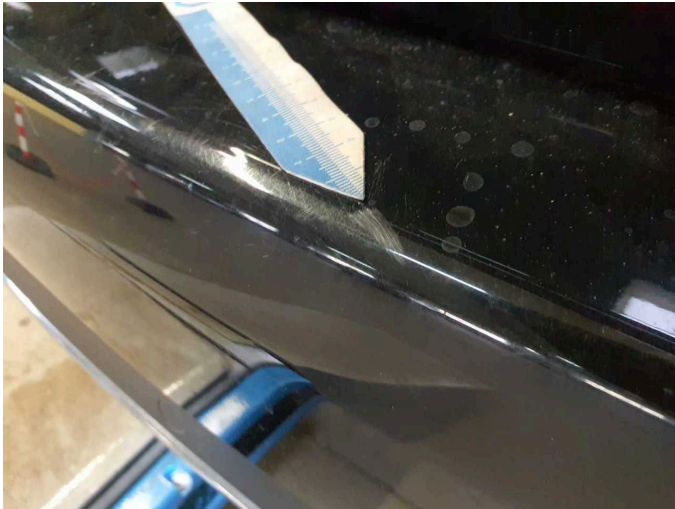
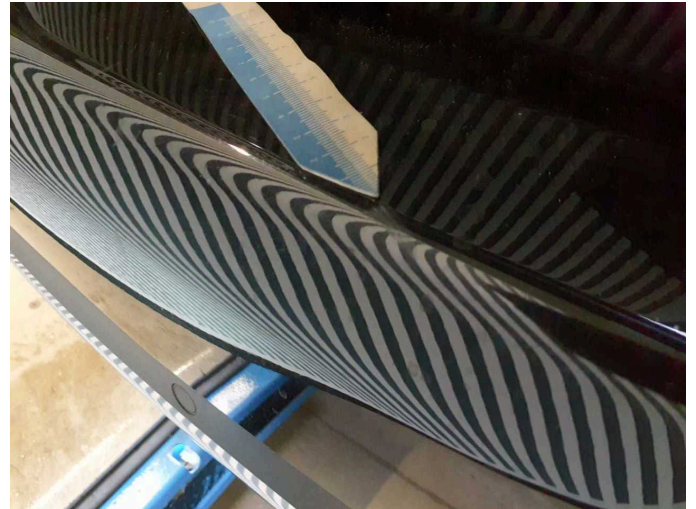
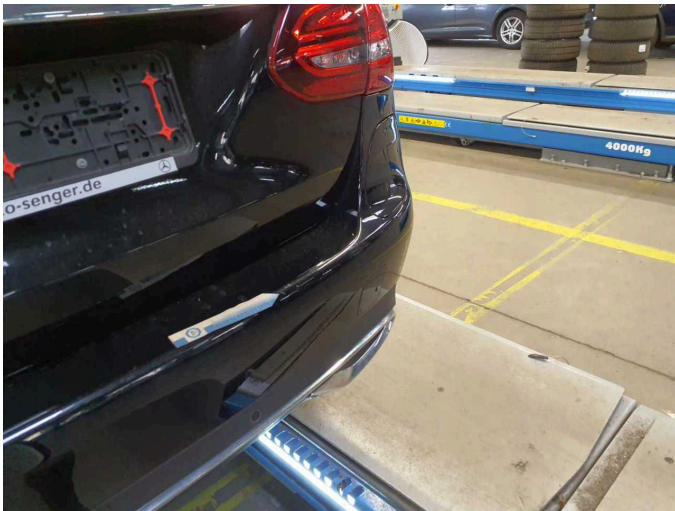
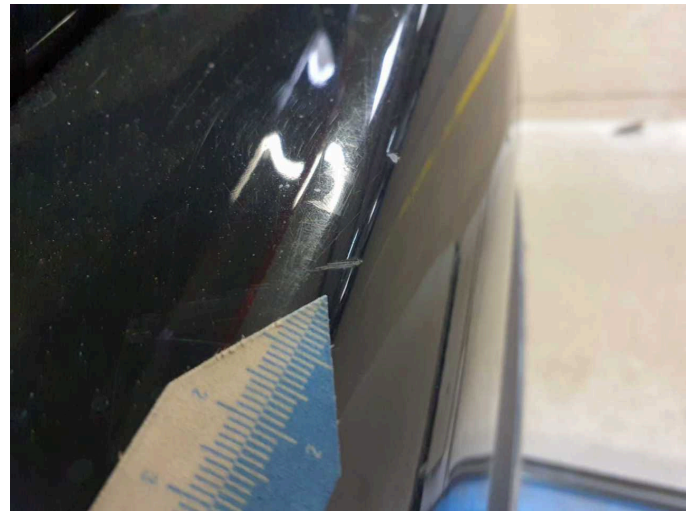
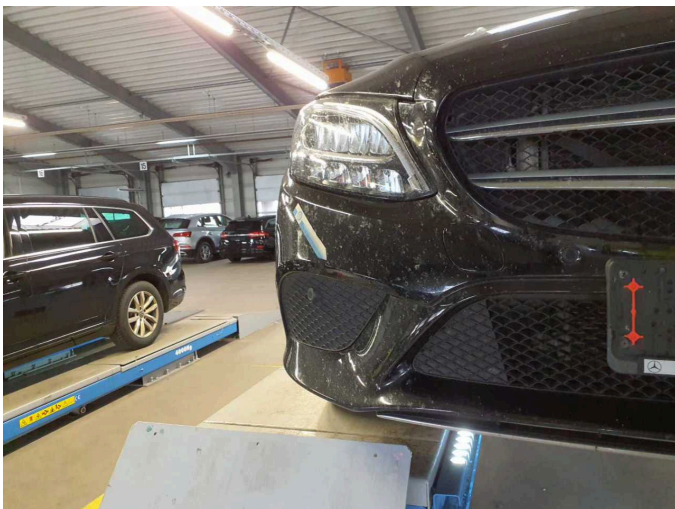
| No. | Component group | Description |
|---|---|---|
| 11 | Rear bumper | Rear bumper - Scratched - Paint |

**Damage 11:** Rear bumper: Rear bumper - Scratched - Paint

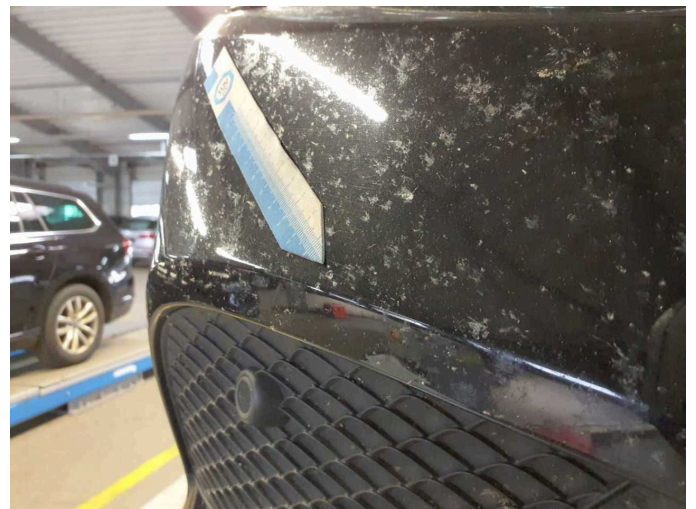
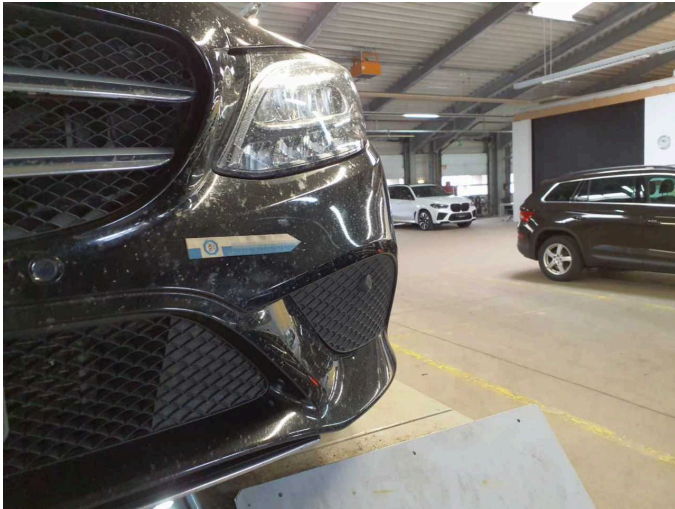
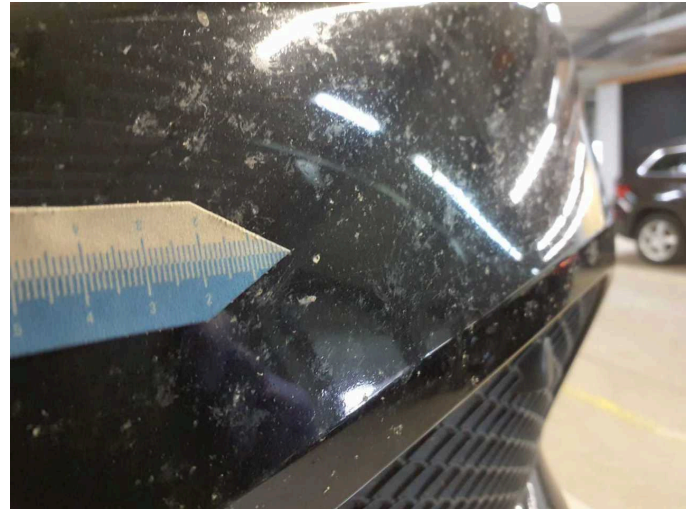
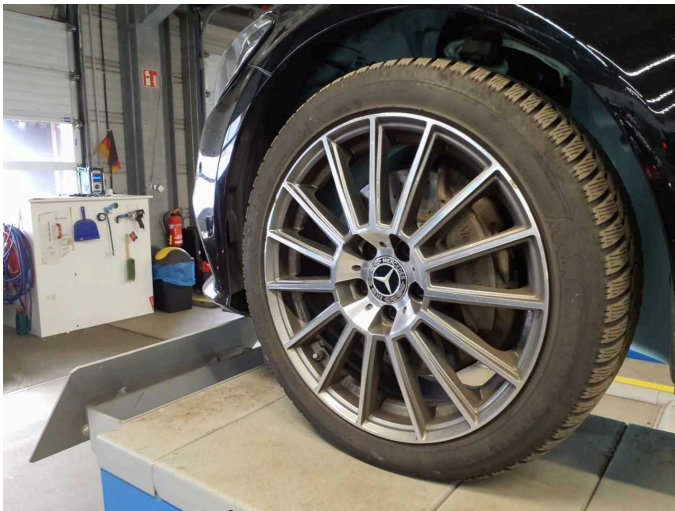
| No. | Component group | Description |
|---|---|---|
| 12 | Front bumper | Front bumper (Sandstrahleffekt) - Stone chips - Paint |

**Damage 12:** Front bumper: Front bumper (Sandstrahleffekt) - Stone chips - Paint

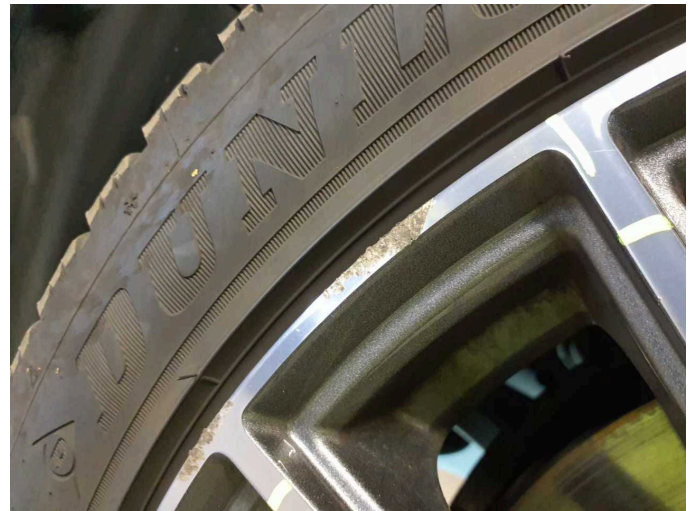
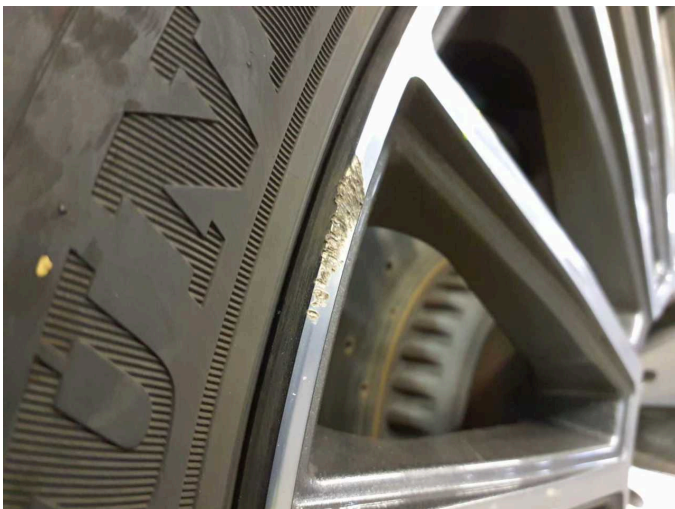
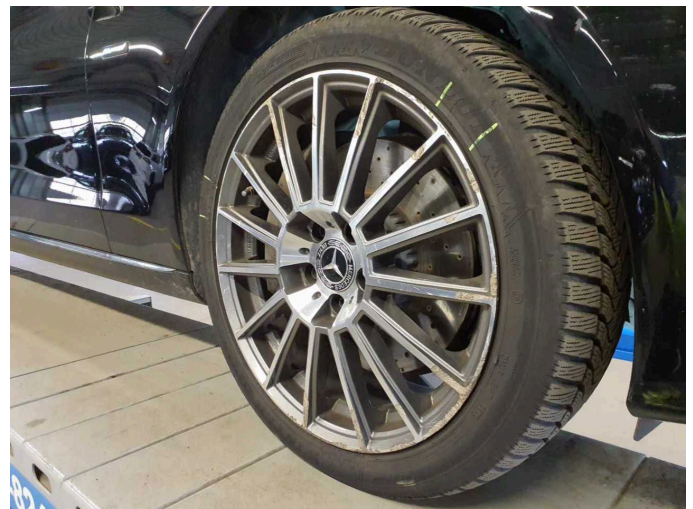
| No. | Component group | Description |
|---|---|---|
| 13 | Wheel / tyres | Alloy rim - front left side (Materialabtrag) - Damaged - Replace |

**Damage 13:** Wheel / tyres: Alloy rim - front left side (Materialabtrag) - Damaged - Replace

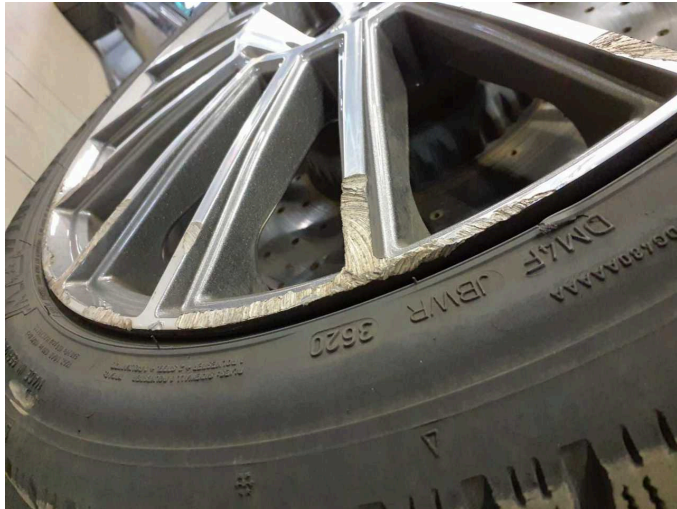
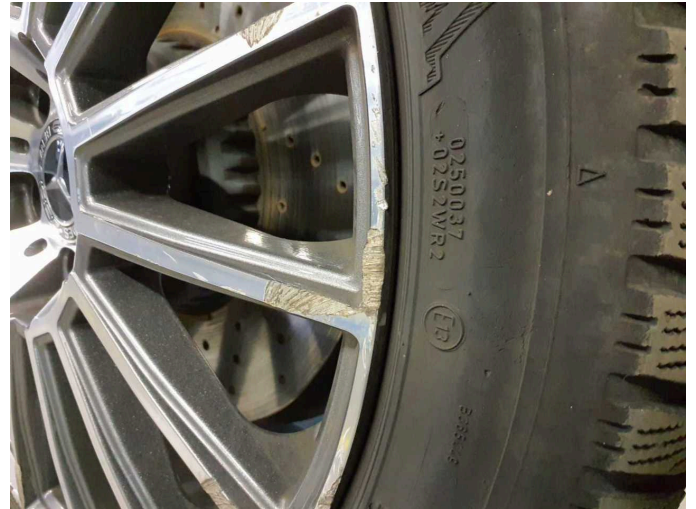
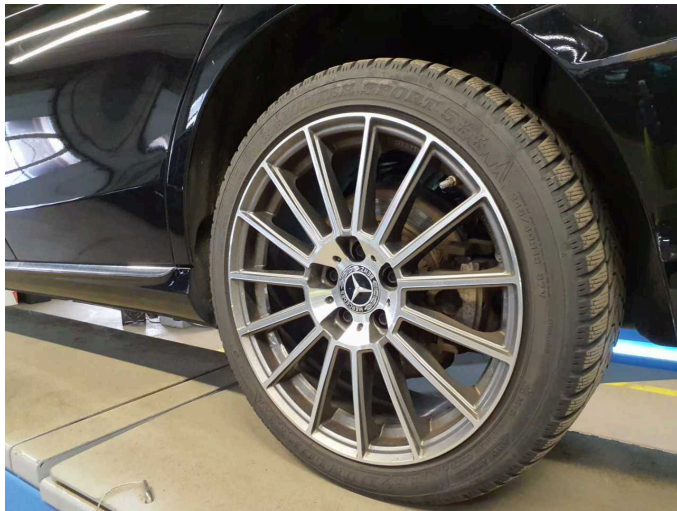
| No. | Component group | Description |
|---|---|---|
| 14 | Wheel / tyres | Alloy rim - front right side (Materialabtrag) - Damaged - Replace |

**Damage 14:** Wheel / tyres: Alloy rim - front right side (Materialabtrag) - Damaged - Replace

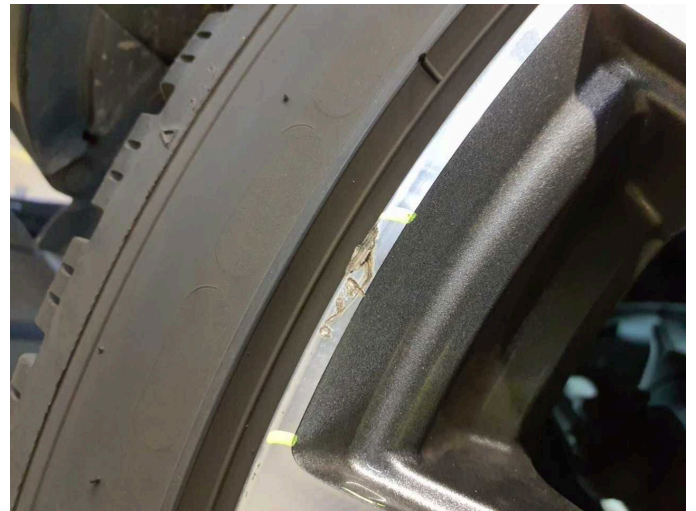
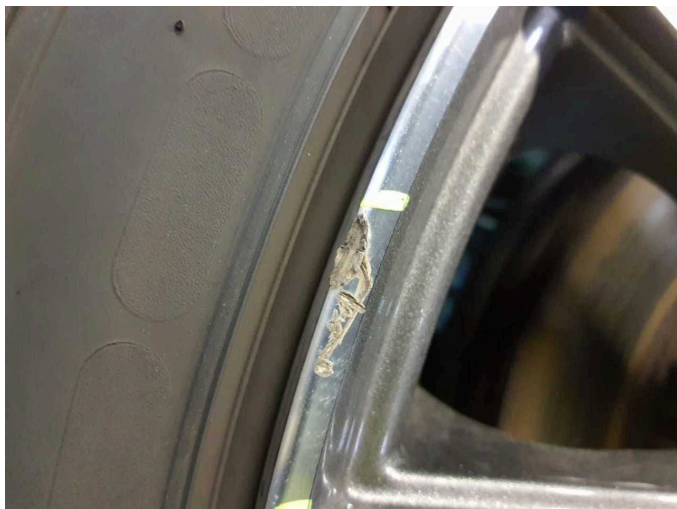
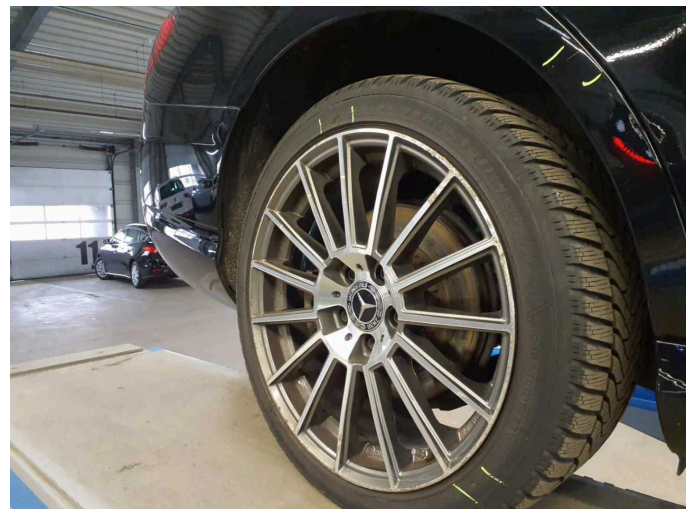
| No. | Component group | Description |
|---|---|---|
| 15 | Wheel / tyres | Alloy rim - rear left side (Materialabtrag) - Damaged - Replace |

**Damage 15:** Wheel / tyres: Alloy rim - rear left side (Materialabtrag) - Damaged - Replace

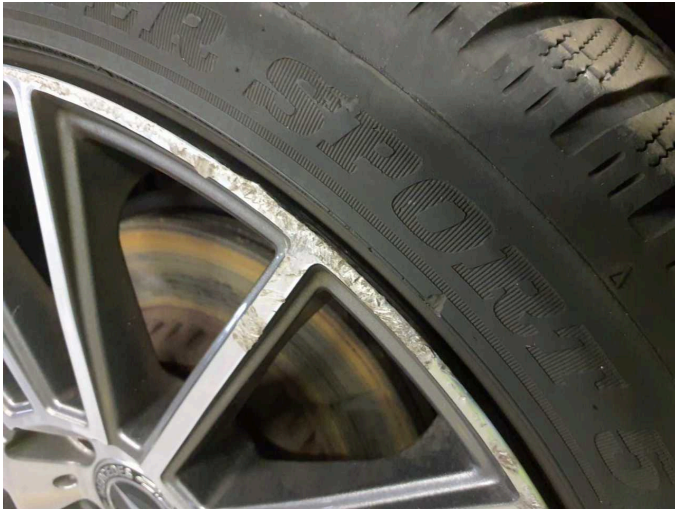
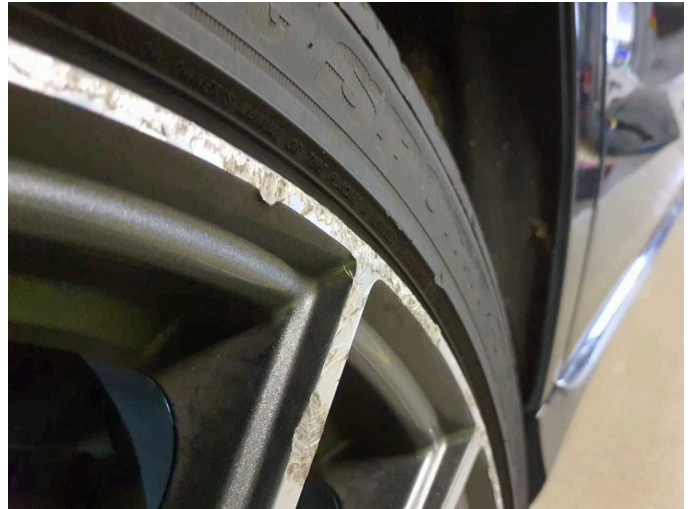
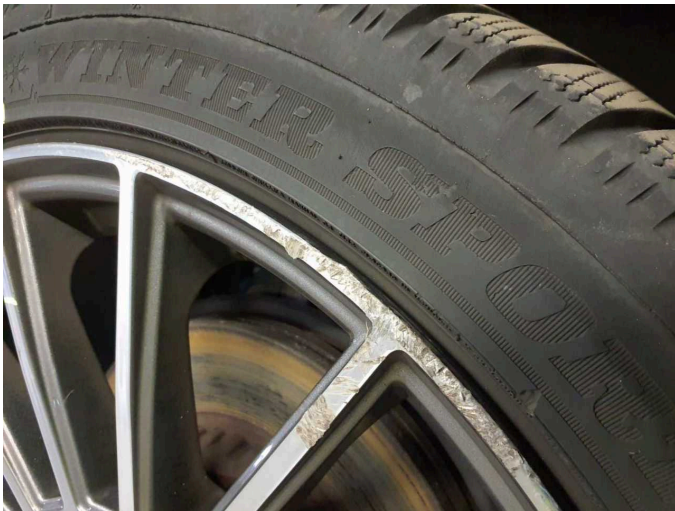
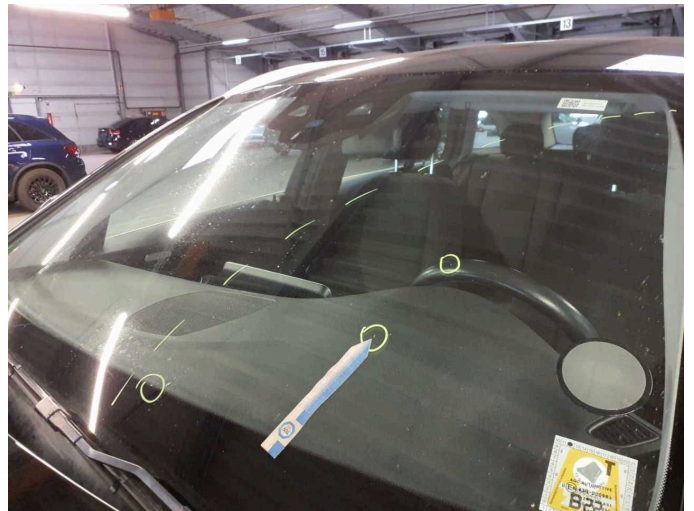
| No. | Component group | Description |
|---|---|---|
| 16 | Wheel / tyres | Alloy rim - rear right side (Materialabtrag) - Damaged - Replace |

**Damage 16:** Wheel / tyres: Alloy rim - rear right side (Materialabtrag) - Damaged - Replace

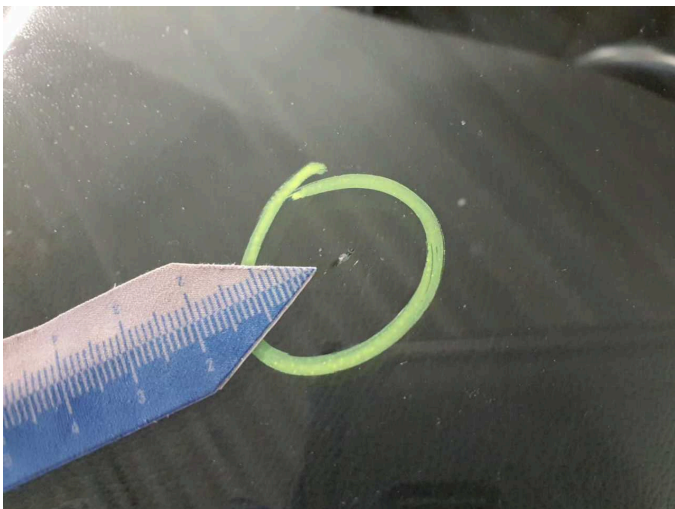
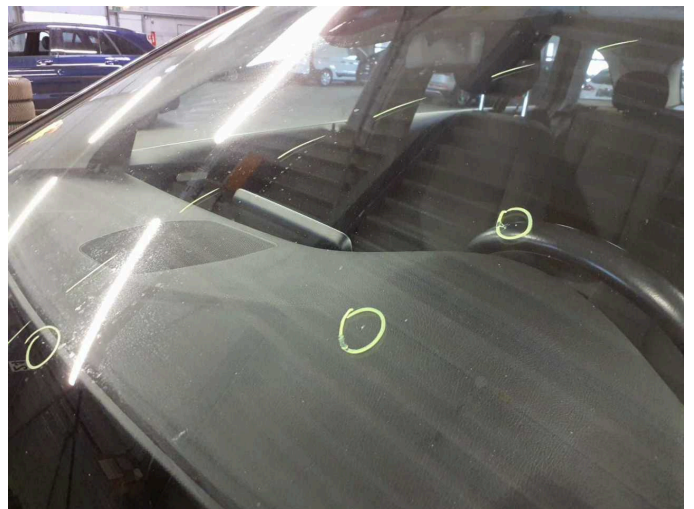
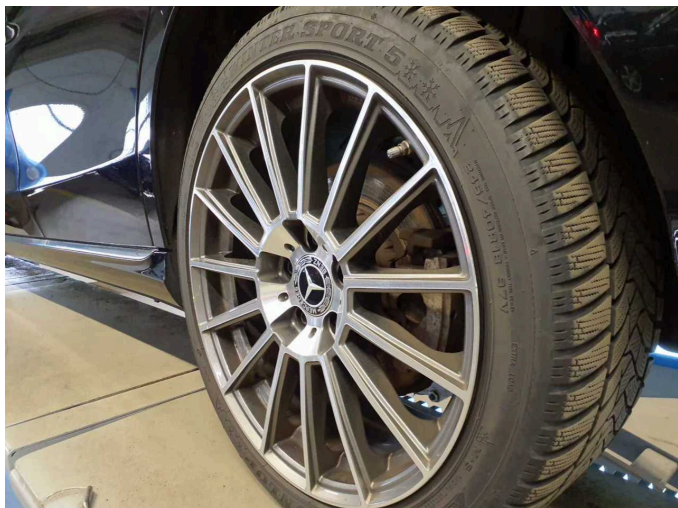
| No. | Component group | Description |
|---|---|---|
| 17 | Vehicle glazing | Windscreen (Rissbildung) - Stone chips - Replace |

**Damage 17:** Vehicle glazing: Windscreen (Rissbildung) - Stone chips - Replace
