Expertise

Protocol number: 41552822  
Order No. / Reference: 25232583  
Inspection date: 15 Sept 2025

Manufacturer: Mercedes-Benz  
VIN: W1K2054141G101013

Model: C 220 d Cabrio 9G-TRONIC AMG Line

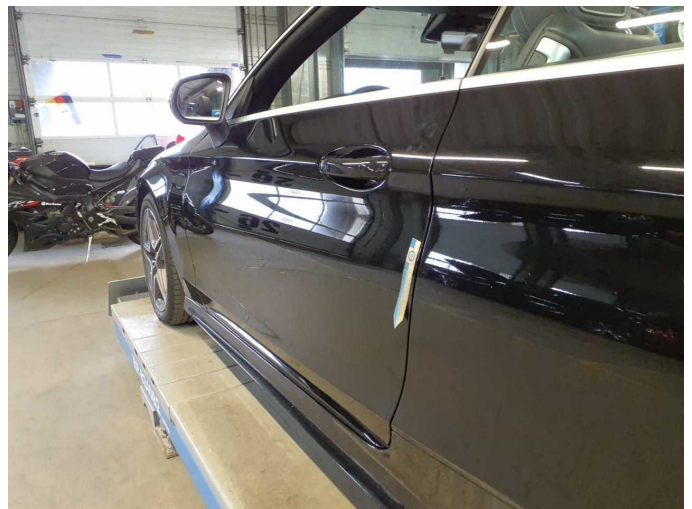
| No. | Component group | Description |
|---|---|---|
| 1 | Door - front left side | Door edge - Scratched - Smart repair |

Damage 1: Door - front left side: Door edge - Scratched - Smart repair

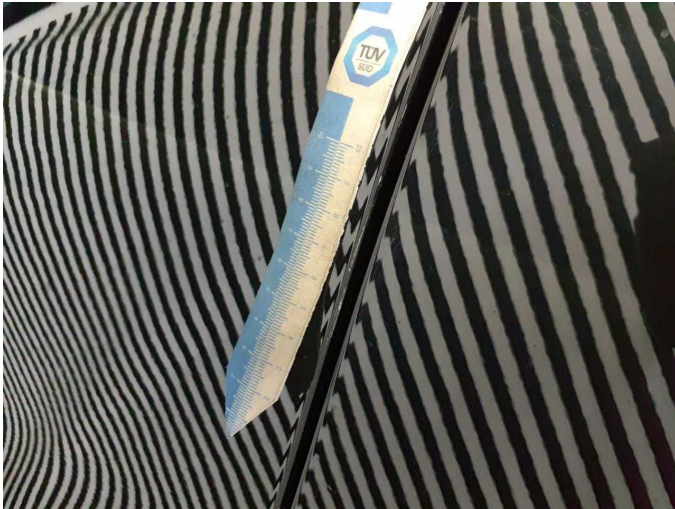
**Damage 1:** Door - front left side: Door edge - Scratched - Smart repair

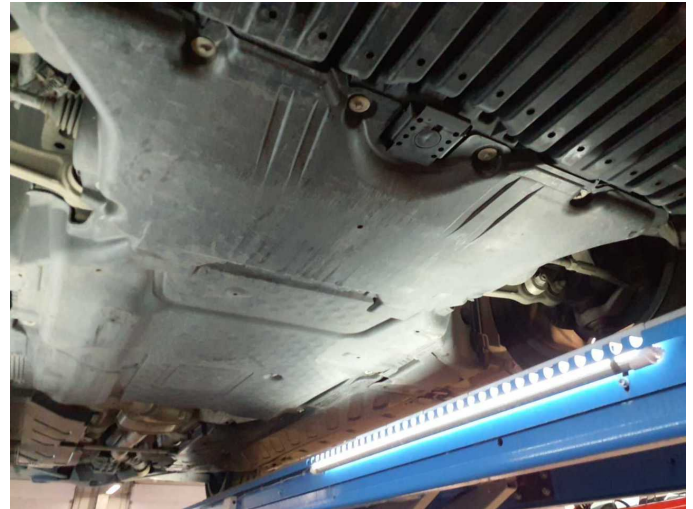
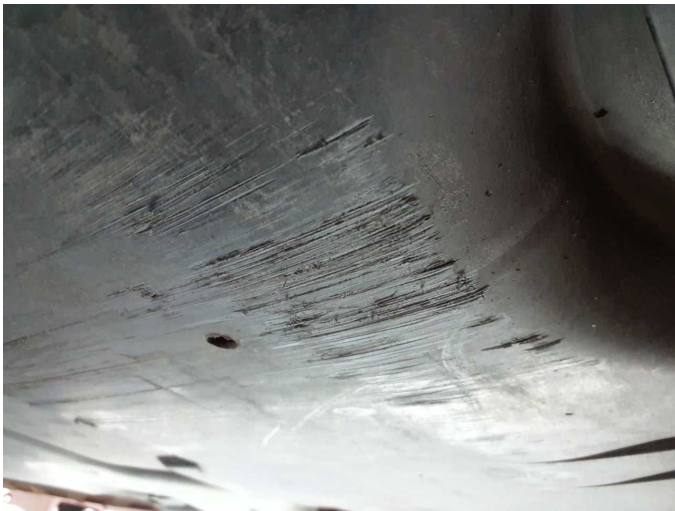
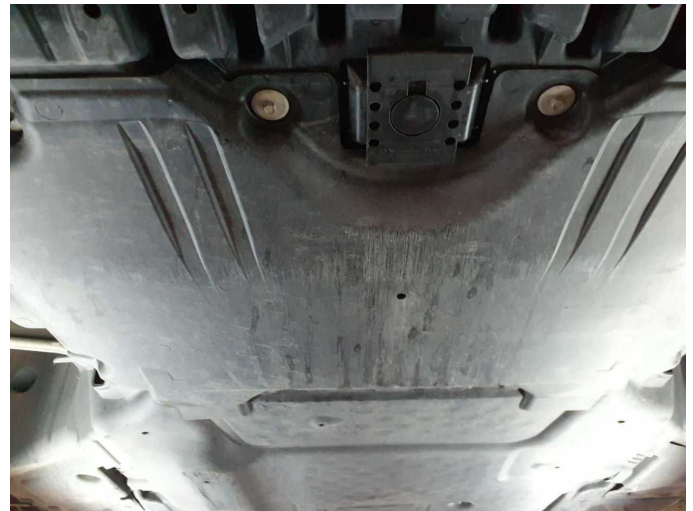
| No. | Component group | Description |
|---|---|---|
| 2 | Body | Underbody panelling - Scratched - Replace |

**Damage 2:** Body: Underbody panelling - Scratched - Replace

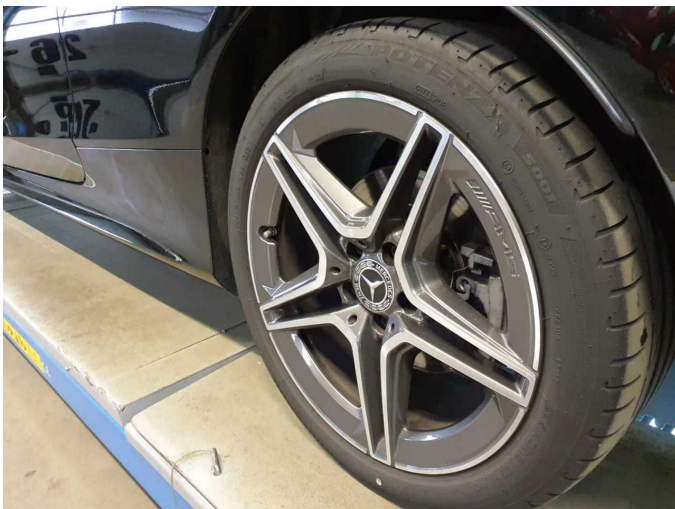
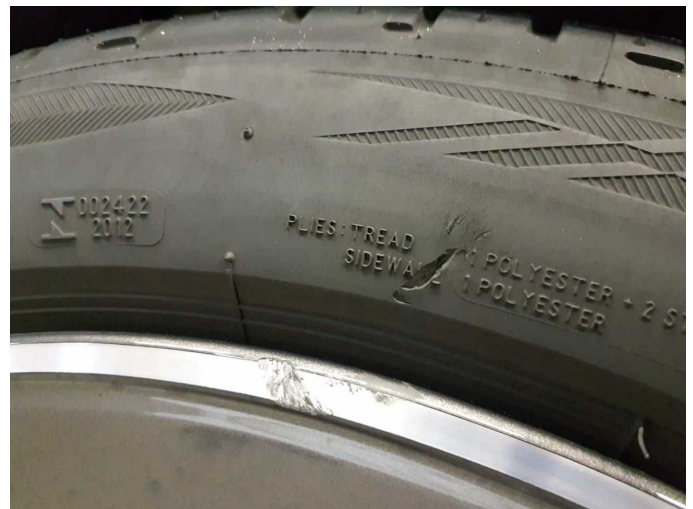
| No. | Component group | Description |
|---|---|---|
| 3 | Wheel / tyres | Tyre - rear left side (nicht fahrbereit) - Porous / cracked - Replace |

**Damage 3:** Wheel / tyres: Tyre - rear left side (nicht fahrbereit) - Porous / cracked - Replace

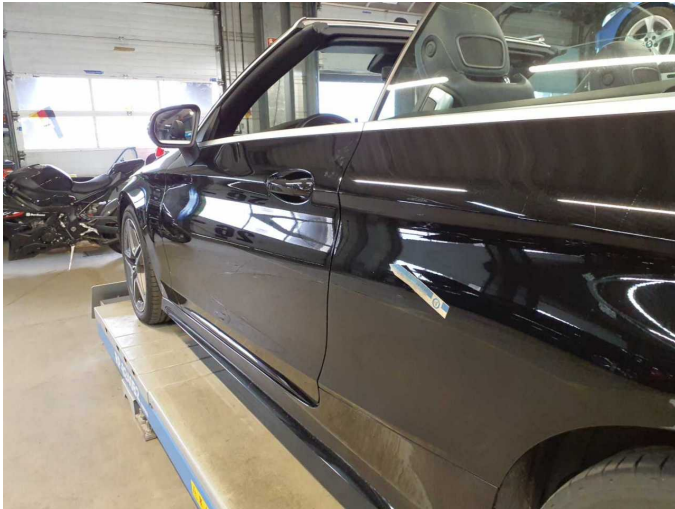
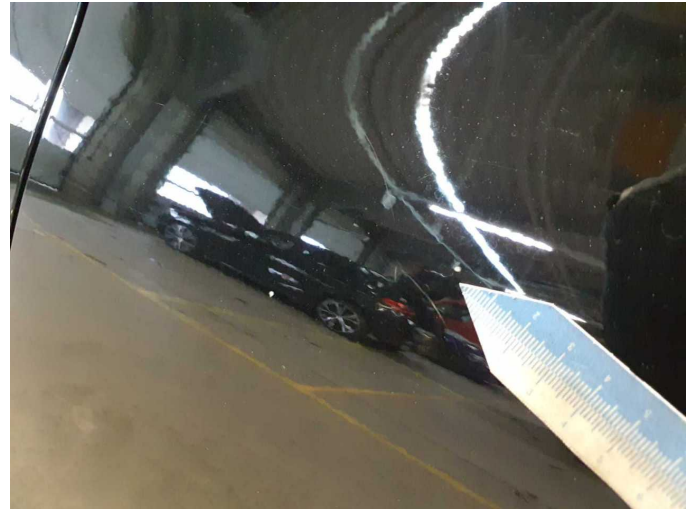
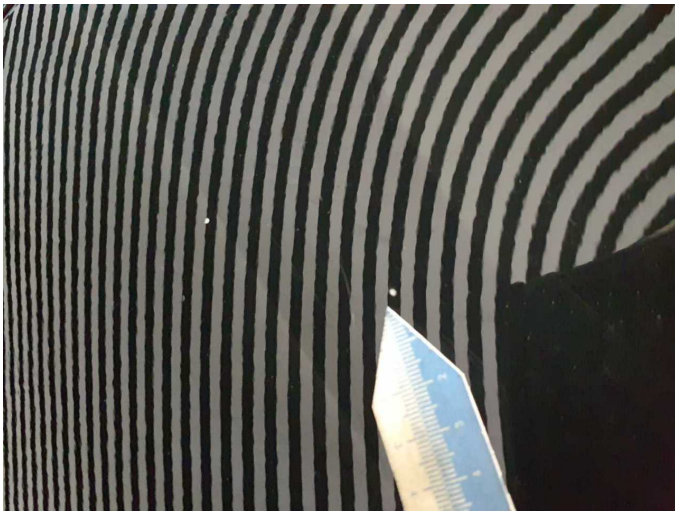
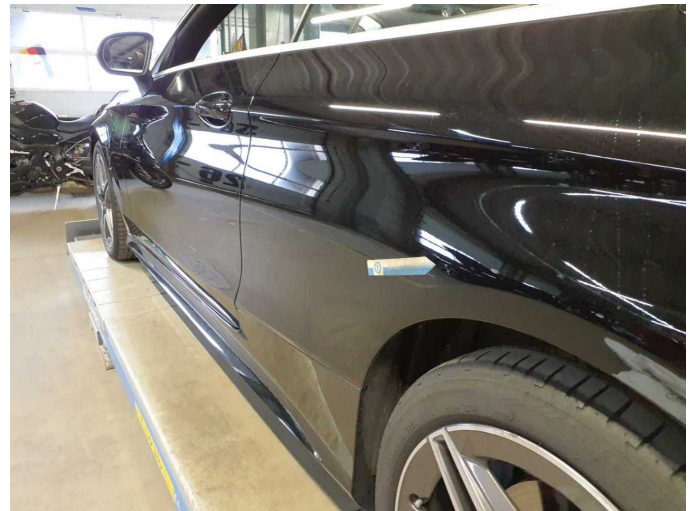
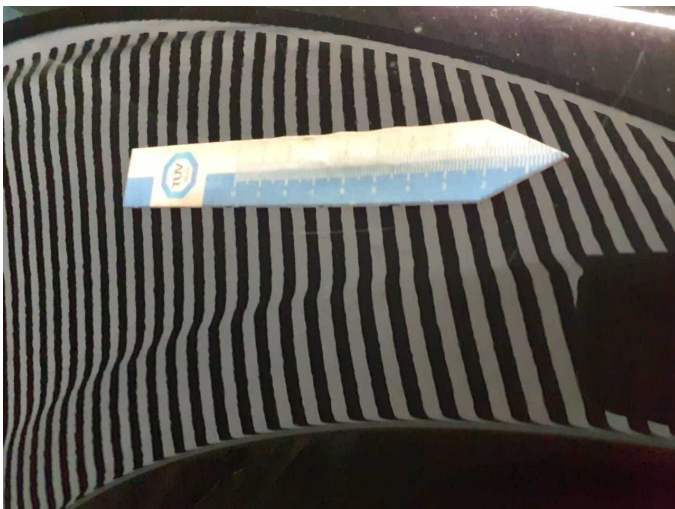
| No. | Component group | Description |
|---|---|---|
| 4 | Side panel - rear left side | Side panel (Kratzer) - Stone chips - Smart repair |

**Damage 4:** Side panel - rear left side: Side panel (Kratzer) - Stone chips - Smart repair

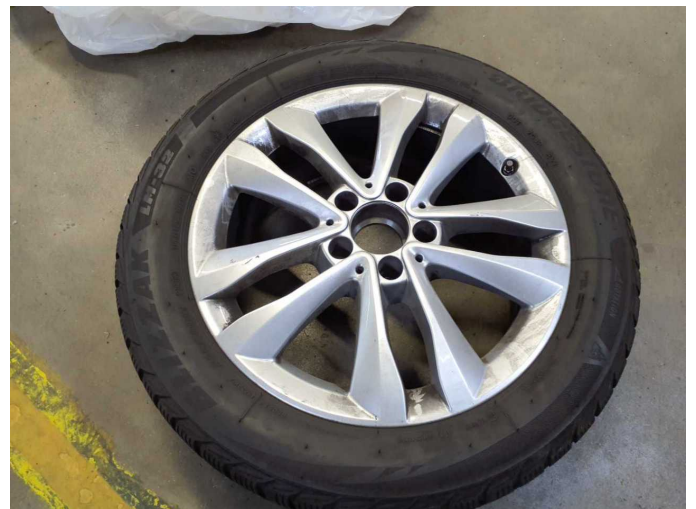
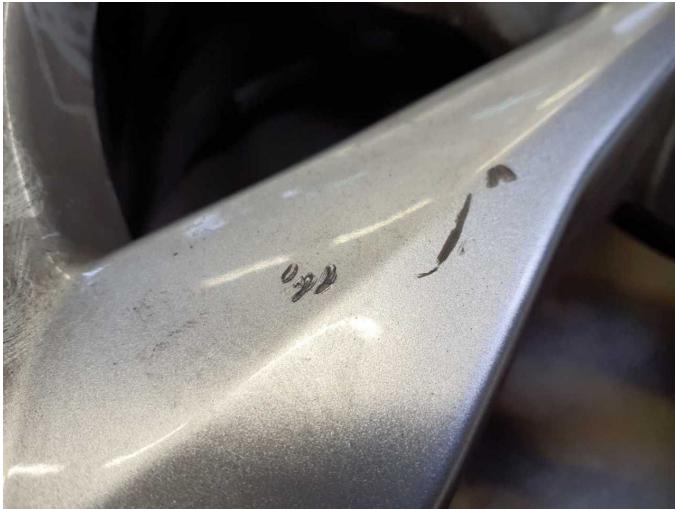
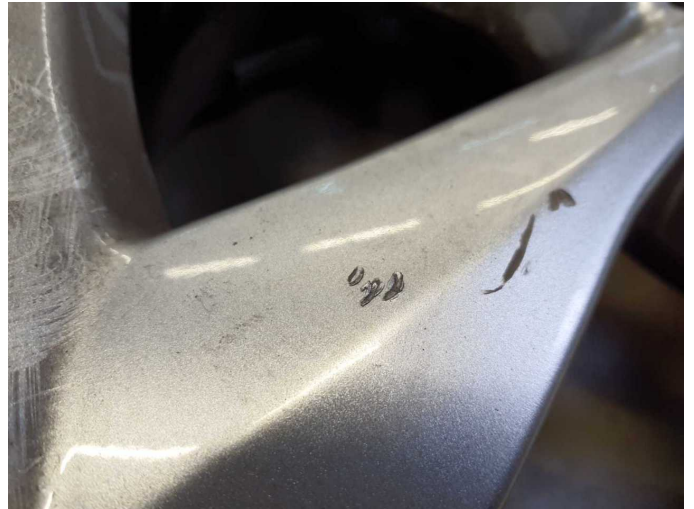
| No. | Component group | Description |
|---|---|---|
| 5 | 2nd wheel set | 1 alloy rim (Materialabtrag) - Damaged - Loss in value |

**Damage 5:** 2nd wheel set: 1 alloy rim (Materialabtrag) - Damaged - Loss in value

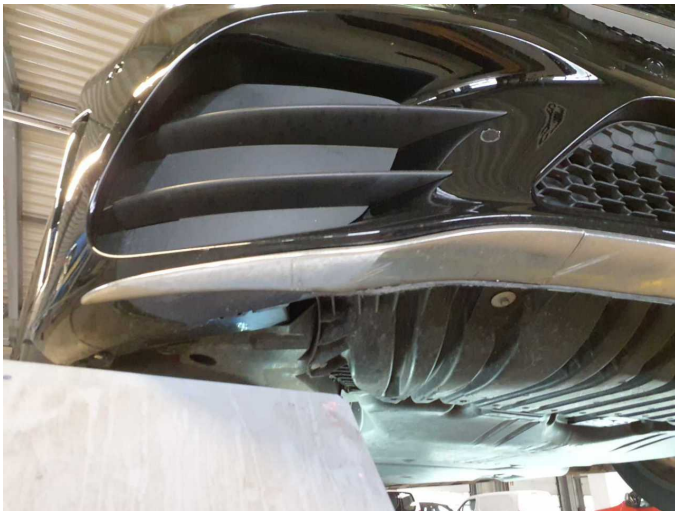
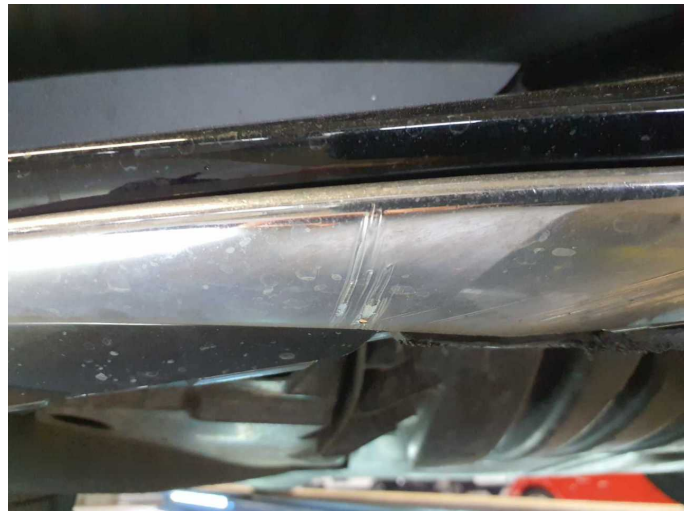
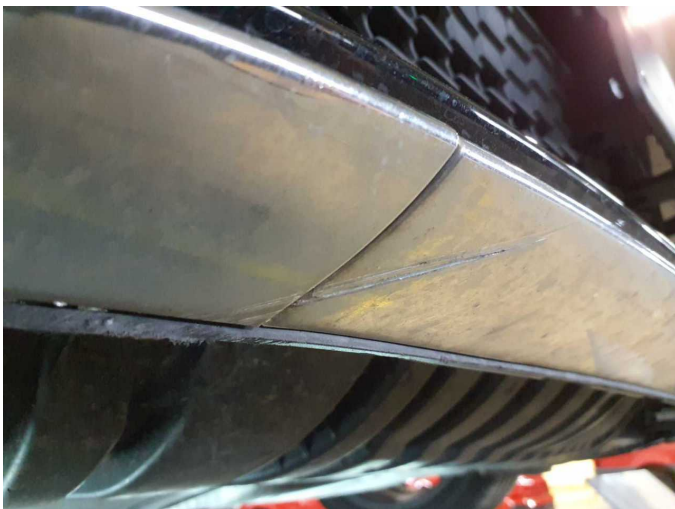
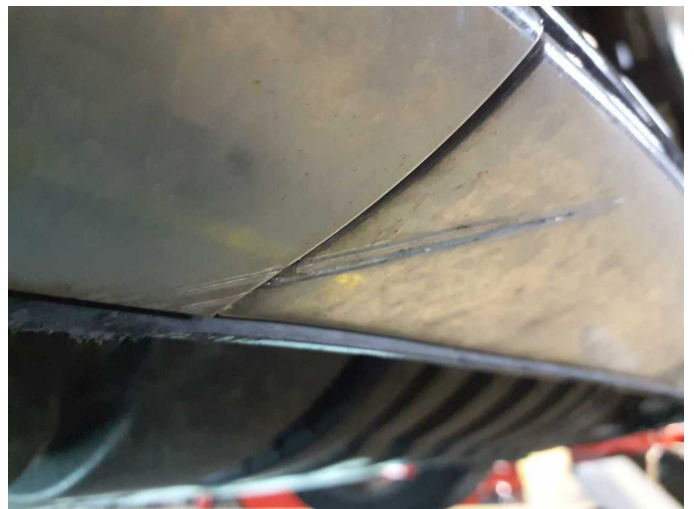
| No. | Component group | Description |
|---|---|---|
| 6 | Front bumper | Spoiler (ZIERL M STOSSF V) - Scratched - Replace |

**Damage 6:** Front bumper: Spoiler (ZIERL M STOSSF V) - Scratched - Replace

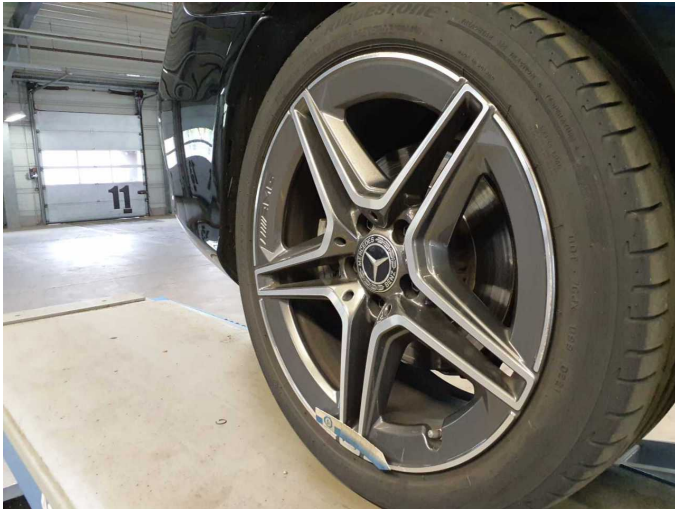
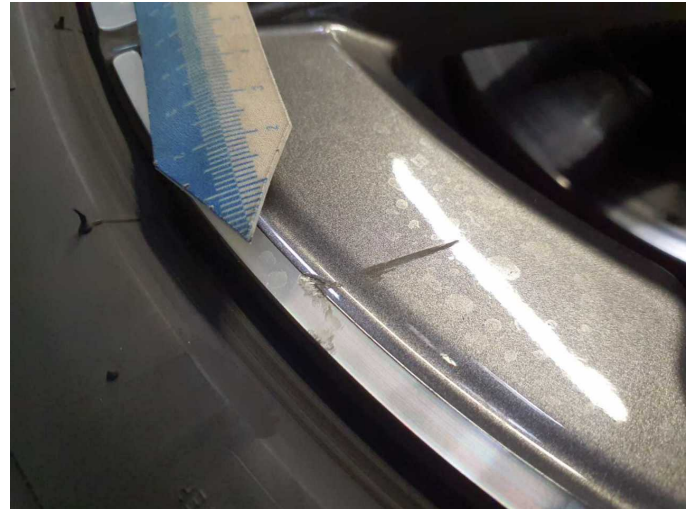
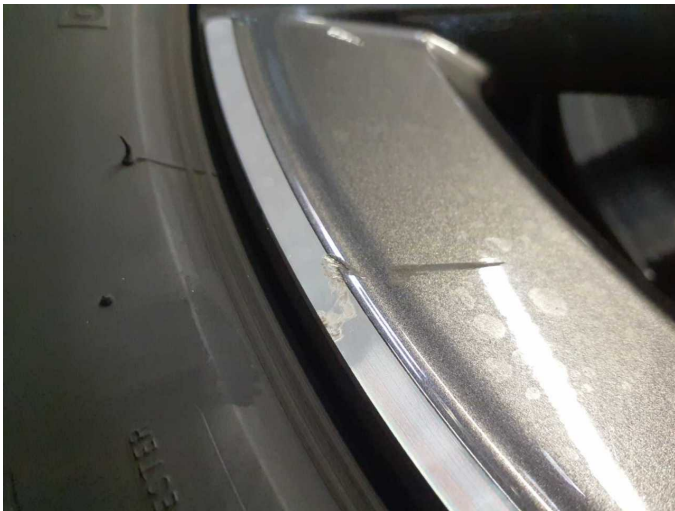
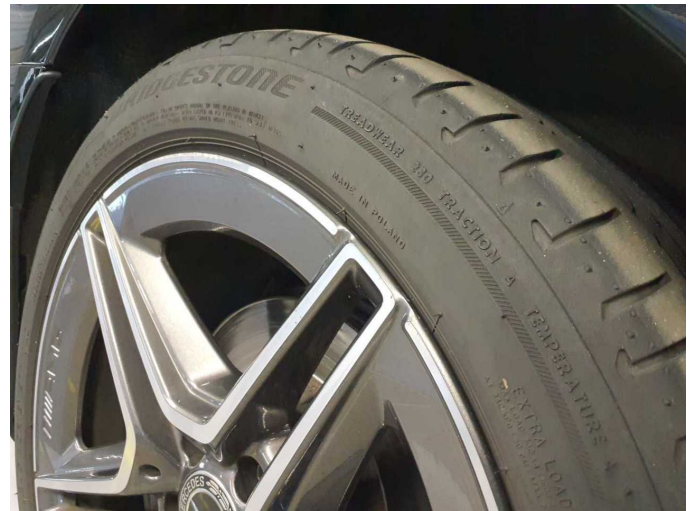
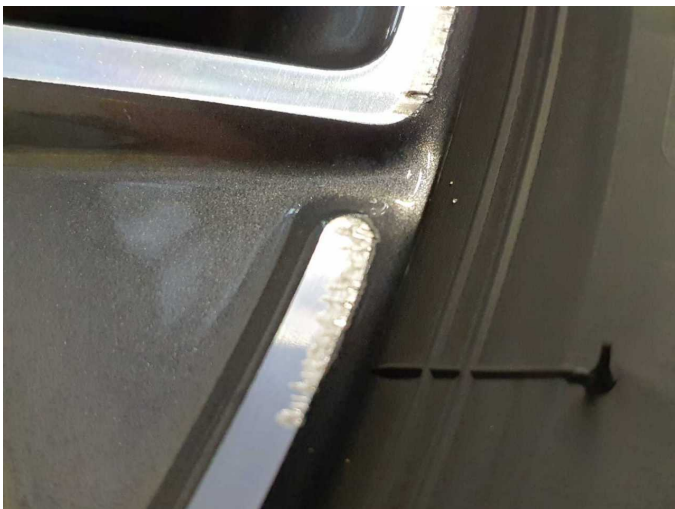
| No. | Component group | Description |
|---|---|---|
| 7 | Wheel / tyres | Alloy rim - rear right side (Materialabtrag) - Damaged - Loss in value |

**Damage 7:** Wheel / tyres: Alloy rim - rear right side (Materialabtrag) - Damaged - Loss in value

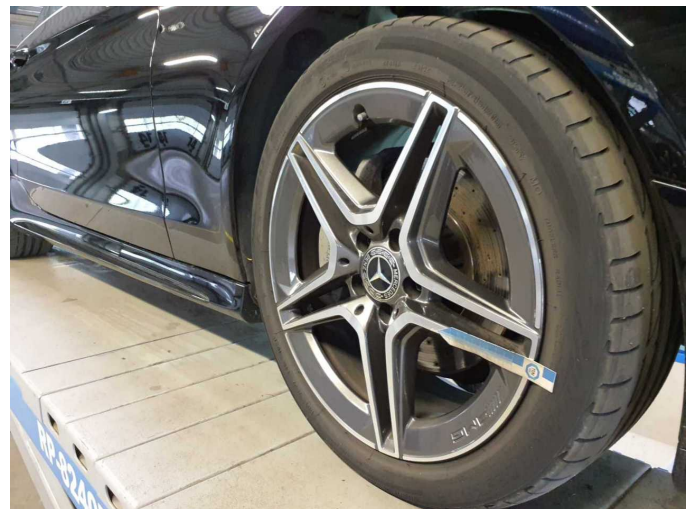
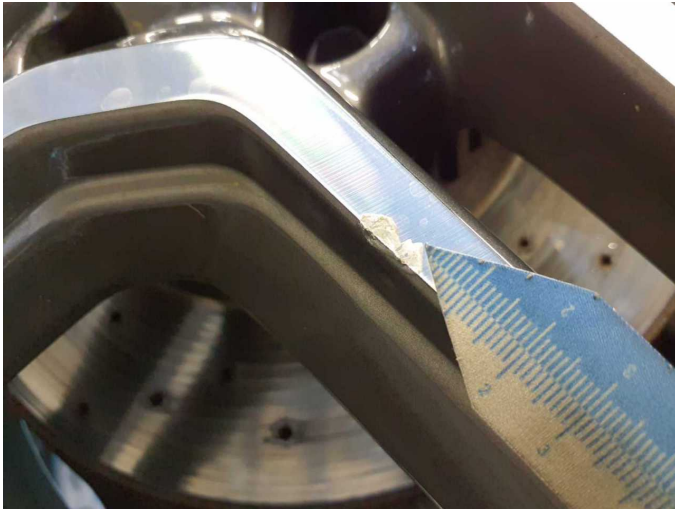
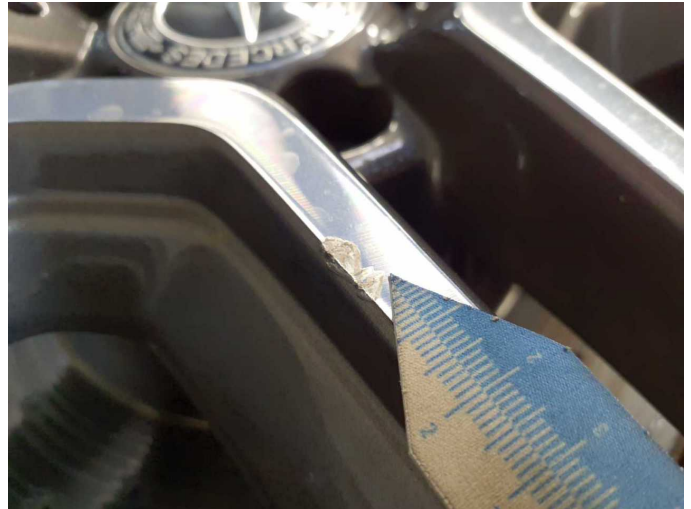
| No. | Component group | Description |
|---|---|---|
| 8 | Wheel / tyres | Alloy rim - front right side (Materialabtrag) - Damaged - Loss in value |

**Damage 8:** Wheel / tyres: Alloy rim - front right side (Materialabtrag) - Damaged - Loss in value

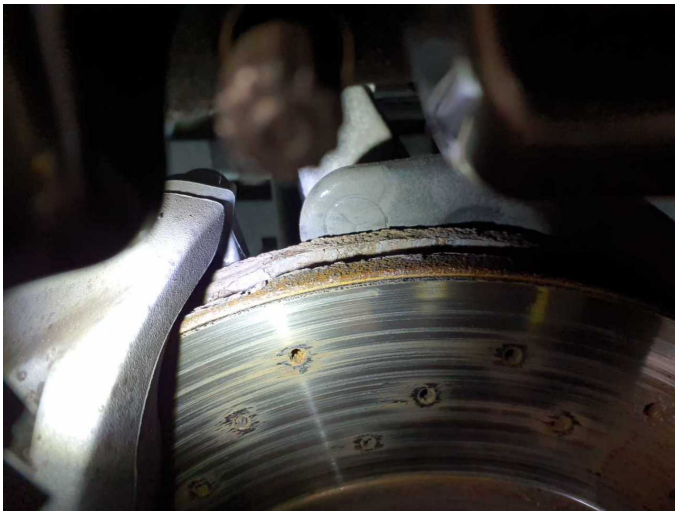
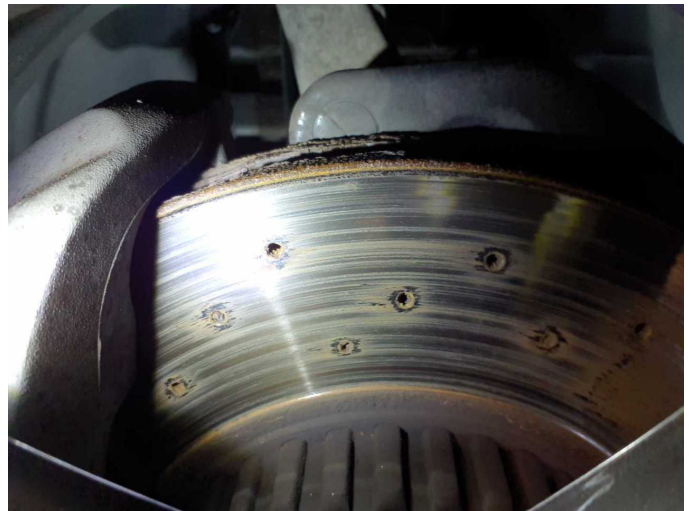
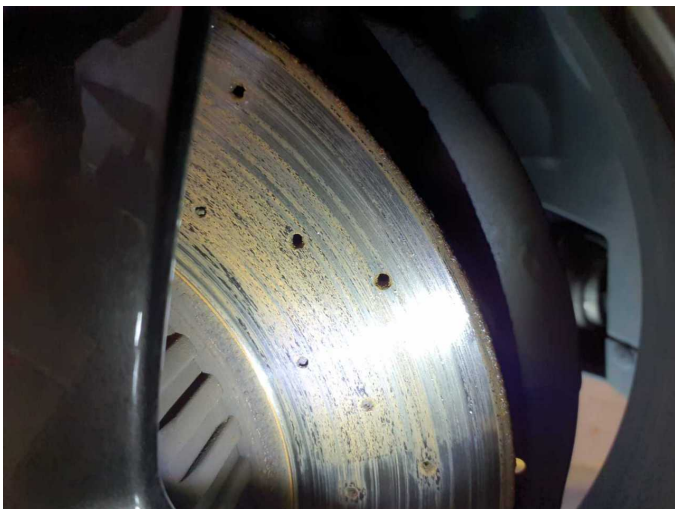
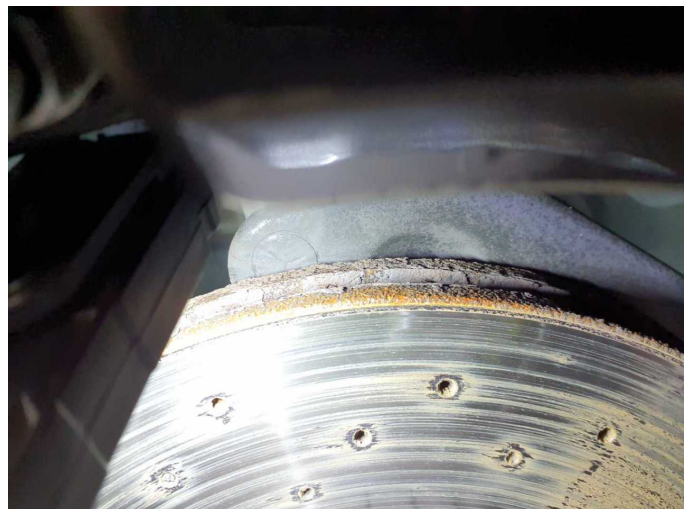
| No. | Component group | Description |
|---|---|---|
| 9 | Braking system | Brake discs - front (Tragbild mangelhaft, Rostrand) - Corrosion - Replace |

**Damage 9:** Braking system: Brake discs - front (Tragbild mangelhaft, Rostrand) - Corrosion - Replace

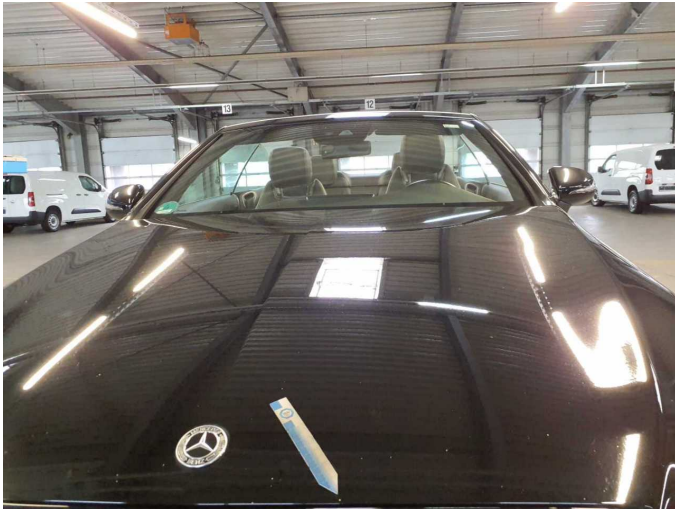
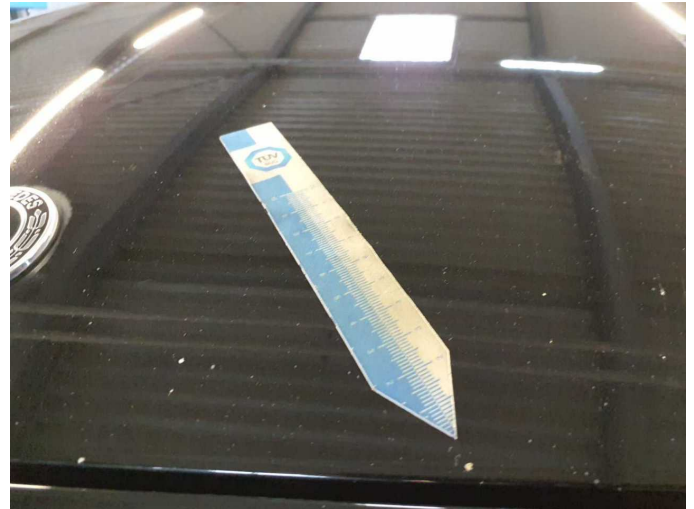
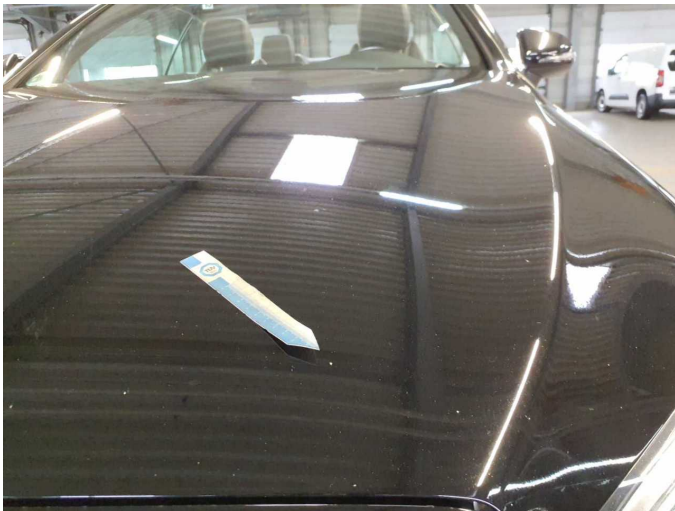
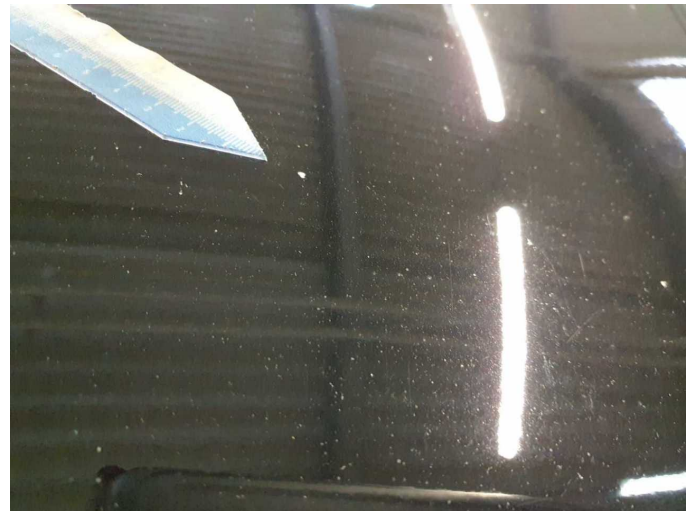
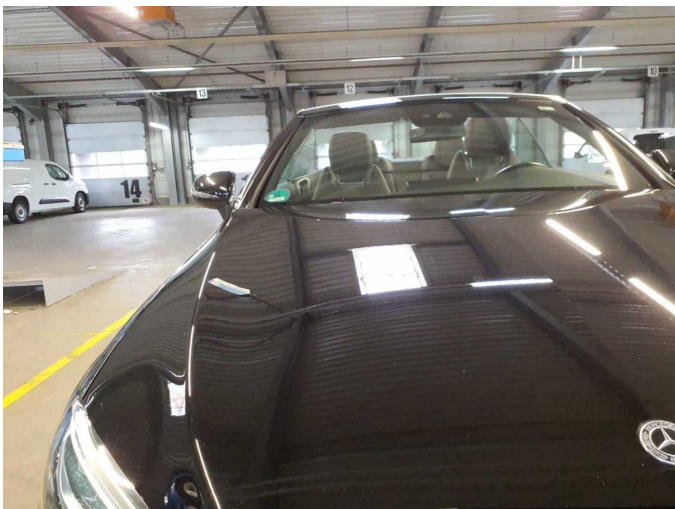
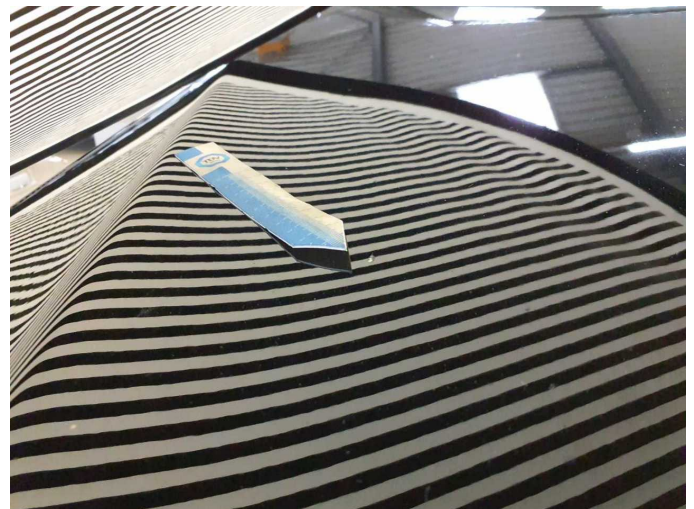
| No. | Component group | Description |
|---|---|---|
| 10 | Bonnet | Bonnet (Sandstrahleffekt) - Stone chips - Paint |

**Damage 10:** Bonnet: Bonnet (Sandstrahleffekt) - Stone chips - Paint

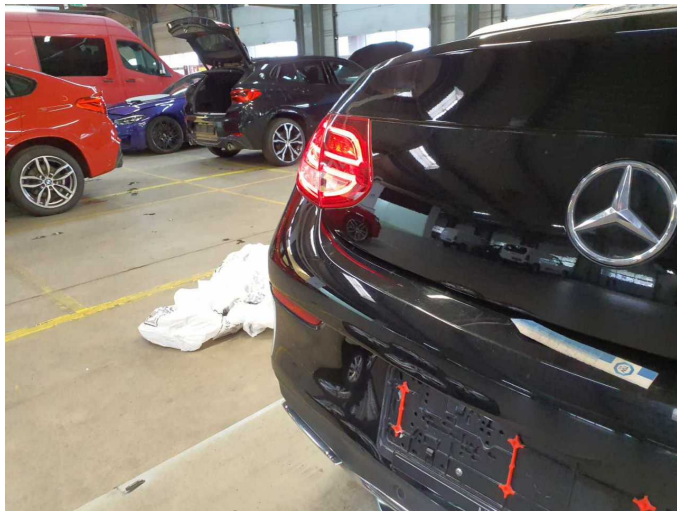
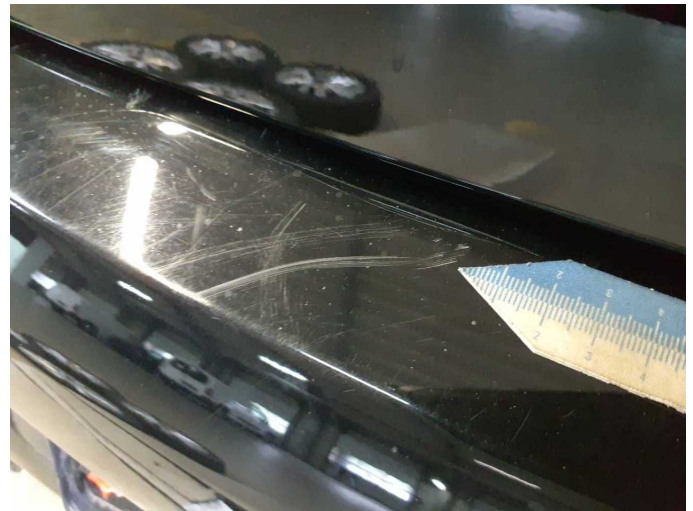
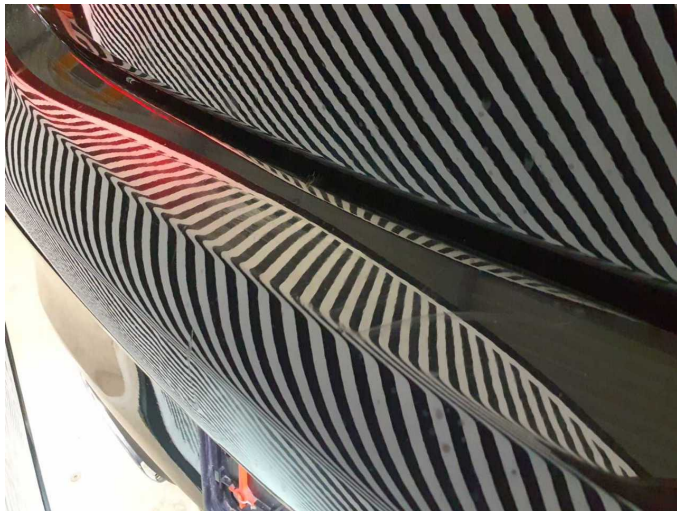
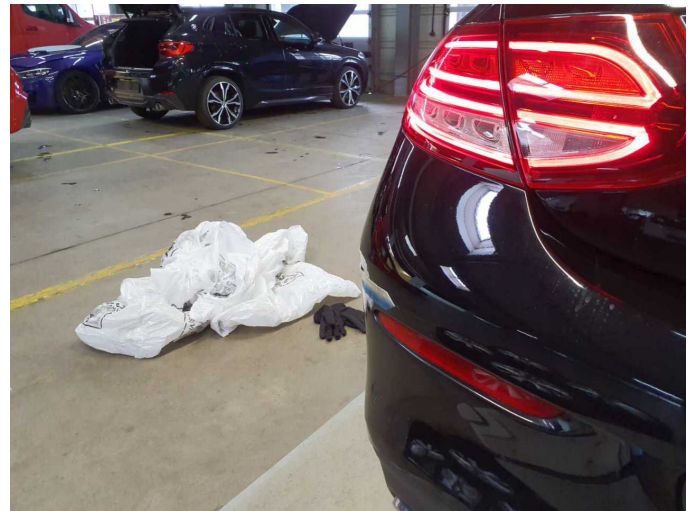
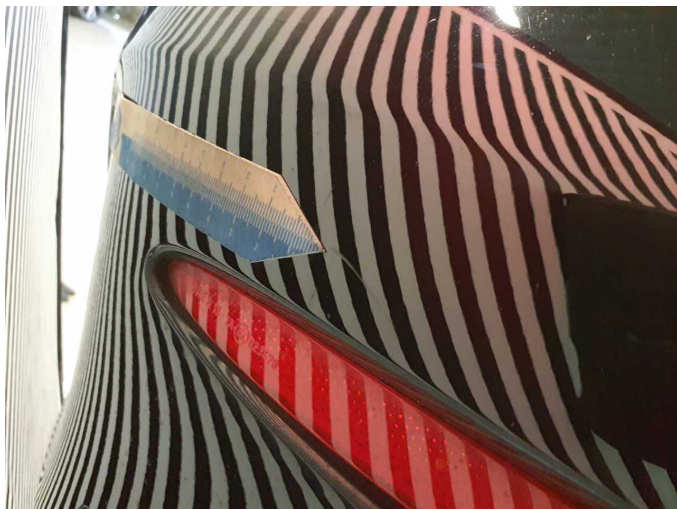
| No. | Component group | Description |
|---|---|---|
| 11 | Rear bumper | Rear bumper - Scratched - Paint |

**Damage 11:** Rear bumper: Rear bumper - Scratched - Paint

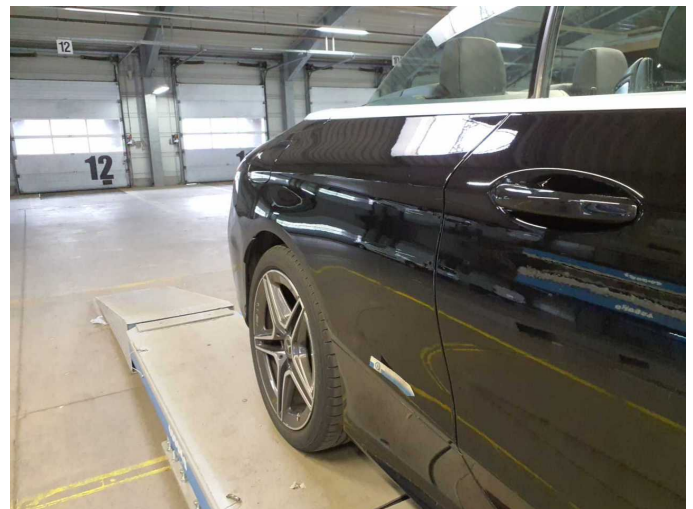
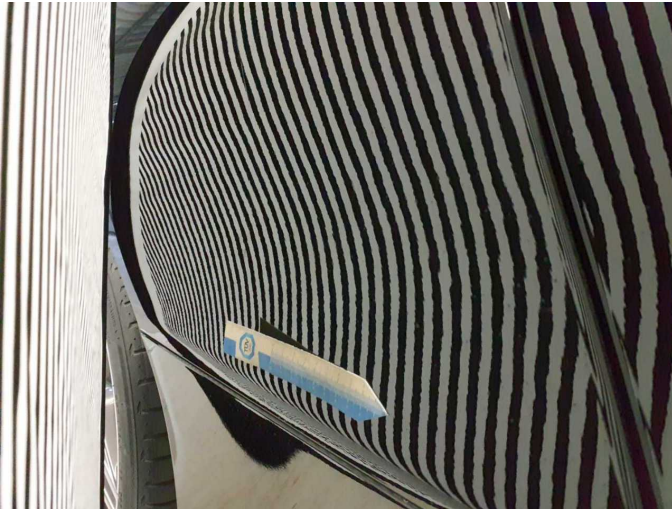
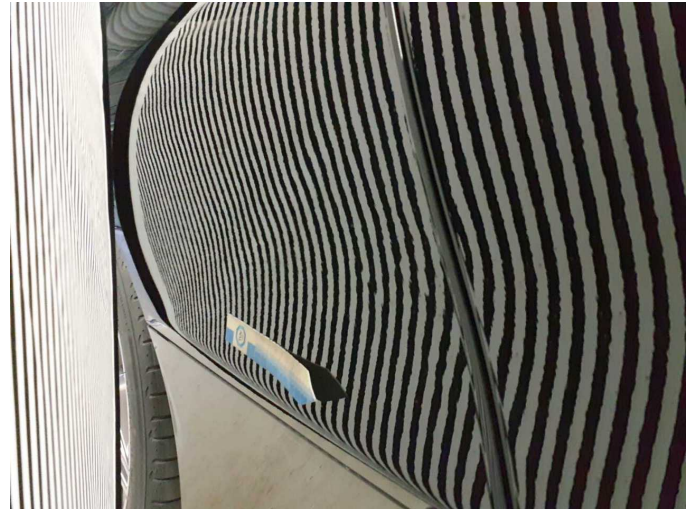
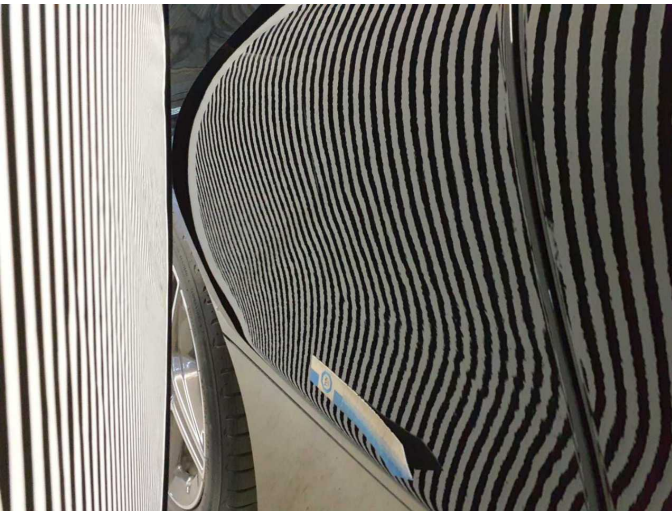
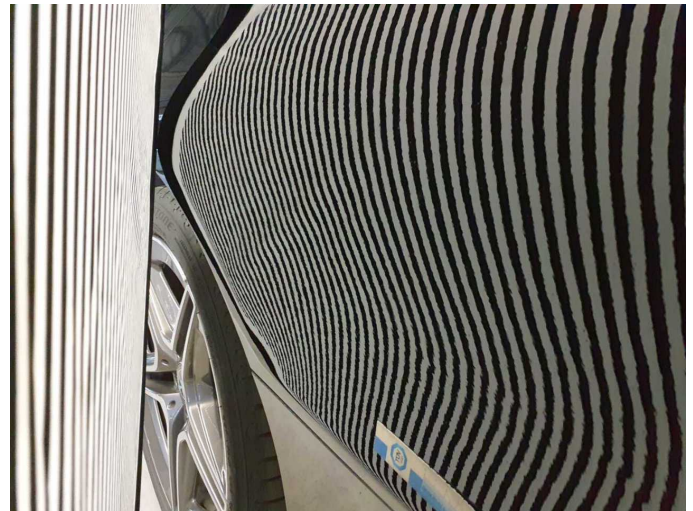
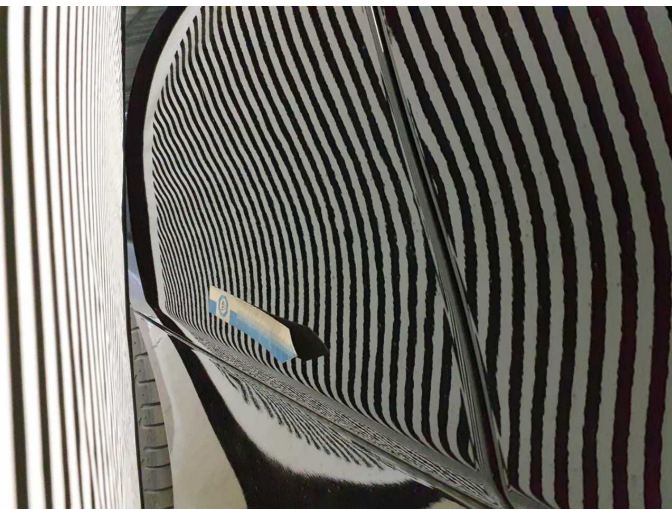
| No. | Component group | Description |
|---|---|---|
| 12 | Side panel - rear right side | Side panel (verformt, wellig, Orangenhaut) - Unprofessionally repaired - Repair and paint |

**Damage 12:** Side panel - rear right side: Side panel (verformt, wellig, Orangenhaut) - Unprofessionally repaired - Repair and paint

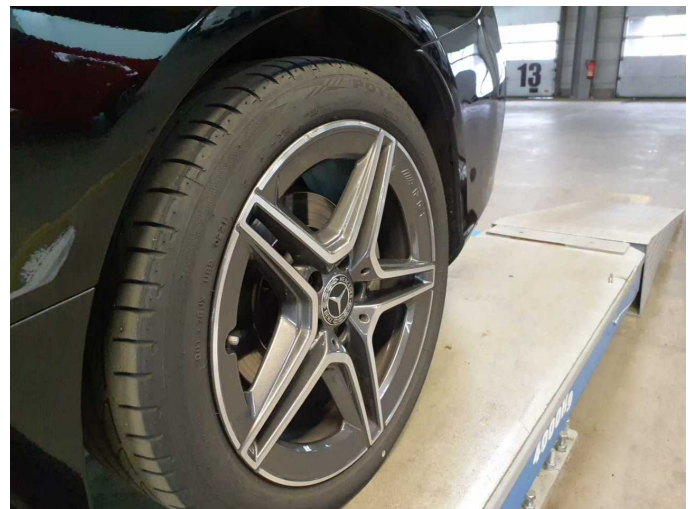
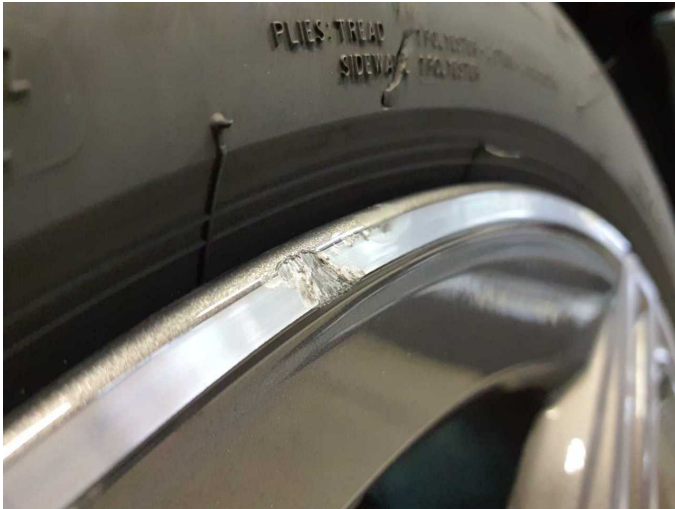
| No. | Component group | Description |
|---|---|---|
| 13 | Wheel / tyres | Alloy rim - rear left side (Materialabtrag) - Damaged - Replace |

**Damage 13:** Wheel / tyres: Alloy rim - rear left side (Materialabtrag) - Damaged - Replace

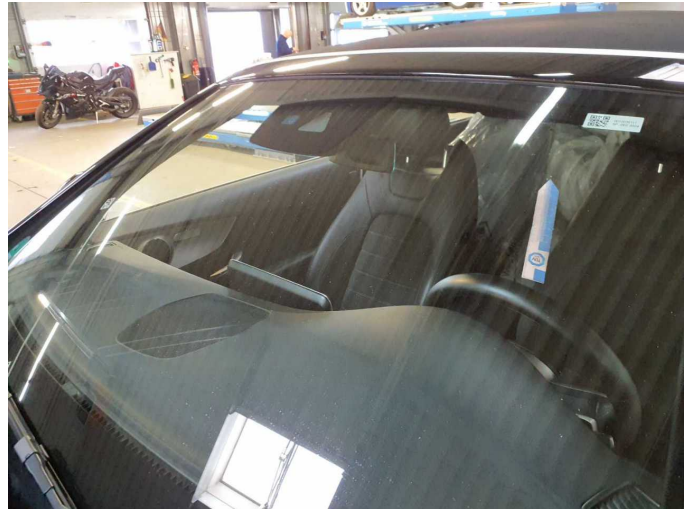
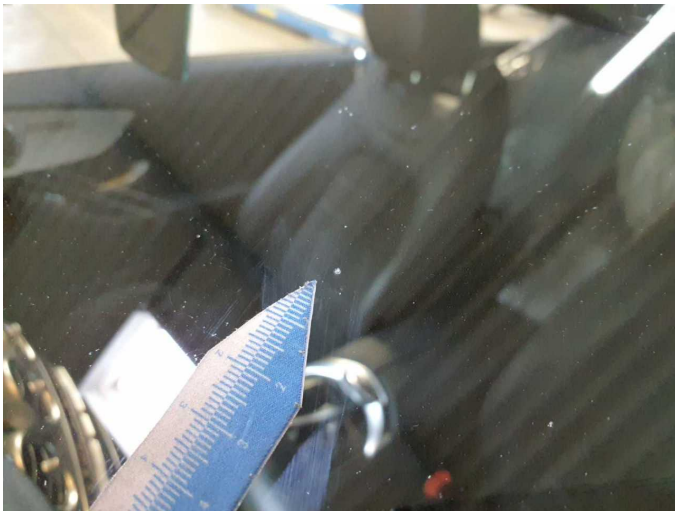
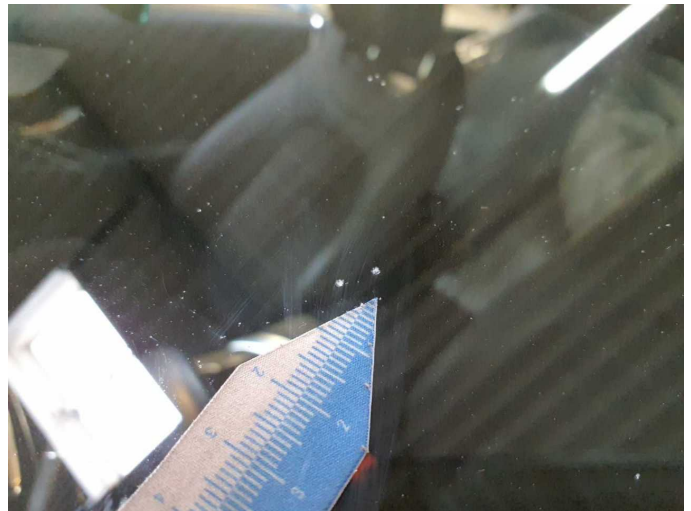
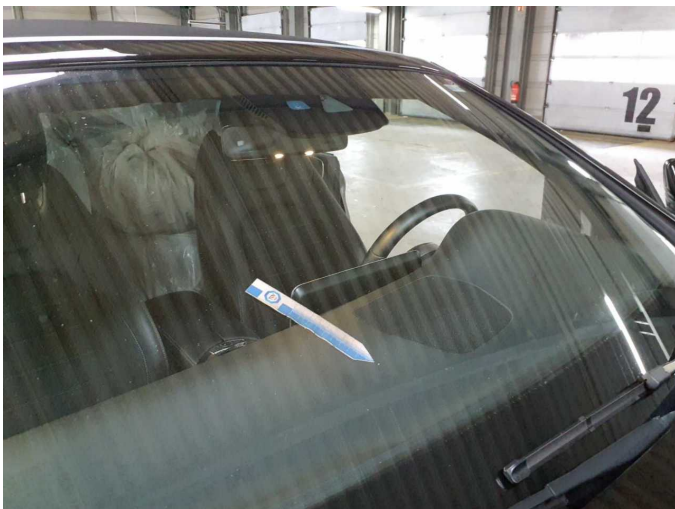
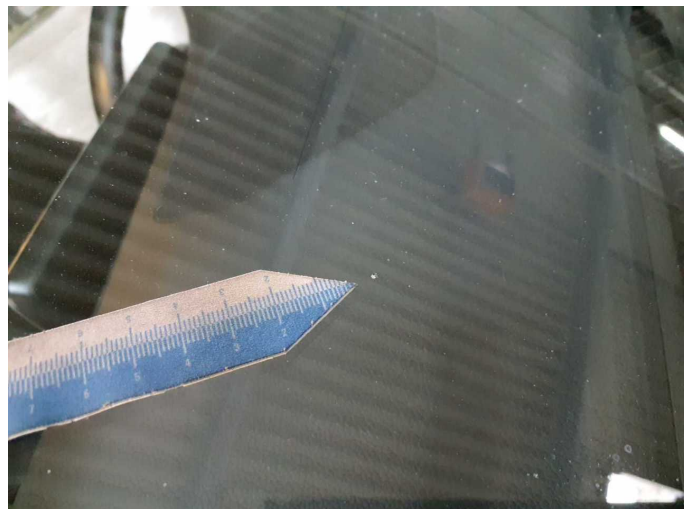
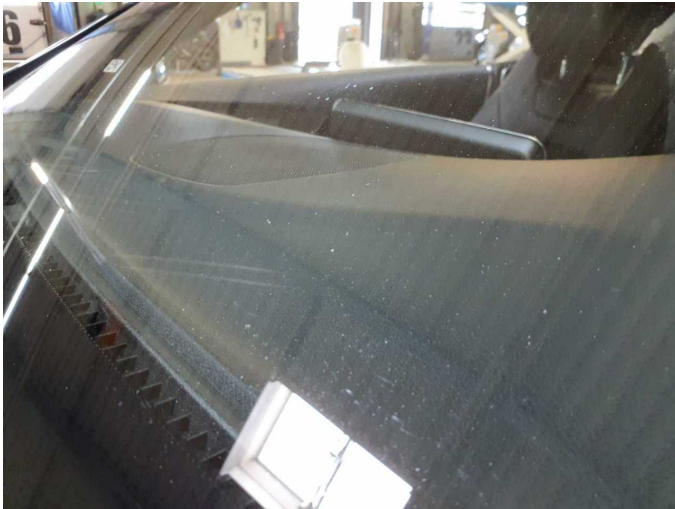
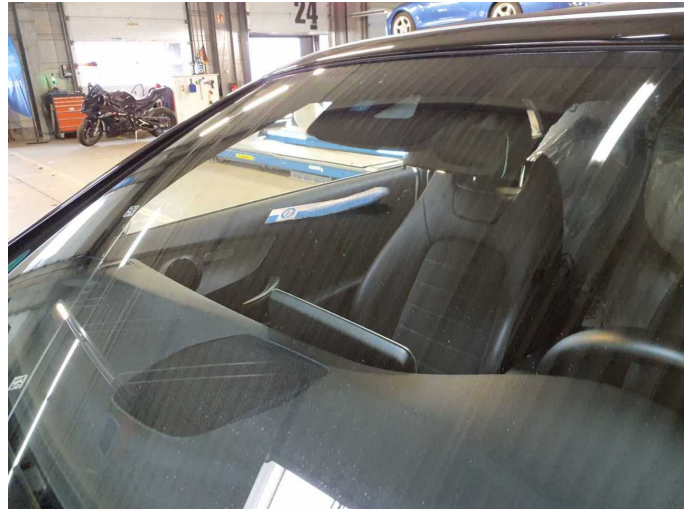
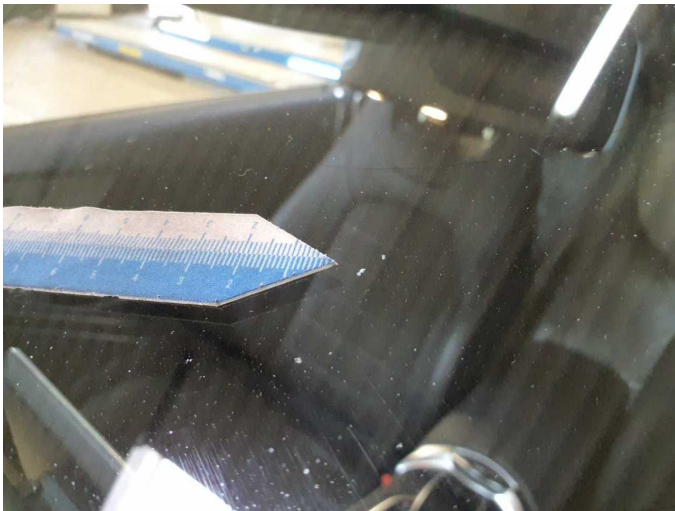
| No. | Component group | Description |
|---|---|---|
| 14 | Vehicle glazing | Windscreen (Sandstrahleffekt) - Stone chips - Replace |

**Damage 14:** Vehicle glazing: Windscreen (Sandstrahleffekt) - Stone chips - Replace

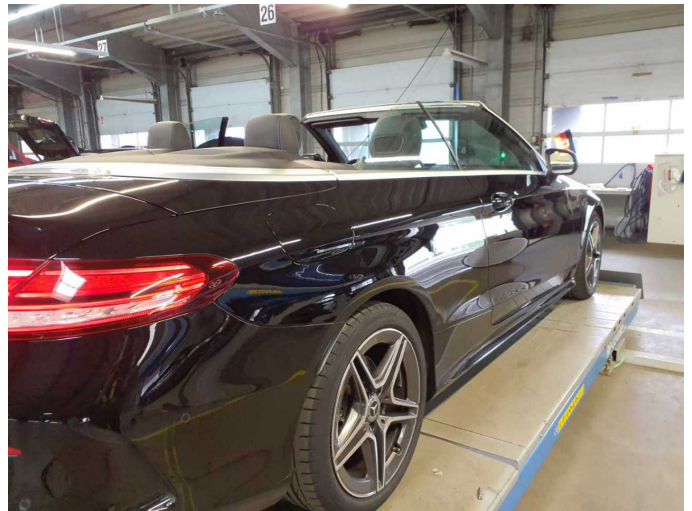
- 1 Side panel - rear right side, Unprofessionally carried out, Invoice of repair done Non-existent
- 2 Door - front right side, Invoice of repair done Non-existent

| Side panel - rear right side | 219 µm | Door - front right side | 204 µm |

**Repainting 1:** Side panel - rear right side
