Expertise

Protocol number: 41646643
Order No. / Reference: 25199952
Inspection date: 22 Sept 2025

Model: CLA 180 d 8G-DCT Progressive

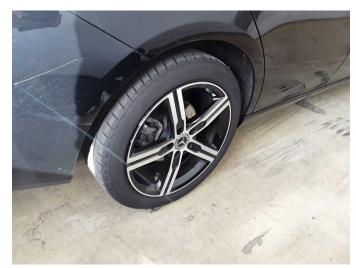
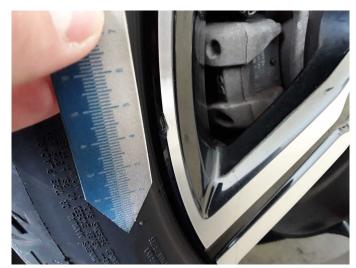
| ١ | ١o. | Component group | Description |
|---|---|---|--|
| 1 | | Wheel / tyres | Alloy rim - rear right side - Scratch(es) - Loss in value |

Damage 1: Wheel / tyres: Alloy rim - rear right side - Scratch(es) - Loss in Damage 1: Wheel / tyres: Alloy rim - rear right side - Scratch(es) - Loss in value

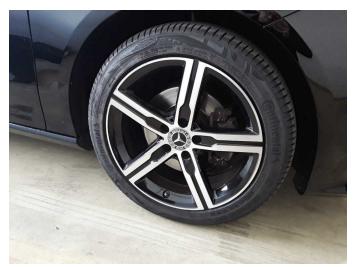
| ١ | ١o. | Component group | Description |
|---|---|---|--|
| 3 | 3 | Wheel / tyres | Alloy rim - front right side - Scratched - Replace |

Damage 3: Wheel / tyres: Alloy rim - front right side - Scratched - Replace

Damage 3: Wheel / tyres: Alloy rim - front right side - Scratched -Replace

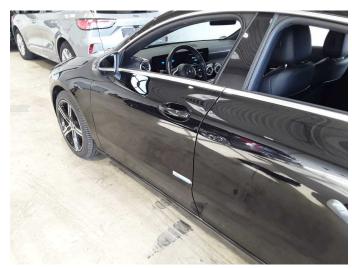
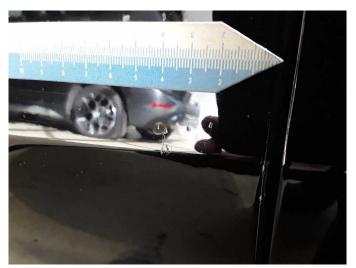
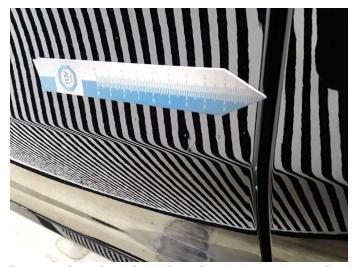
| ١ | ١o. | Component group | Description |
|---|---|---|--|
| 4 | ļ | Door - front left side | Door - Dent / paintcoat damage - Repair and paint |

Damage 4: Door - front left side: Door - Dent / paintcoat damage - Repair Damage 4: Door - front left side: Door - Dent / paintcoat damage - Repair and paint

and paint

Damage 4: Door - front left side: Door - Dent / paintcoat damage - Repair and paint

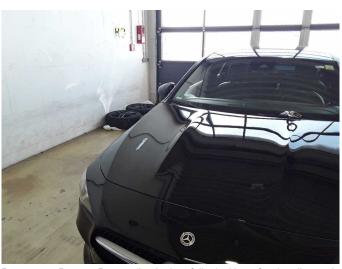
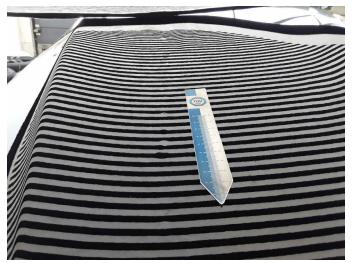
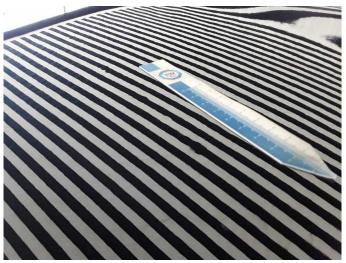
| ١ | ١o. | Component group | Description |
|---|---|---|--|
| 5 | 5 | Bonnet | Bonnet (Lack eingefallen) - Unprofessionally repaired - Repair and paint |

Damage 5: Bonnet: Bonnet (Lack eingefallen) - Unprofessionally repaired - Repair and paint

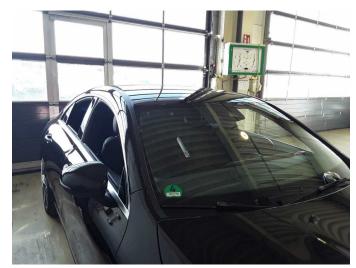
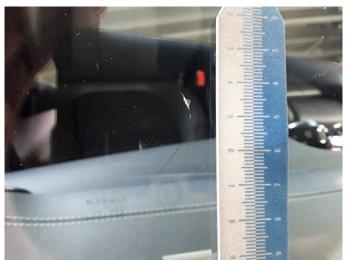
| ١ | ١o. | Component group | Description |
|---|---|---|--|
| 6 | 6 | Vehicle glazing | Windscreen - Broken / torn - Replace |

Damage 6: Vehicle glazing: Windscreen - Broken / torn - Replace

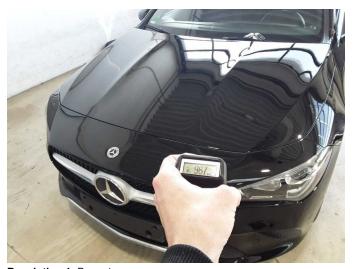
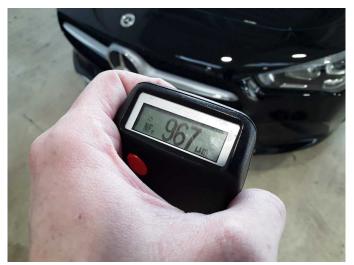
1 Bonnet, Unprofessionally carried out, Invoice of repair done Non-existent

Bonnet 967 µm

Repainting 1: Bonnet
