Expertise

Protocol number: 41810058
Order number / reference: 25135539
Inspection date: 26 Sept 2025

Manufacturer: Mercedes-Benz	Model: CLA 200 d Shooting Brake 8G-DCT
VIN: W1K5M1CB1PN344906

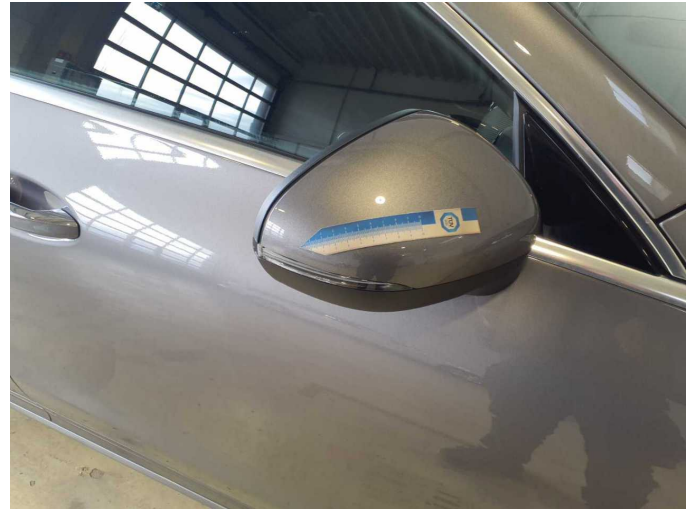
Damage 1: Indicator - front: Mirror - right side - Scratched - Replace

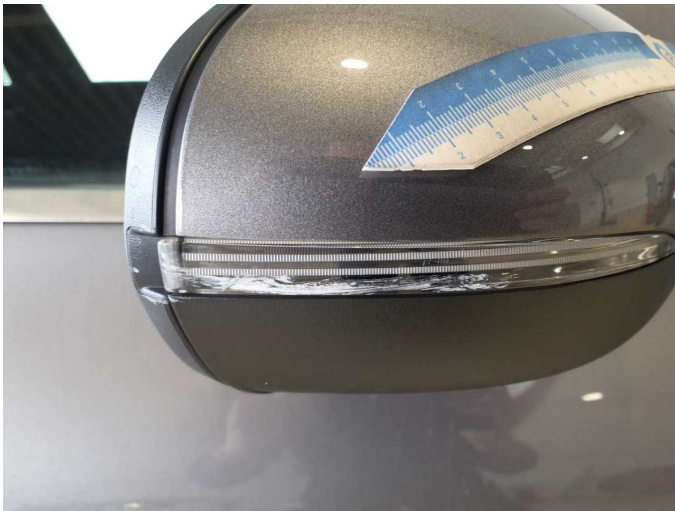
Damage 1: Indicator - front: Mirror - right side - Scratched - Replace

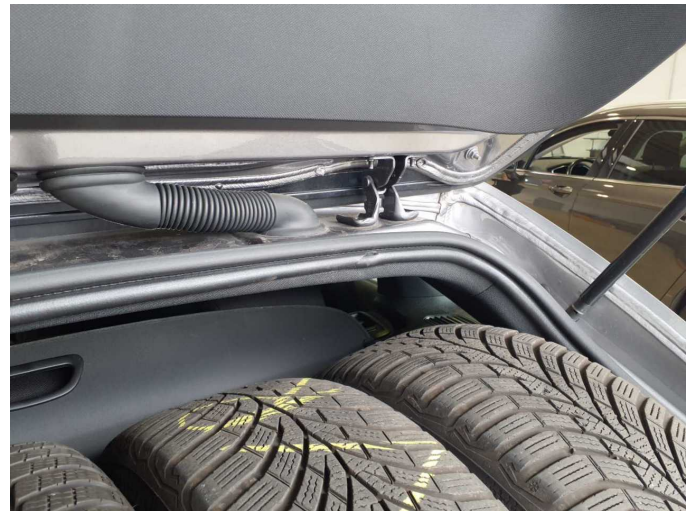
Damage 2: Boot lid / rear door: Seal - Damaged - Replace

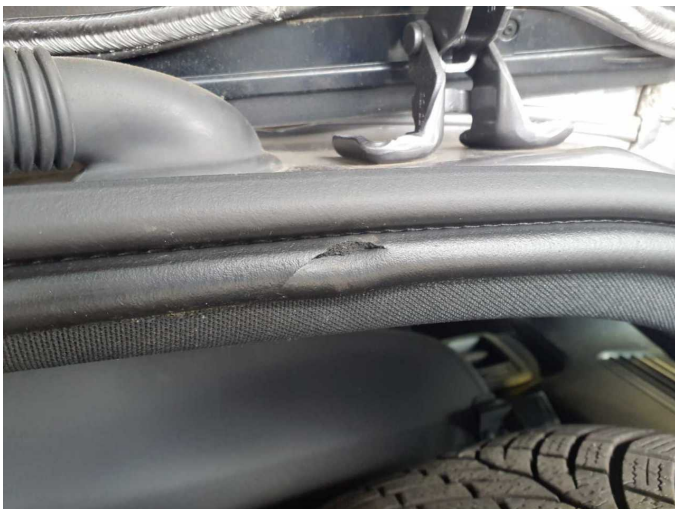
Damage 2: Boot lid / rear door: Seal - Damaged - Replace

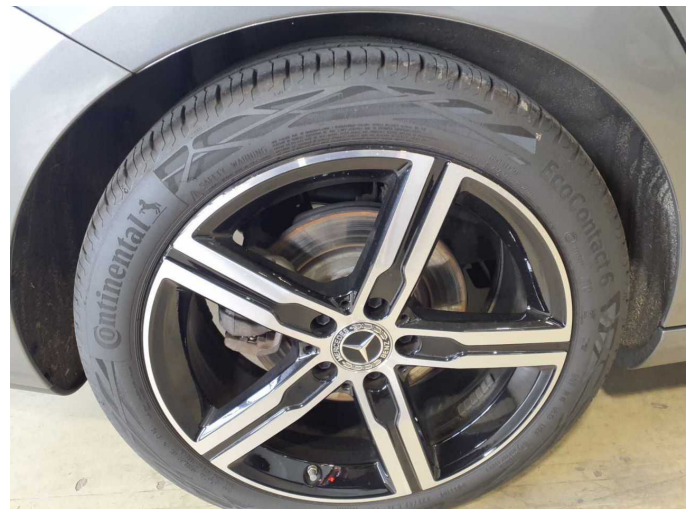
Damage 3: Wheel / tyres: Tyre - rear right side - Damaged - Replace

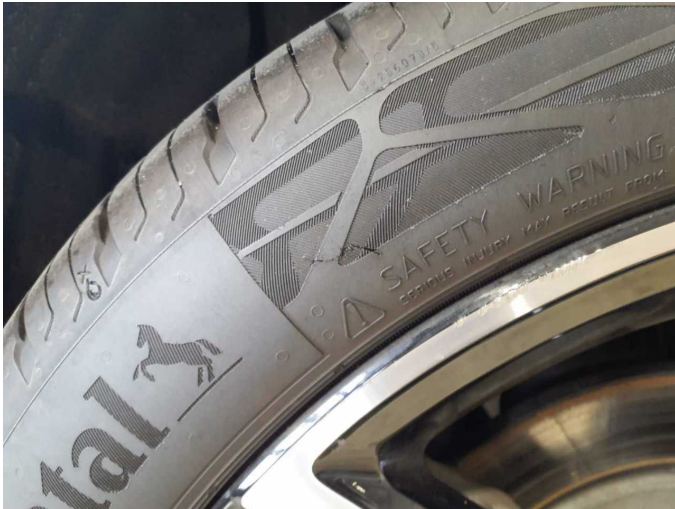
Damage 3: Wheel / tyres: Tyre - rear right side - Damaged - Replace

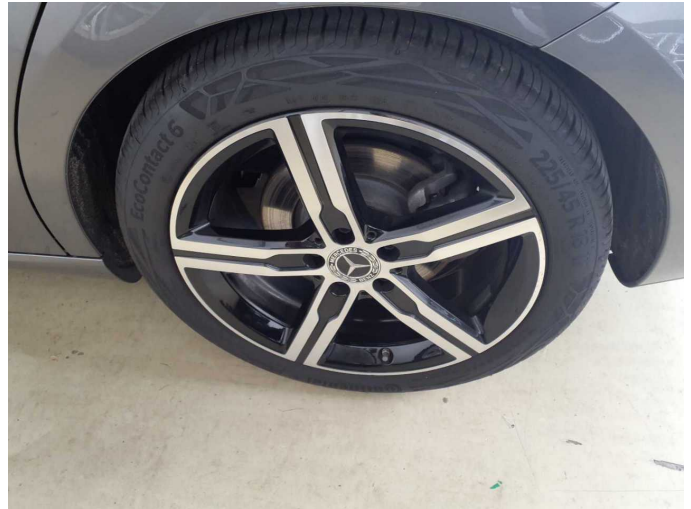
Damage 4: Wheel / tyres: Alloy rim - rear left side - Scratch(es) - Loss in value

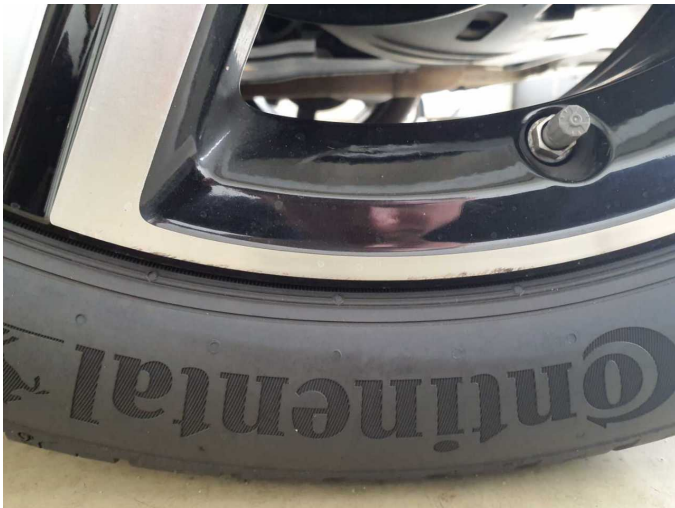
Damage 4: Wheel / tyres: Alloy rim - rear left side - Scratch(es) - Loss in value

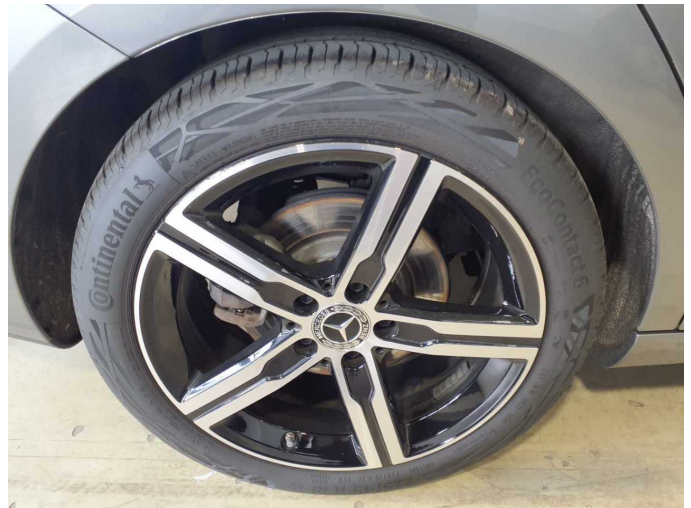
Damage 5: Wheel / tyres: Alloy rim - rear right side - Scratch(es) - Loss in value

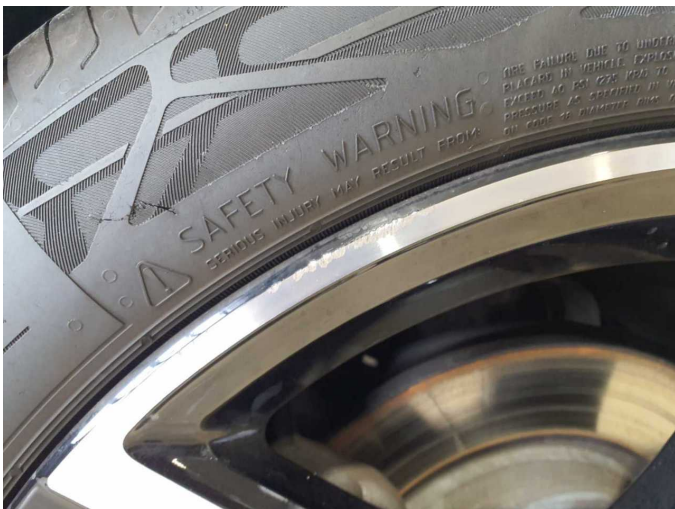
Damage 5: Wheel / tyres: Alloy rim - rear right side - Scratch(es) - Loss in value

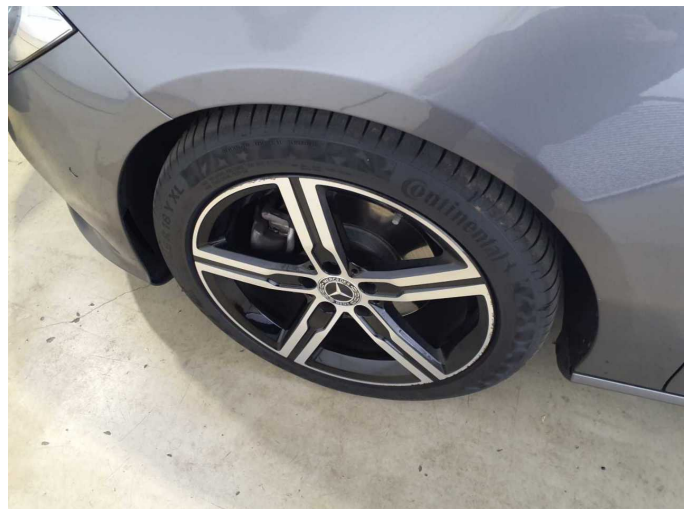
Damage 6: Wheel / tyres: Alloy rim - front left side - Scratched - Replace

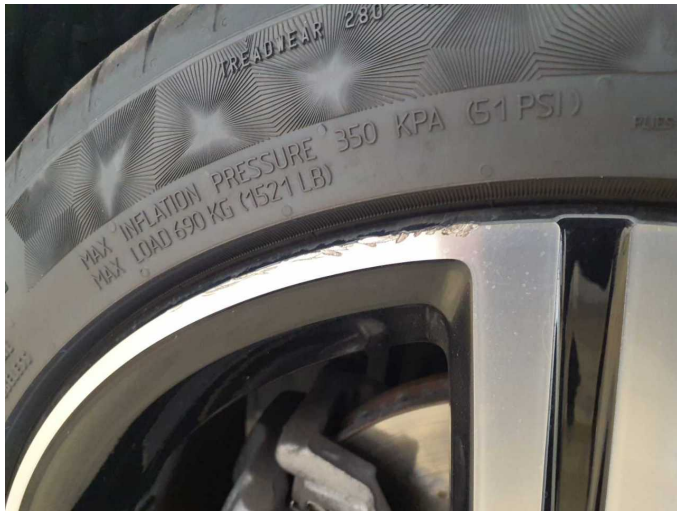
Damage 6: Wheel / tyres: Alloy rim - front left side - Scratched - Replace

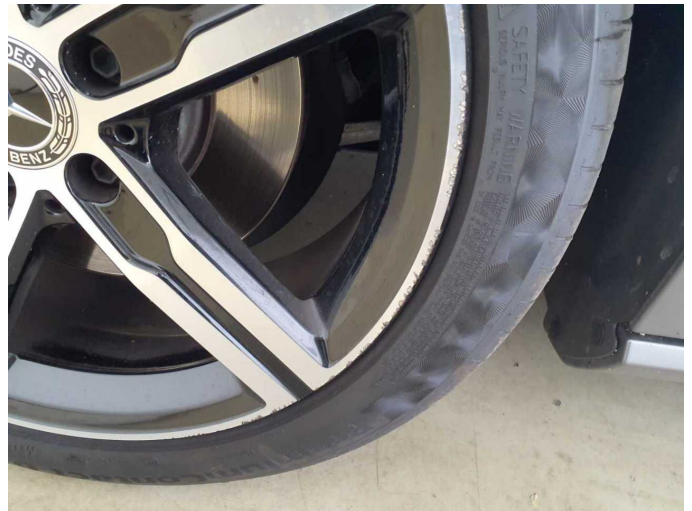
Damage 6: Wheel / tyres: Alloy rim - front left side - Scratched - Replace

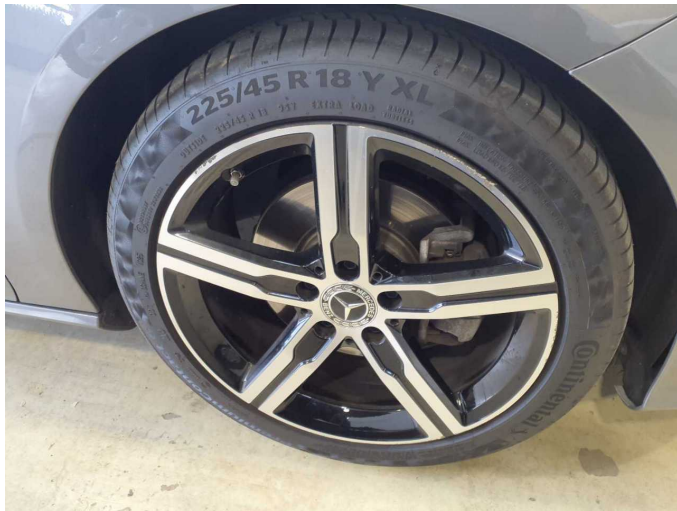
Damage 7: Wheel / tyres: Alloy rim - front right side - Scratched - Replace

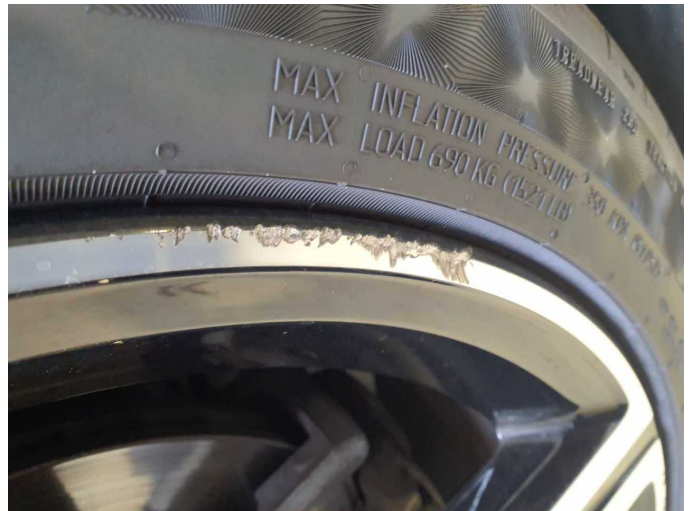
Damage 7: Wheel / tyres: Alloy rim - front right side - Scratched - Replace

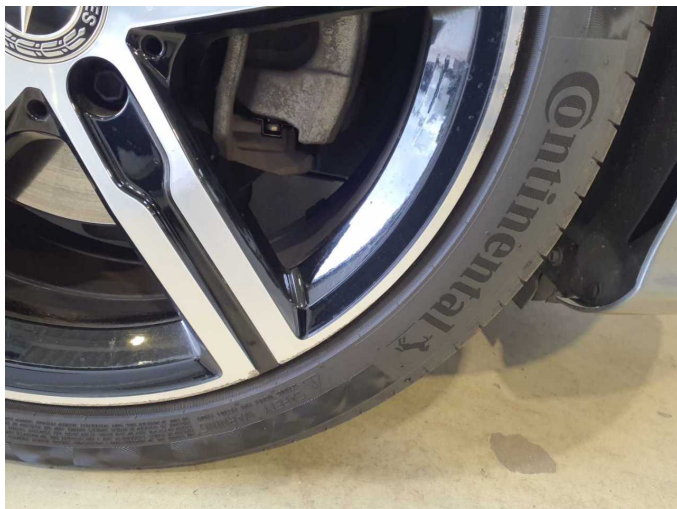
Damage 7: Wheel / tyres: Alloy rim - front right side - Scratched - Replace

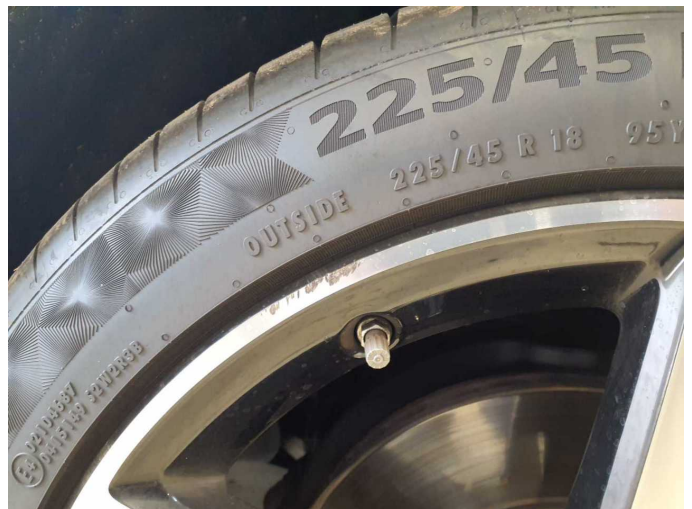
Damage 7: Wheel / tyres: Alloy rim - front right side - Scratched - Replace

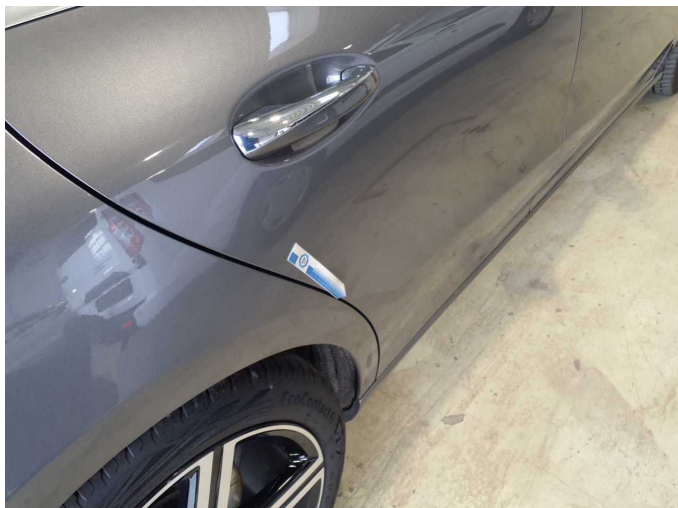
- Side panel - rear right side, Door - rear right side, Unprofessionally carried out, Invoice of repair done Non-existent

Damage 8: Door - rear right side: Door (Wellig) - Unprofessionally repaired - Repair and paint

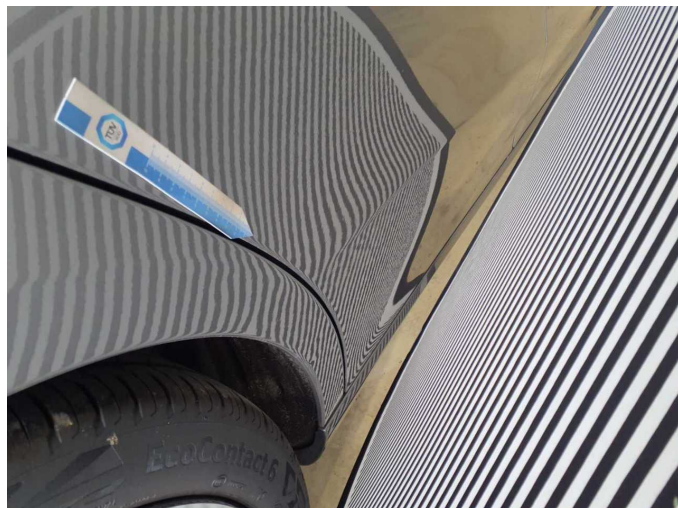
Damage 8: Door - rear right side: Door (Wellig) - Unprofessionally repaired - Repair and paint

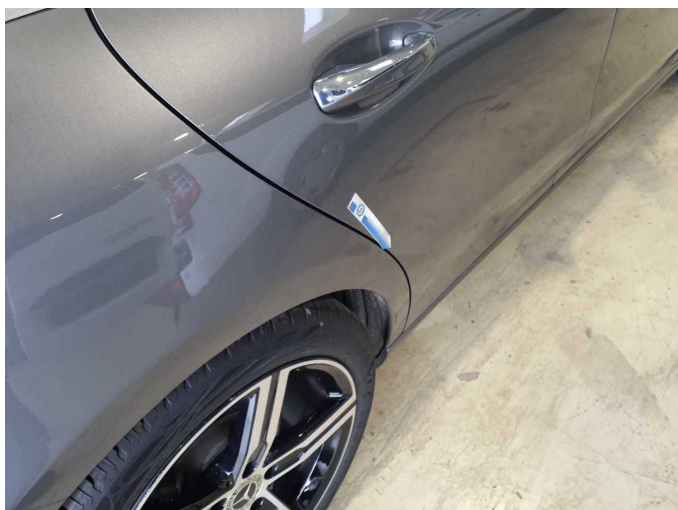
Damage 9: Side panel - rear right side: Side panel (Wellig) - Unprofessionally repaired - Repair and paint

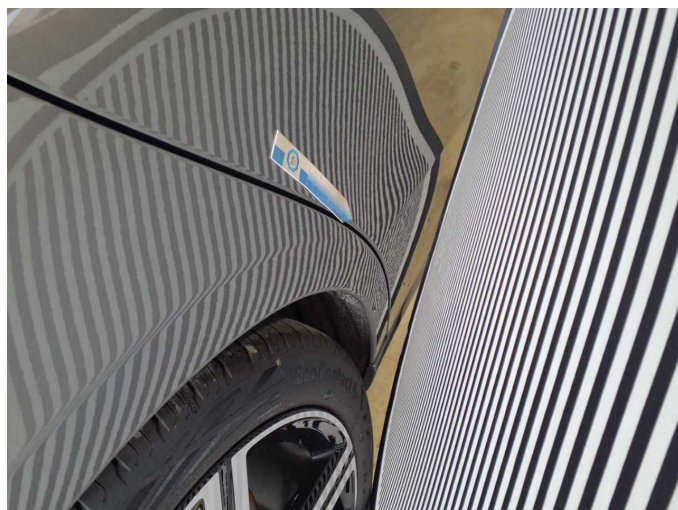
Damage 9: Side panel - rear right side: Side panel (Wellig) - Unprofessionally repaired - Repair and paint

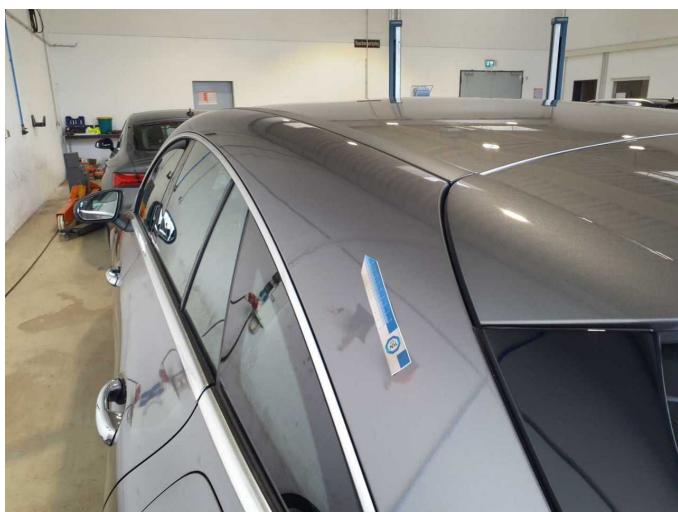
Damage 10: Roof: Roof rail - left side - dent(s) - Replace

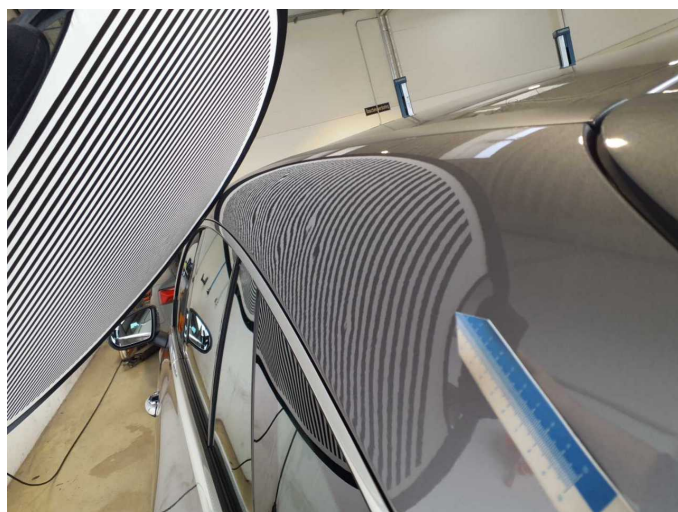
Damage 10: Roof: Roof rail - left side - dent(s) - Replace

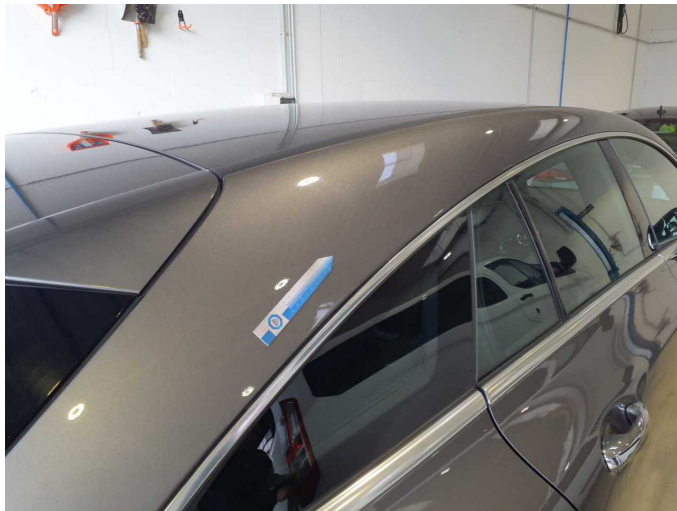
Damage 11: Roof: Roof rail - right side - dent(s) - Repair and paint

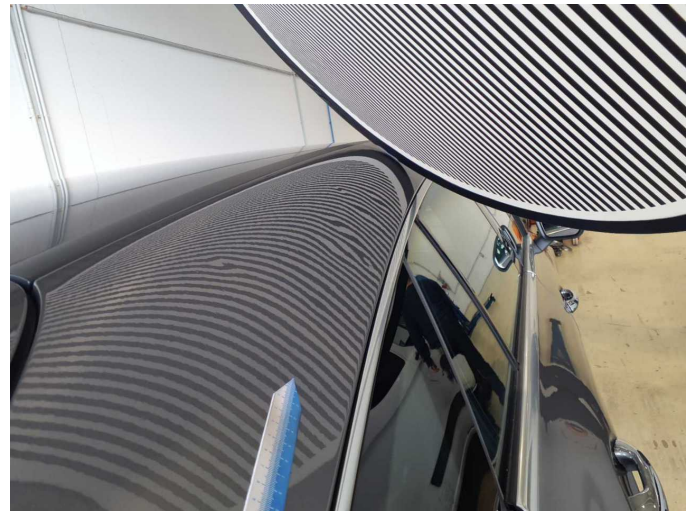
Damage 11: Roof: Roof rail - right side - dent(s) - Repair and paint

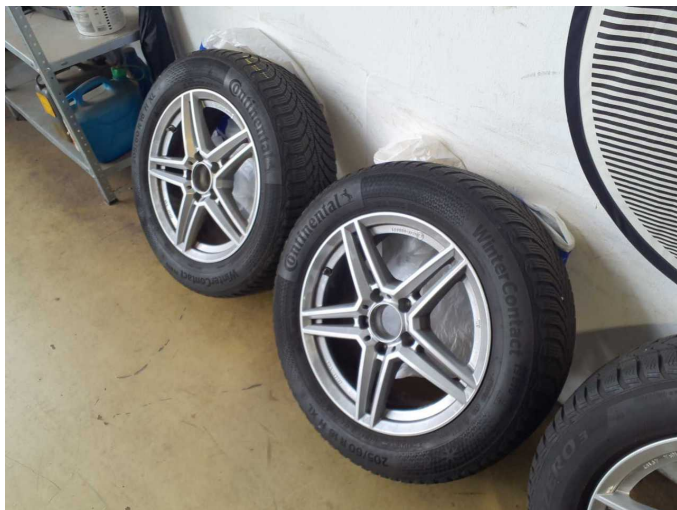
Wear and tear 1: 2nd wheel set: 2 tyres (Kein Bestandteil der Ausstattungsliste) - Does not meet the leasing specifications - No deduction

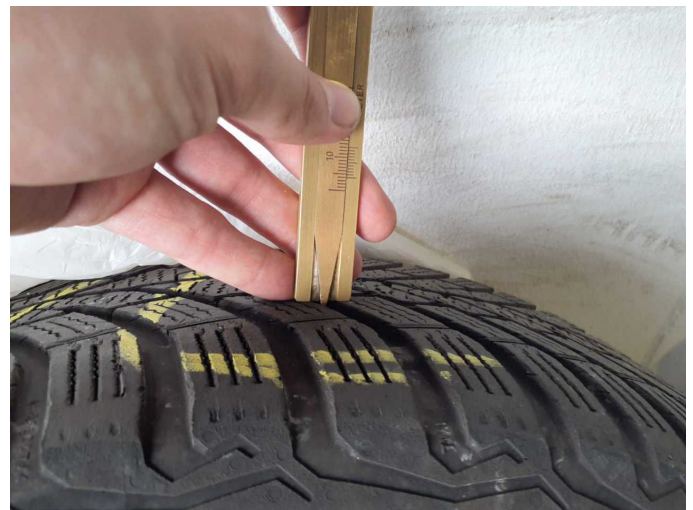
Wear and tear 1: 2nd wheel set: 2 tyres (Kein Bestandteil der Ausstattungsliste) - Does not meet the leasing specifications - No deduction

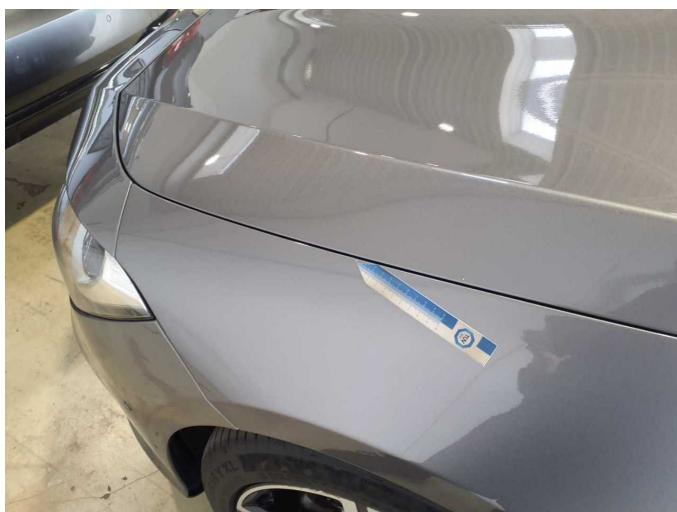
Wear and tear 2: Mudguard - left side: Mudguard - left side - Scratch(es) - No deduction

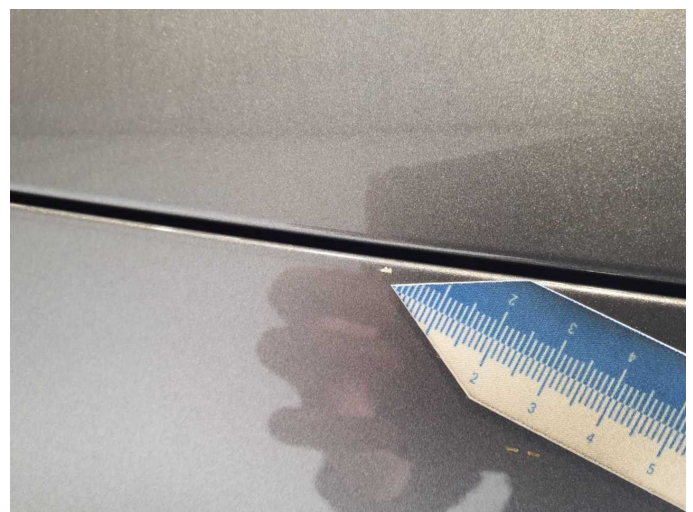
Wear and tear 2: Mudguard - left side: Mudguard - left side - Scratch(es) - No deduction

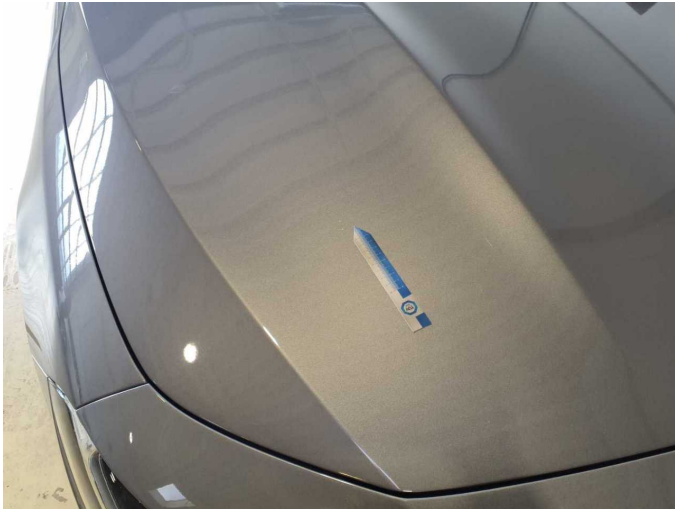
Wear and tear 3: Bonnet: Bonnet - Stone chips - No deduction

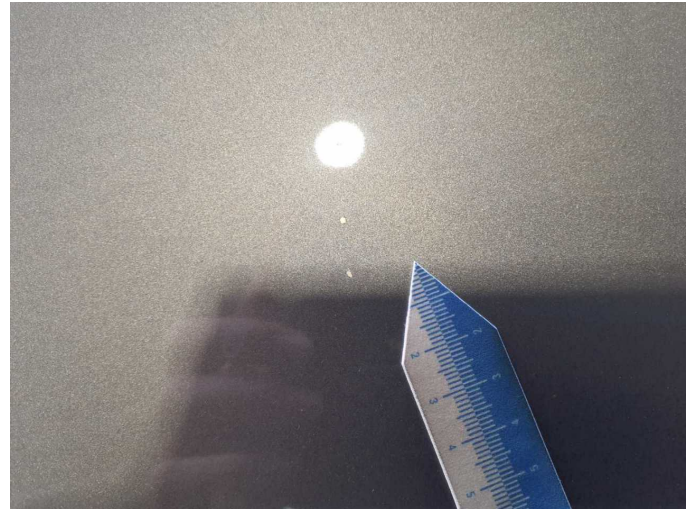
Wear and tear 3: Bonnet: Bonnet - Stone chips - No deduction

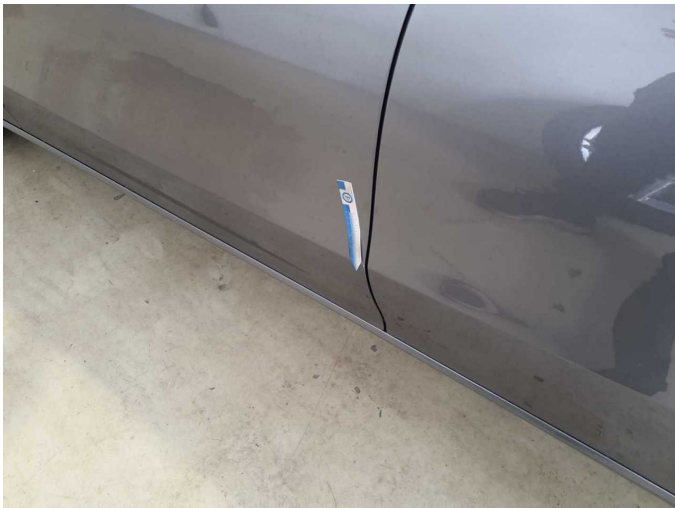
Wear and tear 4: Door - front left side: Door - Scratch(es) - No deduction

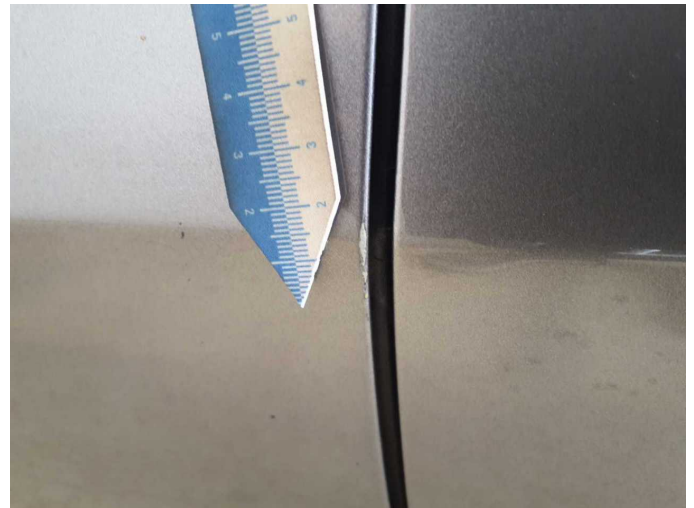
Wear and tear 4: Door - front left side: Door - Scratch(es) - No deduction

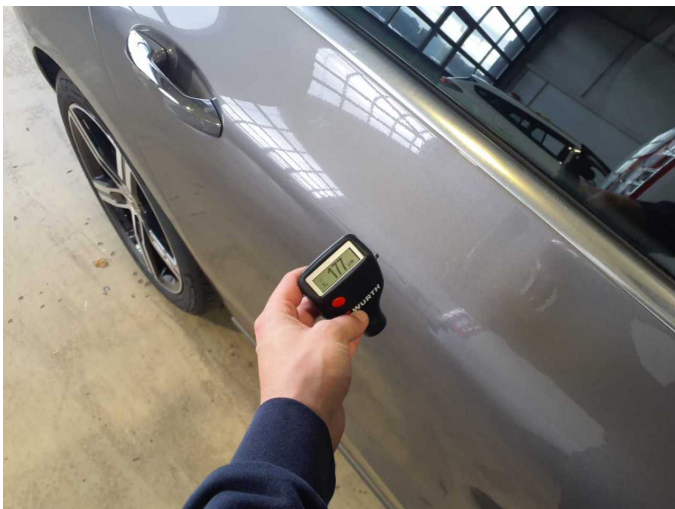
Repainting 1: Side panel - rear right side, Door - rear right side

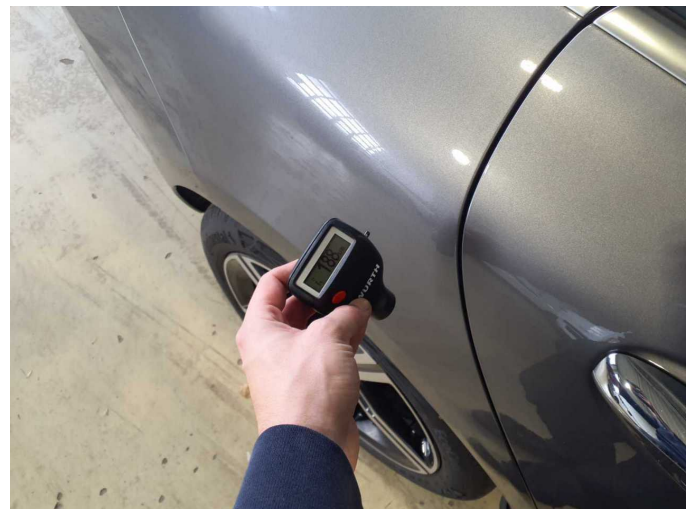
Repainting 1: Side panel - rear right side, Door - rear right side

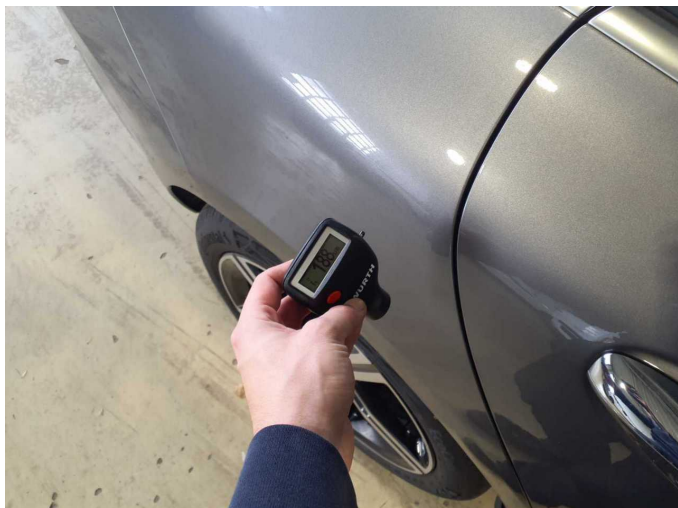
Side panel - rear right side: 188 μ m

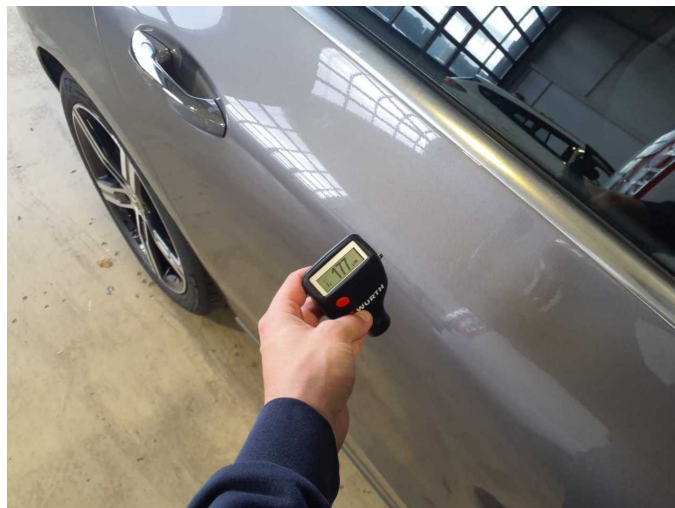
Door - rear right side: 177 μ m
