# MERCEDES-BENZ CLA

## CLA 250 e Shooting Brake 8G-DCT

VIN NO W1K5M8GB1PN366472  
Registration Number B1PN366472

### Inspection Report Summary

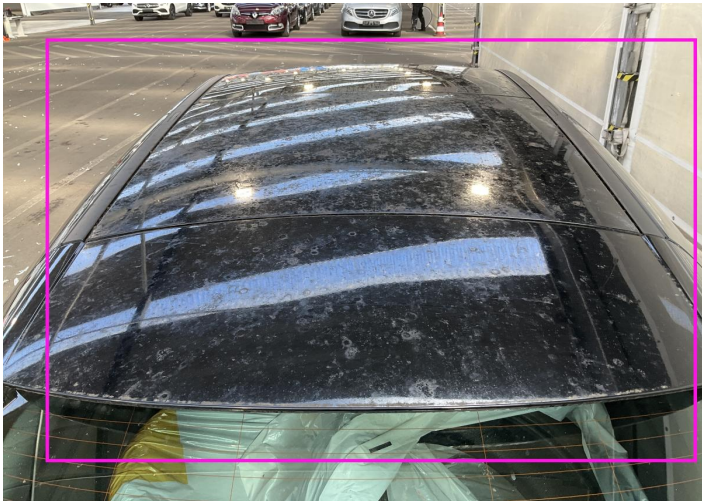
8. Roof  
Paint / Chemical Damage -

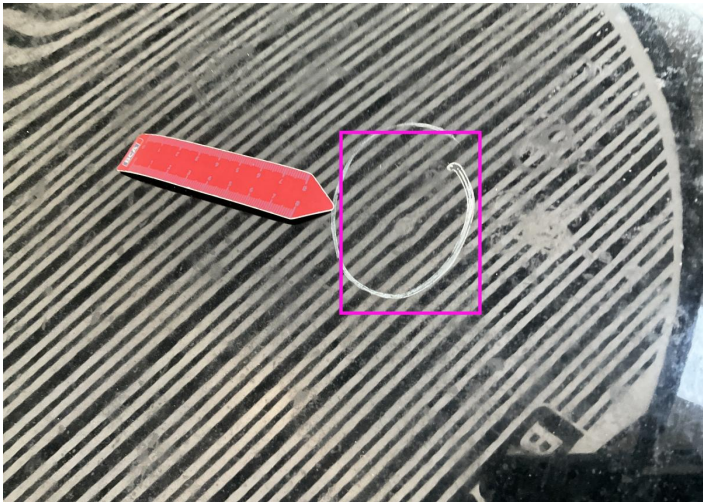
9. Hood  
Bodywork / Dent / Dent -

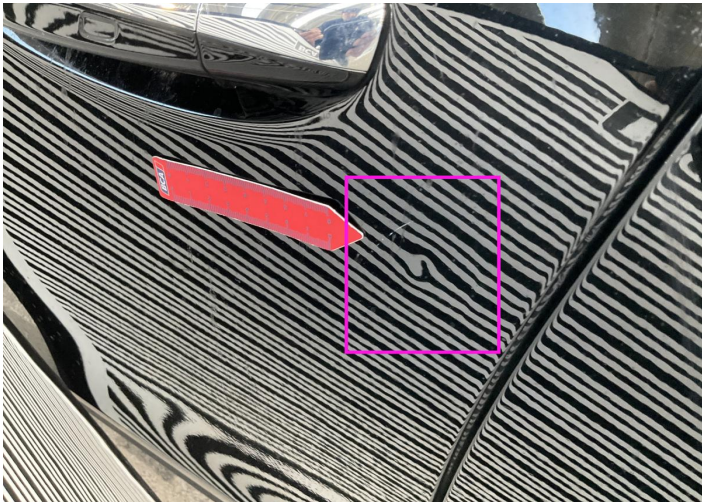
10. Door / Front Left  
Bodywork / Dent / Dent -

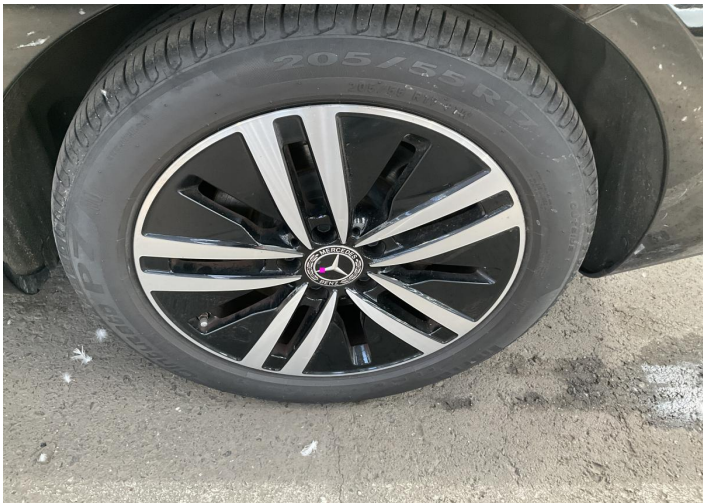
11. Rim / Back Left  
Out of Bodywork / Scratch -

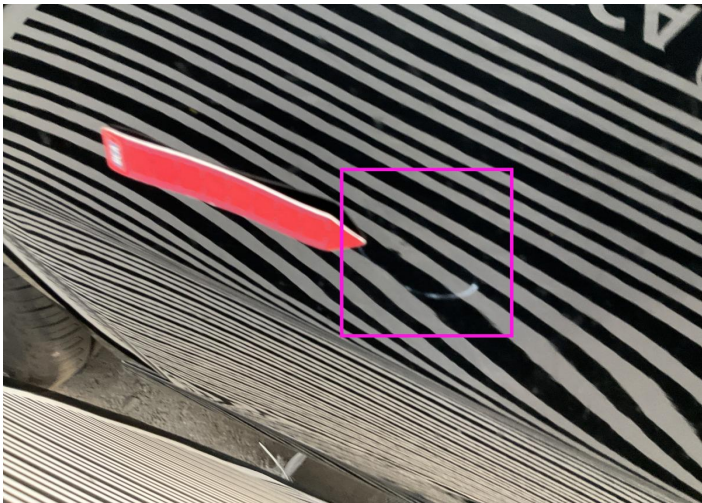
12. Door / Back Right  
Bodywork / Dent / Dent -
