# MERCEDES-BENZ CLA

## CLA 250 e Shooting Brake 8G-DCT

VIN NO W1K5M8GB1PN366472  
Registration Number B1PN366472

### Inspection Report Summary

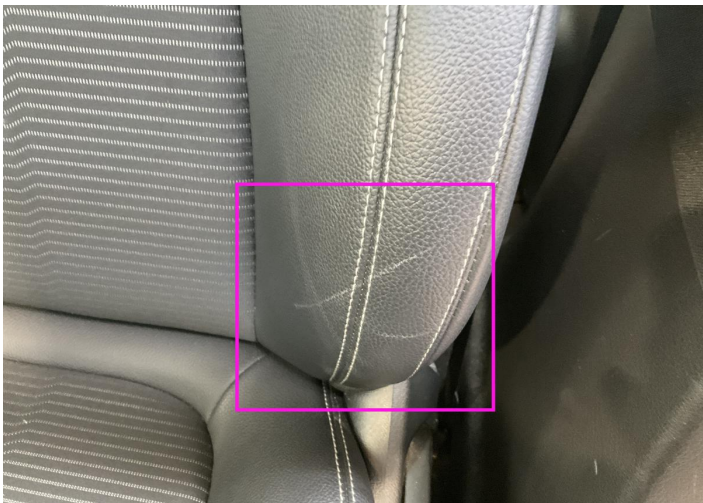
1. Seat / Front Left  
Interior / Scratched -

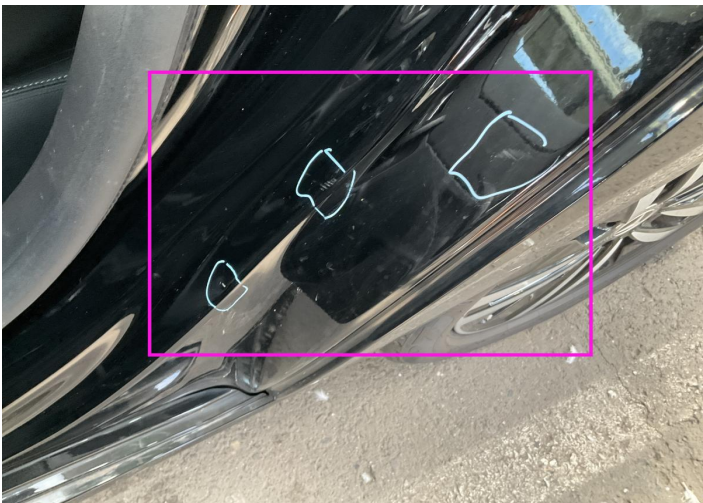
2. Pillar / Back Left  
Paint / Scratch / Scuff -

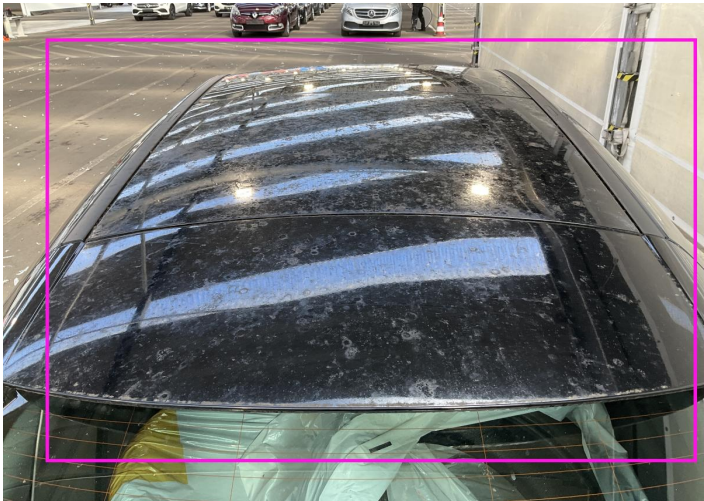
8. Roof  
Paint / Chemical Damage -

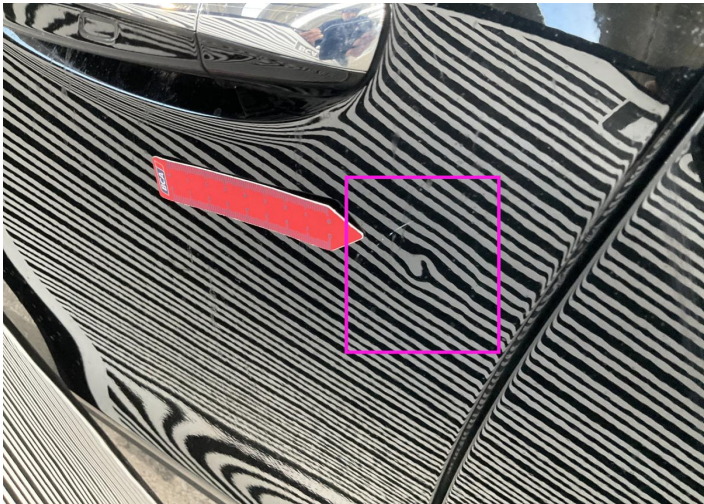
10. Door / Front Left  
Bodywork / Dent / Dent -

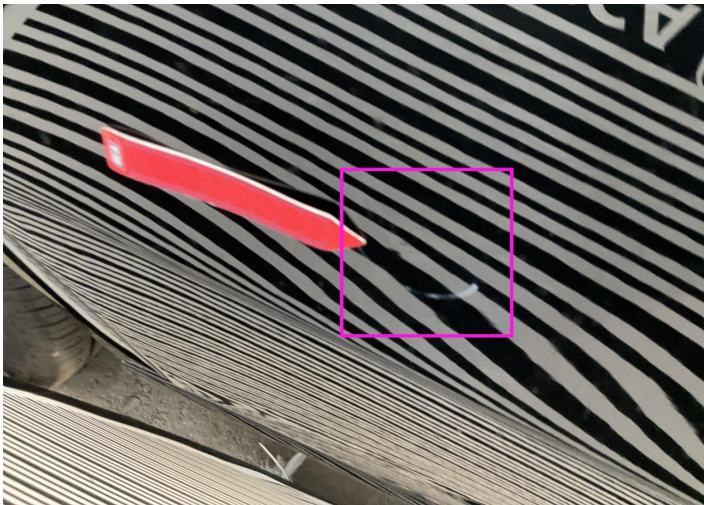
12. Door / Back Right  
Bodywork / Dent / Dent -
