# MERCEDES-BENZ CLA CLA 250 e Shooting Brake 8G-DCT

VIN NO W1K5M8GB1PN366472 Registration Number B1PN366472

## **Inspection Report Summary**

Customer	BCA Online	Report Number	P20250911101335
Inspection Date / Place	2025-09-11 / BCA Neuss	Cosmetic Grade	4

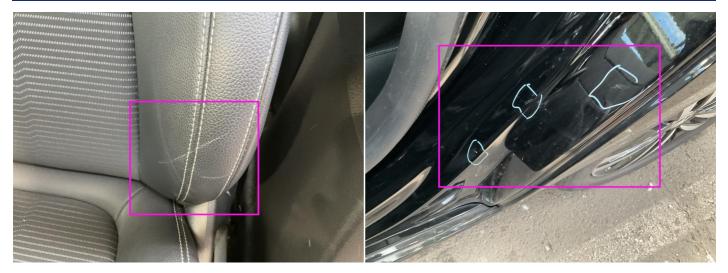
1. Seat / Front Left Interior / Scratched -

2. Pillar / Back Left Paint / Scratch / Scuff -

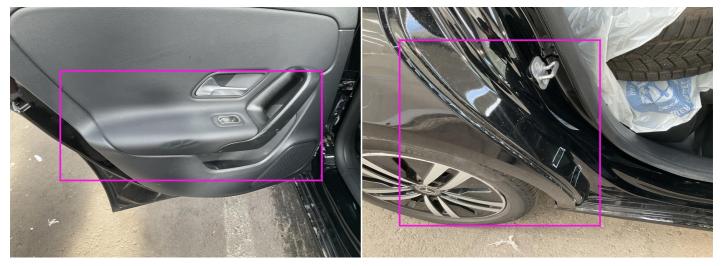
3. Panel Filling / Back Left Interior / Scratched -

4. Pillar / Back Right Paint / Scratch / Scuff -

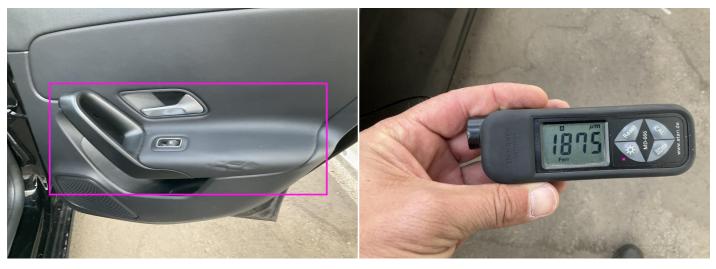
5. Panel Filling / Back Right Interior / Scratched -

6. Fender / Back Right Paint / Poor Previous Repair -

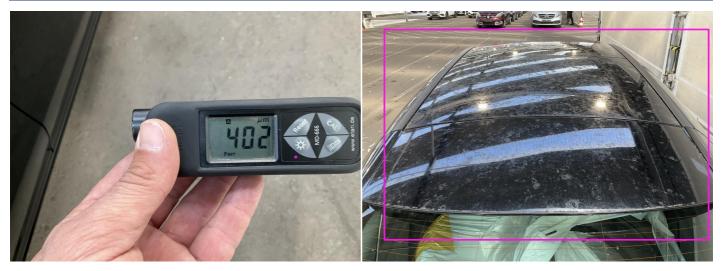
7. Door / Back Right
Paint / Poor Previous Repair -

8. Roof Paint / Chemical Damage -

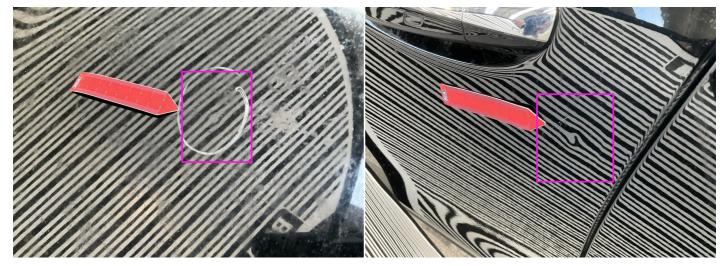
9. Hood Bodywork / Dent / Dent -

10. Door / Front Left Bodywork / Dent / Dent -

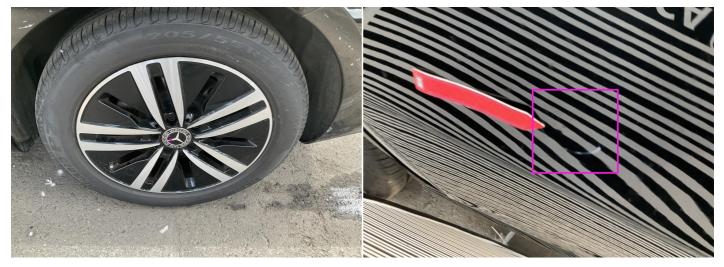
11. Rim / Back Left Out of Bodywork / Scratch -

12. Door / Back Right Bodywork / Dent / Dent -
