# MERCEDES-BENZ CLA

## CLA 250 e Shooting Brake 8G-DCT

VIN NO W1K5M8GB1PN366472  
Registration Number B1PN366472

### Inspection Report Summary

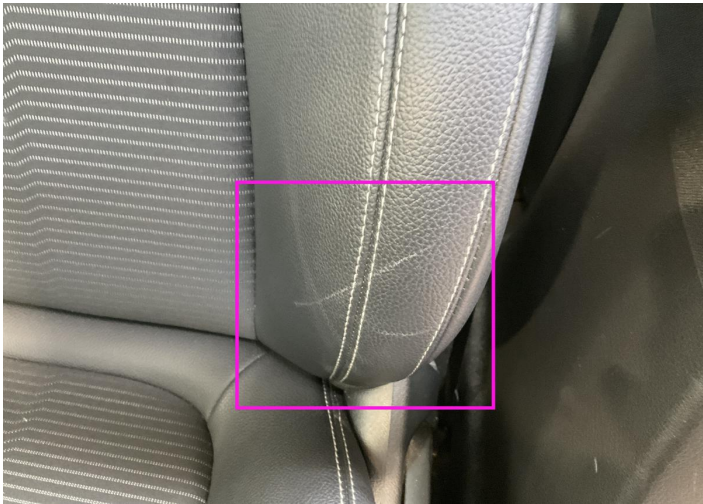
1. Seat / Front Left  
Interior / Scratched -

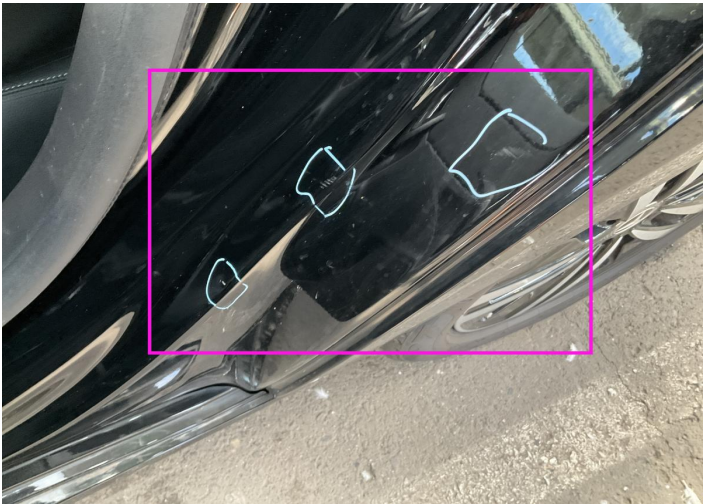
2. Pillar / Back Left  
Paint / Scratch / Scuff -

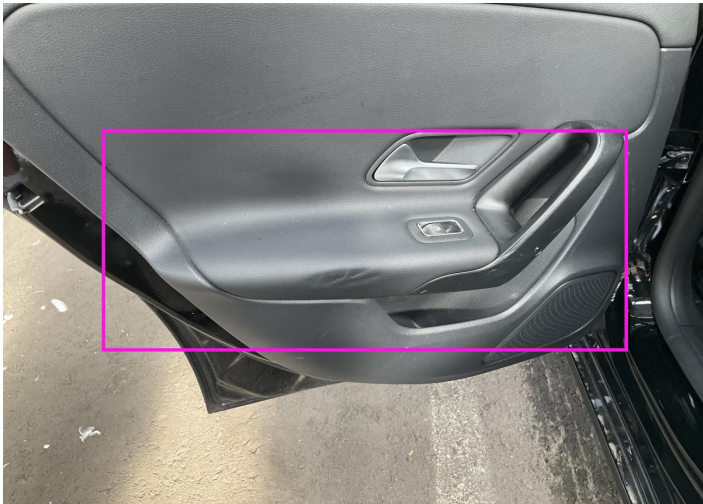
3. Panel Filling / Back Left  
Interior / Scratched -

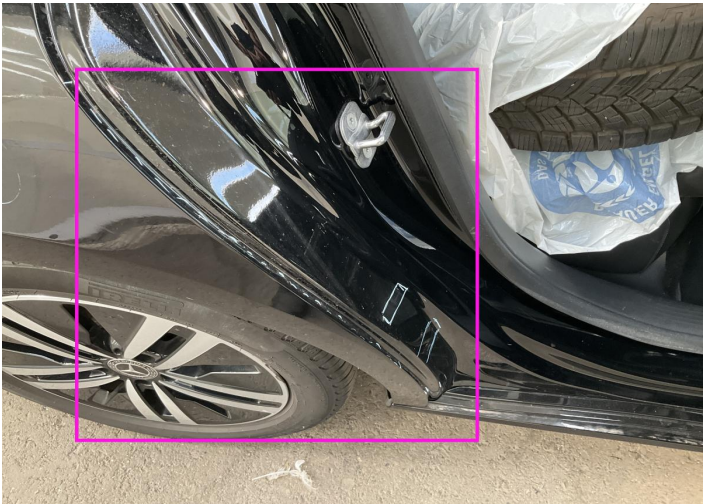
4. Pillar / Back Right  
Paint / Scratch / Scuff -

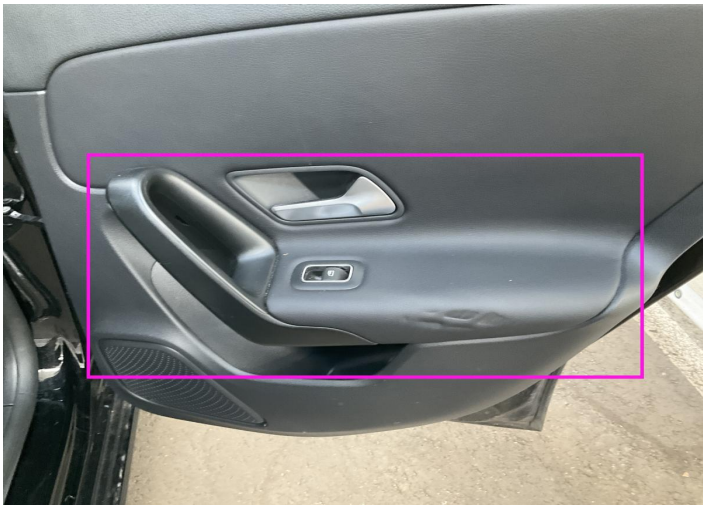
5. Panel Filling / Back Right  
Interior / Scratched -

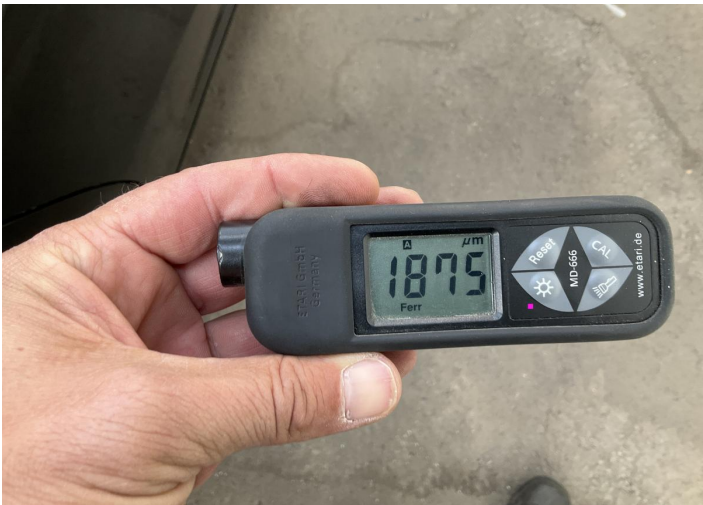
6. Fender / Back Right  
Paint / Poor Previous Repair -

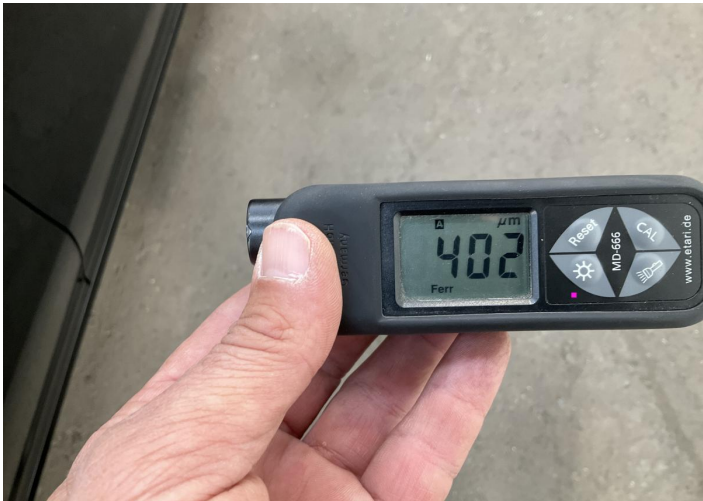
7. Door / Back Right  
Paint / Poor Previous Repair -

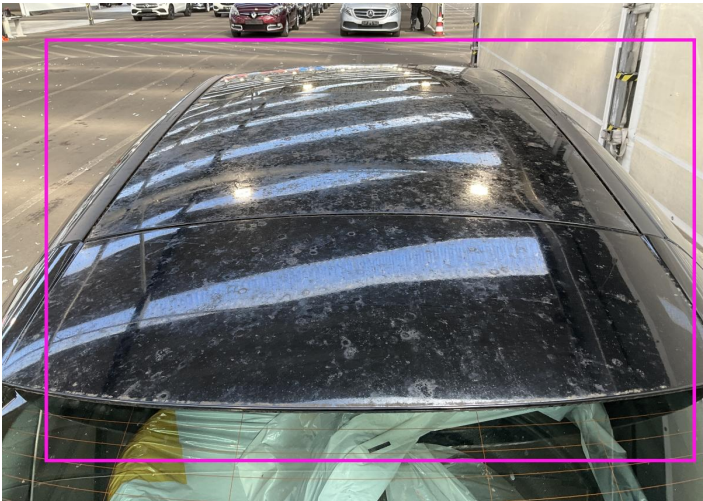
8. Roof  
Paint / Chemical Damage -

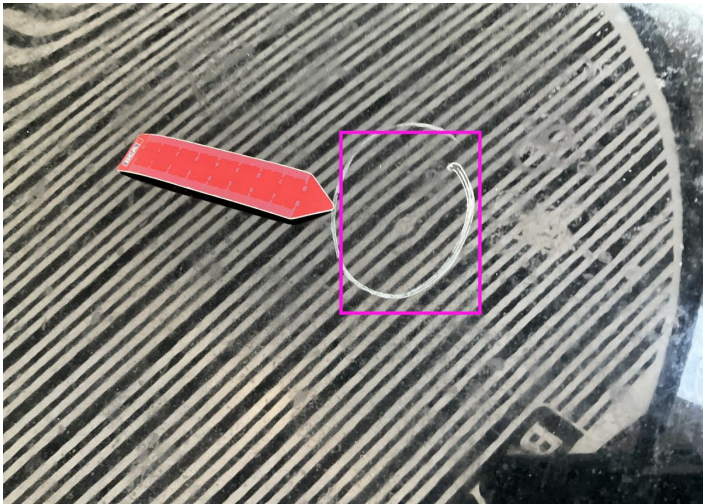
9. Hood  
Bodywork / Dent / Dent -

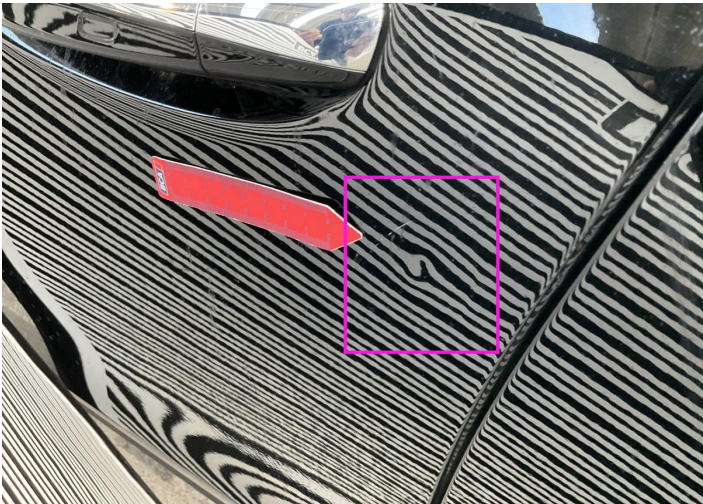
10. Door / Front Left  
Bodywork / Dent / Dent -

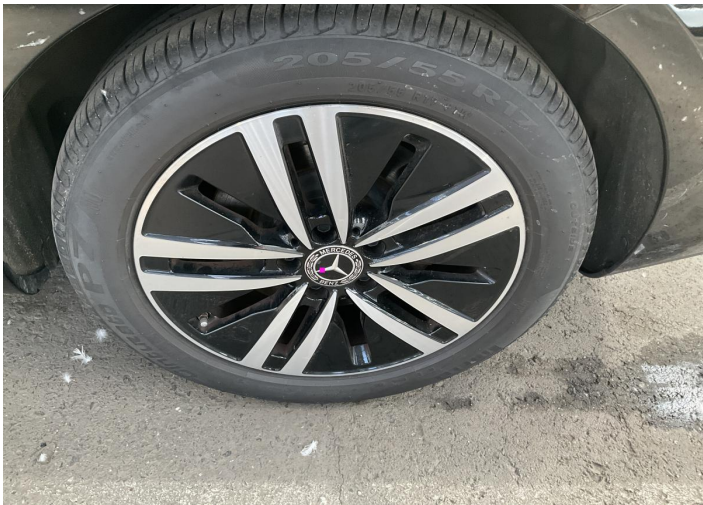
11. Rim / Back Left  
Out of Bodywork / Scratch -

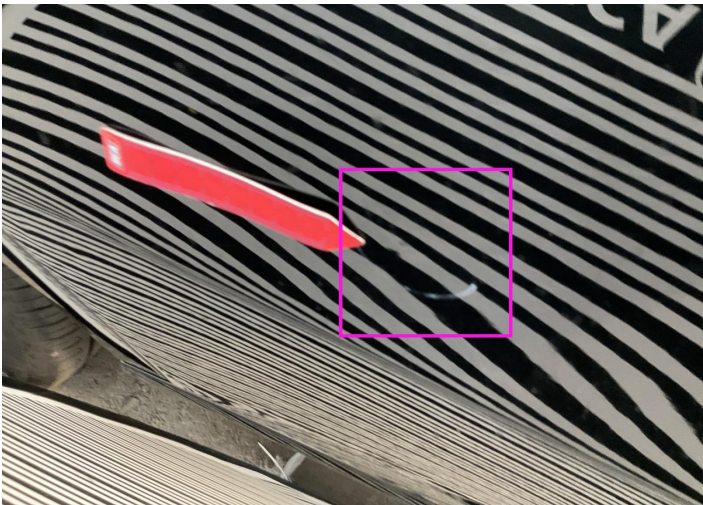
12. Door / Back Right  
Bodywork / Dent / Dent -
