Expertise

Protocol number: 41251634  
Order No. / Reference: 25106317  
Inspection date: 26 Aug 2025

Manufacturer: Mercedes-Benz  
VIN: W1N2476121W047480

Model: GLB 200 d 8G-DCT Style

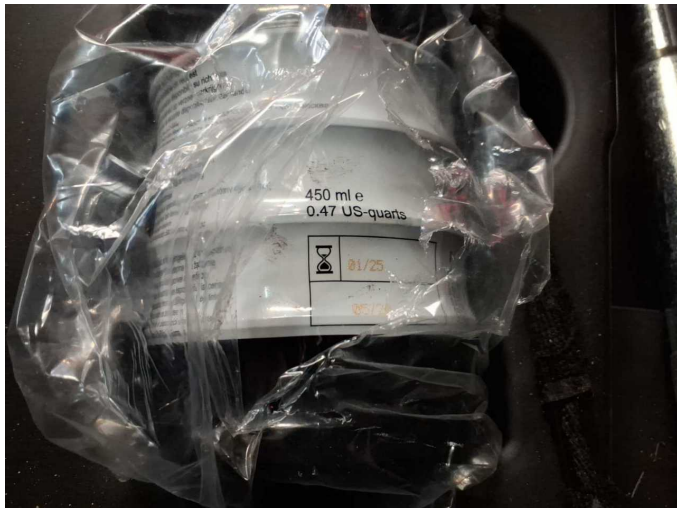
| No. | Component group | Description |
|---|---|---|
| 2 | Equipment | Tirefit filler - Expired - Replace |

**Damage 2:** Equipment: Tirefit filler - Expired - Replace

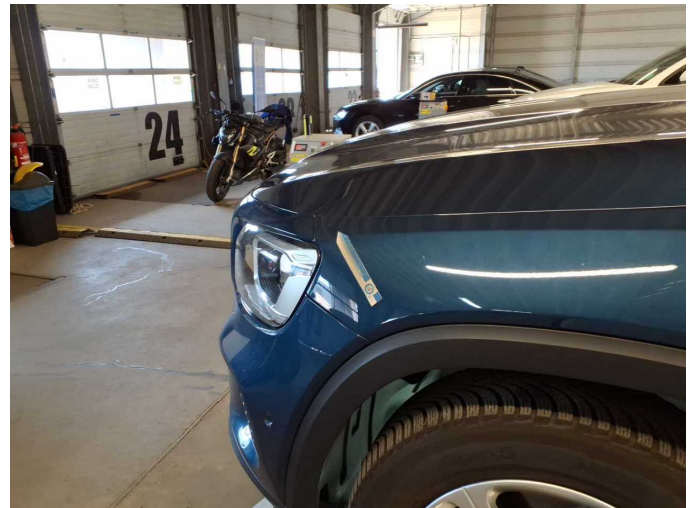
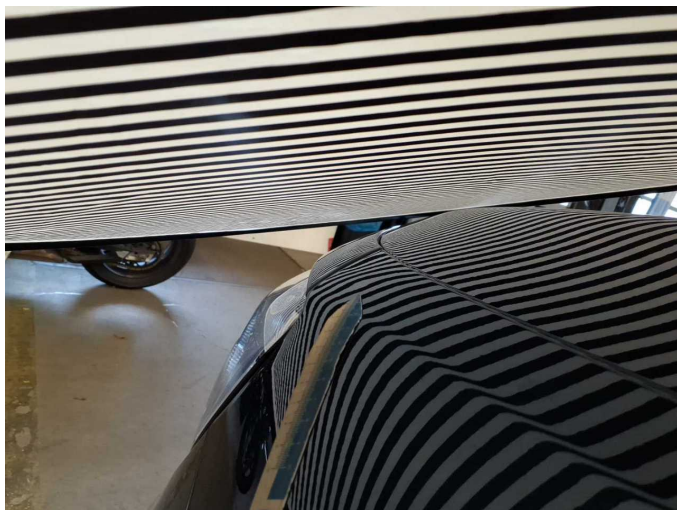
| No. | Component group | Description |
|---|---|---|
| 3 | Mudguard - left side | Mudguard - left side - dent(s) - Smooth repair work |

**Damage 3:** Mudguard - left side: Mudguard - left side - dent(s) - Smooth repair work

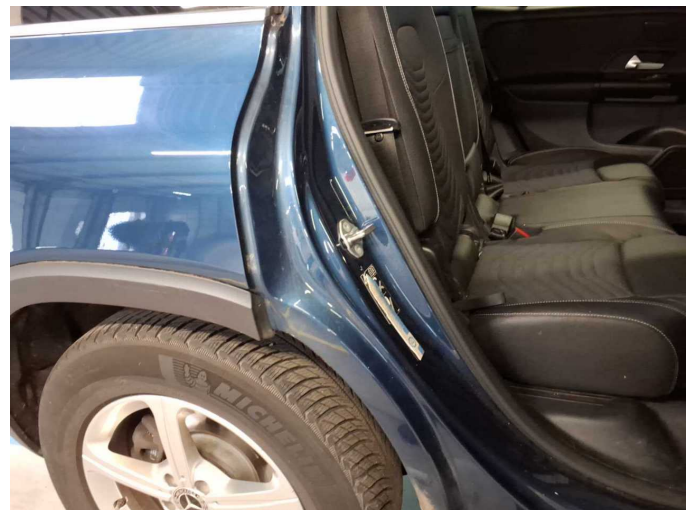
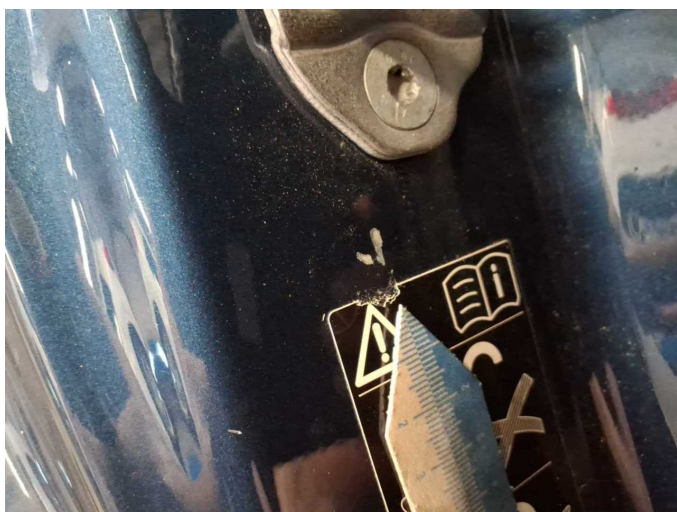
| No. | Component group | Description |
|---|---|---|
| 4 | Side panel - rear right side | Sill - Scratch(es) - Smart repair |

**Damage 4:** Side panel - rear right side: Sill - Scratch(es) - Smart repair

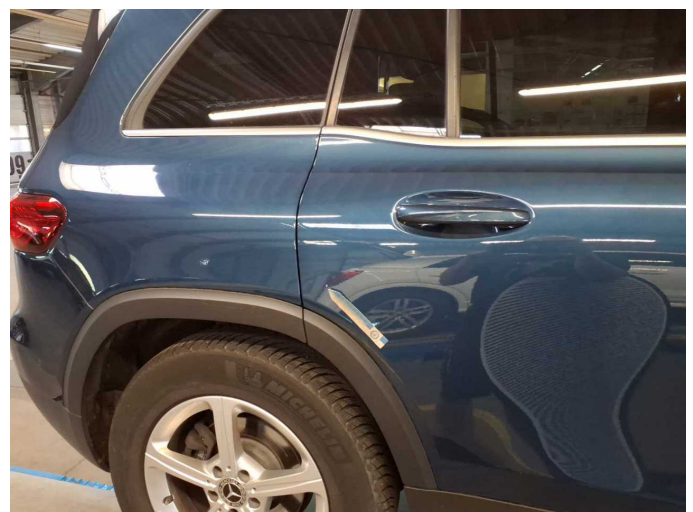
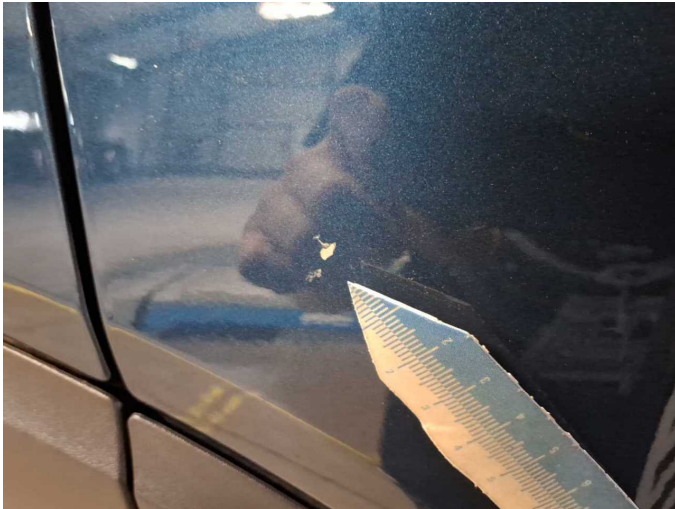
| No. | Component group | Description |
|---|---|---|
| 5 | Door - rear right side | Door - Scratch(es) - Smart repair |

**Damage 5:** Door - rear right side: Door - Scratch(es) - Smart repair

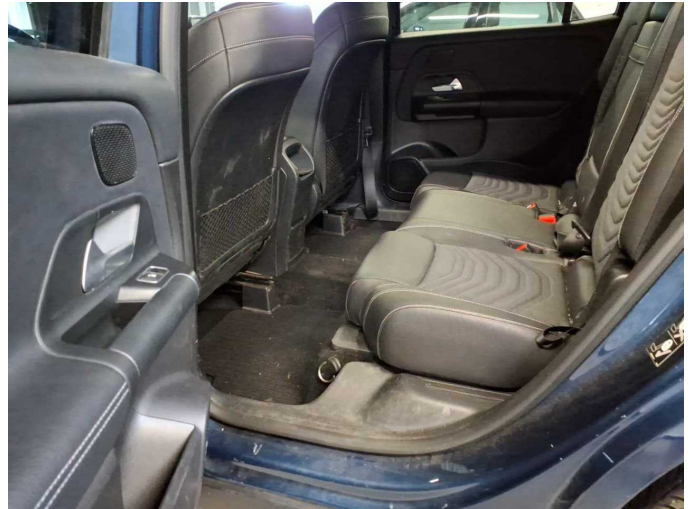
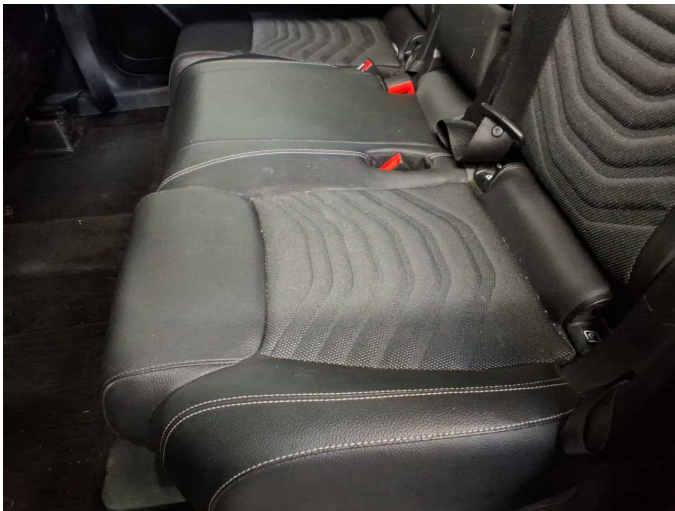
| No. | Component group | Description |
|---|---|---|
| 6 | Interior | Interior (Flecken) - Soiled - Clean |

**Damage 6:** Interior: Interior (Flecken) - Soiled - Clean

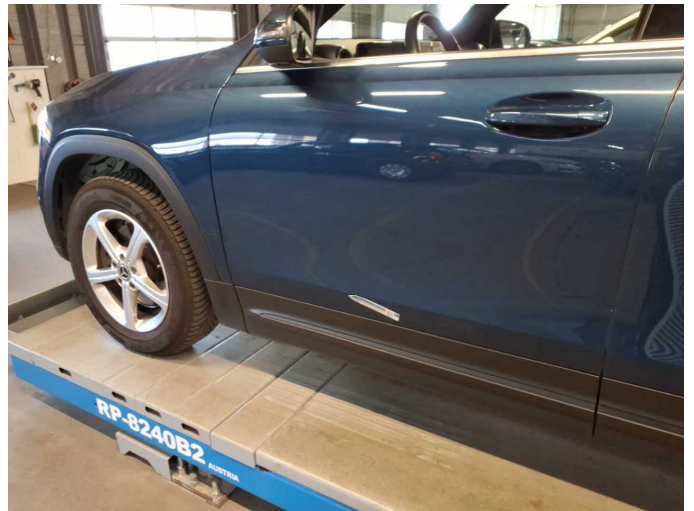
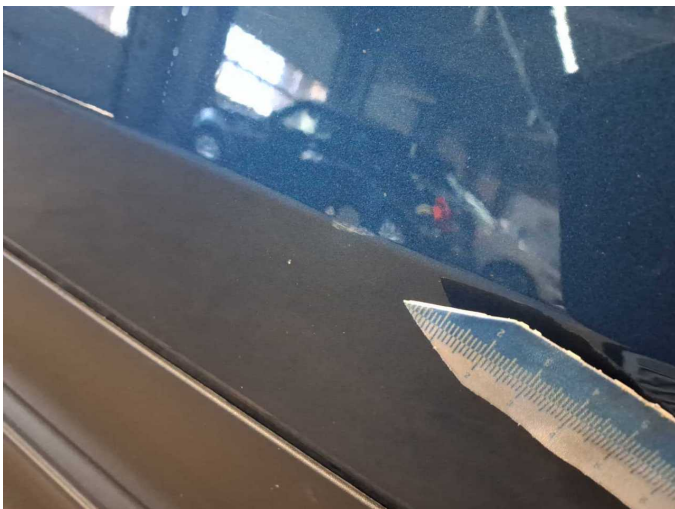
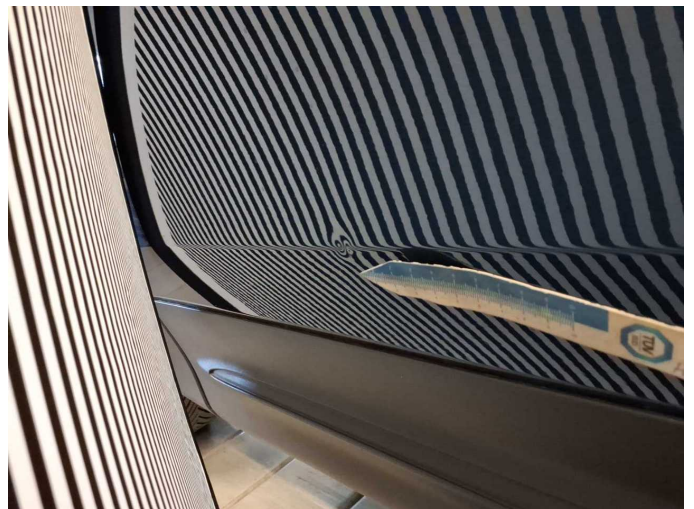
| No. | Component group | Description |
|---|---|---|
| 7 | Door - front left side | Door - Dent / paintcoat damage - Smart repair |

**Damage 7:** Door - front left side: Door - Dent / paintcoat damage - Smart repair

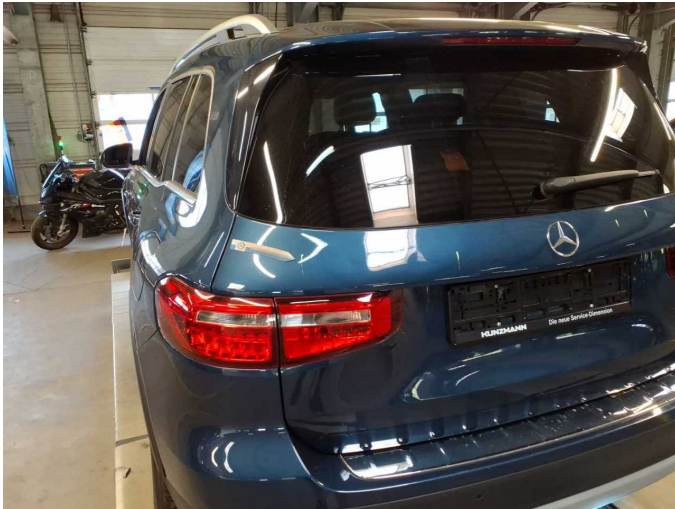
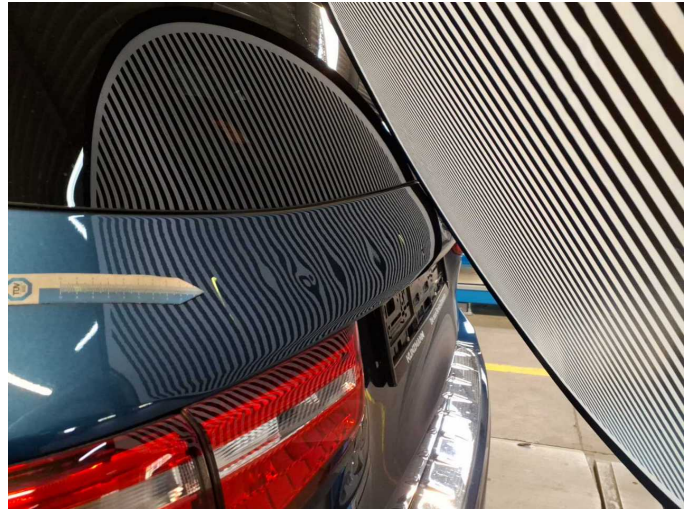
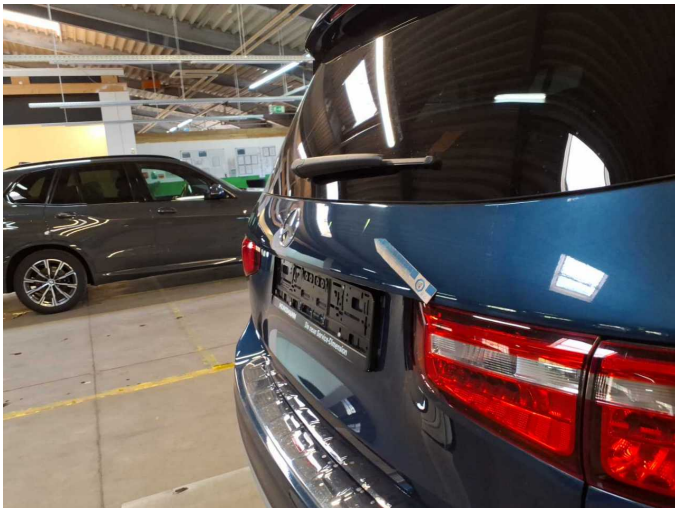
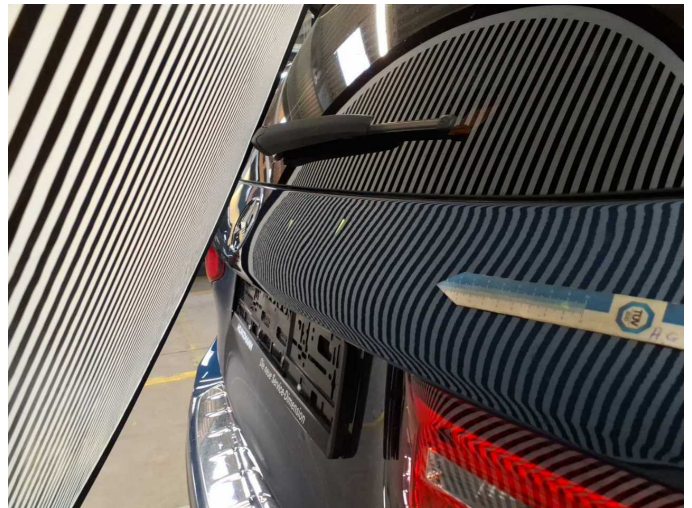
| No. | Component group | Description |
|---|---|---|
| 8 | Boot lid / rear door | Boot lid - dent(s) - Smooth repair work |

**Damage 8:** Boot lid / rear door: Boot lid - dent(s) - Smooth repair work

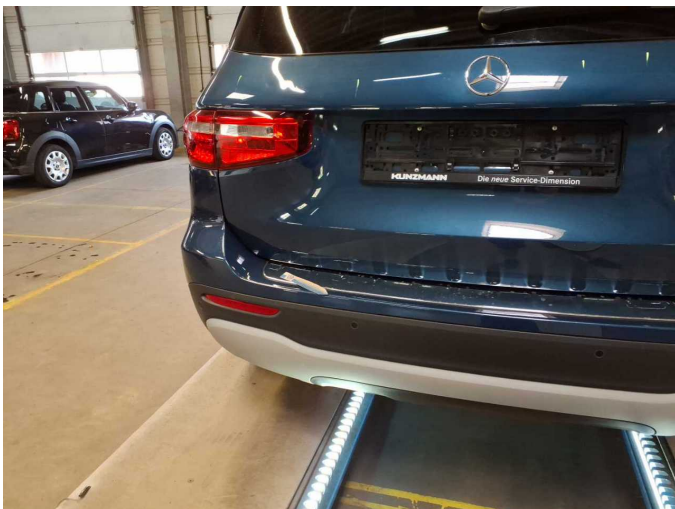
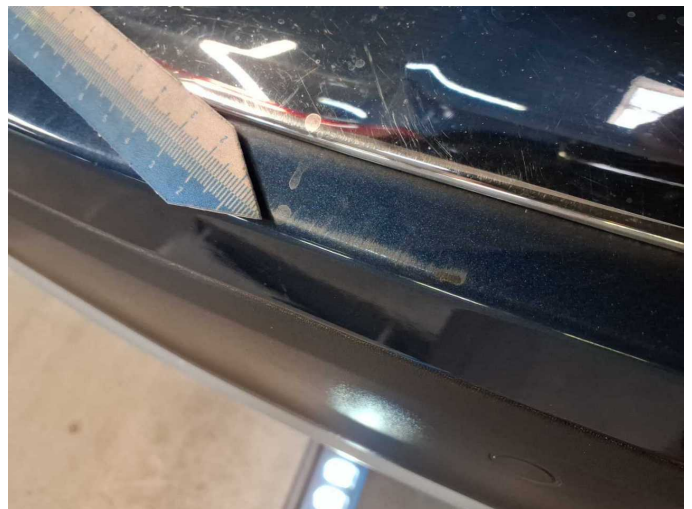
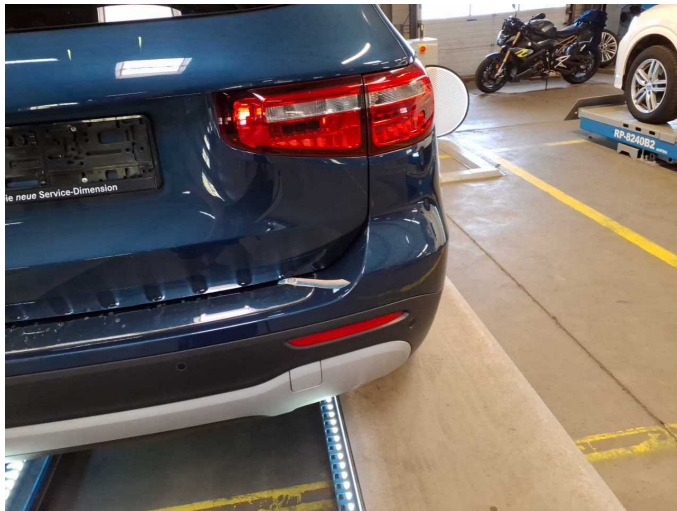
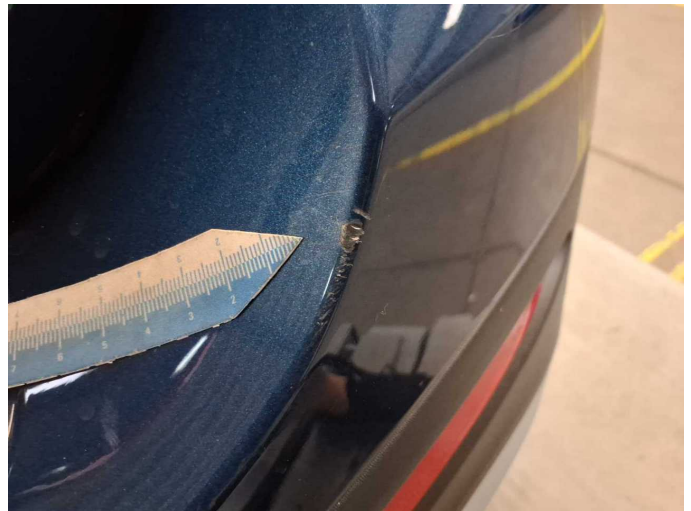
| No. | Component group | Description |
|---|---|---|
| 9 | Rear bumper | Rear bumper - Scratch(es) - Paint |

**Damage 9:** Rear bumper: Rear bumper - Scratch(es) - Paint

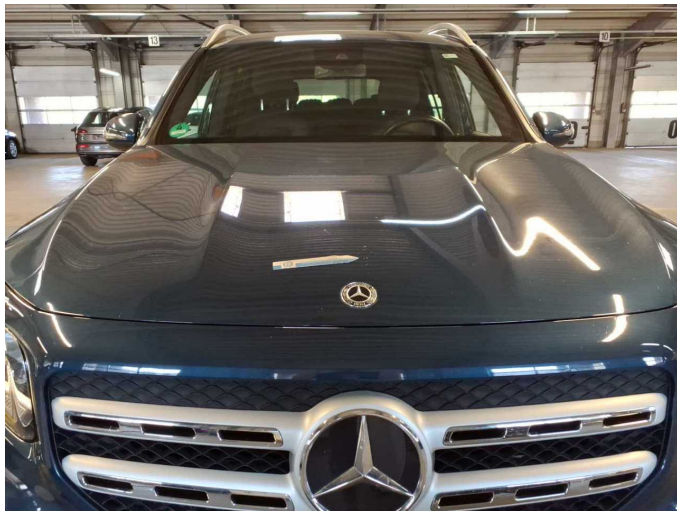
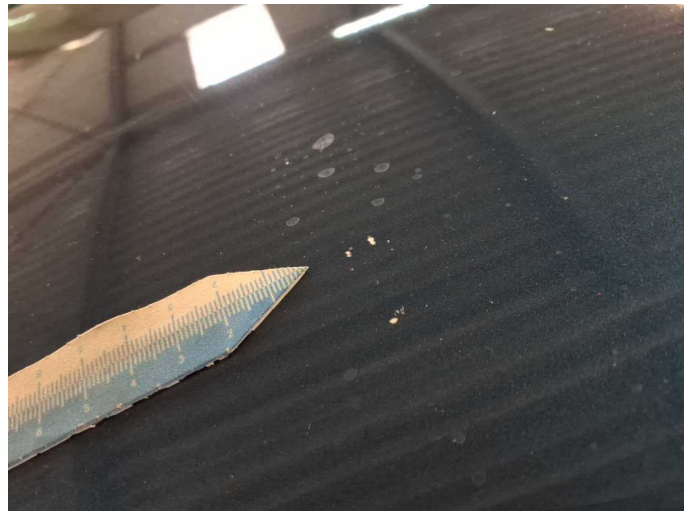
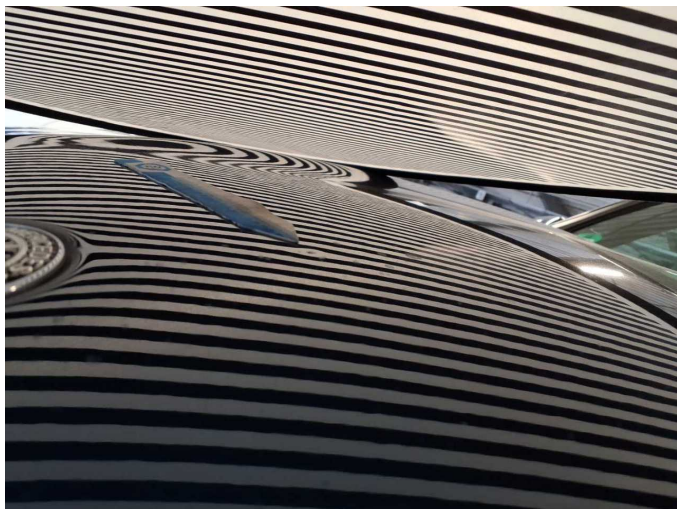
| No. | Component group | Description |
|---|---|---|
| 10 | Bonnet | Bonnet - Dent / paintcoat damage - Repair and paint |

**Damage 10:** Bonnet: Bonnet - Dent / paintcoat damage - Repair and paint

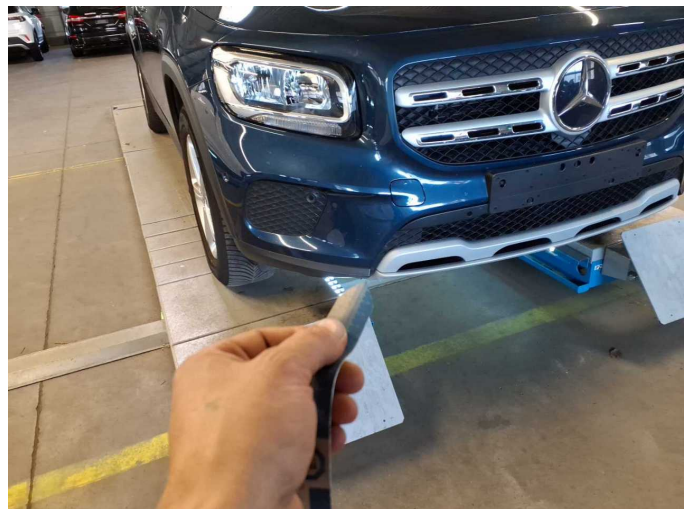
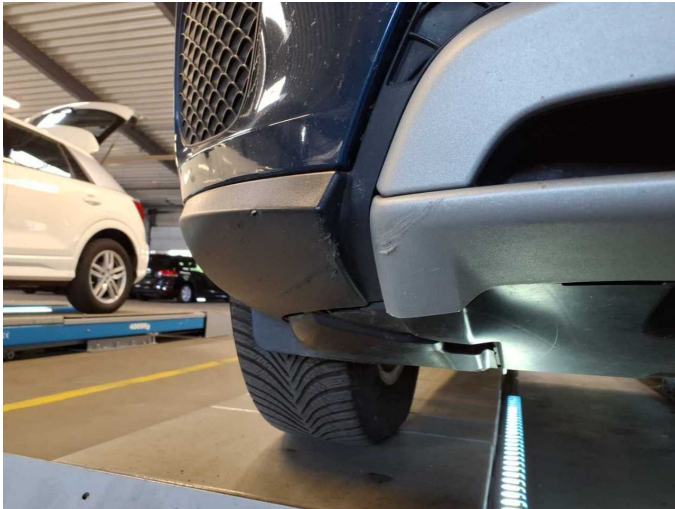
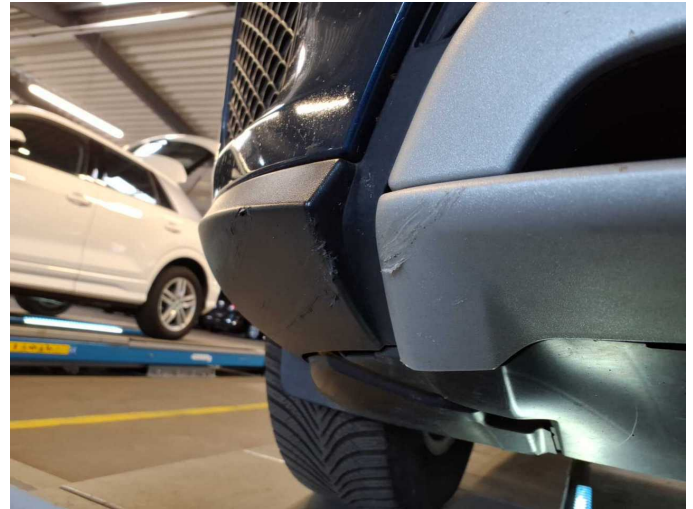
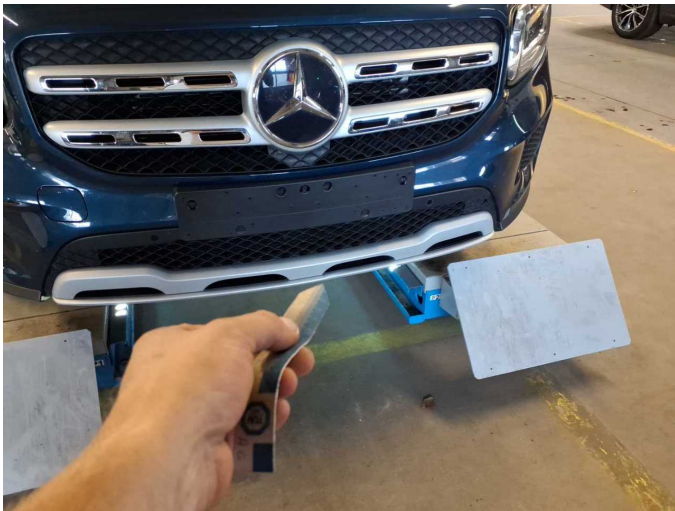
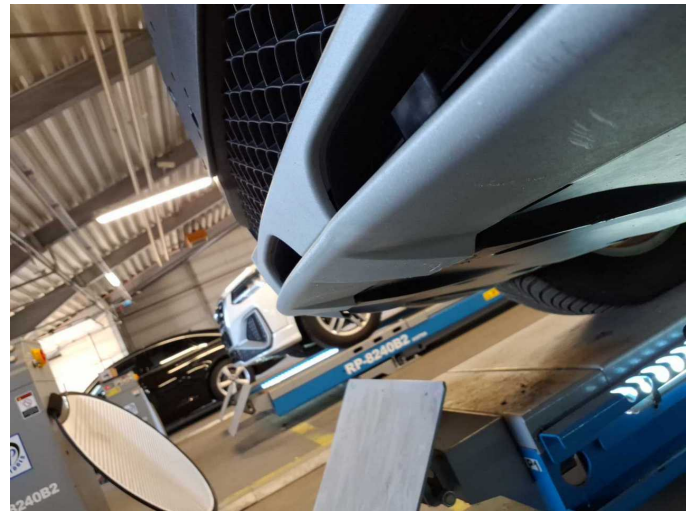
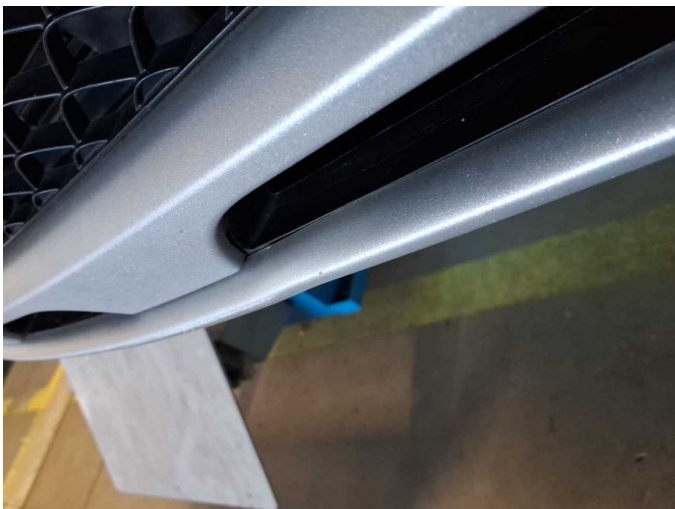
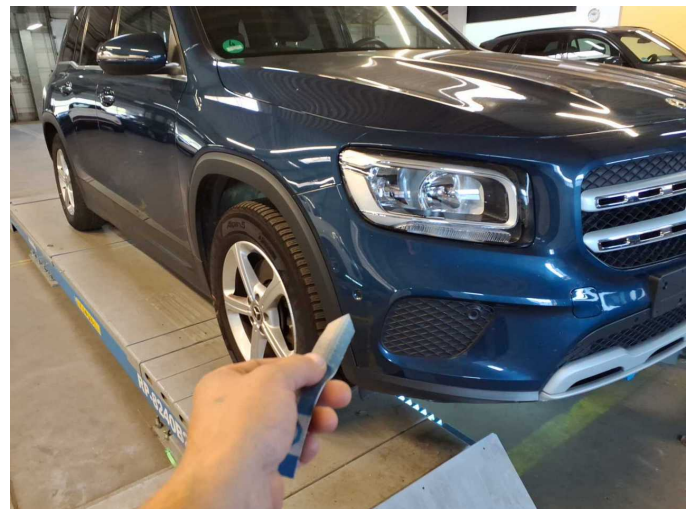
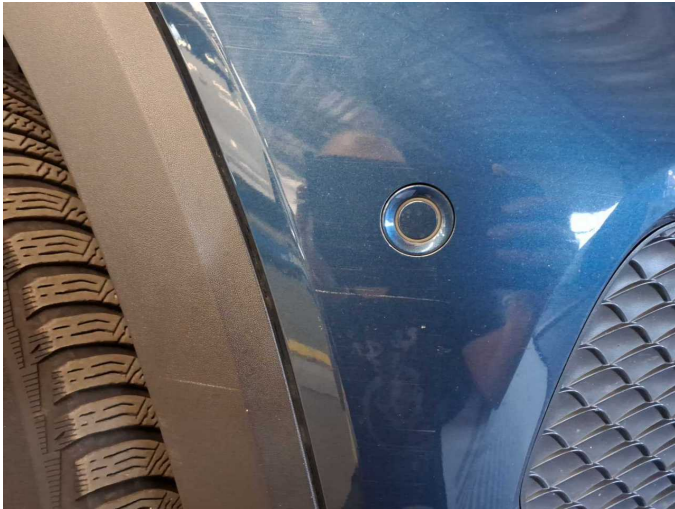
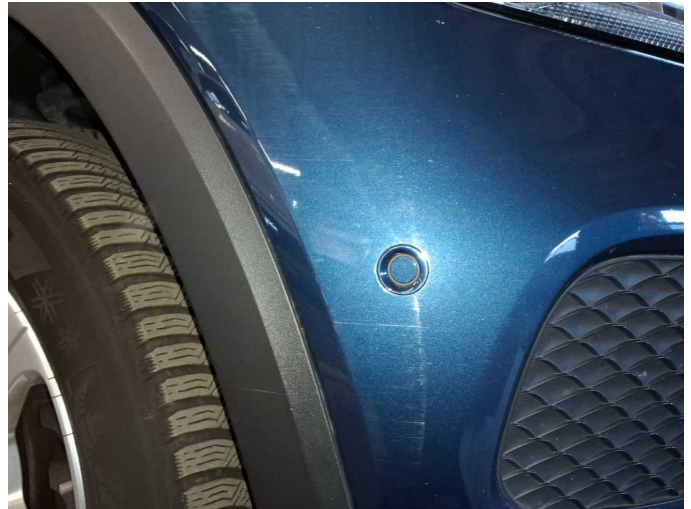
| No. | Component group | Description |
|---|---|---|
| 11 | Front bumper | Front bumper (mit Anbauteile) - Damaged - repair according to calculation |

Die beigelegte Reparaturkostenkalkulation wurde nach bestem Wissen und Gewissen unter eingeschränkten Besichtigungsbedingung im demontagefreien Zustand erstellt. Es können aufgrund verdeckter Beschädigung, Mehrkosten und somit Abweichung der für die Stoßstange ausgewiesenen Reparaturkosten nicht ausgeschlossen werden.

**Damage 11:** Front bumper: Front bumper (mit Anbauteile) - Damaged - repair according to calculation

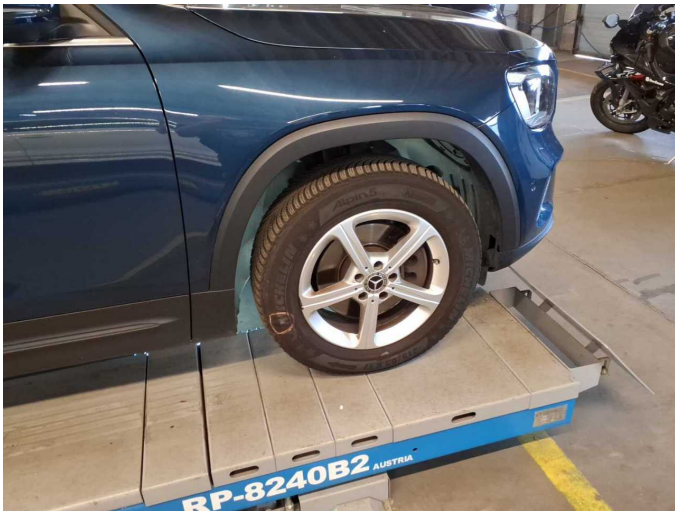
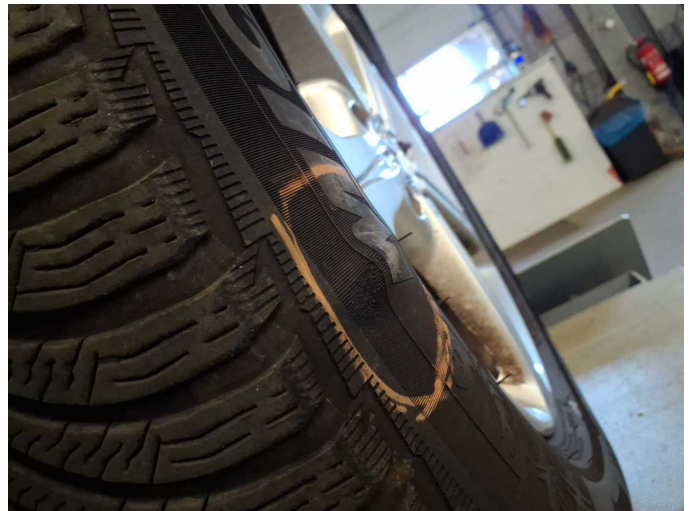
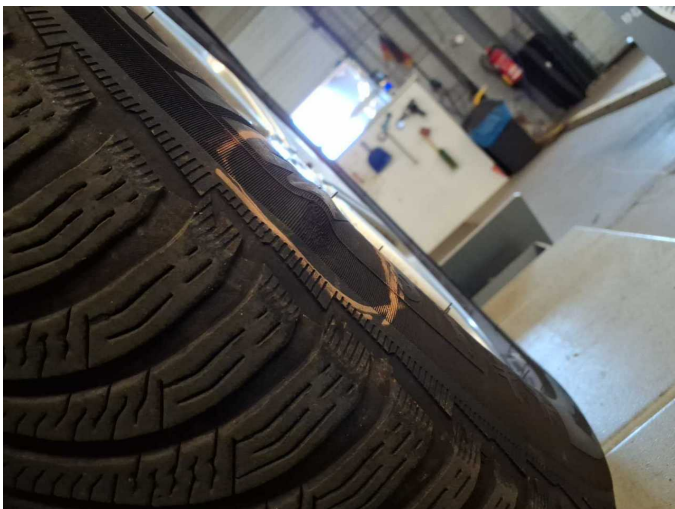
| No. | Component group | Description |
|---|---|---|
| 1 | Wheel / tyres | Tyre - front right side (Flanke, nicht fahrtauglich) - Damaged - No deduction |

Der montierte Winterradsatz ist nicht Bestandteil der vorliegenden Fahrzeugausstattung. Nicht fahrtauglich-Reifen defekt.

**Wear and tear 1:** Wheel / tyres: Tyre - front right side (Flanke, nicht fahrtauglich) - Damaged - No deduction
