## status report

**customer:** Bank 11, Neuss  
**contract number:** 1034400430  
**reference:**

#### Mercedes-Benz GLB -Klasse GLB 200

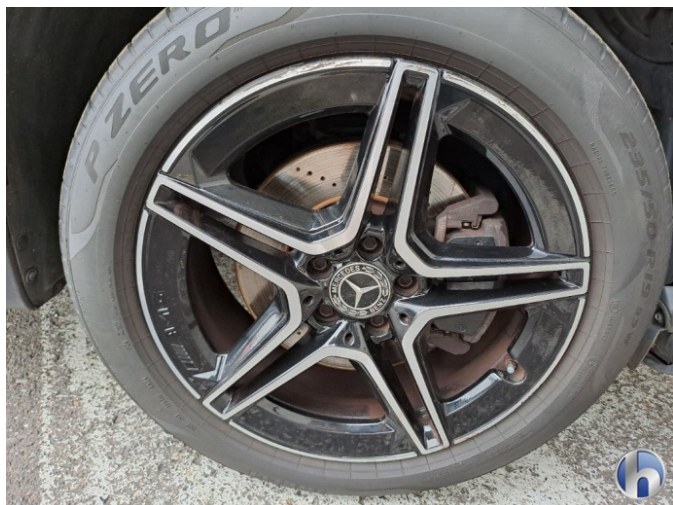
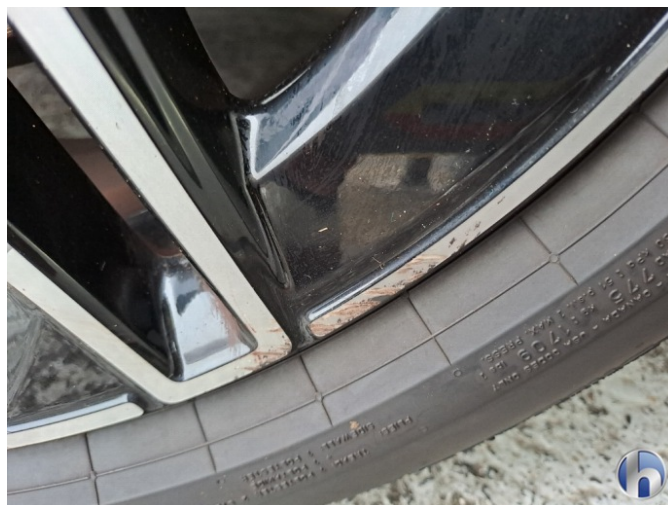
| | component | Damage | Rep kind |
|---|---|---|---|
| 1. | Rim front - right | Damaged | Replace |

1. Rim front - right

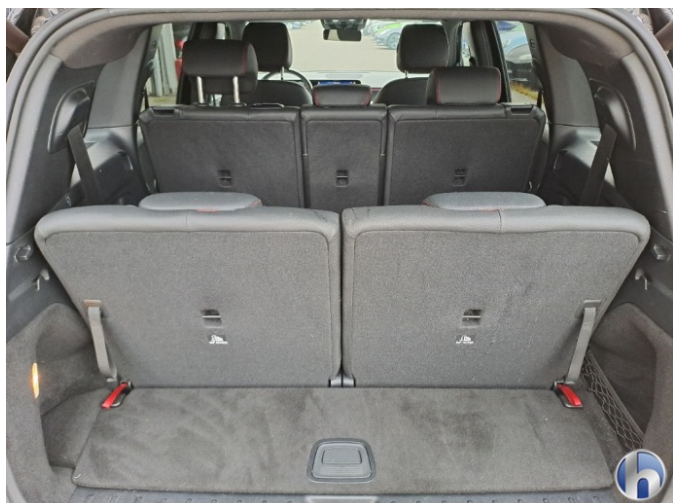
| | component | Damage | Rep kind |
|---|---|---|---|
| 3. | Cargo cover | Missing | Replace |

3. Cargo cover

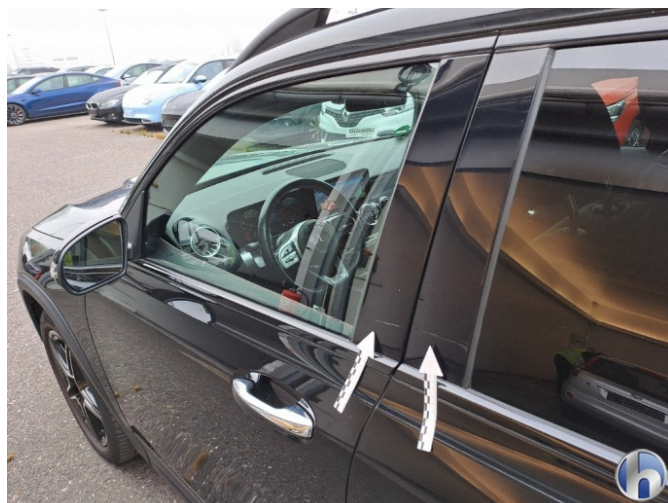
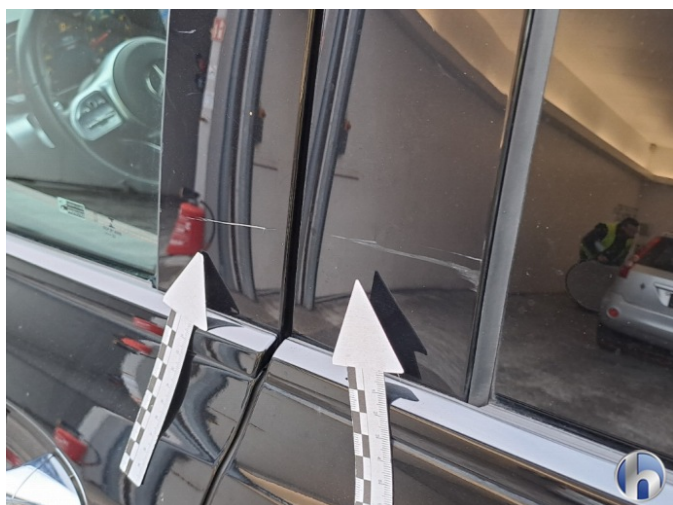
| | component | Damage | Rep kind |
|---|---|---|---|
| 4. | Blende Türe VL und HL | Scratch(es) | Replace |

4. Blende Türe VL und HL

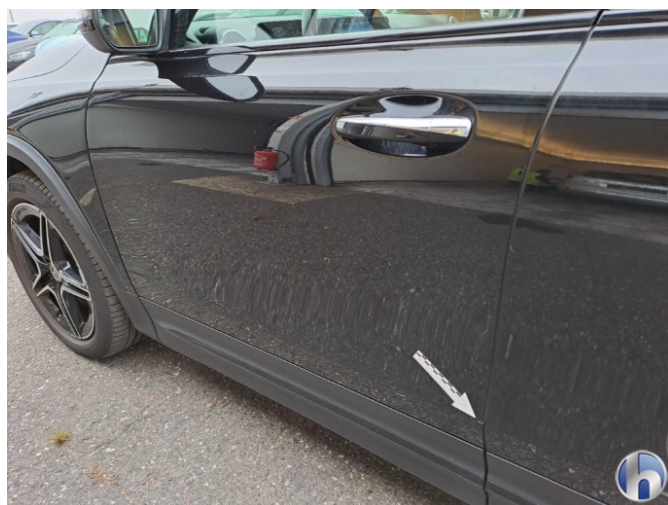
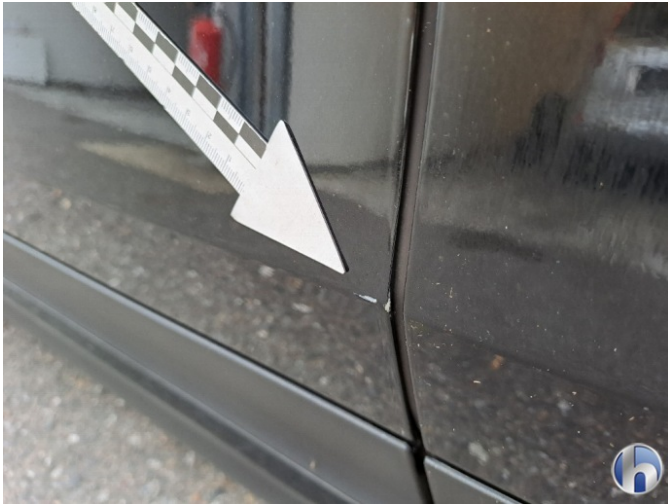
| | component | Damage | Rep kind |
|---|---|---|---|
| 5. | Front door - left | Scratch(es) | Smart repair |

5. Front door - left

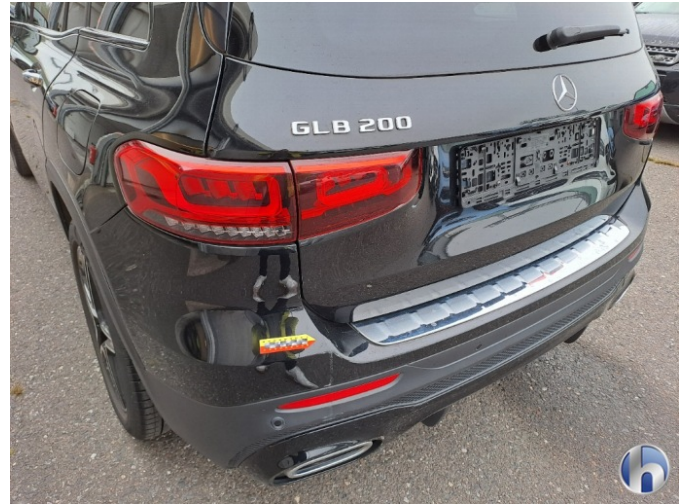
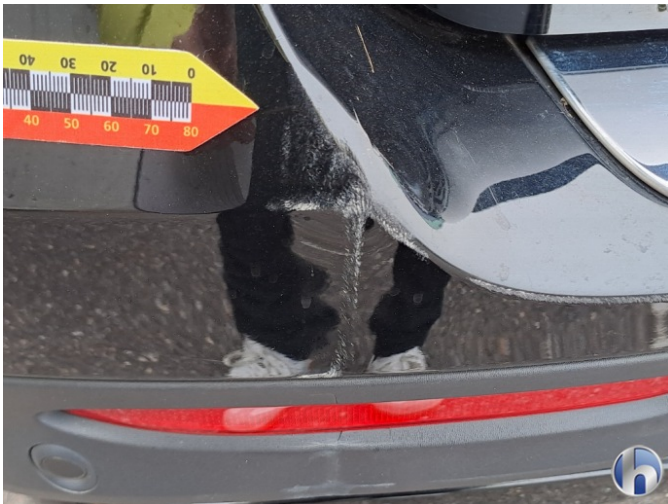
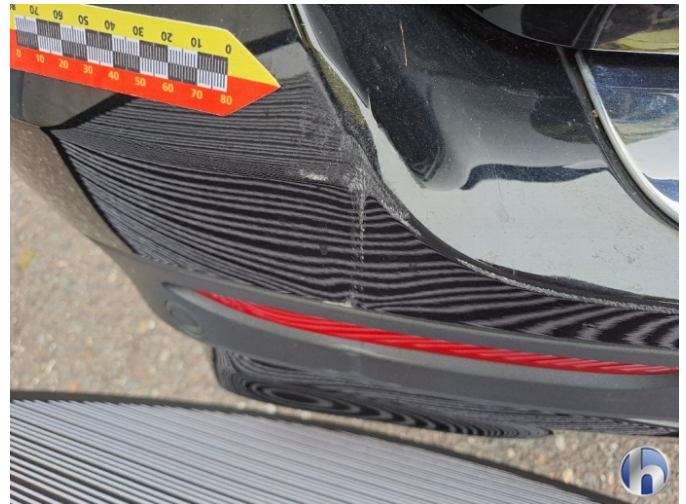
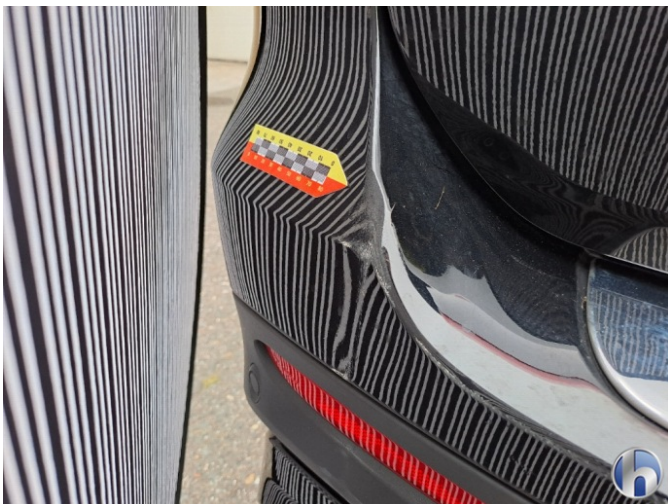
| | component | Damage | Rep kind |
|---|---|---|---|
| 6. | Rear bumper | Damaged | Replace |

6. Rear bumper

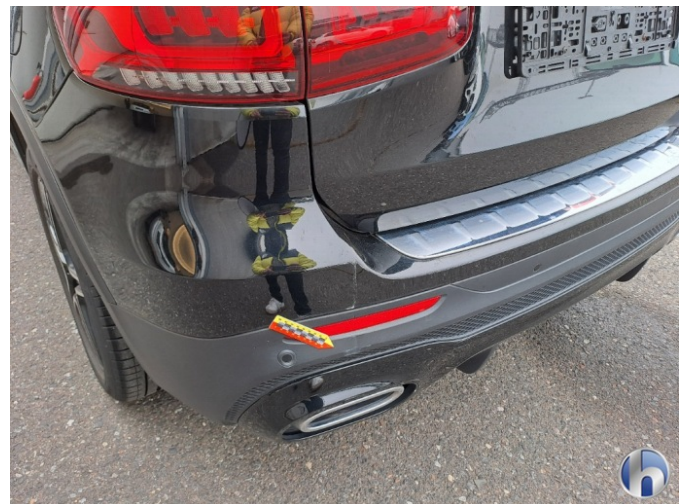
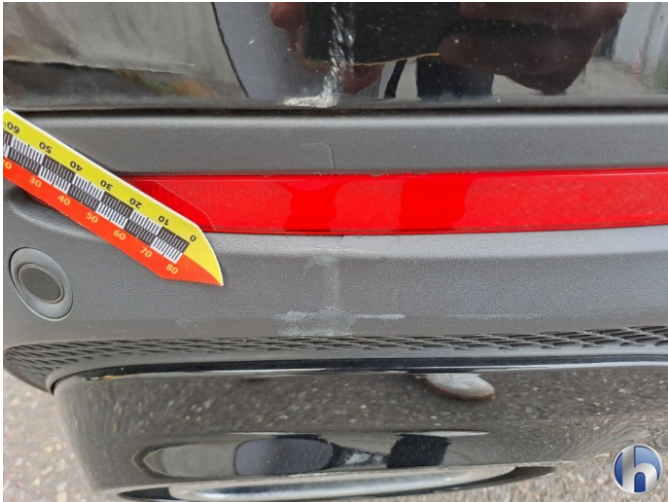
| | component | Damage | Rep kind |
|---|---|---|---|
| 7. | Blende Stoßfänger hinten | Damaged | Replace |

7. Blende Stoßfänger hinten

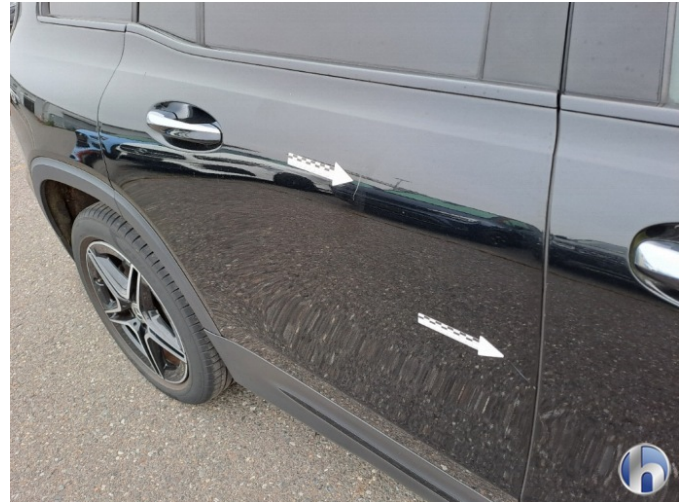
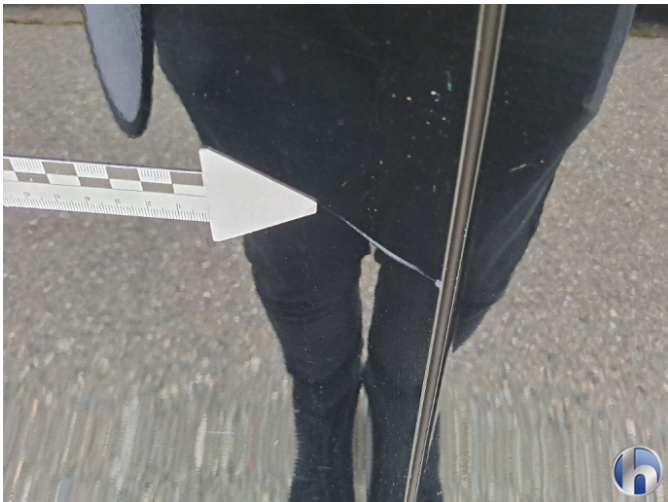
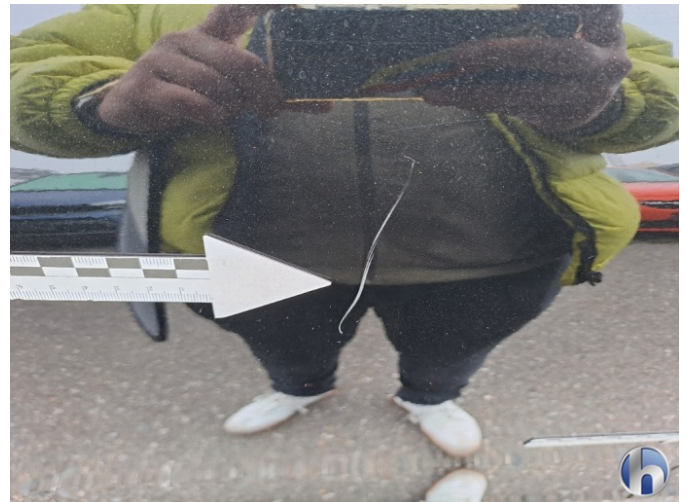
| | component | Damage | Rep kind |
|---|---|---|---|
| 8. | Door Rear - right | Scratch(es) | Paint |

8. Door Rear - right

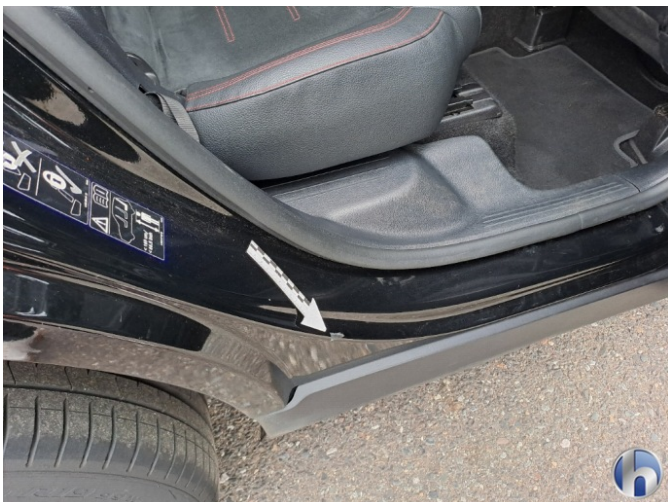
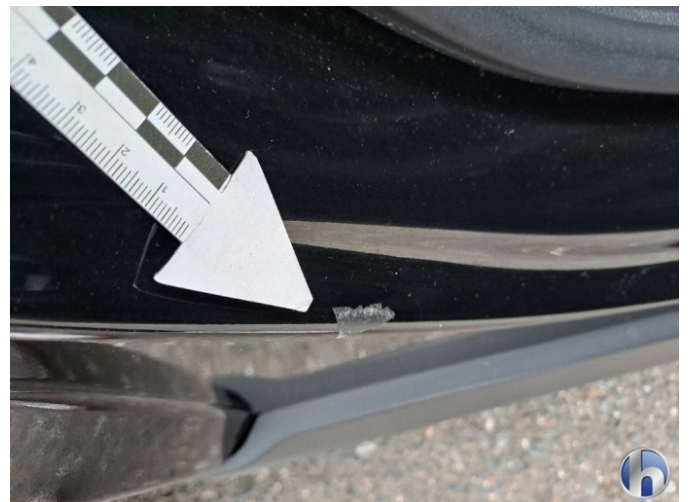
| | component | Damage | Rep kind |
|---|---|---|---|
| 9. | Türeinstieg Hinten - Rechts | Scrape | Refurbish and paint |

9. Türeinstieg Hinten - Rechts

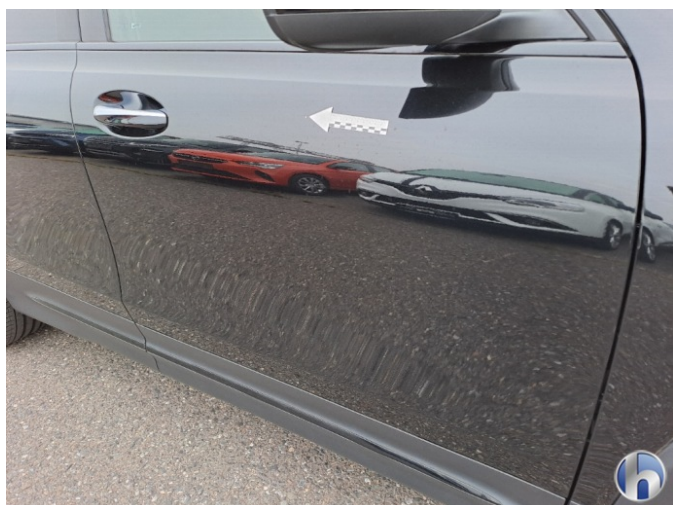
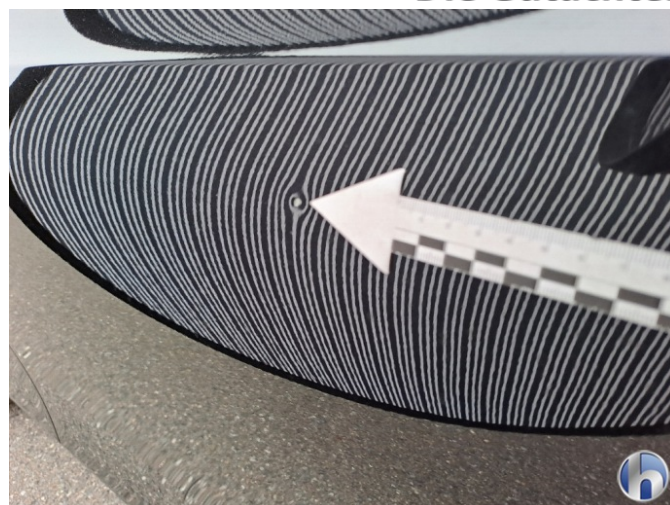
| | component | Damage | Rep kind |
|---|---|---|---|
| 10. | Front door - right | | Refurbish and paint |

10. Front door - right

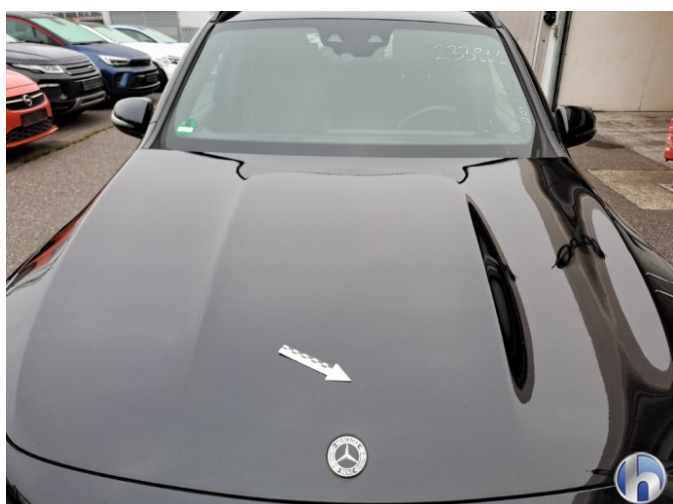
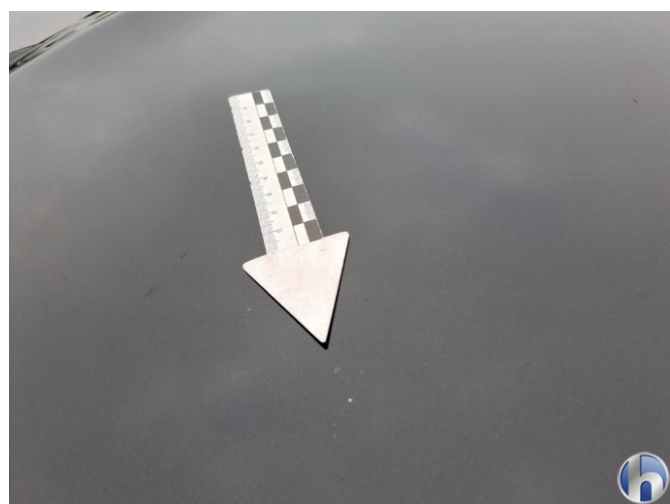
| | component | Damage | Rep kind |
|---|---|---|---|
| 11. | hood | Wear and tear | acceptable |

11. hood

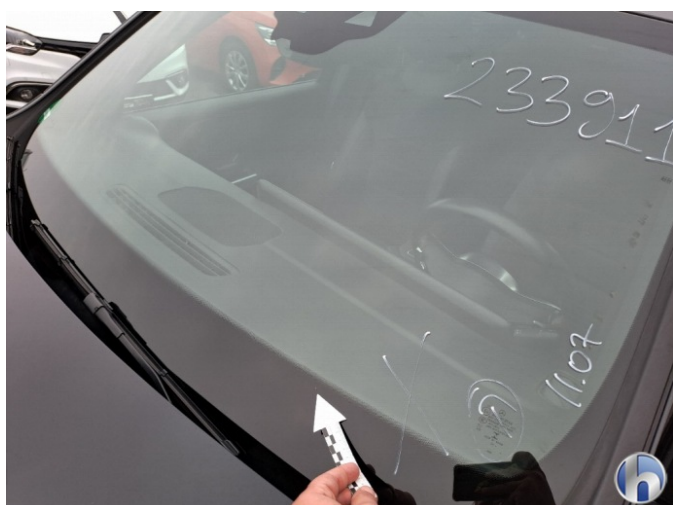
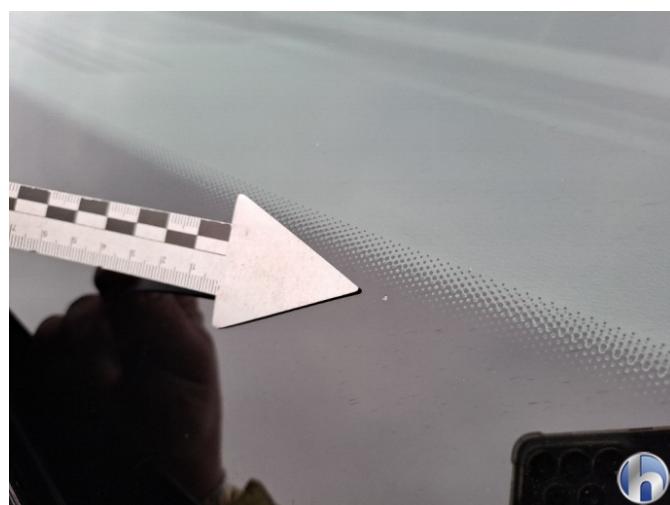
| | component | Damage | Rep kind |
|---|---|---|---|
| 12. | Windshield | Wear and tear | acceptable |

12. Windshield

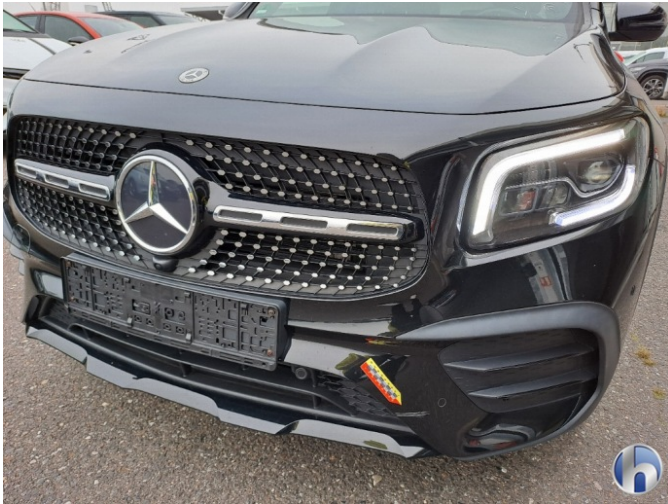
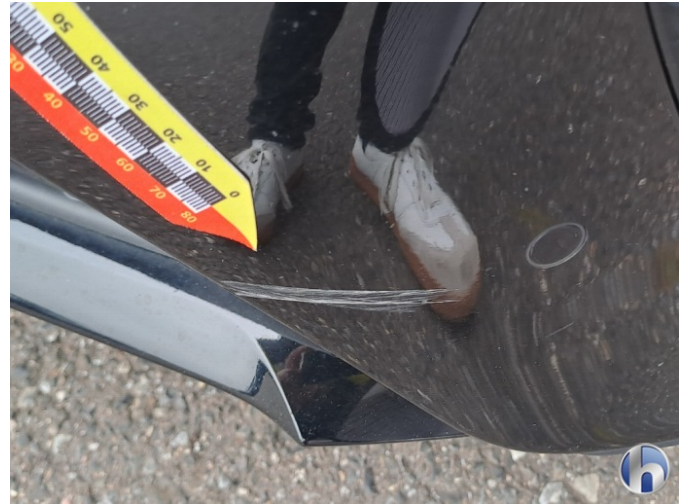
| | component | Damage | Rep kind |
|---|---|---|---|
| 13. | Front bumper | Scratch(es) | Paint |

13. Front bumper
