Expertise

Protocol number: 41404528
Order No. / Reference: 25144990
Inspection date: 4 Sept 2025

Manufacturer: Mercedes-Benz

Model: GLC-Coupe 300 d 4Matic 9G-TRONIC AMG Line

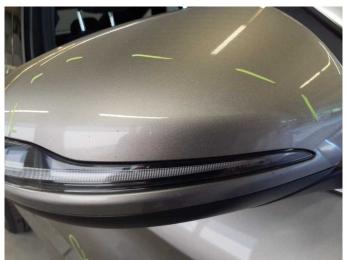
| No. | Component group | Description |
|---|---|---|
| 3 | Wing mirror - right side | Cap - Stone chips - Smart repair |

Damage 3: Wing mirror - right side: Cap - Stone chips - Smart repair

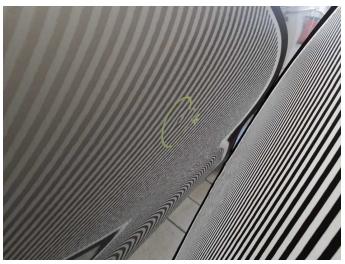
| No. | Component group | Description |
|---|---|---|
| 4 | Door - front right side | Door - dent(s) - Smooth repair work |

Damage 4: Door - front right side: Door - dent(s) - Smooth repair work

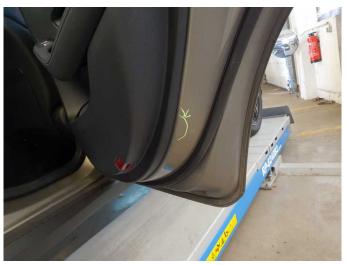
| No. | Component group | Description |
|---|---|---|
| 6 | Door - rear right side | Door - dent(s) - Smooth repair work |

Damage 6: Door - rear right side: Door - dent(s) - Smooth repair work

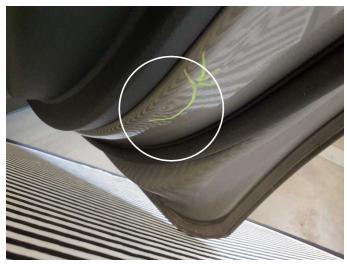
Damage 6: Door - rear right side: Door - dent(s) - Smooth repair work

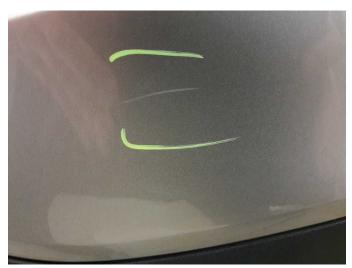
| No. | Component group | Description |
|---|---|---|
| 7 | Rear bumper | Rear bumper - Scratched - Smart repair |

Damage 7: Rear bumper: Rear bumper - Scratched - Smart repair

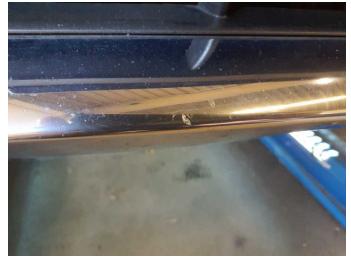
| No. | Component group | Description |
|---|---|---|
| 8 | Front bumper | Spoiler - Scratched - Replace |

Damage 8: Front bumper: Spoiler - Scratched - Replace

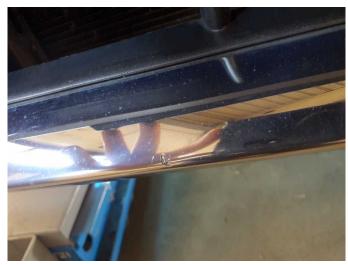
Damage 8: Front bumper: Spoiler - Scratched - Replace

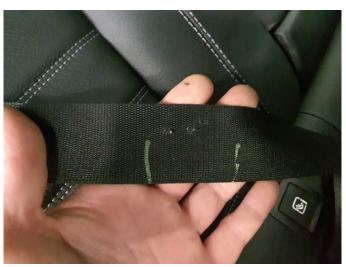
| No. | Component group | Description |
|---|---|---|
| 9 | Seat belts - rear | Seat belt - rear right side - Broken / torn - Replace |

Damage 9: Seat belts - rear: Seat belt - rear right side - Broken / torn - Replace

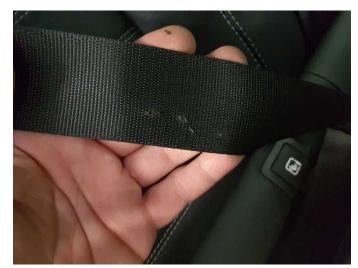
Damage 9: Seat belts - rear: Seat belt - rear right side - Broken / torn - Replace

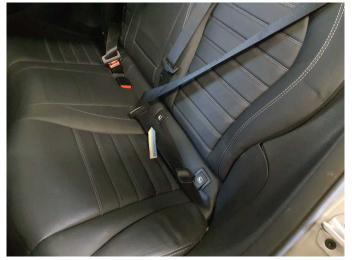
Damage 9: Seat belts - rear: Seat belt - rear right side - Broken / torn - Replace

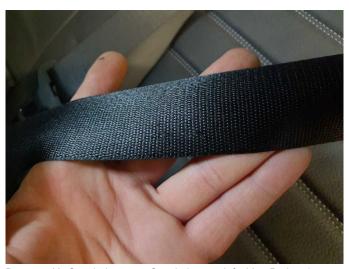
| No. | Component group | Description |
|---|---|---|
| 10 | Seat belts - rear | Seat belt - rear left side - Broken / torn - Replace |

Damage 10: Seat belts - rear: Seat belt - rear left side - Broken / torn - Replace

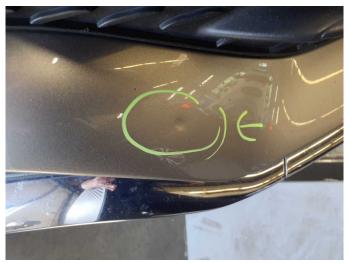
| No. | Component group | Description |
|---|---|---|
| 11 | Front bumper | Front bumper - Dent / paintcoat damage - Repair and paint |

Damage 11: Front bumper: Front bumper - Dent / paintcoat damage - Repair and paint

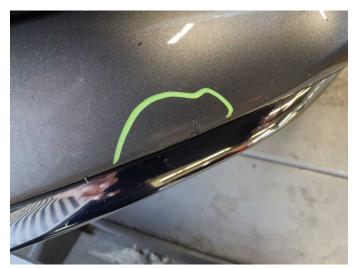
Damage 11: Front bumper: Front bumper - Dent / paintcoat damage - Repair and paint

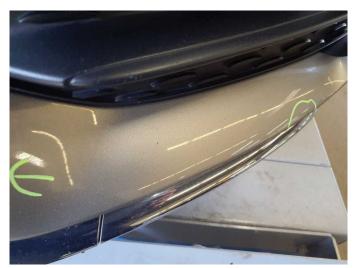
Damage 11: Front bumper: Front bumper - Dent / paintcoat damage - Repair and paint

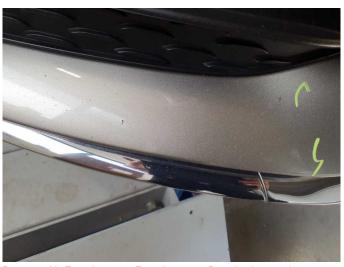
Damage 11: Front bumper: Front bumper - Dent / paintcoat damage - Repair and paint

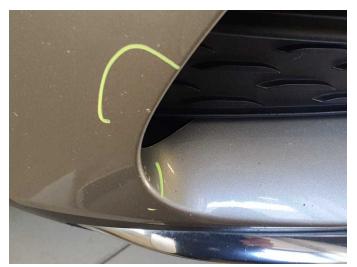
Damage 11: Front bumper: Front bumper - Dent / paintcoat damage - Repair and paint

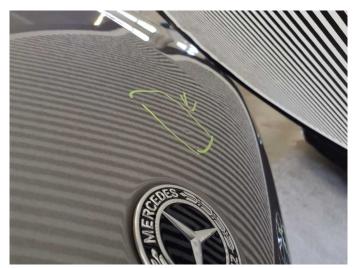
| No. | Component group | Description |
|---|---|---|
| 12 | Bonnet | Bonnet - Dent / paintcoat damage - Repair and paint |

Damage 12: Bonnet: Bonnet - Dent / paintcoat damage - Repair and paint

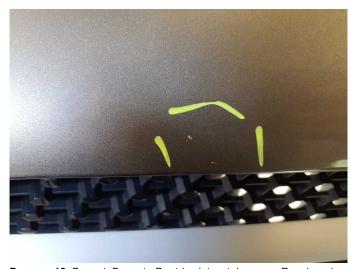
Damage 12: Bonnet: Bonnet - Dent / paintcoat damage - Repair and paint

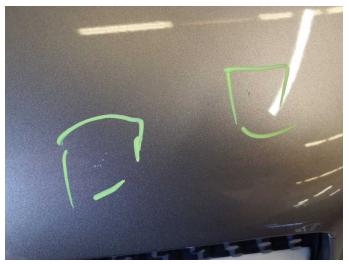
Damage 12: Bonnet: Bonnet - Dent / paintcoat damage - Repair and paint

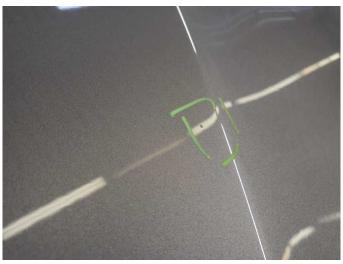
Damage 12: Bonnet: Bonnet - Dent / paintcoat damage - Repair and paint

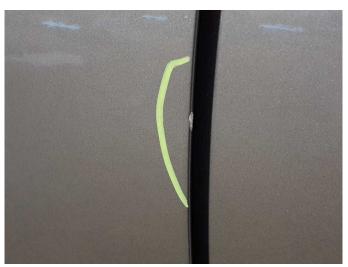
| No. | Component group | Description |
|---|---|--|
| 4 | Door - front left side | Door edge - Scratched - No deduction |

Wear and tear 4: Door - front left side: Door edge - Scratched - No deduction

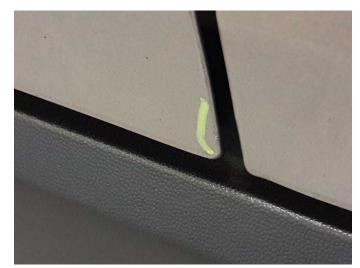
Wear and tear 4: Door - front left side: Door edge - Scratched - No deduction

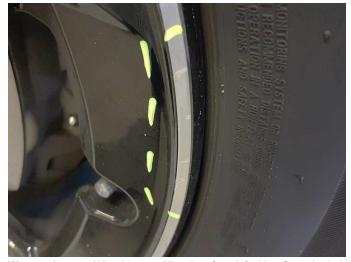
| No. | Component group | Description |
|---|---|--|
| 5 | Wheel / tyres | Alloy rim - front left side - Scratched - No deduction |

Wear and tear 5: Wheel / tyres: Alloy rim - front left side - Scratched - No deduction

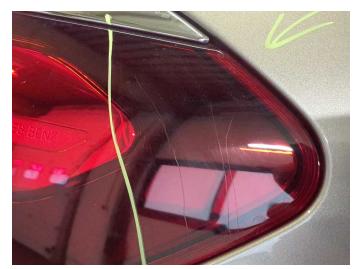
| No. | Component group | Description |
|---|---|--|
| 6 | Tail light | Tail lamp - right side - Scratched - No deduction |

Wear and tear 6: Tail light: Tail lamp - right side - Scratched - No deduction
