Expertise

Protocol number: 41720142  
Order number / reference: 25186768  
Inspection date: 24 Sept 2025

Manufacturer: Mercedes-Benz

Model: GLC 300 de 4Matic 9G-TRONIC

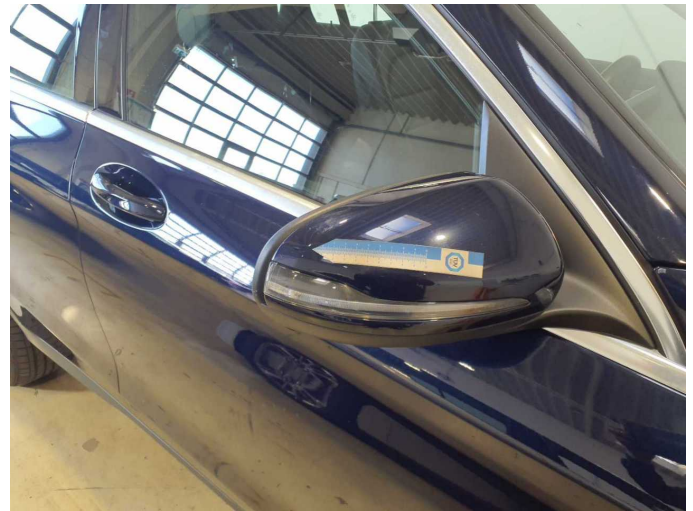
| No. | Component group | Description |
|---|---|---|
| 1 | Wing mirror - right side | Cap - Scratched - Smart repair |

**Damage 1:** Wing mirror - right side: Cap - Scratched - Smart repair

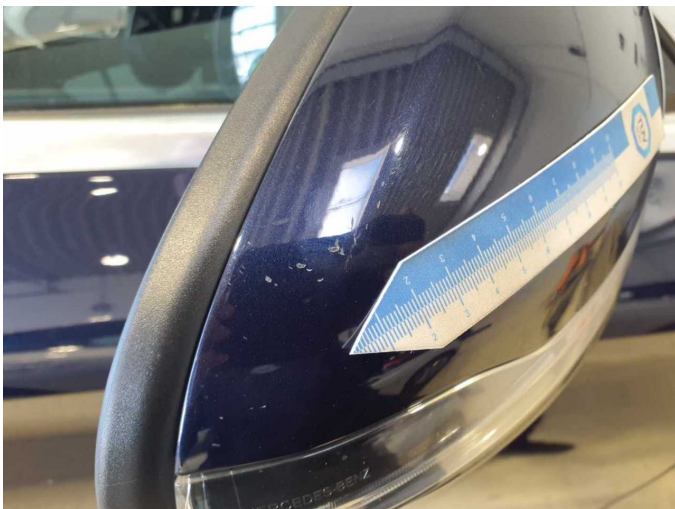
**Damage 1:** Wing mirror - right side: Cap - Scratched - Smart repair

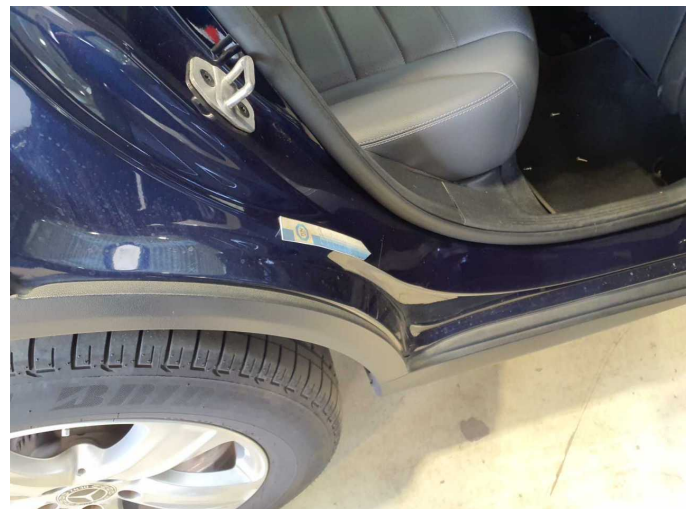
| No. | Component group | Description |
|---|---|---|
| 2 | Side panel - rear right side | Sill - Scratch(es) - Smart repair |

**Damage 2:** Side panel - rear right side: Sill - Scratch(es) - Smart repair

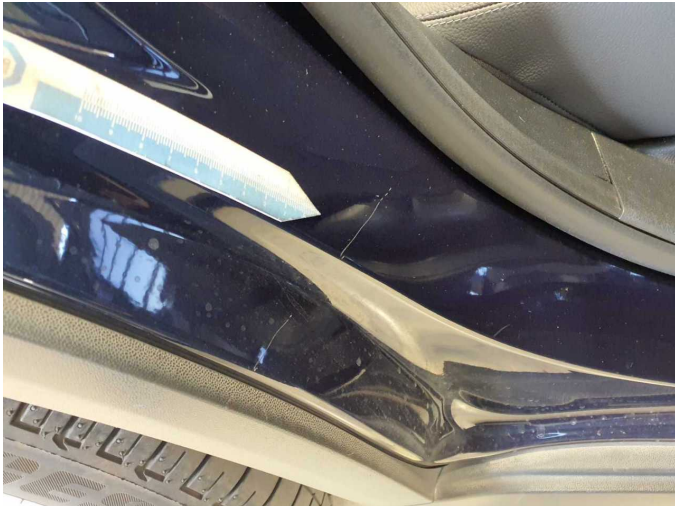
**Damage 2:** Side panel - rear right side: Sill - Scratch(es) - Smart repair

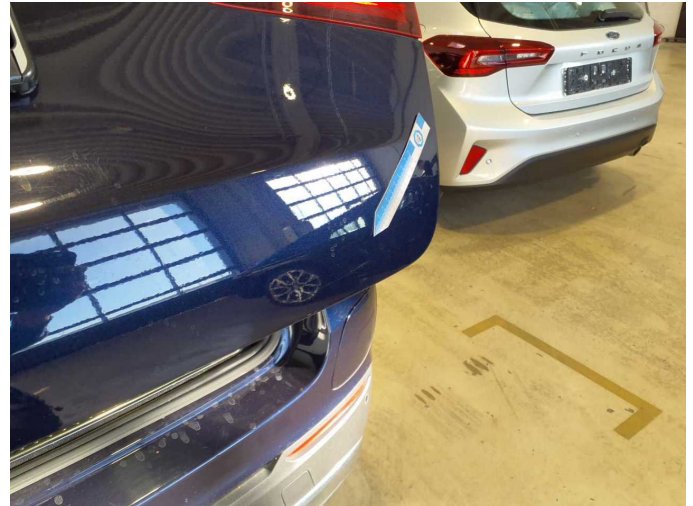
| No. | Component group | Description |
|---|---|---|
| 3 | Boot lid / rear door | Boot lid - Scratched - Smart repair |

**Damage 3:** Boot lid / rear door: Boot lid - Scratched - Smart repair

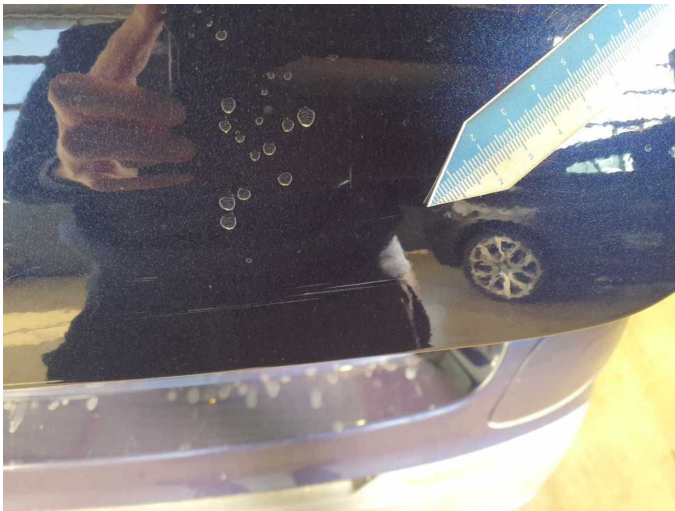
**Damage 3:** Boot lid / rear door: Boot lid - Scratched - Smart repair

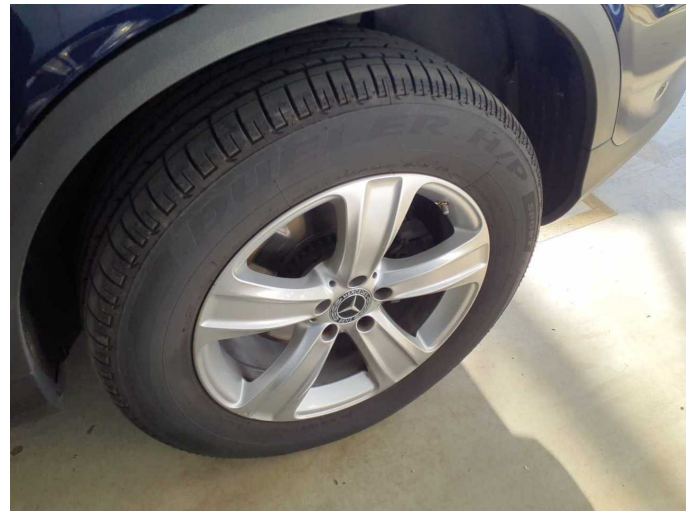
| No. | Component group | Description |
|---|---|---|
| 4 | Wheel / tyres | Alloy rim - rear left side - Scratched - Loss in value |

**Damage 4:** Wheel / tyres: Alloy rim - rear left side - Scratched - Loss in value

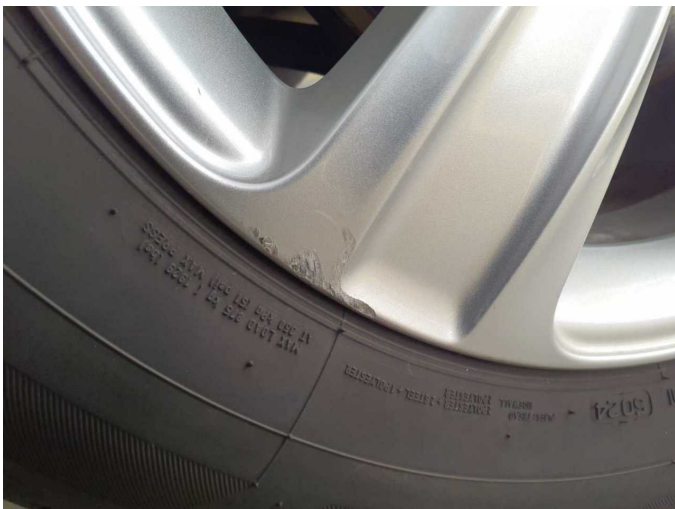
**Damage 4:** Wheel / tyres: Alloy rim - rear left side - Scratched - Loss in value

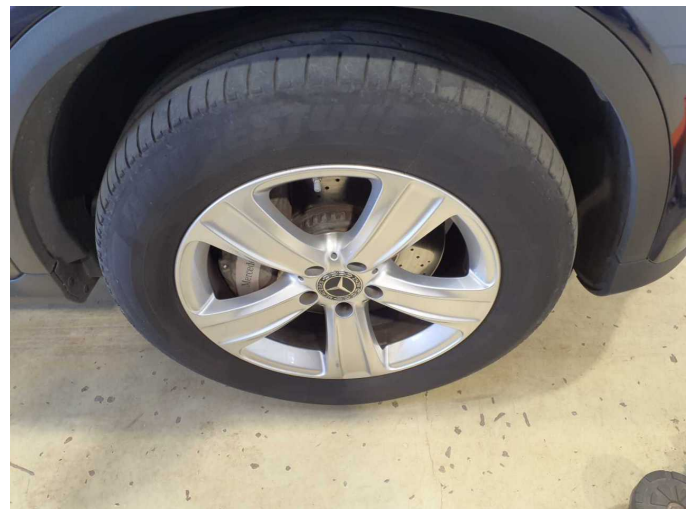
| No. | Component group | Description |
|---|---|---|
| 5 | Wheel / tyres | Alloy rim - front right side - Scratched - Loss in value |

**Damage 5:** Wheel / tyres: Alloy rim - front right side - Scratched - Loss in value

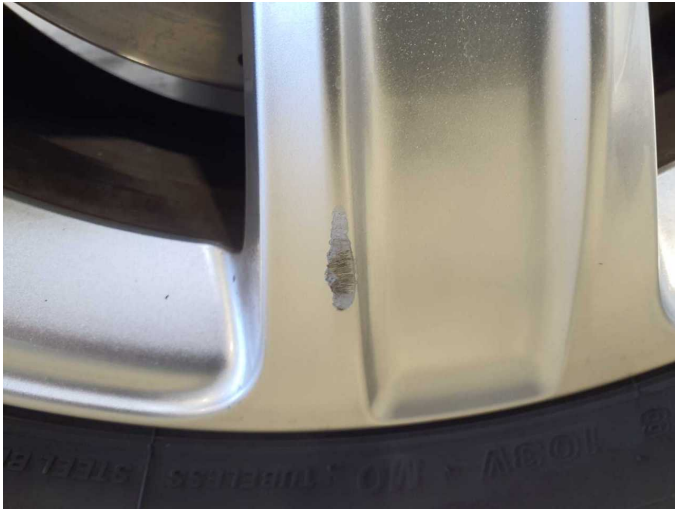
**Damage 5:** Wheel / tyres: Alloy rim - front right side - Scratched - Loss in value

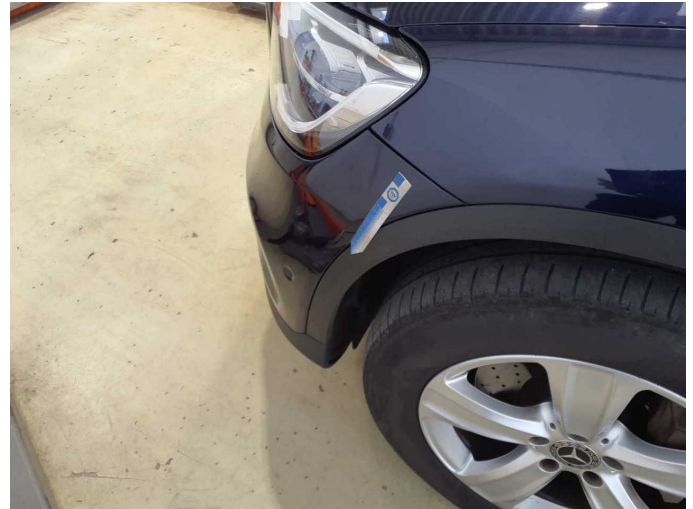
| No. | Component group | Description |
|---|---|---|
| 6 | Mudguard - left side | Wheel arch - Scratched - Replace |

**Damage 6:** Mudguard - left side: Wheel arch - Scratched - Replace

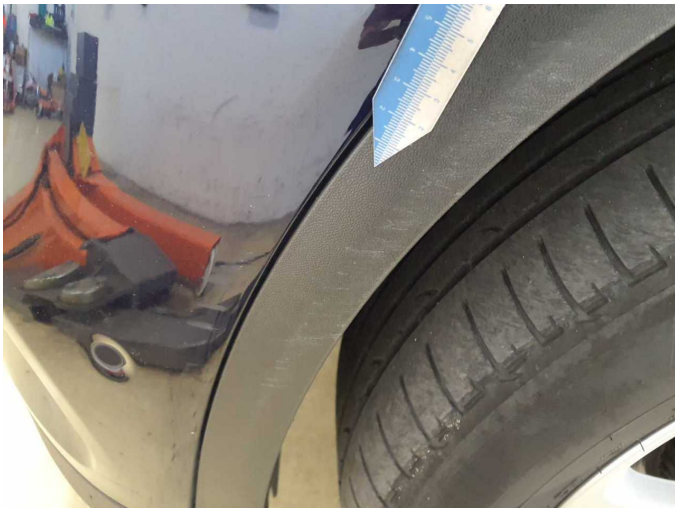
**Damage 6:** Mudguard - left side: Wheel arch - Scratched - Replace

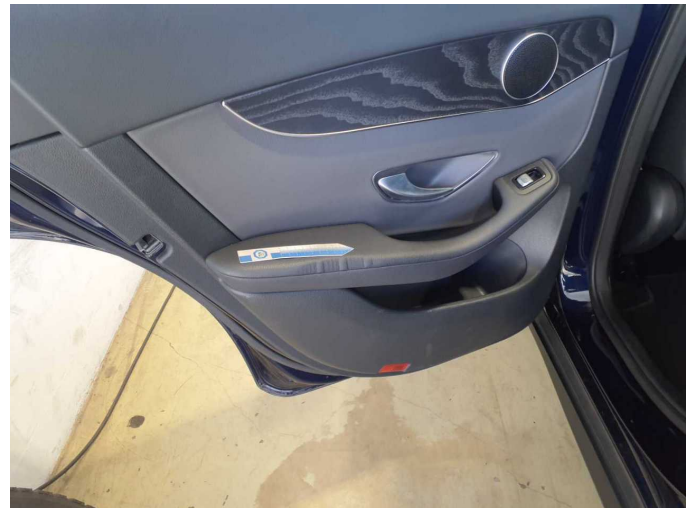
| No. | Component group | Description |
|---|---|---|
| 7 | Interior | Armrest - rear (HL) - Deformed - Replace |

**Damage 7:** Interior: Armrest - rear (HL) - Deformed - Replace

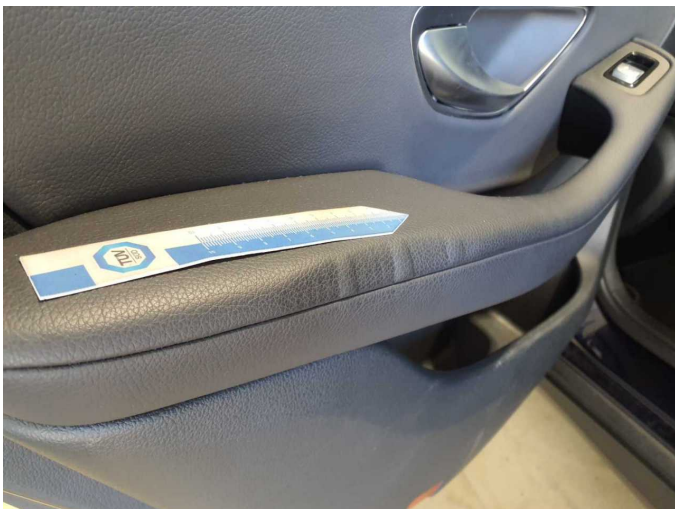
**Damage 7:** Interior: Armrest - rear (HL) - Deformed - Replace

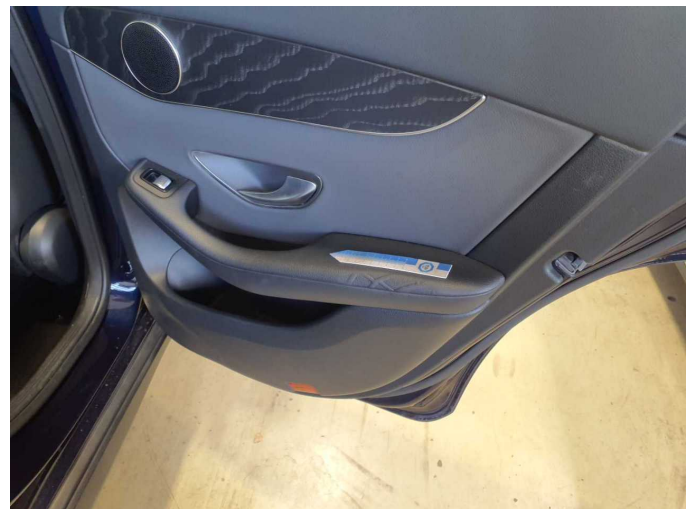
| No. | Component group | Description |
|---|---|---|
| 8 | Interior | Armrest - rear (HR) - Deformed - Replace |

**Damage 8:** Interior: Armrest - rear (HR) - Deformed - Replace

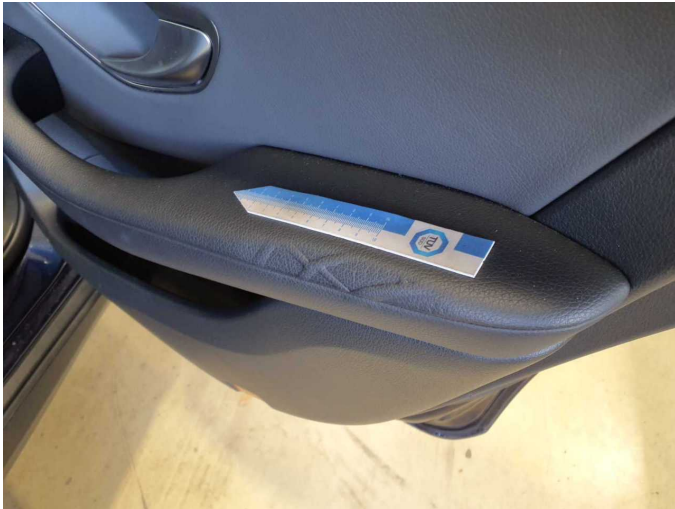
**Damage 8:** Interior: Armrest - rear (HR) - Deformed - Replace

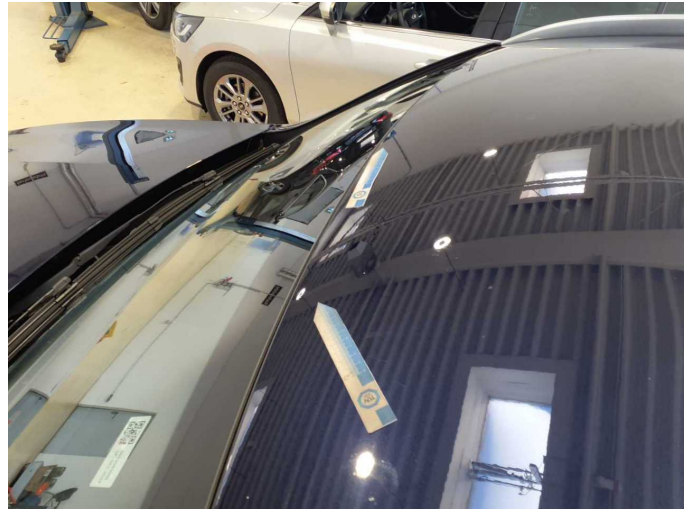
| No. | Component group | Description |
|---|---|---|
| 9 | Roof | Roof - Stone chips - Loss in value |

**Damage 9:** Roof: Roof - Stone chips - Loss in value

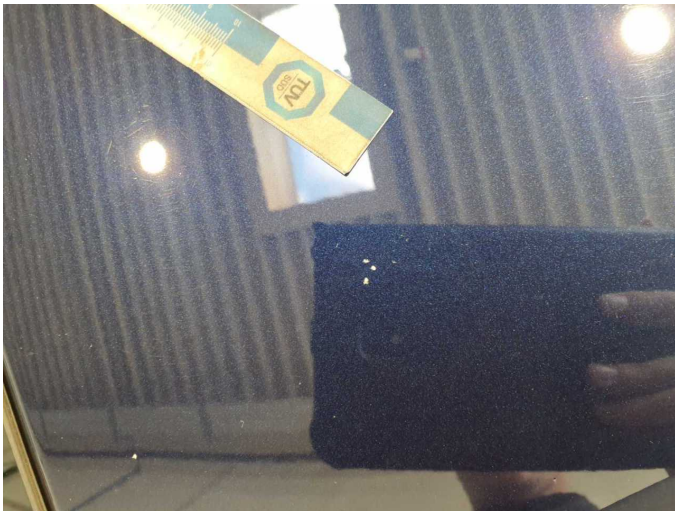
**Damage 9:** Roof: Roof - Stone chips - Loss in value

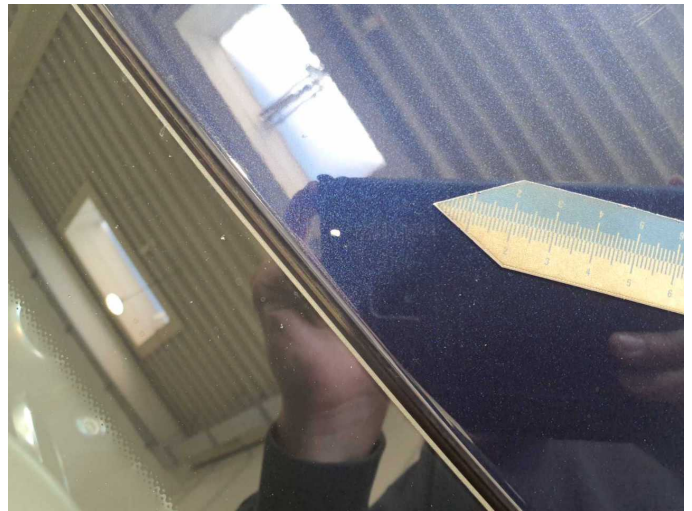
**Damage 9:** Roof: Roof - Stone chips - Loss in value

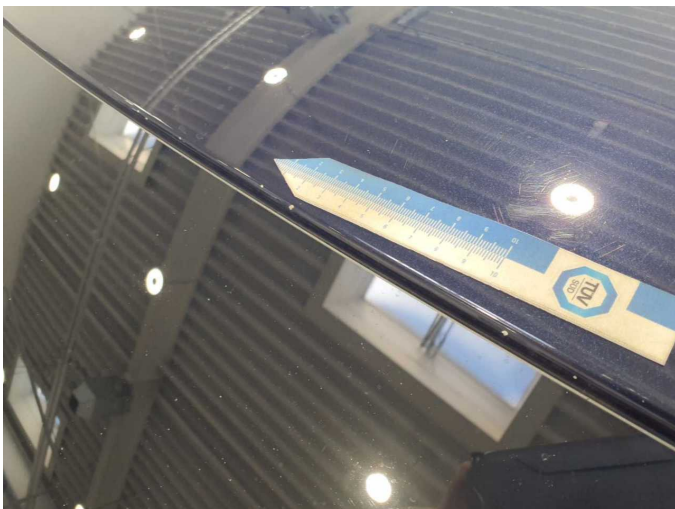
**Damage 9:** Roof: Roof - Stone chips - Loss in value

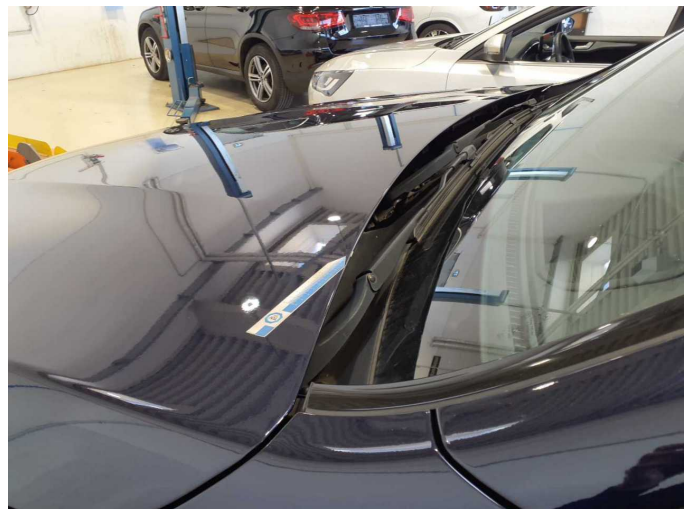
| No. | Component group | Description |
|---|---|---|
| 10 | Bonnet | Bonnet - Scratched - Paint |

**Damage 10:** Bonnet: Bonnet - Scratched - Paint

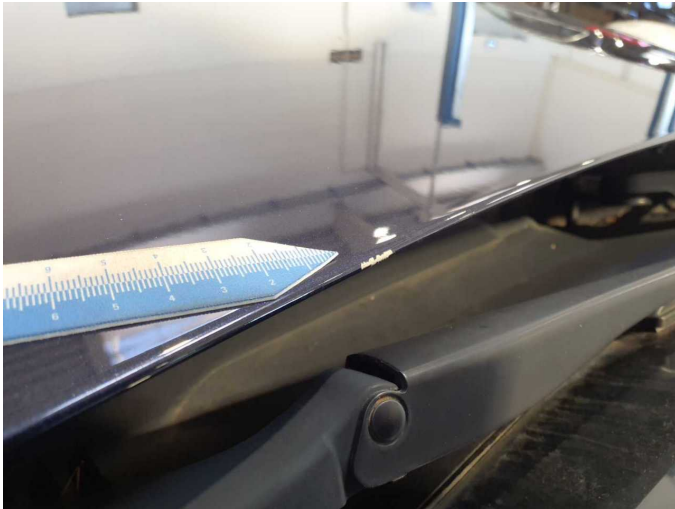
**Damage 10:** Bonnet: Bonnet - Scratched - Paint

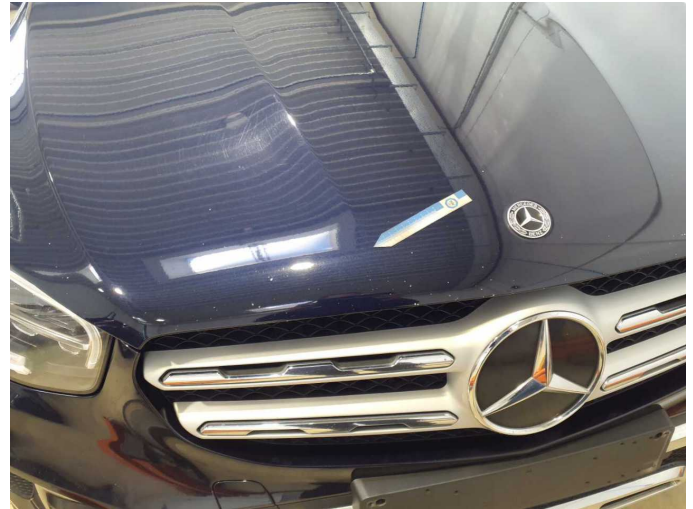
**Damage 10:** Bonnet: Bonnet - Scratched - Paint

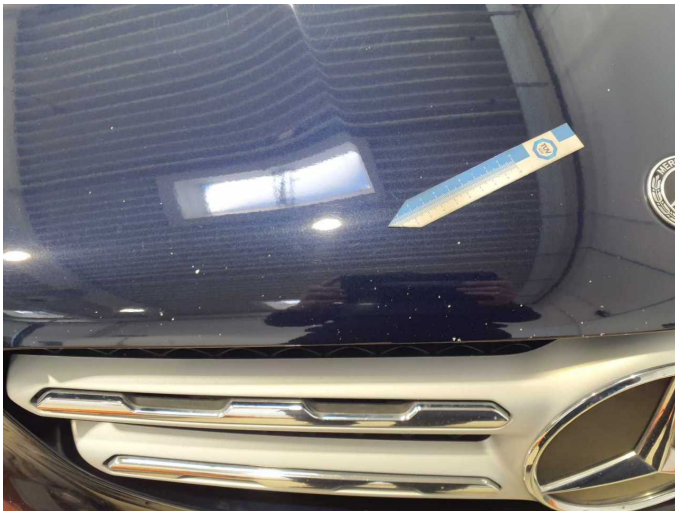
**Damage 10:** Bonnet: Bonnet - Scratched - Paint

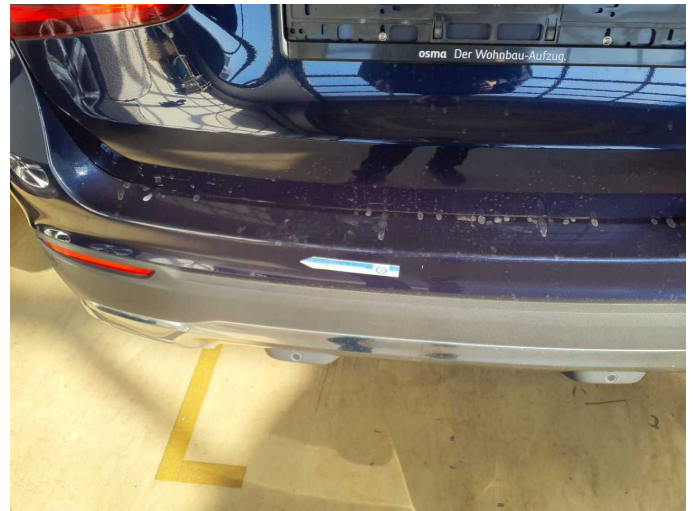
| No. | Component group | Description |
|---|---|---|
| 11 | Rear bumper | Rear bumper - Scratched - Paint |

**Damage 11:** Rear bumper: Rear bumper - Scratched - Paint

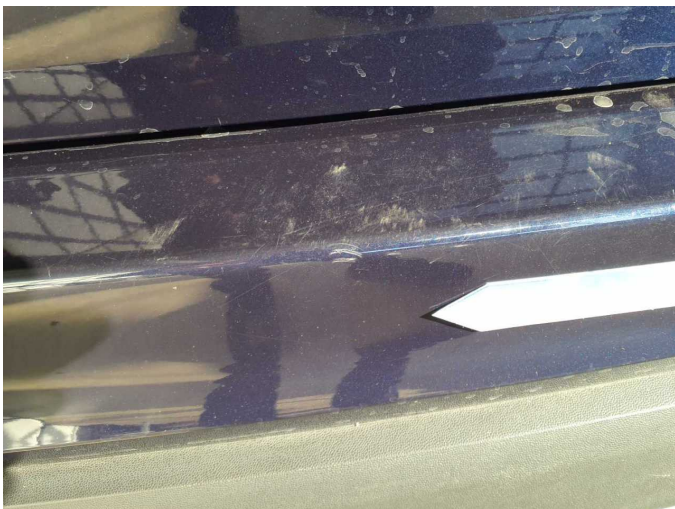
**Damage 11:** Rear bumper: Rear bumper - Scratched - Paint

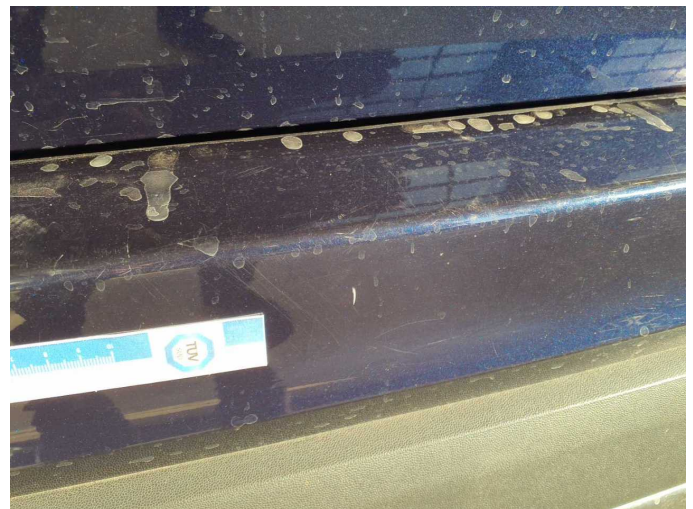
**Damage 11:** Rear bumper: Rear bumper - Scratched - Paint

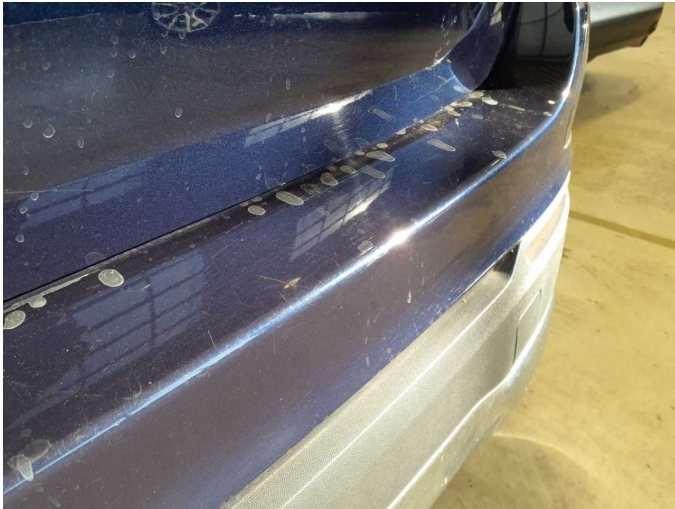
**Damage 11:** Rear bumper: Rear bumper - Scratched - Paint

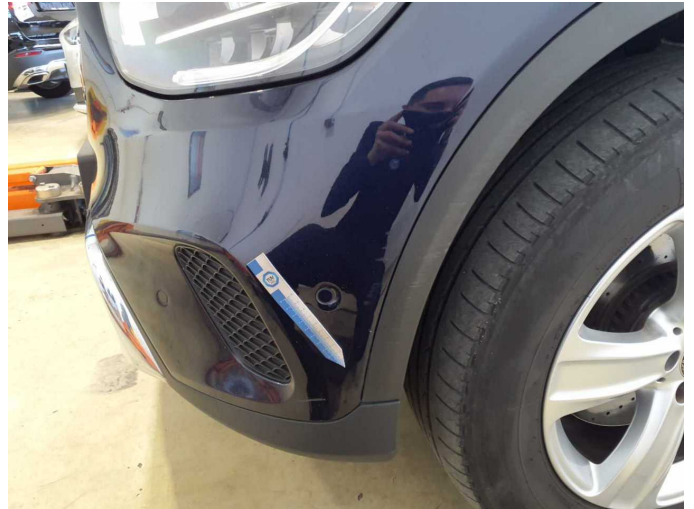
| No. | Component group | Description |
|---|---|---|
| 12 | Front bumper | Front bumper - Scratched - Paint |

**Damage 12:** Front bumper: Front bumper - Scratched - Paint

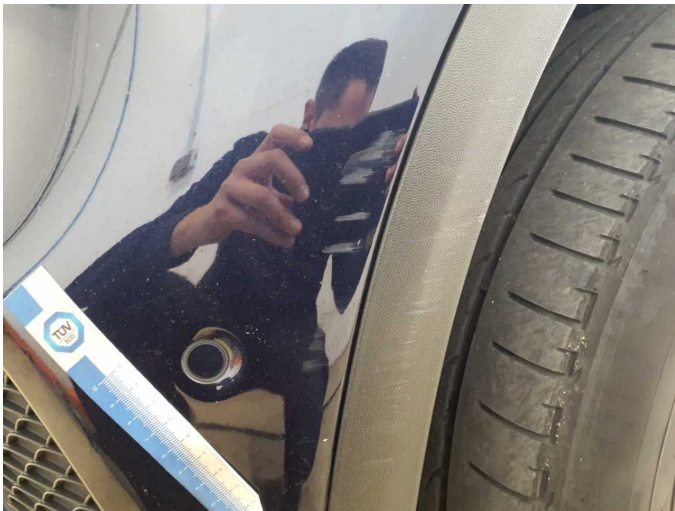
**Damage 12:** Front bumper: Front bumper - Scratched - Paint

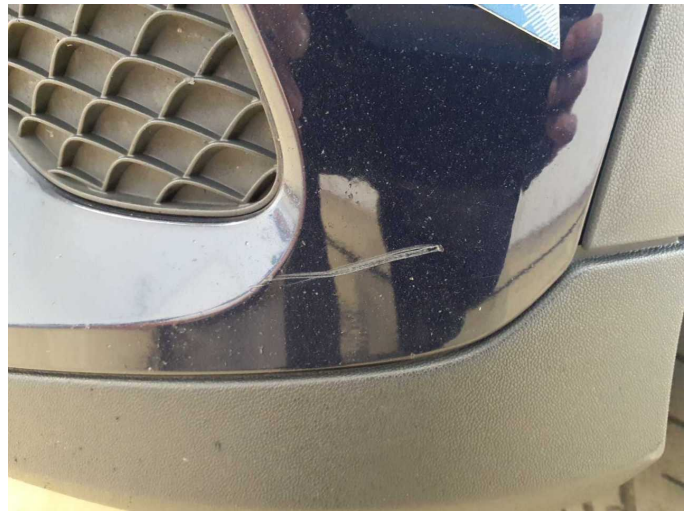
**Damage 12:** Front bumper: Front bumper - Scratched - Paint

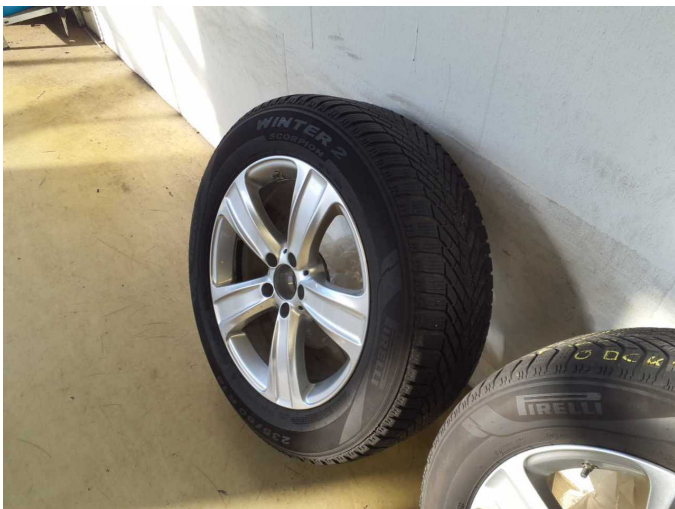
| No. | Component group | Description |
|---|---|---|
| 13 | 2nd wheel set | Tyres - complete set - Worn - Replace |

**Damage 13:** 2nd wheel set: Tyres - complete set - Worn - Replace

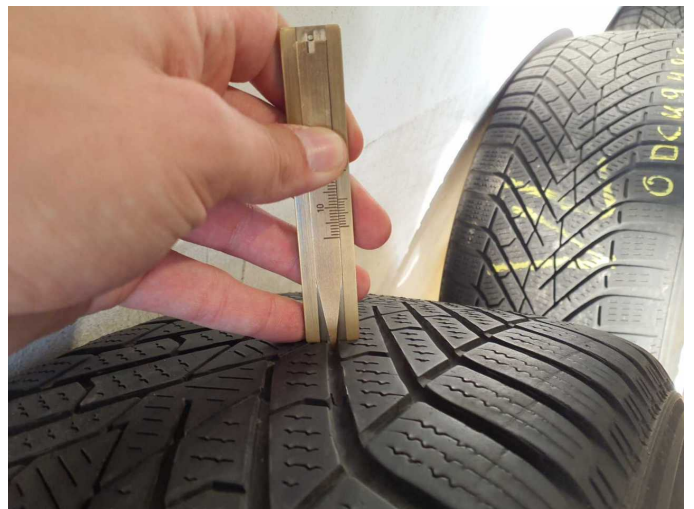
**Damage 13:** 2nd wheel set: Tyres - complete set - Worn - Replace

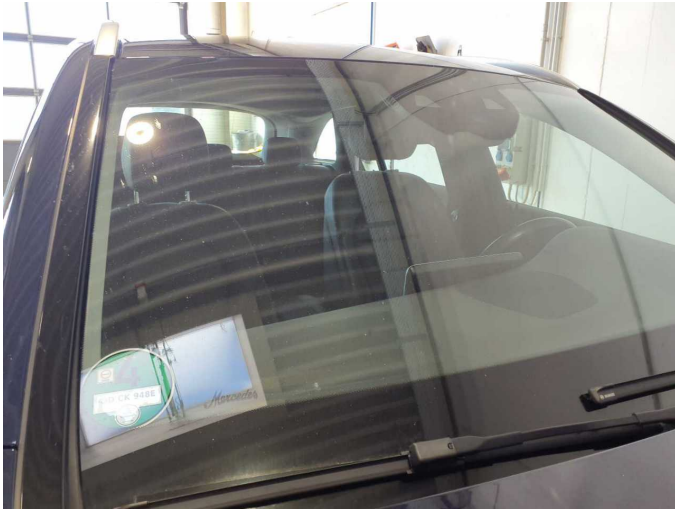
| No. | Component group | Description |
|---|---|---|
| 14 | Vehicle glazing | Windscreen with lane departure assistant (Sandstrahleffekt) - Stone chips - Replace |

**Damage 14:** Vehicle glazing: Windscreen with lane departure assistant (Sandstrahleffekt) - Stone chips - Replace

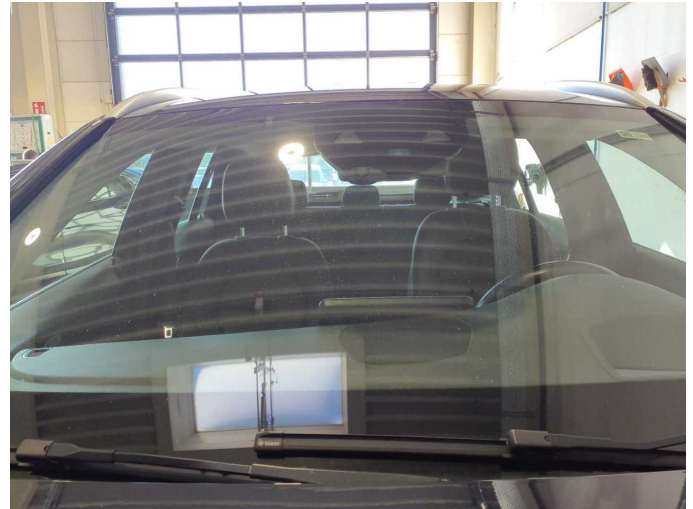
**Damage 14:** Vehicle glazing: Windscreen with lane departure assistant (Sandstrahleffekt) - Stone chips - Replace

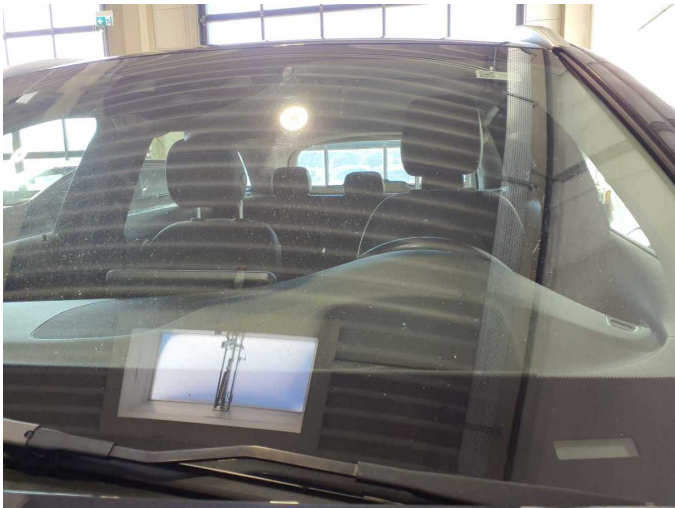
**Damage 14:** Vehicle glazing: Windscreen with lane departure assistant (Sandstrahleffekt) - Stone chips - Replace

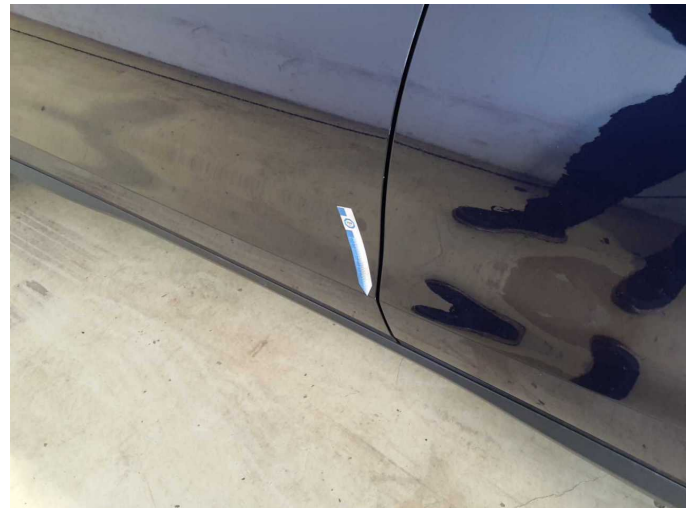
| No. | Component group | Description |
|---|---|---|
| 1 | Door - front left side | Door edge - Scratched - No deduction |

**Wear and tear 1:** Door - front left side: Door edge - Scratched - No deduction

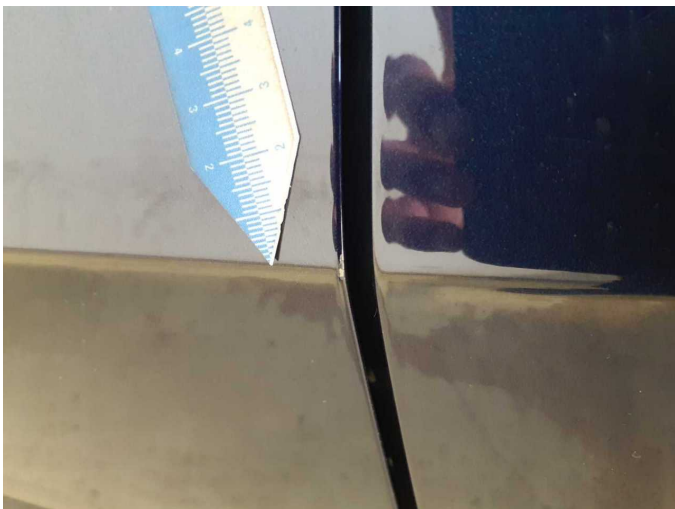
**Wear and tear 1:** Door - front left side: Door edge - Scratched - No deduction
