MERCEDES-BENZ GLC GLC 300 de 4Matic 9G-TRONIC

VIN NO W1N2539111V299011 Registration Number 111V299011

Inspection Report Summary

Customer	BCA Online	Report Number	P20250530150419
Inspection Date / Place	2025-05-30 / BCA Neuss	Cosmetic Grade	3

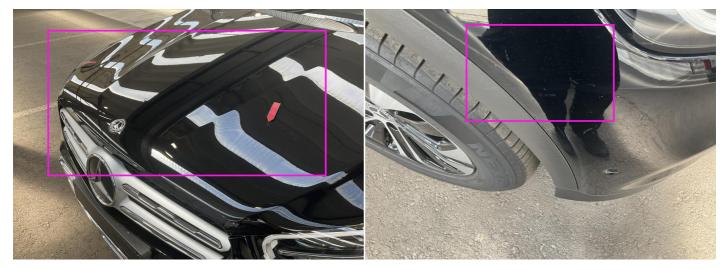
1. Hood Paint / Stone Chip -

2. Bumper / Front Paint / Scratch / Scuff -

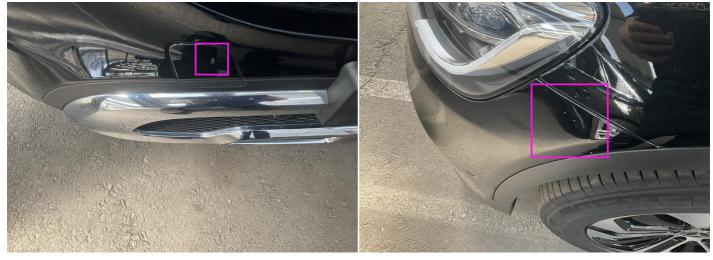
3. Bumper / Front Paint / Scratch / Scuff -

4. Bumper / Front Paint / Stone Chip -

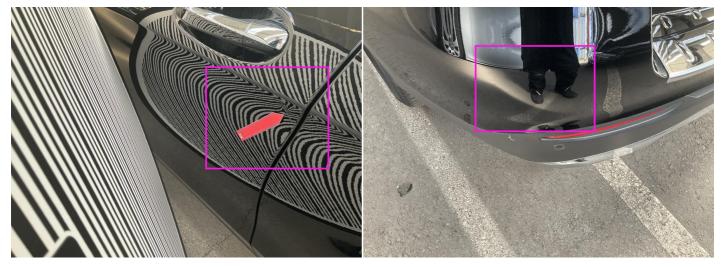
5. Door / Front Left Bodywork / Dent / Dent -

6. Bumper / Back Paint / Scratch / Scuff -

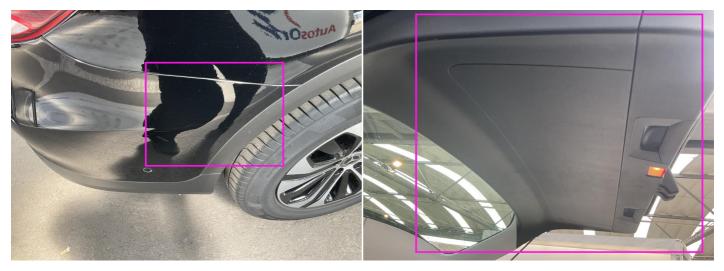
7. Bumper / Back Paint / Scratch / Scuff -

8. Tailgate Upholstery / Back Interior / Scraped -

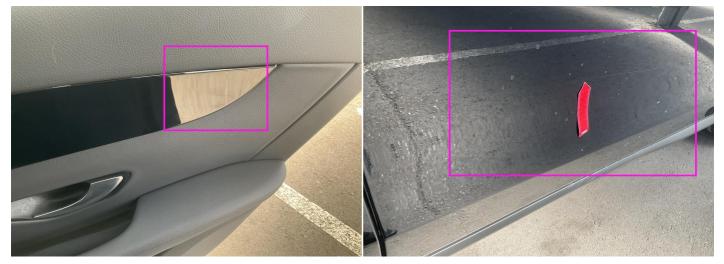
9. Panel Filling / Back Right Interior / Scraped -

10. Door / Front Right Paint / Scratch / Scuff -

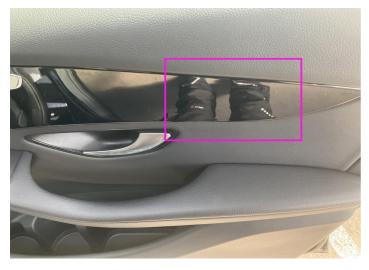
11. Panel Filling / Front Right Interior / Scraped -
