MERCEDES GLC - X253 2019 Diesel
GLC 300 de phEV (eq-power) Sport 4matic
auto

VIN NO W1N2539111V314841
Registration Number GG876RV

Inspection Report Summary

Customer	BCA Lodi	Report Number	P20250919163553
Inspection Date / Place	2025-09-19 / BCA Lodi	Cosmetic Grade	3

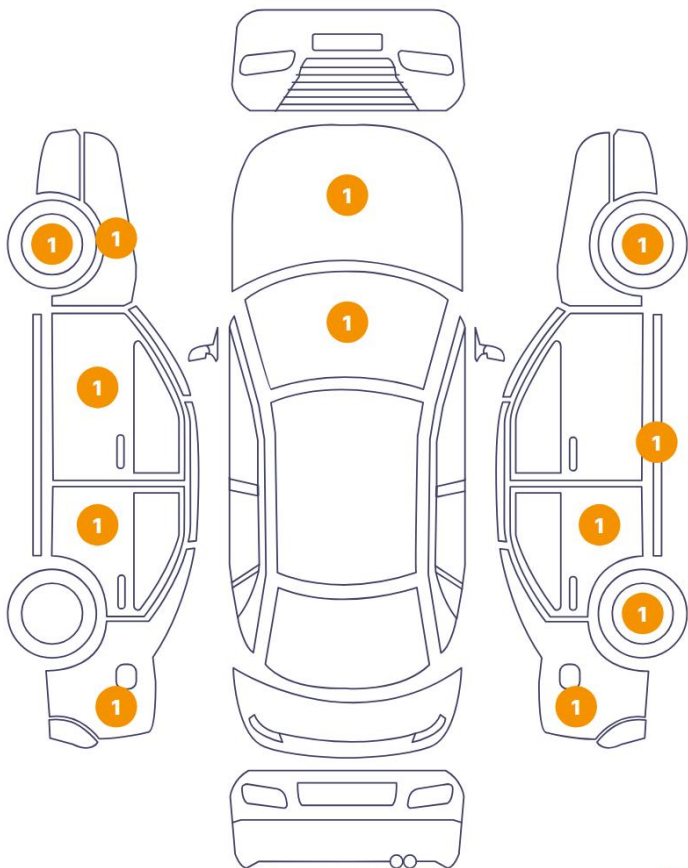
13 Danni

Component		Damage	Comments
1	Roof Upholstery	Interior / Worn - out	
2	Rim / Front Left	Out of Bodywork / Scratch	
3	Fender / Front Left	Paint / Chipping	
4	Door / Front Left	Bodywork / Poor Previous Repair	
5	Door / Back Left	Bodywork / Poor Previous Repair	
6	Fender / Back Left	Bodywork / Poor Previous Repair	
7	Fender / Back Right	Bodywork / Poor Previous Repair	
8	Door / Back Right	Bodywork / Poor Previous Repair	
9	Rim / Front Right	Out of Bodywork / Scratch	
10	Rim / Back Right	Out of Bodywork / Scratch	
11	Rocker Panel / Center Right	Paint / Scratch / Line	
12	Hood	Bodywork / Poor Previous Repair

13	Other	Bodywork / Poor Previous Repair
----	-------	---------------------------------

14	Windshield / Front	Glass Break
----	--------------------	-------------

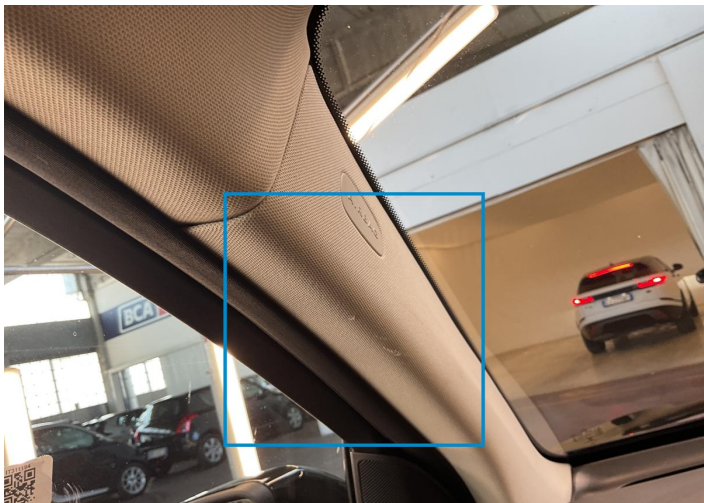
1. Roof Upholstery
Interior / Worn - out -

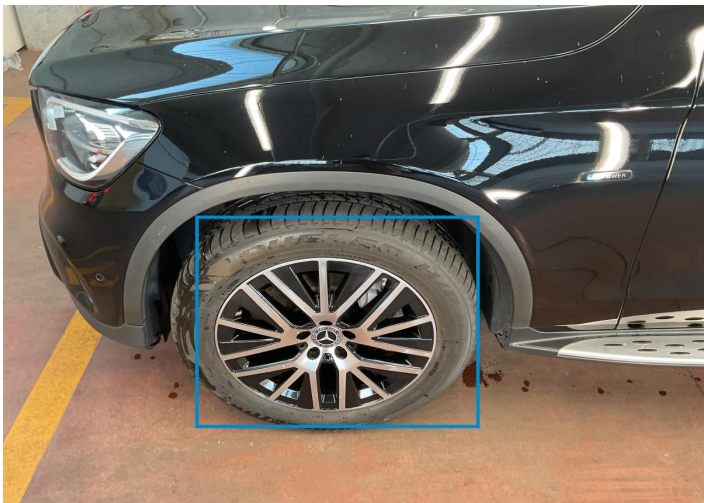
2. Rim / Front Left
Out of Bodywork / Scratch -

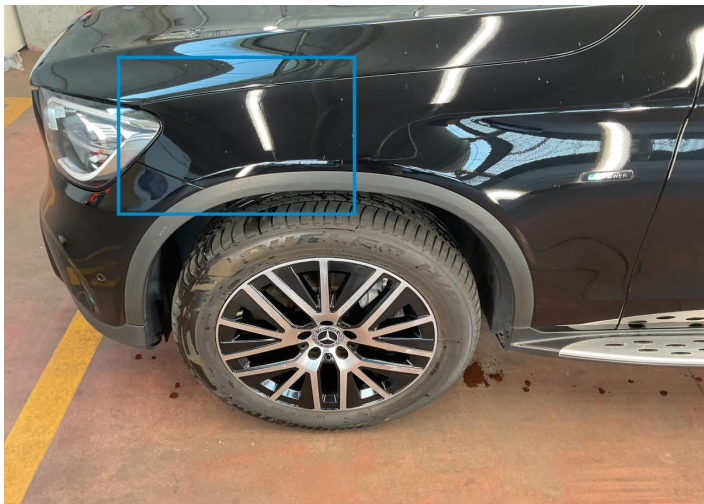
3. Fender / Front Left
Paint / Chipping -

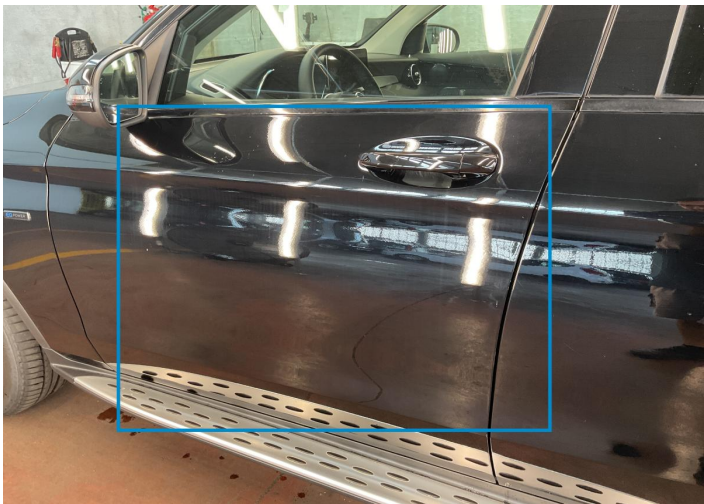
4. Door / Front Left
Bodywork / Poor Previous Repair -

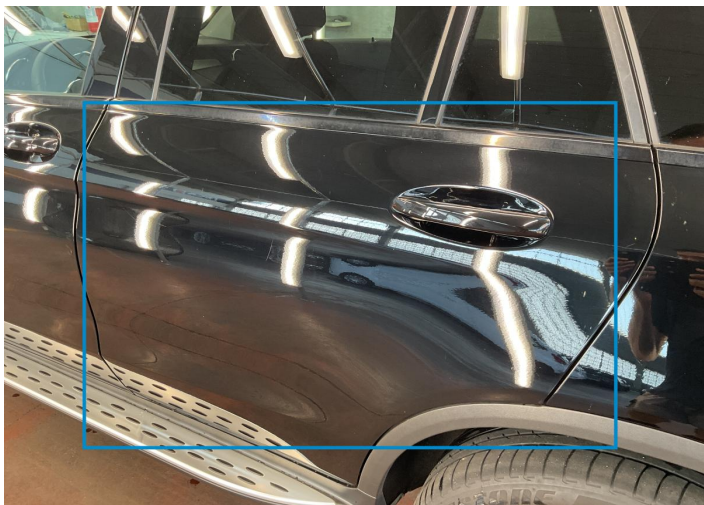
5. Door / Back Left
Bodywork / Poor Previous Repair -

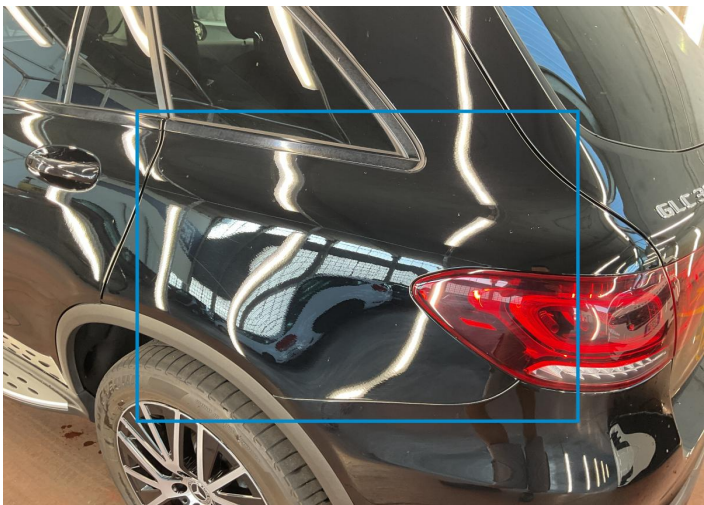
6. Fender / Back Left
Bodywork / Poor Previous Repair -

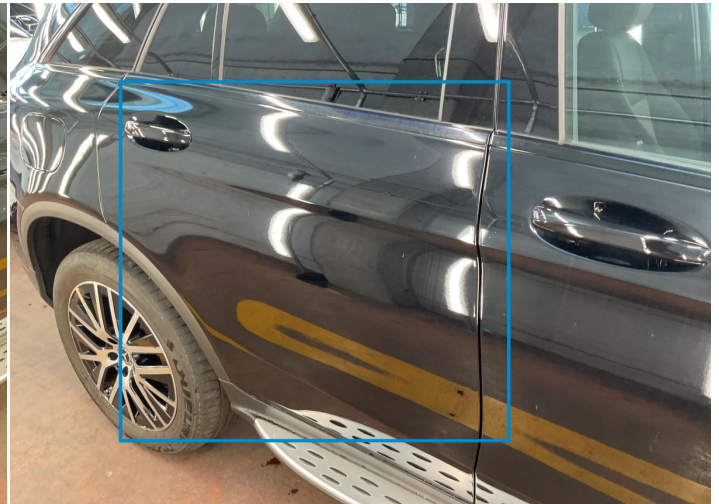
8. Door / Back Right
Bodywork / Poor Previous Repair -

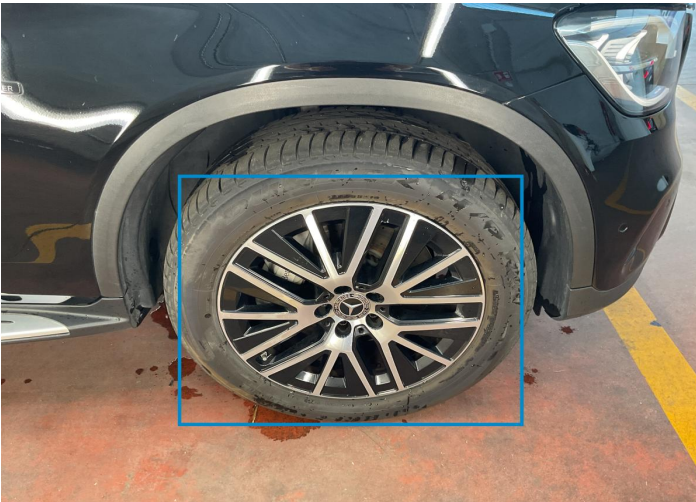
9. Rim / Front Right
Out of Bodywork / Scratch -

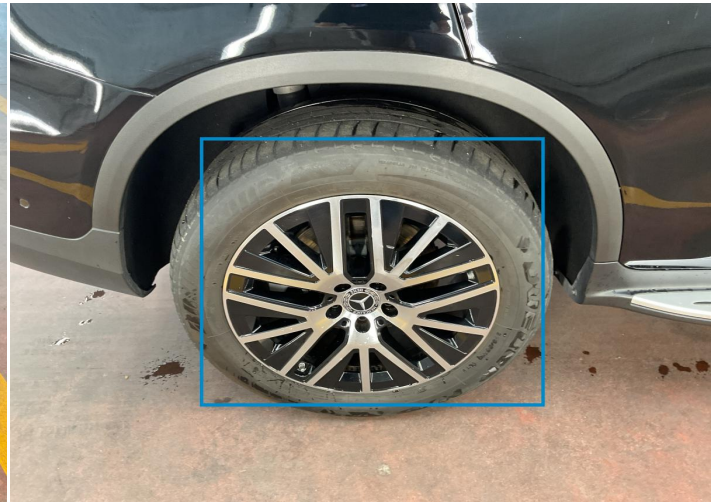
10. Rim / Back Right
Out of Bodywork / Scratch -

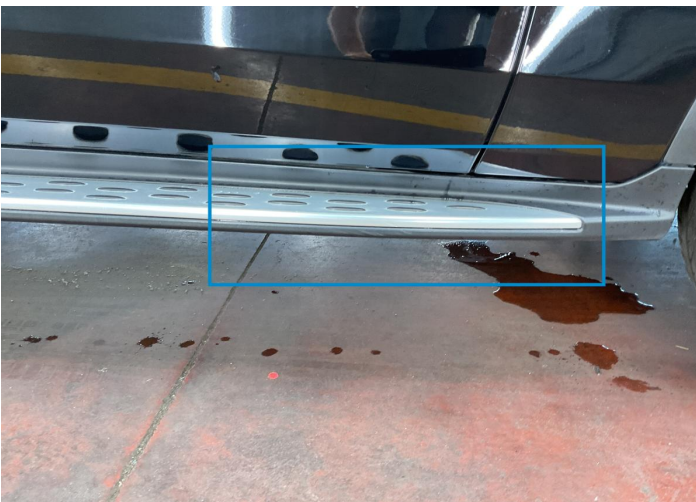
11. Rocker Panel / Center Right
Paint / Scratch / Line -

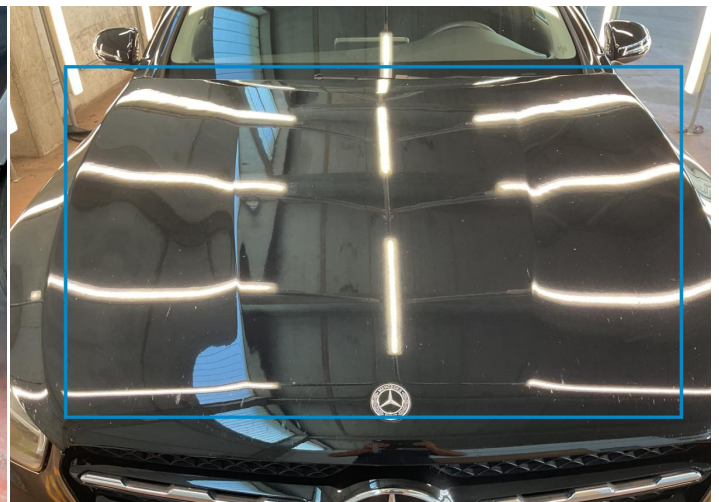
12. Hood
Bodywork / Poor Previous Repair -

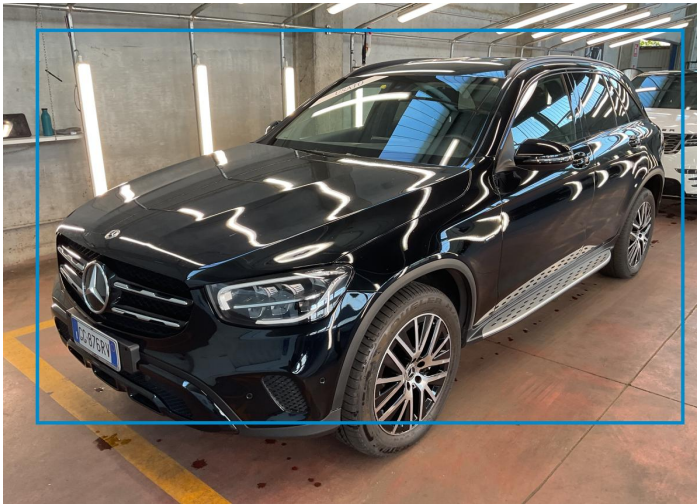
13.
Bodywork / Poor Previous Repair -

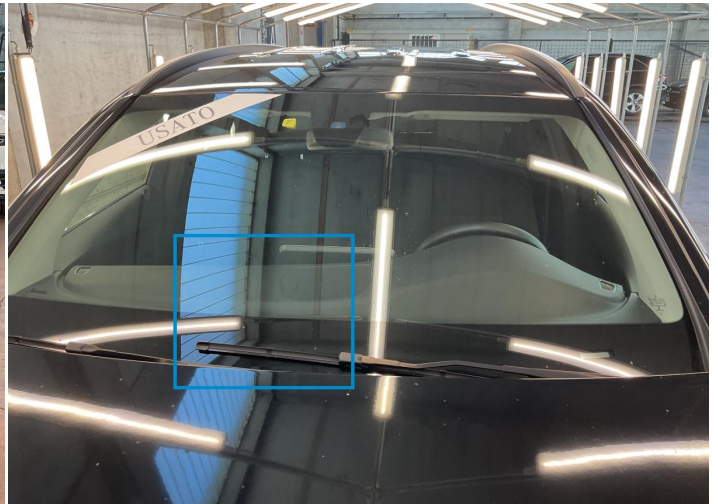
14. Windshield / Front
Glass Break -
