Expertise

Protocol number: 41343610
Order No. / Reference: 25129466
Inspection date: 28 Aug 2025

Model: GLC 300 de 4Matic 9G-TRONIC

VIN: W1N2539111V317868

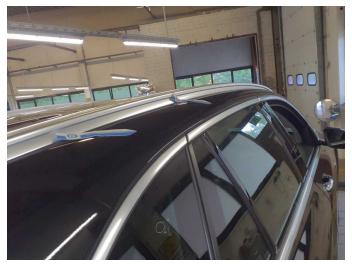
Damage 1: Roof: Roof rail - right side (2 Dellen) - dent(s) - Smooth repair work

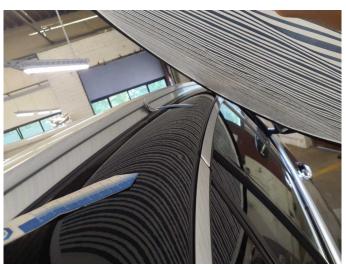
Damage 1: Roof: Roof rail - right side (2 Dellen) - dent(s) - Smooth repair work

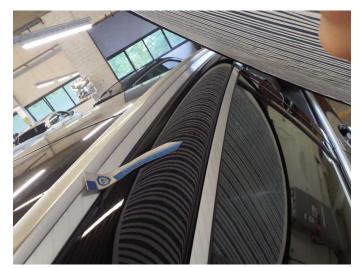
Damage 1: Roof: Roof rail - right side (2 Dellen) - dent(s) - Smooth repair Damage 2: Boot lid / rear door: Boot lid - dent(s) - Repair work

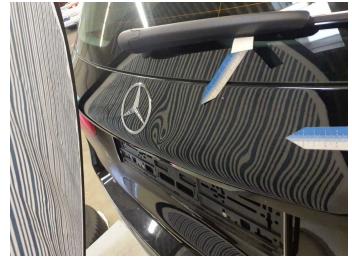
Damage 2: Boot lid / rear door: Boot lid - dent(s) - Repair

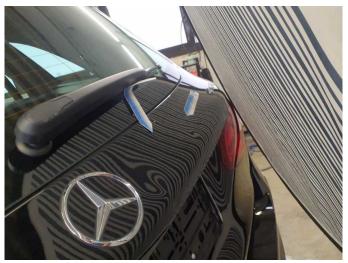
Damage 2: Boot lid / rear door: Boot lid - dent(s) - Repair

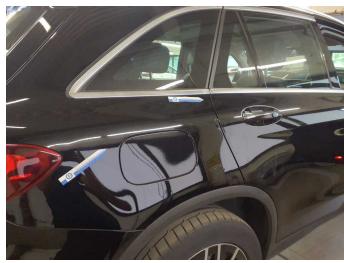
Damage 3: Side panel - rear right side: Side panel - Scratch(es) - Cover /

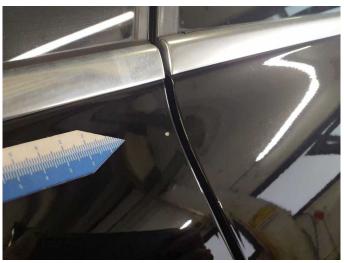
Damage 3: Side panel - rear right side: Side panel - Scratch(es) - Cover / polish

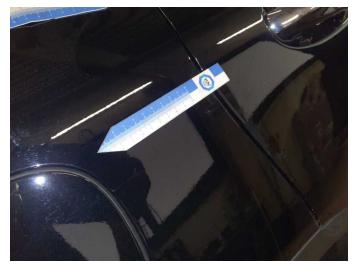
Damage 3: Side panel - rear right side: Side panel - Scratch(es) - Cover / Damage 4: Front bumper: Front bumper - Scratch(es) - Cover / polish

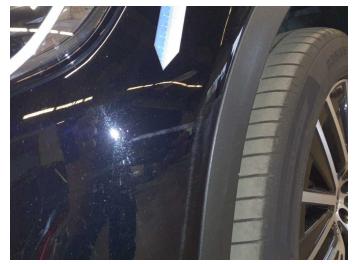
Damage 4: Front bumper: Front bumper - Scratch(es) - Cover / polish

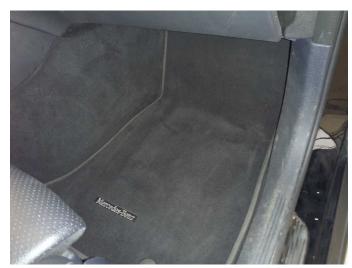
Damage 5: Interior: Interior - Soiled - Conditioning

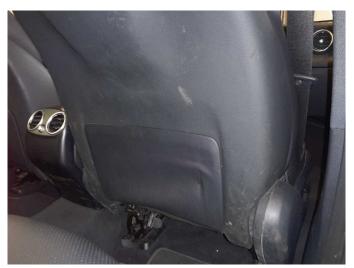
Damage 5: Interior: Interior - Soiled - Conditioning

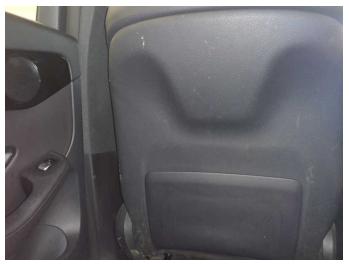
Damage 5: Interior: Interior - Soiled - Conditioning

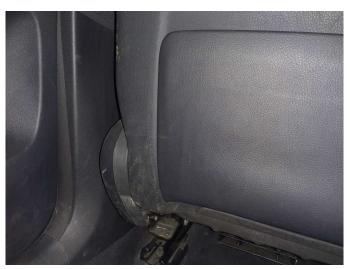
Damage 5: Interior: Interior - Soiled - Conditioning

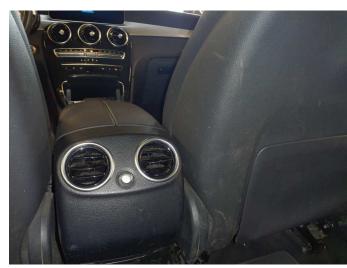
Damage 5: Interior: Interior - Soiled - Conditioning

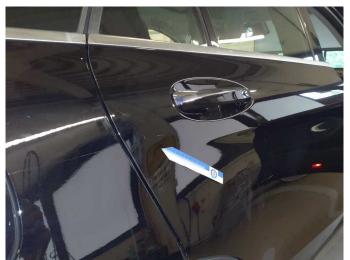
Damage 6: Door - rear right side: Door - Scratch(es) - Paint

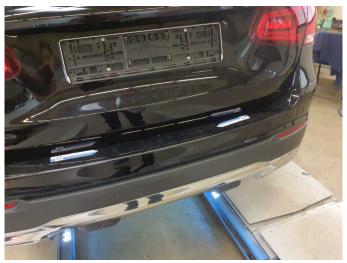
Damage 7: Rear bumper: Rear bumper - Scratch(es) - Paint

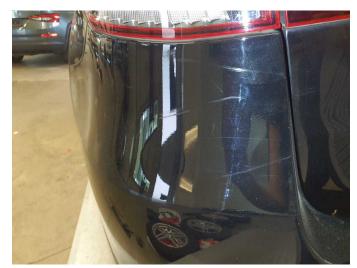
Damage 7: Rear bumper: Rear bumper - Scratch(es) - Paint

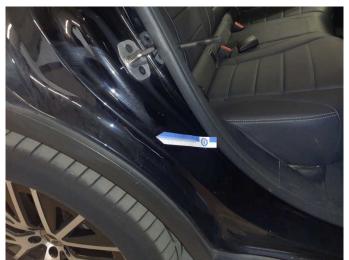
Damage 8: Sill - right side: Sill - Scratch(es) - Paint

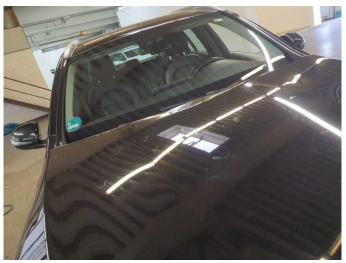
Damage 9: Bonnet: Bonnet - Paint defect - Paint

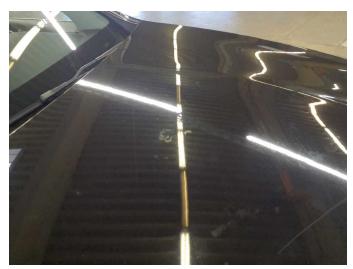
Damage 9: Bonnet: Bonnet - Paint defect - Paint

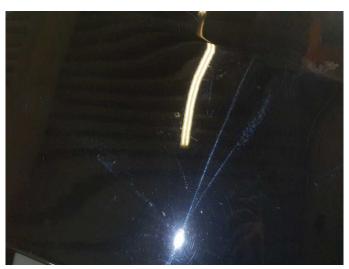
Damage 9: Bonnet: Bonnet - Paint defect - Paint

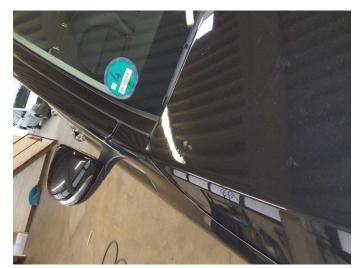
Damage 9: Bonnet: Bonnet - Paint defect - Paint

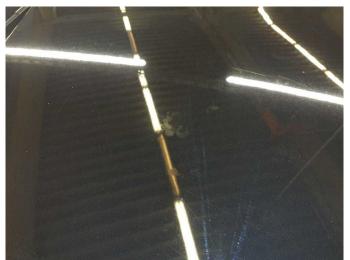
Damage 9: Bonnet: Bonnet - Paint defect - Paint

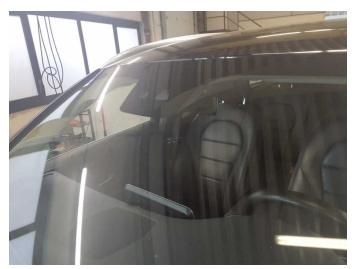
Damage 10: Vehicle glazing: Windscreen - Broken / torn - Replace

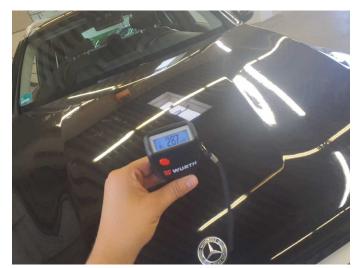
Repainting 1: Bonnet

1 Bonnet, Professionally carried out, Invoice of repair done Non-existent

Roof	100 µm	Roof rail - left side	120 µm
Roof rail - right side	120 µm	Boot lid / rear door	120 µm
Mudguard - left side	120 µm	Mudguard - right side	120 µm
Bonnet	287 µm	Sill - left side	120 µm
Sill - right side	80 µm	Side panel - rear left side	120 µm
Side panel - rear right side	120 µm	Door - rear left side	120 µm
Door - rear right side	120 µm	Door - front left side	120 µm
Door - front right side	120 µm
