Expertise

Protocol number: 41594832
Order No. / Reference: 25139942
Inspection date: 16 Sept 2025

Manufacturer: Mercedes-Benz
VIN: W1V4156031U282018

Model: Citan 111Kasten CDI lang

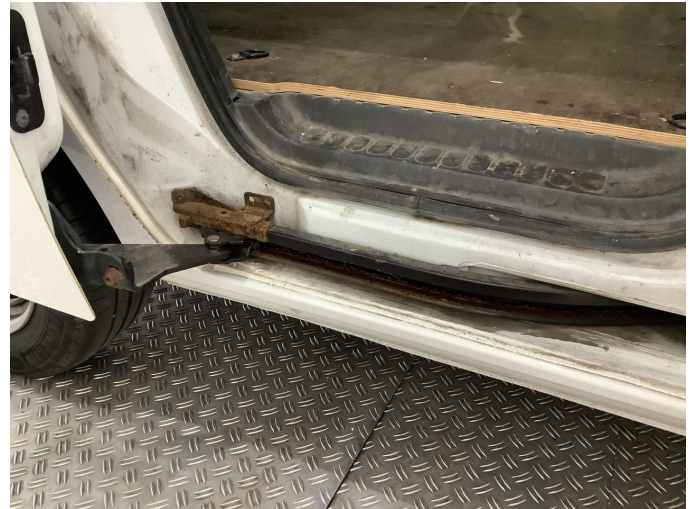
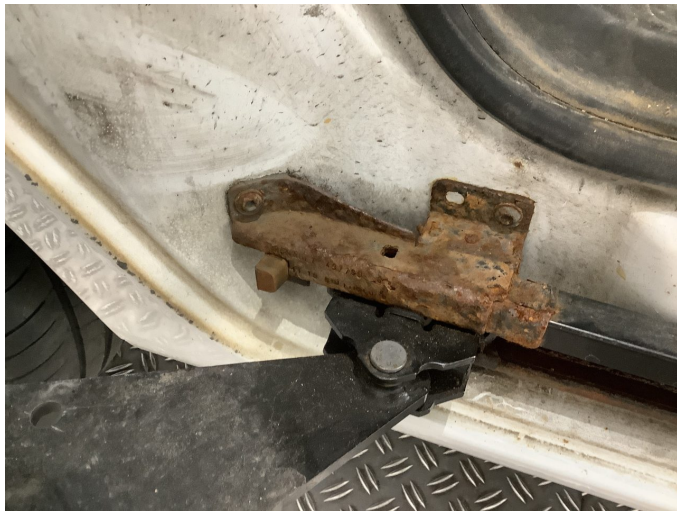
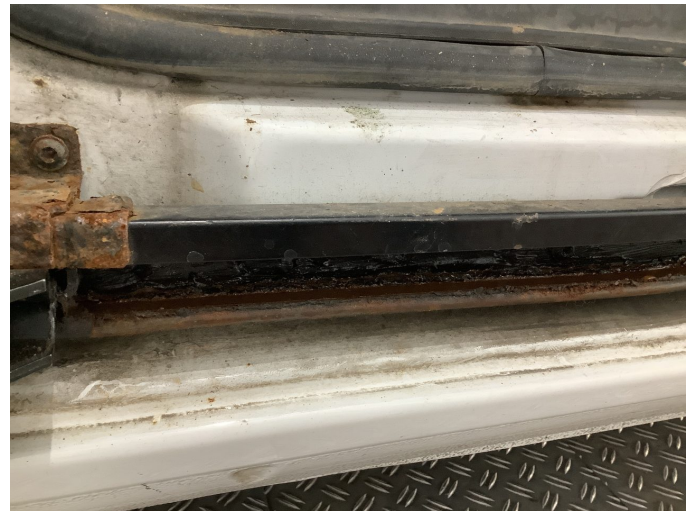
Damage 1: Sliding door, right: Guide rail - Corrosion - Replace

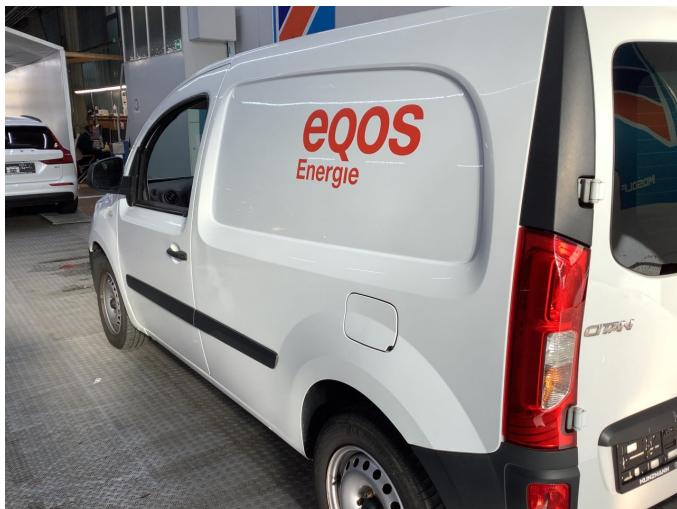
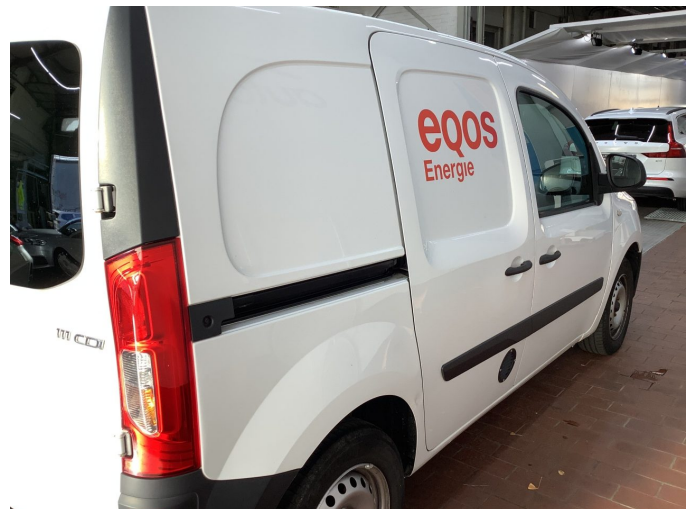
Damage 2: Body: Body - Glued / labelled - De-glue / neutralise

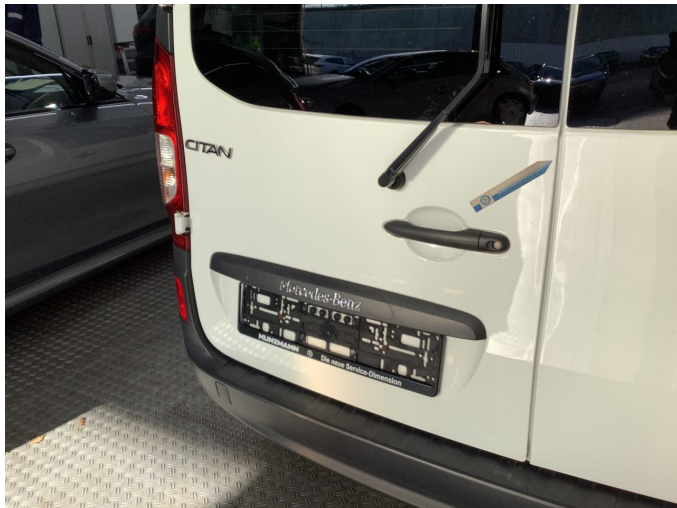
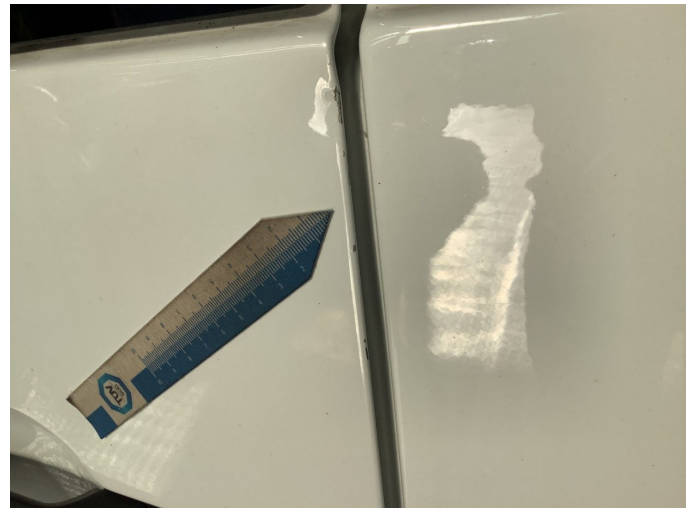
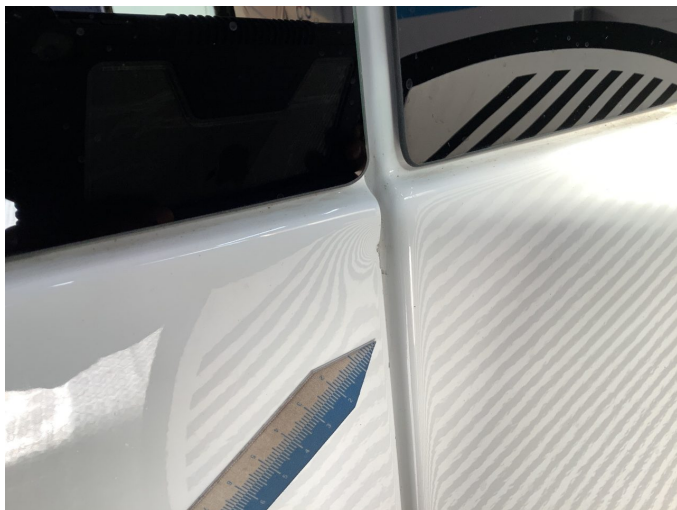
Damage 3: Boot lid / rear door: Rear door - left side - Dent / paintcoat damage - Loss in value

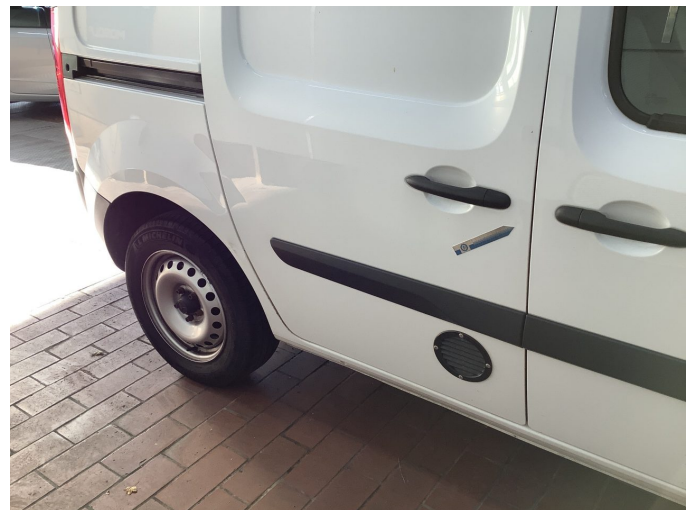
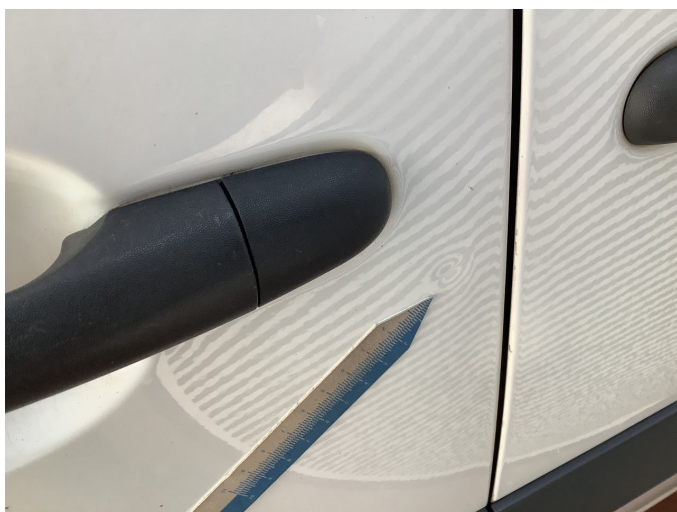
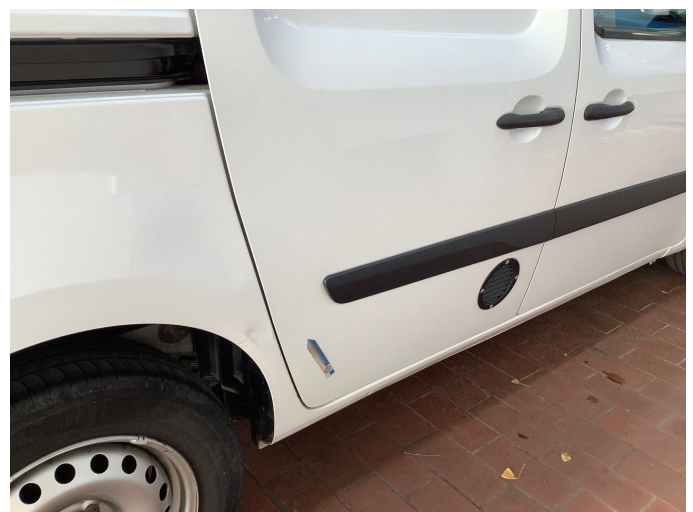
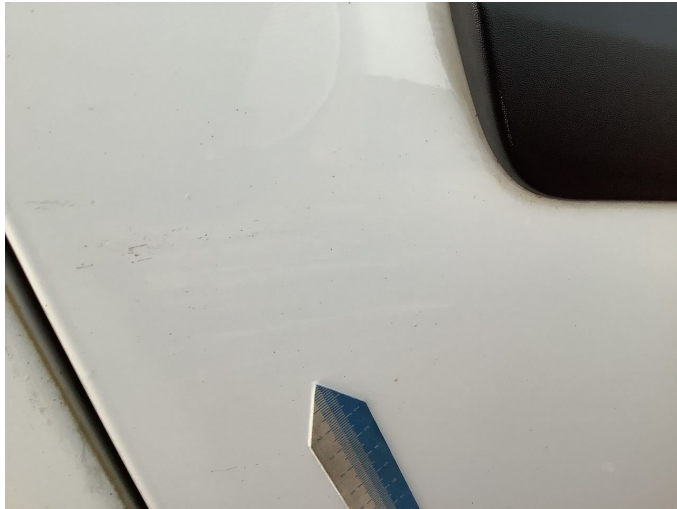
Damage 4: Sliding door, right: Sliding door - Dent / paintcoat damage - Loss in value

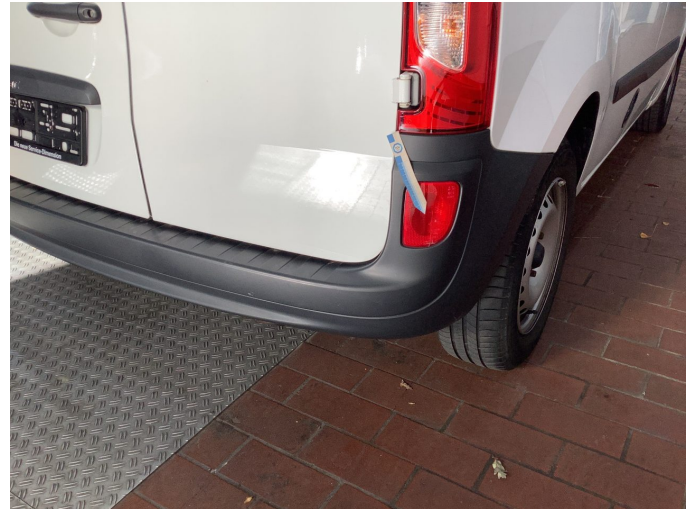
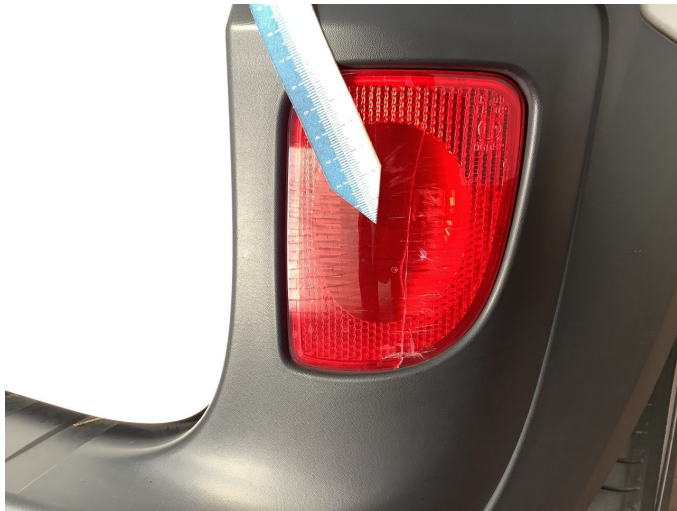
Damage 5: Fog lamp: Fog lamp - rear right side - Broken / torn - Replace

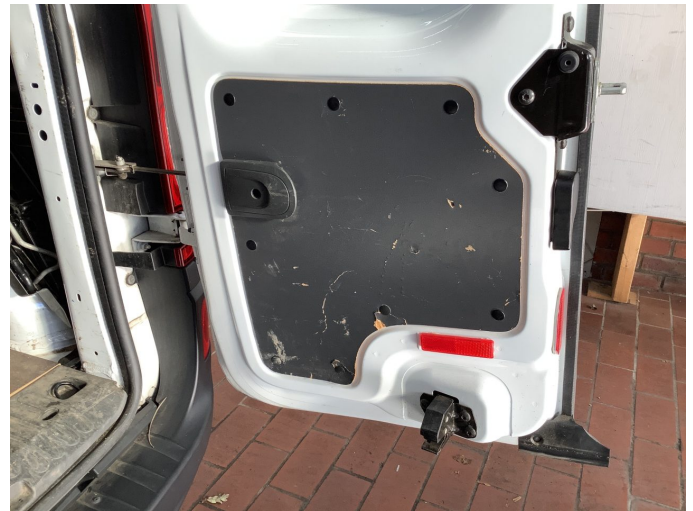
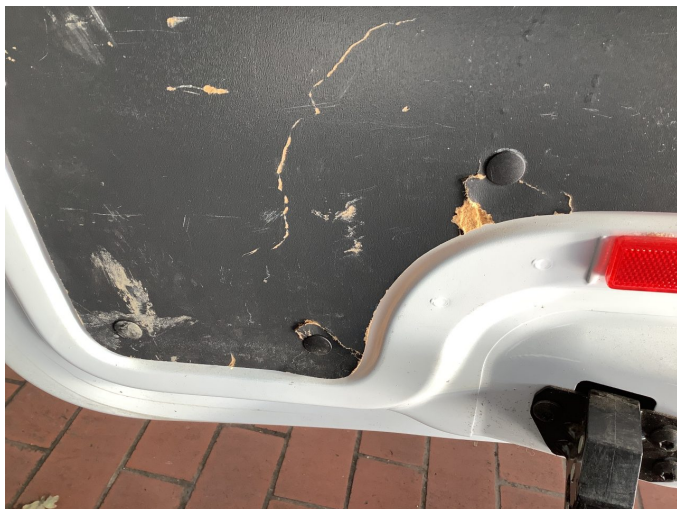
Damage 6: Boot lid / rear door: Trim rear door - plywood - lower - Damaged - Replace

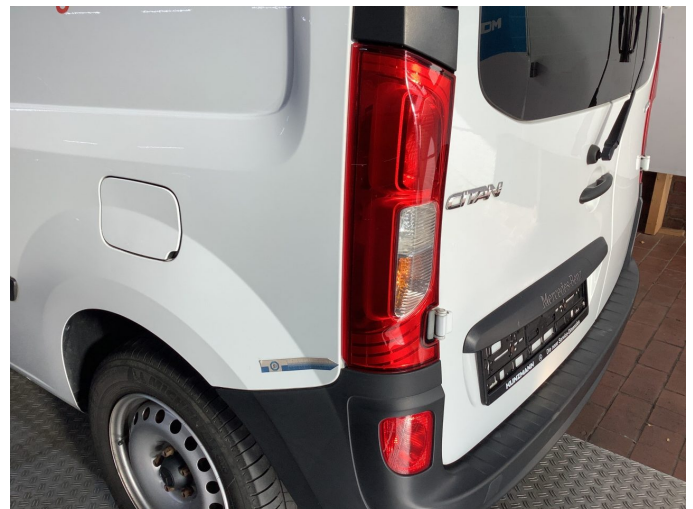
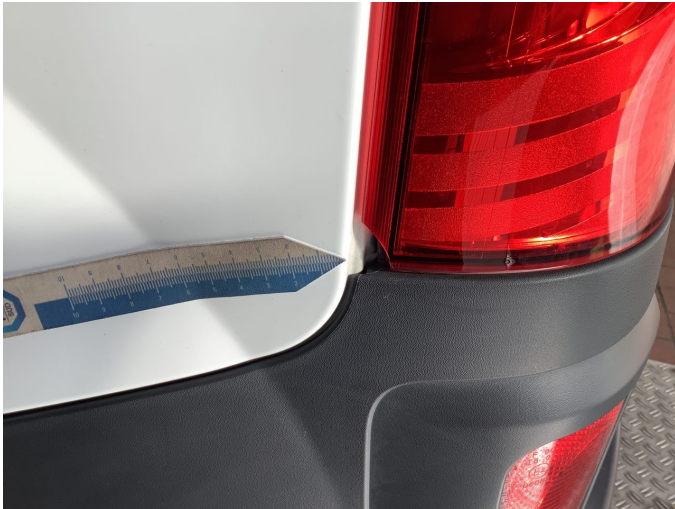
Damage 7: Tail light: Tail lamp - left side - Damaged - Replace

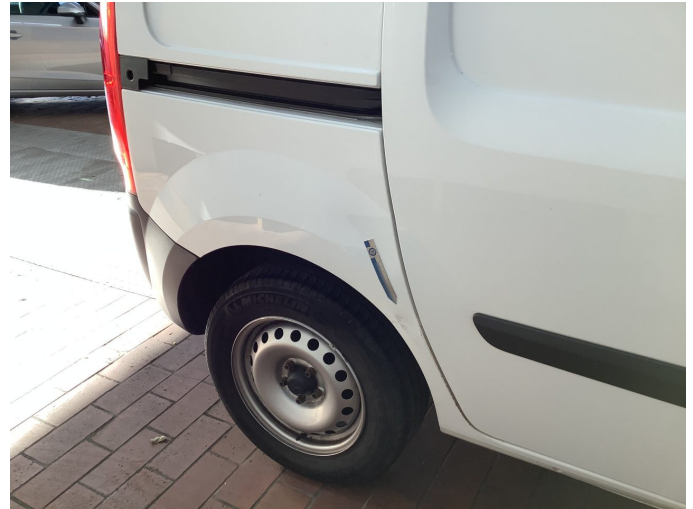
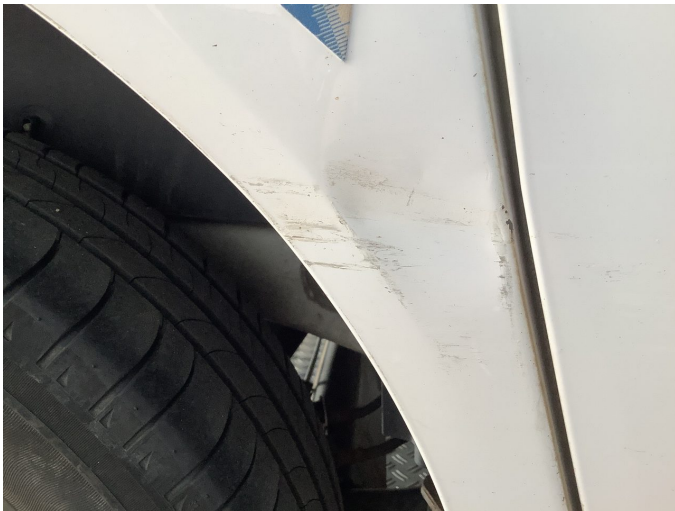
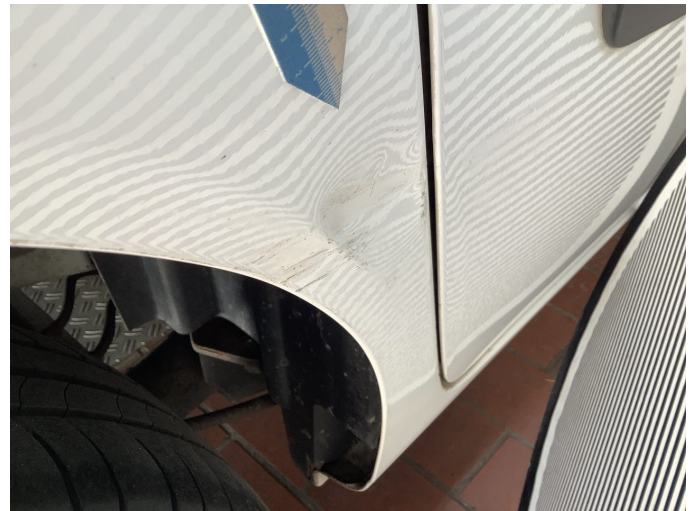
Damage 8: Side panel - rear right side: Side panel (Unterhalb) - Dent / paintcoat damage - Repair and paint

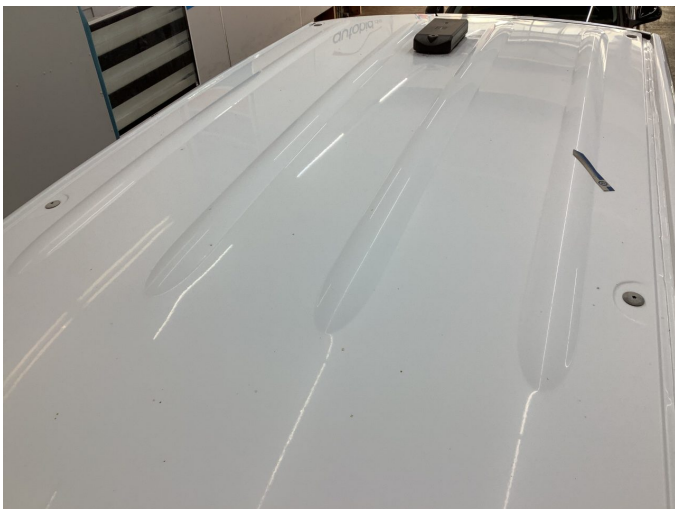
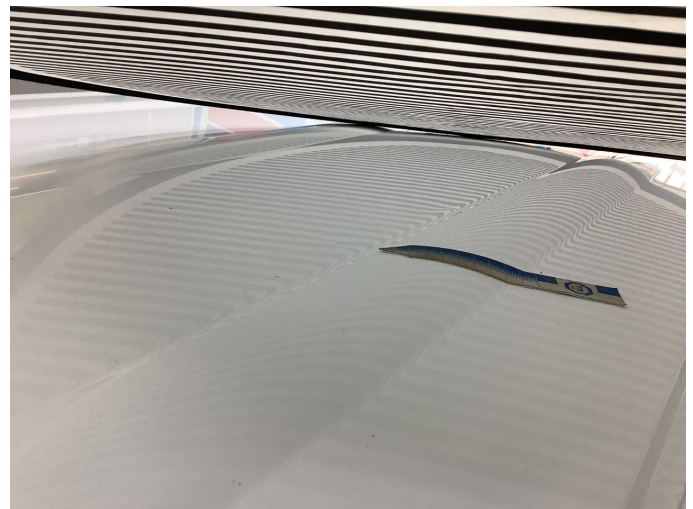
Wear and tear 1: Roof: Roof - dent(s) - No deduction

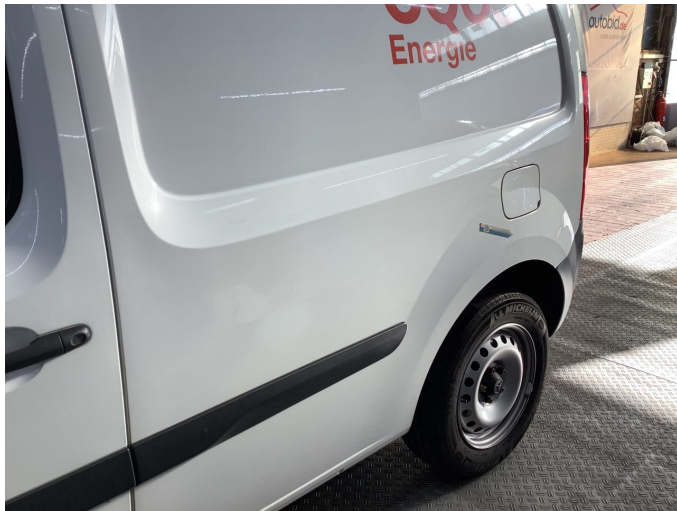
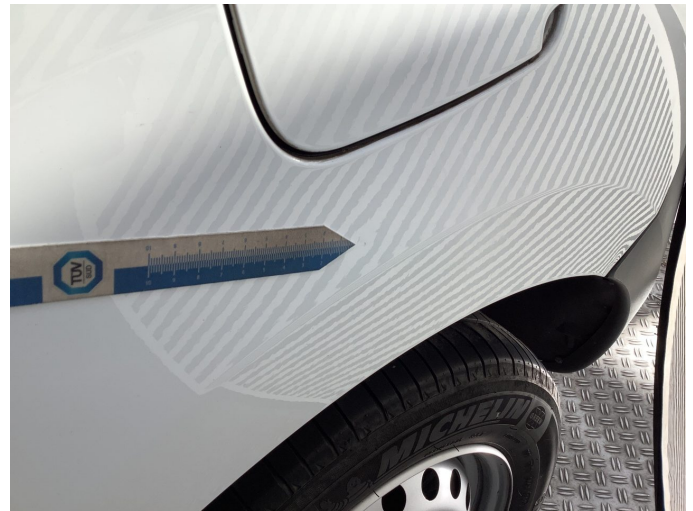
Wear and tear 2: Side panel - rear left side: Side panel - dent(s) - No deduction

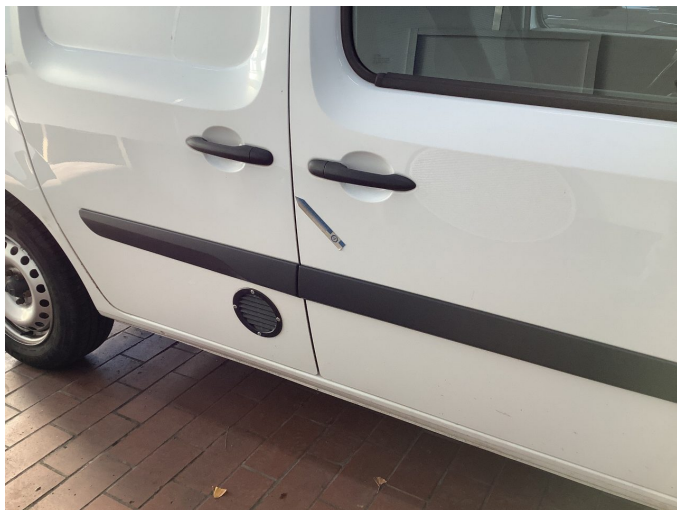
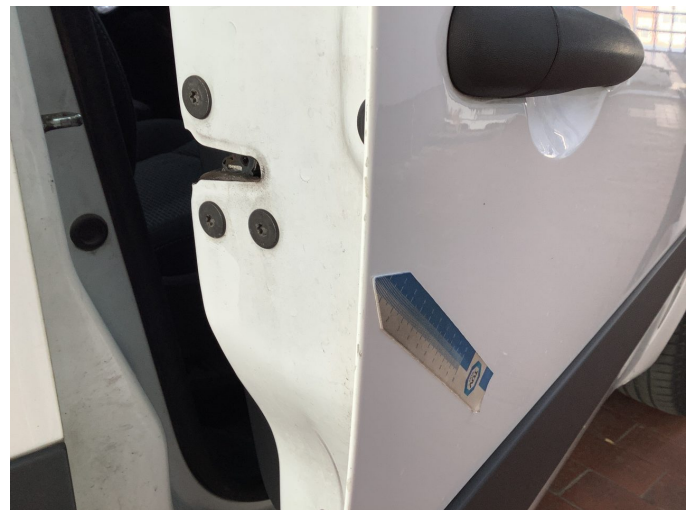
Wear and tear 3: Door - front right side: Door edge - Scratch(es) - No deduction

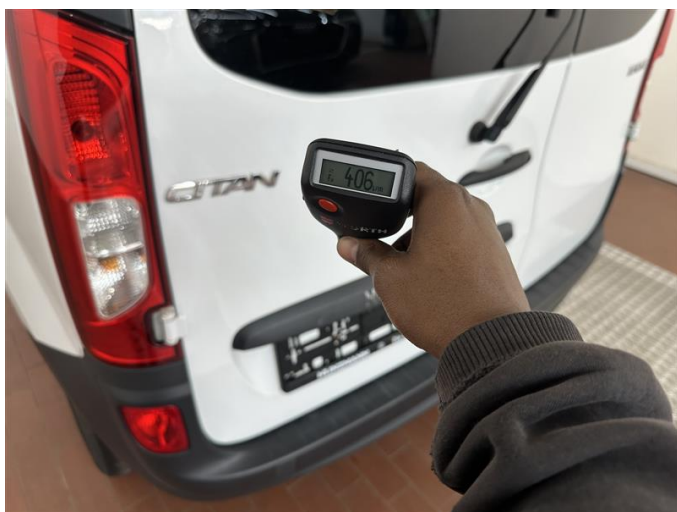
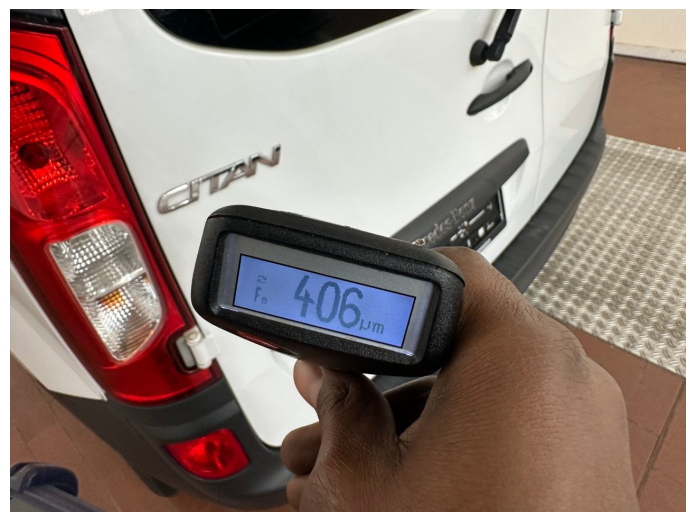
Boot lid / rear door	406 µm
----------------------	--------

Repainting 1: Boot lid / rear door
