MERCEDES CITAN  
CITAN FGN 109 CDI LONG

VIN NO W1V4156031U299900  
Registration Number GC701KM

Inspection Report Summary

Customer	BCAuto Encheres	Report Number	P20250711080002
Inspection Date / Place	2025-07-11 / BCA GARONS	Cosmetic Grade	5

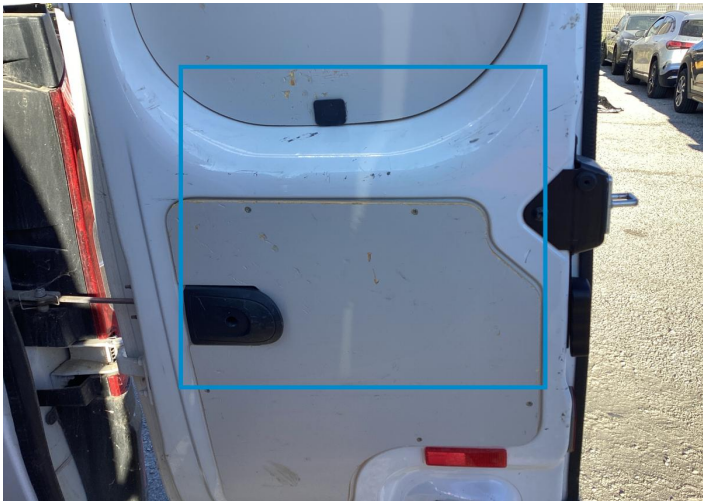
1. Tailgate Upholstery / Back Interior / Scraped -

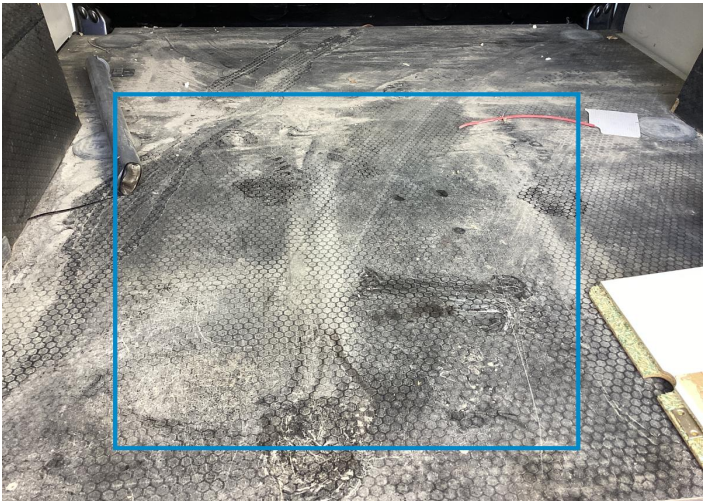
2. Trunk Carpet Interior / Scraped -

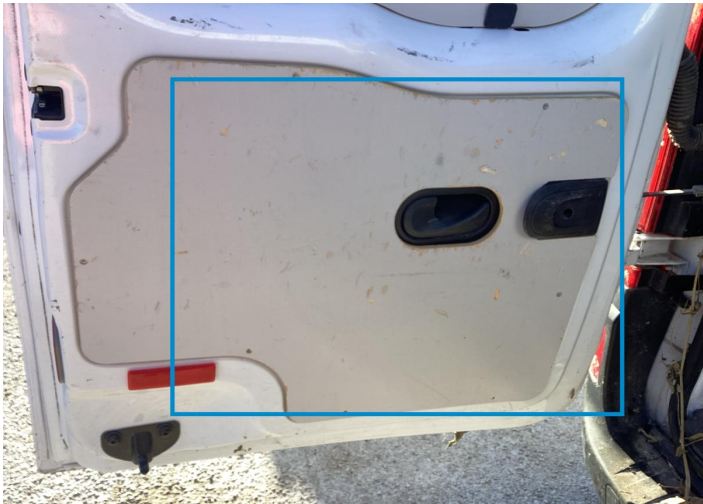
3. Tailgate Upholstery / Back Interior / Scraped -

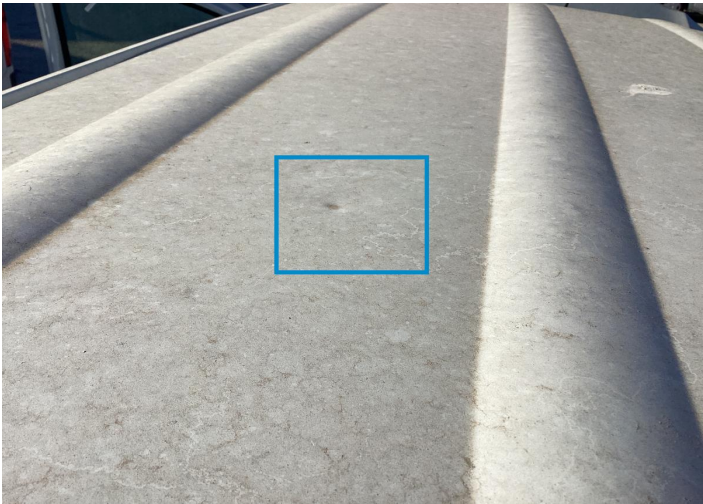
4. Roof Bodywork / Dent / Dent -

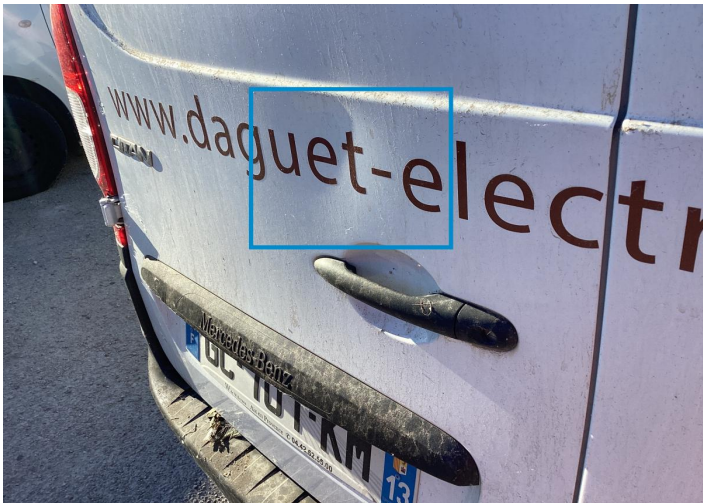
5. Tailgate Bodywork / Dent / Deformation -

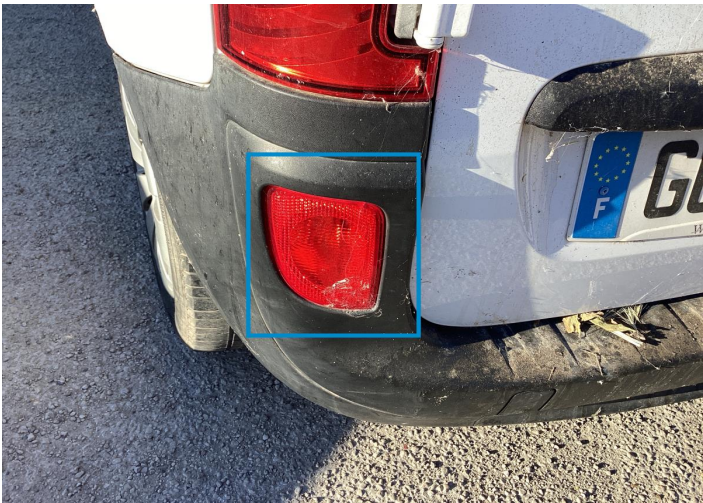
6. Reflector / Back Left Bodywork / Breakage / Crack -

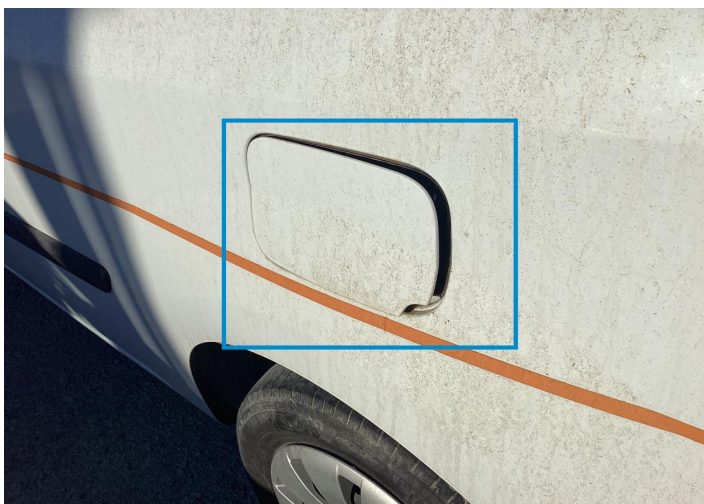
7. Fuel Door / Back Left  
Bodywork / Breakage / Crack -

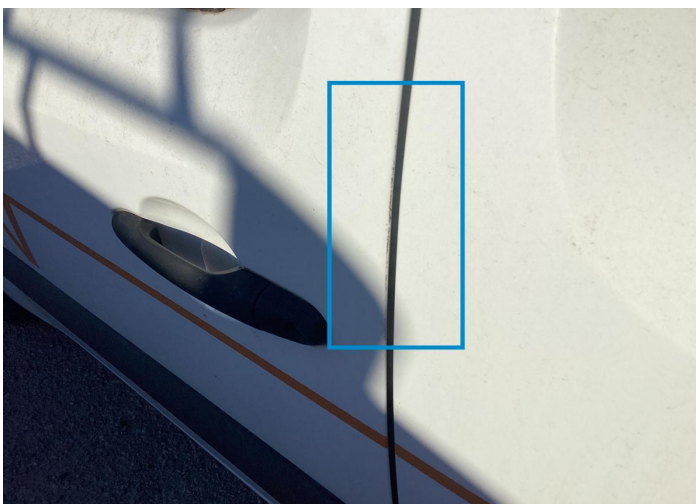
8. Door / Front Left  
Paint / Scratch / Line -

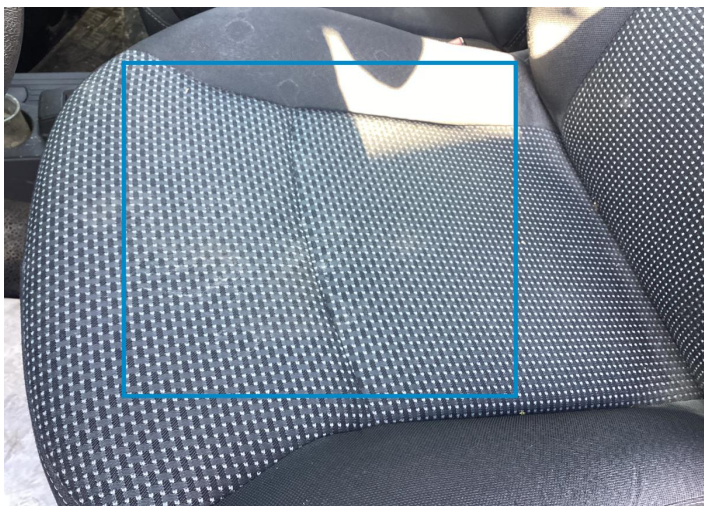
9. Seat Cushion / Front Left  
Interior / Dirty -

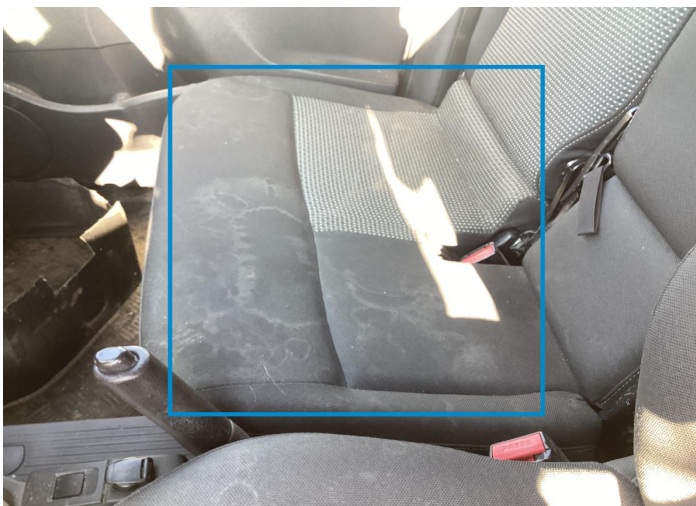
10. Seat Cushion / Front Right  
Interior / Dirty -

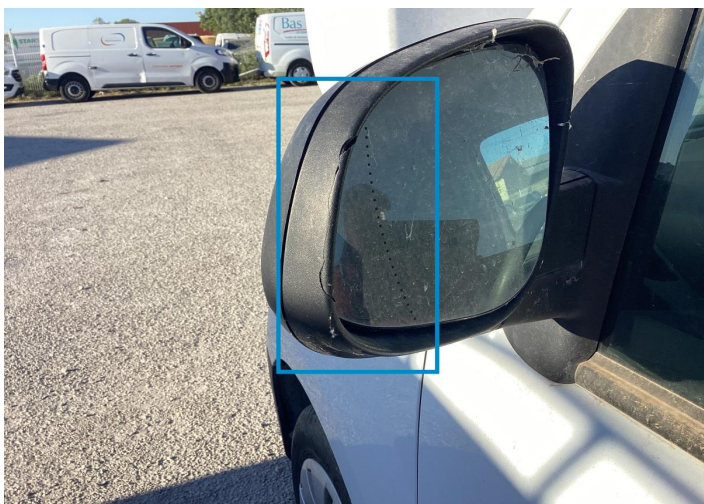
11. Mirror / Front Left  
Bodywork / Breakage / Crack -

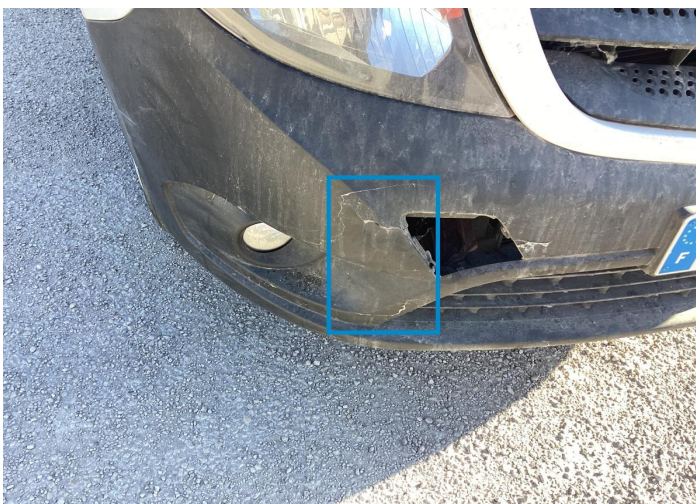
12. Bumper / Front  
Bodywork / Breakage / Crack -

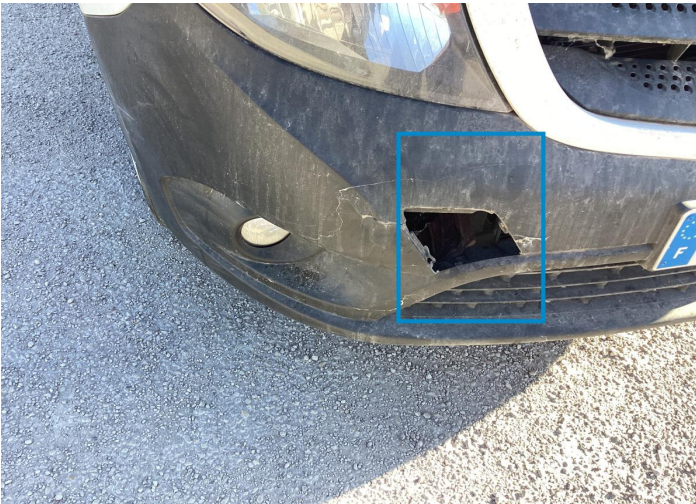
13. Bumper / Front  
Missing Part -

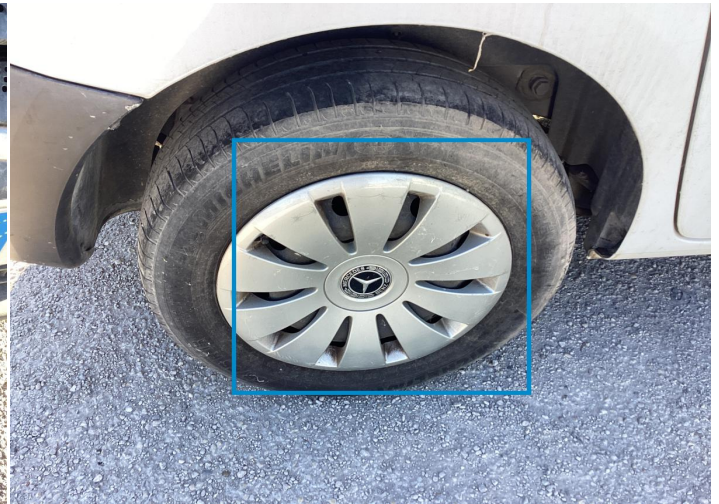
14. Hubcap / Back Right  
Out of Bodywork / Scratch -
