Expertise

Protocol number: 41333585
Order No. / Reference: 25160948
Inspection date: 27 Aug 2025

Manufacturer: Mercedes-Benz

Model: Vito 114 CDI Kompakt HA Aut. BASE

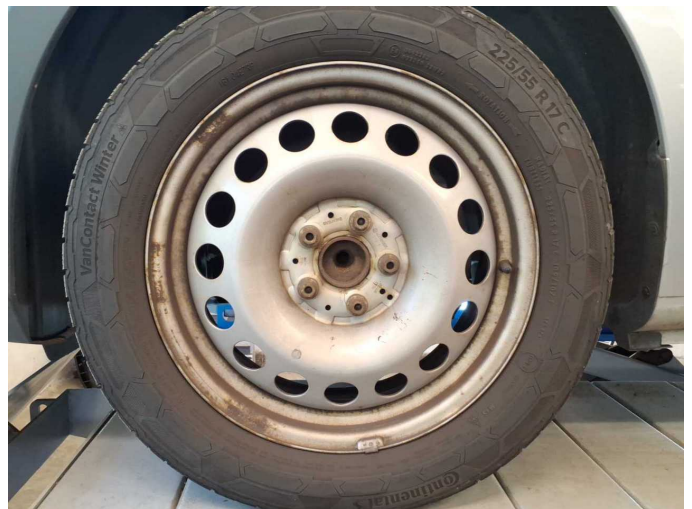
Damage 1: Wheel / tyres: Wheel cover - front left side (Radnabendeckel)
- Missing - Replace

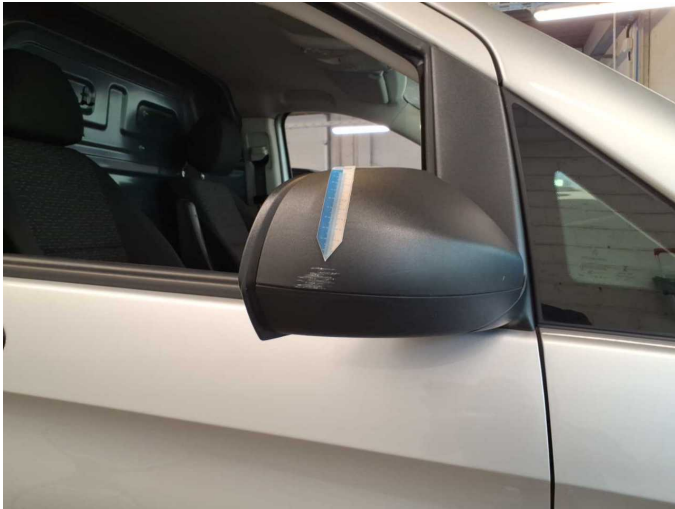
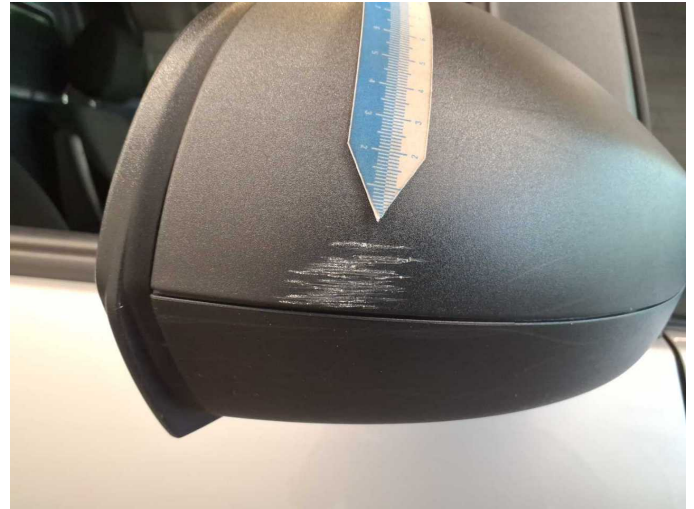
Damage 2: Wing mirror - right side: Cap - Scratch(es) - Smart repair

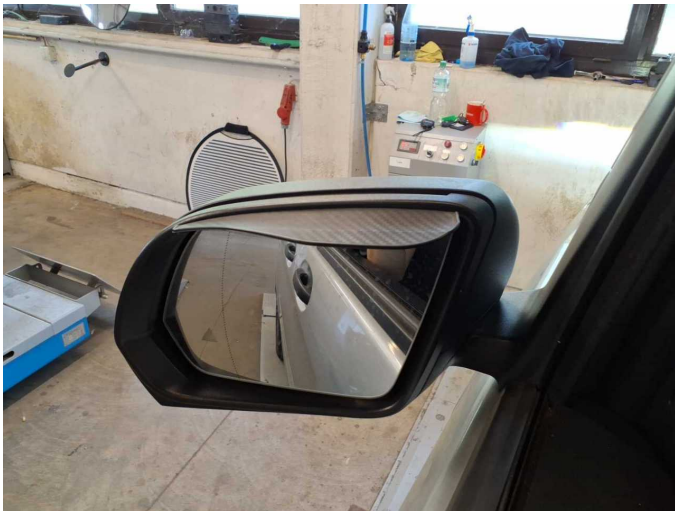
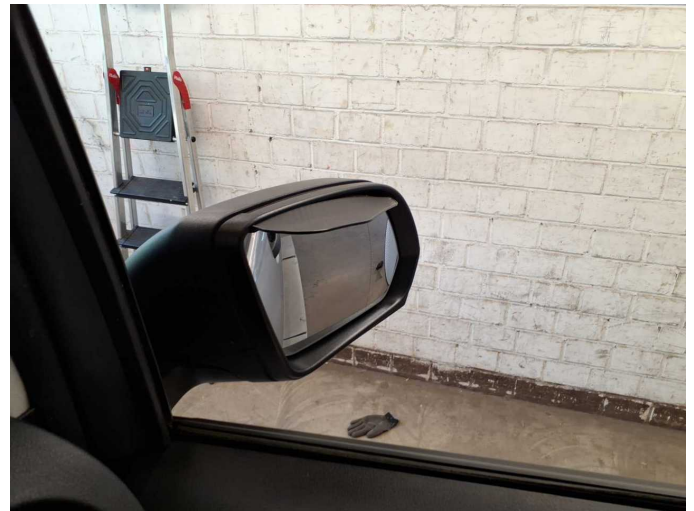
Damage 3: Wing mirror - left side: Cap - Glued / labelled - De-glue / neutralise

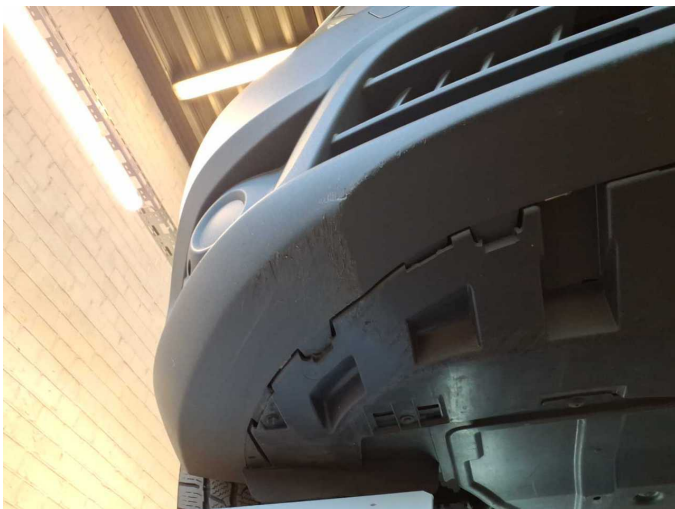
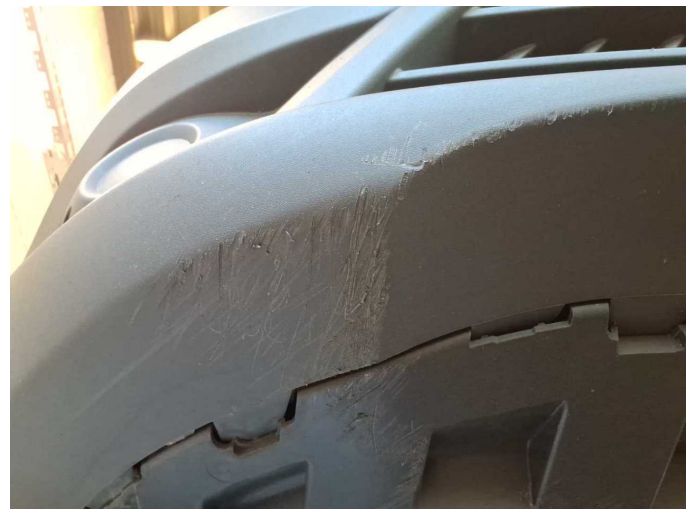
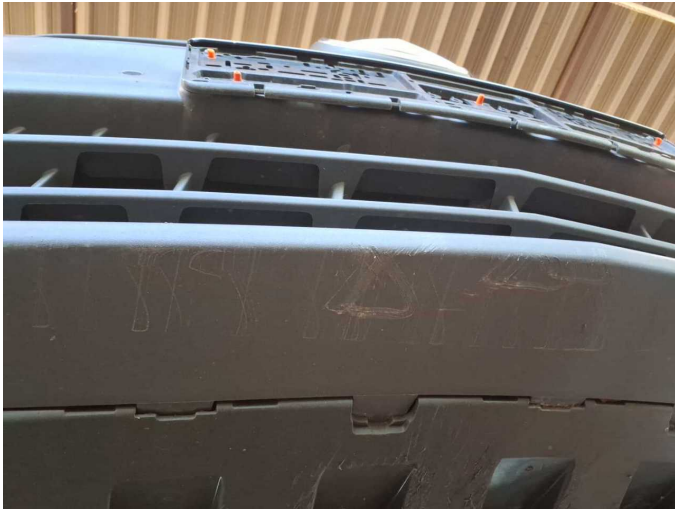
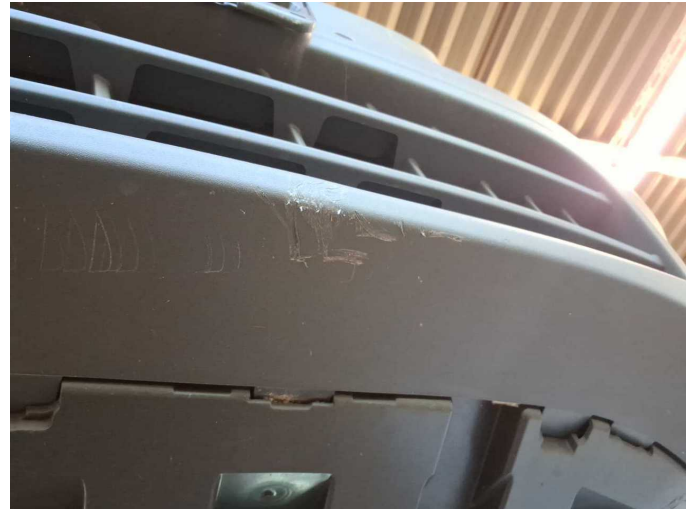
Damage 4: Front bumper: Front bumper - Scratch(es) - Smart repair

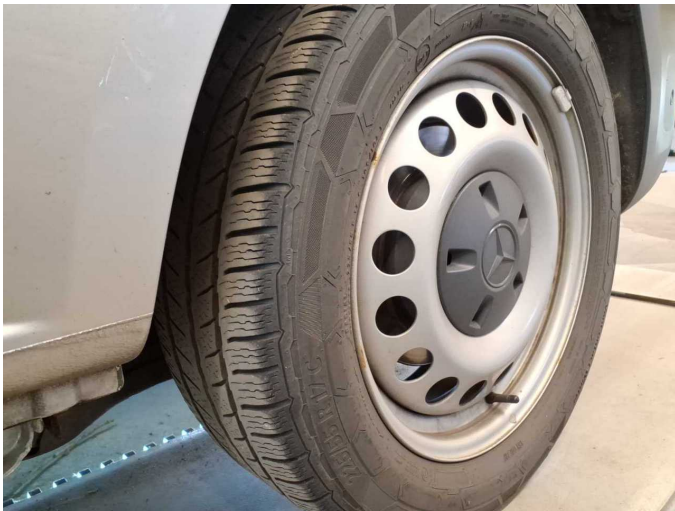
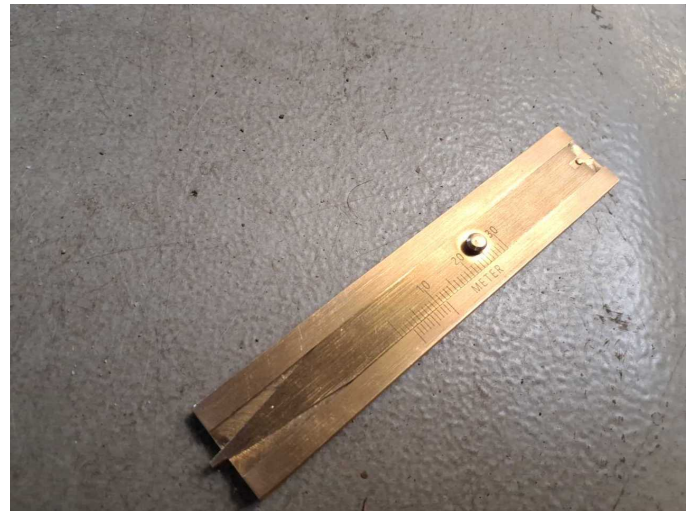
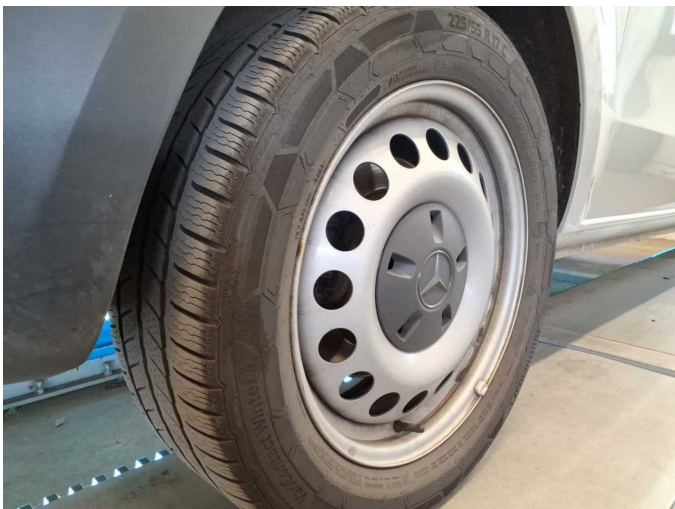
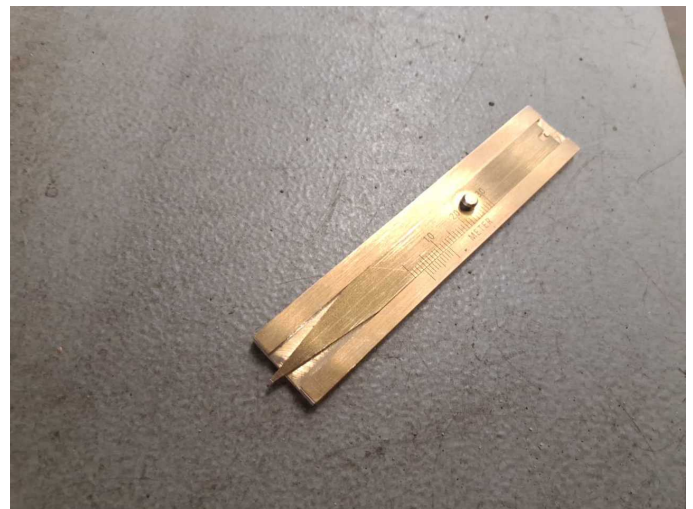
Damage 5: Wheel / tyres: Tyre - right - Does not meet the leasing specifications - Replace

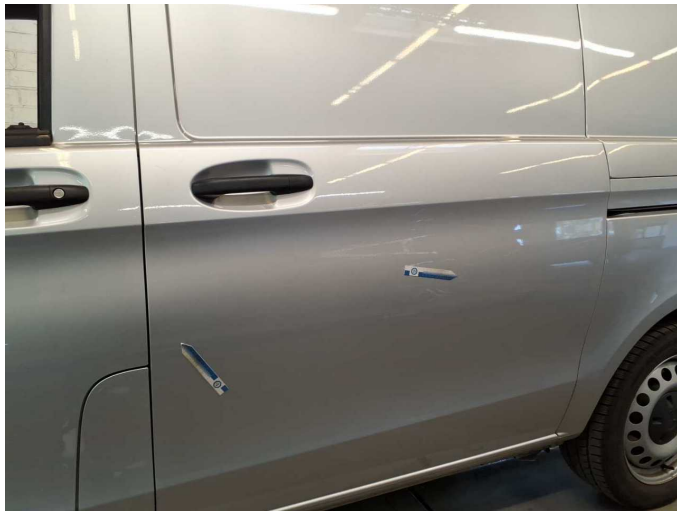
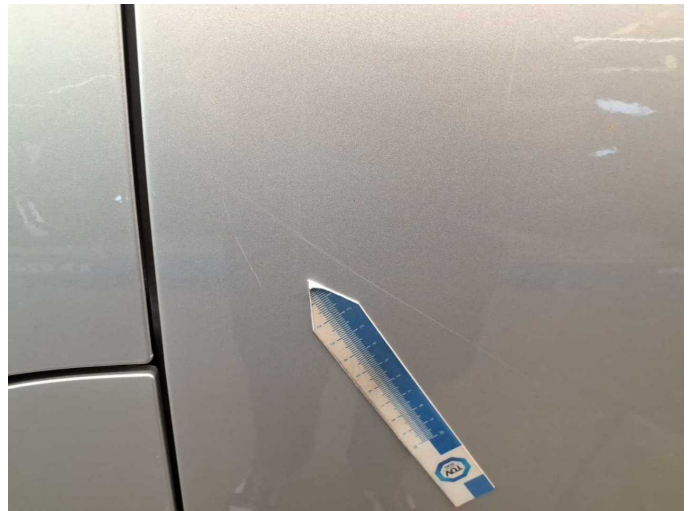
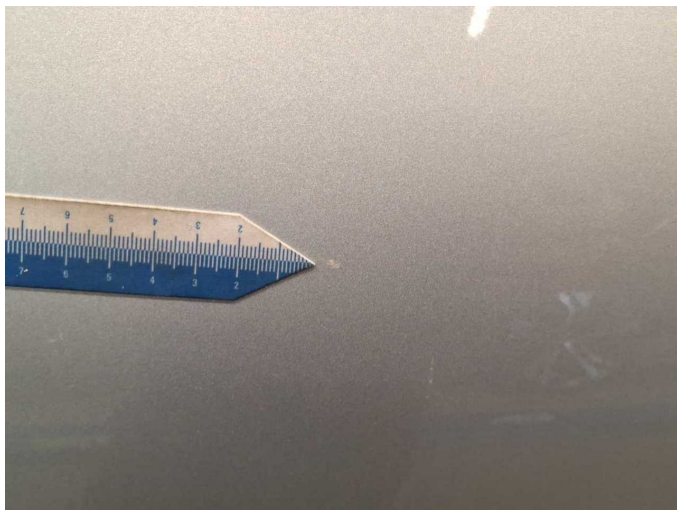
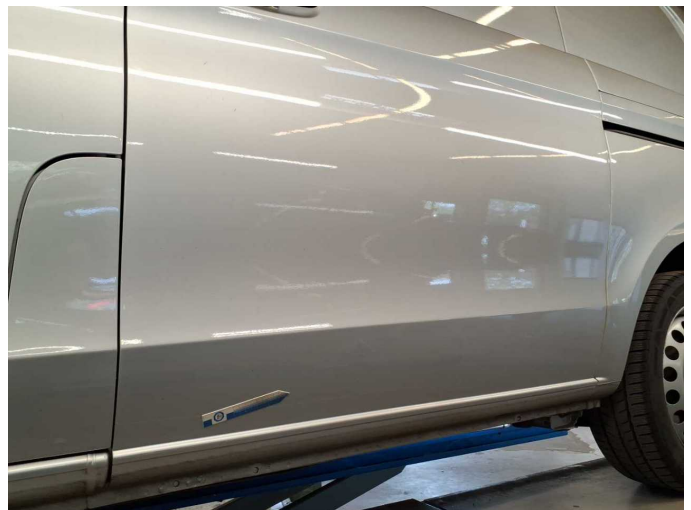
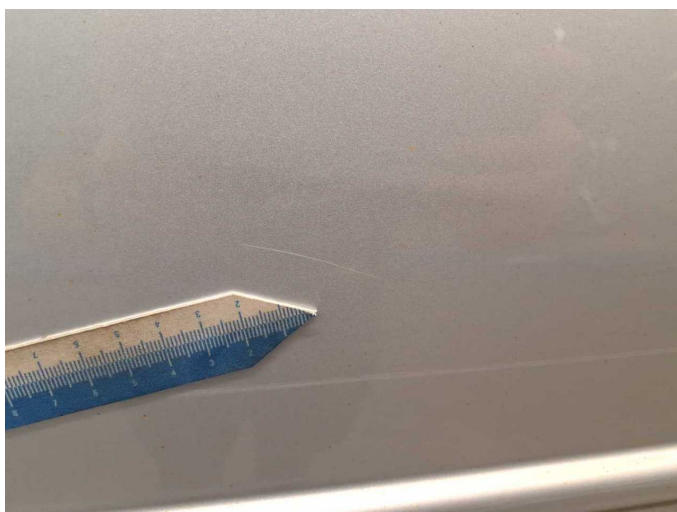
Damage 6: Sliding door - left side: Sliding door - Scratch(es) - Paint

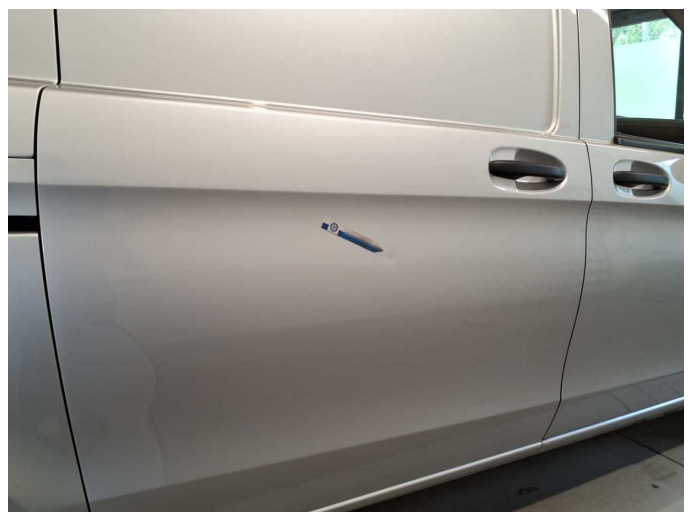
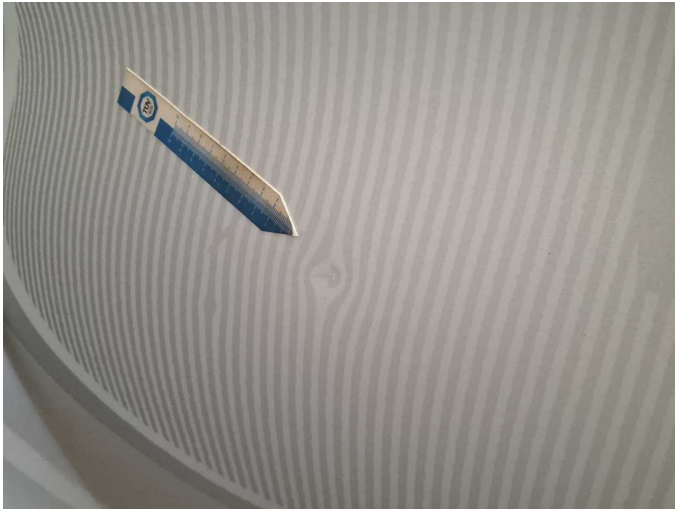
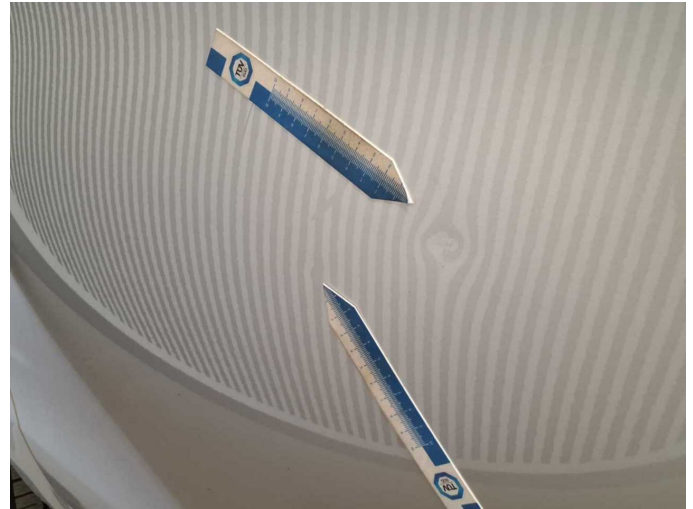
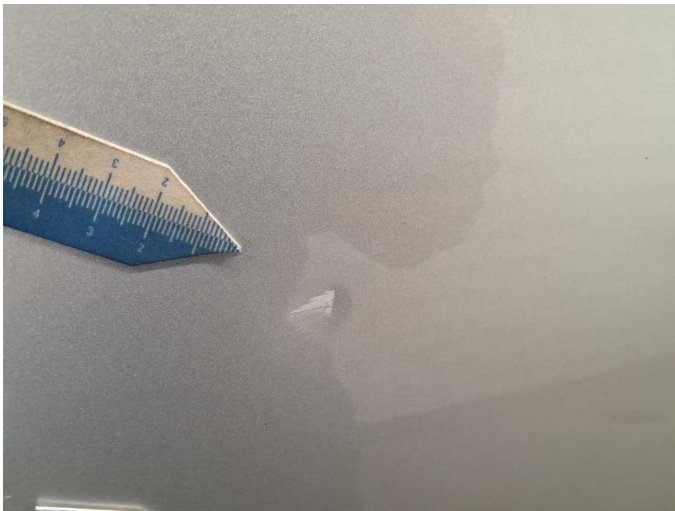
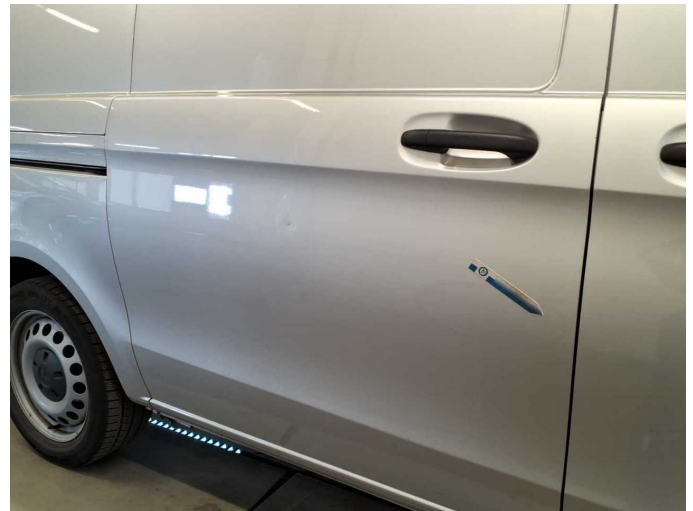
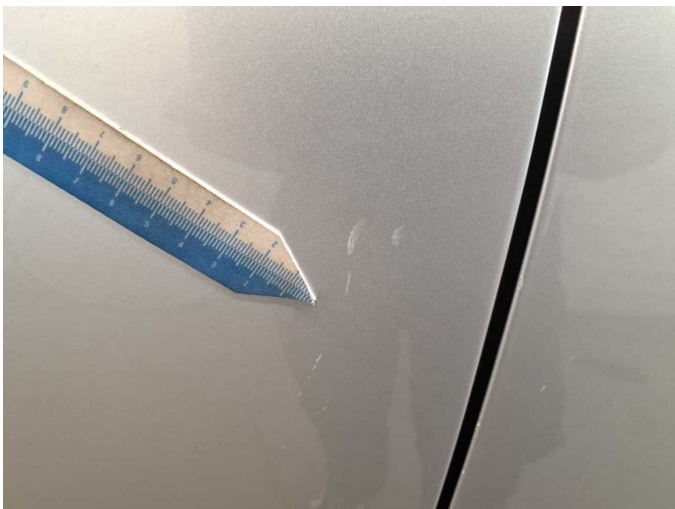
Damage 7: Sliding door, right: Sliding door - Dent / paintcoat damage - Repair and paint

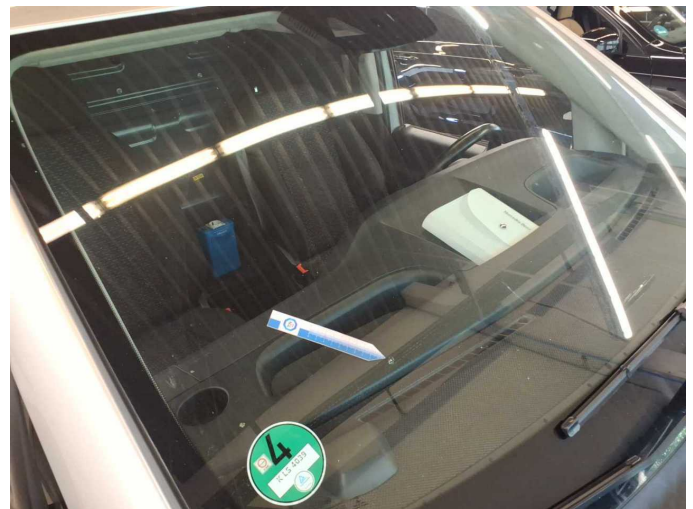
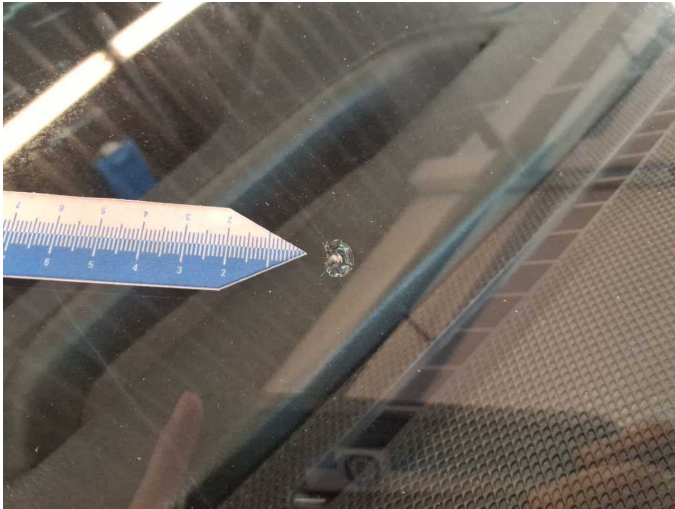
Damage 8: Vehicle glazing: Windscreen - Broken / torn - repair according to calculation

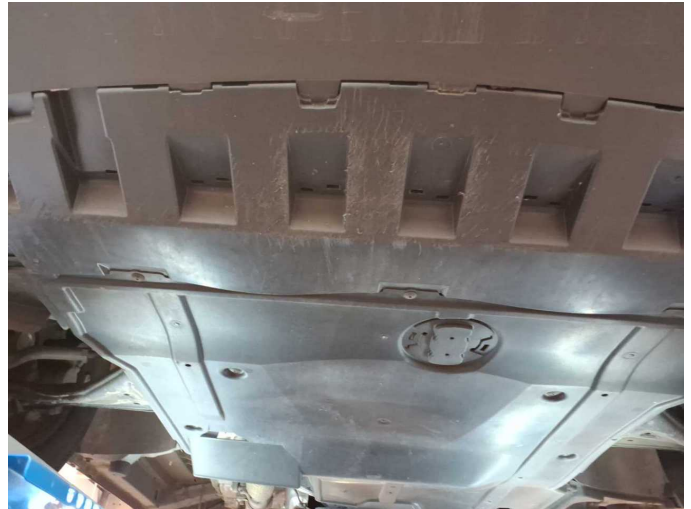
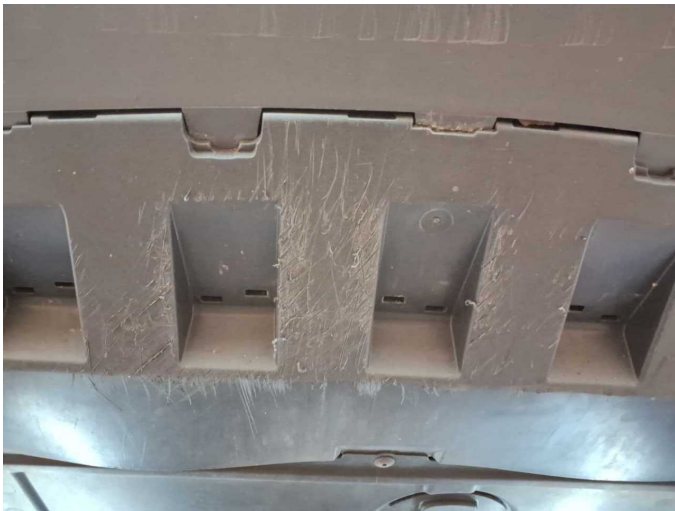
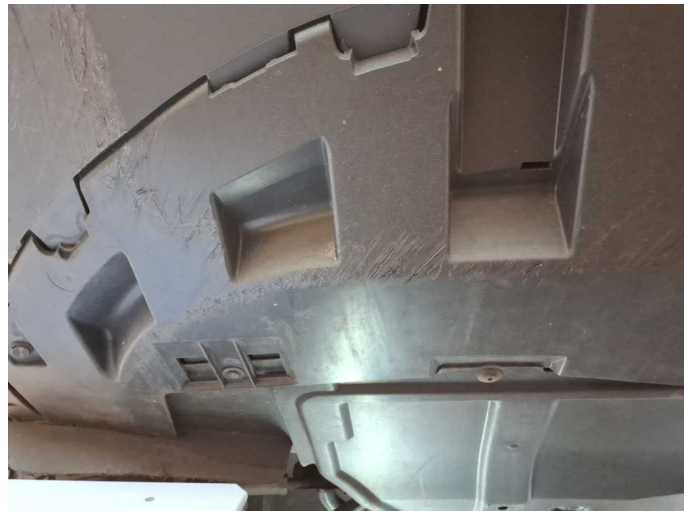
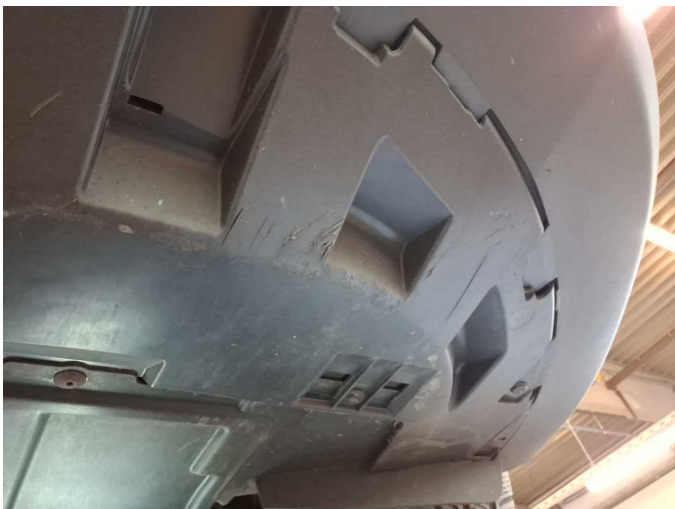
Wear and tear 7: Engine: Engine cowling lower front - Scratch(es) - No deduction

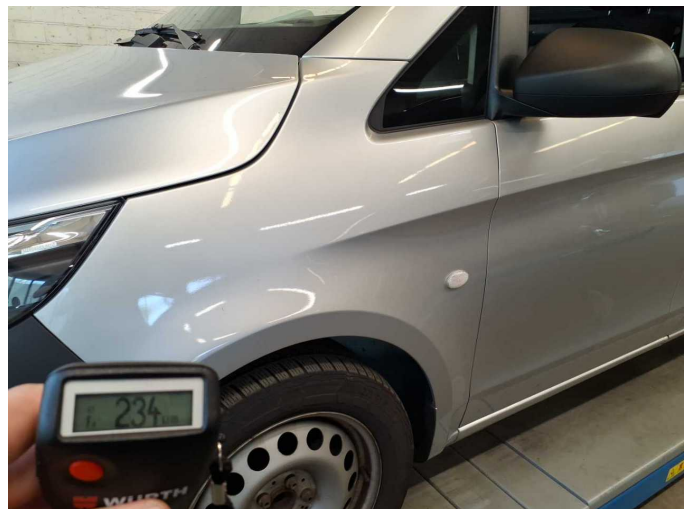
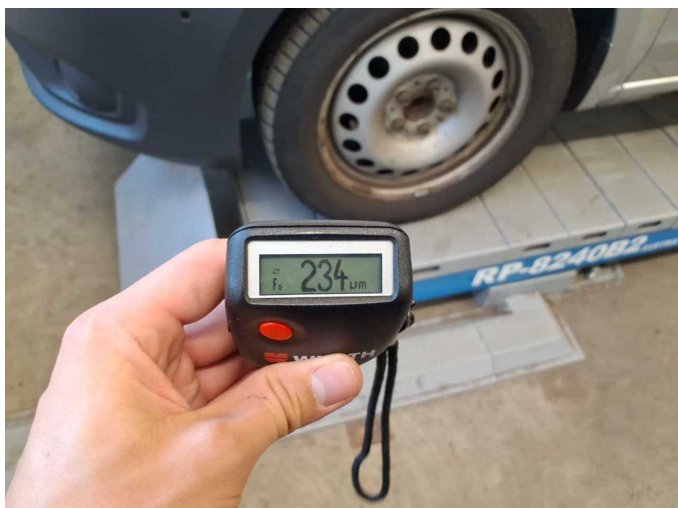
Mudguard - left side	234 µm	Door - front left side	275 µm
----------------------	--------	------------------------	--------

Repainting 1: Mudguard - left side

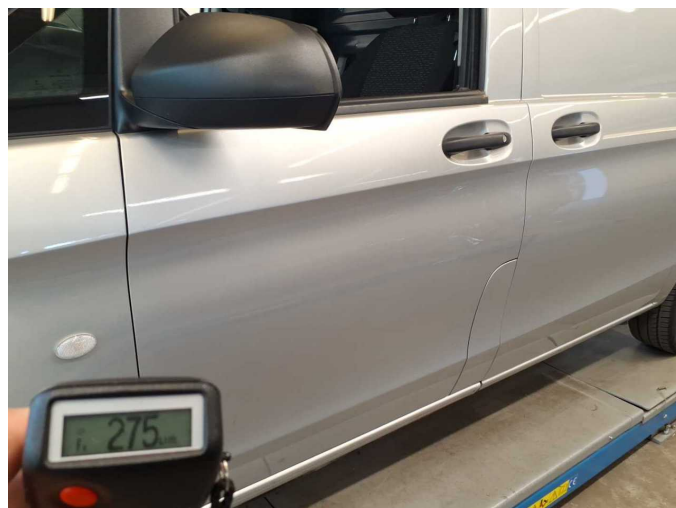
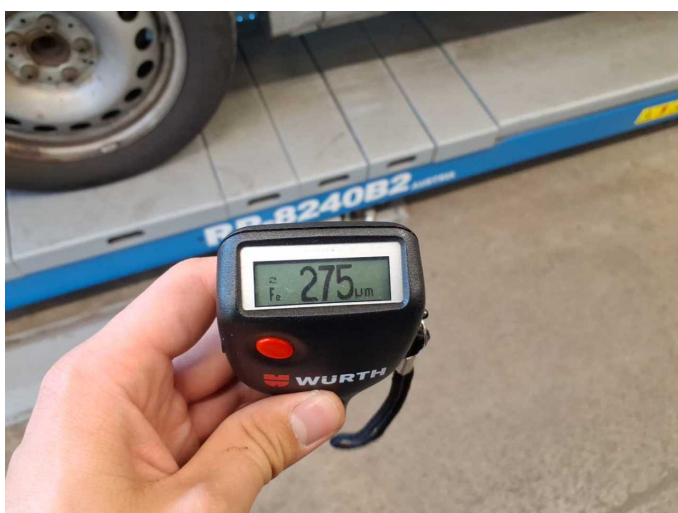
Repainting 2: Door - front left side
