Expertise

Protocol number: 39990061  
Order No. / Reference: 24843575  
Inspection date: 2 Jun 2025

Manufacturer: Mercedes-Benz

Model: Vito 114 CDI Kompakt HA Aut. BASE

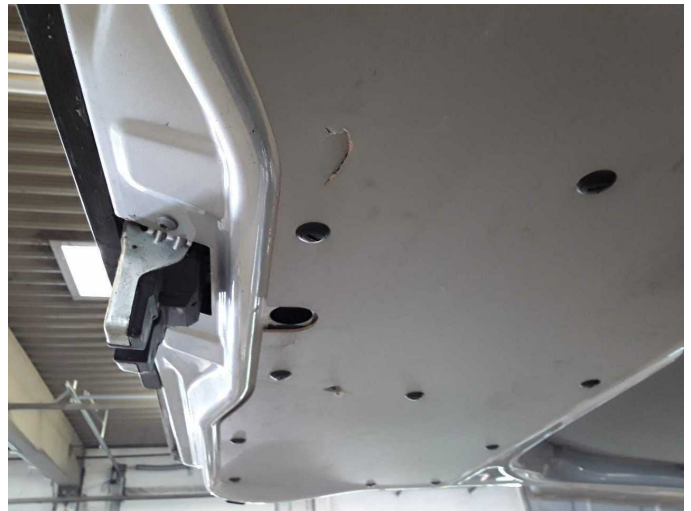
**Damage 1:** Trim / covers: Boot lid - interior trim - Damaged - Replace

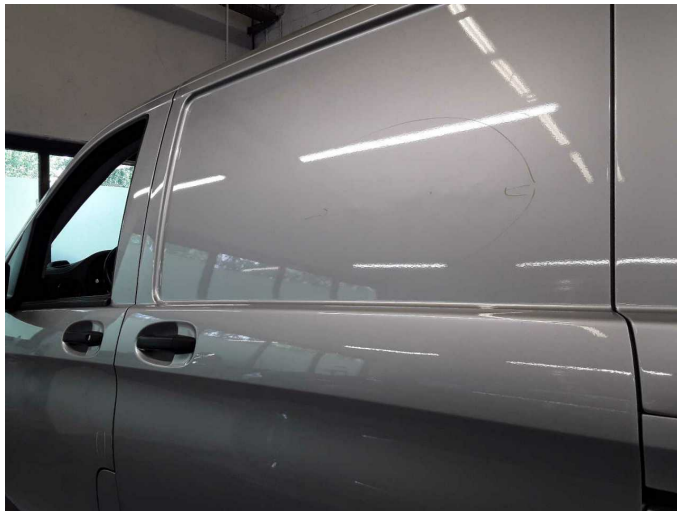
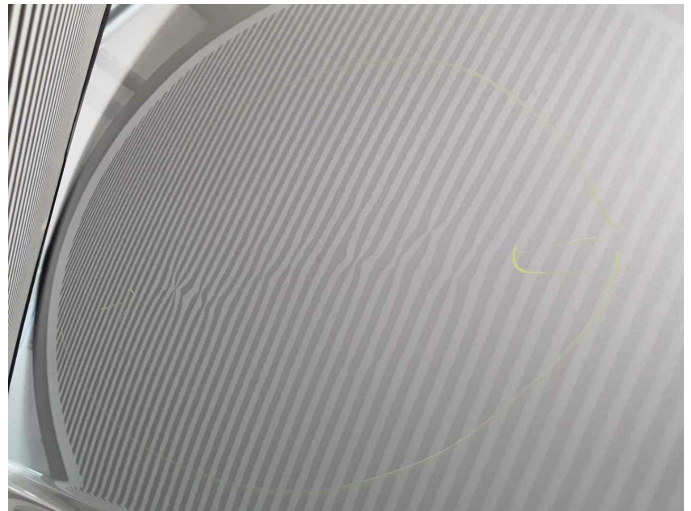
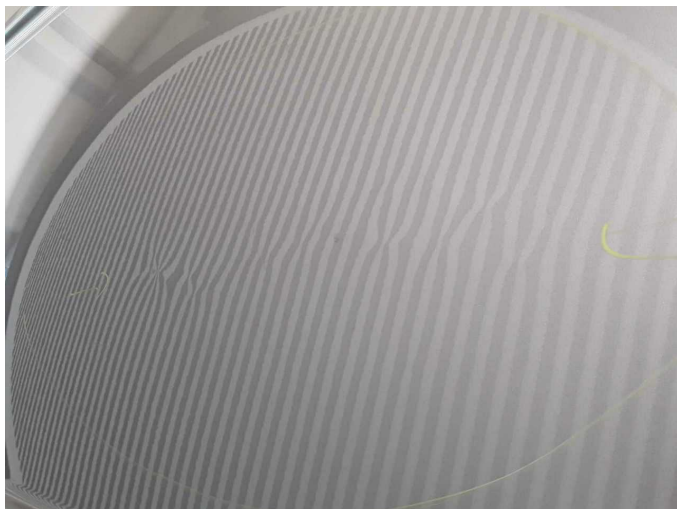
**Damage 2:** Sliding door - left side: Sliding door - Deformed - Repair and paint

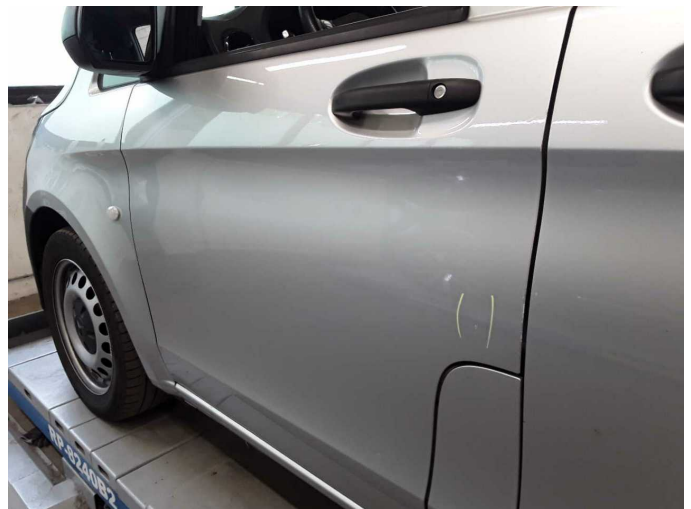
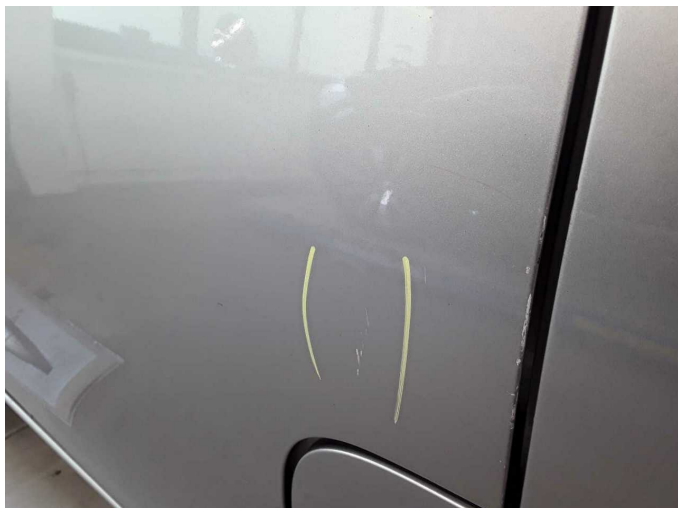
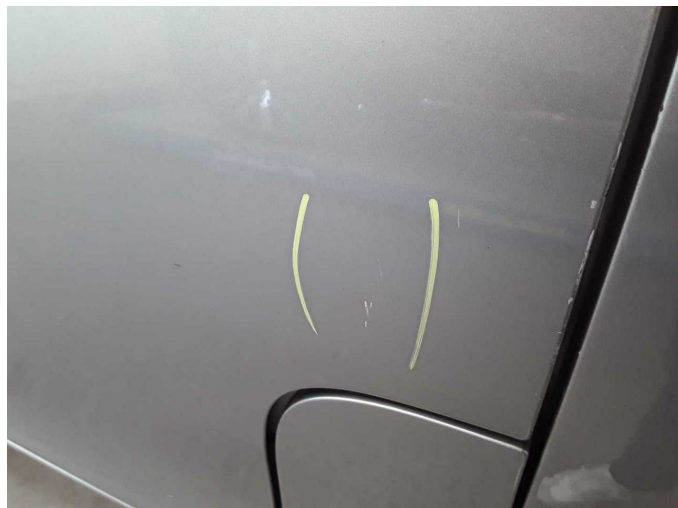
**Damage 3:** Door - front left side: Door - Scratch(es) - Paint

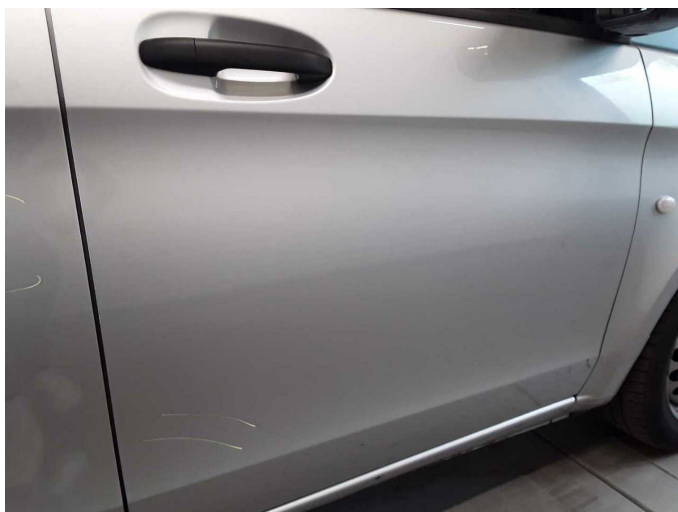
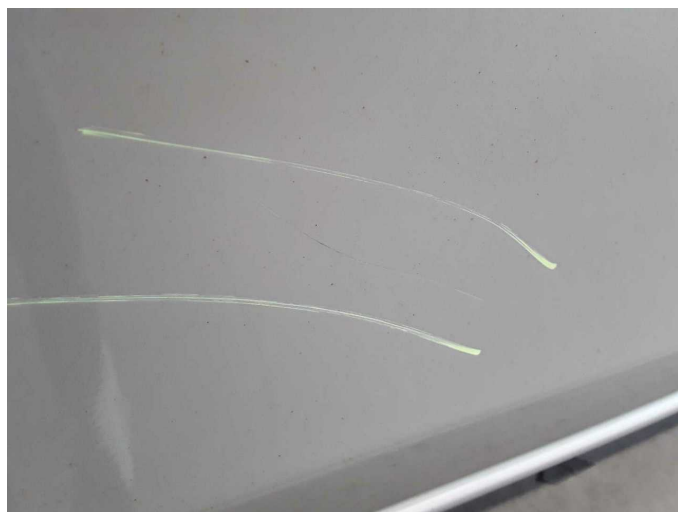
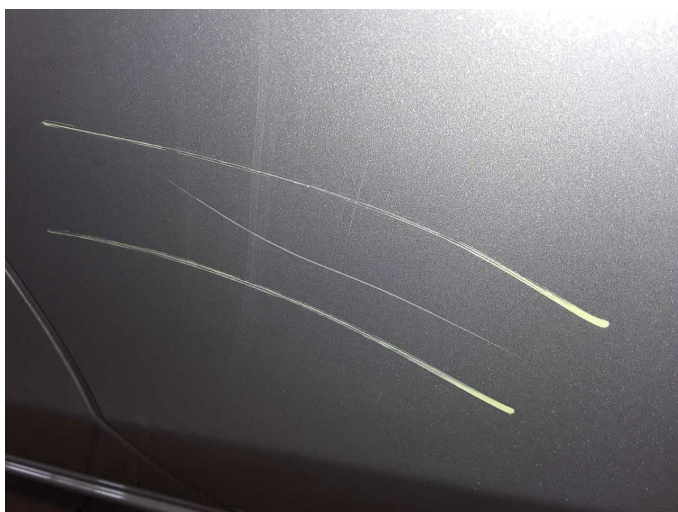
**Damage 4:** Door - front right side: Door - Scratch(es) - Paint

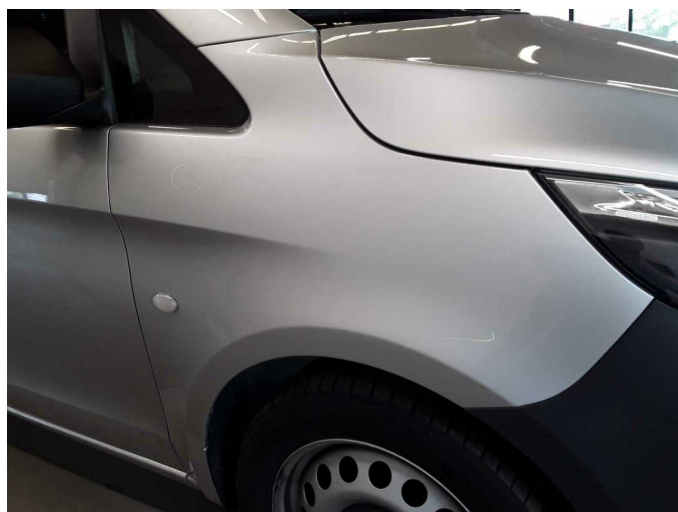
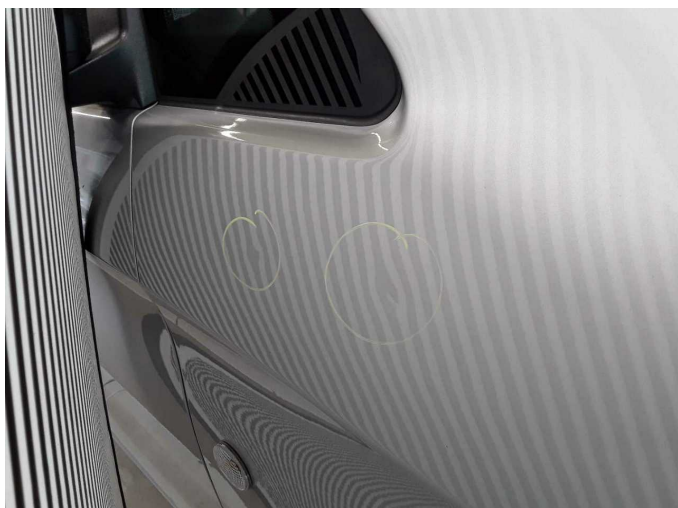
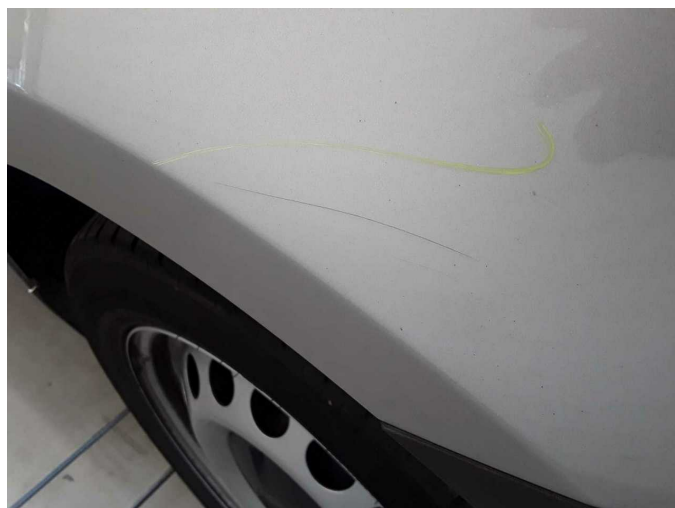
**Damage 5:** Mudguard - right side: Mudguard - right side - Dent / paintcoat damage - Repair and paint

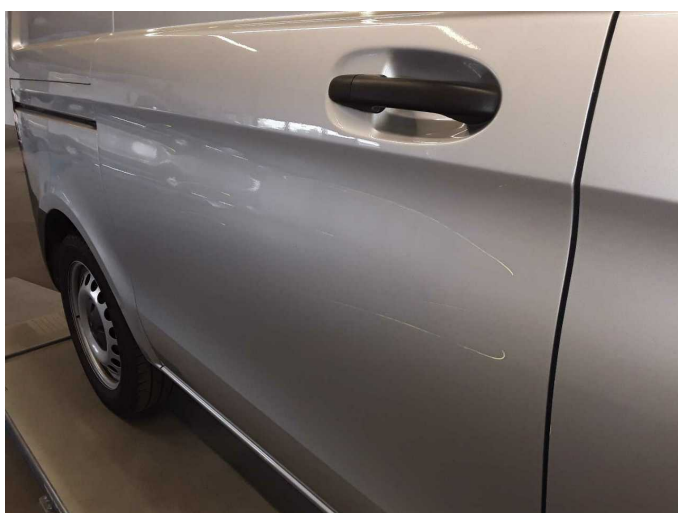
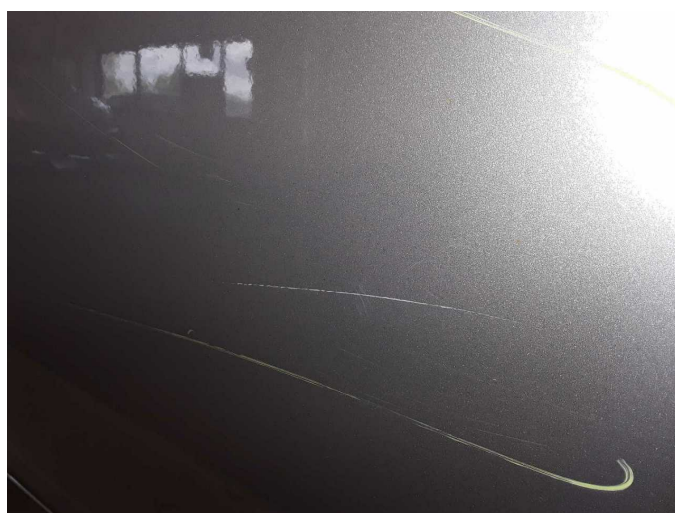
**Damage 6:** Sliding door, right: Sliding door - Scratch(es) - Paint

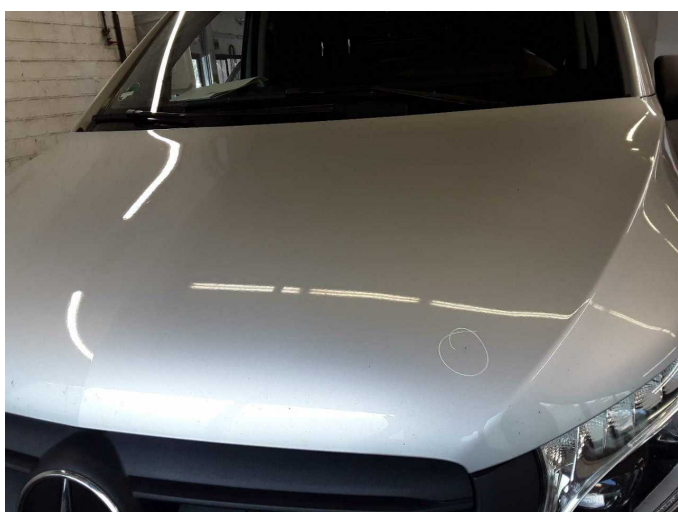
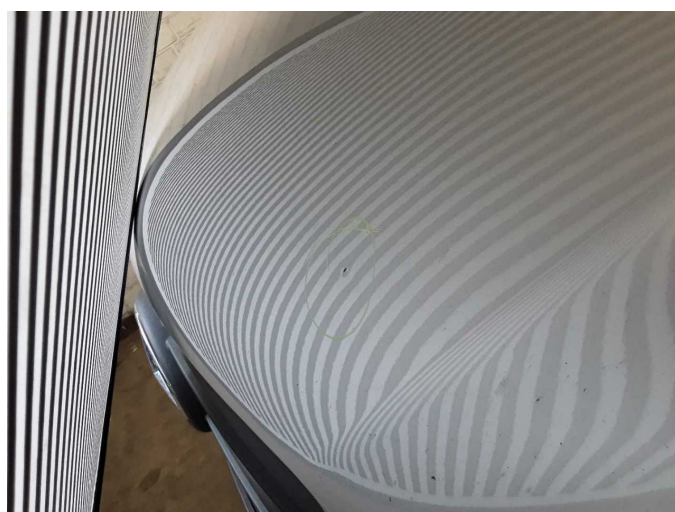
**Damage 7:** Bonnet: Bonnet - Dent / paintcoat damage - Repair and paint

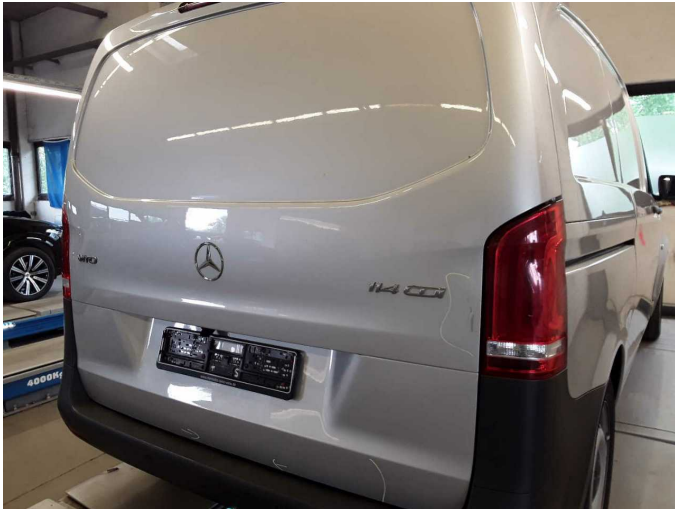
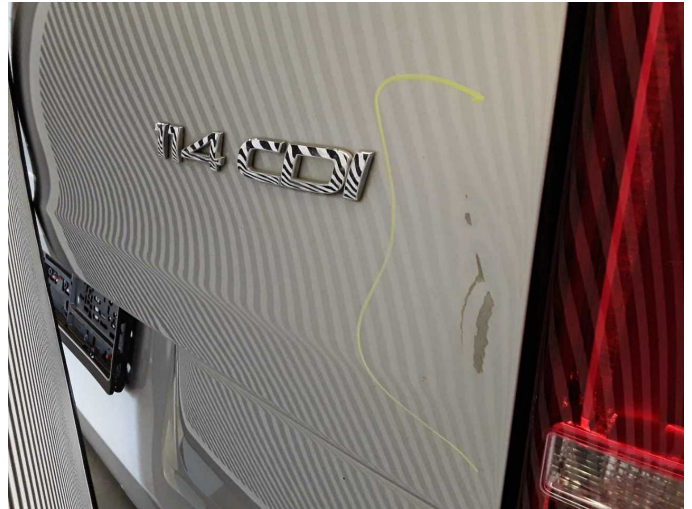
**Damage 8:** Boot lid / rear door: Boot lid - Dent / paintcoat damage - Repair and paint

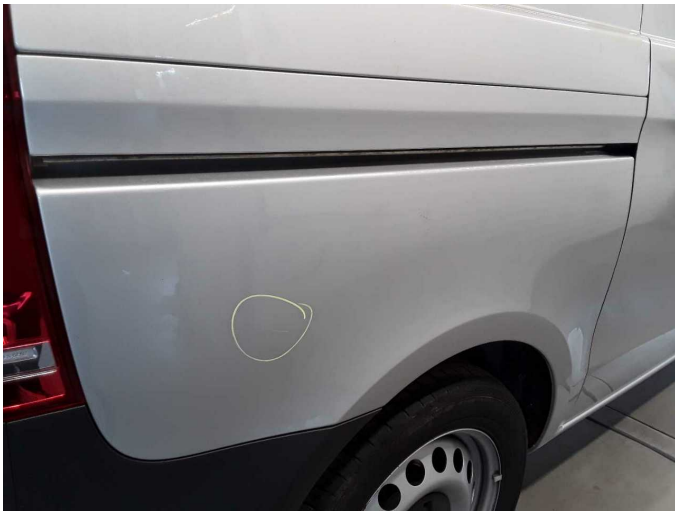
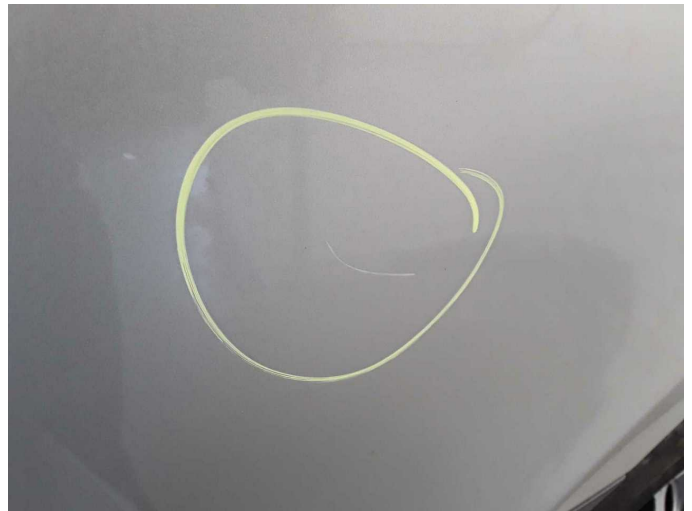
**Damage 9:** Side panel - rear right side: Side panel - Scratch(es) - Paint

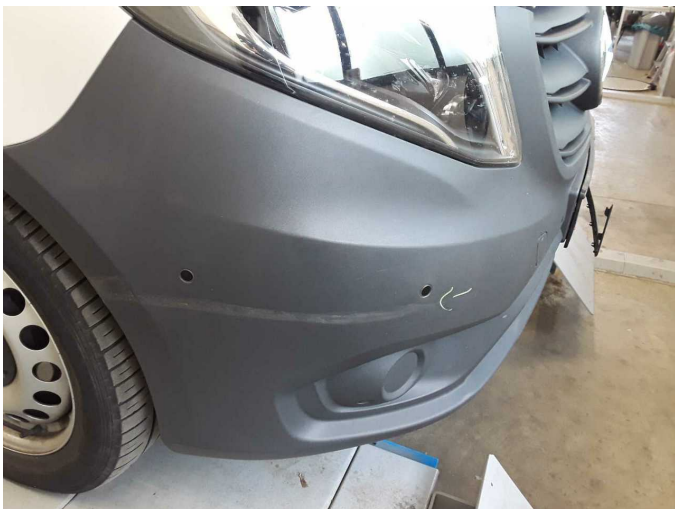
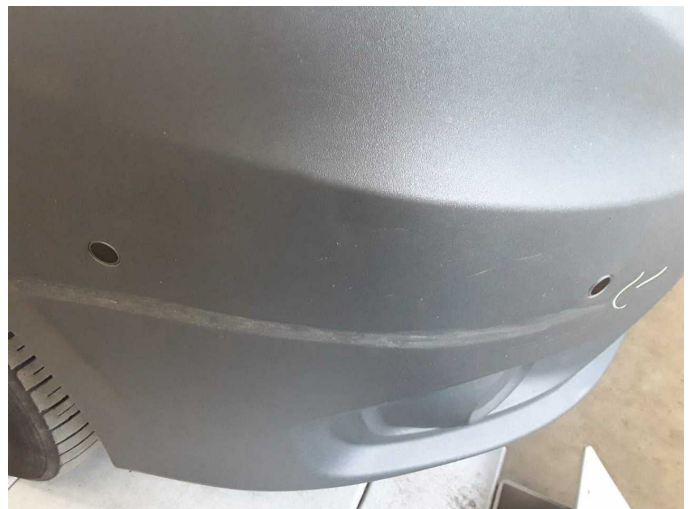
**Wear and tear 1:** Front bumper: Front bumper - Scratch(es) - No deduction

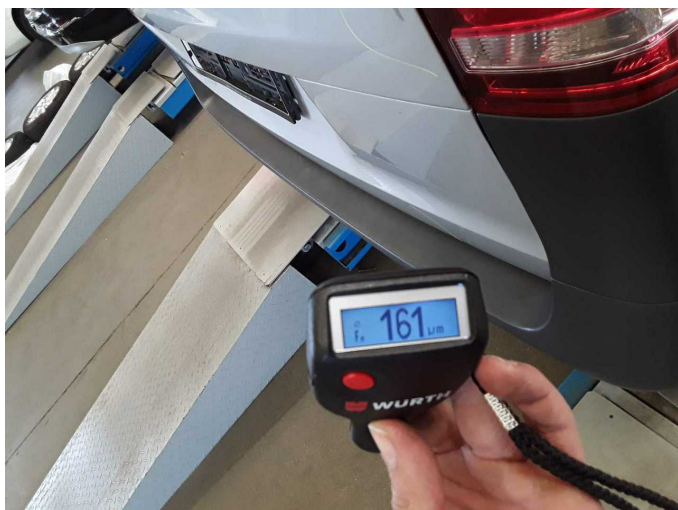
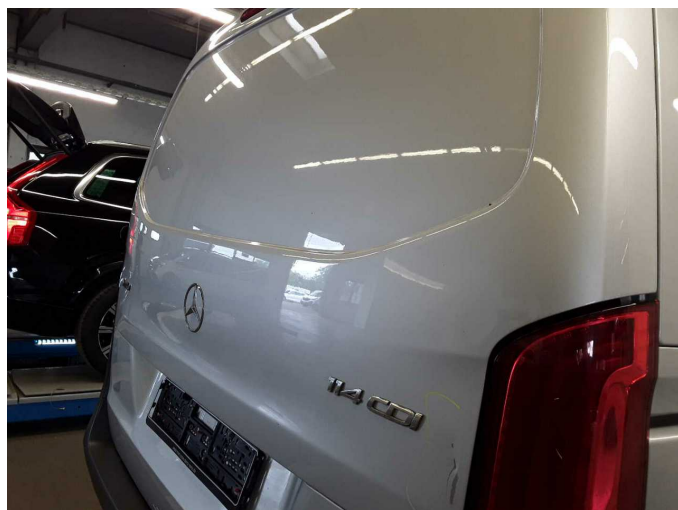
1 Boot lid / rear door, Professionally carried out, Invoice of repair done Non-existent

Boot lid / rear door 161  $\mu\text{m}$  |

**Repainting 1:** Boot lid / rear door
