Expertise

Protocol number: 41830063
Order number / reference: 25283749
Inspection date: 6 Oct 2025

Manufacturer: Mercedes-Benz	Model: Vito 114 CDI Kompakt HA Aut. BASE
VIN: W1V44760114123584

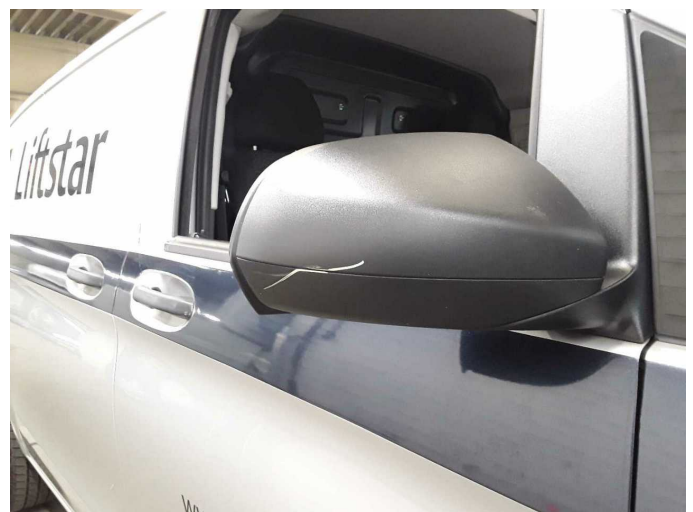
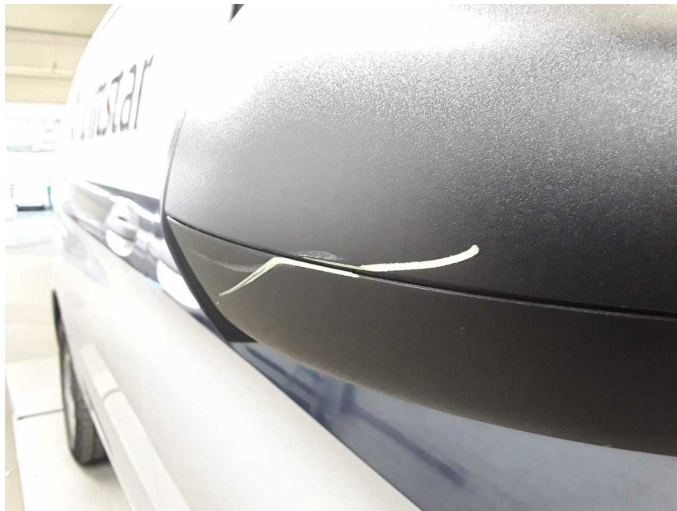
No.	Component group	Description
1	Misc.	Main inspection - No evidence - No deduction
2	Wing mirror - right side	Cap - Scratch(es) - Smart repair
3	Door - rear right side	Door - dent(s) - Smooth repair work
4	Door - front left side	Door - Dent / paintcoat damage - Smart repair
5	Body	Body - Glued / labelled - De-glue / neutralise
6	Door - rear left side	Door - Scratch(es) - Paint
7	Misc.	Inspection / maintenance - Due - Perform
8	Bonnet	Bonnet - Dent / paintcoat damage - Repair and paint
9	Boot lid / rear door	Boot lid - Deformed - Repair and paint
10	Vehicle glazing	Windscreen (Rissbildung) - Stone chips - repair according to calculation

Damage 2: Wing mirror - right side: Cap - Scratch(es) - Smart repair

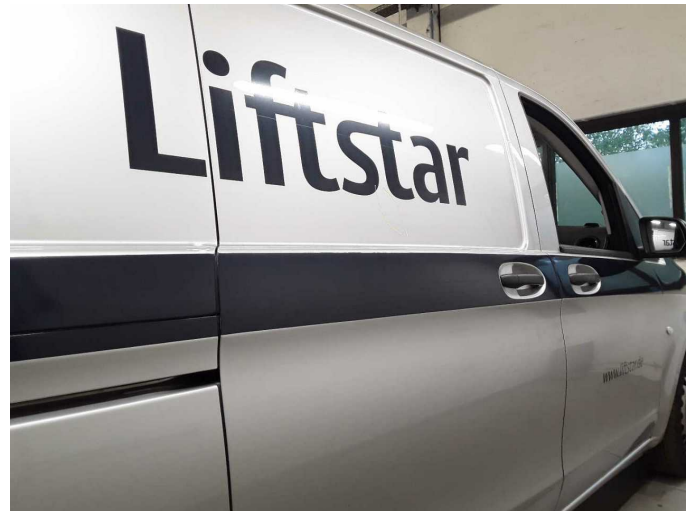
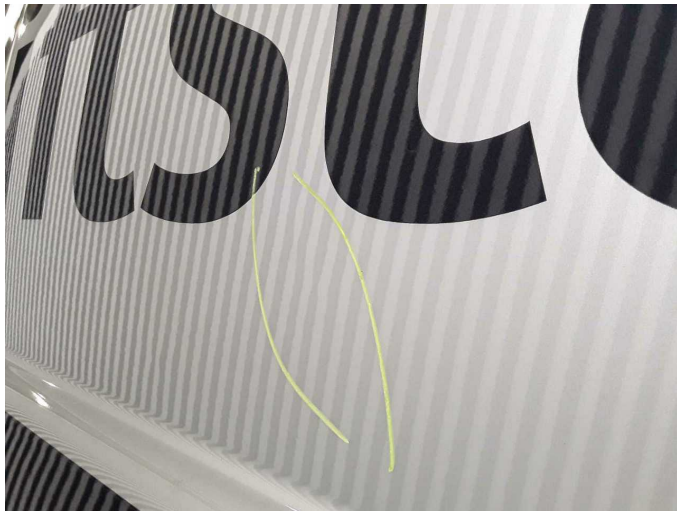
Damage 3: Door - rear right side: Door - dent(s) - Smooth repair work

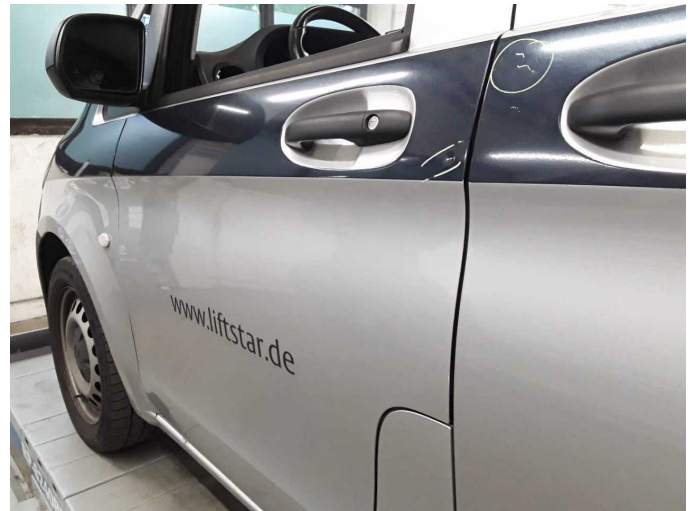
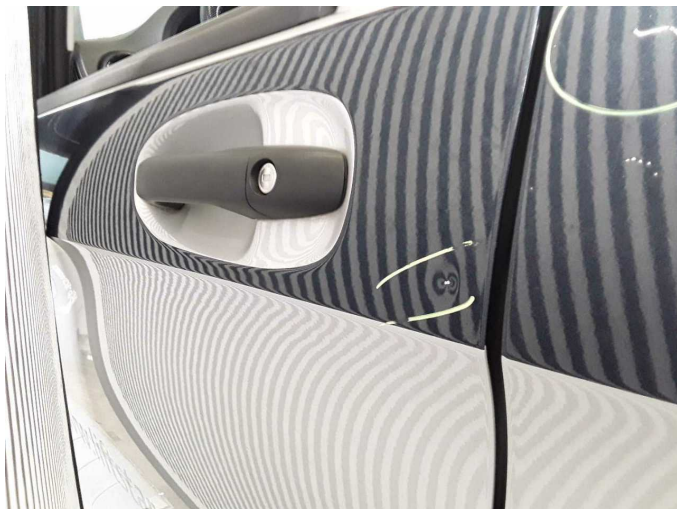
Damage 4: Door - front left side: Door - Dent / paintcoat damage - Smart repair

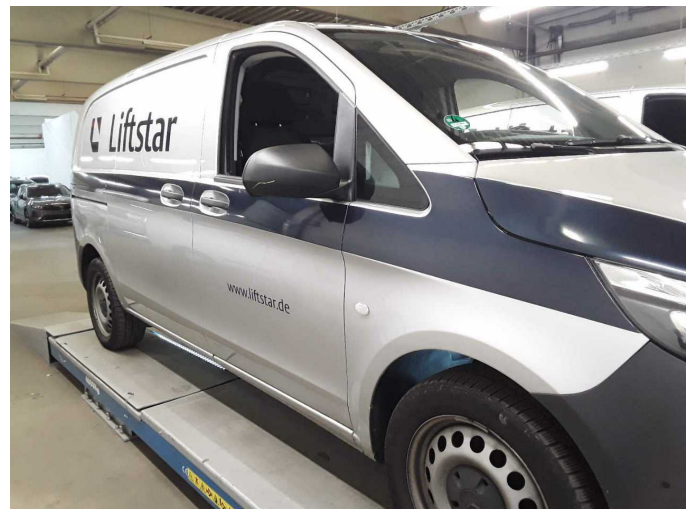
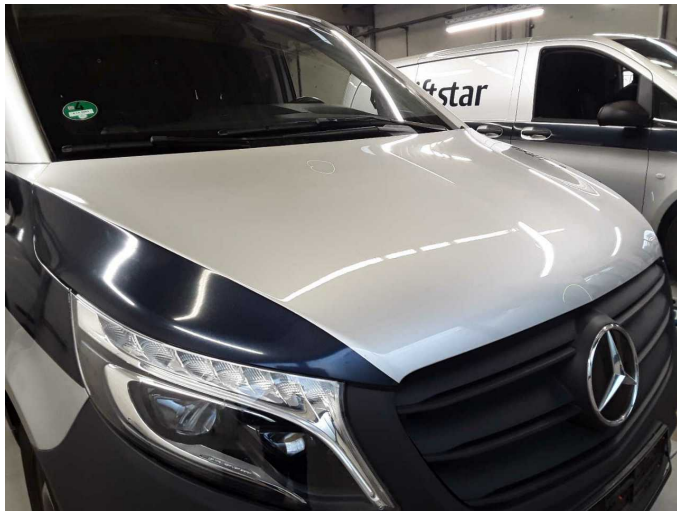
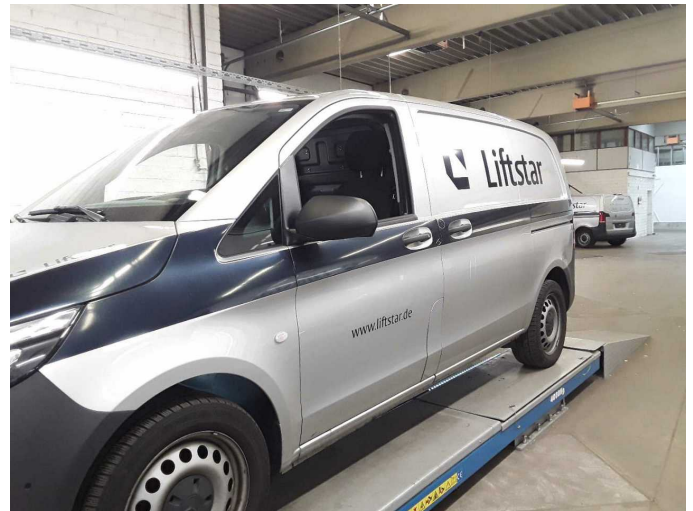
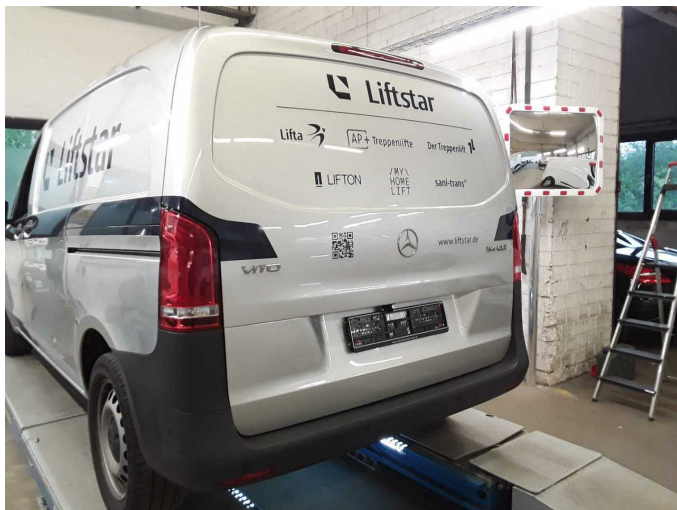
Damage 5: Body: Body - Glued / labelled - De-glue / neutralise

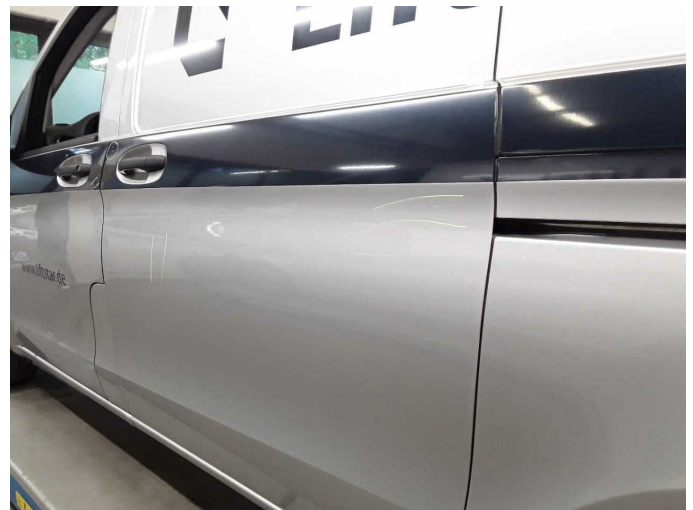
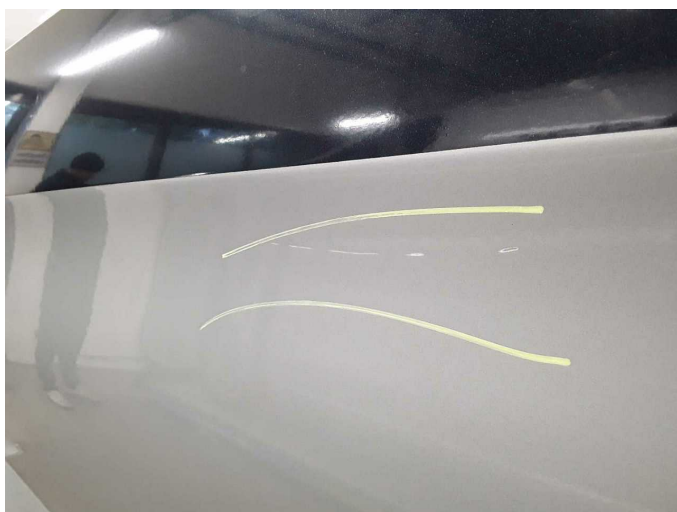
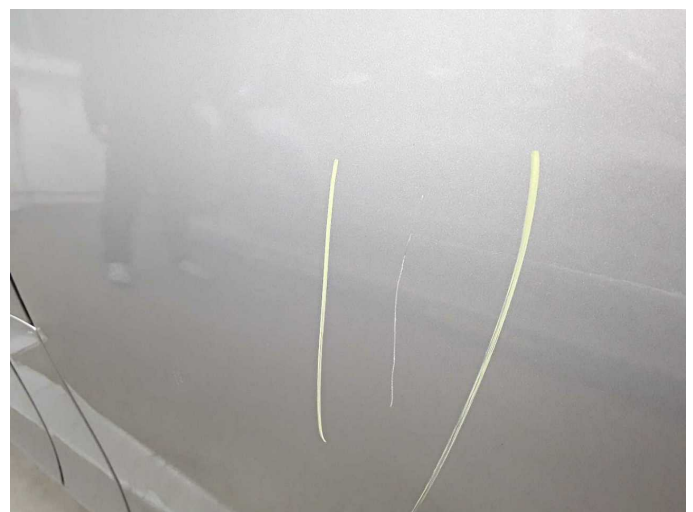
Damage 6: Door - rear left side: Door - Scratch(es) - Paint

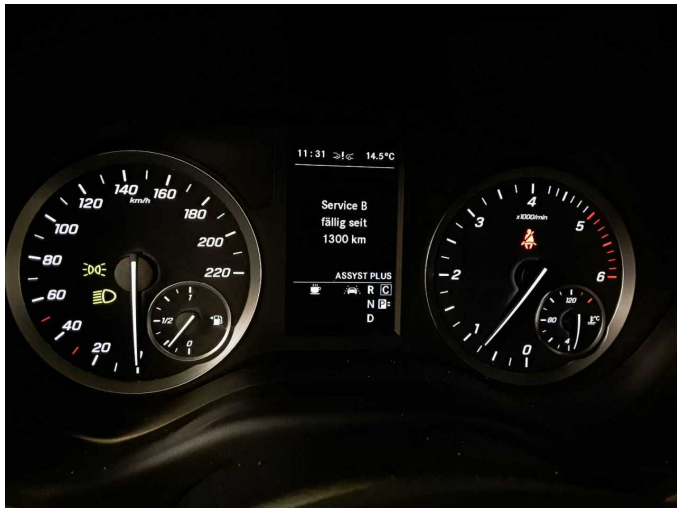
Damage 7: Misc.: Inspection / maintenance - Due - Perform

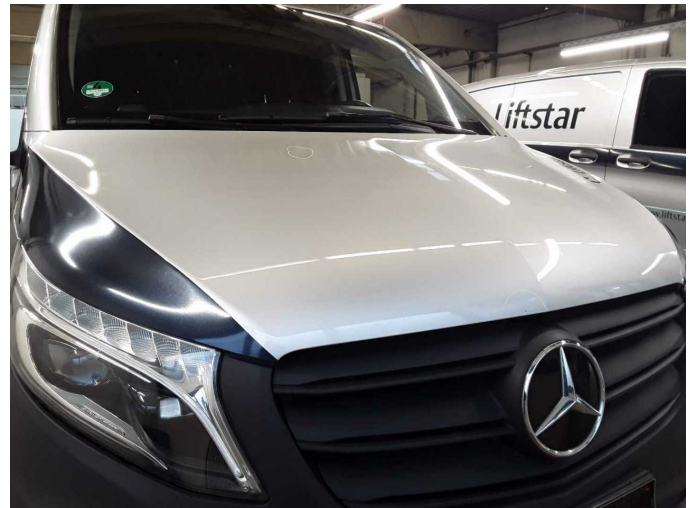
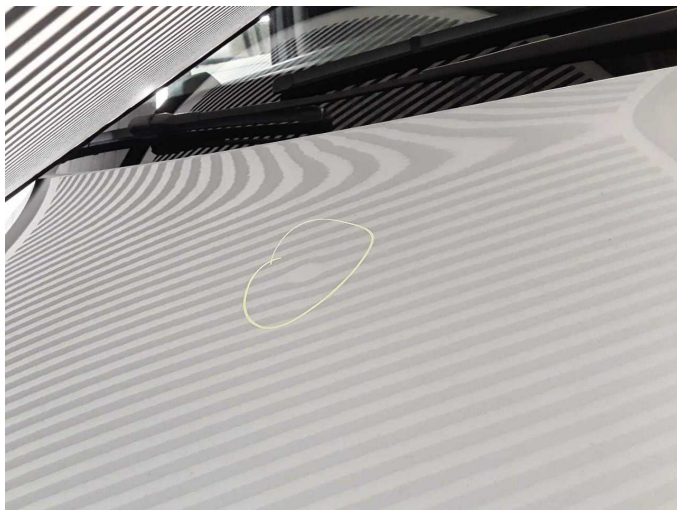
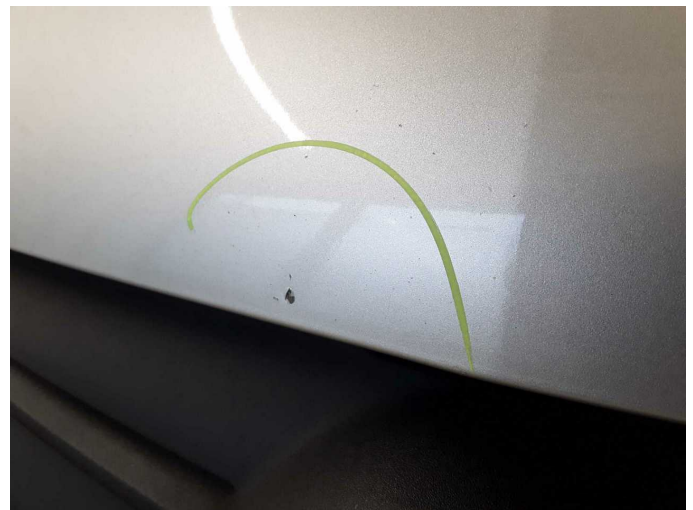
Damage 8: Bonnet: Bonnet - Dent / paintcoat damage - Repair and paint

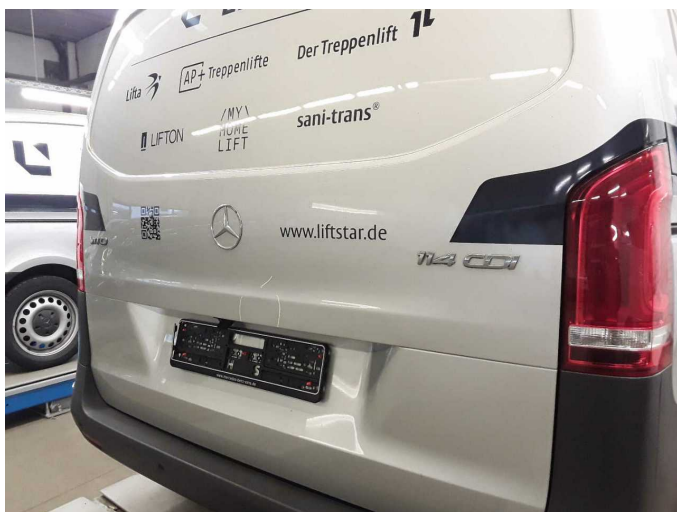
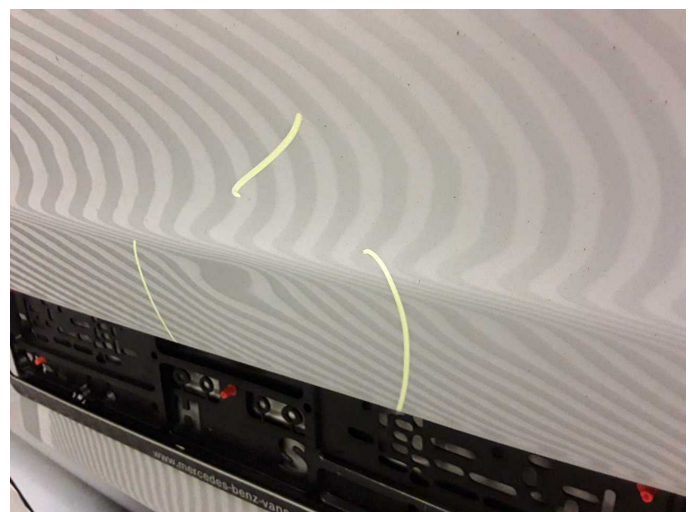
Damage 9: Boot lid / rear door: Boot lid - Deformed - Repair and paint

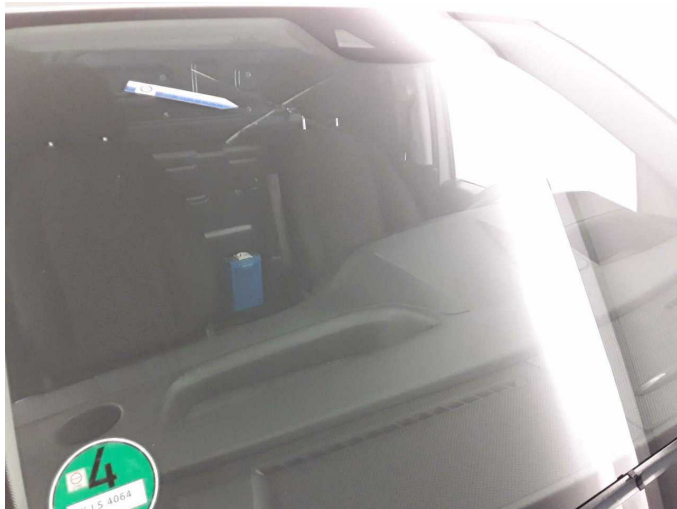
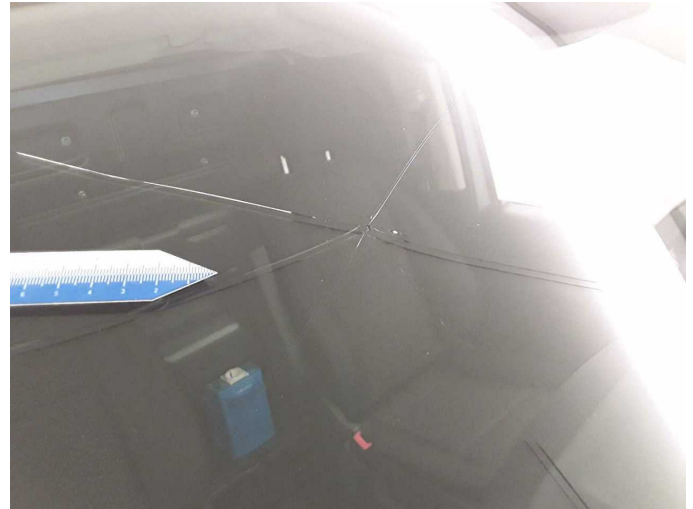
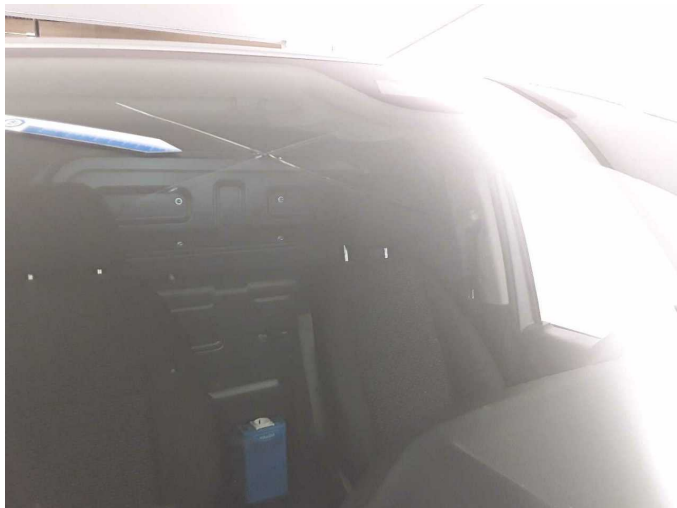
Damage 10: Vehicle glazing: Windscreen (Rissbildung) - Stone chips - repair according to calculation

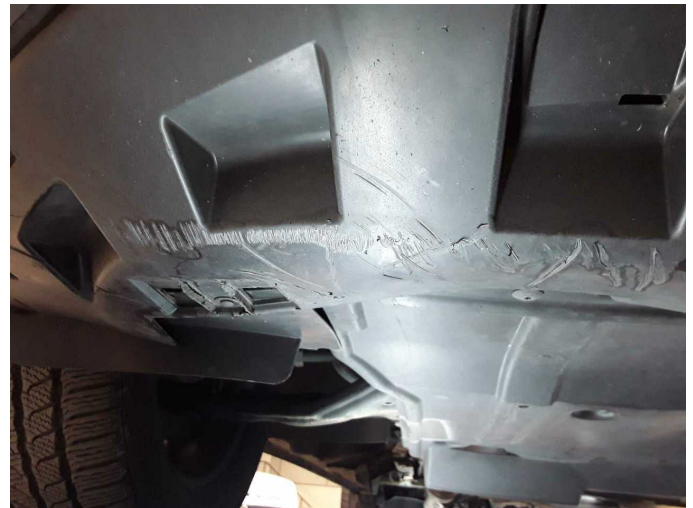
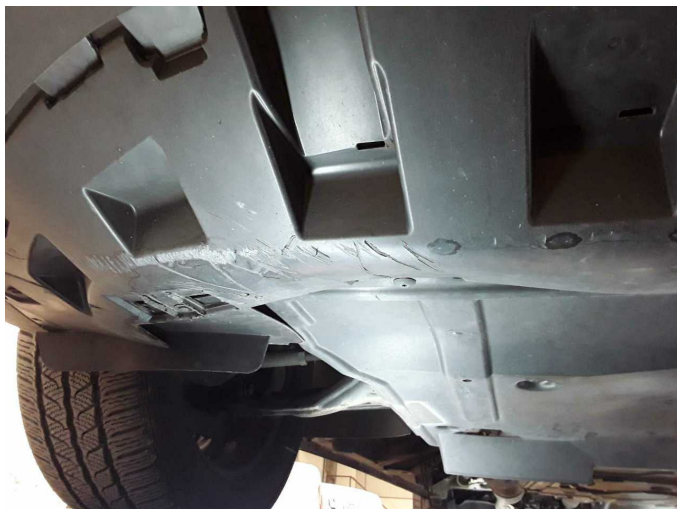
No.	Component group	Description
1	Body	Underbody panelling - Scratched - No deduction
2	Interior	Interior - Scratch(es) - No deduction

Wear and tear 1: Body: Underbody panelling - Scratched - No deduction

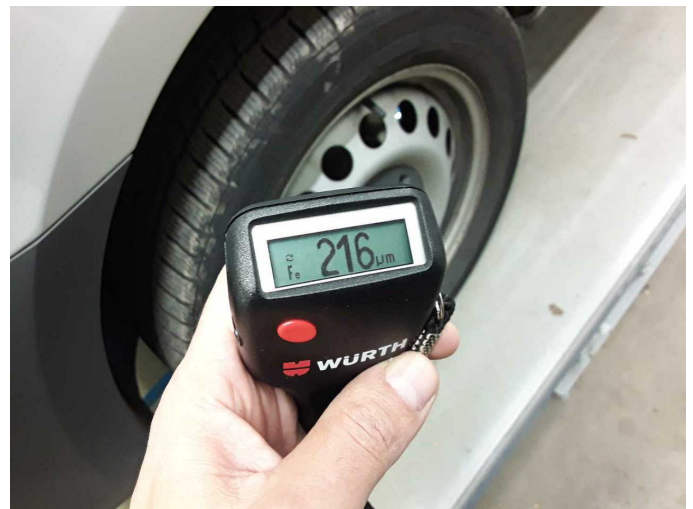
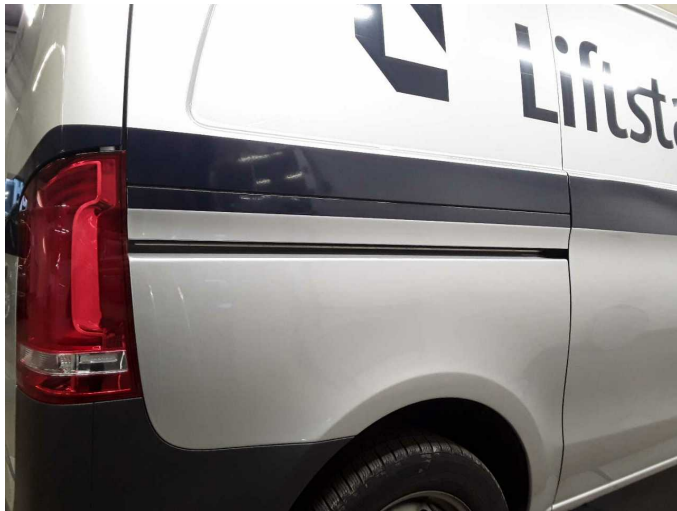
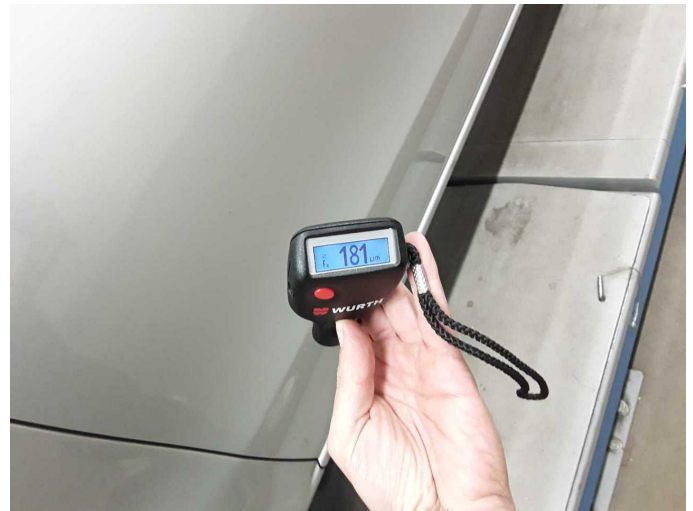
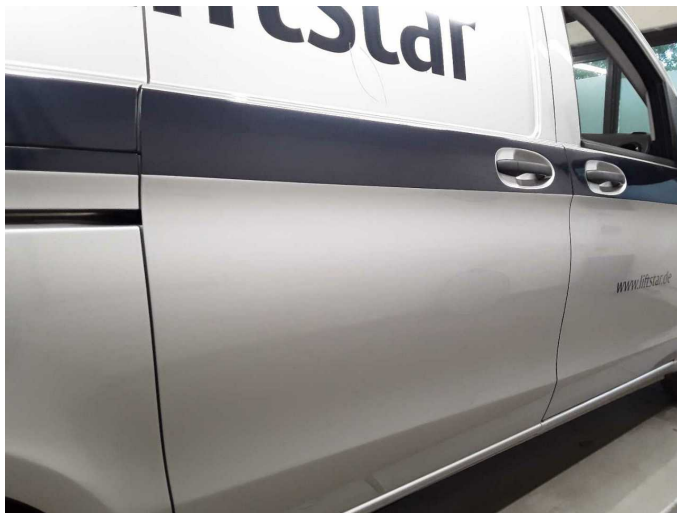
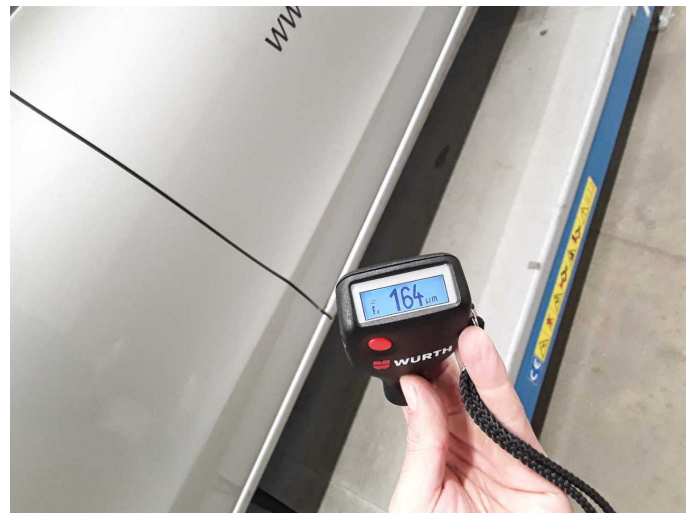
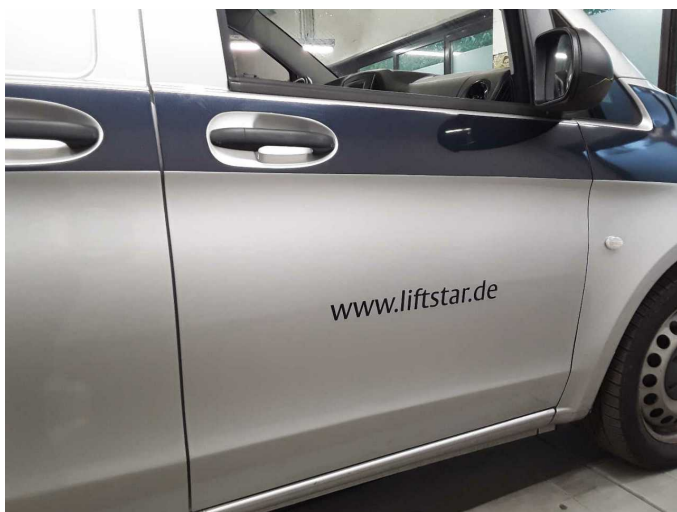
No.	Repainting
1	Side panel - rear right side, Door - rear right side, Door - front right side, Professionally carried out, Invoice of repair done Non-existent

Side panel - rear right side	216 µm	Door - rear right side	181 µm
------------------------------	--------	------------------------	--------

Door - front right side

164 µm

Repainting 1: Side panel - rear right side, Door - rear right side, Door - front right side
