Expertise

Protocol number: 41826000
Order number / reference: 25255817
Inspection date: 6 Oct 2025

Manufacturer: Mercedes-Benz

Model: Vito 114 CDI Kompakt HA Aut. BASE

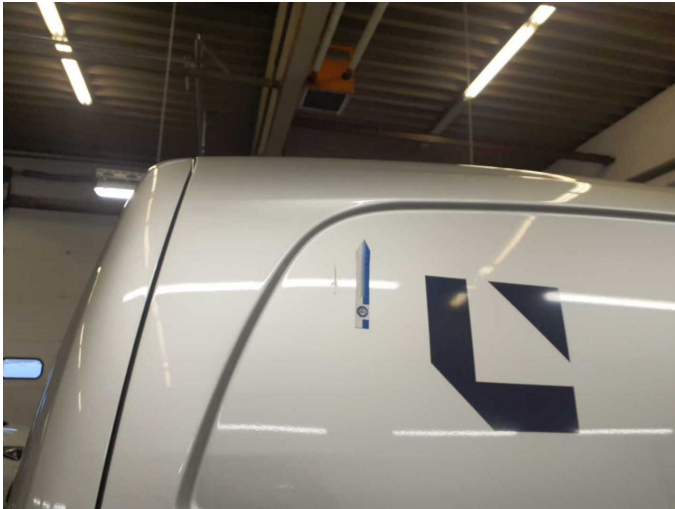
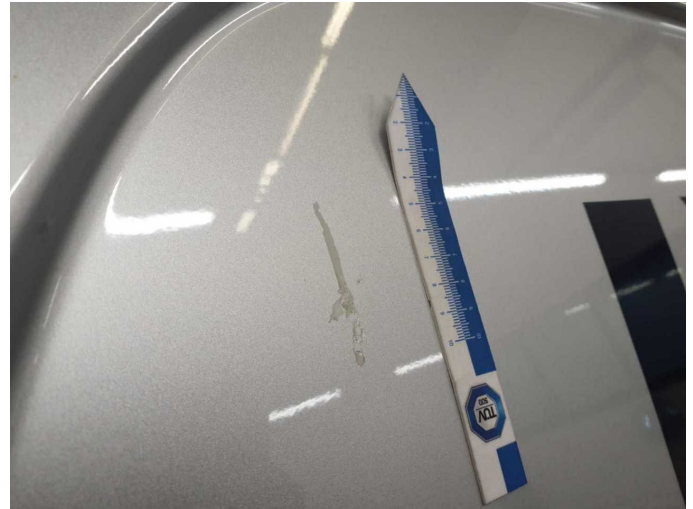
Damage 1: Side panel - rear right side: Side panel (Harz) - Paint defect - Remove

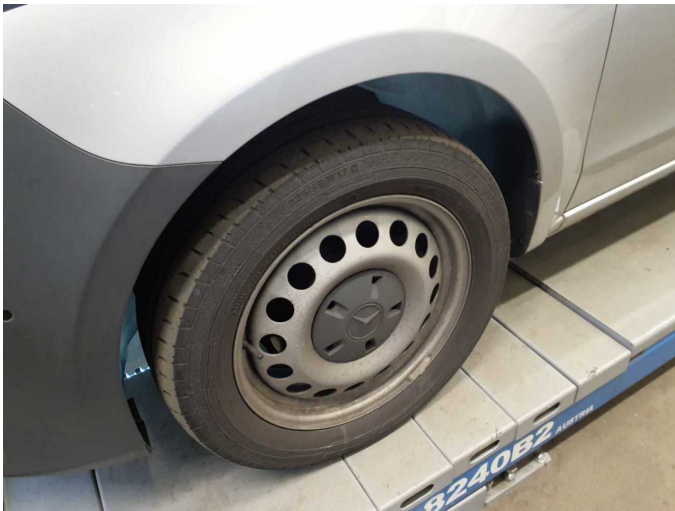
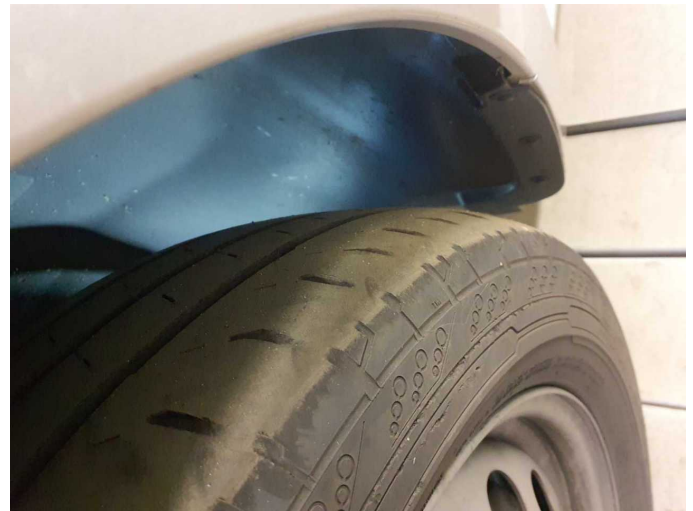
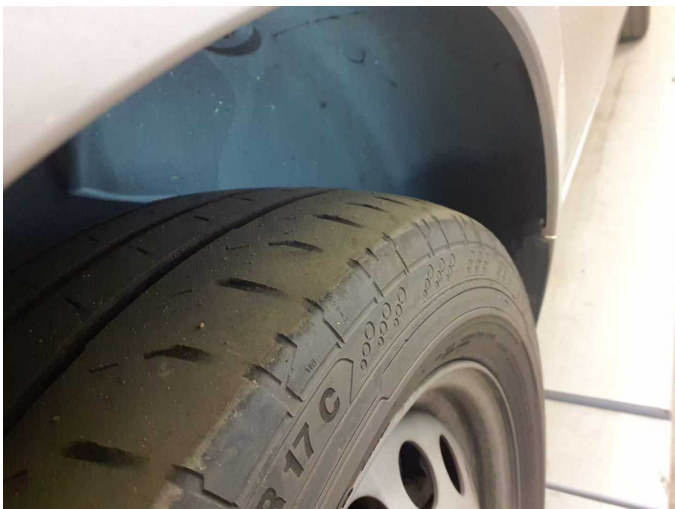
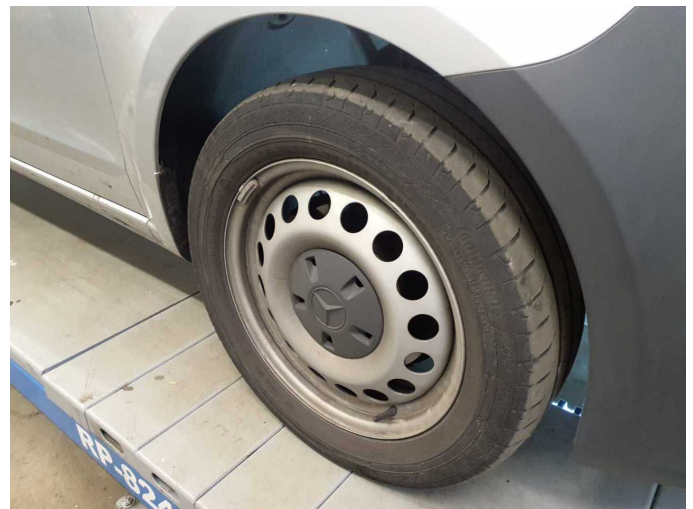
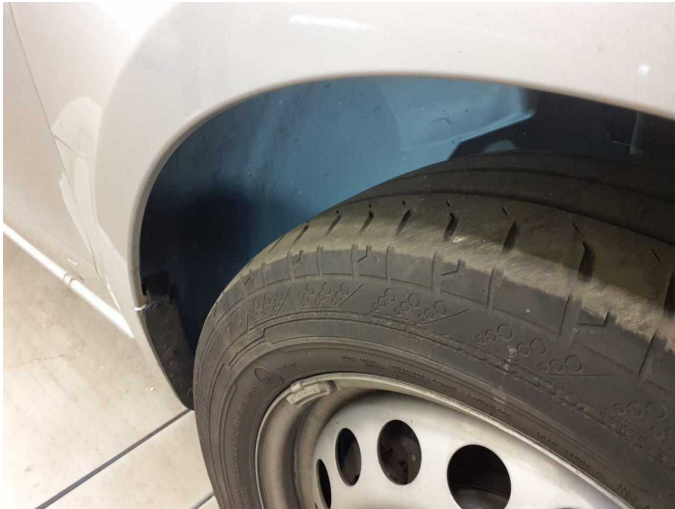
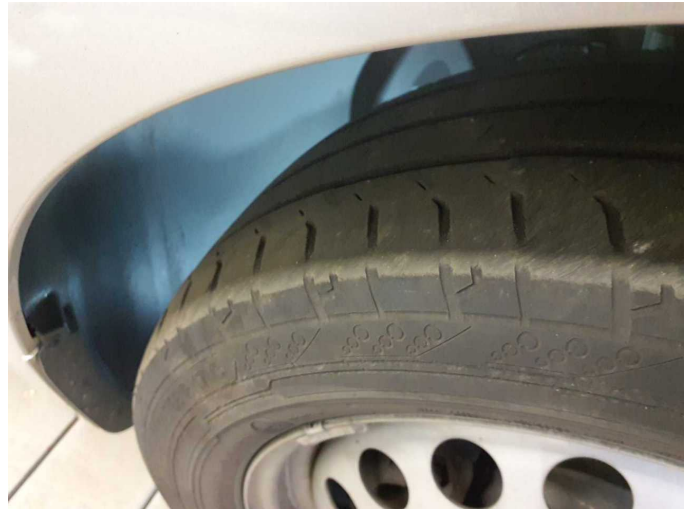
Damage 3: Wheel / tyres: Tyre - front (Einseitig abgefahren, nicht fahrbereit) - Worn - Replace

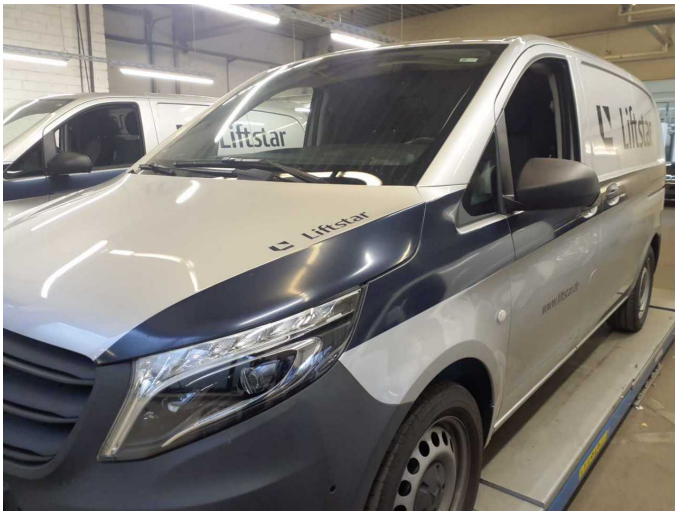
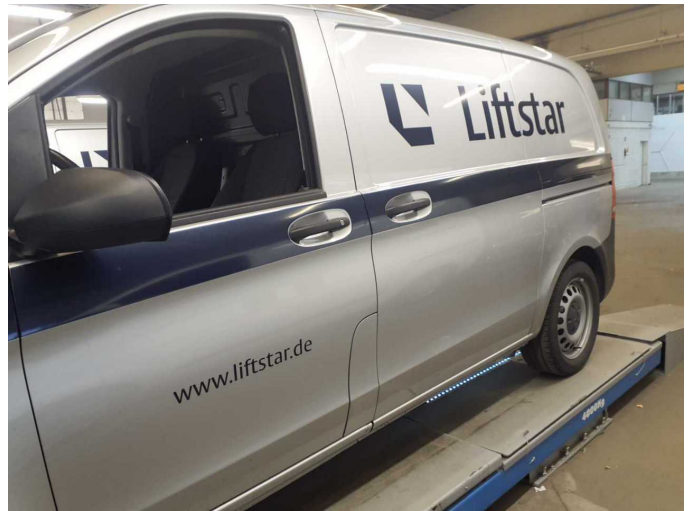
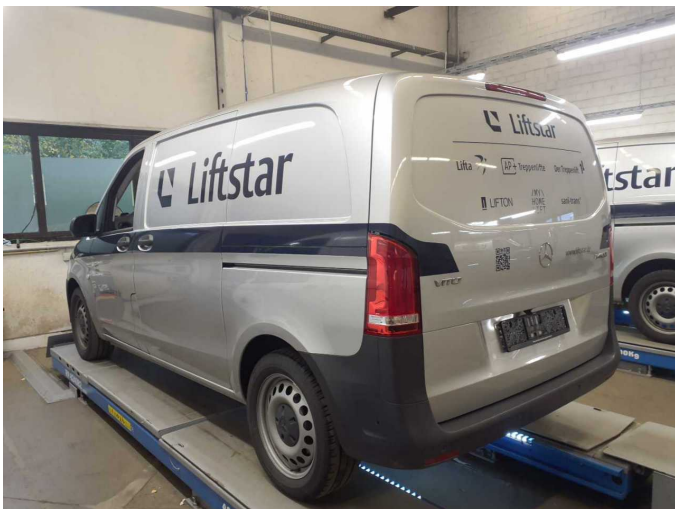
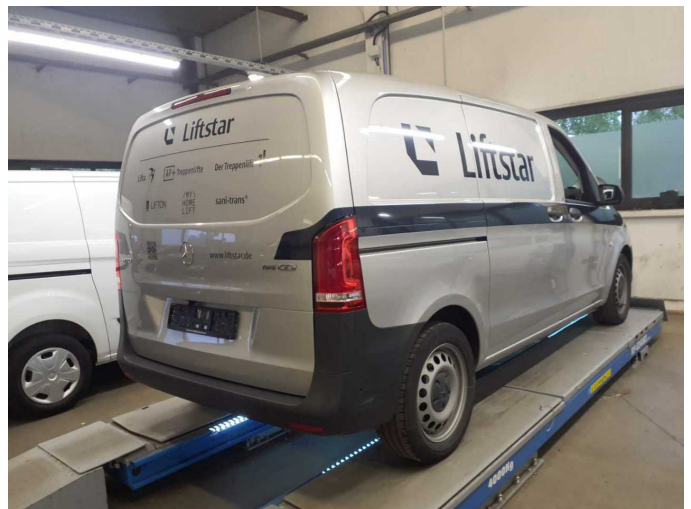
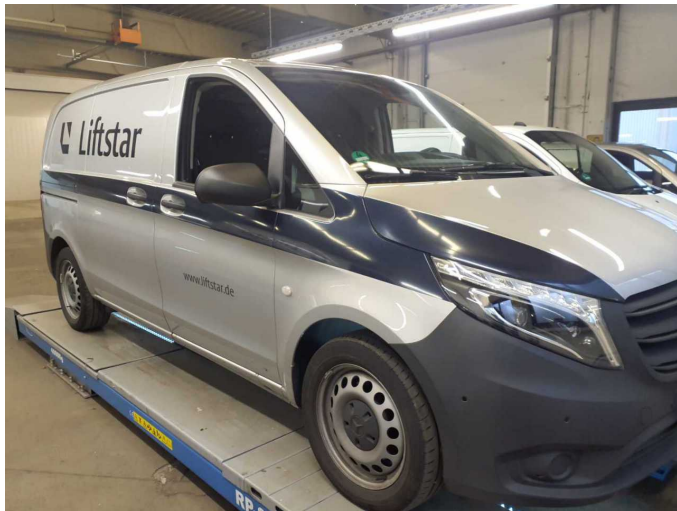
Damage 4: Body: Body - Glued / labelled - De-glue / neutralise

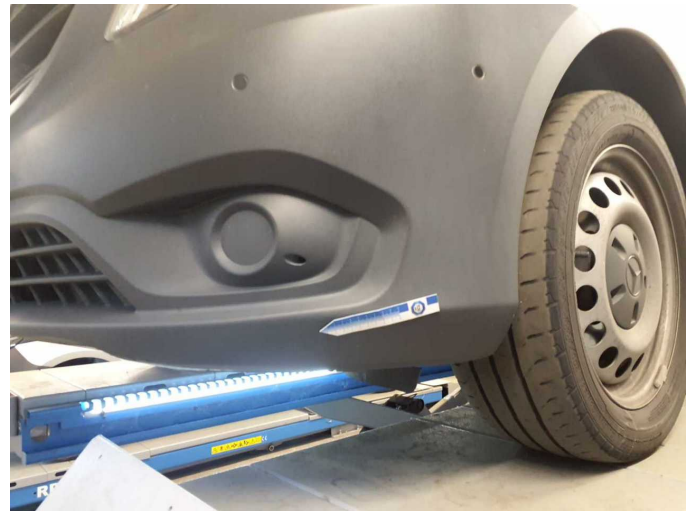
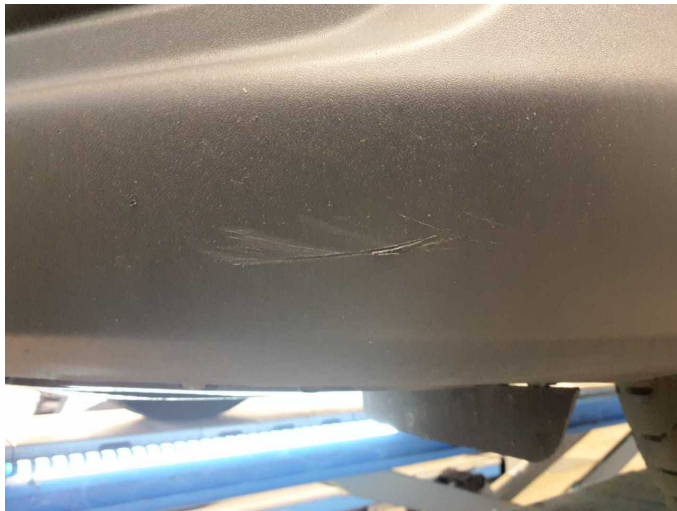
Wear and tear 2: Front bumper: Front bumper - Scratch(es) - No deduction

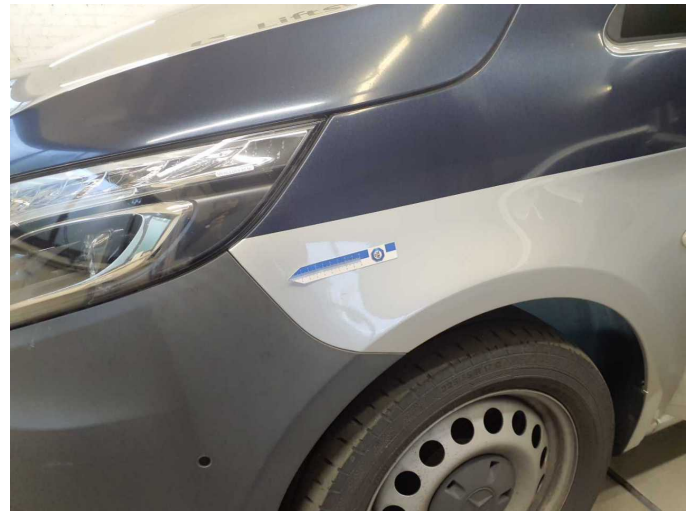
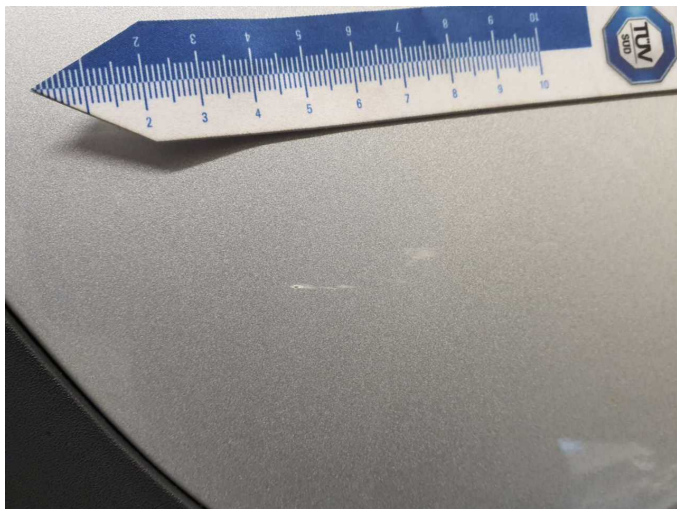
Wear and tear 4: Mudguard - left side: Mudguard - left side - Scratch(es) - No deduction
