Expertise

Protocol number: 41793044
Order number / reference: 25261345
Inspection date: 1 Oct 2025

Manufacturer: Mercedes-Benz	Model: Vito 114 CDI Kompakt HA Aut. BASE
VIN: W1V44760114125080

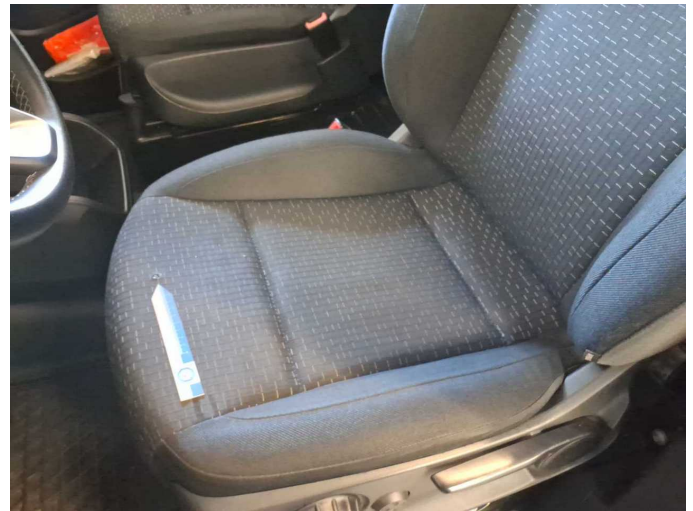
Damage 1: Seat - front: Seat cover - left side - Holes - Smart repair

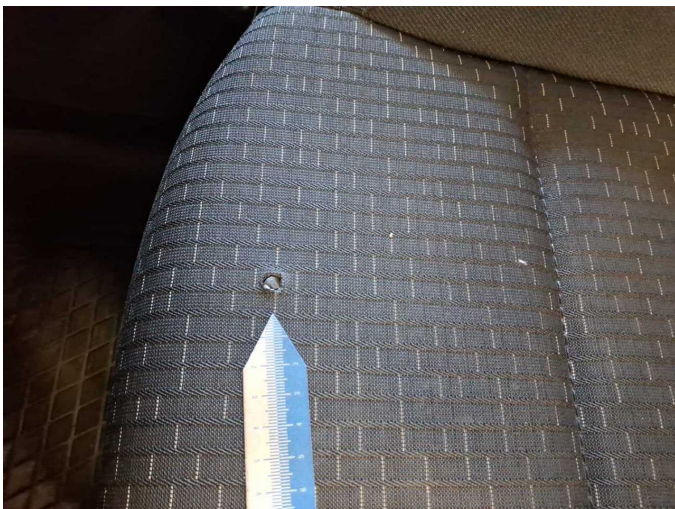
Damage 1: Seat - front: Seat cover - left side - Holes - Smart repair

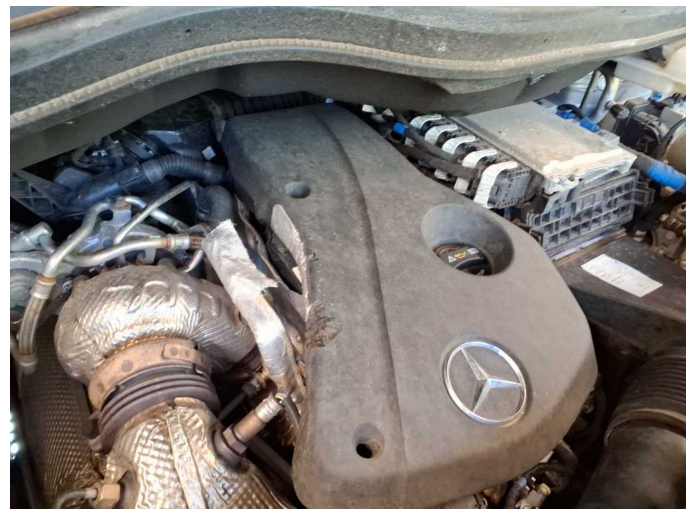
Damage 2: Engine: Engine cover - Damage caused by marten / rodent - Replace

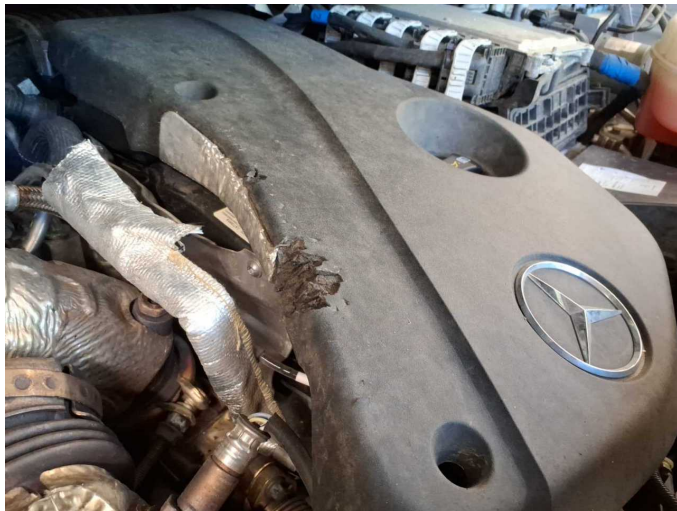
Damage 2: Engine: Engine cover - Damage caused by marten / rodent - Replace

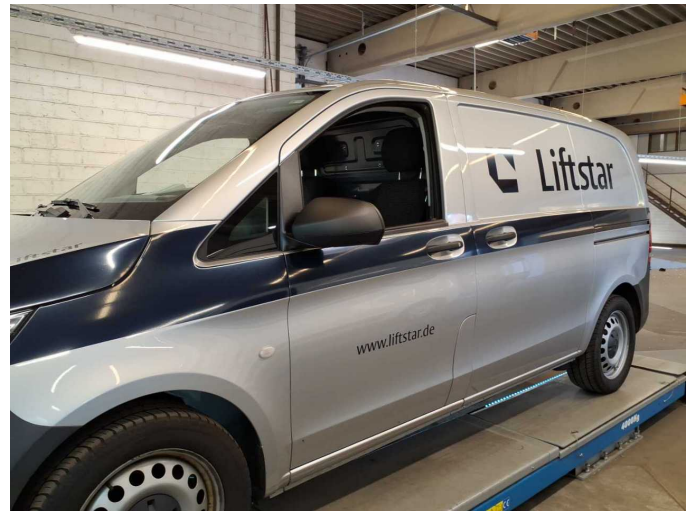
Damage 3: Body: Body - Glued / labelled - De-glue / neutralise

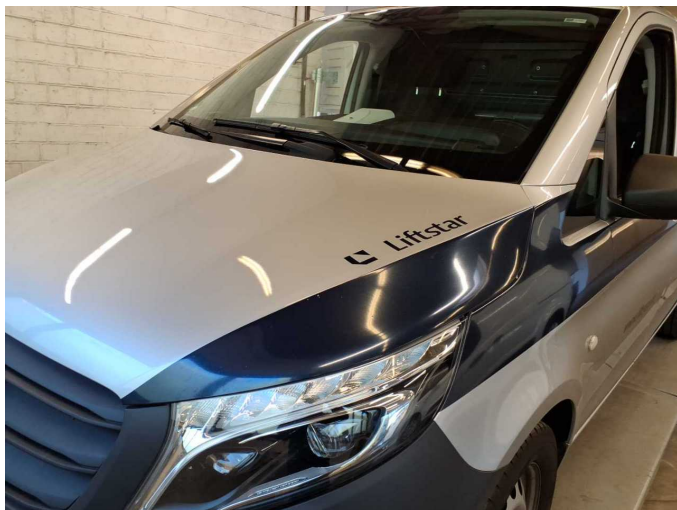
Damage 3: Body: Body - Glued / labelled - De-glue / neutralise

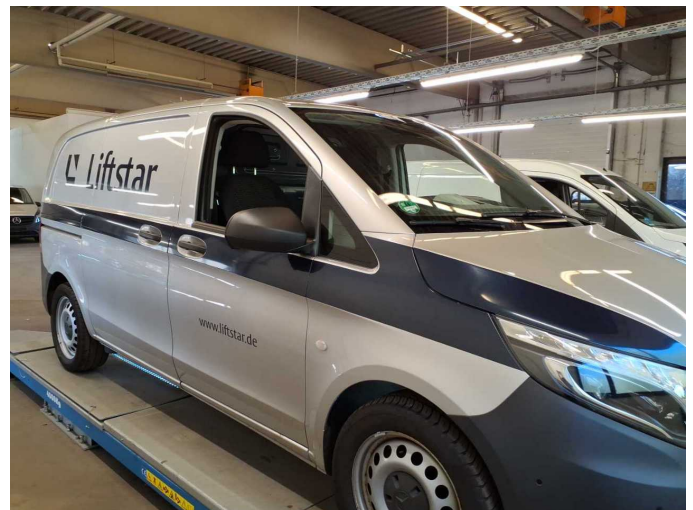
Damage 3: Body: Body - Glued / labelled - De-glue / neutralise

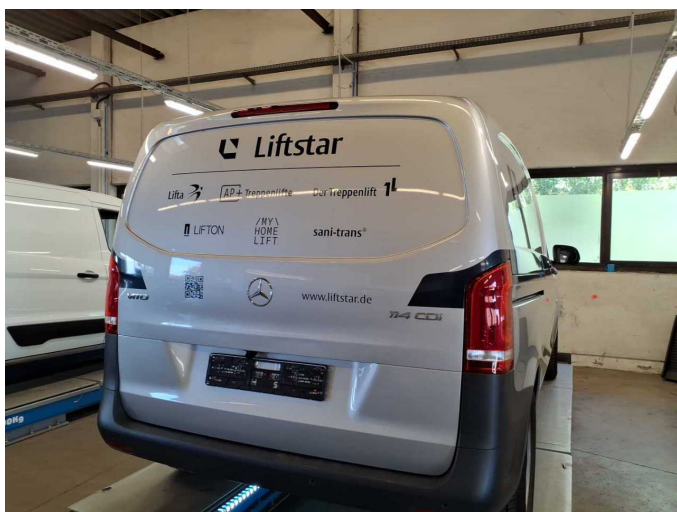
Damage 3: Body: Body - Glued / labelled - De-glue / neutralise

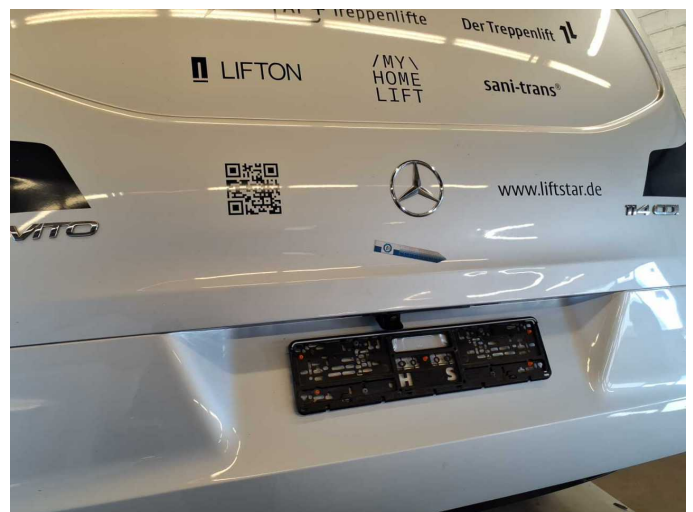
Damage 4: Boot lid / rear door: Boot lid (Ca 13 Dellen + Kratzer) - Dent / paintcoat damage - Repair and paint

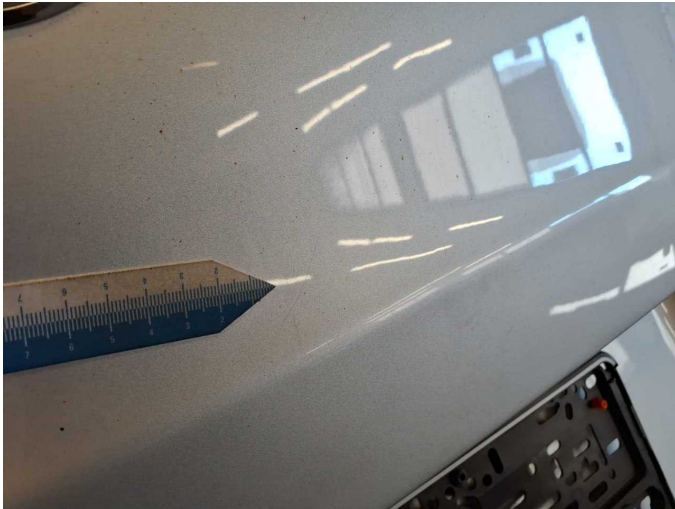
Damage 4: Boot lid / rear door: Boot lid (Ca 13 Dellen + Kratzer) - Dent / paintcoat damage - Repair and paint

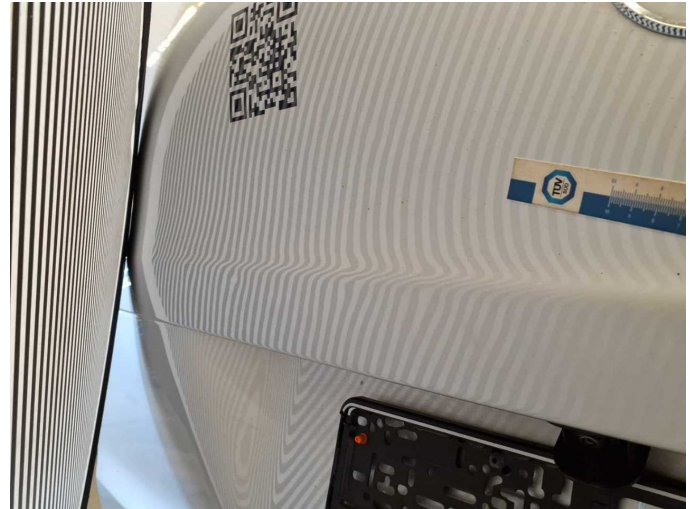
Damage 4: Boot lid / rear door: Boot lid (Ca 13 Dellen + Kratzer) - Dent / paintcoat damage - Repair and paint

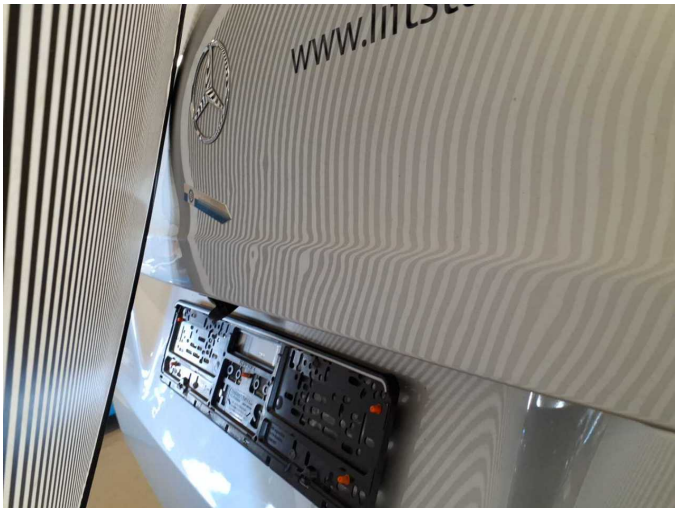
Damage 4: Boot lid / rear door: Boot lid (Ca 13 Dellen + Kratzer) - Dent / paintcoat damage - Repair and paint

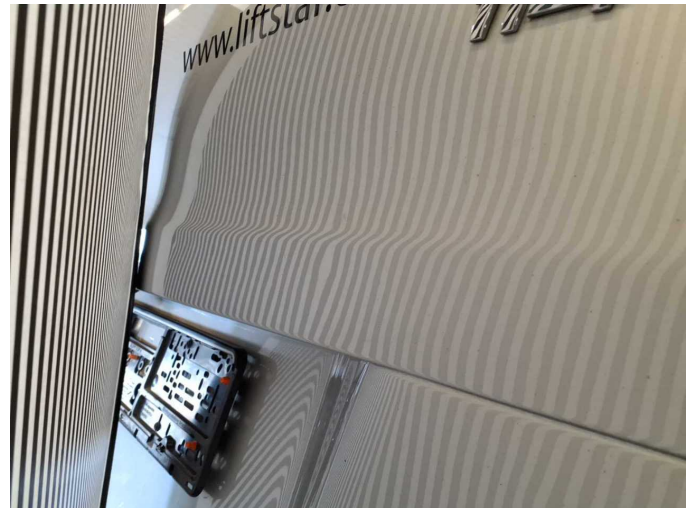
Damage 4: Boot lid / rear door: Boot lid (Ca 13 Dellen + Kratzer) - Dent / paintcoat damage - Repair and paint

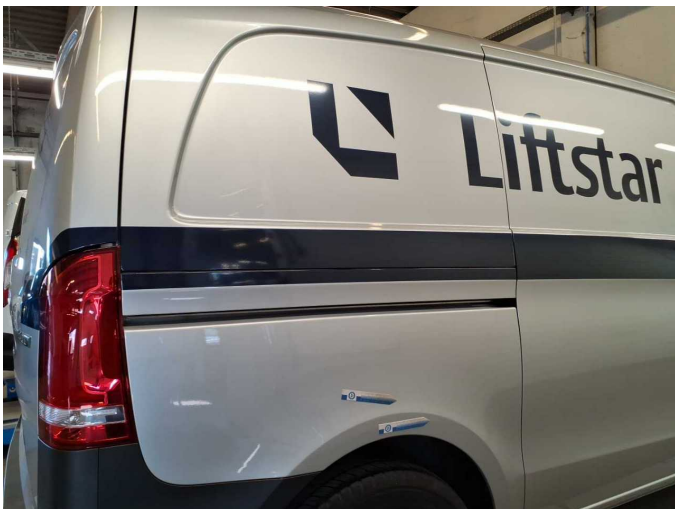
Damage 5: Side panel - rear right side: Side panel - Scratch(es) - Paint

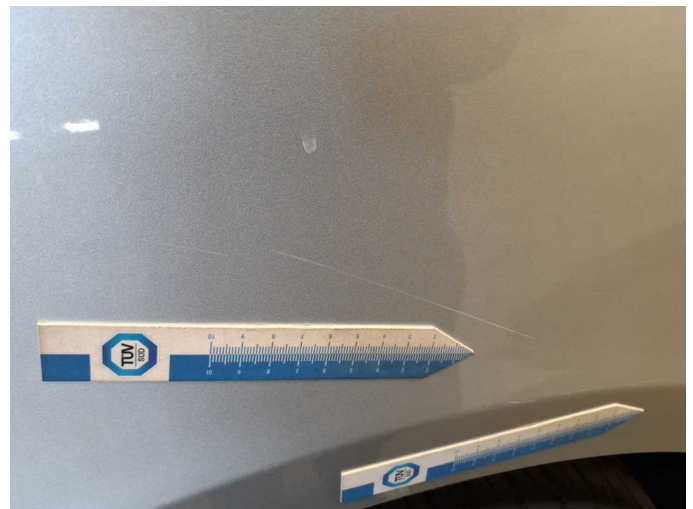
Damage 5: Side panel - rear right side: Side panel - Scratch(es) - Paint

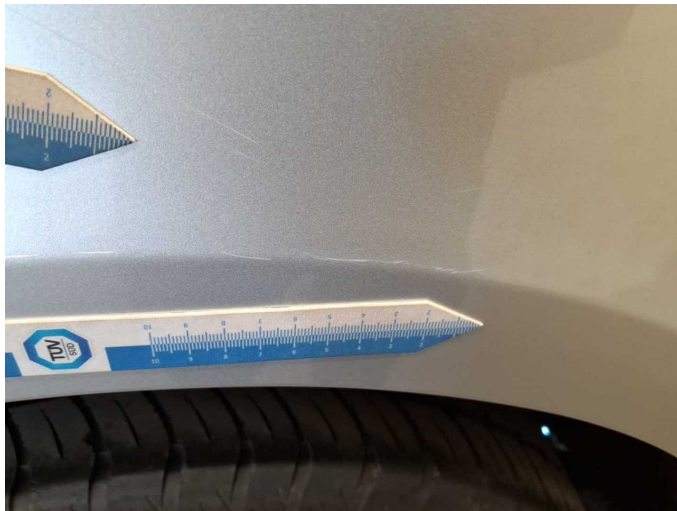
Damage 5: Side panel - rear right side: Side panel - Scratch(es) - Paint

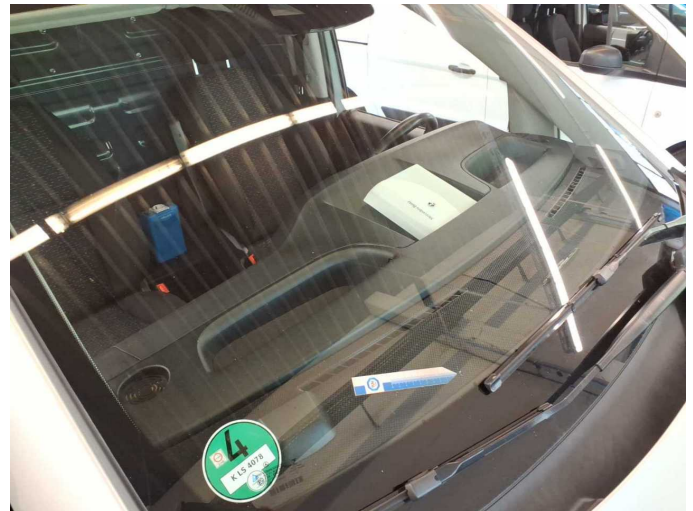
Damage 6: Vehicle glazing: Windscreen - Broken / torn - repair according to calculation

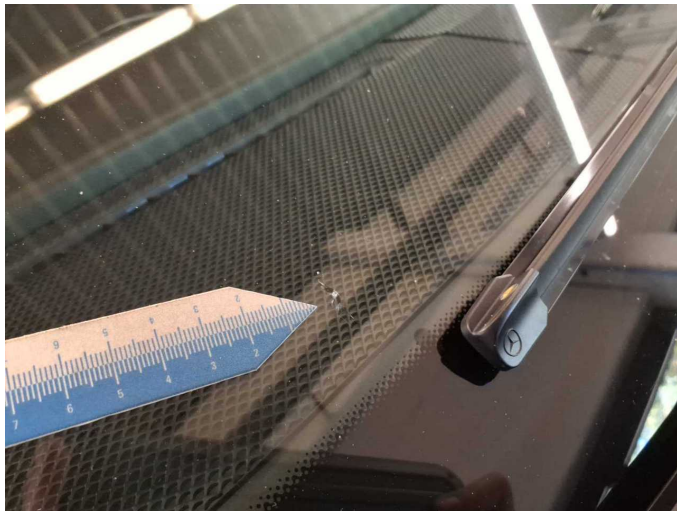
Damage 6: Vehicle glazing: Windscreen - Broken / torn - repair according to calculation

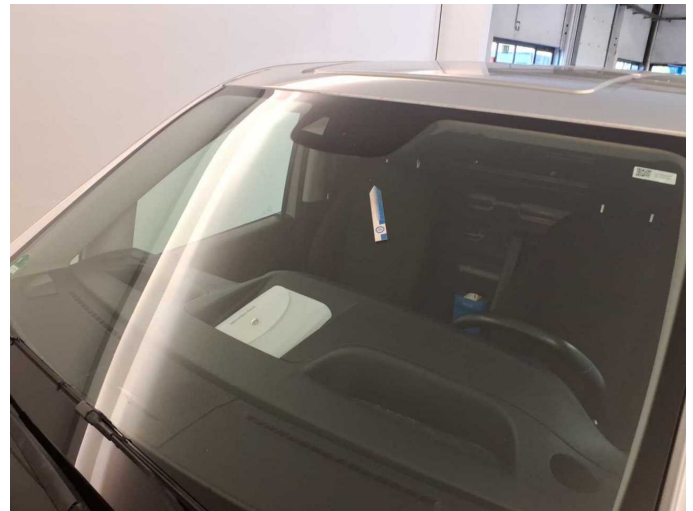
Damage 6: Vehicle glazing: Windscreen - Broken / torn - repair according to calculation

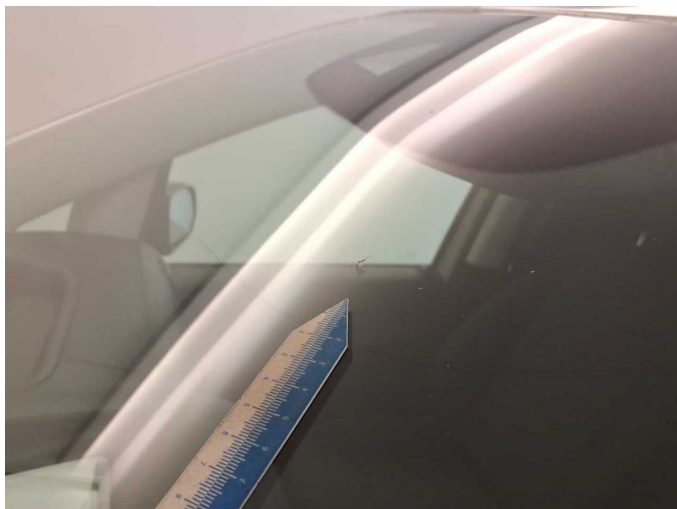
Damage 6: Vehicle glazing: Windscreen - Broken / torn - repair according to calculation

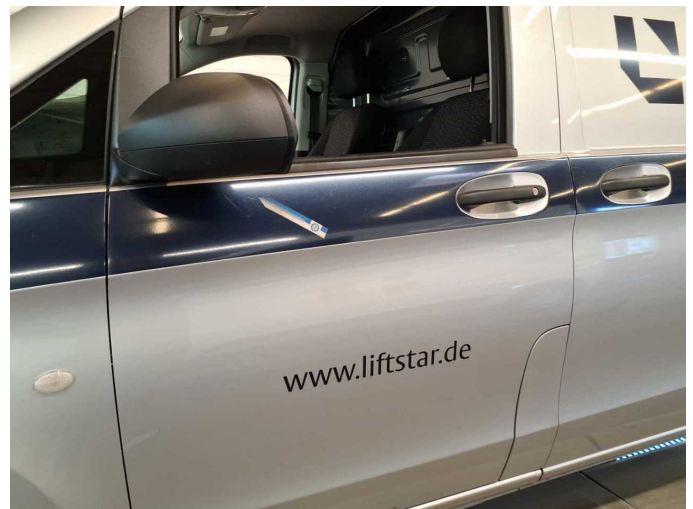
Wear and tear 3: Door - front left side: Door - Scratch(es) - No deduction

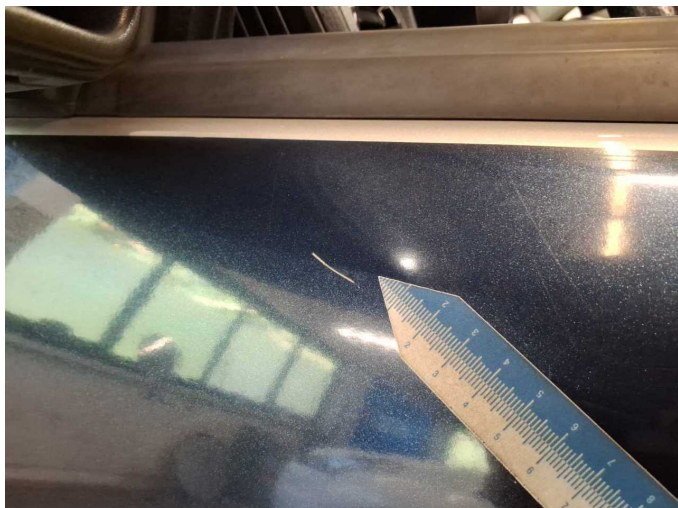
Wear and tear 3: Door - front left side: Door - Scratch(es) - No deduction
