Expertise

Protocol number: 41826342  
Order number / reference: 25255874  
Inspection date: 6 Oct 2025

| Manufacturer: Mercedes-Benz | Model: Vito 114 CDI Kompakt HA Aut. BASE |

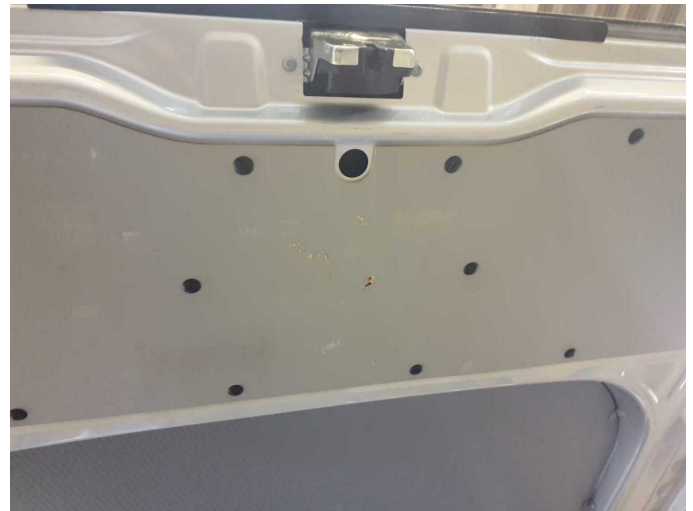
| No. | Component group | Description |
|---|---|---|
| 1 | Trim / covers | Boot lid - interior trim - Broken / torn - Replace |

**Damage 1:** Trim / covers: Boot lid - interior trim - Broken / torn - Replace

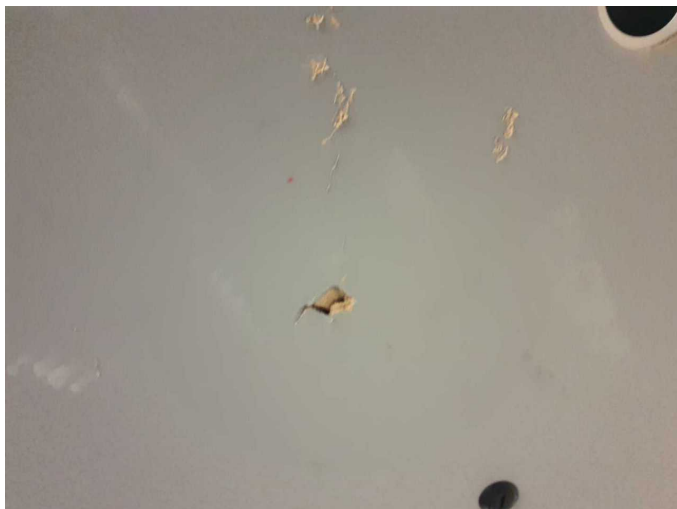
**Damage 1:** Trim / covers: Boot lid - interior trim - Broken / torn - Replace

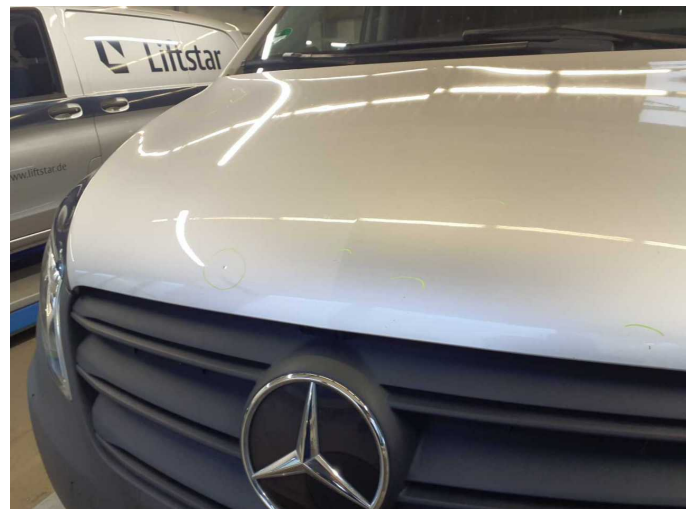
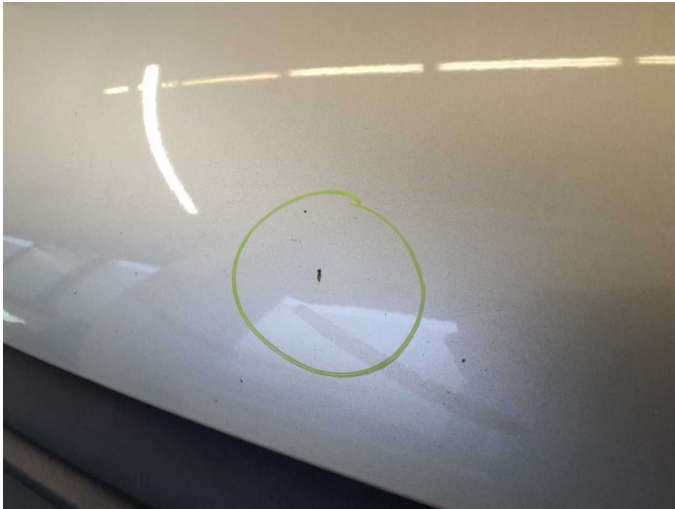
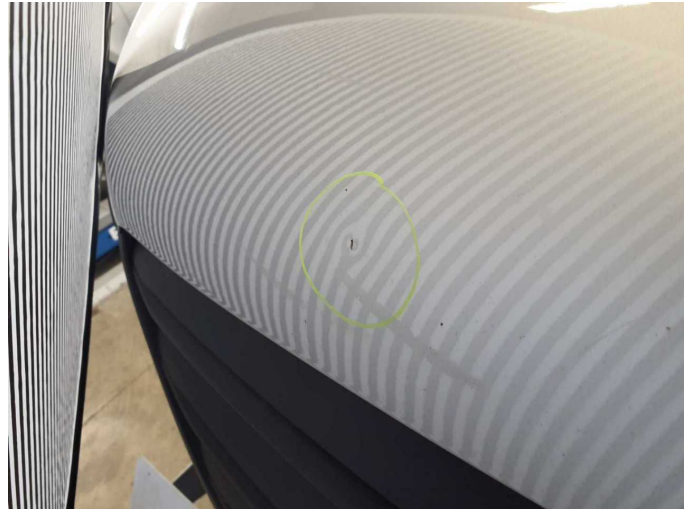
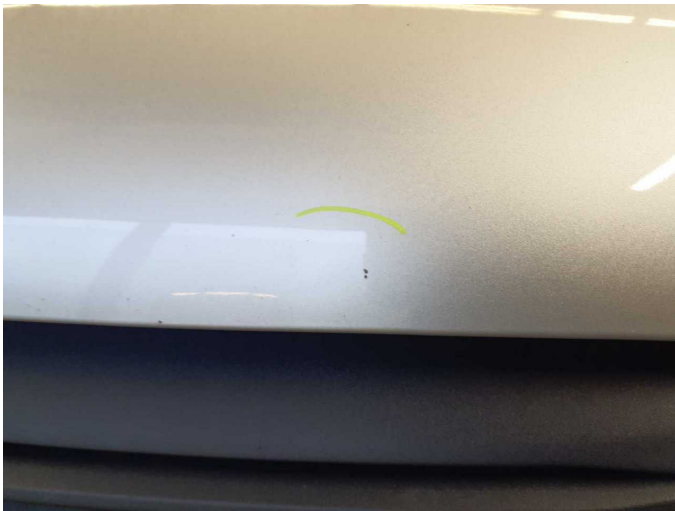
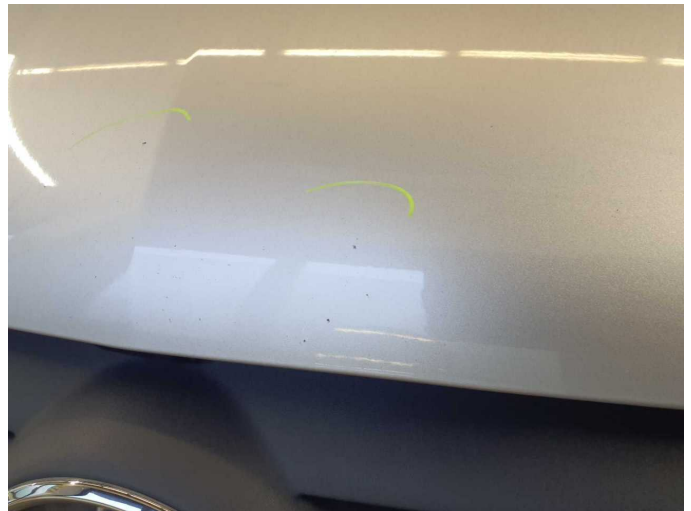
| No. | Component group | Description |
|---|---|---|
| 2 | Bonnet | Bonnet (Delle wurde schon berücksichtigt.) - Scratch(es) - Smart repair |

**Damage 2:** Bonnet: Bonnet (Delle wurde schon berücksichtigt.) - Scratch(es) - Smart repair

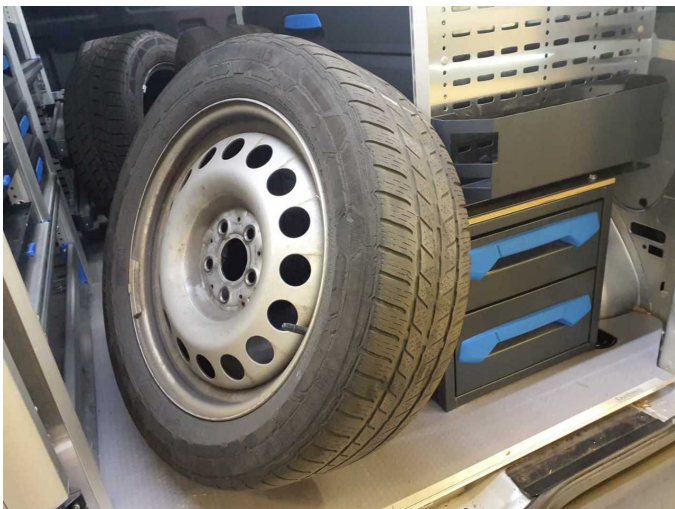
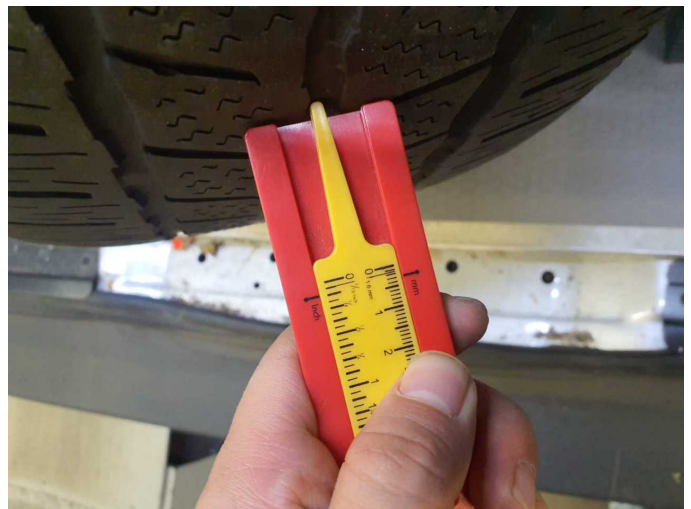
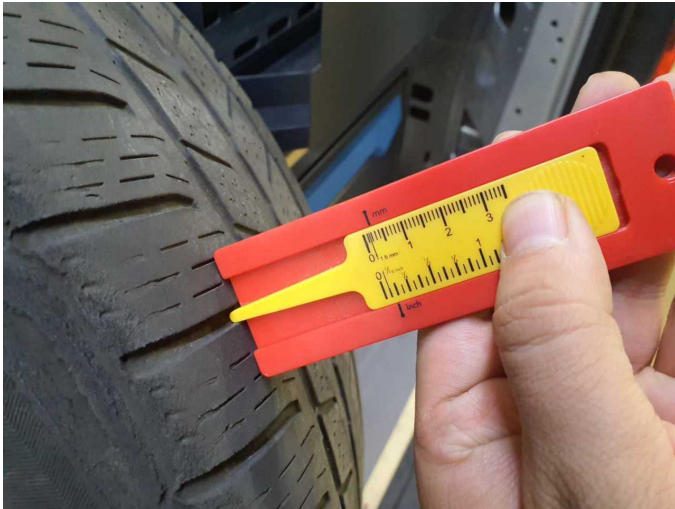
| # | Tyre size | Type of tyre | Manufacturer | Tread depth |
|---|---|---|---|---|
| 1) | 225/55 R17 107T | Winter tyres on Steel | Continental | 3mm / 7mm |

| No. | Component group | Description |
|---|---|---|
| 3 | 2nd wheel set | 1 tyre - Does not meet the leasing specifications - Replace |

**Damage 3:** 2nd wheel set: 1 tyre - Does not meet the leasing specifications - Replace

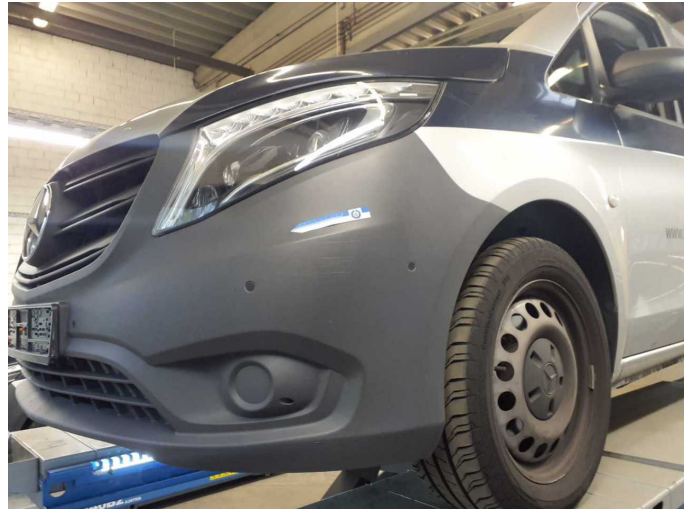
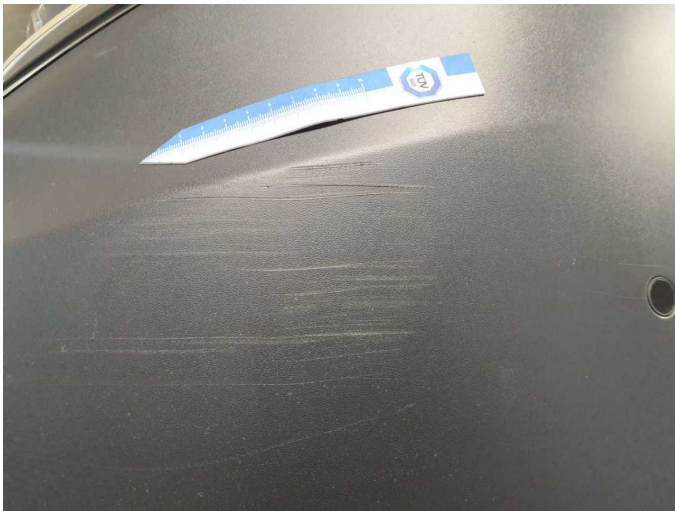
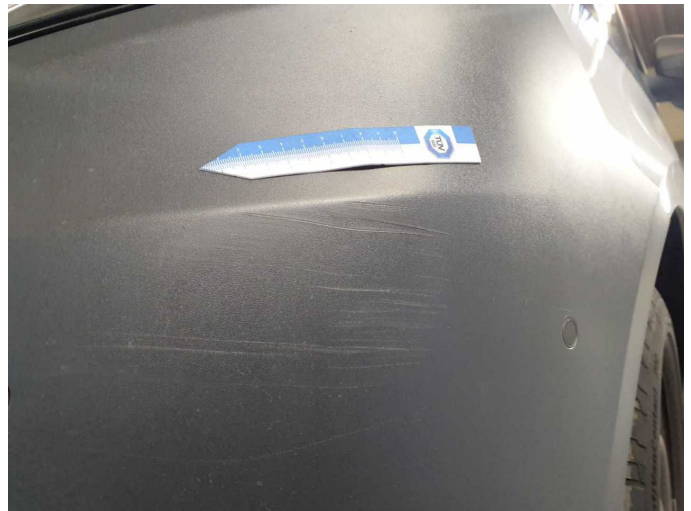
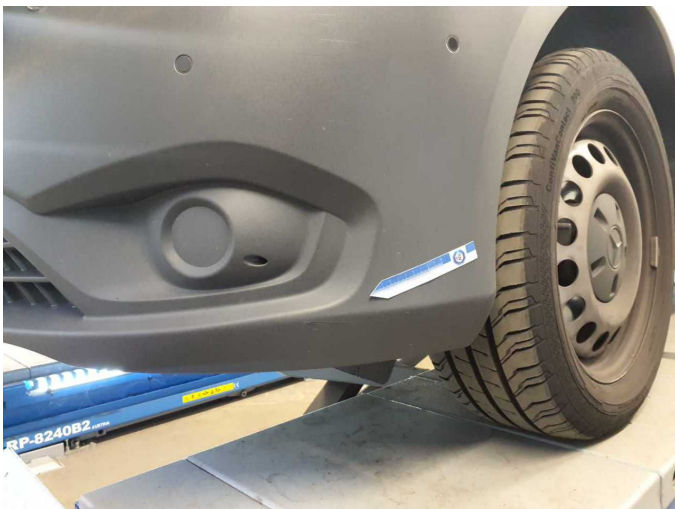
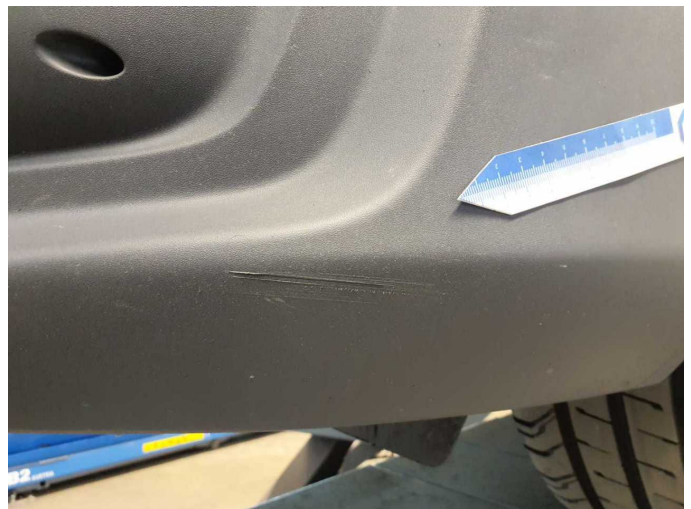
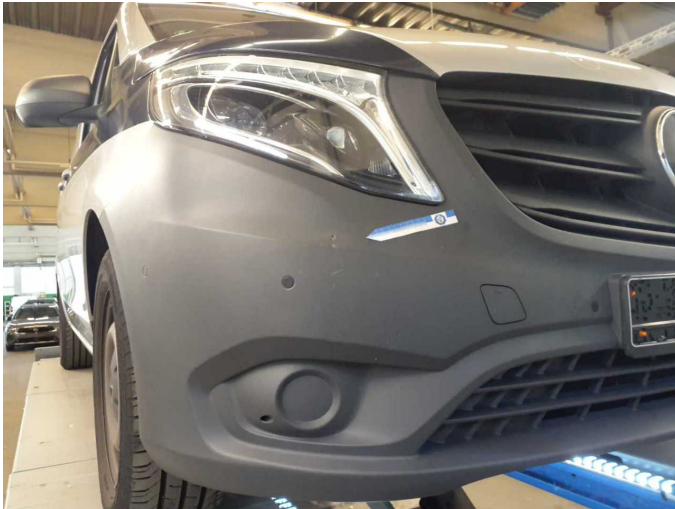
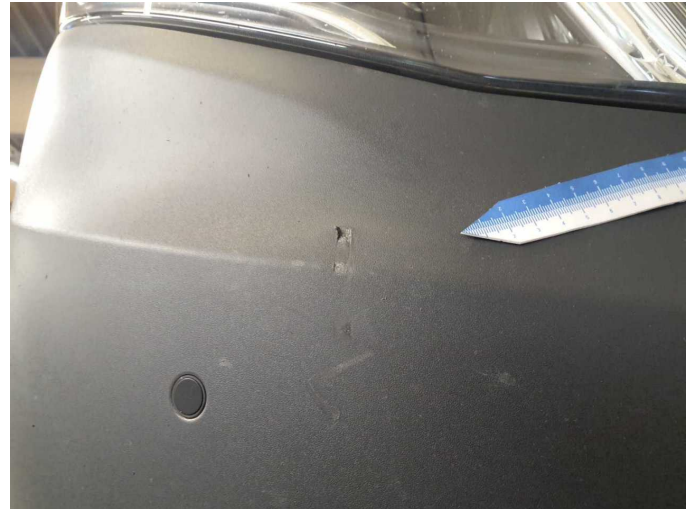
| No. | Component group | Description |
|---|---|---|
| 4 | Front bumper | Front bumper - Scratch(es) - Loss in value |

**Damage 4:** Front bumper: Front bumper - Scratch(es) - Loss in value

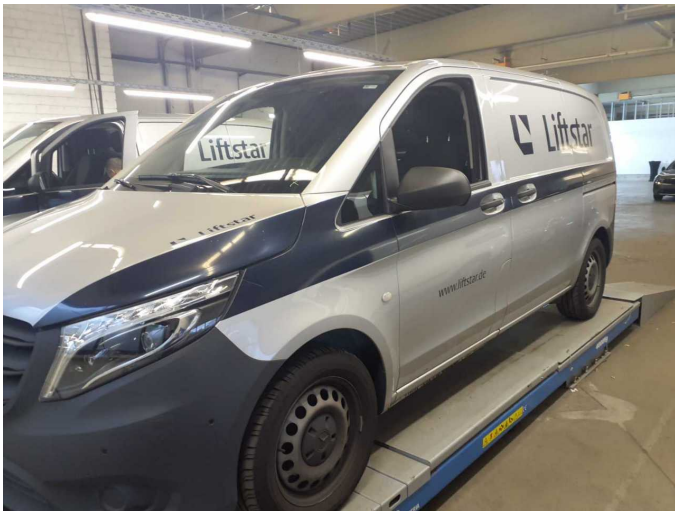
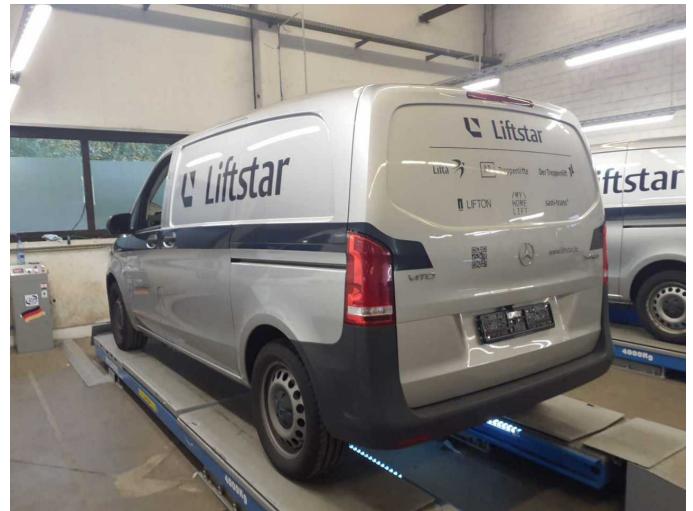
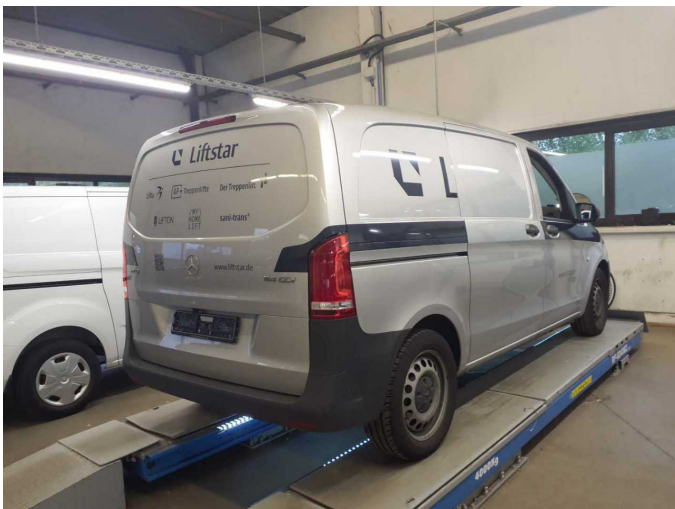
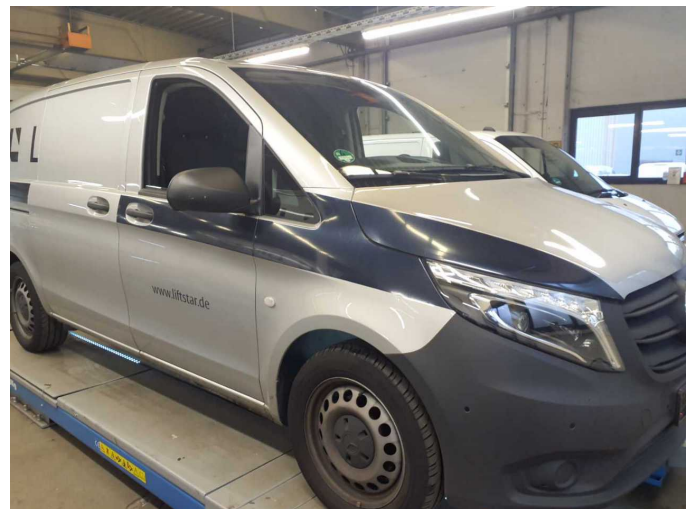
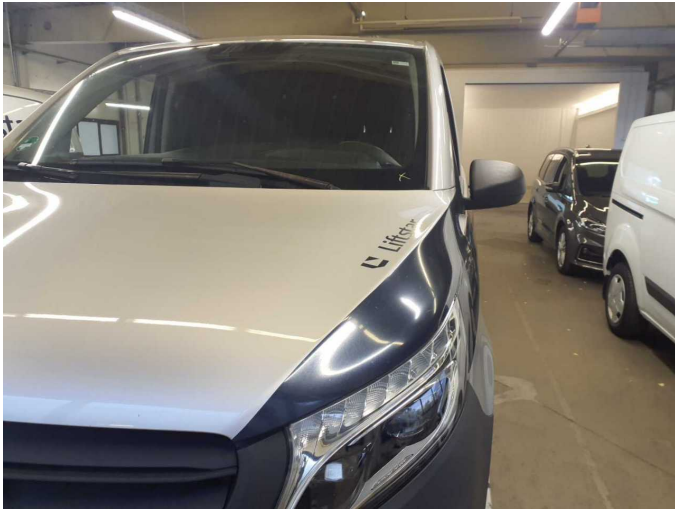
| No. | Component group | Description |
|---|---|---|
| 5 | Body | Body - Glued / labelled - De-glue / neutralise |

**Damage 5:** Body: Body - Glued / labelled - De-glue / neutralise

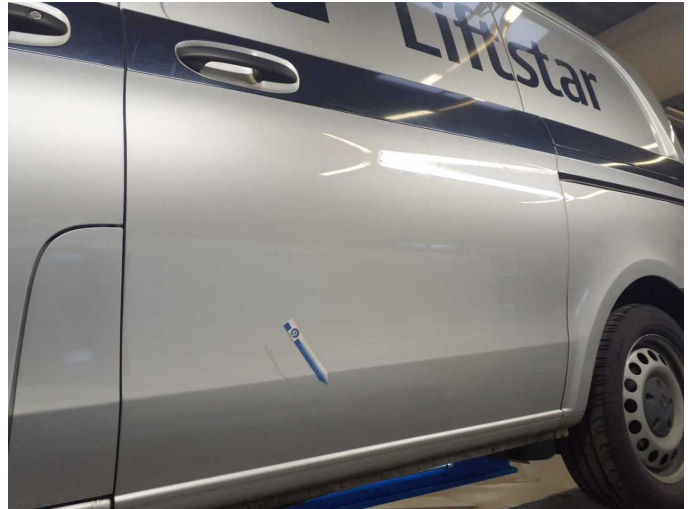
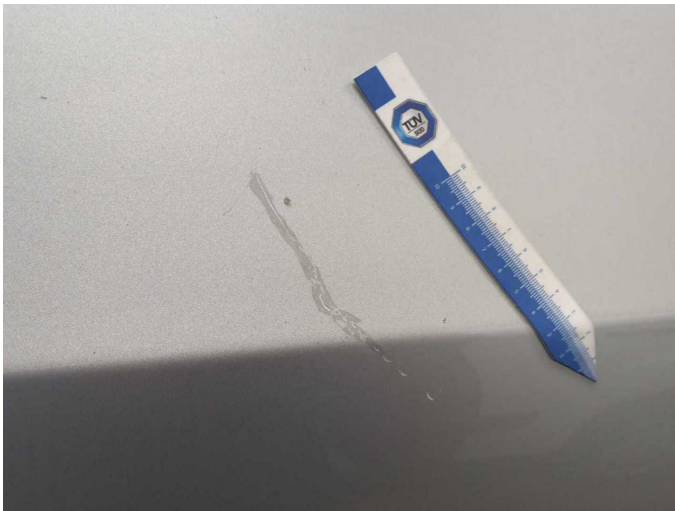
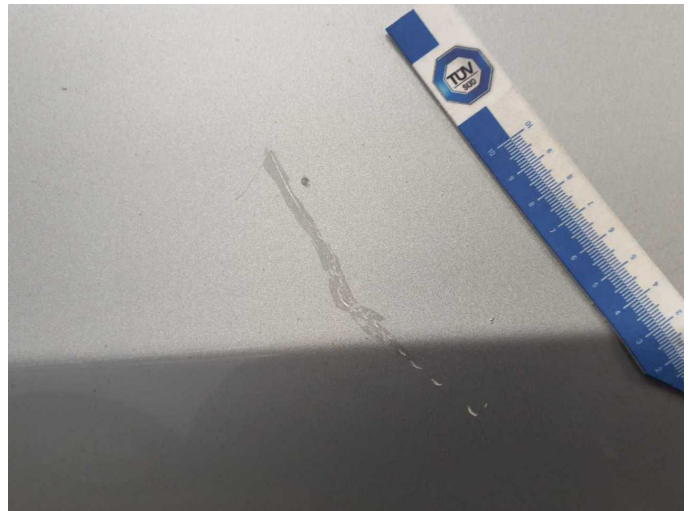
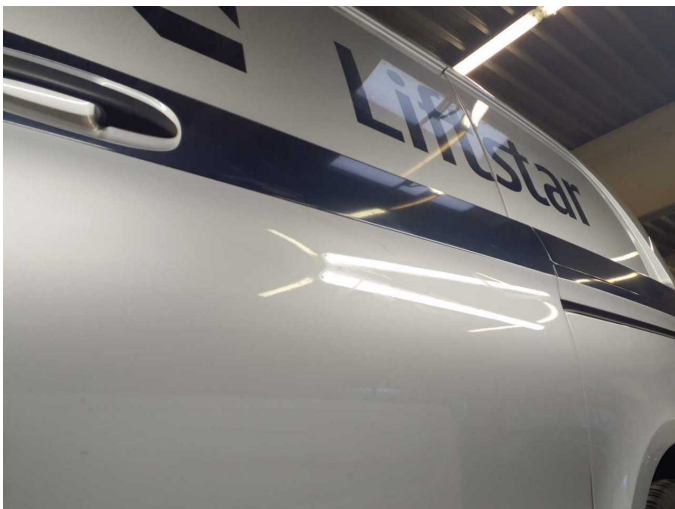
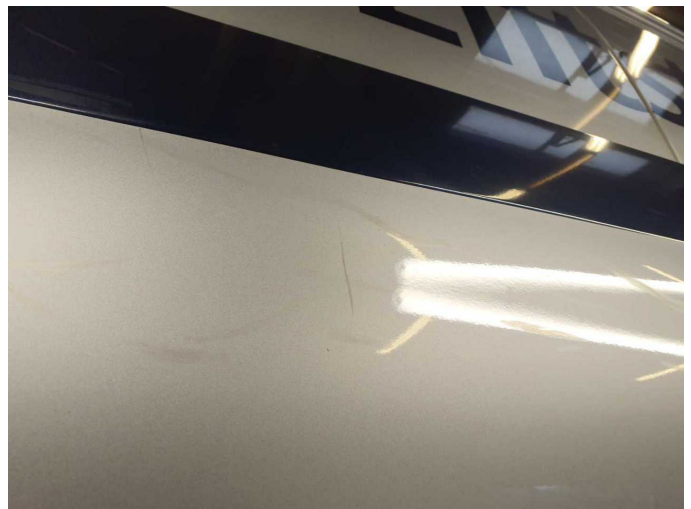
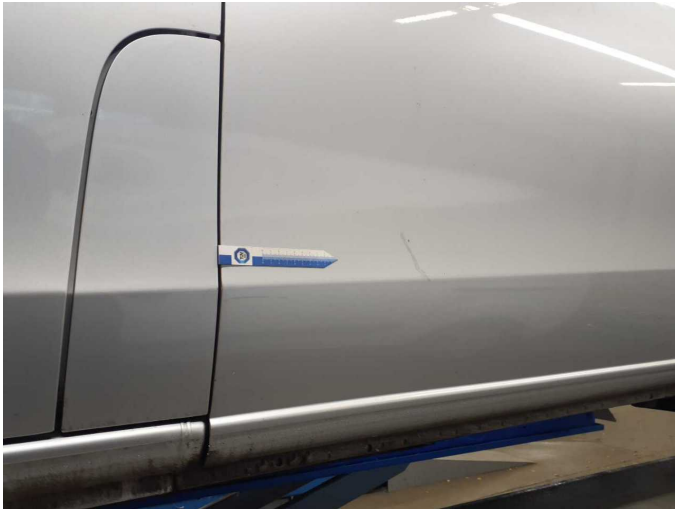
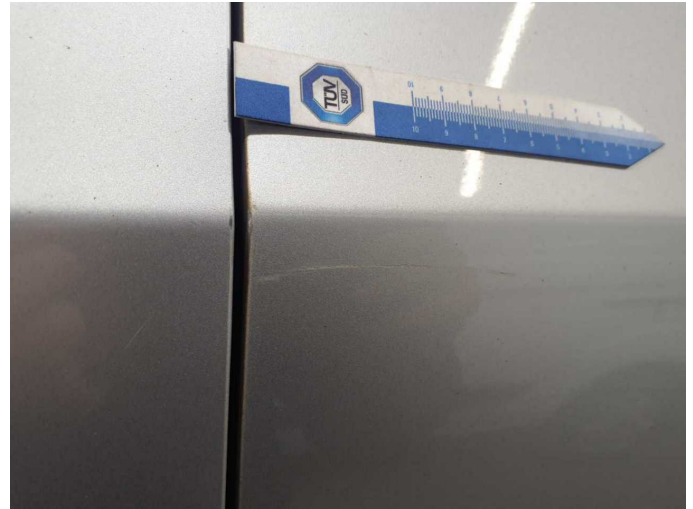
| No. | Component group | Description |
|---|---|---|
| 6 | Sliding door - left side | Sliding door - Scratch(es) - Paint |

**Damage 6:** Sliding door - left side: Sliding door - Scratch(es) - Paint

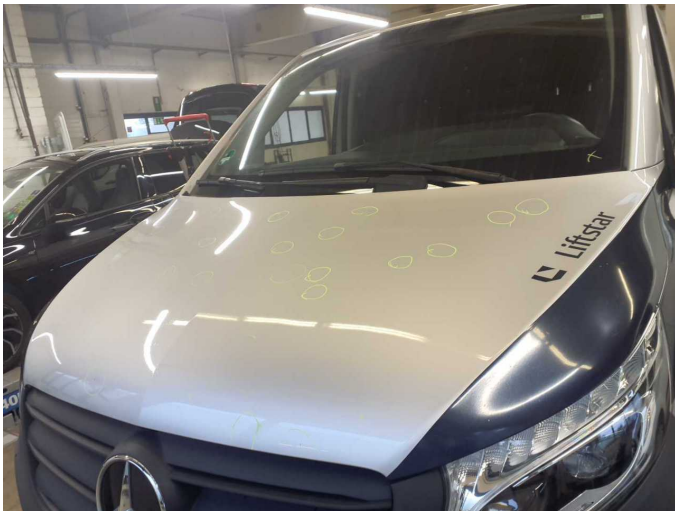
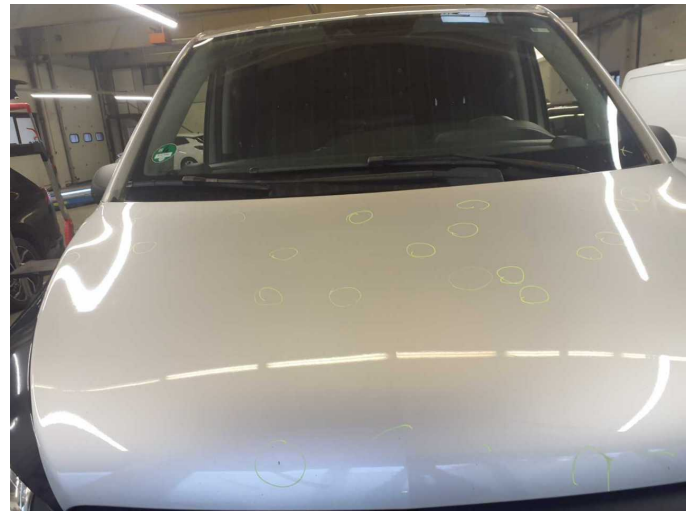
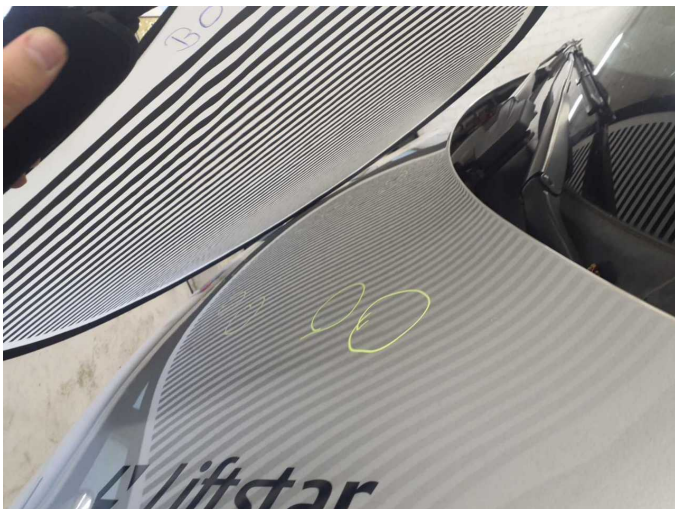
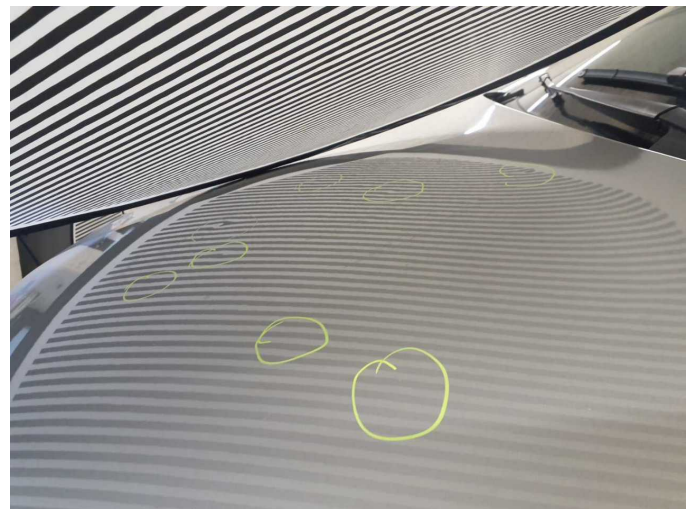
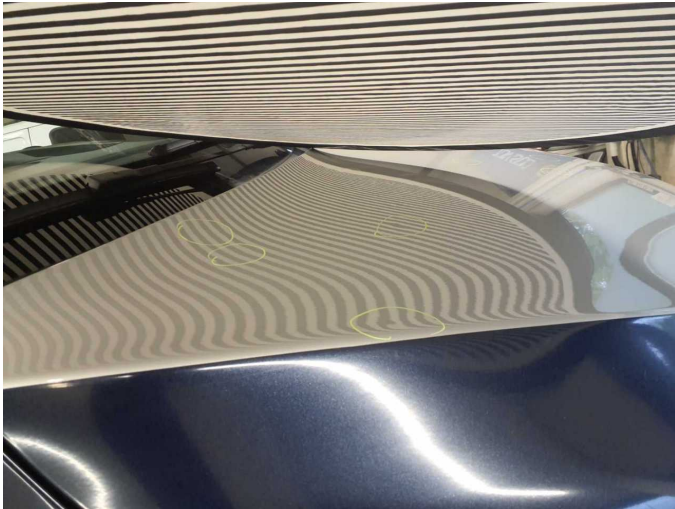
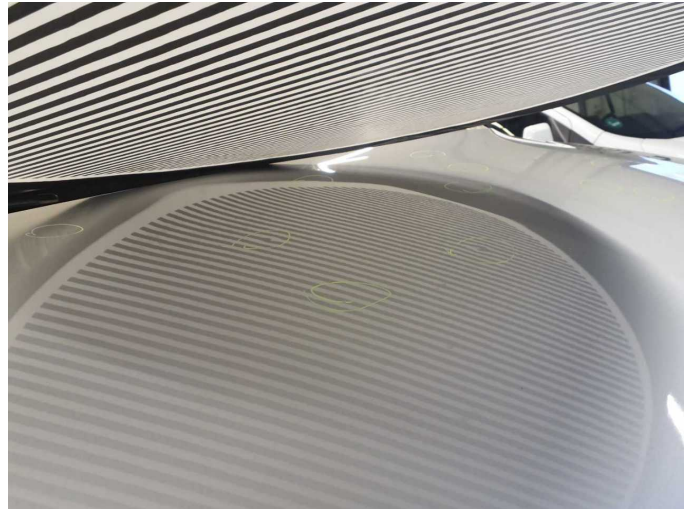
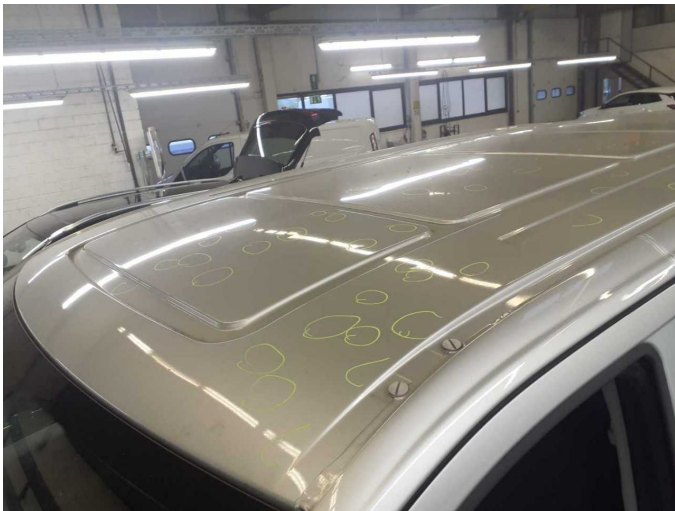
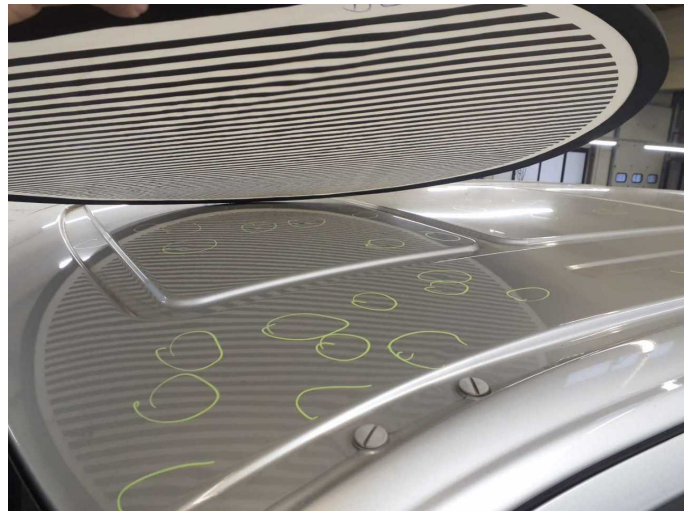
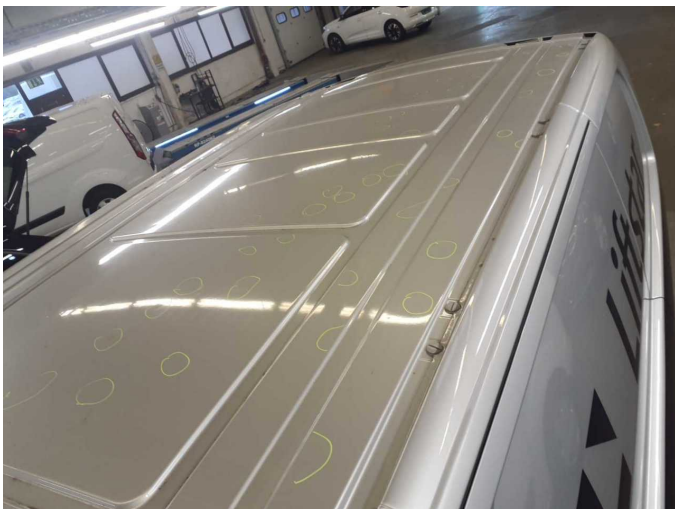
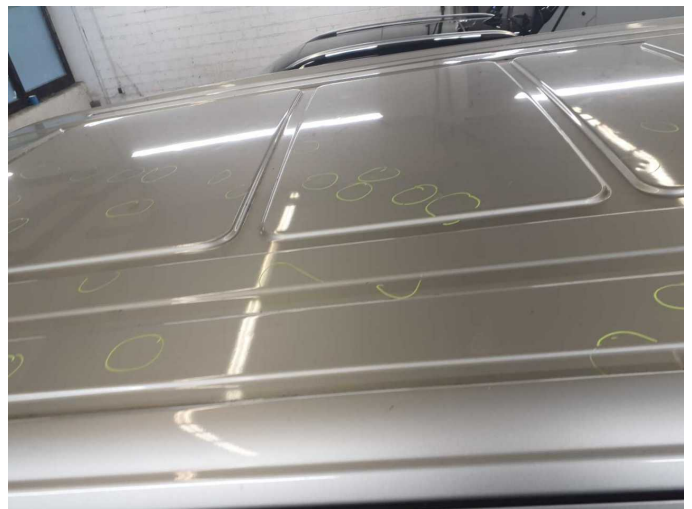
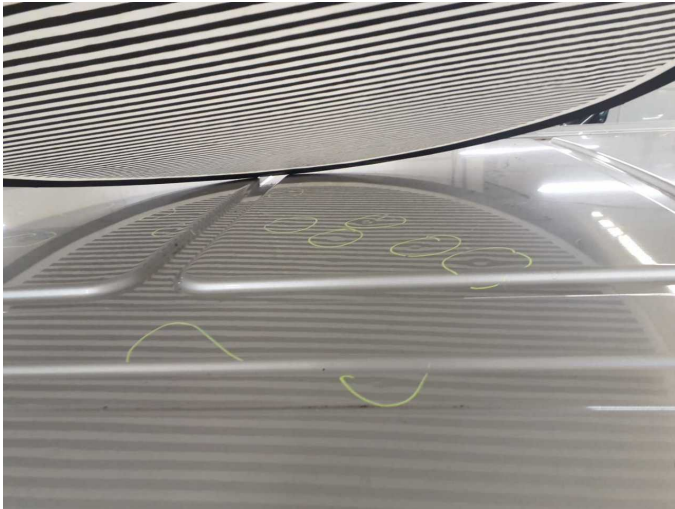
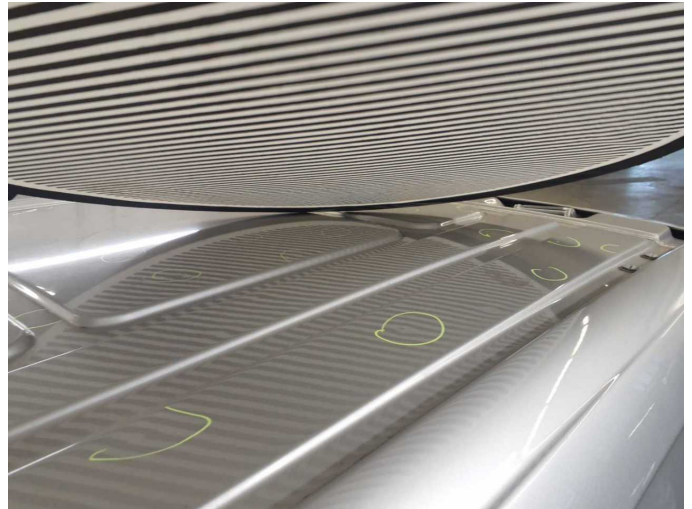
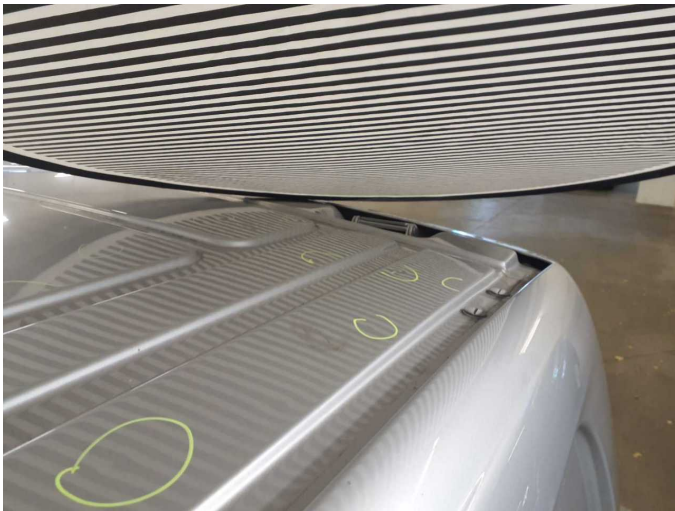
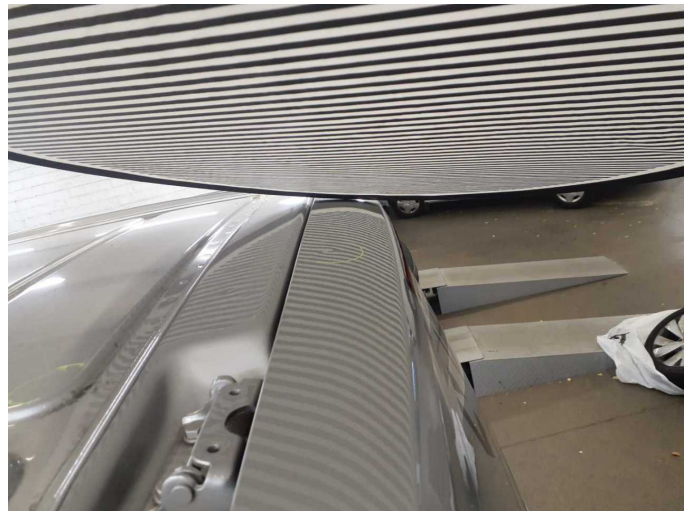
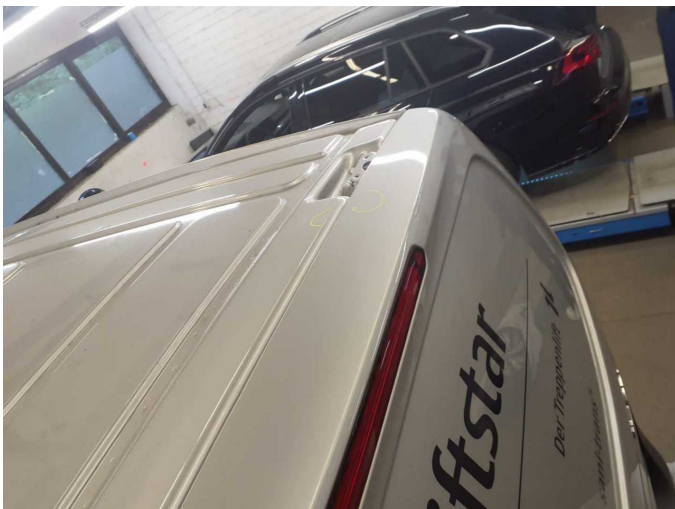
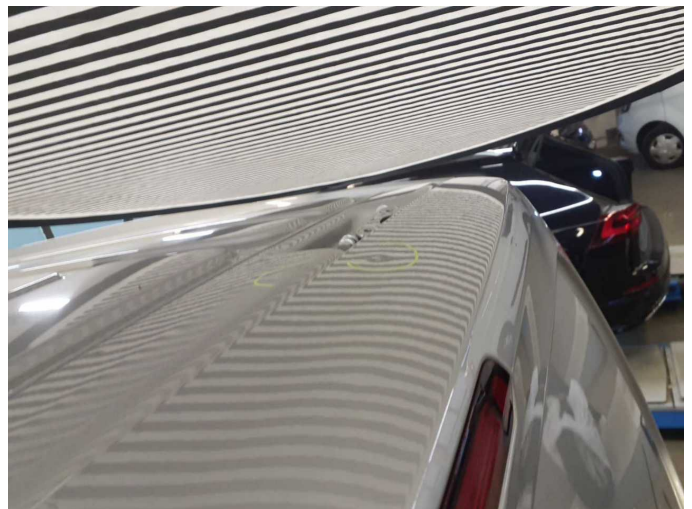
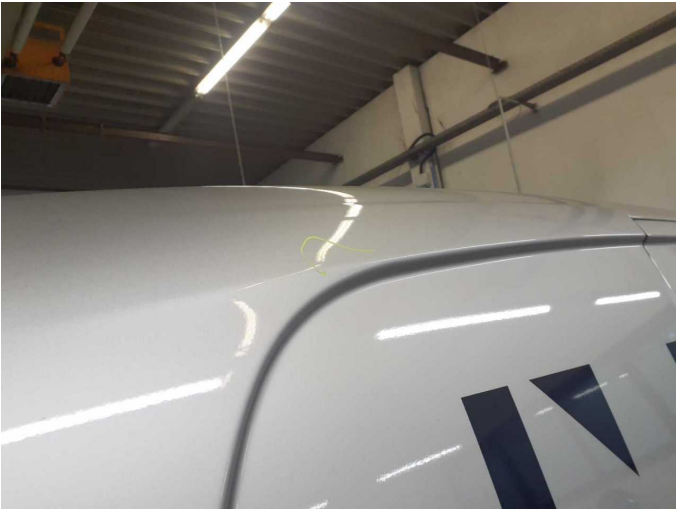
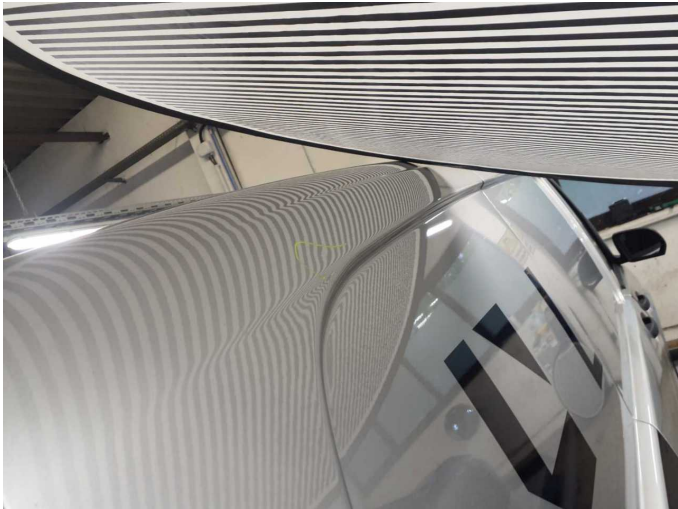
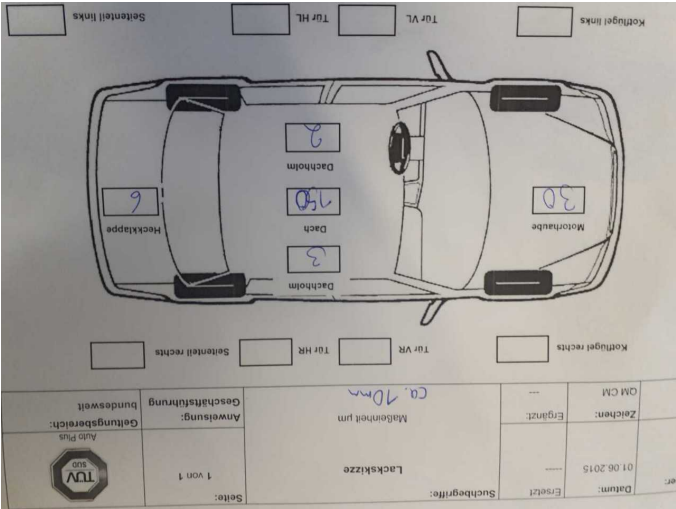
| No. | Component group | Description |
|---|---|---|
| 7 | Body | Body - Damage by hail - repair according to calculation |

Die beigefügte Reparaturkostenkalkulation wurde nach bestem Wissen und Gewissen im demontagefreien Zustand erstellt. Es können Mehrkosten und somit Abweichung der für den Hagelschaden ausgewiesener Reparaturkosten nicht ausgeschlossen werden.

**Damage 7:** Body: Body - Damage by hail - repair according to calculation

Damage 7: Body: Body - Damage by hail - repair according to calculation

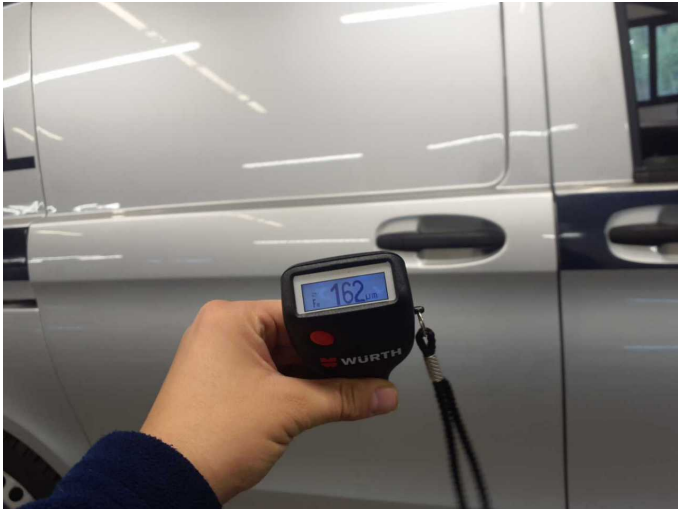
- 1 Door - rear right side, Professionally carried out, Invoice of repair done Non-existent

Door - rear right side 162 µm |

Repainting 1: Door - rear right side
