Expertise

Protocol number: 41826165
Order number / reference: 25255855
Inspection date: 6 Oct 2025

Manufacturer: Mercedes-Benz	Model: Vito 114 CDI Kompakt HA Aut. BASE
VIN: W1V44760114125538

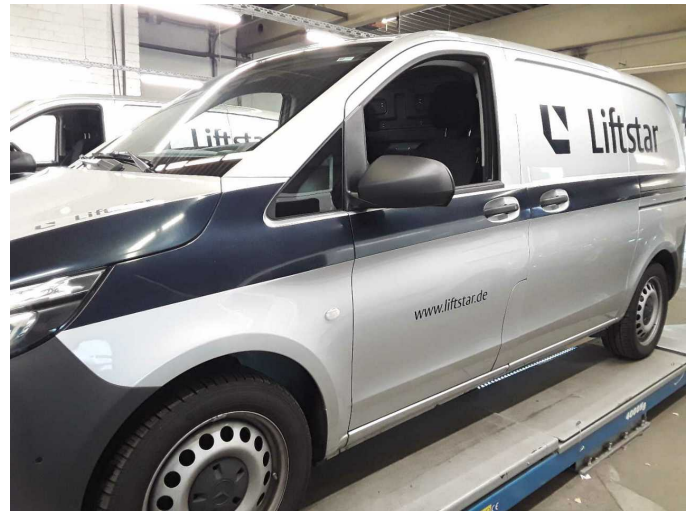
No.	Component group	Description
1	Misc.	Main inspection - No evidence - No deduction
2	Body	Body - Glued / labelled - De-glue / neutralise
3	Door - rear right side	Door - Scratch(es) - Paint
4	Door - front right side	Door - Dent / paintcoat damage - Repair and paint
5	Door - rear left side	Door - Dent / paintcoat damage - Repair and paint
6	Bonnet	Bonnet - Dent / paintcoat damage - Repair and paint
7	Boot lid / rear door	Boot lid - Deformed - Repair and paint

Damage 2: Body: Body - Glued / labelled - De-glue / neutralise

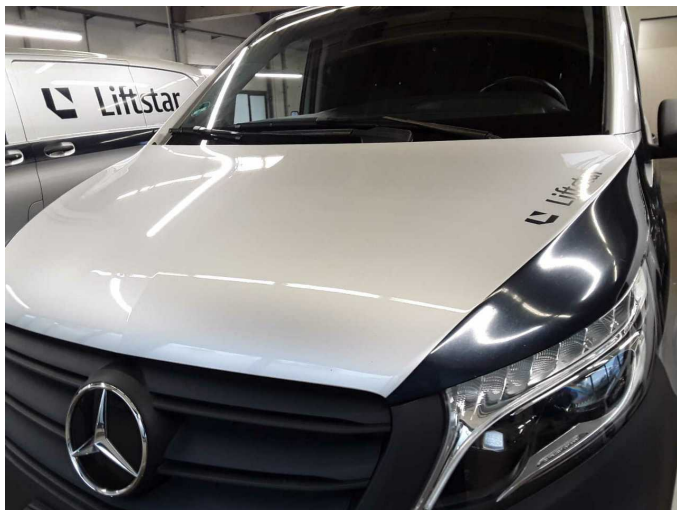
Damage 2: Body: Body - Glued / labelled - De-glue / neutralise

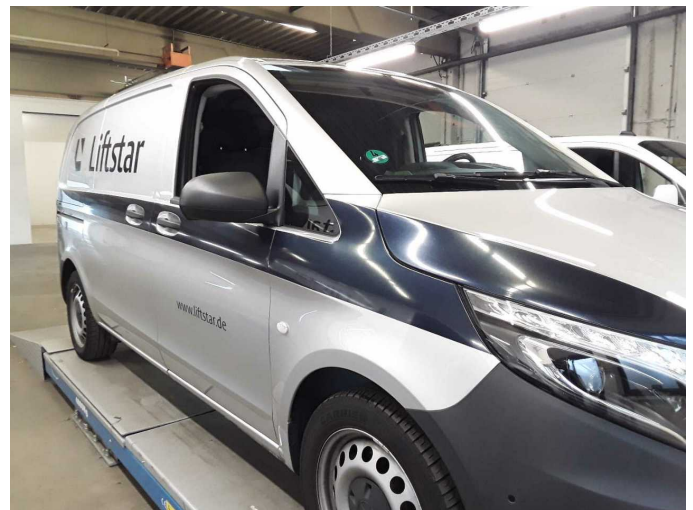
Damage 2: Body: Body - Glued / labelled - De-glue / neutralise

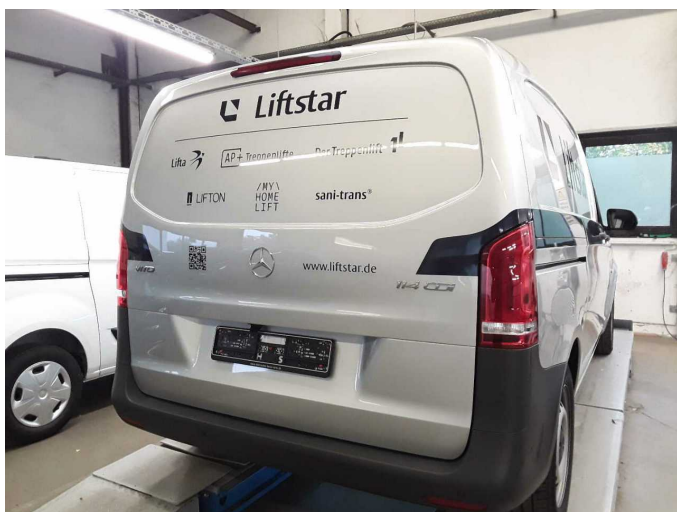
Damage 2: Body: Body - Glued / labelled - De-glue / neutralise

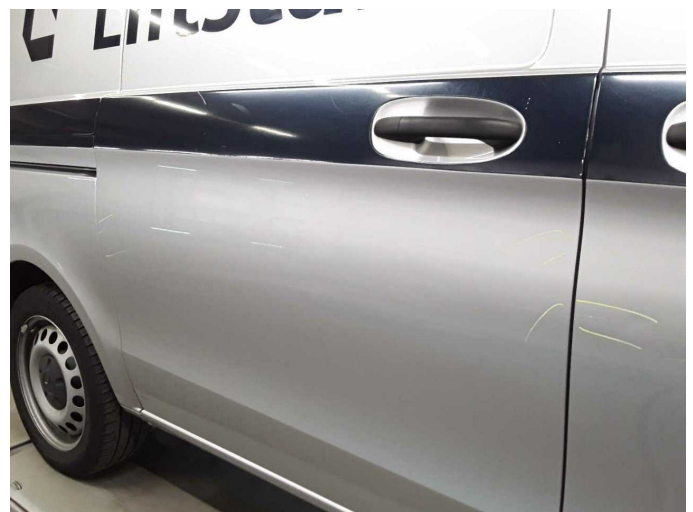
Damage 3: Door - rear right side: Door - Scratch(es) - Paint

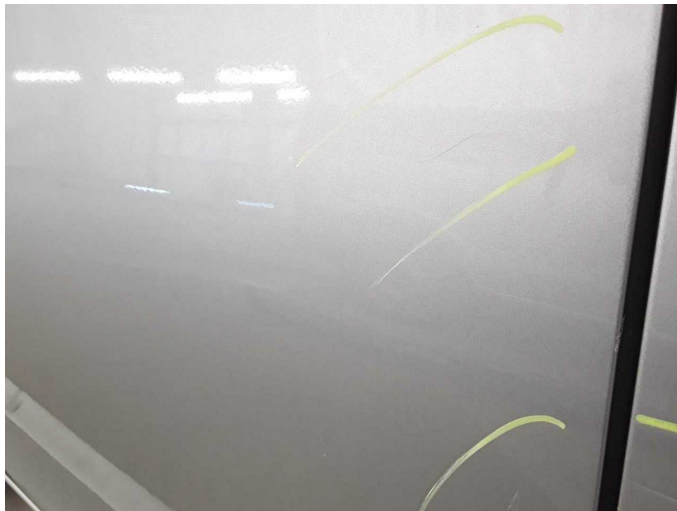
Damage 3: Door - rear right side: Door - Scratch(es) - Paint

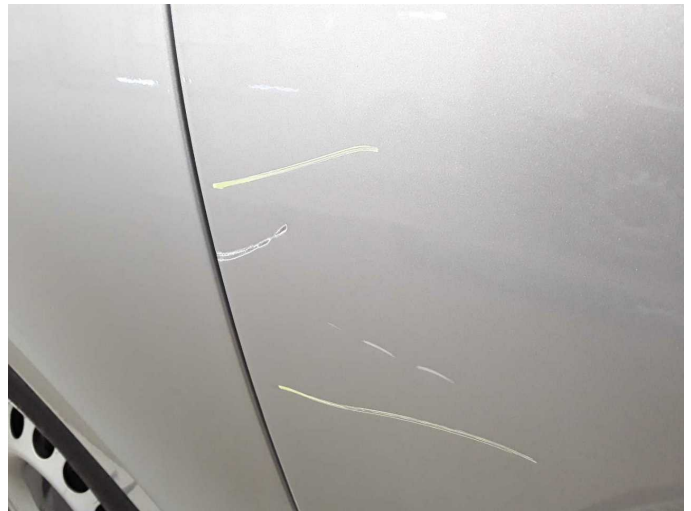
Damage 3: Door - rear right side: Door - Scratch(es) - Paint

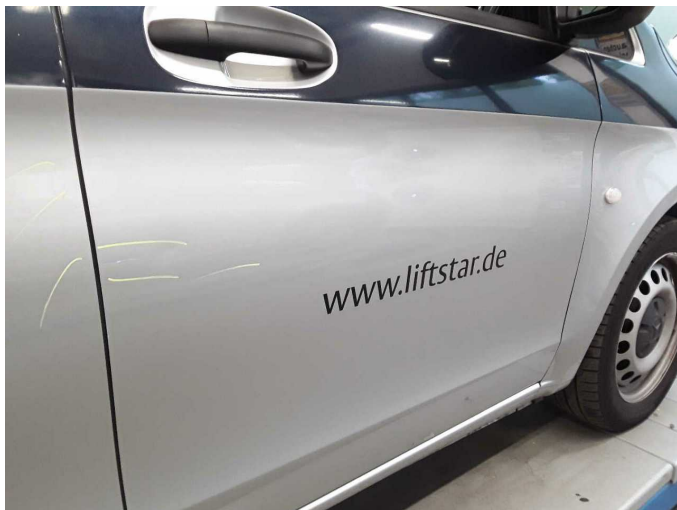
Damage 4: Door - front right side: Door - Dent / paintcoat damage - Repair and paint

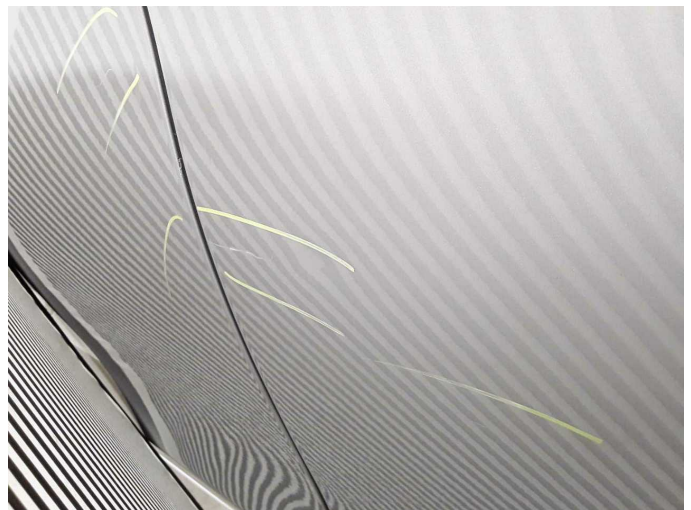
Damage 4: Door - front right side: Door - Dent / paintcoat damage - Repair and paint

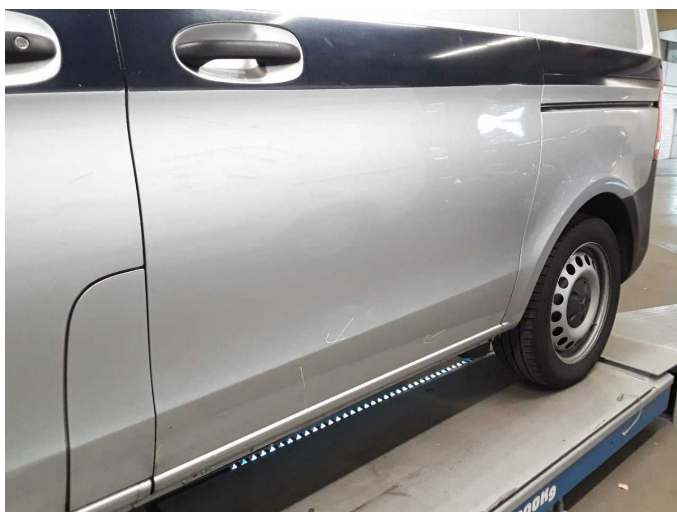
Damage 5: Door - rear left side: Door - Dent / paintcoat damage - Repair and paint

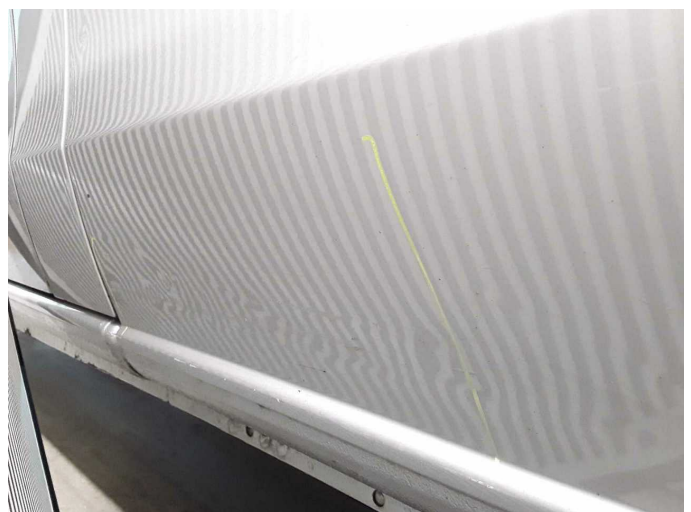
Damage 5: Door - rear left side: Door - Dent / paintcoat damage - Repair and paint

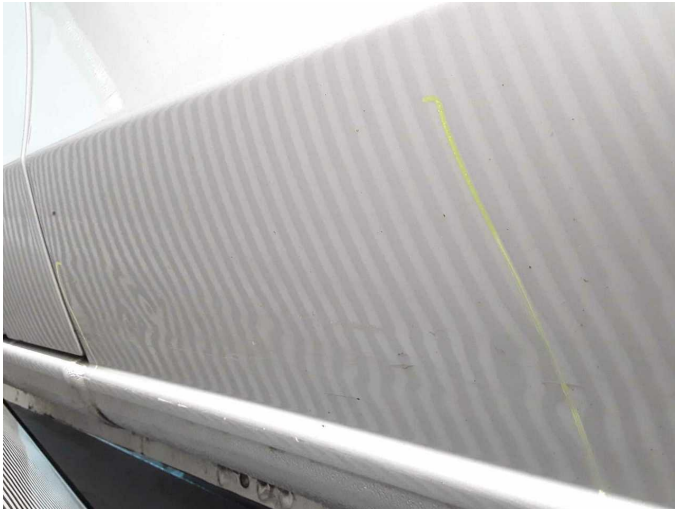
Damage 5: Door - rear left side: Door - Dent / paintcoat damage - Repair and paint

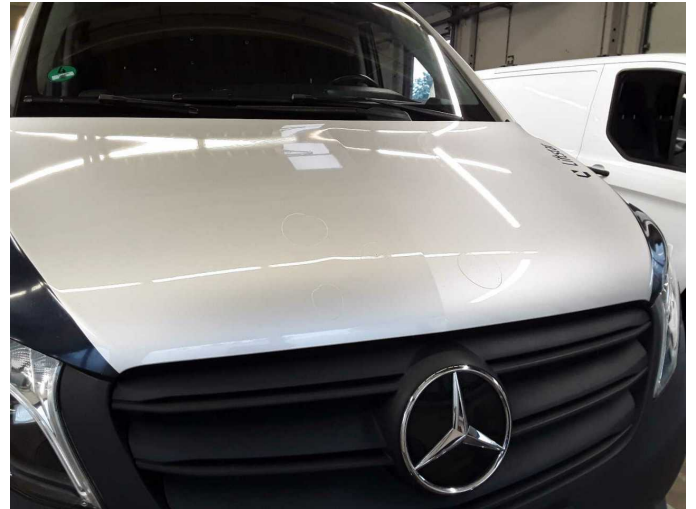
Damage 6: Bonnet: Bonnet - Dent / paintcoat damage - Repair and paint

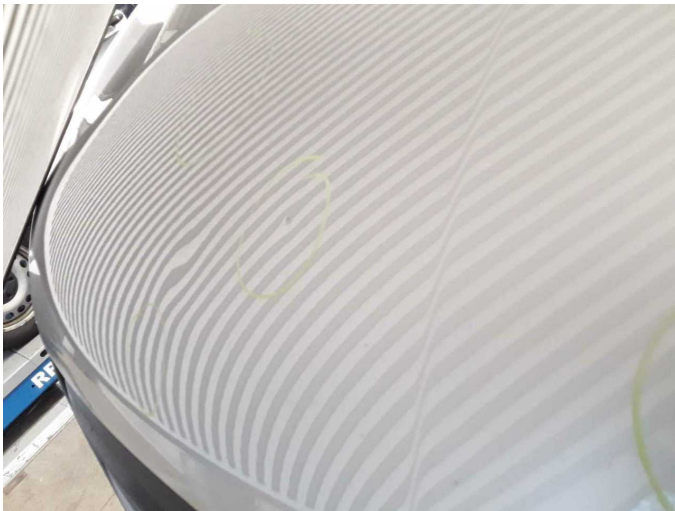
Damage 6: Bonnet: Bonnet - Dent / paintcoat damage - Repair and paint

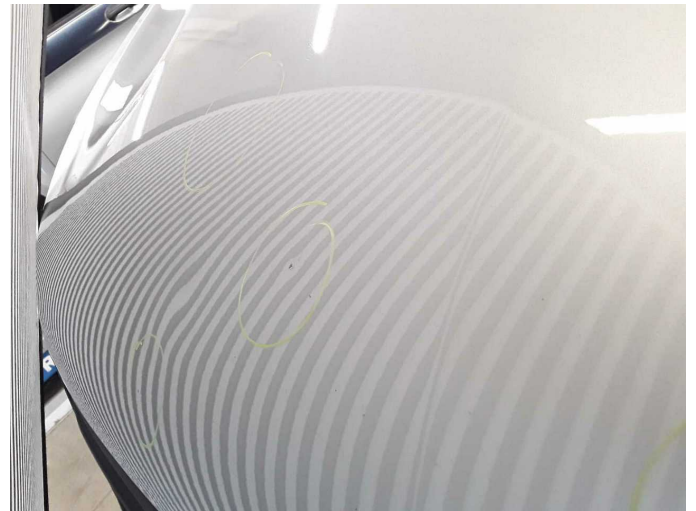
Damage 6: Bonnet: Bonnet - Dent / paintcoat damage - Repair and paint

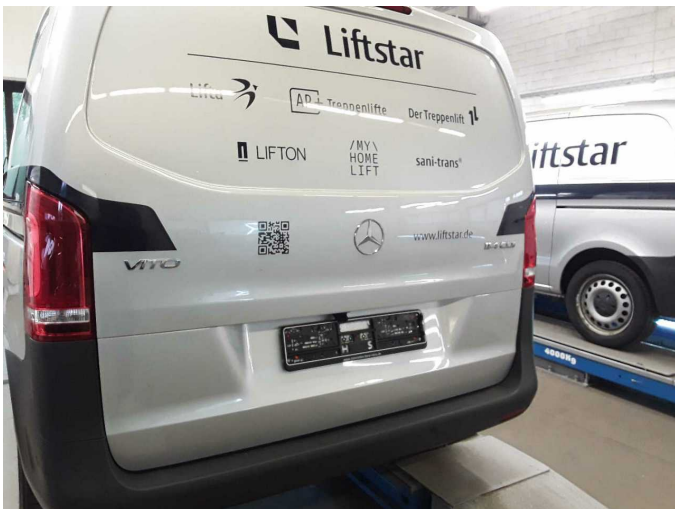
Damage 7: Boot lid / rear door: Boot lid - Deformed - Repair and paint

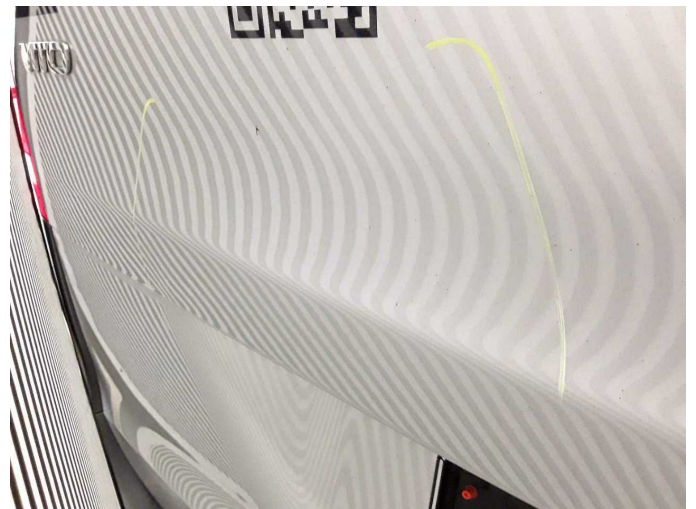
Damage 7: Boot lid / rear door: Boot lid - Deformed - Repair and paint

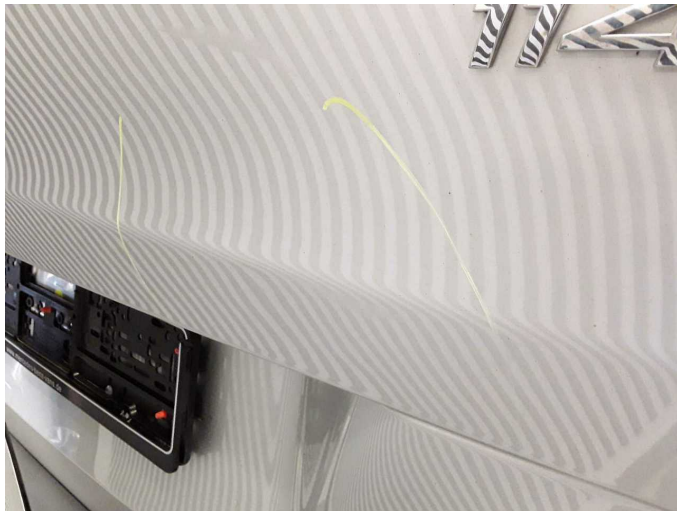
Damage 7: Boot lid / rear door: Boot lid - Deformed - Repair and paint

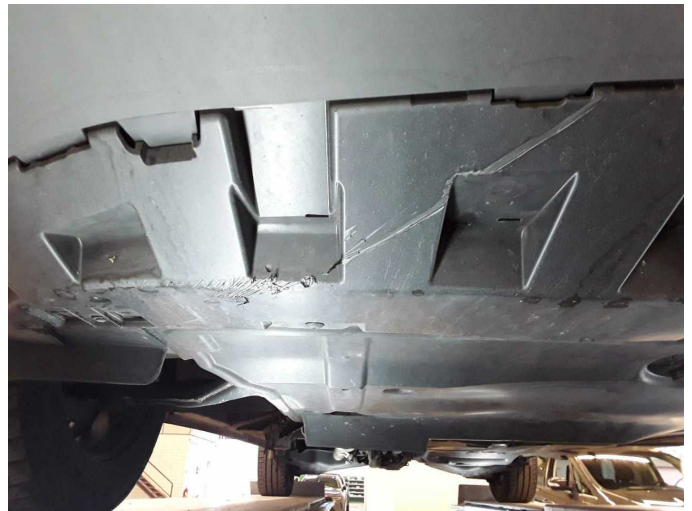
No.	Component group	Description
1	Body	Underbody panelling - Scratched - No deduction
2	Interior	Interior - Scratch(es) - No deduction

Wear and tear 1: Body: Underbody panelling - Scratched - No deduction

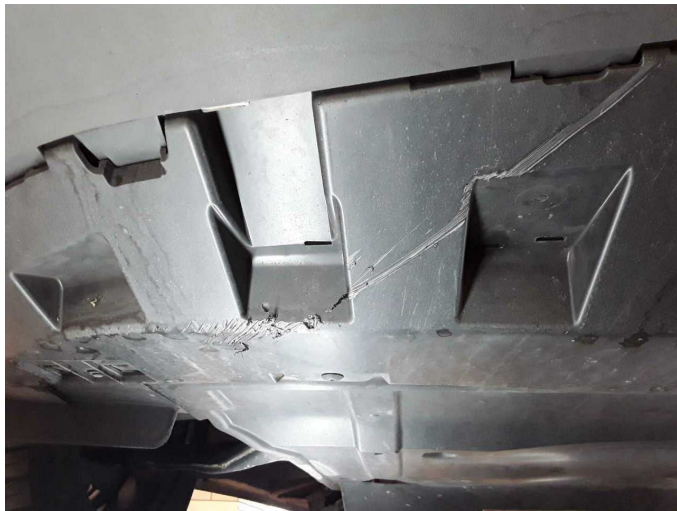
Wear and tear 1: Body: Underbody panelling - Scratched - No deduction
