Expertise

Protocol number: 41590254
Order No. / Reference: 25211237
Inspection date: 17 Sept 2025

Manufacturer: Mercedes-Benz

Model: Vito 114 CDI Kompakt HA Aut. BASE

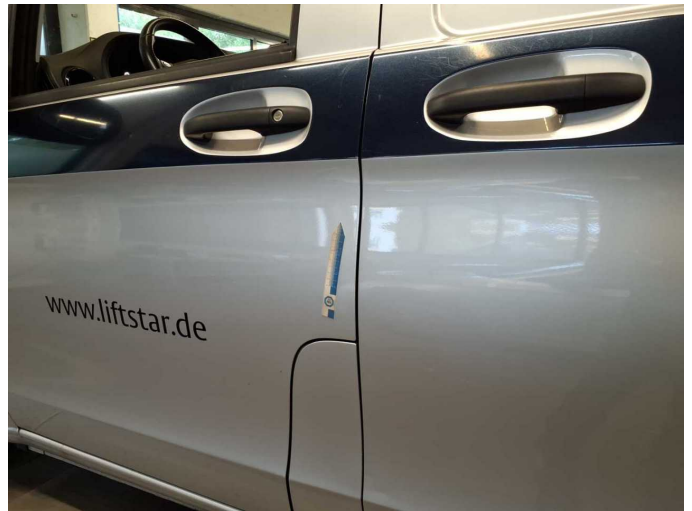
No.	Component group	Description
1	Misc.	Inspection / maintenance - No evidence - No deduction
2	Door - front left side	Door edge - Scratch(es) - Smart repair
3	Body	Body - Glued / labelled - De-glue / neutralise
4	Wing mirror - right side	Mirror housing - Holes - Replace
5	Door - rear left side	Door - Scratch(es) - Paint

Damage 2: Door - front left side: Door edge - Scratch(es) - Smart repair

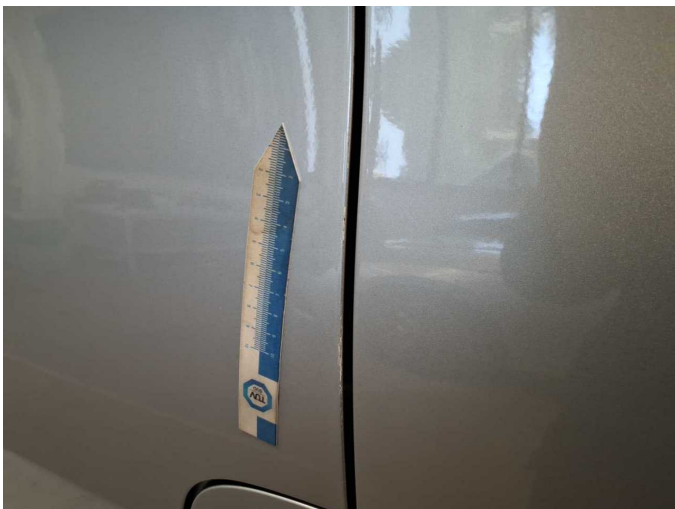
Damage 2: Door - front left side: Door edge - Scratch(es) - Smart repair

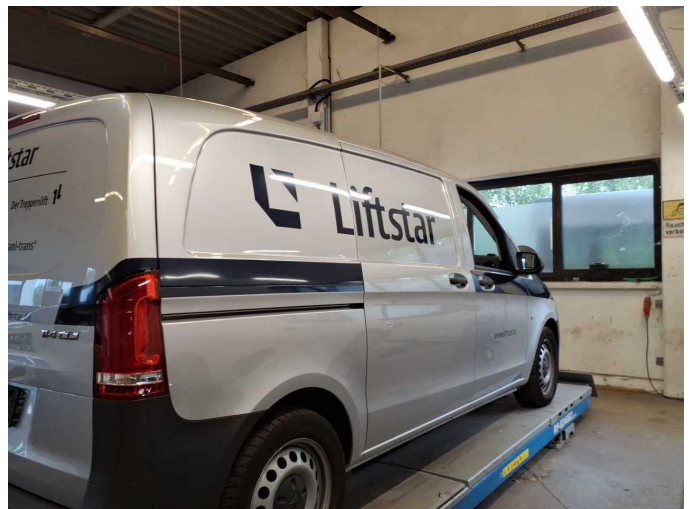
Damage 3: Body: Body - Glued / labelled - De-glue / neutralise

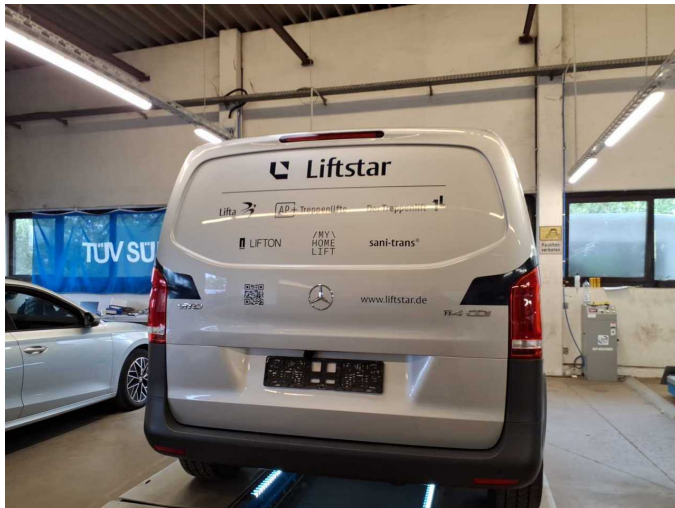
Damage 3: Body: Body - Glued / labelled - De-glue / neutralise

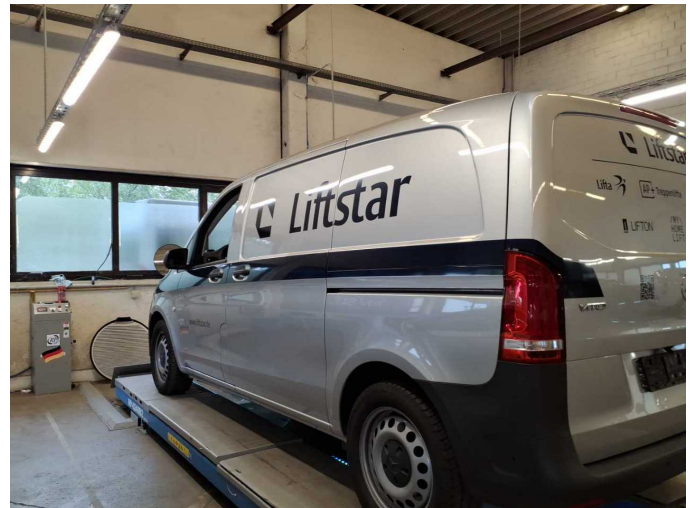
Damage 3: Body: Body - Glued / labelled - De-glue / neutralise

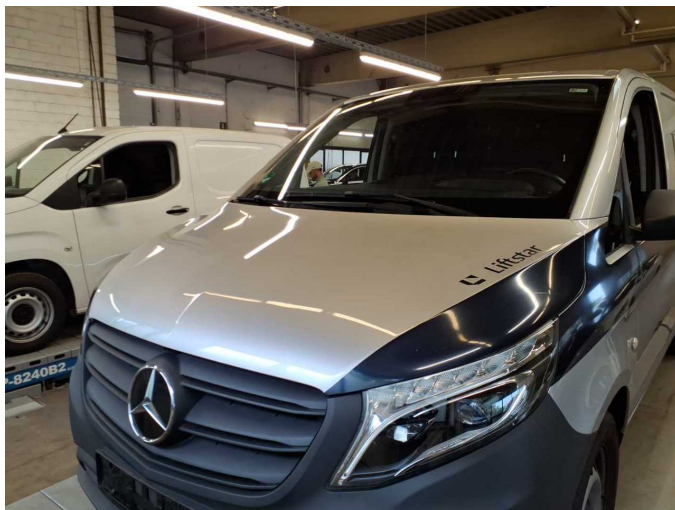
Damage 3: Body: Body - Glued / labelled - De-glue / neutralise

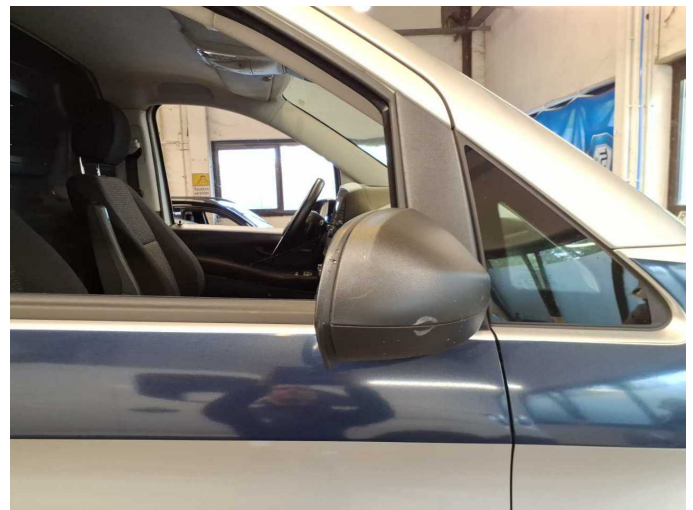
Damage 4: Wing mirror - right side: Mirror housing - Holes - Replace

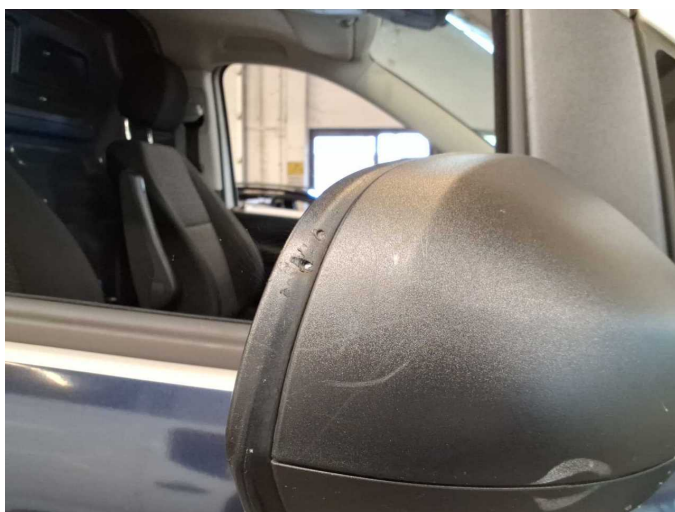
Damage 4: Wing mirror - right side: Mirror housing - Holes - Replace

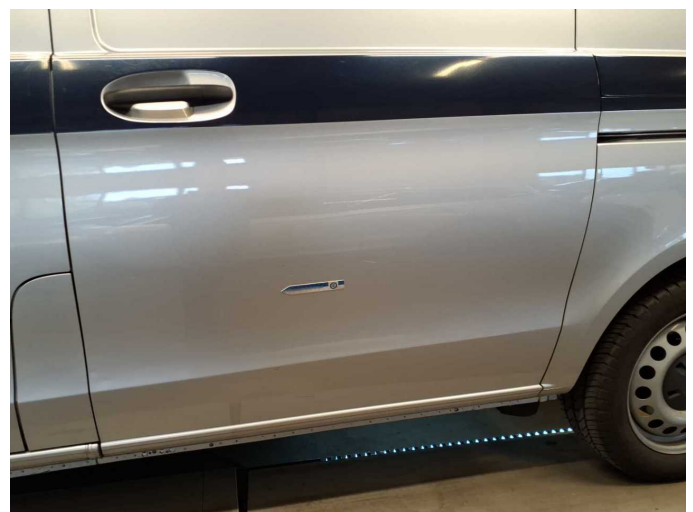
Damage 5: Door - rear left side: Door - Scratch(es) - Paint

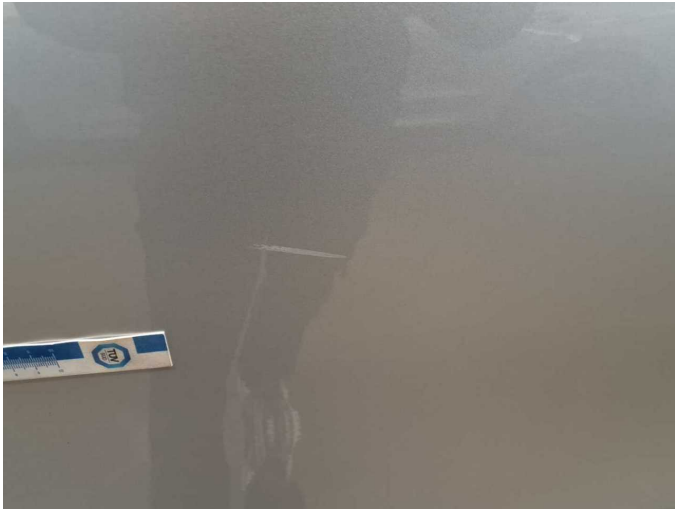
Damage 5: Door - rear left side: Door - Scratch(es) - Paint

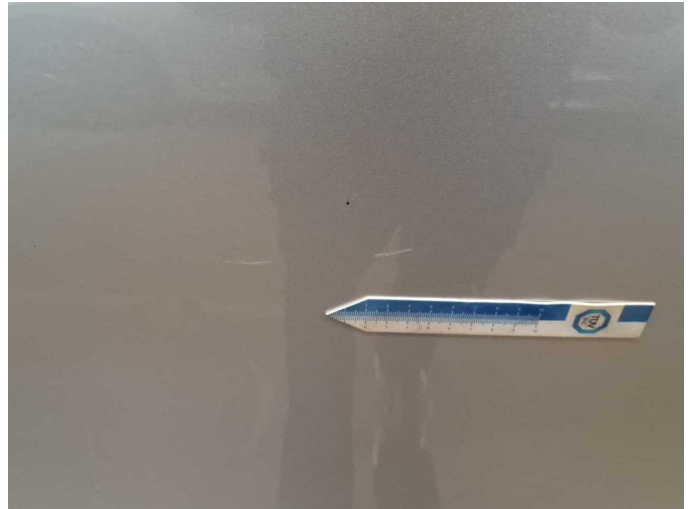
Damage 5: Door - rear left side: Door - Scratch(es) - Paint

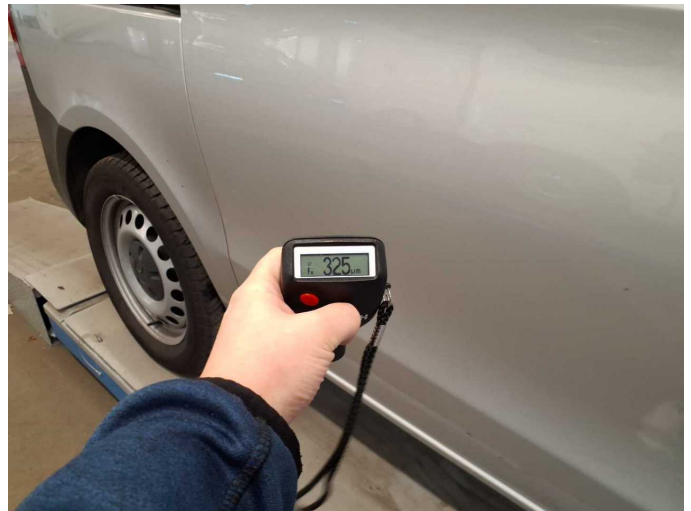
No.	Repainting
1	Door - rear right side, Professionally carried out, Invoice of repair done

Door - rear right side	325 µm
------------------------	--------

Repainting 1: Door - rear right side

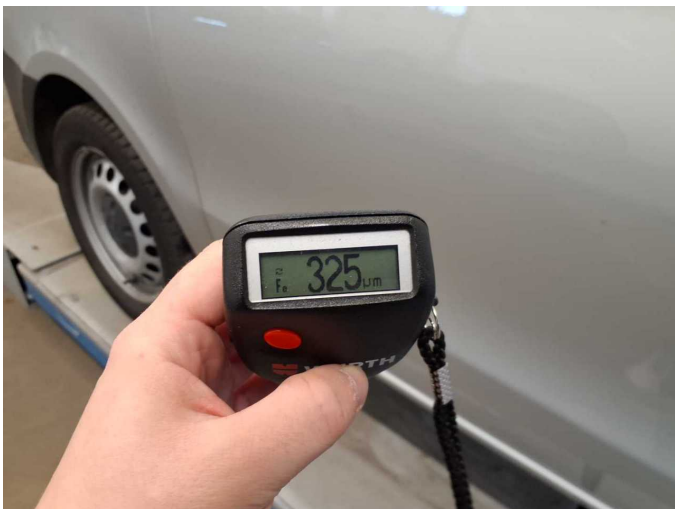
Repainting 1: Door - rear right side
