Expertise

Protocol number: 41492134
Order No. / Reference: 25188403
Inspection date: 10 Sept 2025

Manufacturer: Mercedes-Benz

Model: Vito 114 CDI Kompakt HA Aut. BASE

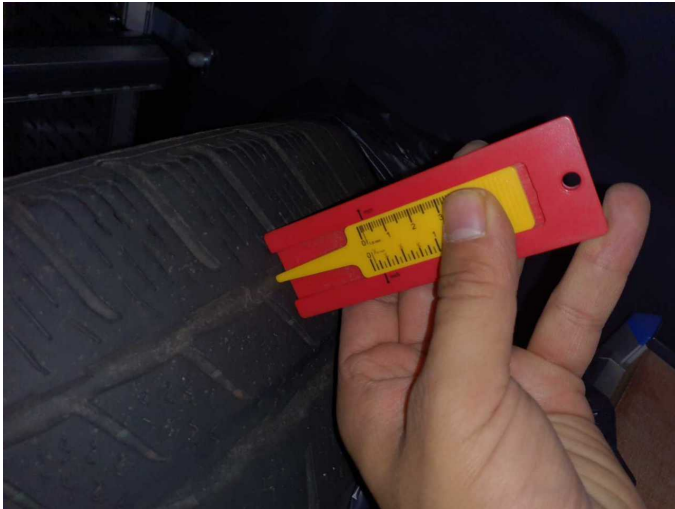
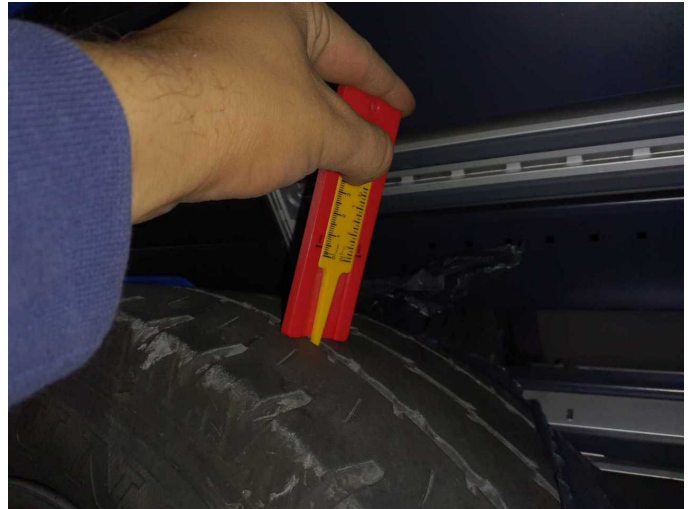
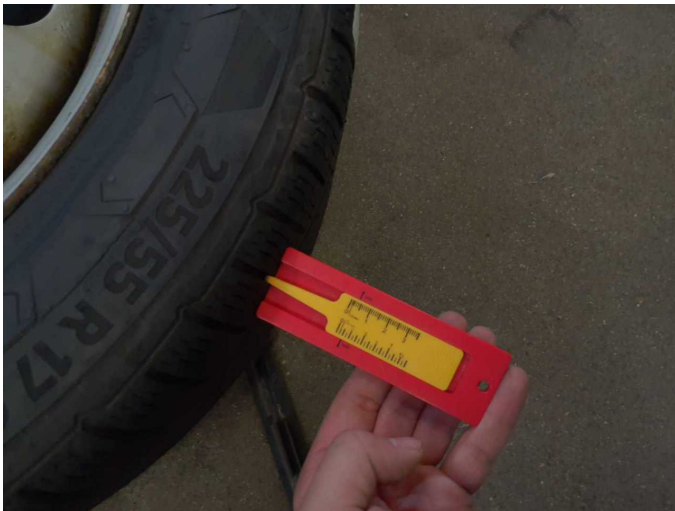
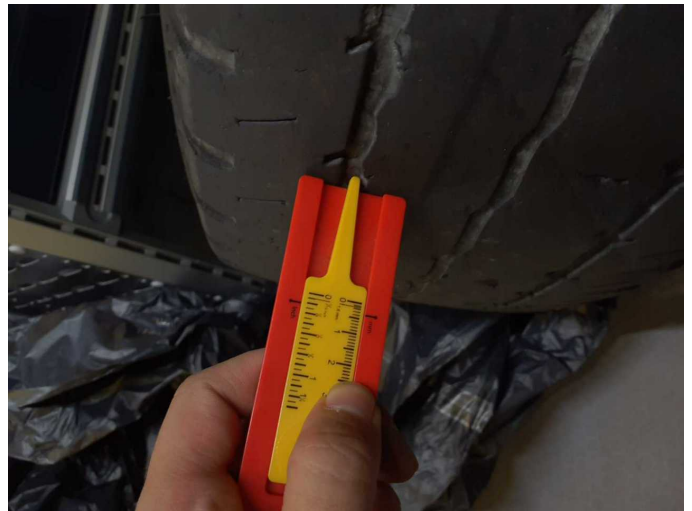
Damage 1: 2nd wheel set: Tyres - complete set - Does not meet the leasing specifications - No deduction

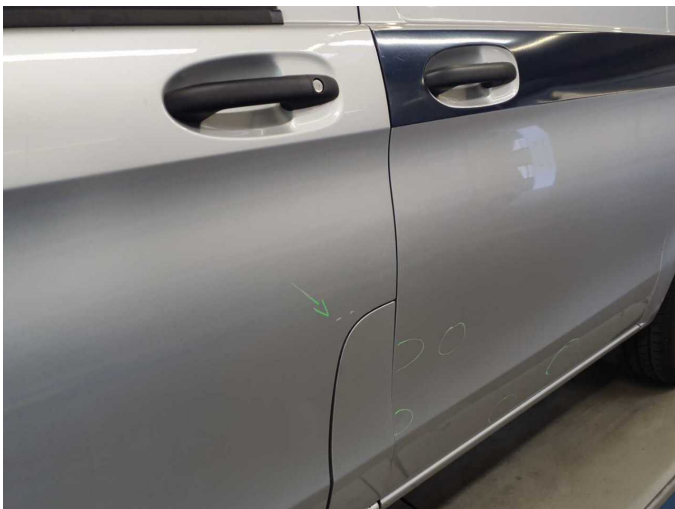
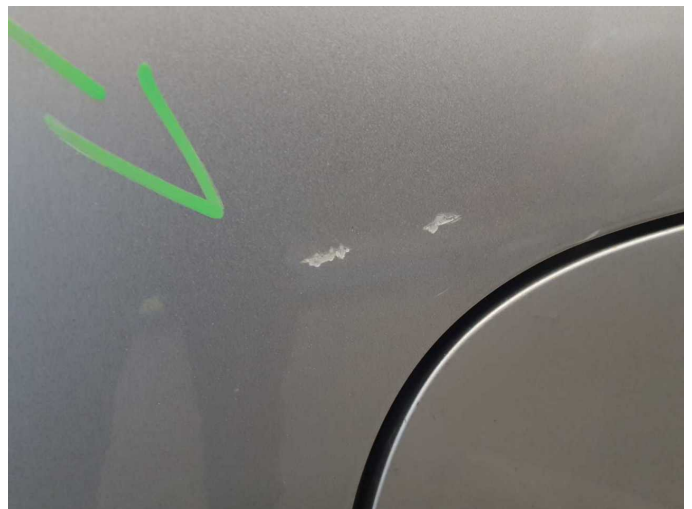
Damage 3: Door - front left side: Door - Scratch(es) - Smart repair

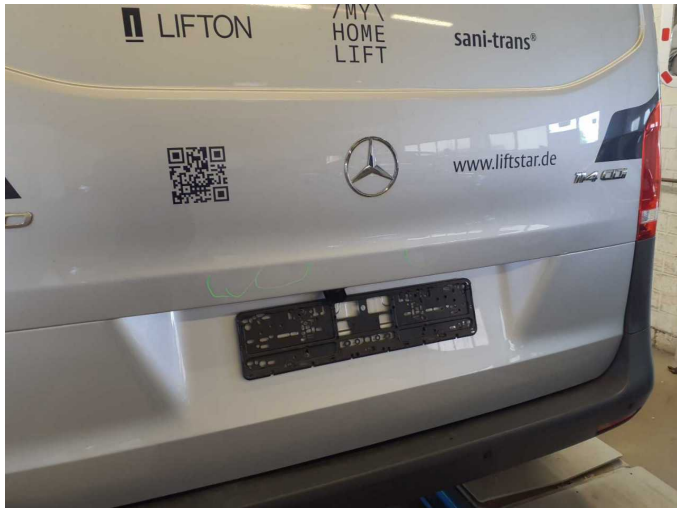
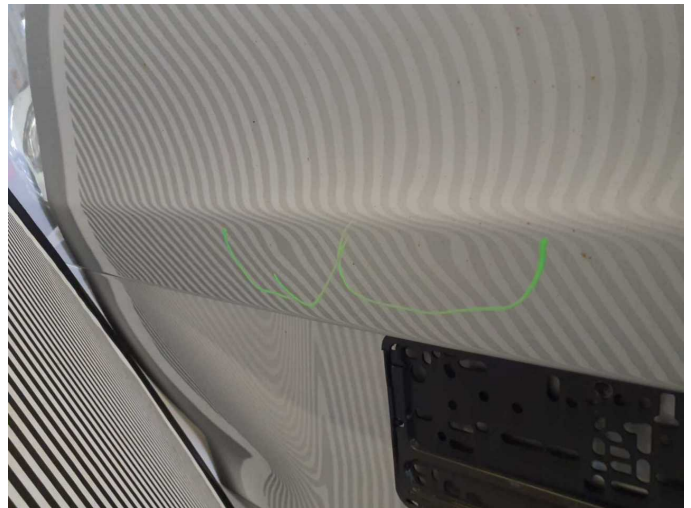
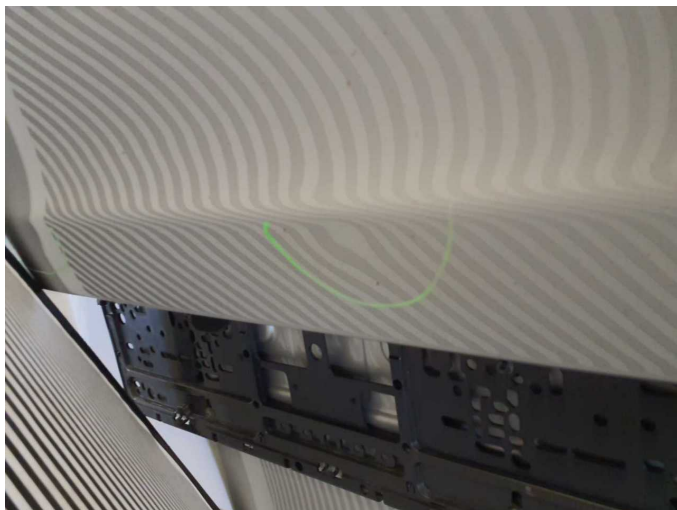
Damage 4: Boot lid / rear door: Boot lid - dent(s) - Smart repair

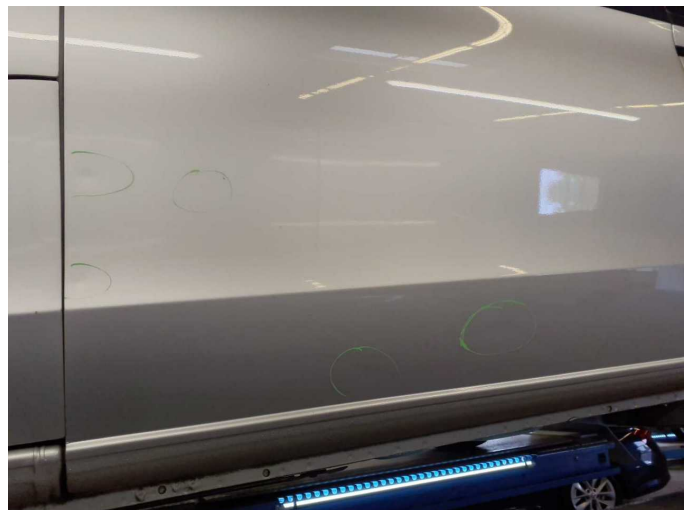
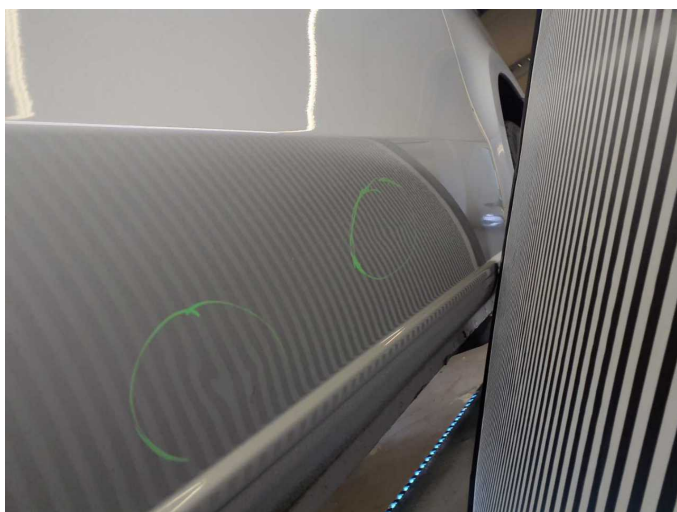
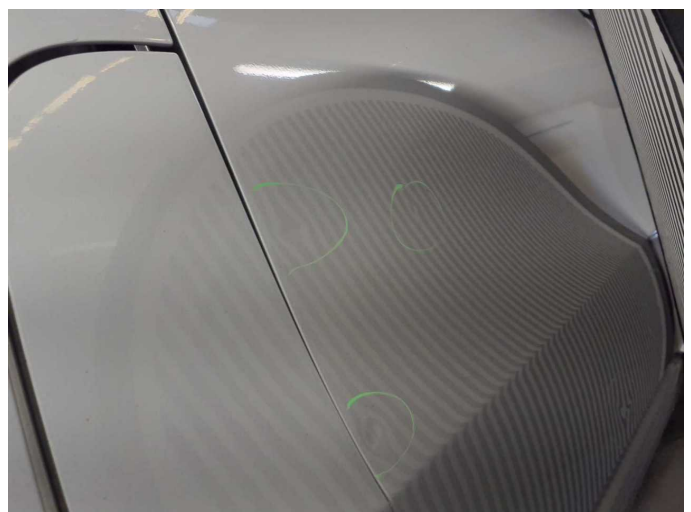
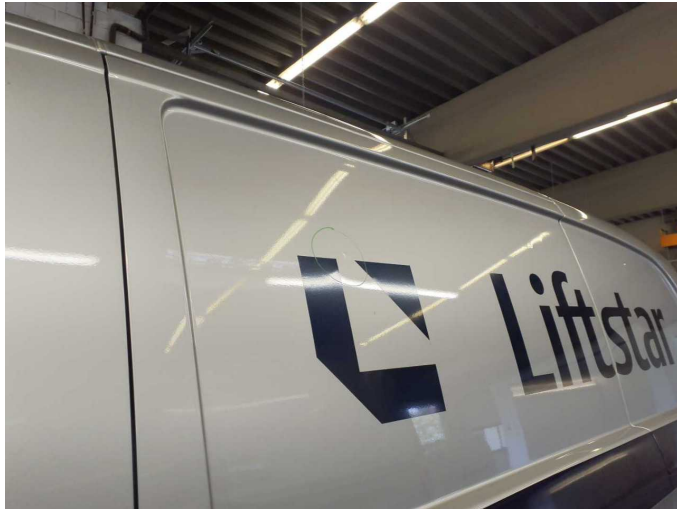
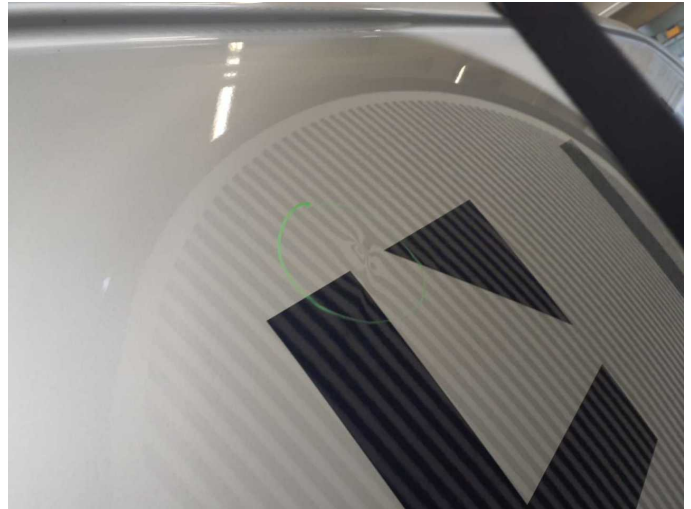
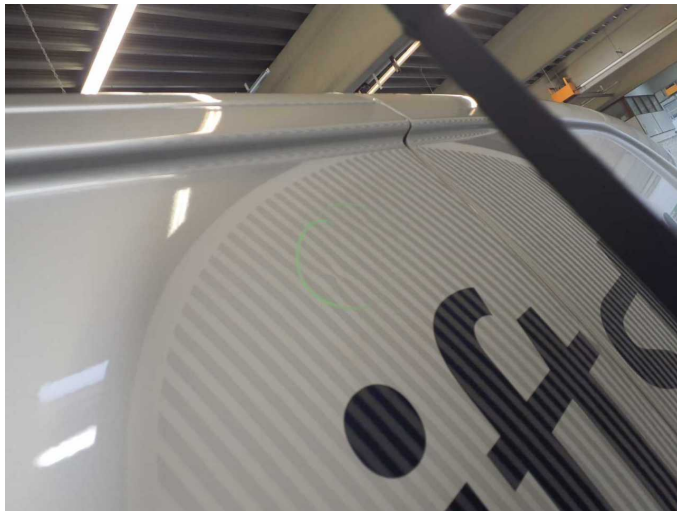
Damage 5: Sliding door - left side: Sliding door (Dellen+Beulen) - dent(s) - Smart repair

Damage 5: Sliding door - left side: Sliding door (Dellen+Beulen) - dent(s)
- Smart repair

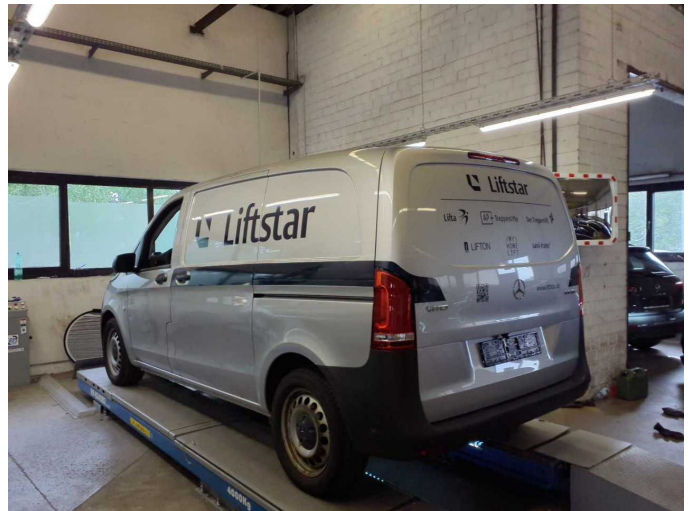
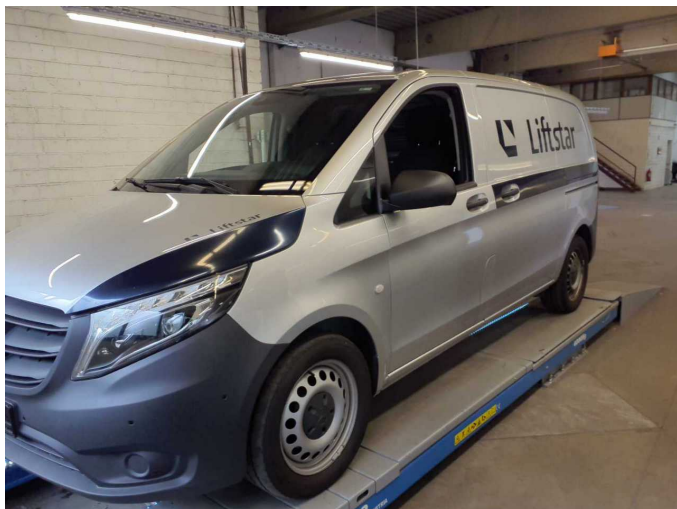
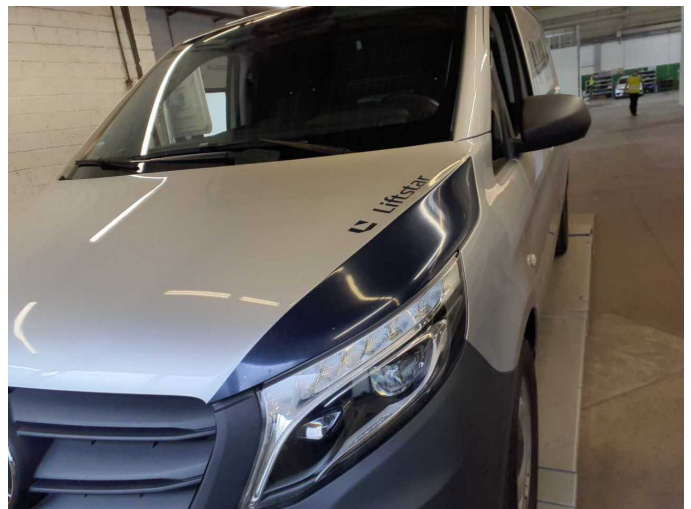
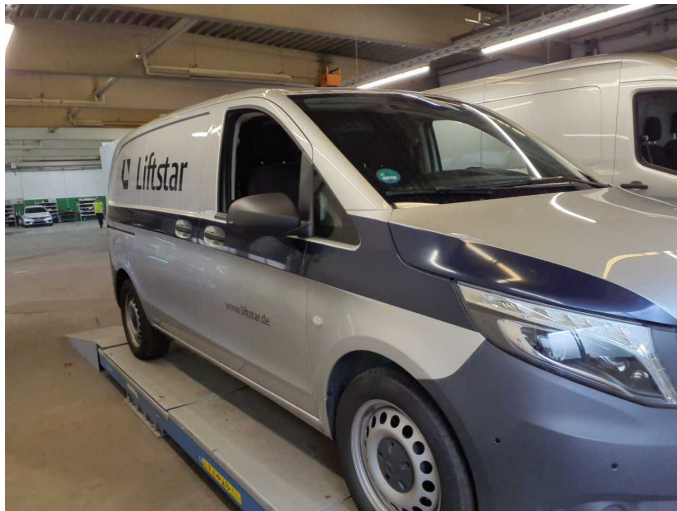
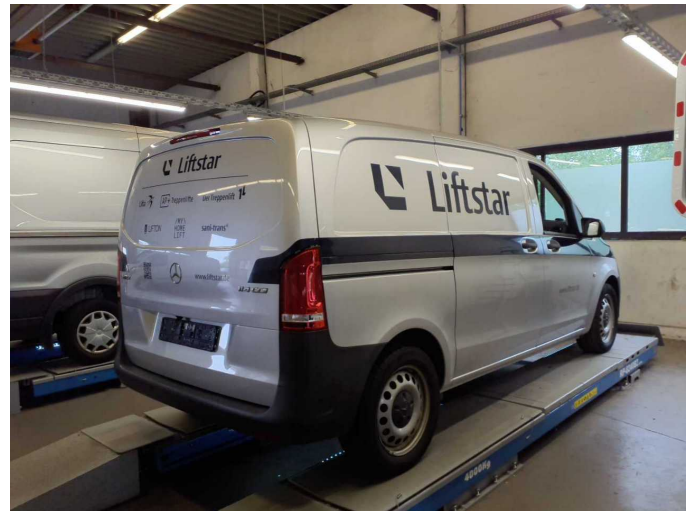
Damage 6: Body: Body - Glued / labelled - De-glue / neutralise

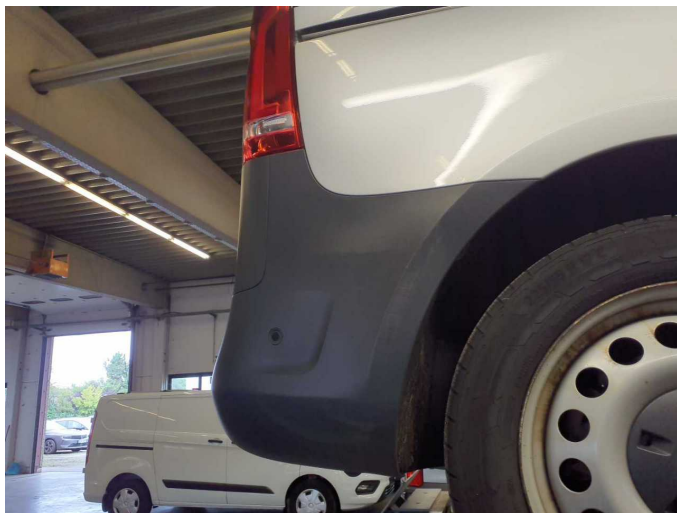
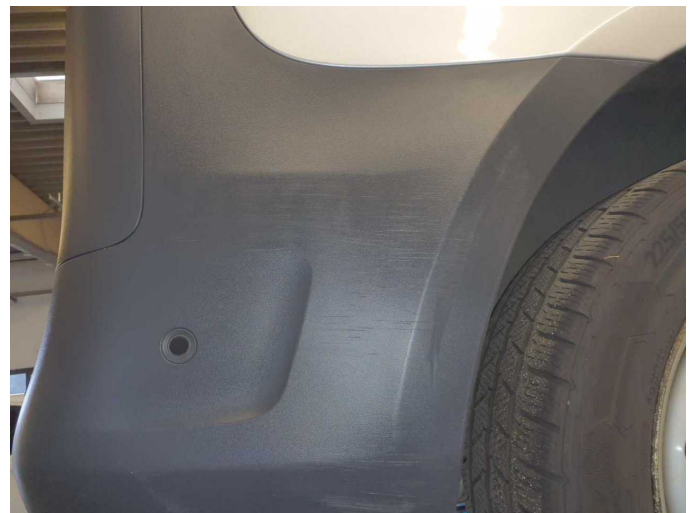
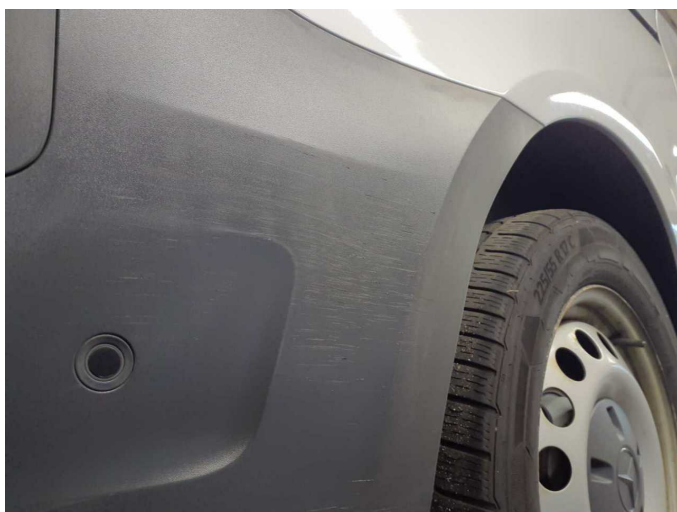
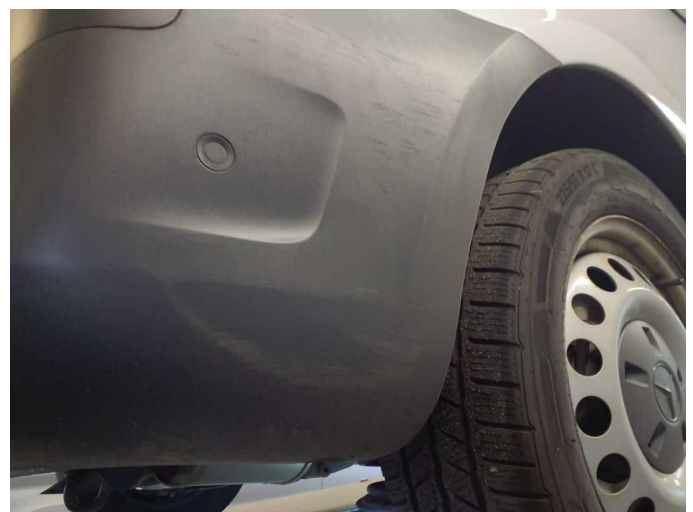
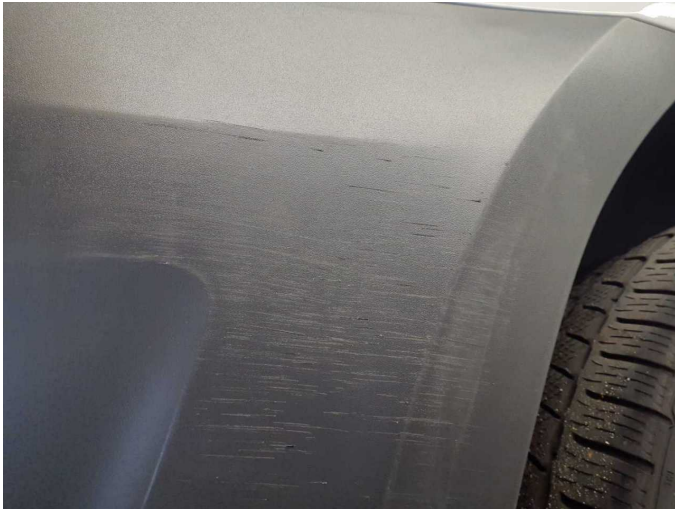
Damage 7: Rear bumper: Rear bumper - Scratched - Replace

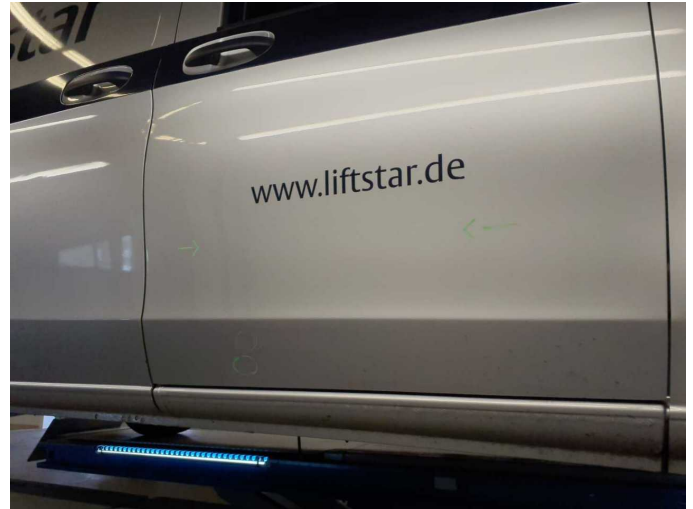
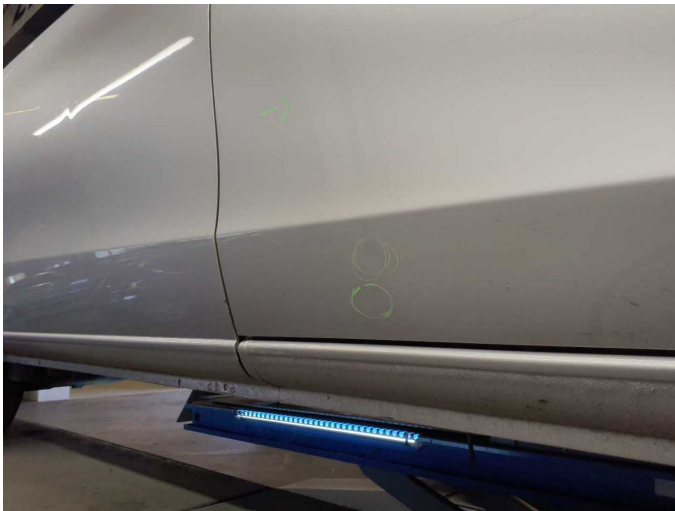
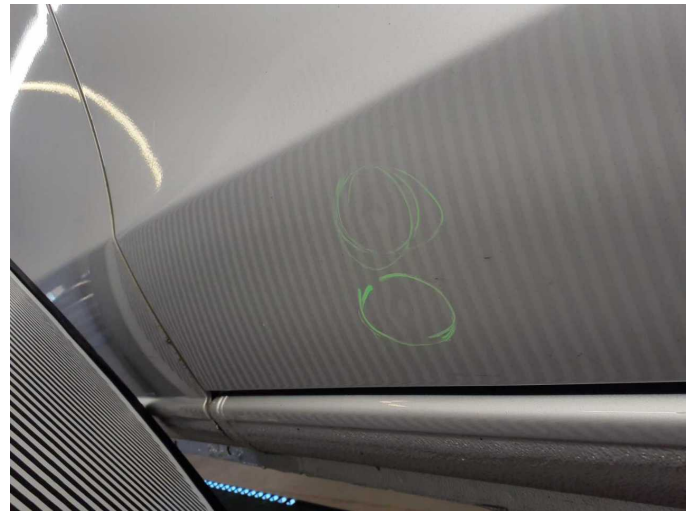
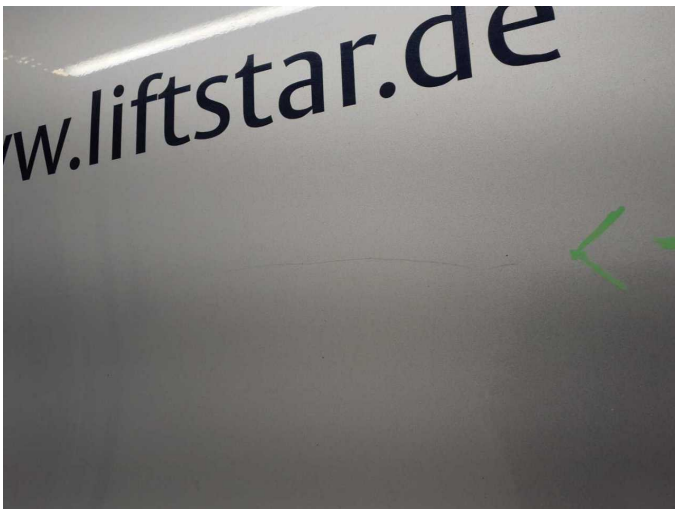
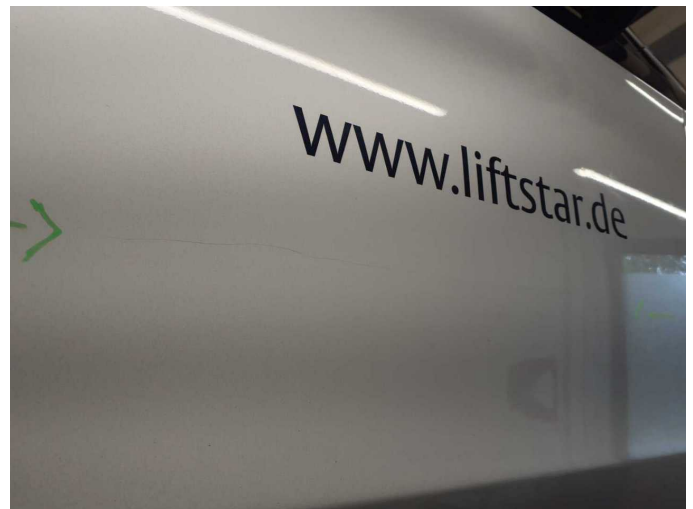
Damage 8: Door - front right side: Door (Dellen+Kratzer) - Dent / paintcoat damage - Repair and paint

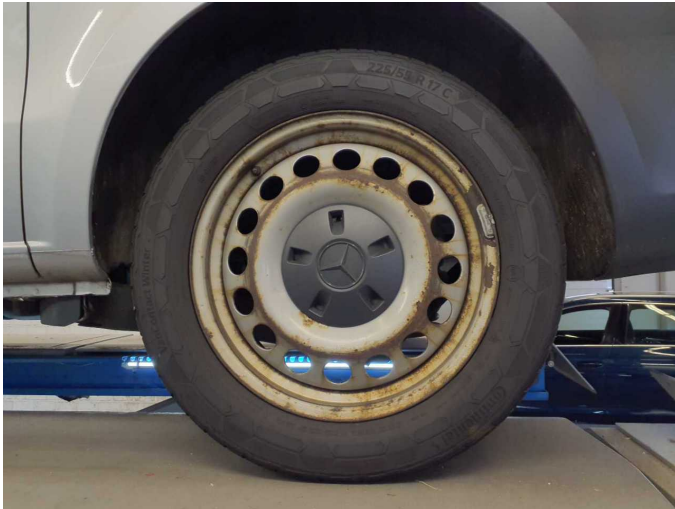
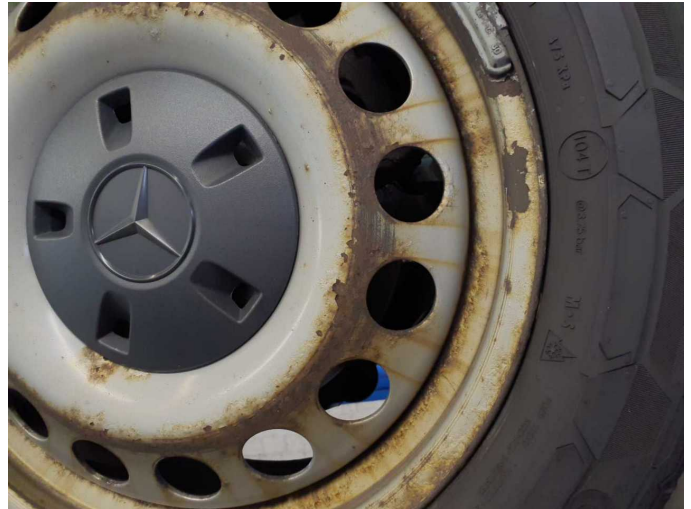
Wear and tear 2: Wheel / tyres: Wheel rim - rear left side - Corrosion - No deduction

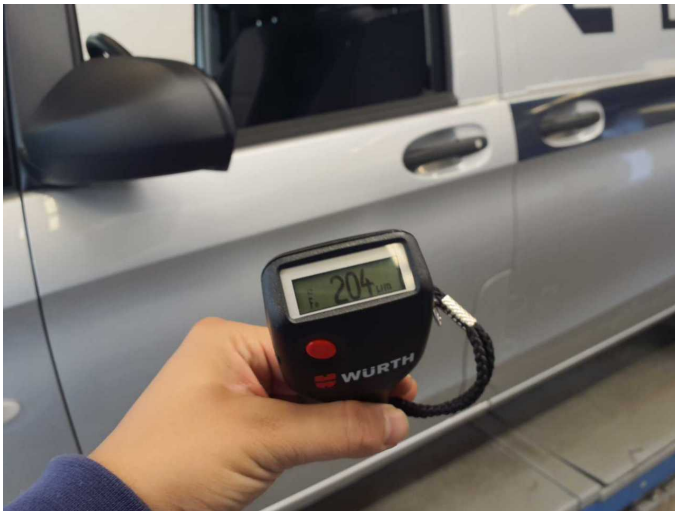
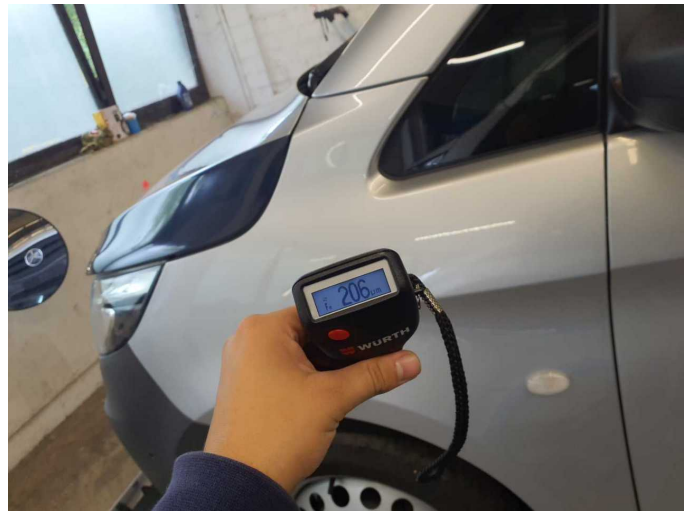
- 1 Mudguard - left side, Door - front left side, Professionally carried out, Invoice of repair done Non-existent

Mudguard - left side	206 µm	Door - front left side	204 µm
----------------------	--------	------------------------	--------

Repainting 1: Mudguard - left side, Door - front left side
