Expertise

Protocol number: 41816593  
Order number / reference: 25255836  
Inspection date: 2 Oct 2025

Manufacturer: Mercedes-Benz	Model: Vito 114 CDI Kompakt HA Aut. BASE
VIN: W1V44760114127521

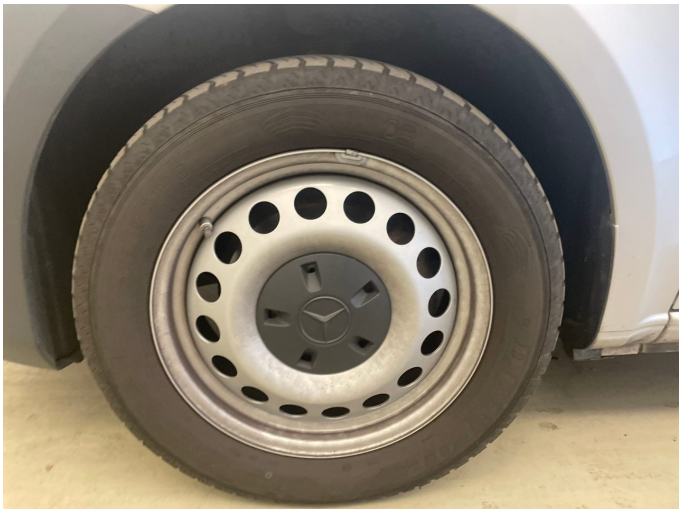
Figure 12: Mounted tyres

#	Tyre size	Type of tyre	Manufacturer	Tread depth
1)	225/55 R17 107H	Summer tyres on Steel rim with wheel cover	Dunlop	5mm / 5mm
2)	225/55 R17 107H	Summer tyres on Steel rim with wheel cover	Dunlop	5mm / 5mm

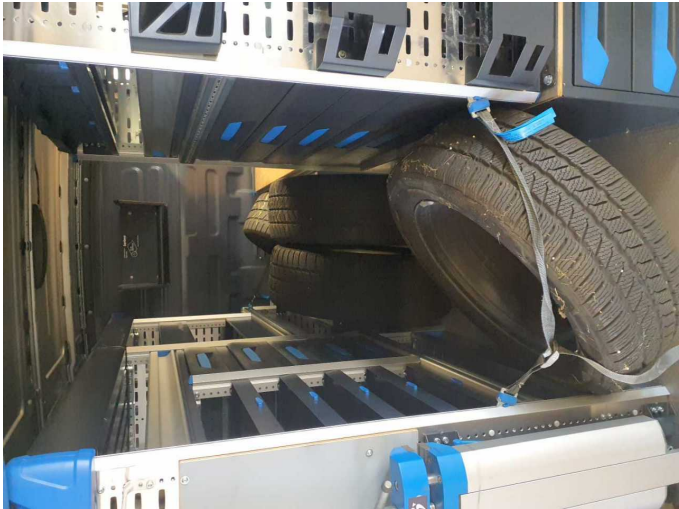
Figure 20: Additional tyres

#	Tyre size	Type of tyre	Manufacturer	Tread depth
1)	225/55 R17 107T	Winter tyres on Steel	Continental	6mm / 6mm
2)	225/55 R17 107T	Winter tyres on Steel	Continental	6mm / 6mm

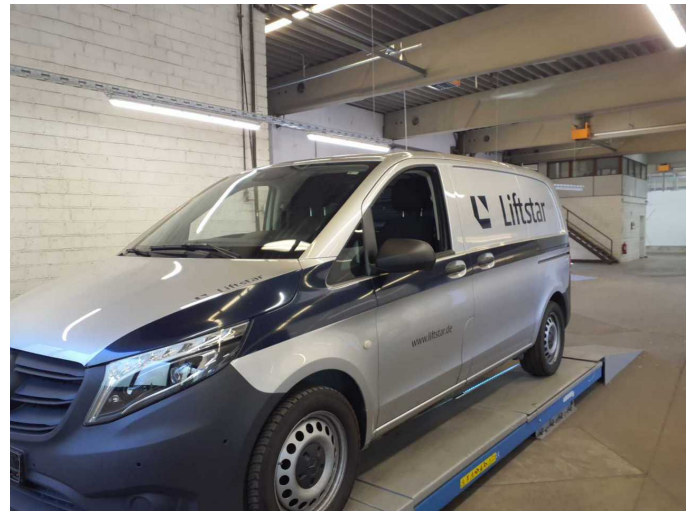
Damage 1: Body: Body - Glued / labelled - De-glue / neutralise

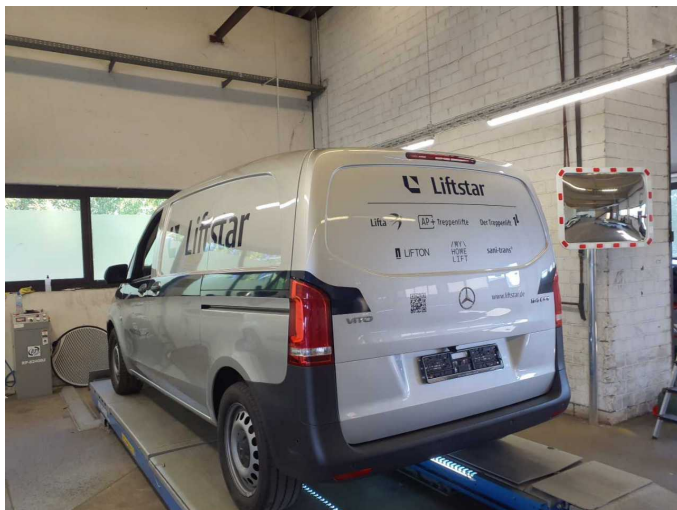
Damage 1: Body: Body - Glued / labelled - De-glue / neutralise

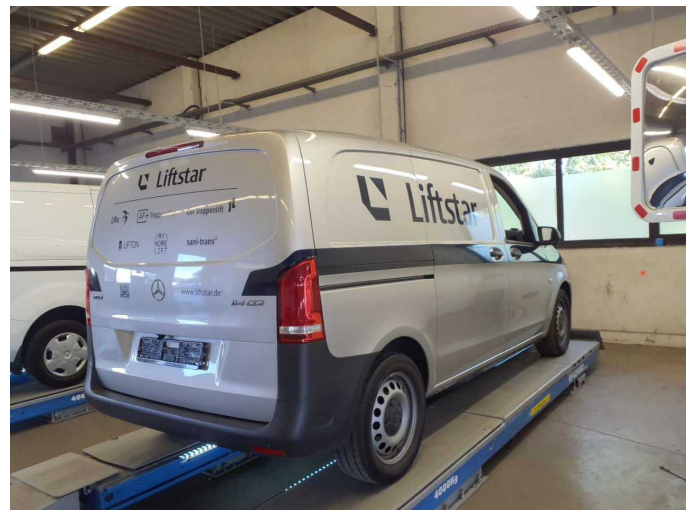
Damage 1: Body: Body - Glued / labelled - De-glue / neutralise

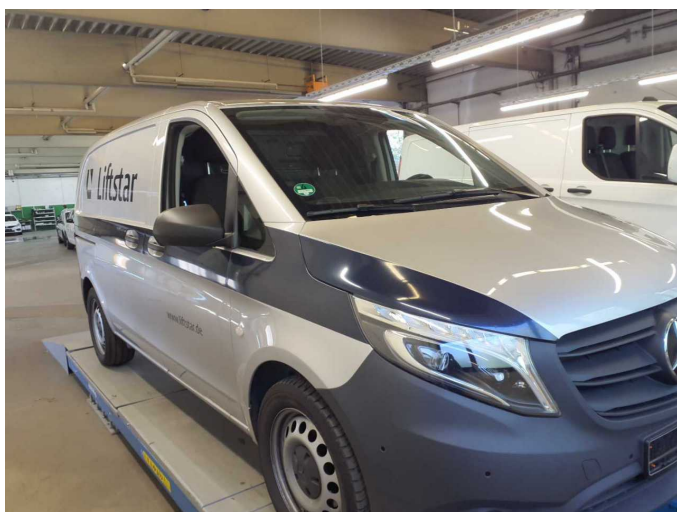
Damage 1: Body: Body - Glued / labelled - De-glue / neutralise

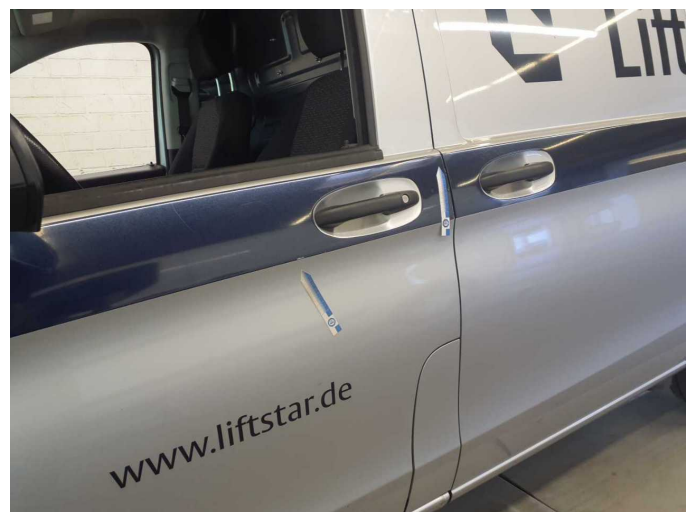
Damage 2: Door - front left side: Door - Dent / paintcoat damage - Repair and paint

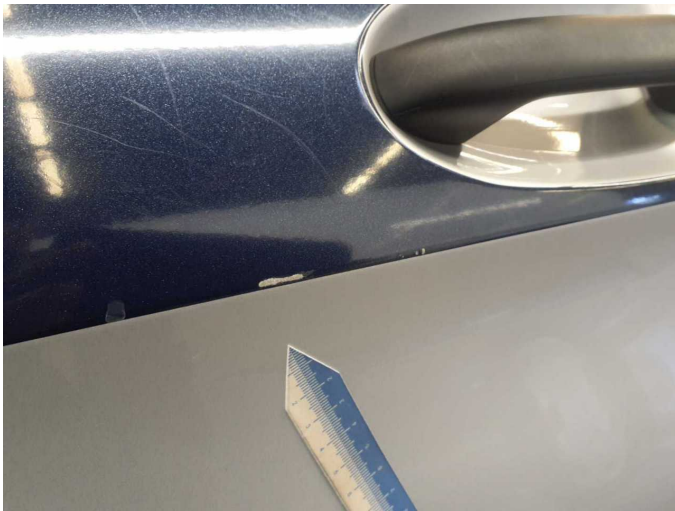
**Damage 2:** Door - front left side: Door - Dent / paintcoat damage - Repair and paint

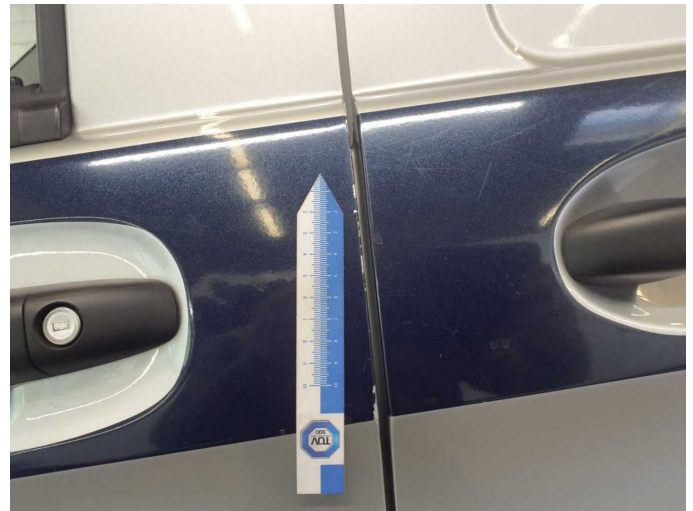
**Damage 2:** Door - front left side: Door - Dent / paintcoat damage - Repair and paint

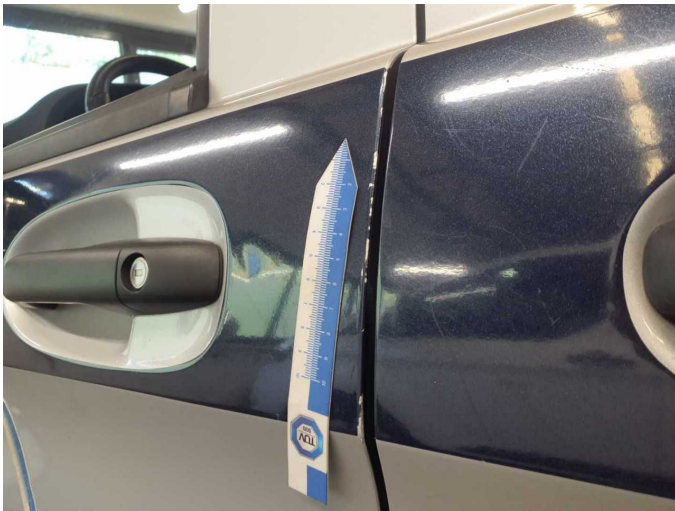
**Damage 2:** Door - front left side: Door - Dent / paintcoat damage - Repair and paint

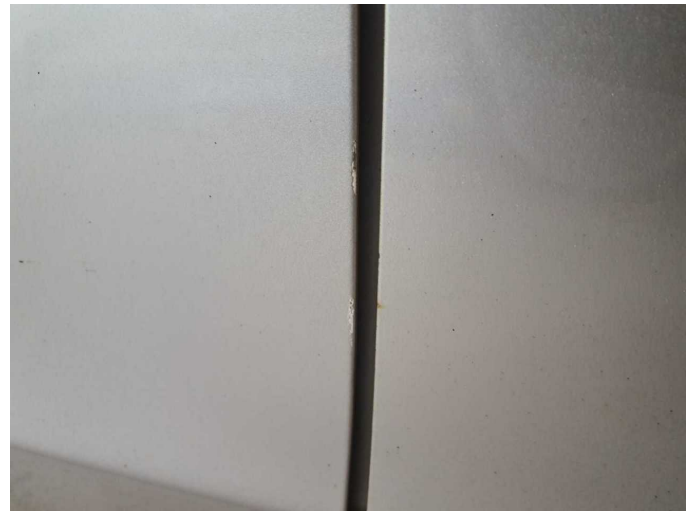
**Damage 2:** Door - front left side: Door - Dent / paintcoat damage - Repair and paint

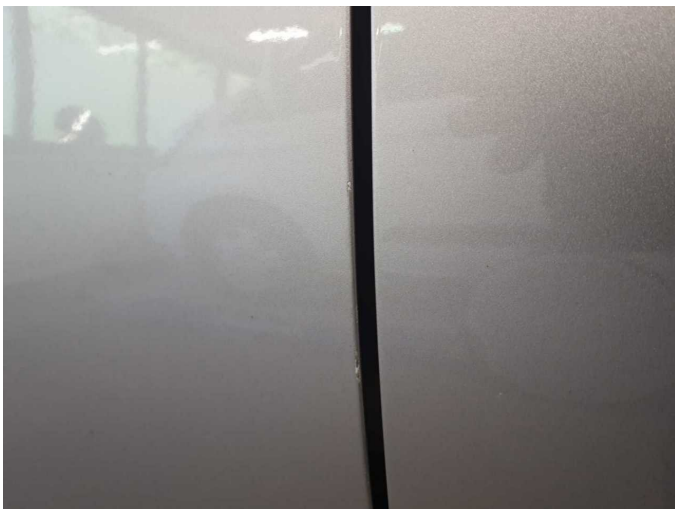
**Damage 2:** Door - front left side: Door - Dent / paintcoat damage - Repair and paint

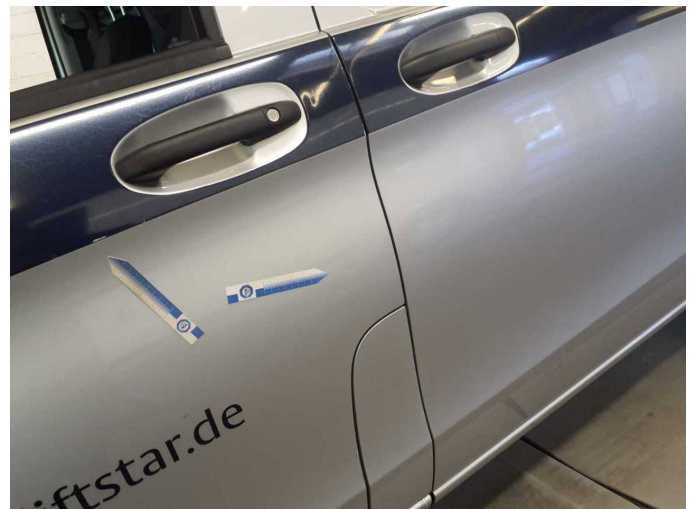
**Damage 2:** Door - front left side: Door - Dent / paintcoat damage - Repair and paint

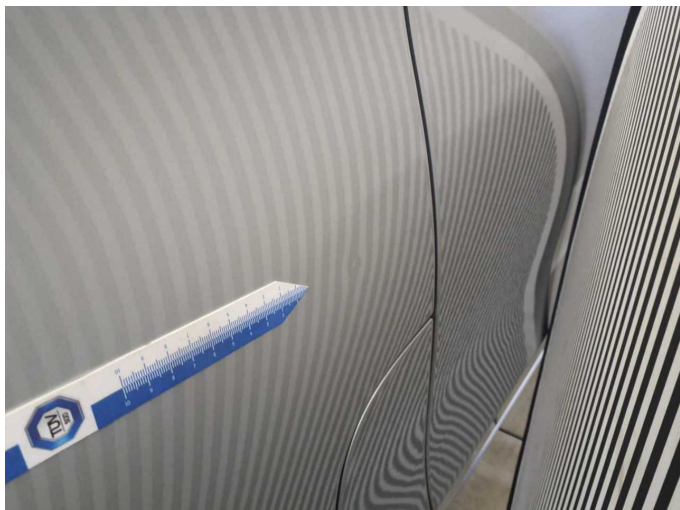
**Damage 2:** Door - front left side: Door - Dent / paintcoat damage - Repair and paint

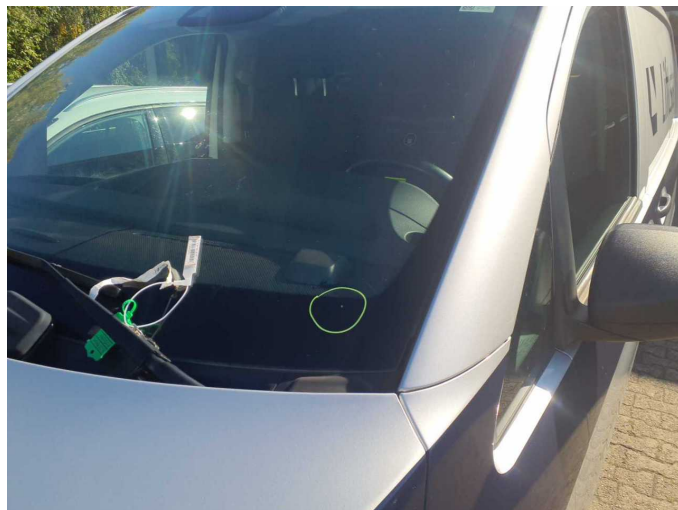
**Damage 3:** Vehicle glazing: Windscreen - Broken / torn - Replace

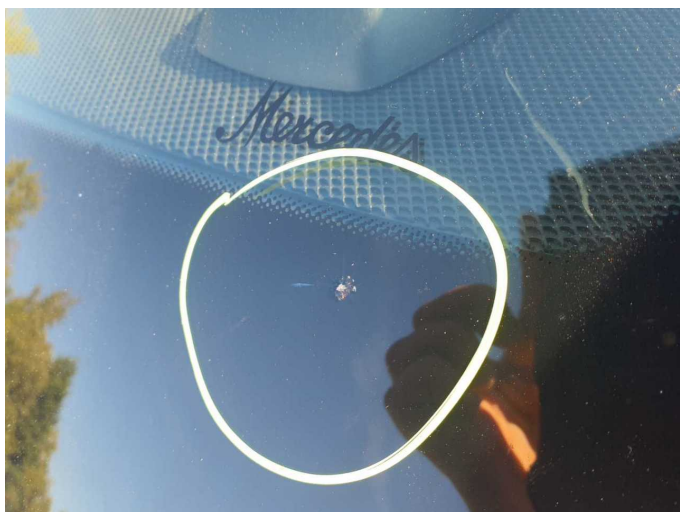
**Damage 3:** Vehicle glazing: Windscreen - Broken / torn - Replace
