Expertise

Protocol number: 41637072  
Order No. / Reference: 25139839  
Inspection date: 18 Sept 2025

Manufacturer: Mercedes-Benz  
VIN: W1V44760313751299

Model: Vito 110 CDI Lang VA

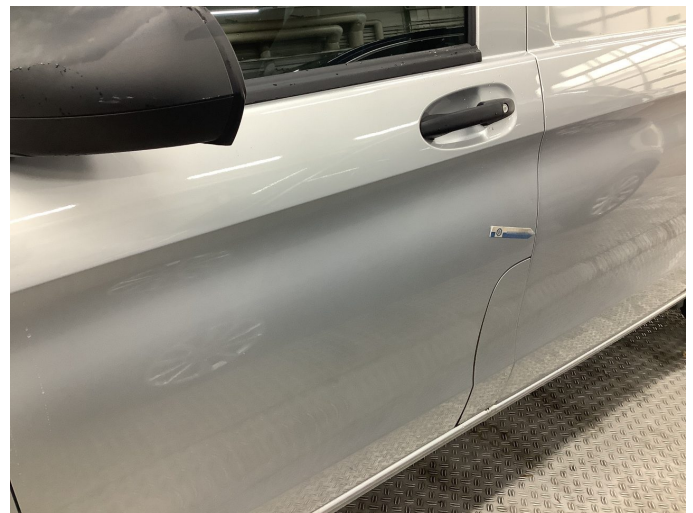
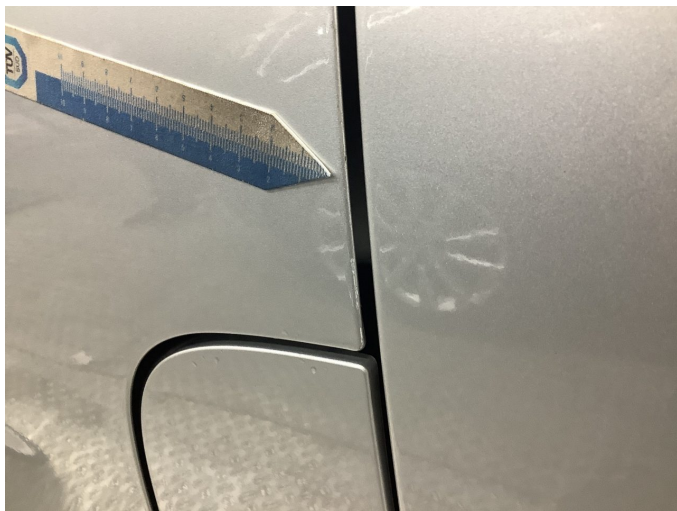
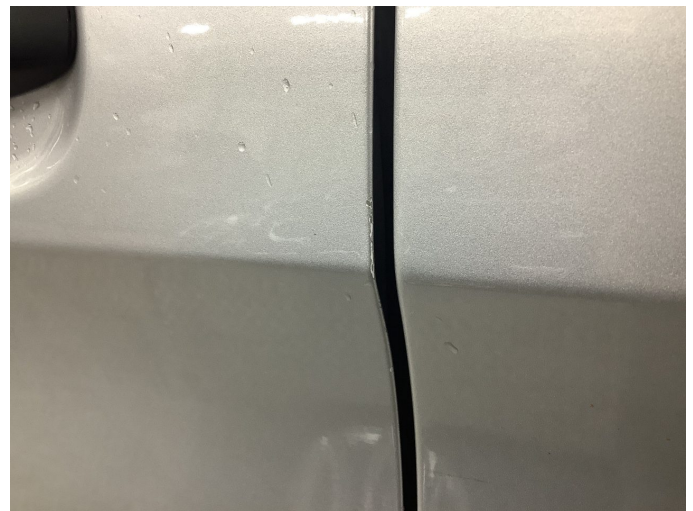
| No. | Component group | Description |
|---|---|---|
| 1 | Door - front left side | Door edge - Scratch(es) - Smart repair |

Damage 1: Door - front left side: Door edge - Scratch(es) - Smart repair

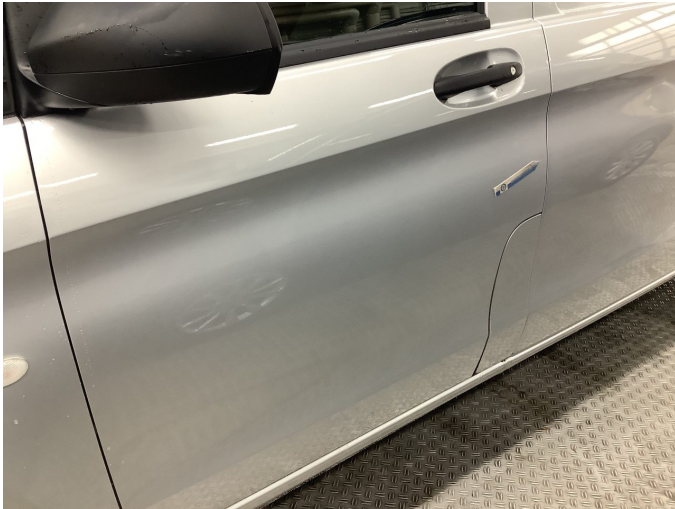
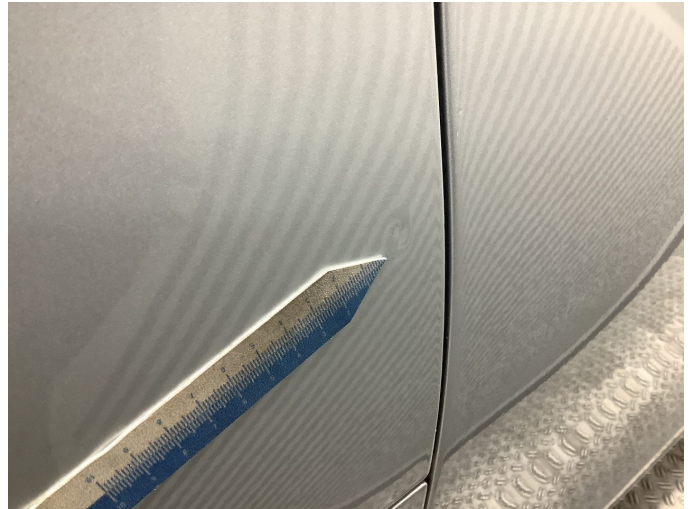
| No. | Component group | Description |
|---|---|---|
| 2 | Door - front left side | Door - dent(s) - Smart repair |

**Damage 2:** Door - front left side: Door - dent(s) - Smart repair

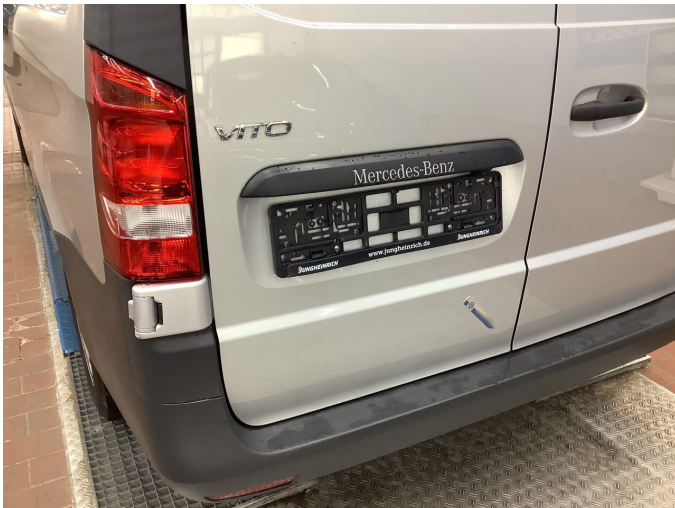
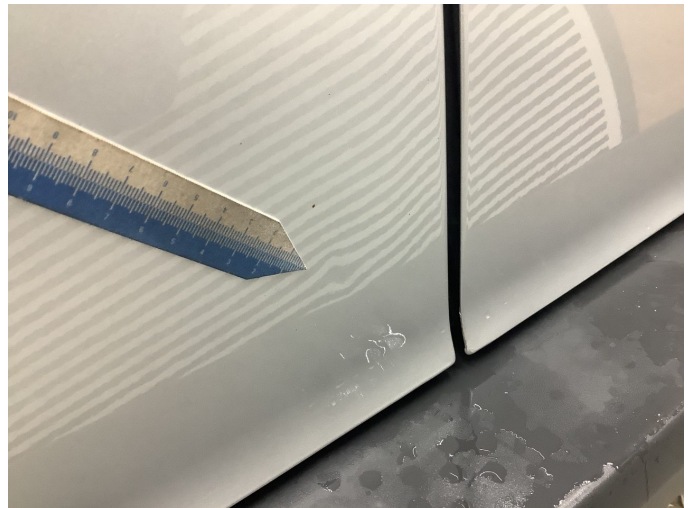
| No. | Component group | Description |
|---|---|---|
| 3 | Boot lid / rear door | Rear door - left side - dent(s) - Smart repair |

**Damage 3:** Boot lid / rear door: Rear door - left side - dent(s) - Smart repair

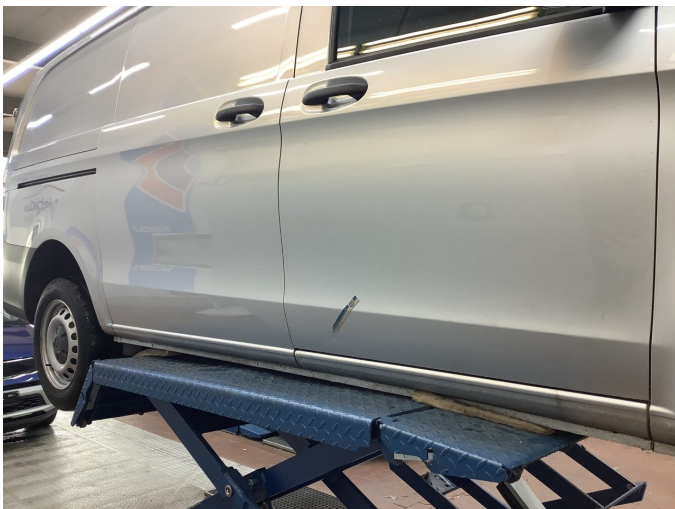
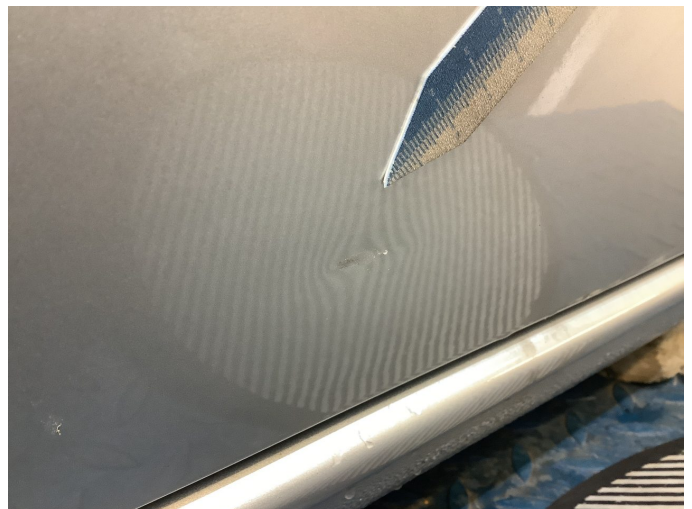
| No. | Component group | Description |
|---|---|---|
| 4 | Door - front right side | Door - dent(s) - Smart repair |

**Damage 4:** Door - front right side: Door - dent(s) - Smart repair

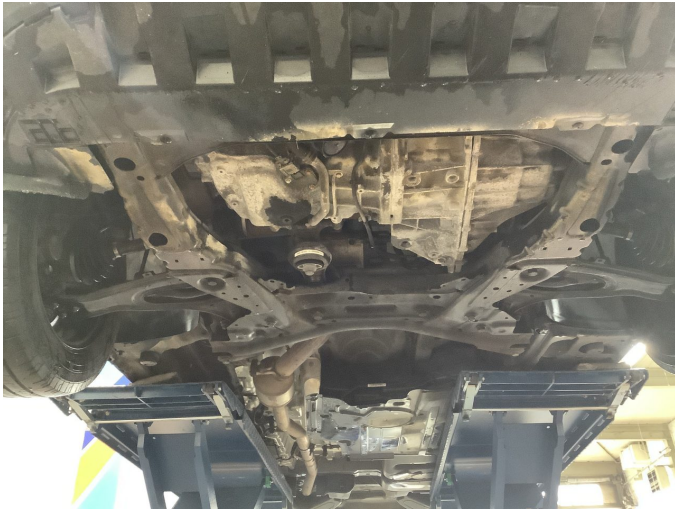
| No. | Component group | Description |
|---|---|---|
| 5 | Body | Underbody panelling - Missing - Replace |

**Damage 5:** Body: Underbody panelling - Missing - Replace

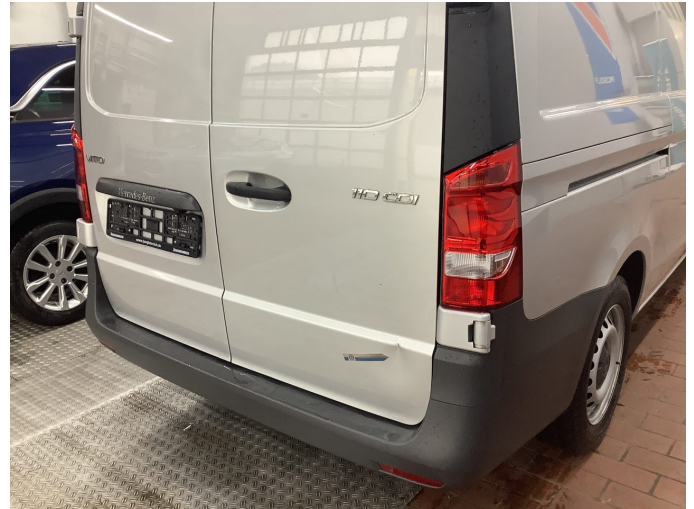
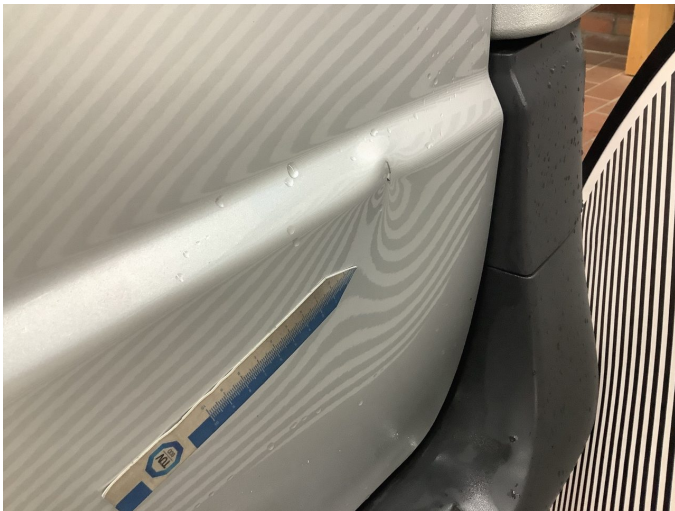
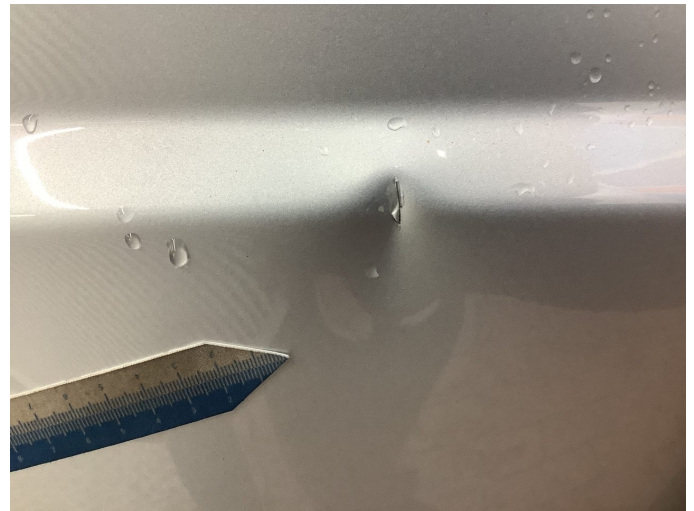
| No. | Component group | Description |
|---|---|---|
| 6 | Boot lid / rear door | Rear door - right side - Dent / paintcoat damage - Repair and paint |

**Damage 6:** Boot lid / rear door: Rear door - right side - Dent / paintcoat damage - Repair and paint

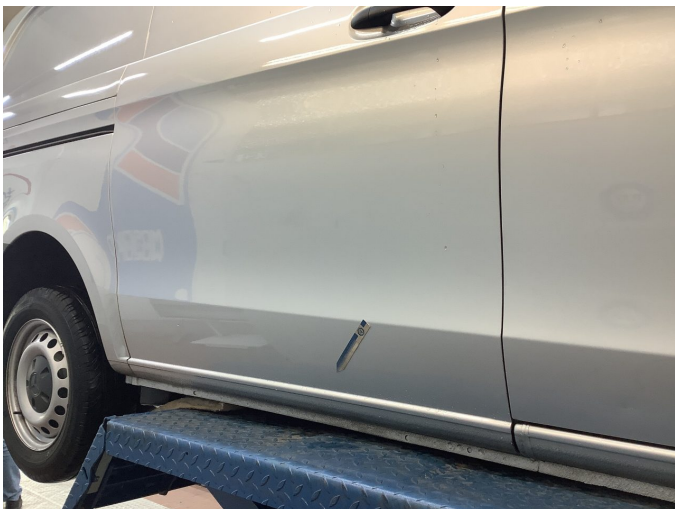
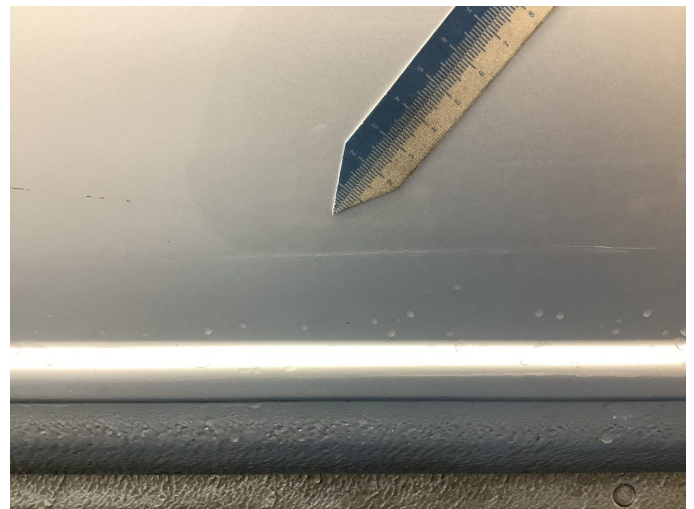
| No. | Component group | Description |
|---|---|---|
| 7 | Sliding door, right | Sliding door - Scratch(es) - Paint |

**Damage 7:** Sliding door, right: Sliding door - Scratch(es) - Paint

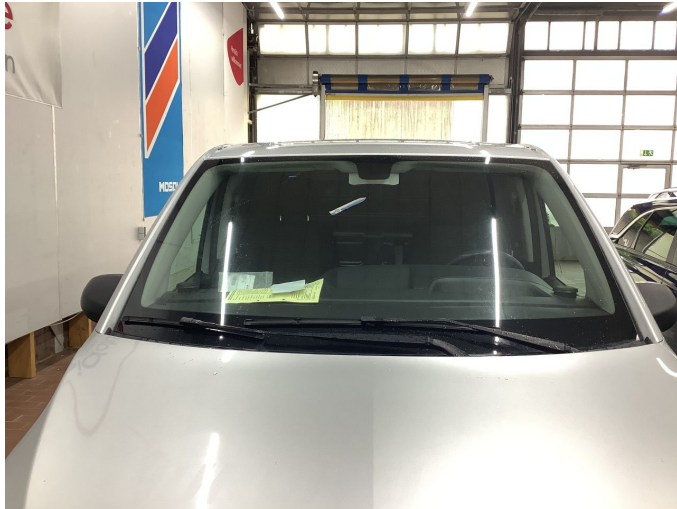
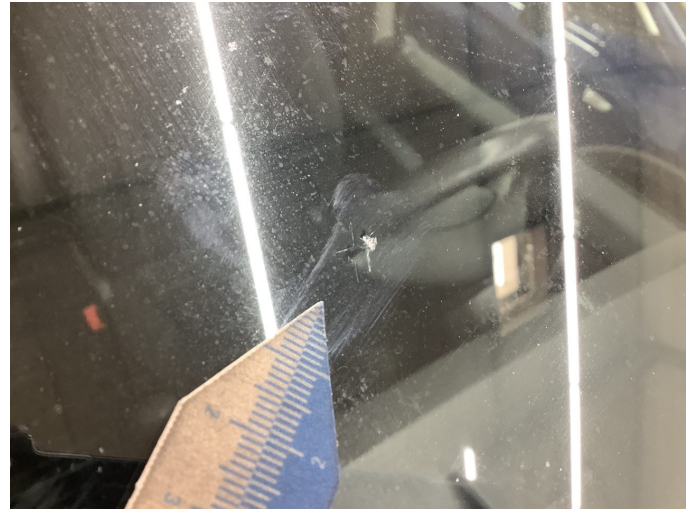
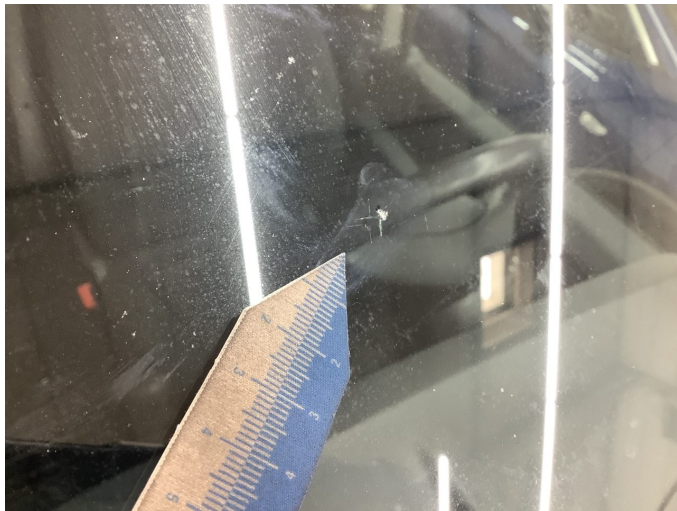
| No. | Component group | Description |
|---|---|---|
| 8 | Vehicle glazing | Windscreen with rain sensor - Stone chips - Replace |

**Damage 8:** Vehicle glazing: Windscreen with rain sensor - Stone chips - Replace

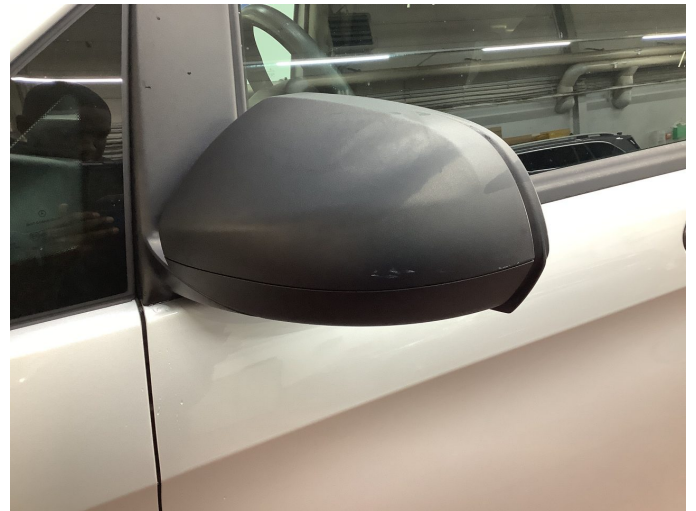
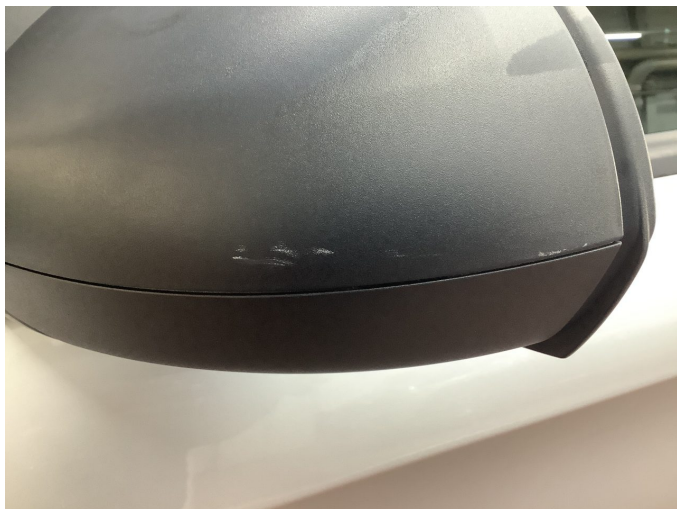
| No. | Component group | Description |
|---|---|---|
| 1 | Wing mirror - left side | Cap - Scratch(es) - No deduction |

**Wear and tear 1:** Wing mirror - left side: Cap - Scratch(es) - No deduction
