Expertise

Protocol number: 41545684  
Order No. / Reference: 25144452  
Inspection date: 12 Sept 2025

Manufacturer: Mercedes-Benz  
VIN: W1V44760313821905

Model: Vito 114 CDI Kastenwagen Lang VA BASE

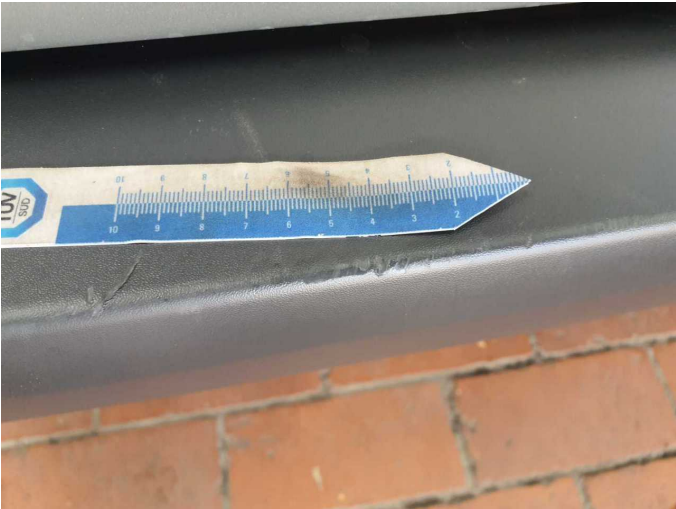
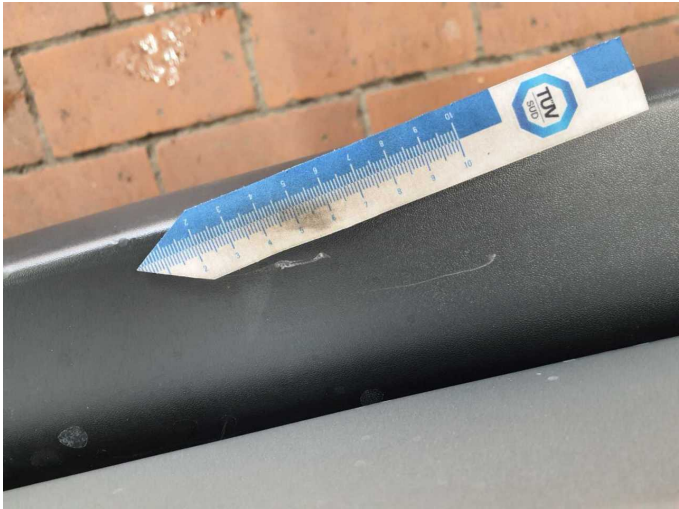
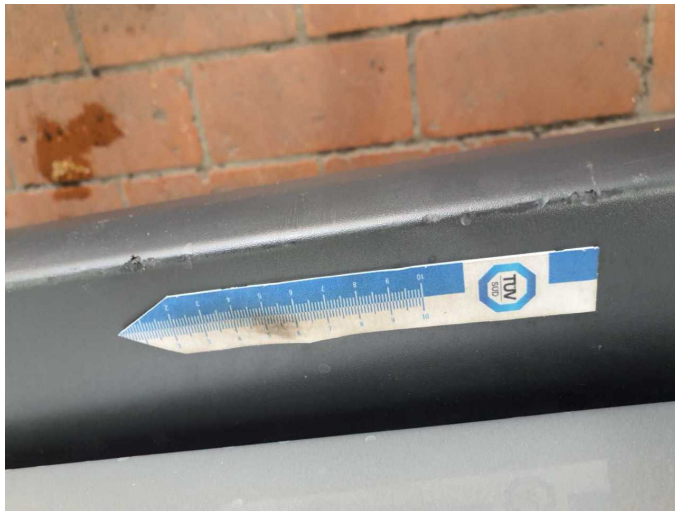
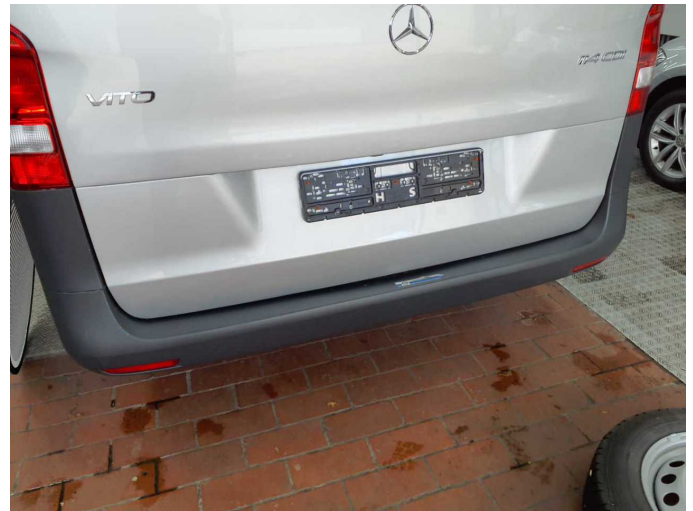
| No. | Component group | Description |
|---|---|---|
| 1 | Rear bumper | Rear bumper - Scratch(es) - No deduction |

Damage 1: Rear bumper: Rear bumper - Scratch(es) - No deduction

**Damage 1:** Rear bumper: Rear bumper - Scratch(es) - No deduction

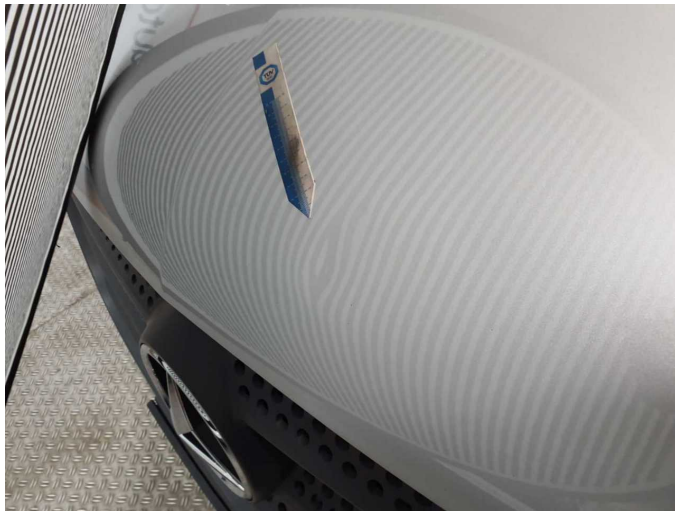
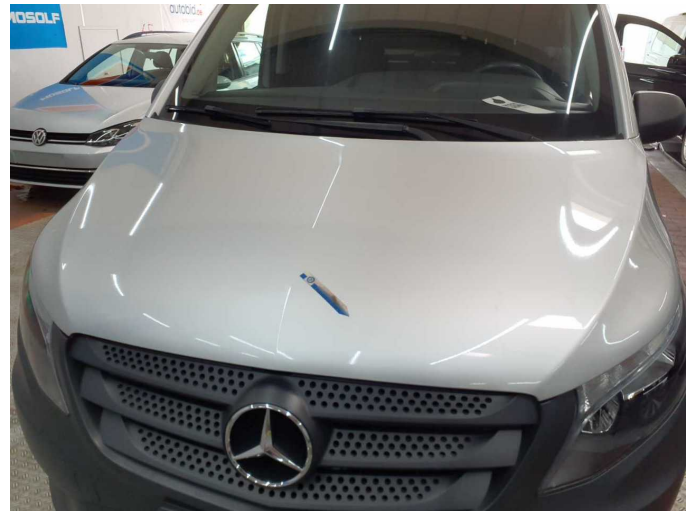
| No. | Component group | Description |
|---|---|---|
| 2 | Bonnet | Bonnet - dent(s) - Smooth repair work |

**Damage 2:** Bonnet: Bonnet - dent(s) - Smooth repair work

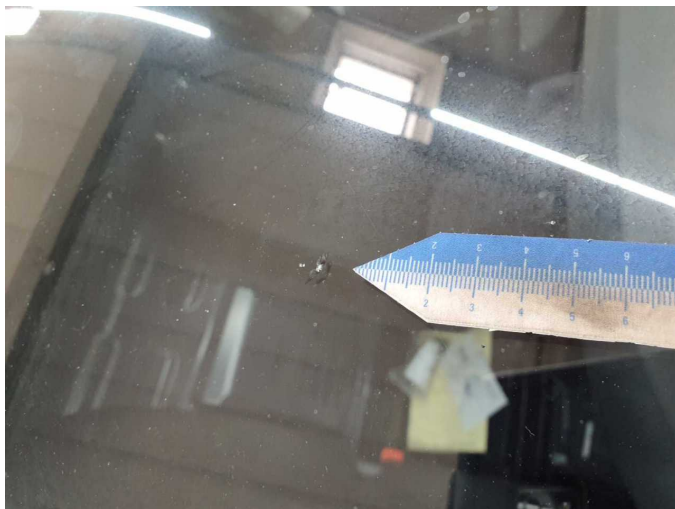
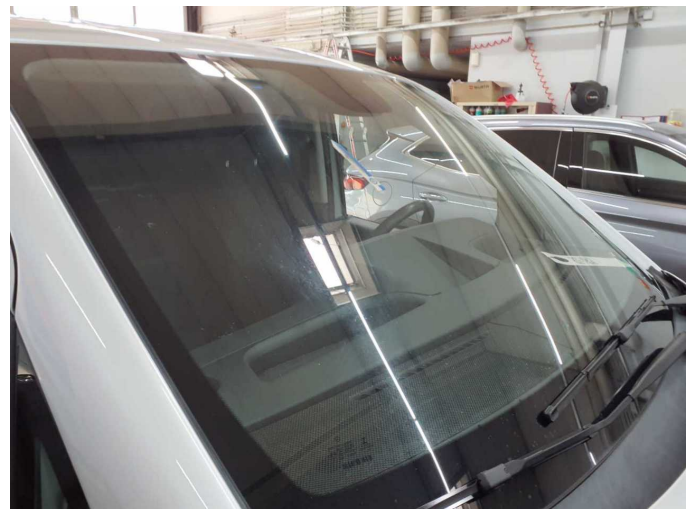
| No. | Component group | Description |
|---|---|---|
| 3 | Vehicle glazing | Windscreen - Stone chips - Smart repair |

**Damage 3:** Vehicle glazing: Windscreen - Stone chips - Smart repair

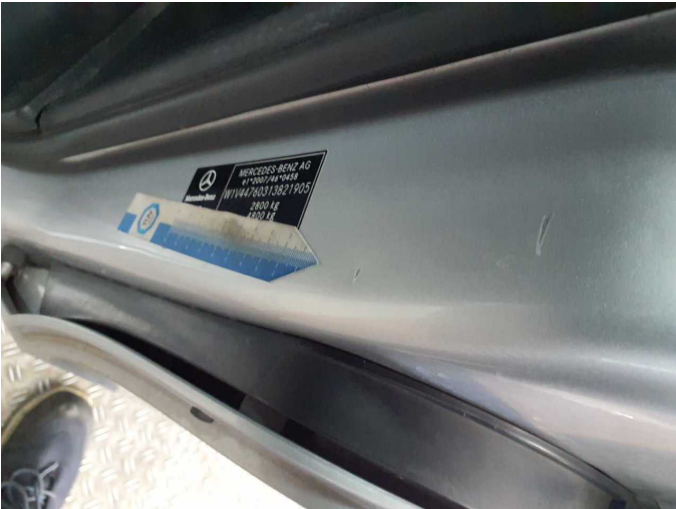
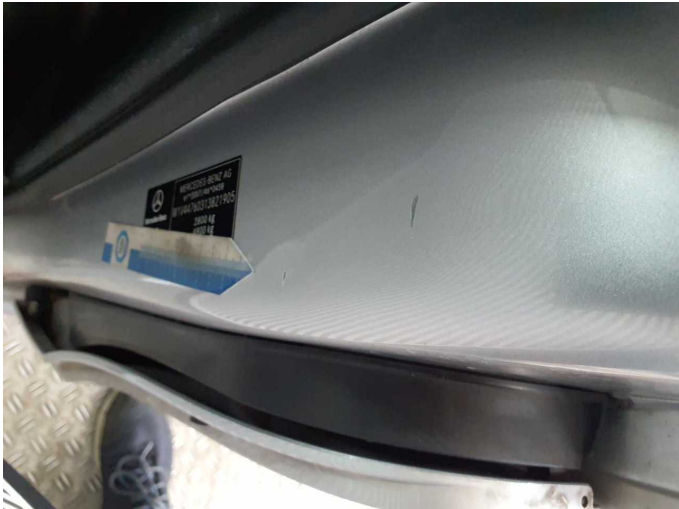
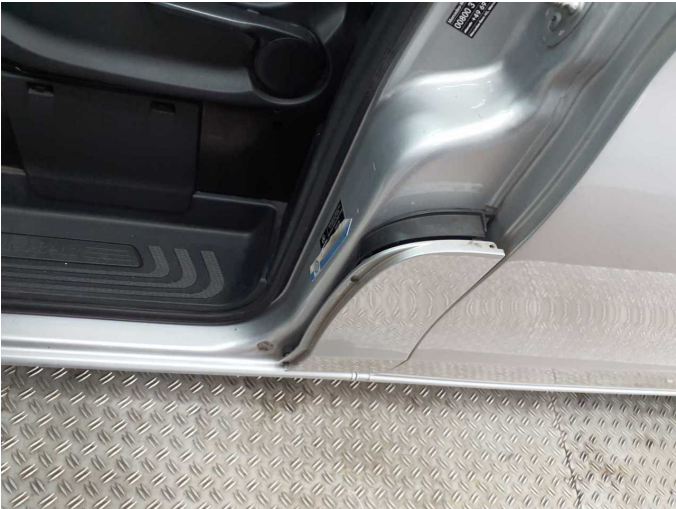
| No. | Component group | Description |
|---|---|---|
| 4 | Sill - left side | Sill - Dent / paintcoat damage - Smart repair |

Damage 4: Sill - left side: Sill - Dent / paintcoat damage - Smart repair

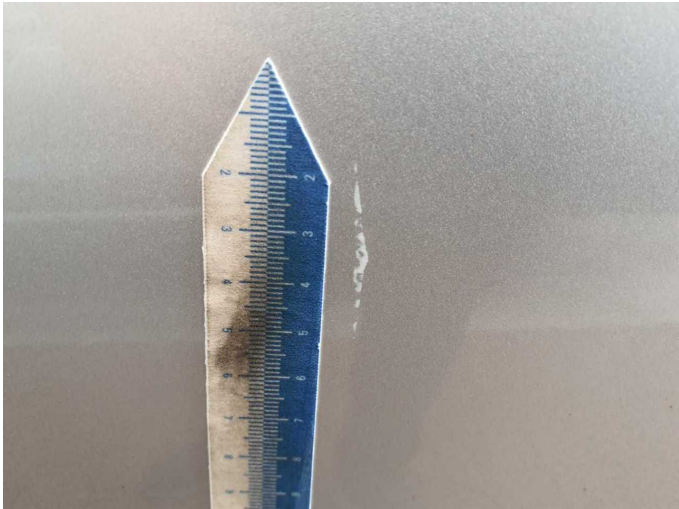
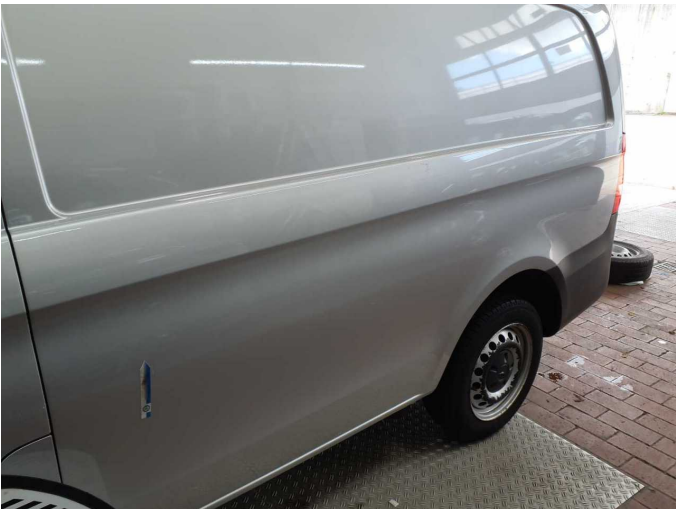
| No. | Component group | Description |
|---|---|---|
| 5 | Side panel - rear left side | Side panel - Scratch(es) - Loss in value |

Damage 5: Side panel - rear left side: Side panel - Scratch(es) - Loss in value

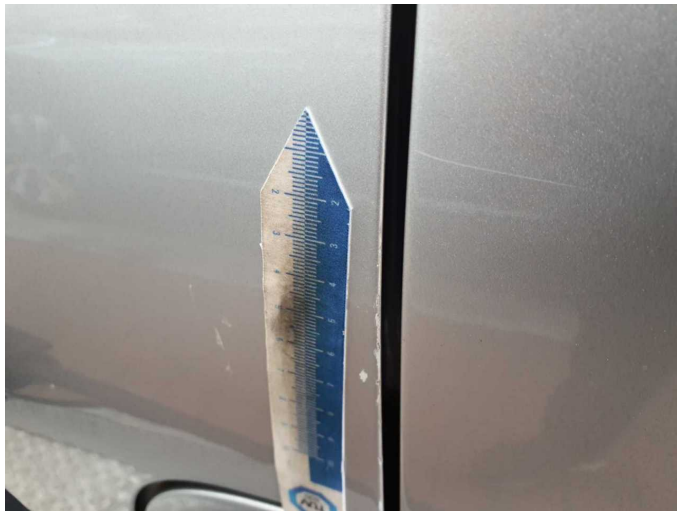
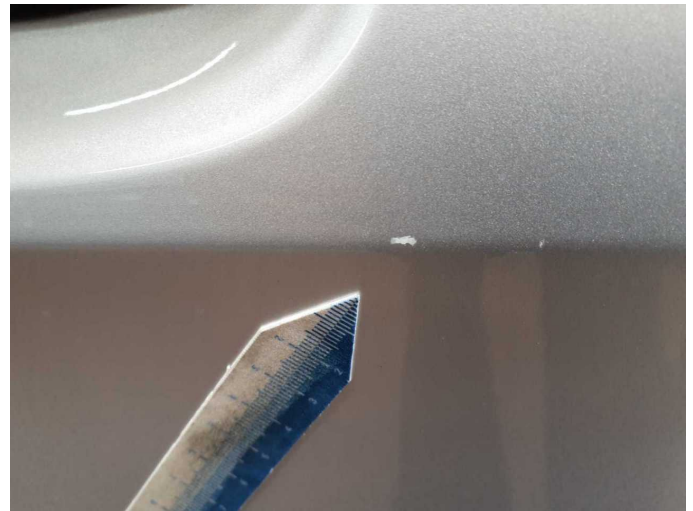
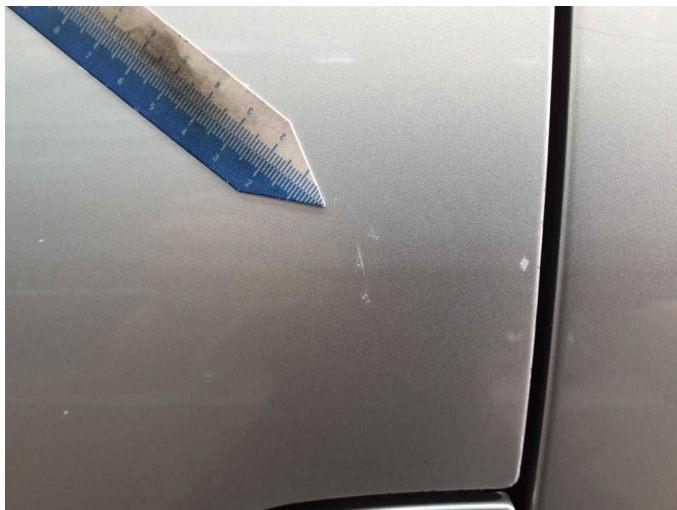
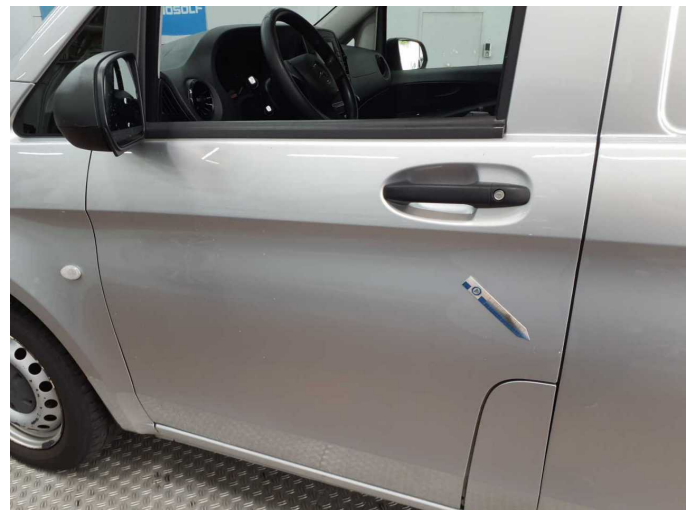
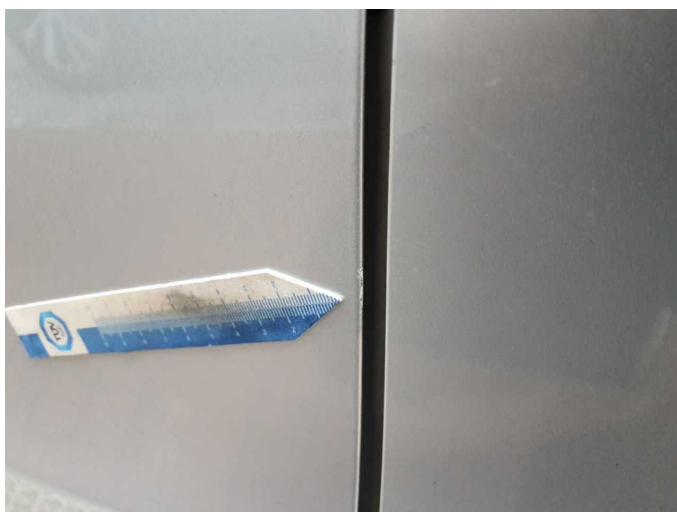
| No. | Component group | Description |
|---|---|---|
| 7 | Door - front left side | Door - Scratch(es) - Paint |

**Damage 7:** Door - front left side: Door - Scratch(es) - Paint

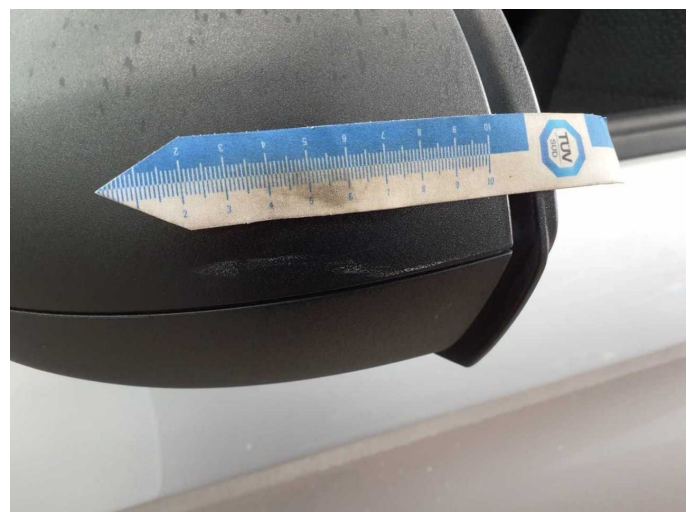
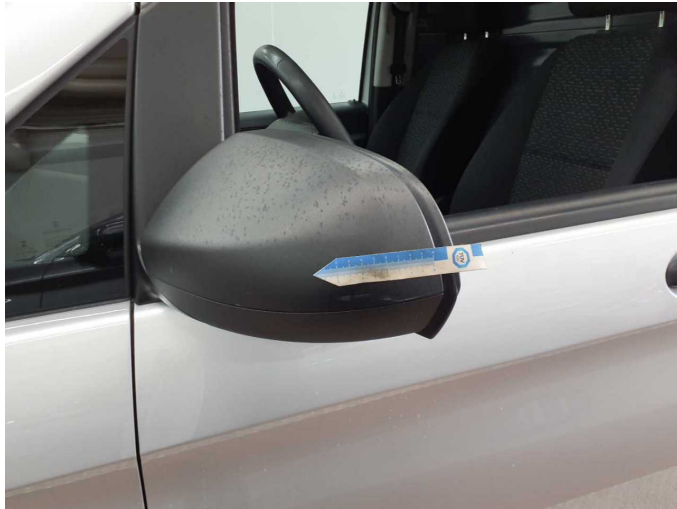
| No. | Component group | Description |
|---|---|---|
| 1 | Wing mirror - left side | Cap - Scratch(es) - No deduction |

**Wear and tear 1:** Wing mirror - left side: Cap - Scratch(es) - No deduction

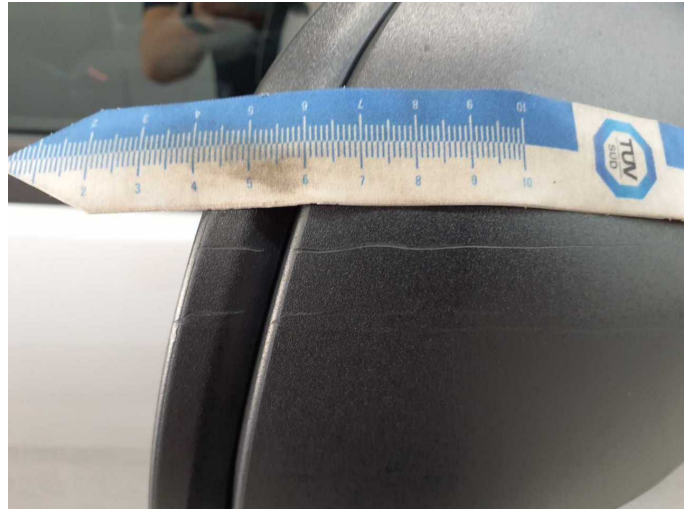
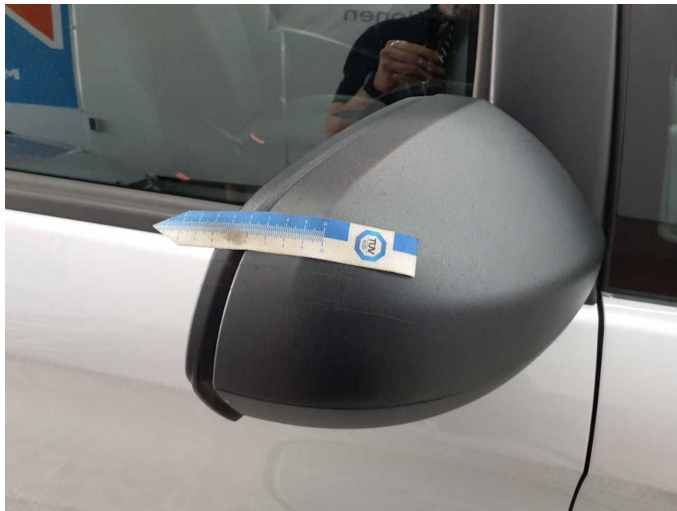
| No. | Component group | Description |
|---|---|---|
| 2 | Wing mirror - right side | Mirror housing - Scratch(es) - No deduction |

**Wear and tear 2:** Wing mirror - right side: Mirror housing - Scratch(es) - No deduction

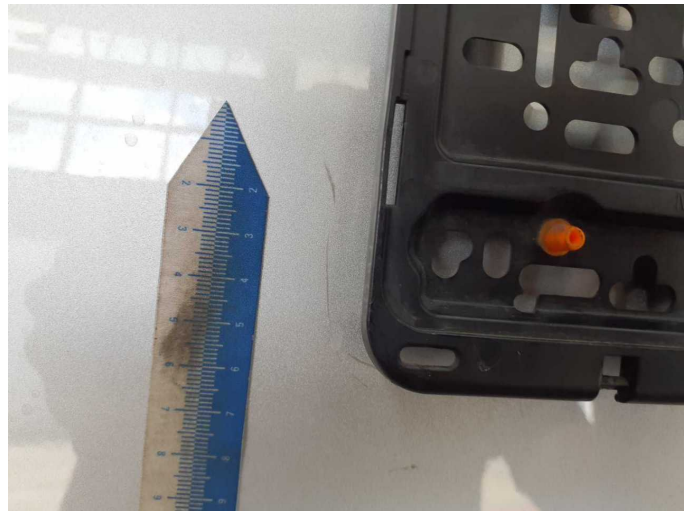
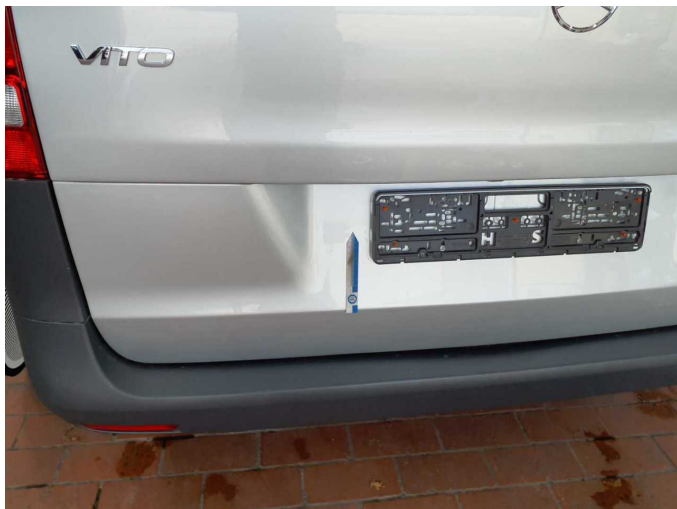
| No. | Component group | Description |
|---|---|---|
| 3 | Boot lid / rear door | Boot lid - Scratch(es) - No deduction |

**Wear and tear 3:** Boot lid / rear door: Boot lid - Scratch(es) - No deduction

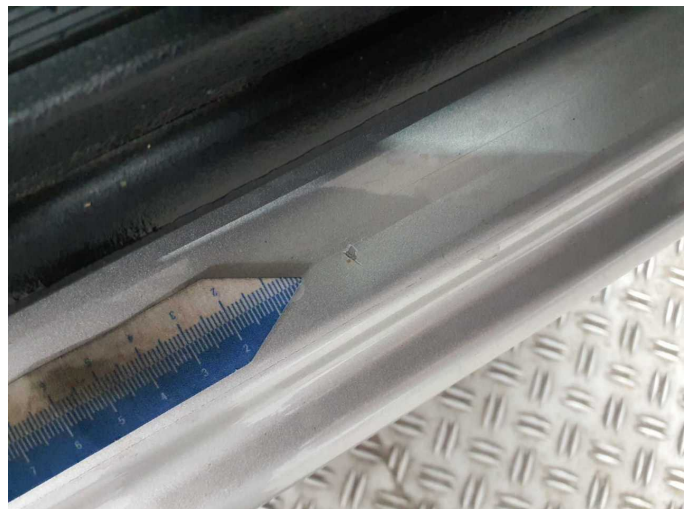
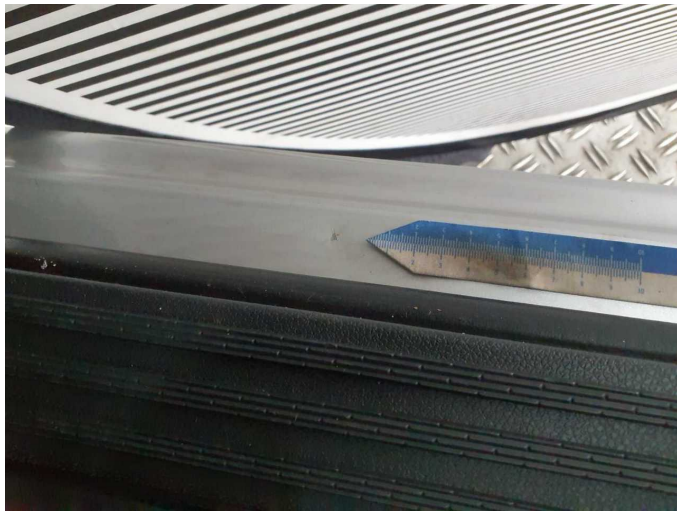
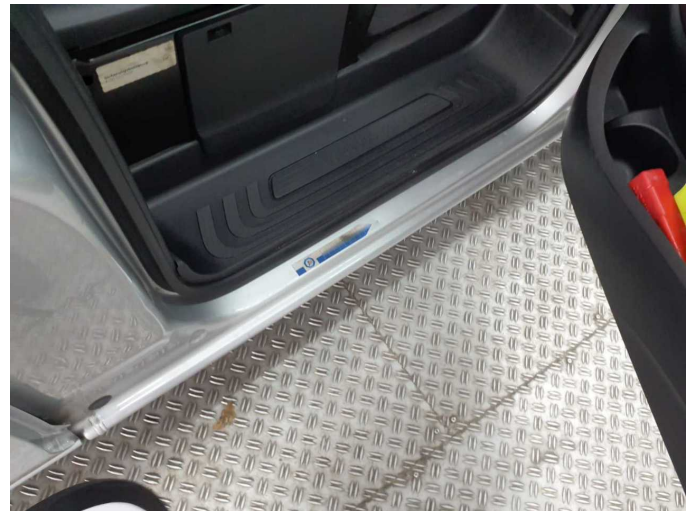
| No. | Component group | Description |
|---|---|---|
| 4 | Sill - right side | Sill - Dent / paintcoat damage - No deduction |

**Wear and tear 4:** Sill - right side: Sill - Dent / paintcoat damage - No deduction

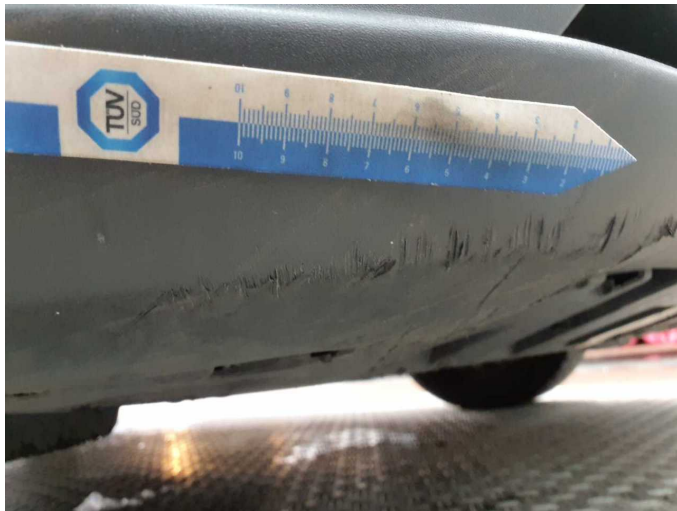
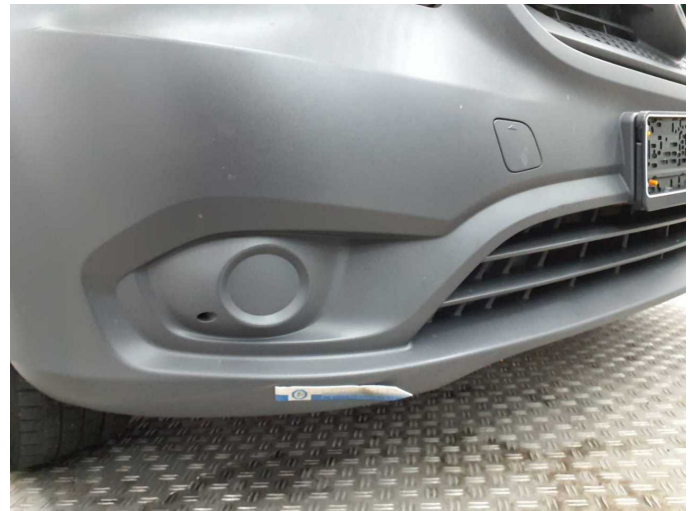
| No. | Component group | Description |
|---|---|---|
| 5 | Front bumper | Front bumper (Unterhalb Sichtkante) - Scratched - No deduction |

**Wear and tear 5:** Front bumper: Front bumper (Unterhalb Sichtkante) - Scratched - No deduction

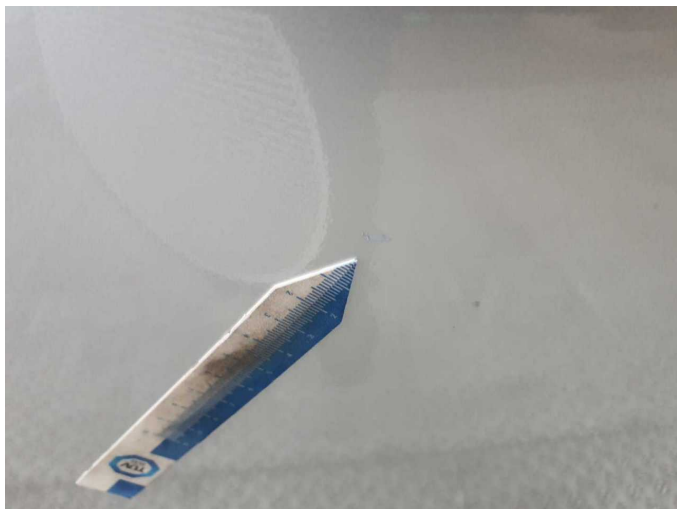
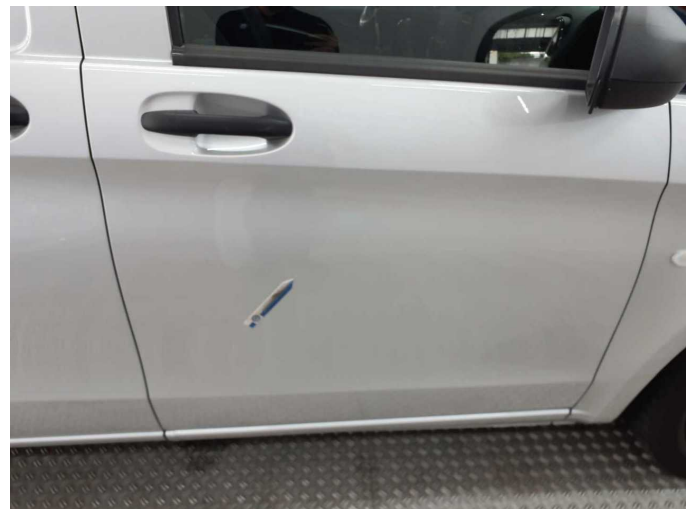
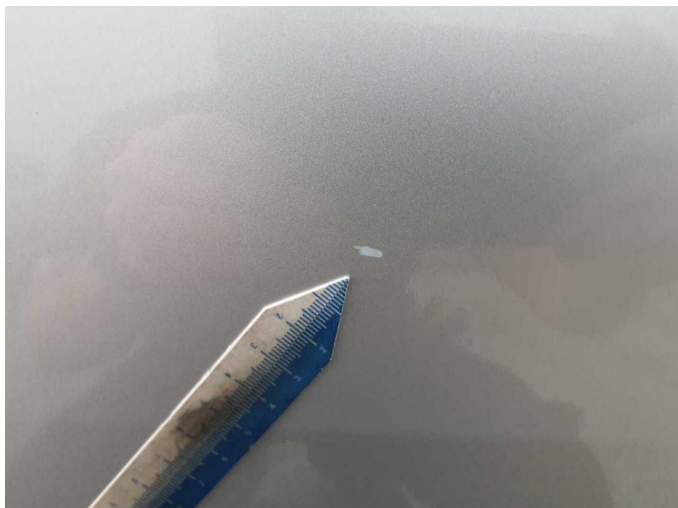
| No. | Component group | Description |
|---|---|---|
| 6 | Door - front right side | Door - Scratch(es) - No deduction |

**Wear and tear 6:** Door - front right side: Door - Scratch(es) - No deduction

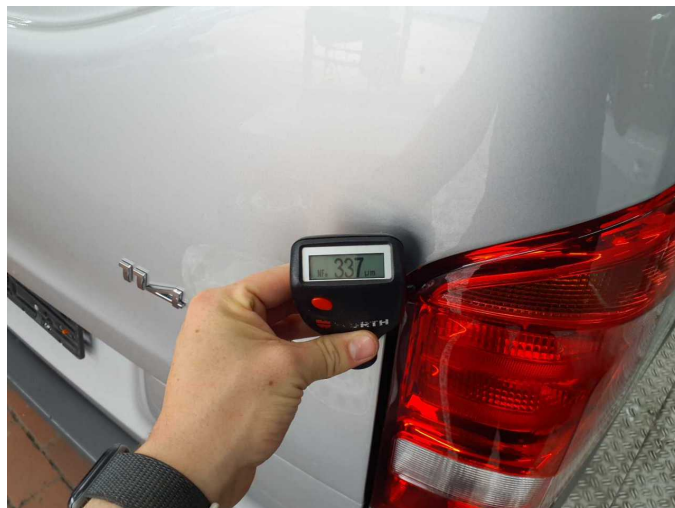
| No. | Repainting |
|---|---|
| 1 | Boot lid / rear door, Professionally carried out, Invoice of repair done Non-existent |

| Boot lid / rear door | 337 µm | Side panel - rear right side | 359 µm |

**Repainting 1:** Boot lid / rear door

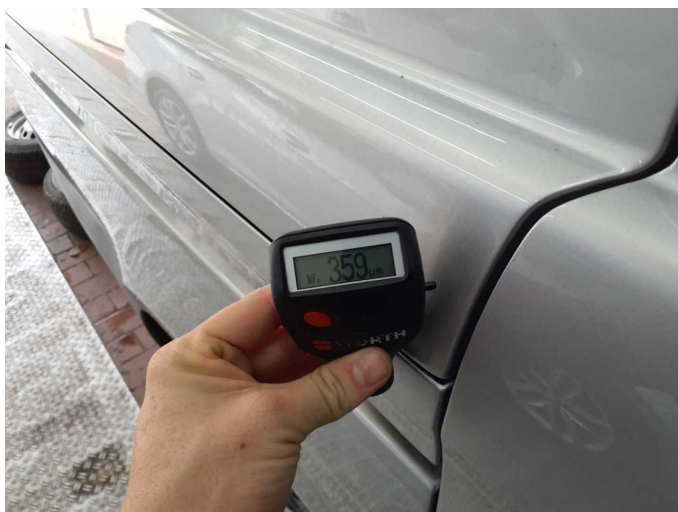
| No. | Repainting |
|---|---|
| 2 | Side panel - rear right side, Professionally carried out, Invoice of repair done Non-existent |

**Repainting 2:** Side panel - rear right side
