Expertise

Protocol number: 41410844
Order No. / Reference: 25158883
Inspection date: 4 Sept 2025

Manufacturer: Mercedes-Benz

Model: Vito 116 CDI Kastenwagen Lang HA Aut. BASE

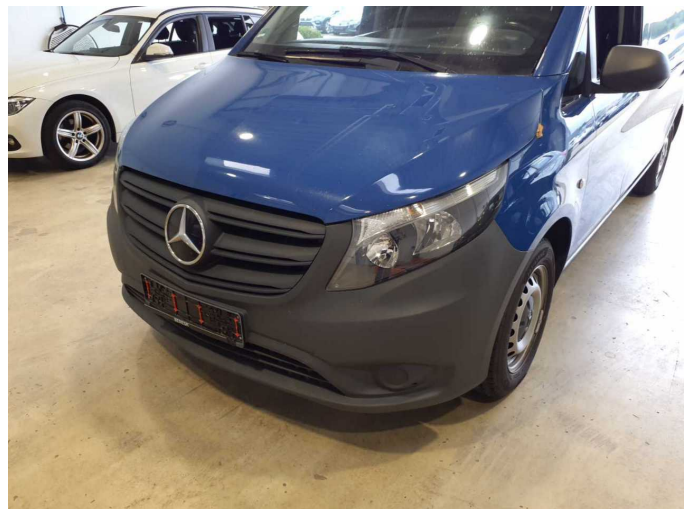
No.	Component group	Description
1	Front bumper	Front bumper (unpainted) - Scratch(es) - Loss in value
2	Bonnet	Bonnet - Corrosion - Repair and paint

Damage 1: Front bumper: Front bumper (unpainted) - Scratch(es) - Loss in value

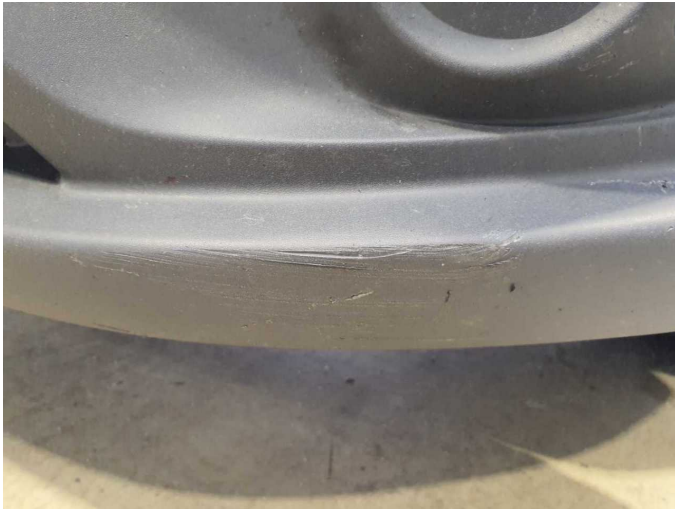
Damage 1: Front bumper: Front bumper (unpainted) - Scratch(es) - Loss in value

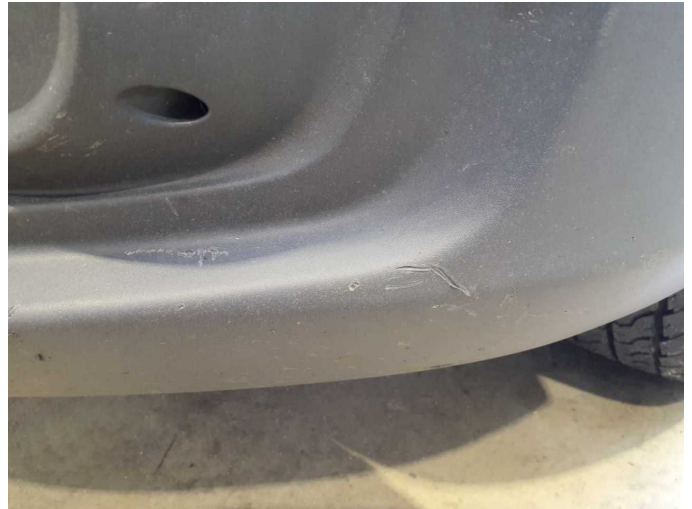
Damage 1: Front bumper: Front bumper (unpainted) - Scratch(es) - Loss in value

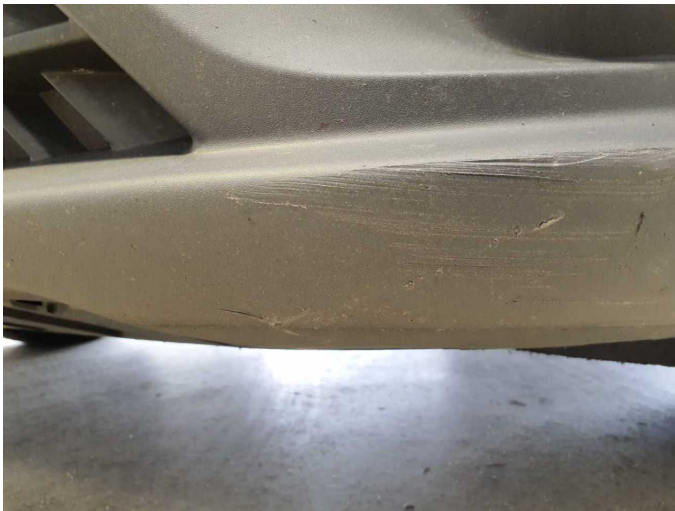
Damage 1: Front bumper: Front bumper (unpainted) - Scratch(es) - Loss in value

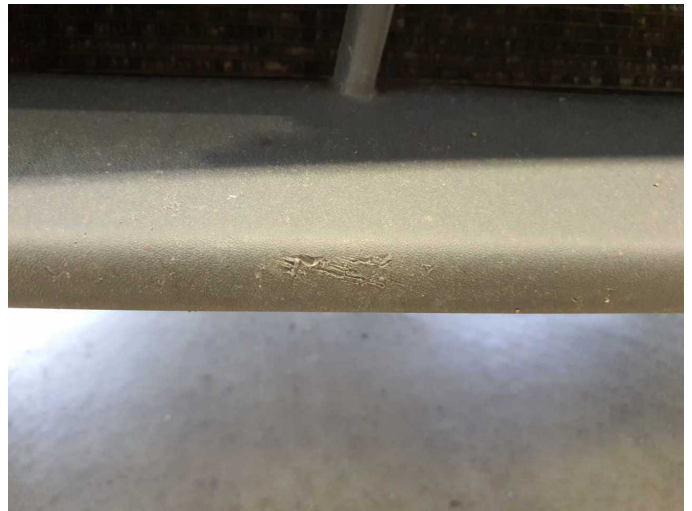
Damage 1: Front bumper: Front bumper (unpainted) - Scratch(es) - Loss in value

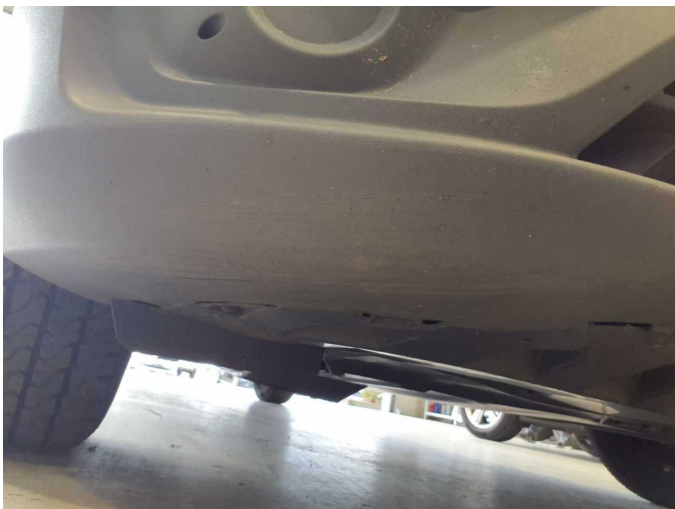
Damage 1: Front bumper: Front bumper (unpainted) - Scratch(es) - Loss in value

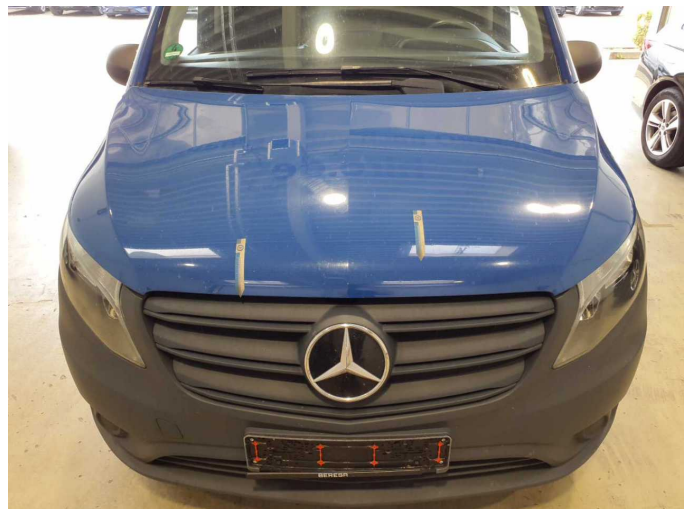
Damage 2: Bonnet: Bonnet - Corrosion - Repair and paint

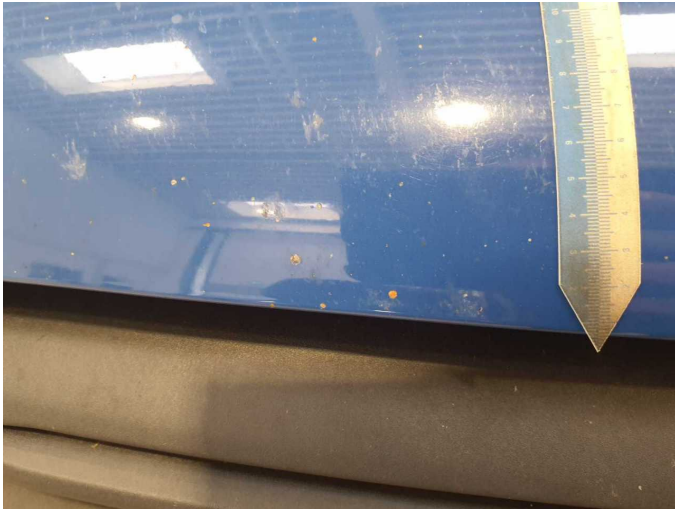
Damage 2: Bonnet: Bonnet - Corrosion - Repair and paint

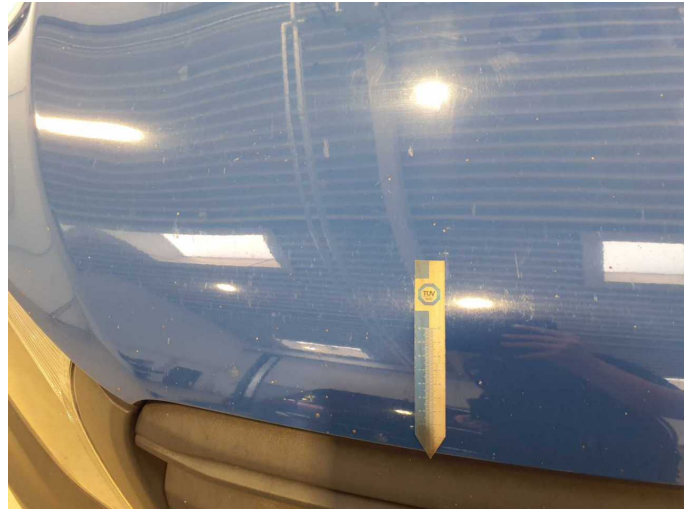
Damage 2: Bonnet: Bonnet - Corrosion - Repair and paint

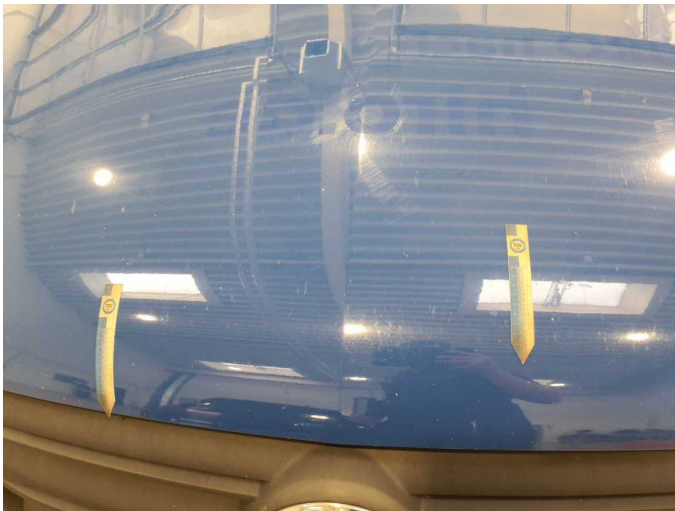
Damage 2: Bonnet: Bonnet - Corrosion - Repair and paint

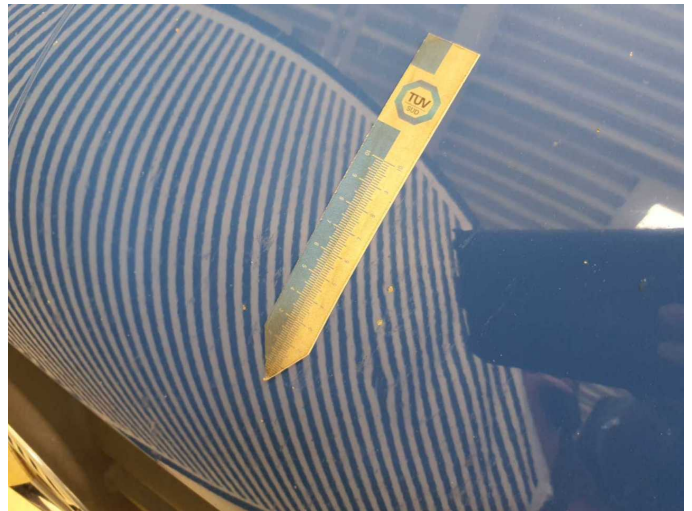
Damage 2: Bonnet: Bonnet - Corrosion - Repair and paint

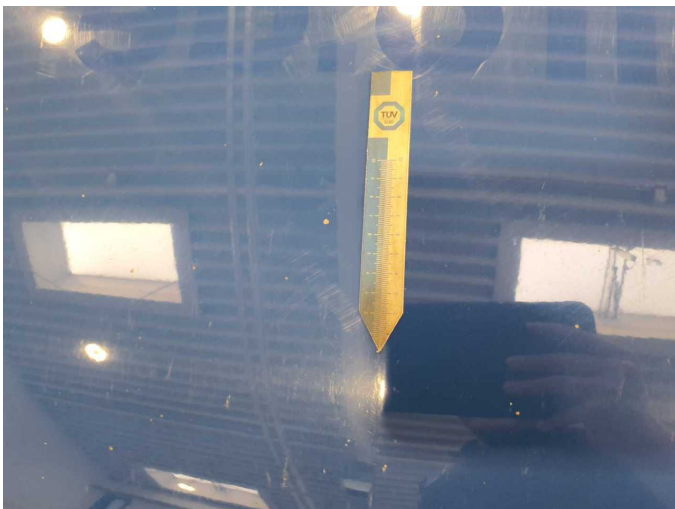
Damage 2: Bonnet: Bonnet - Corrosion - Repair and paint

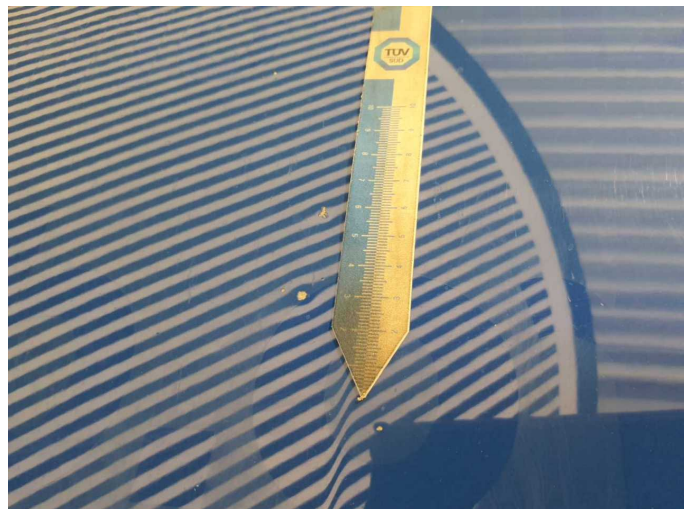
Damage 2: Bonnet: Bonnet - Corrosion - Repair and paint

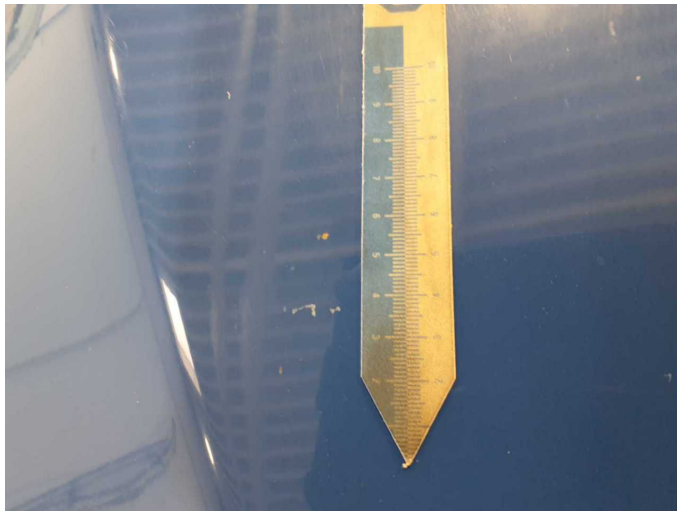
Damage 2: Bonnet: Bonnet - Corrosion - Repair and paint

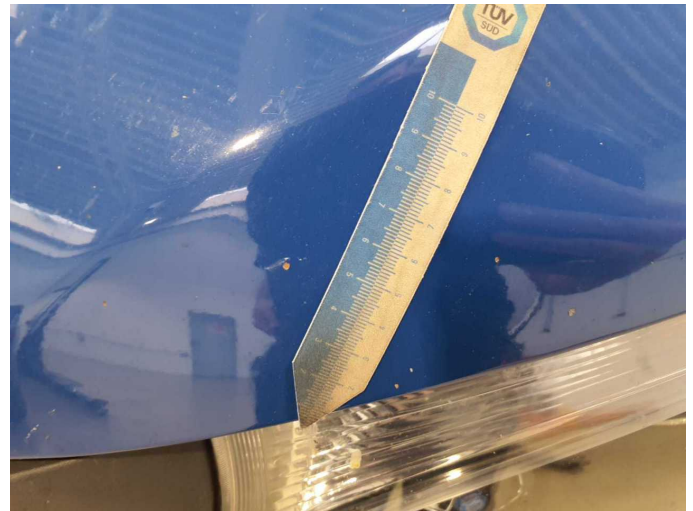
Damage 2: Bonnet: Bonnet - Corrosion - Repair and paint

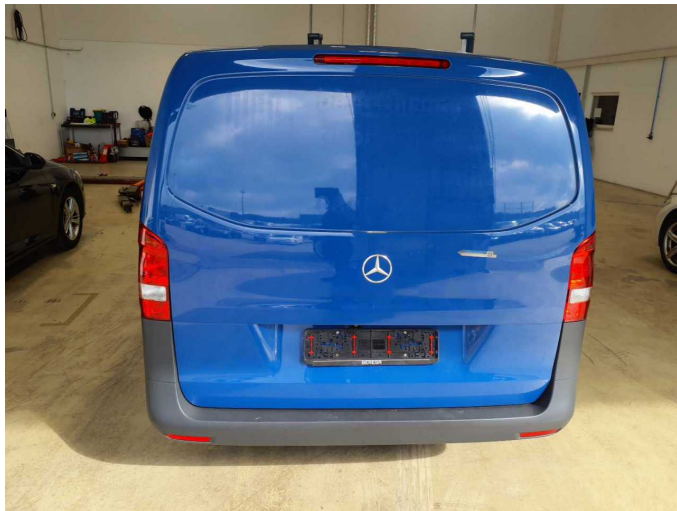
Wear and tear 9: Boot lid / rear door: Boot lid - Dent / paintcoat damage - No deduction

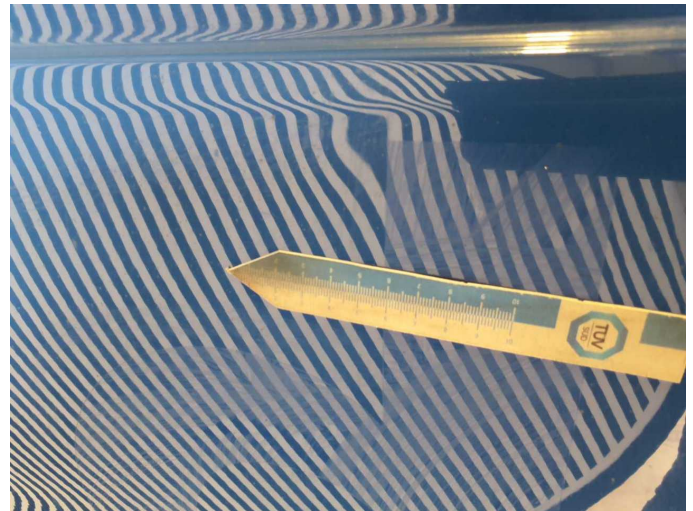
Wear and tear 9: Boot lid / rear door: Boot lid - Dent / paintcoat damage - No deduction

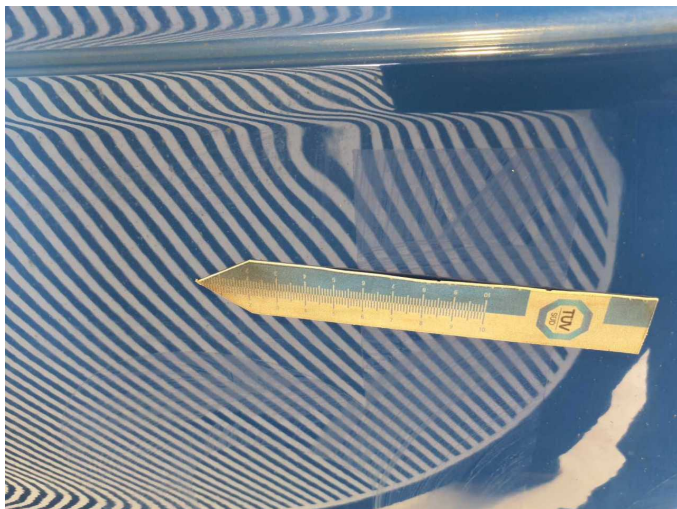
Wear and tear 9: Boot lid / rear door: Boot lid - Dent / paintcoat damage - No deduction

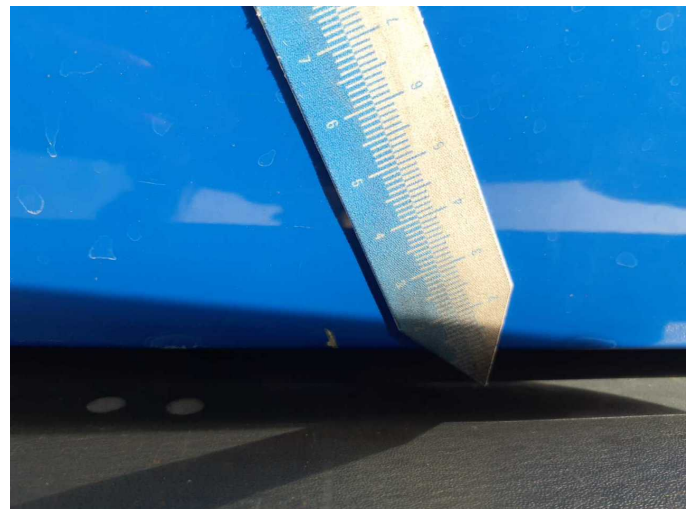
Wear and tear 9: Boot lid / rear door: Boot lid - Dent / paintcoat damage - No deduction

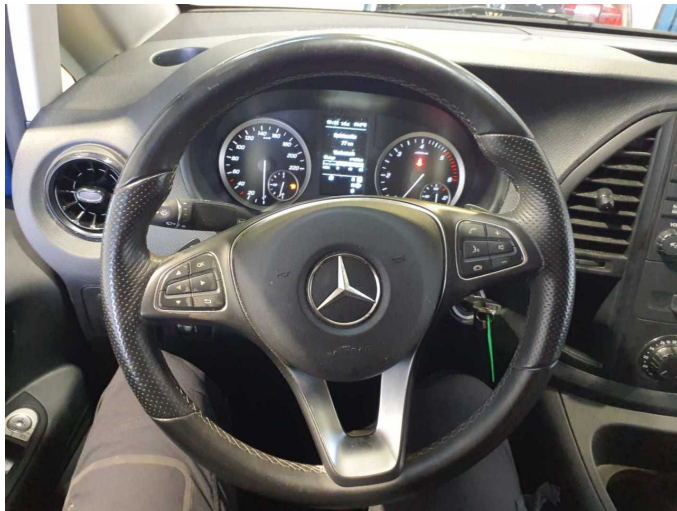
Wear and tear 10: Steering system: Steering wheel - Soiled - No deduction

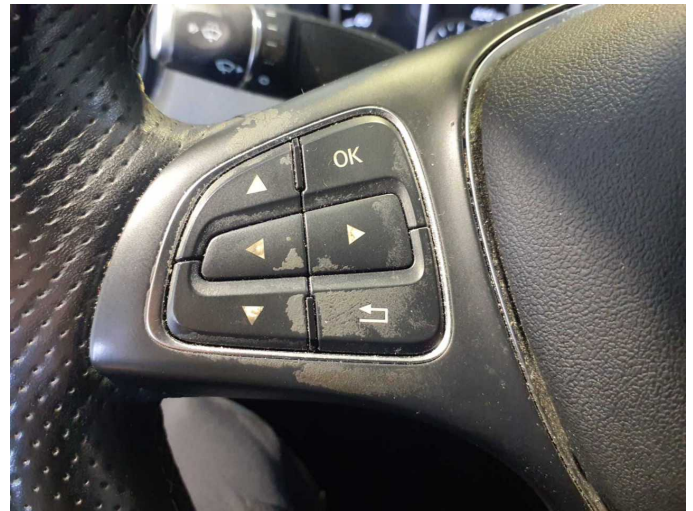
Wear and tear 10: Steering system: Steering wheel - Soiled - No deduction
