Expertise

Protocol number: 41810386
Order number / reference: 25257642
Inspection date: 2 Oct 2025

Manufacturer: Mercedes-Benz	Model: Vito 114 CDI 4MATIC Lang Aut. BASE
VIN: W1V44760314100217

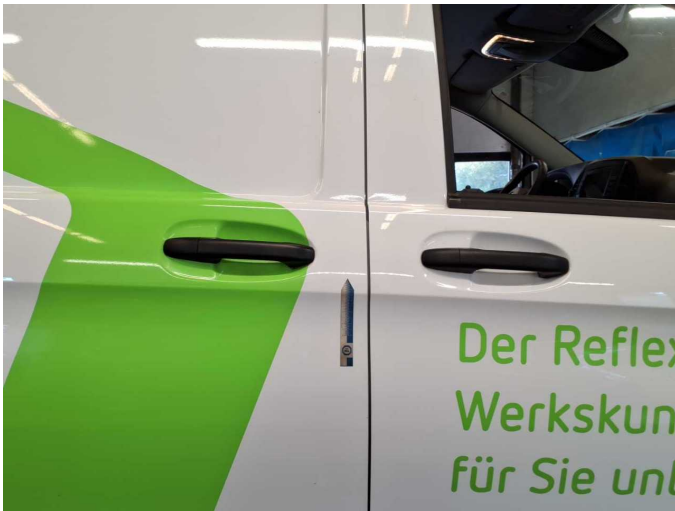
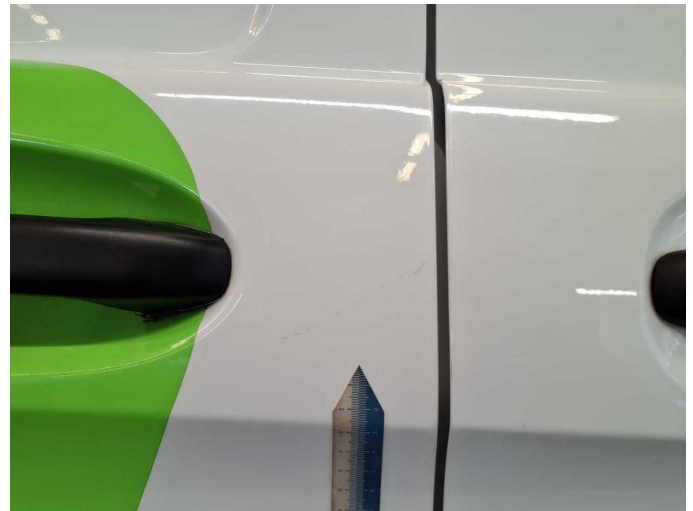
No.	Component group	Description
1	Sliding door, right	Sliding door - Scratch(es) - Smart repair
2	Body	Body - Glued / labelled - De-glue / neutralise

Damage 1: Sliding door, right: Sliding door - Scratch(es) - Smart repair

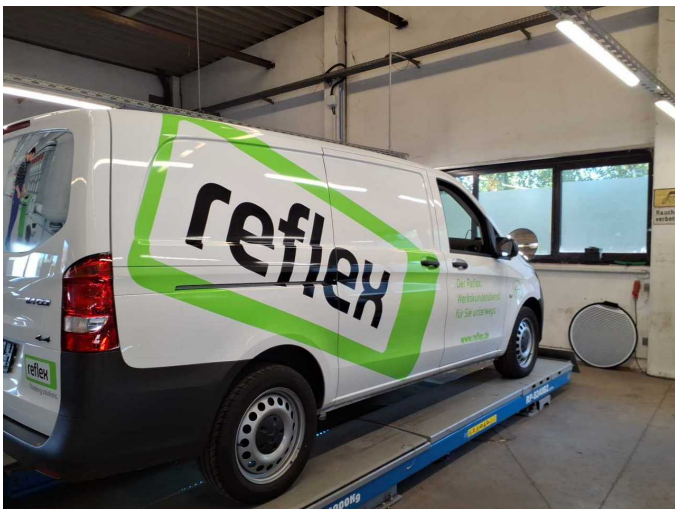
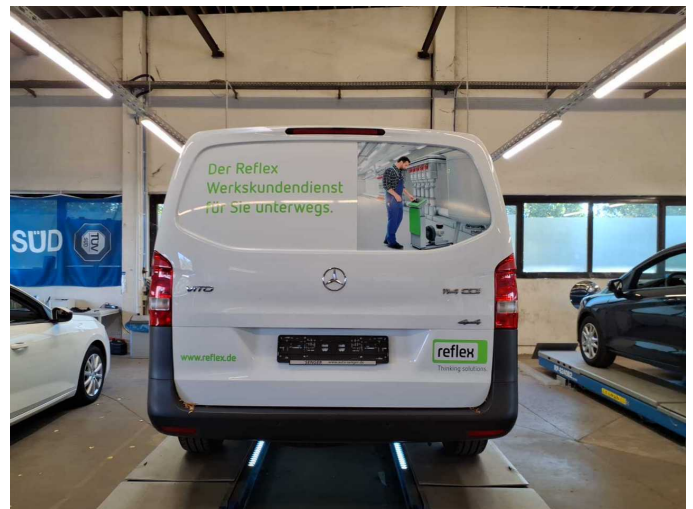
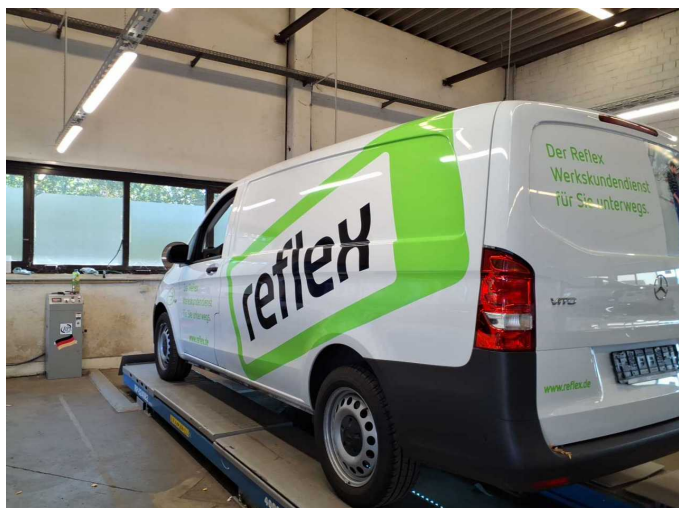
Damage 2: Body: Body - Glued / labelled - De-glue / neutralise
