Expertise

Protocol number: 41530908  
Order No. / Reference: 25177463  
Inspection date: 15 Sept 2025

Manufacturer: Mercedes-Benz  
VIN: W1V44760314134448

Model: Vito 114 CDI Lang HA Aut. PRO

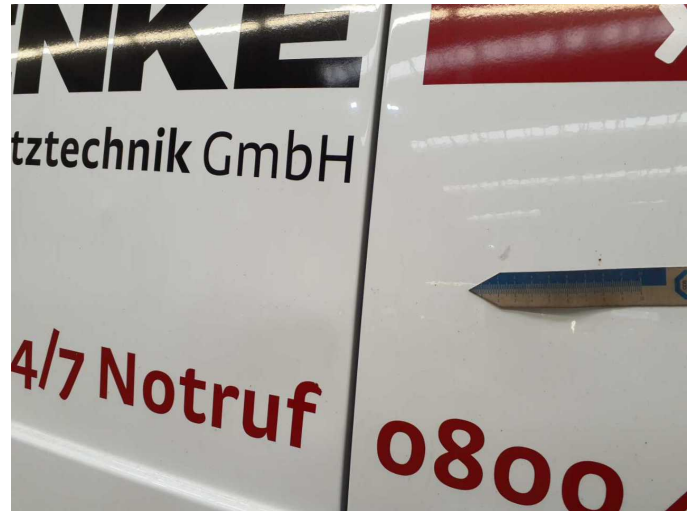
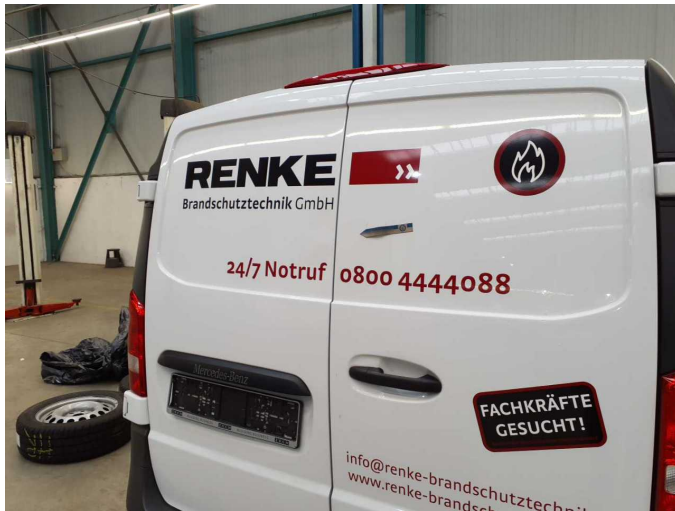
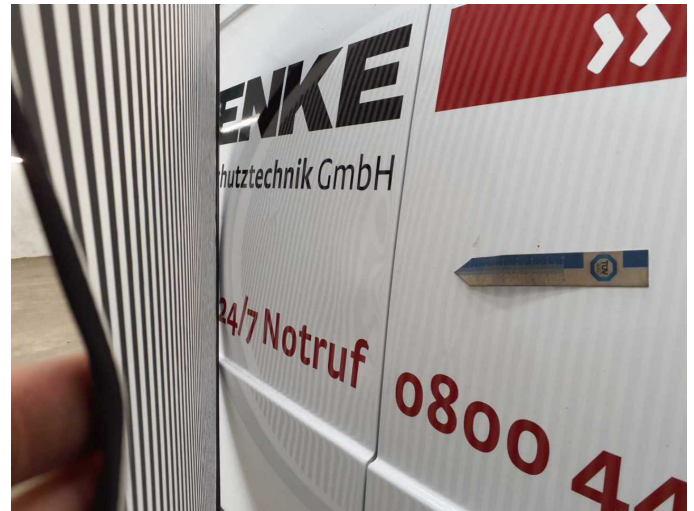
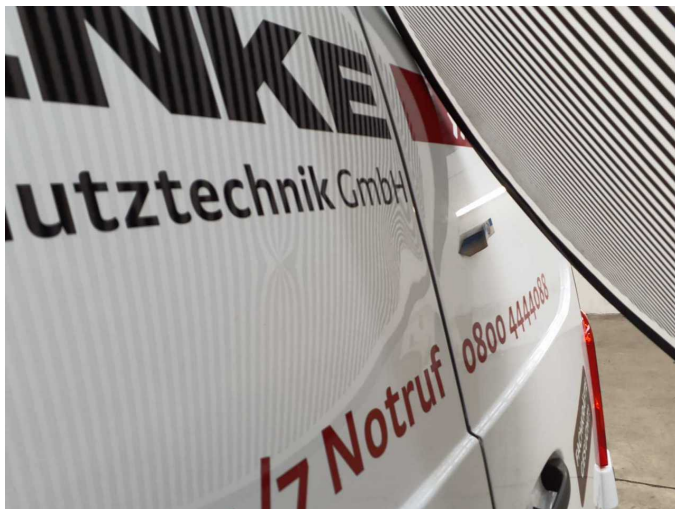
| No. | Component group | Description |
|---|---|---|
| 1 | Boot lid / rear door | Boot lid - dent(s) - Smooth repair work |

Damage 1: Boot lid / rear door: Boot lid - dent(s) - Smooth repair work

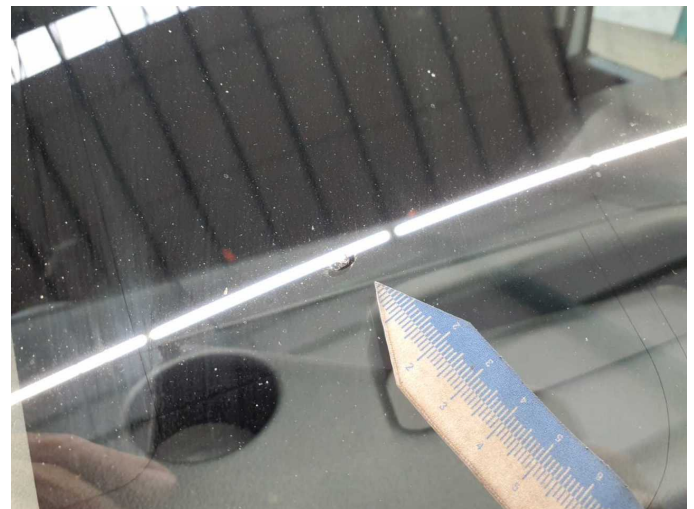
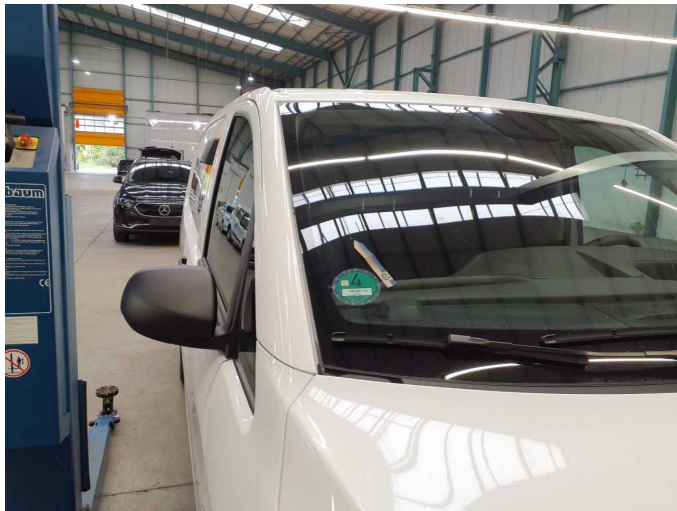
| No. | Component group | Description |
|---|---|---|
| 2 | Vehicle glazing | Windscreen - Stone chips - Smart repair |

Damage 2: Vehicle glazing: Windscreen - Stone chips - Smart repair

**Damage 2:** Vehicle glazing: Windscreen - Stone chips - Smart repair

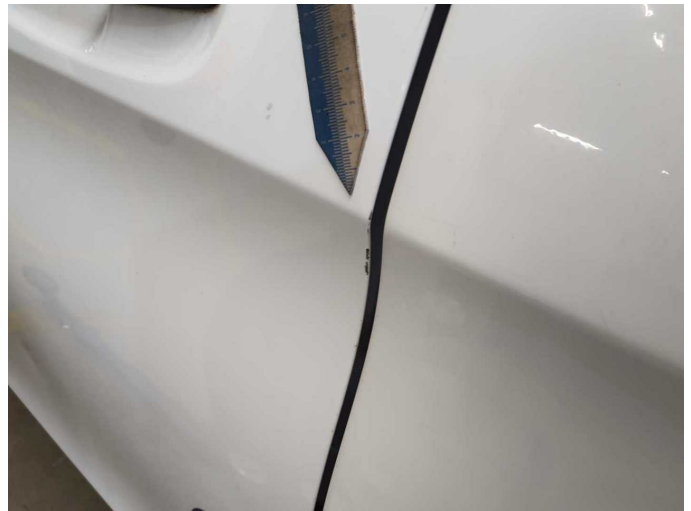
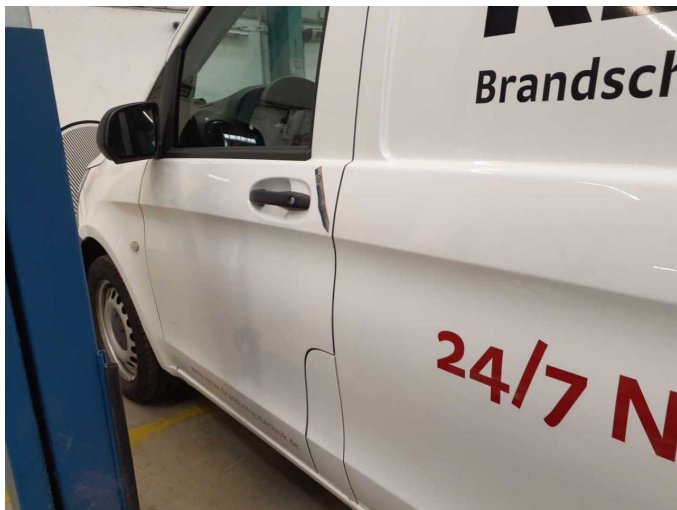
| No. | Component group | Description |
|---|---|---|
| 3 | Door - front left side | Door edge - Scratch(es) - Smart repair |

**Damage 3:** Door - front left side: Door edge - Scratch(es) - Smart repair

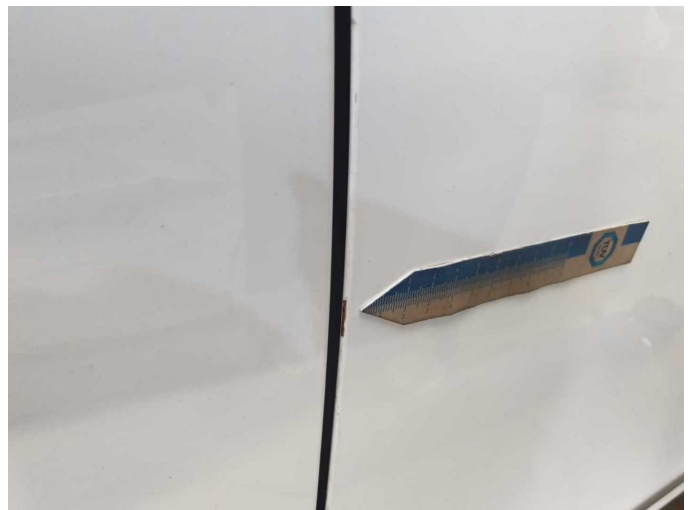
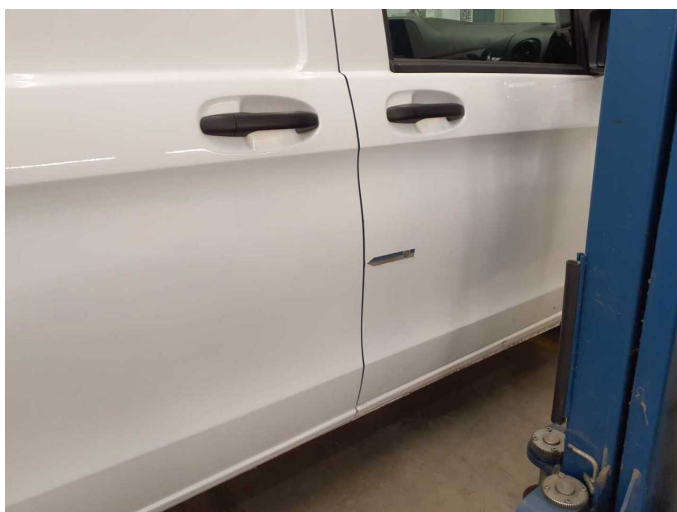
| No. | Component group | Description |
|---|---|---|
| 4 | Door - front right side | Door edge - Scratch(es) - Smart repair |

**Damage 4:** Door - front right side: Door edge - Scratch(es) - Smart repair

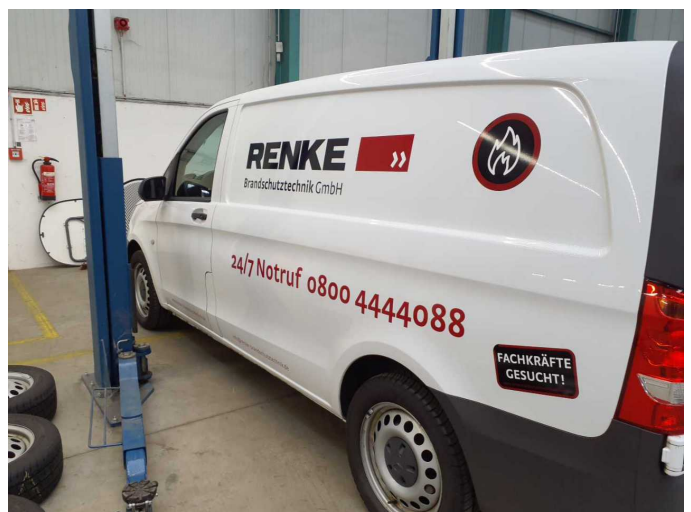
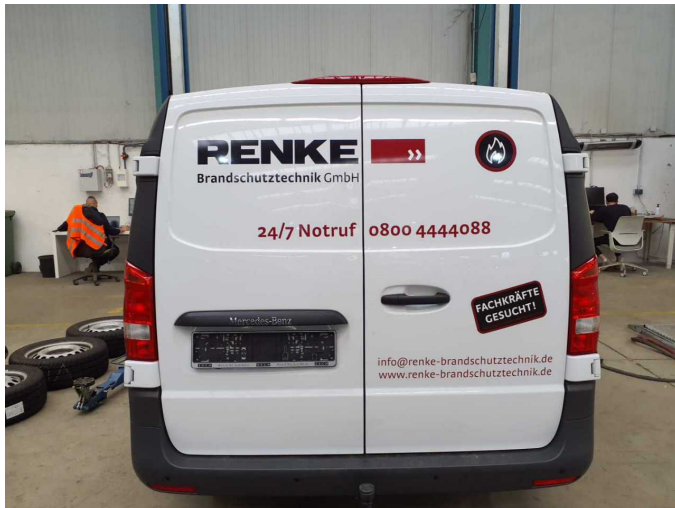
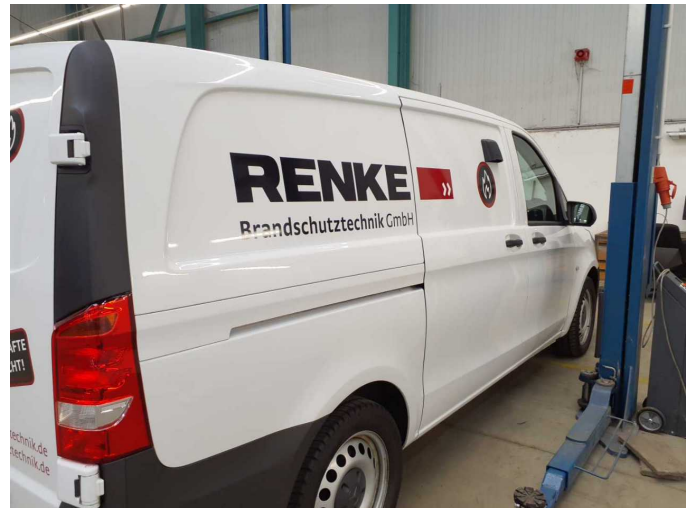
| No. | Component group | Description |
|---|---|---|
| 5 | Body | Body - Glued / labelled - De-glue / neutralise |

**Damage 5:** Body: Body - Glued / labelled - De-glue / neutralise

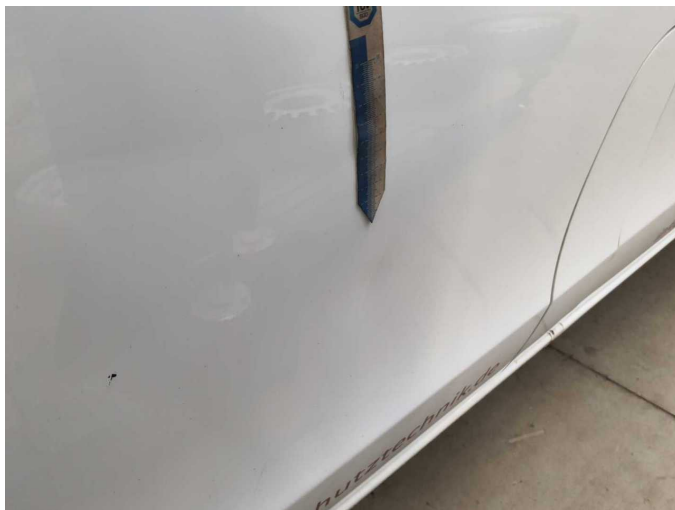
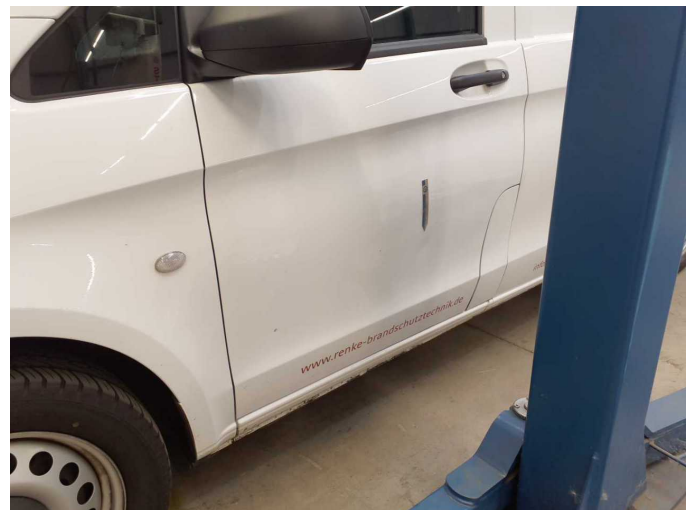
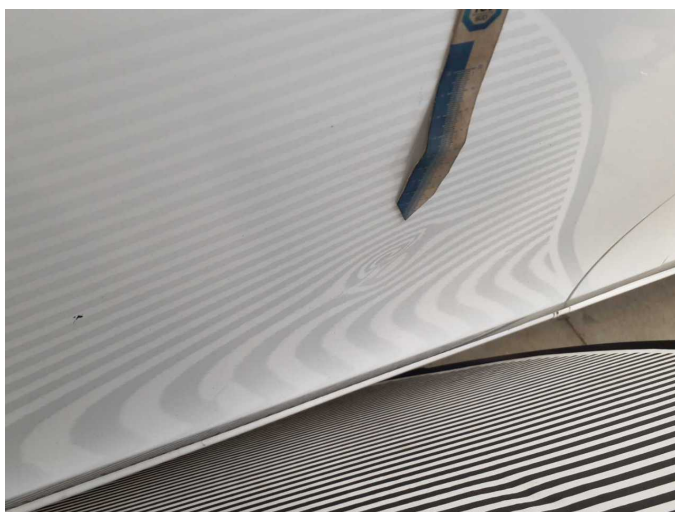
| No. | Component group | Description |
|---|---|---|
| 6 | Door - front left side | Door - Dent / paintcoat damage - Repair and paint |

**Damage 6:** Door - front left side: Door - Dent / paintcoat damage - Repair and paint

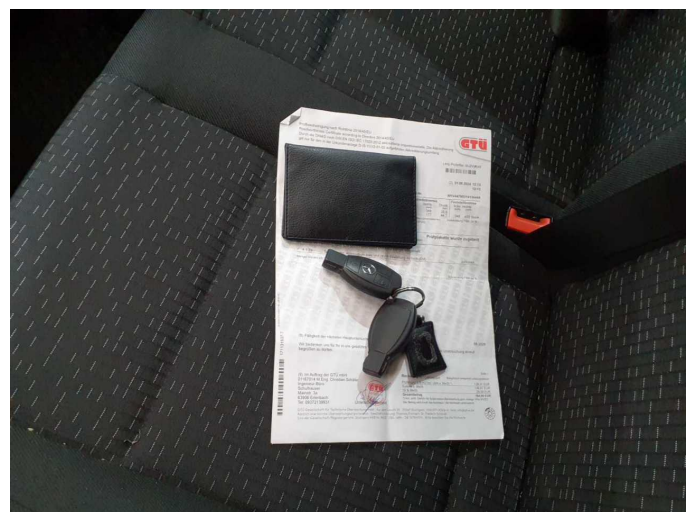
Documents - Log book

**Missing part 1:** Documents: Log book - Missing - Replace

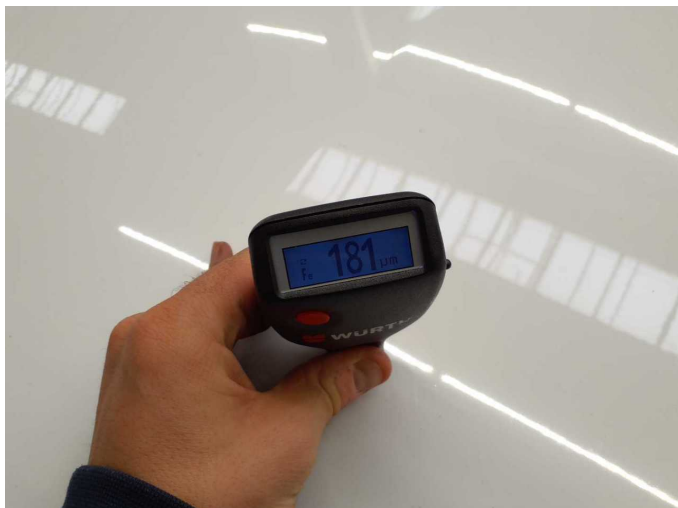
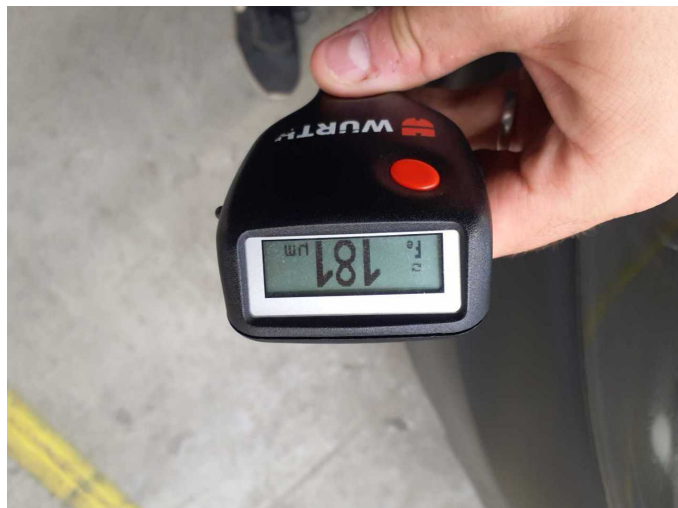
**Repainting 1: Bonnet**

| 1 | Bonnet, Professionally carried out, Invoice of repair done Non-existent |

| Bonnet | 181 µm | Door - front right side | 401 µm |

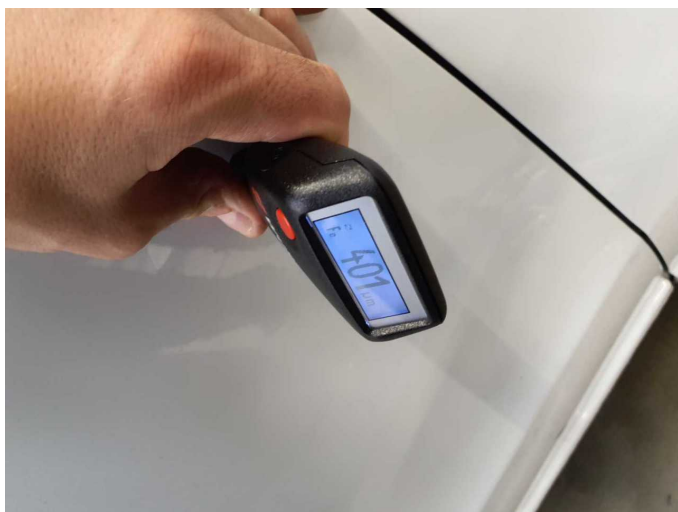
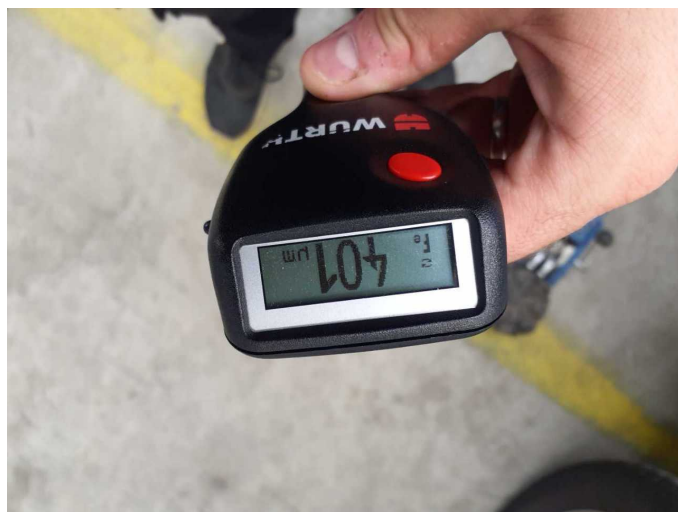
**Repainting 2: Door - front right side**

| 2 | Door - front right side, Professionally carried out, Invoice of repair done Non-existent |
