Expertise

Protocol number: 41578488
Order No. / Reference: 25214286
Inspection date: 17 Sept 2025

Manufacturer: Mercedes-Benz
VIN: W1V44760314134473

Model: Vito 114 CDI Lang HA Aut. PRO

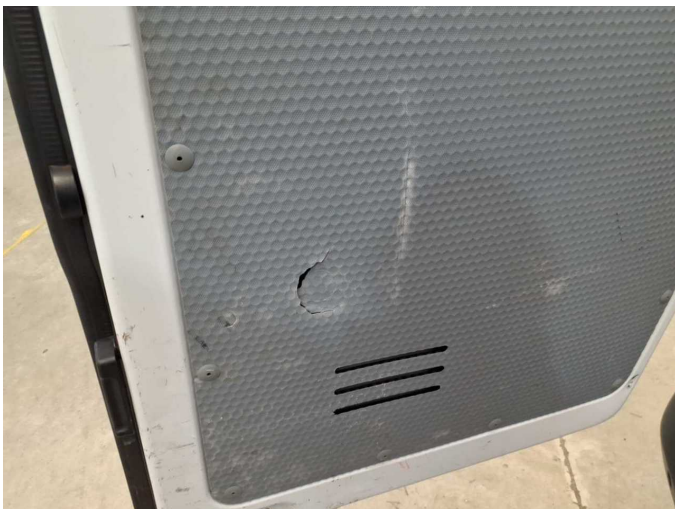
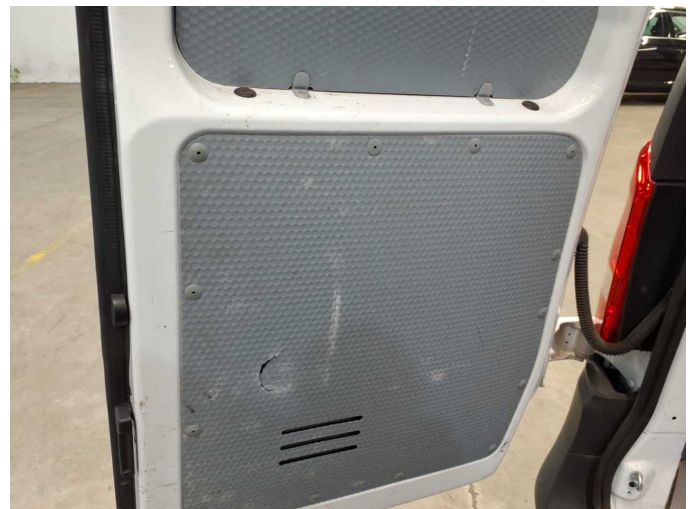
No.	Component group	Description
1	Trim / covers	Boot lid - interior trim - Broken / torn - Replace
2	Rear bumper	Rear bumper - Scratched - Smart repair
3	Body	Body - Glued / labelled - De-glue / neutralise
4	Side panel - rear left side	Side panel - Dent / paintcoat damage - Repair and paint

Damage 1: Trim / covers: Boot lid - interior trim - Broken / torn - Replace

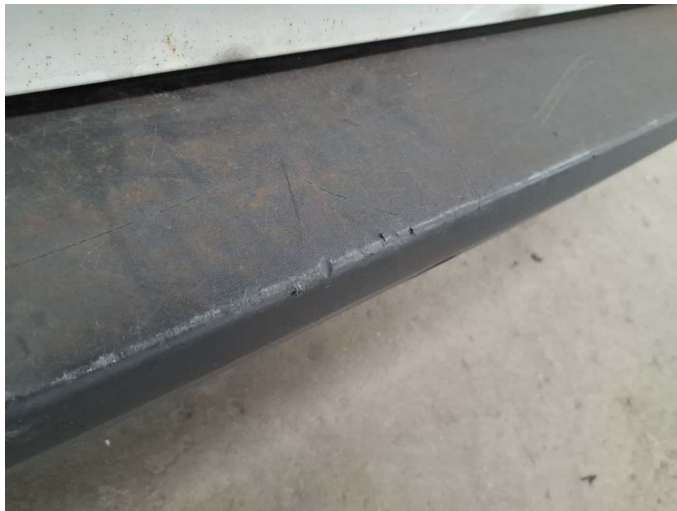
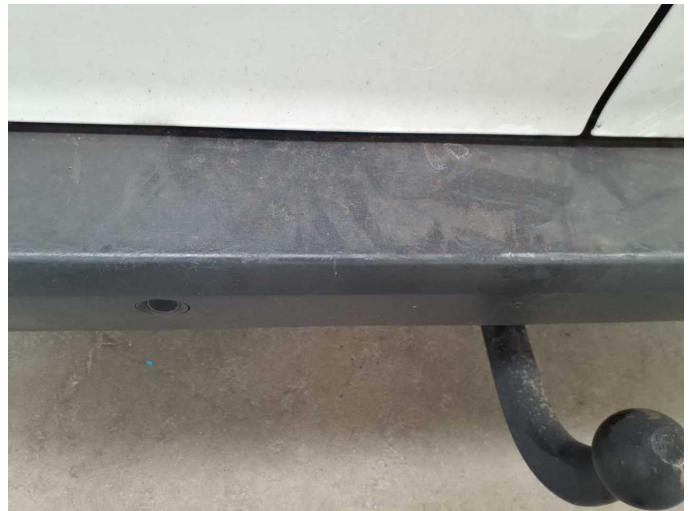
Damage 2: Rear bumper: Rear bumper - Scratched - Smart repair

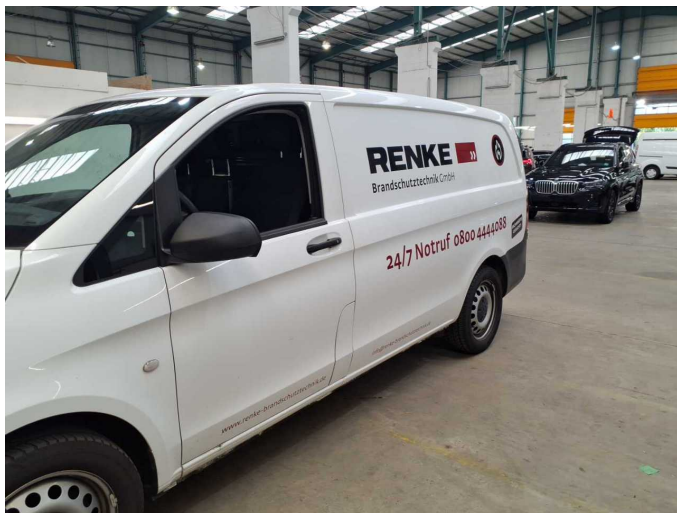
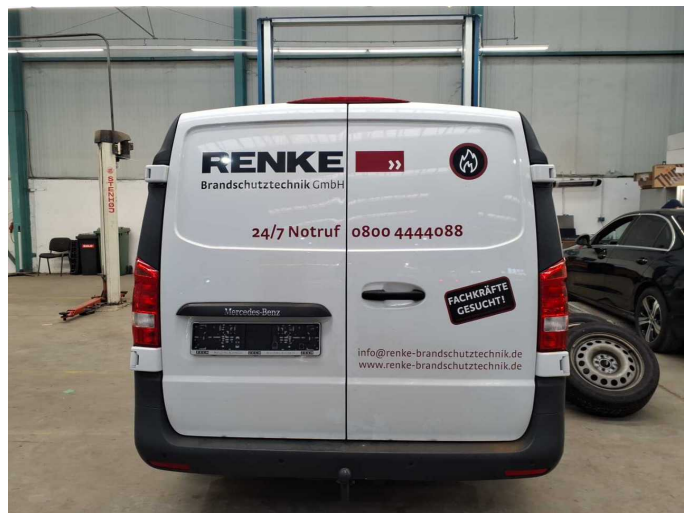
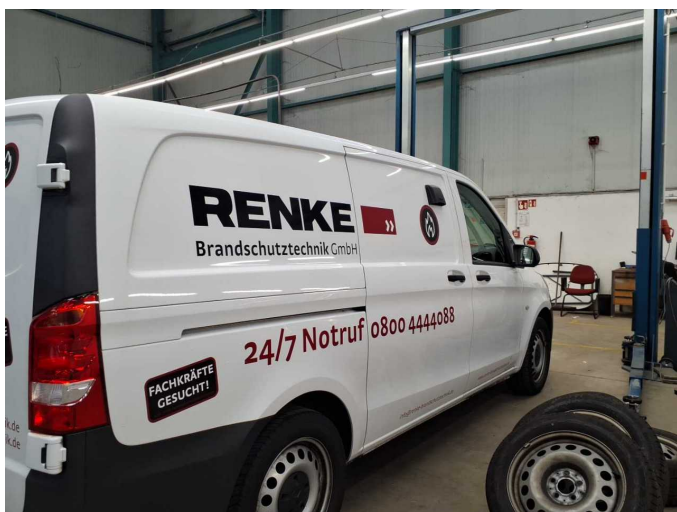
Damage 3: Body: Body - Glued / labelled - De-glue / neutralise

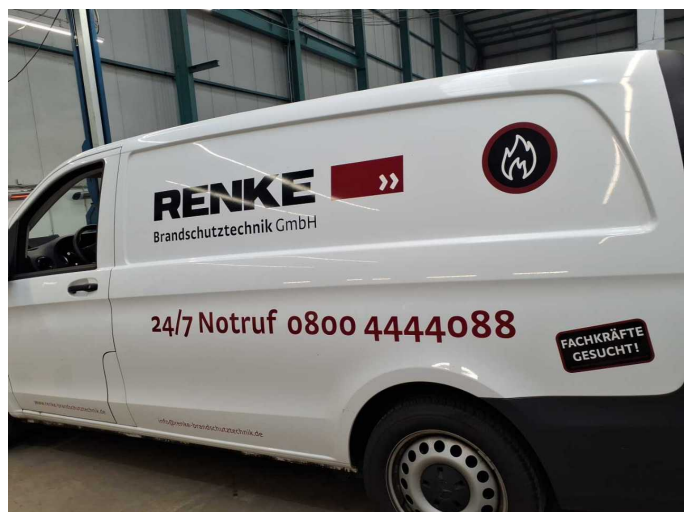
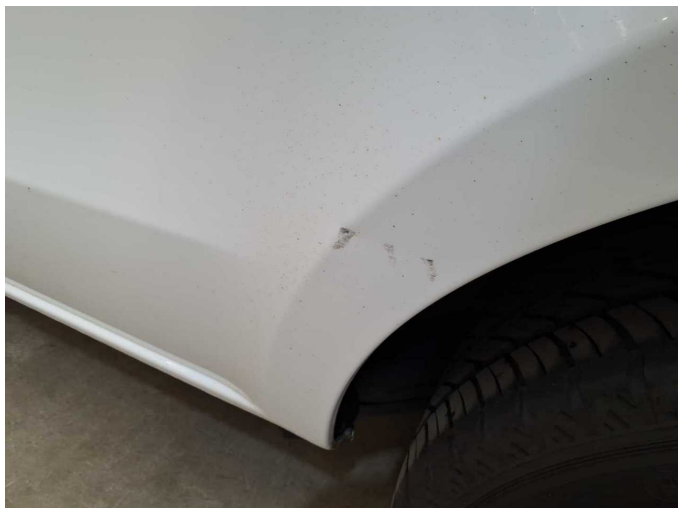
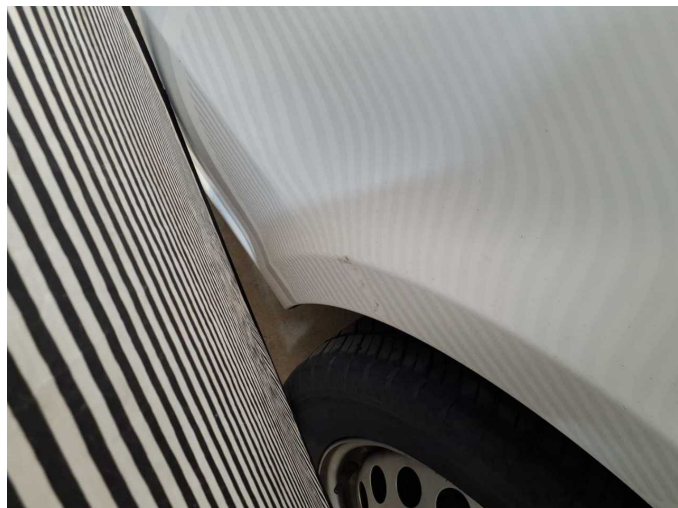
Damage 4: Side panel - rear left side: Side panel - Dent / paintcoat damage - Repair and paint
