Expertise

Protocol number: 41569589
Order No. / Reference: 25214327
Inspection date: 17 Sept 2025

Manufacturer: Mercedes-Benz
VIN: W1V44760314135856

Model: Vito 114 CDI Lang HA Aut. PRO

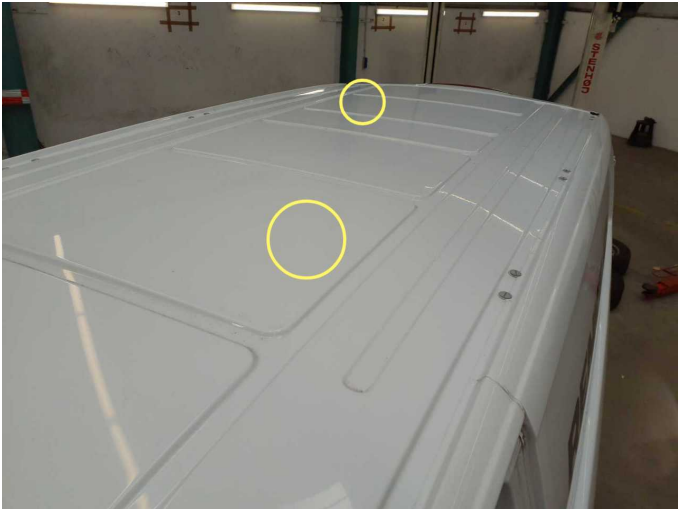
Damage 1: Roof: Roof (2x) - dent(s) - Smooth repair work

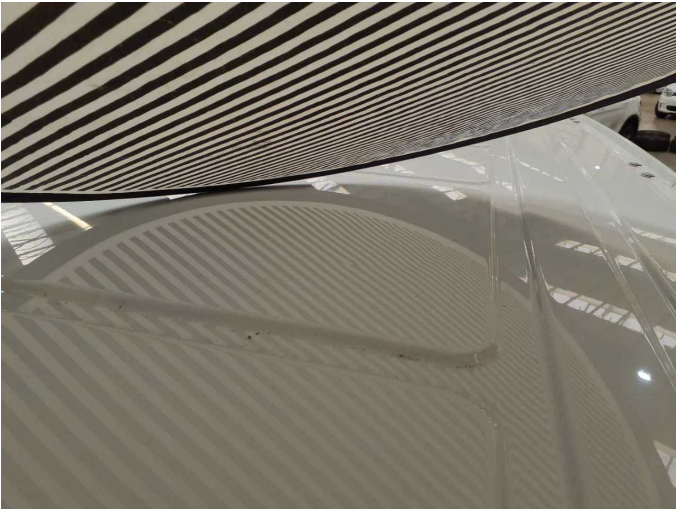
Damage 1: Roof: Roof (2x) - dent(s) - Smooth repair work

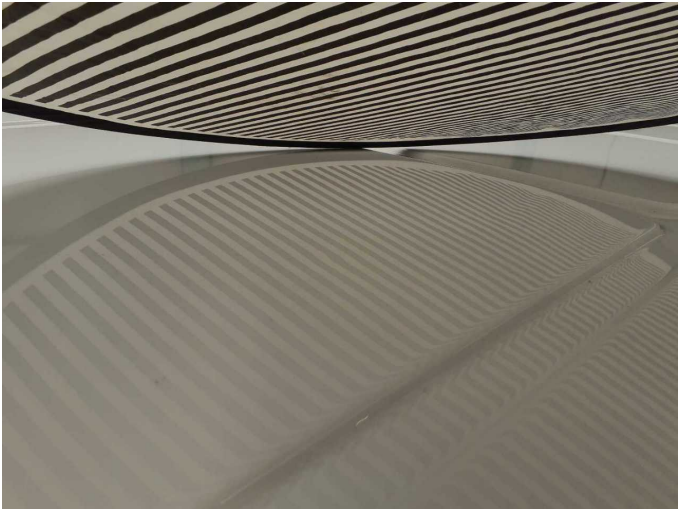
Damage 1: Roof: Roof (2x) - dent(s) - Smooth repair work

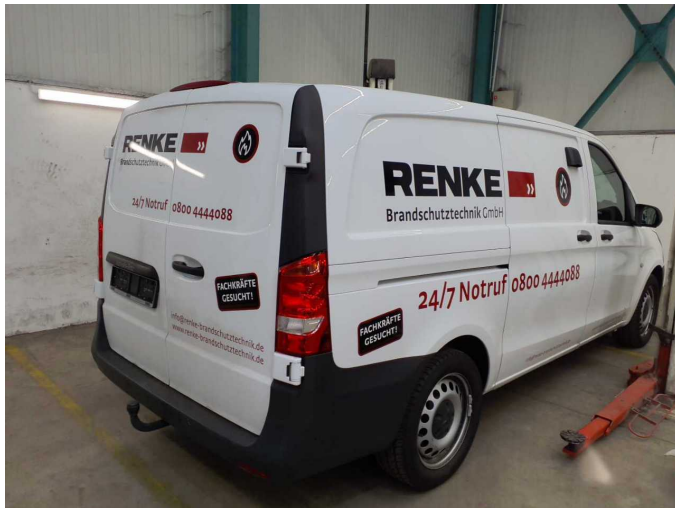
Damage 2: Body: Body - Glued / labelled - De-glue / neutralise

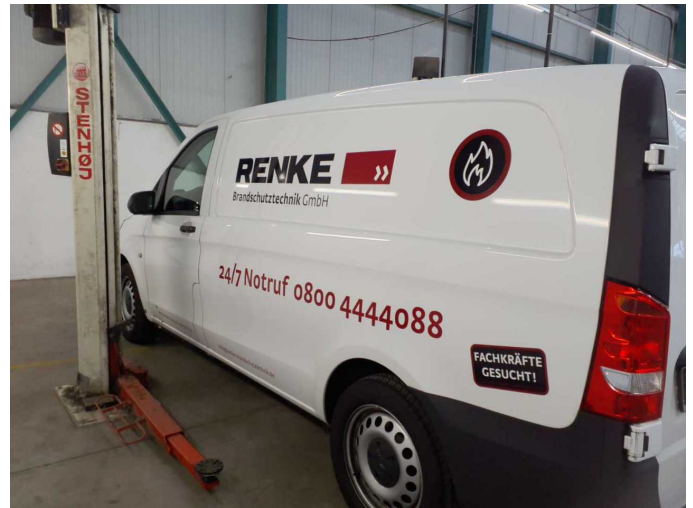
Damage 2: Body: Body - Glued / labelled - De-glue / neutralise

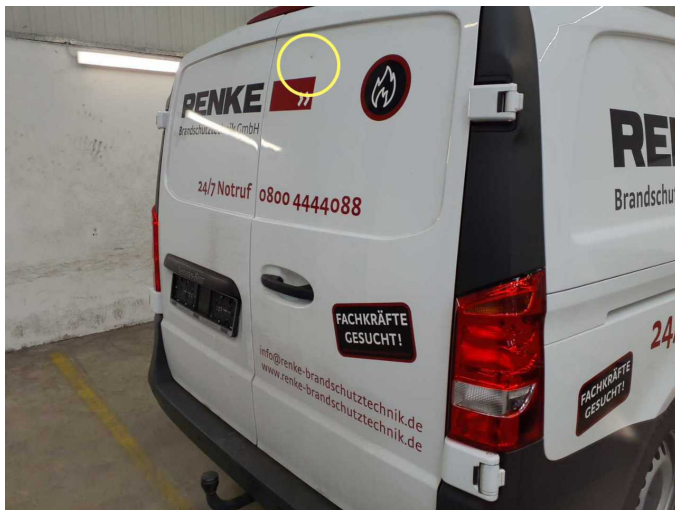
Damage 3: Boot lid / rear door: Rear door - right side - Dent / paintcoat damage - Repair and paint

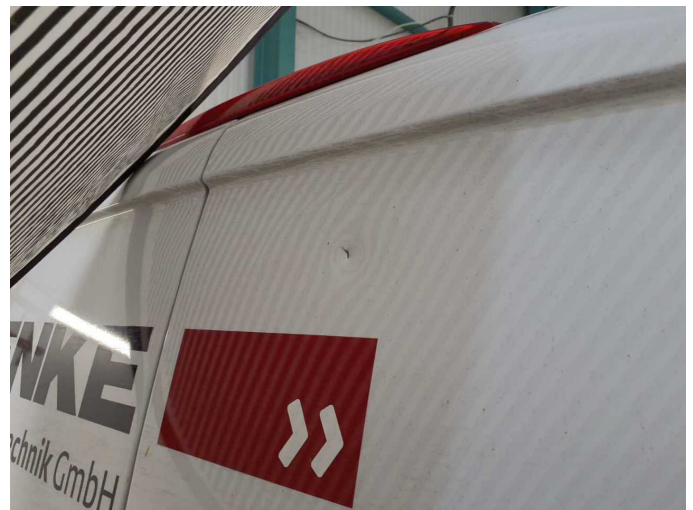
Damage 3: Boot lid / rear door: Rear door - right side - Dent / paintcoat damage - Repair and paint

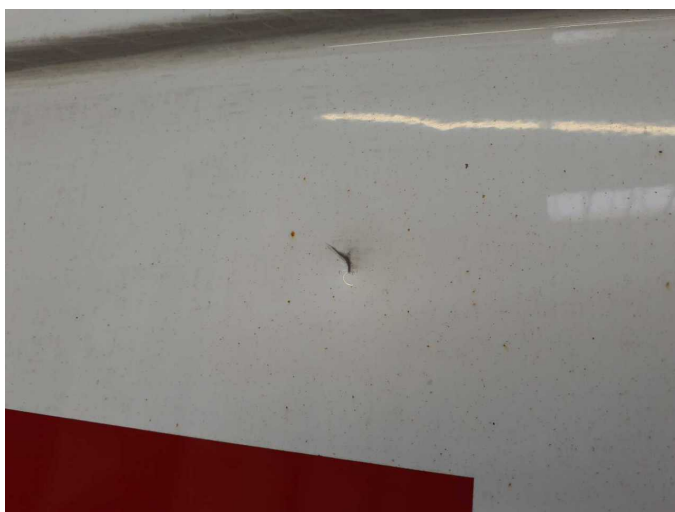
Damage 3: Boot lid / rear door: Rear door - right side - Dent / paintcoat damage - Repair and paint

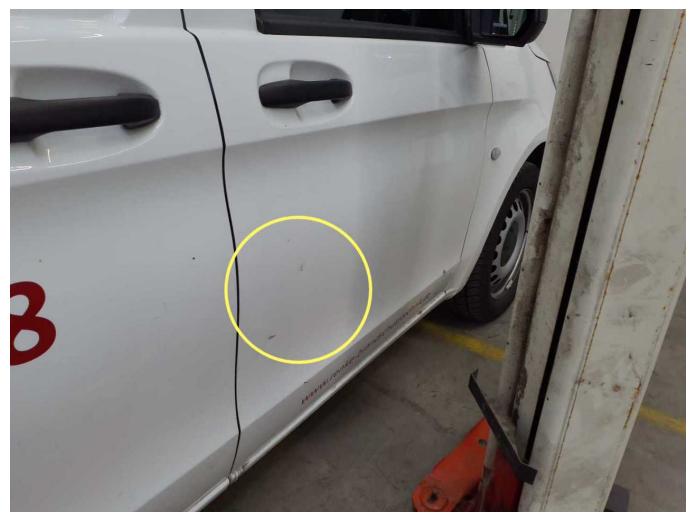
Damage 4: Door - front right side: Door - Dent / paintcoat damage - Repair and paint

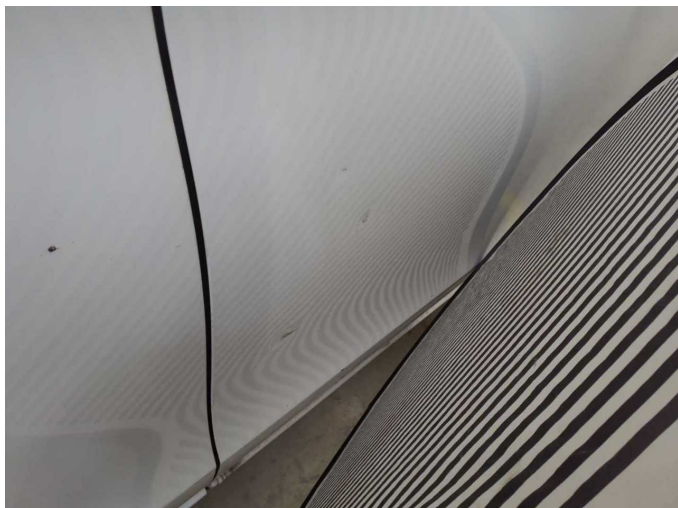
Damage 4: Door - front right side: Door - Dent / paintcoat damage - Repair and paint

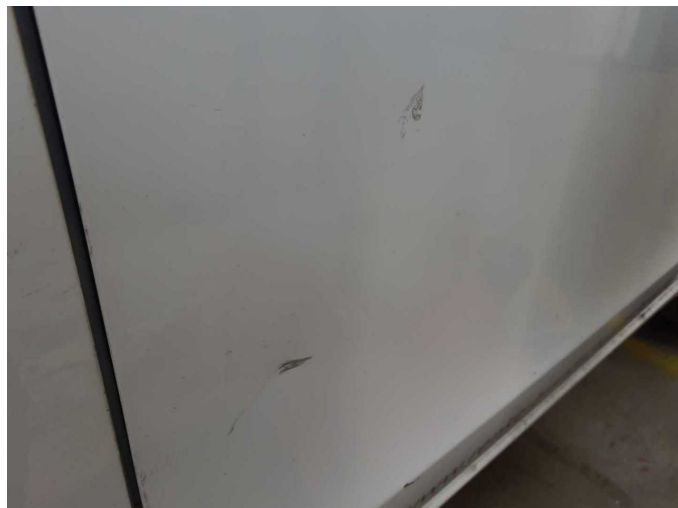
Damage 4: Door - front right side: Door - Dent / paintcoat damage - Repair and paint

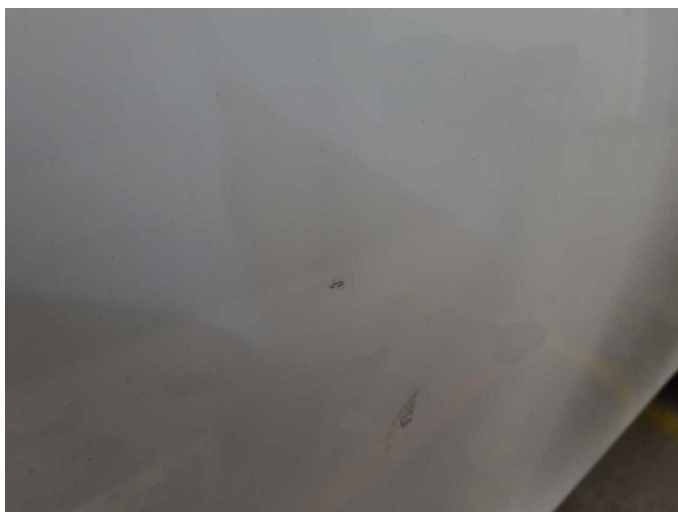
Damage 4: Door - front right side: Door - Dent / paintcoat damage - Repair and paint

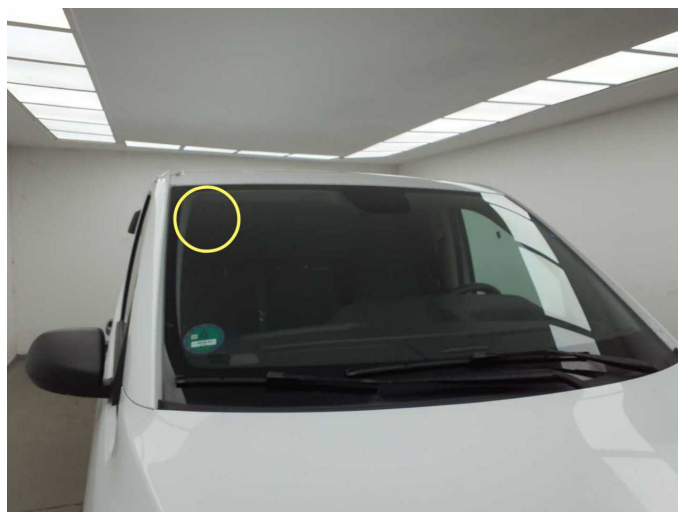
Damage 5: Vehicle glazing: Windscreen - Broken / torn - Replace

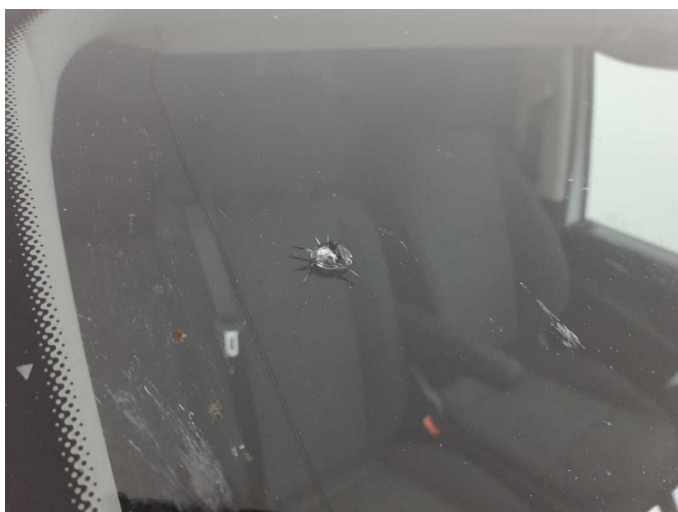
Damage 5: Vehicle glazing: Windscreen - Broken / torn - Replace
