Expertise

Protocol number: 41735863
Order number / reference: 25251863
Inspection date: 26 Sept 2025

Model: Vito 114 CDI Lang HA Aut. PRO

VIN: W1V44760314136041

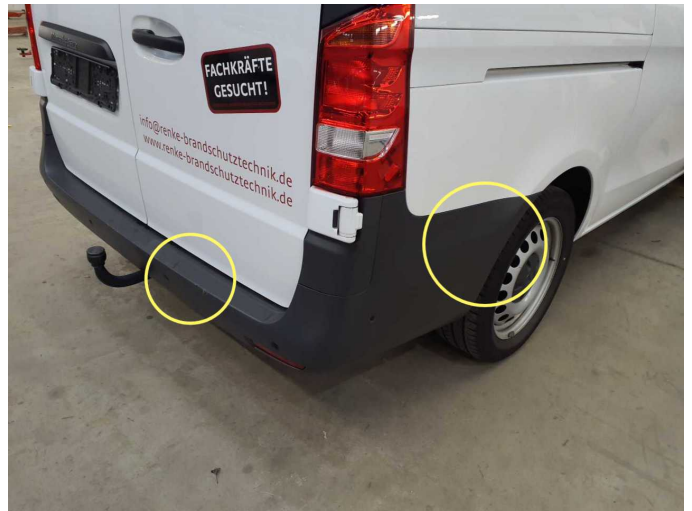
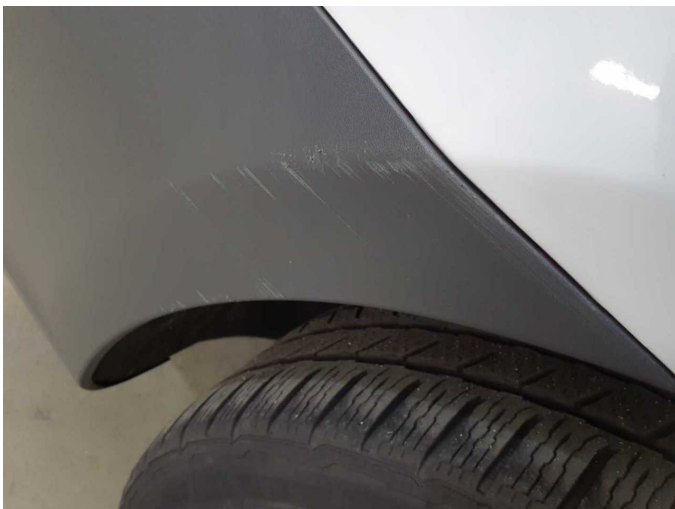
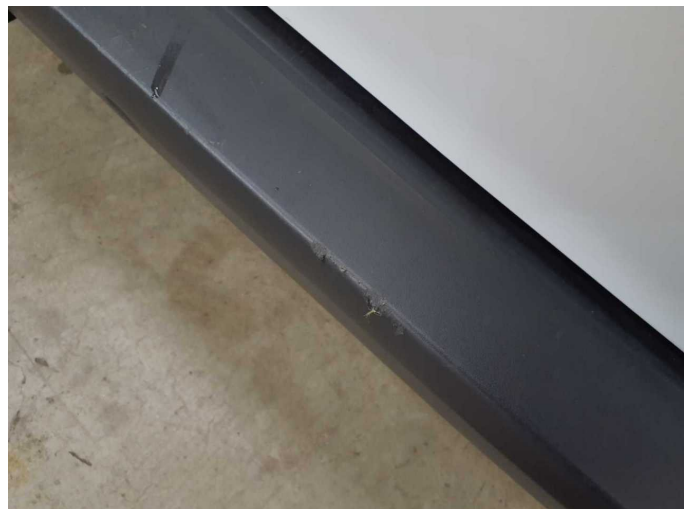
Damage 1: Rear bumper: Rear bumper (unpainted) - Scratched - Loss in value

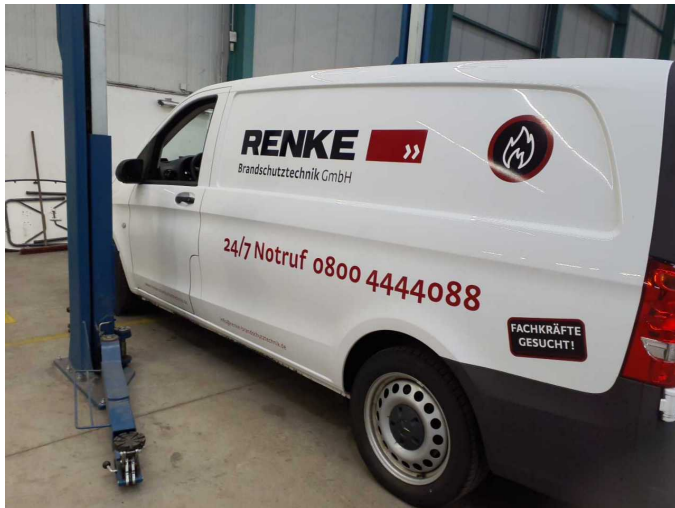
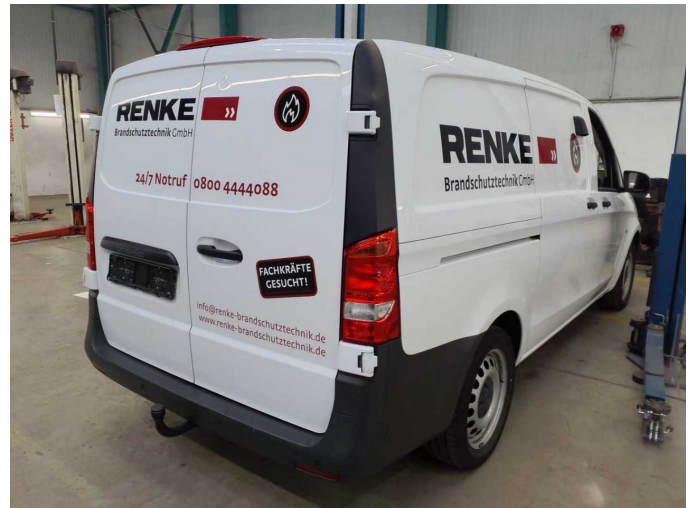
Damage 2: Body: Body - Glued / labelled - De-glue / neutralise

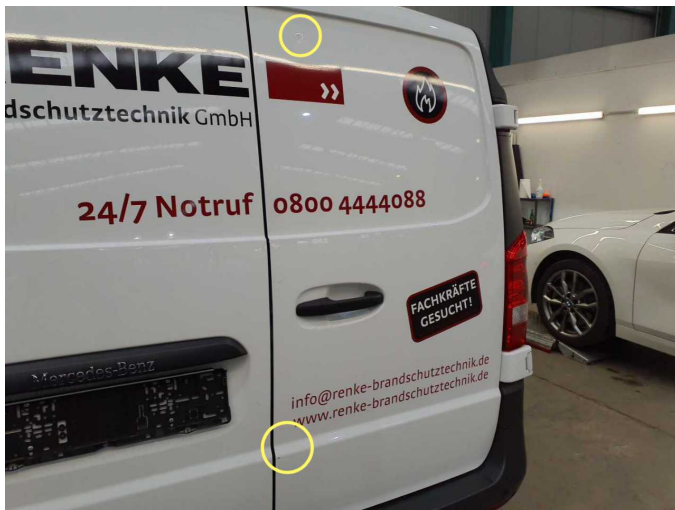
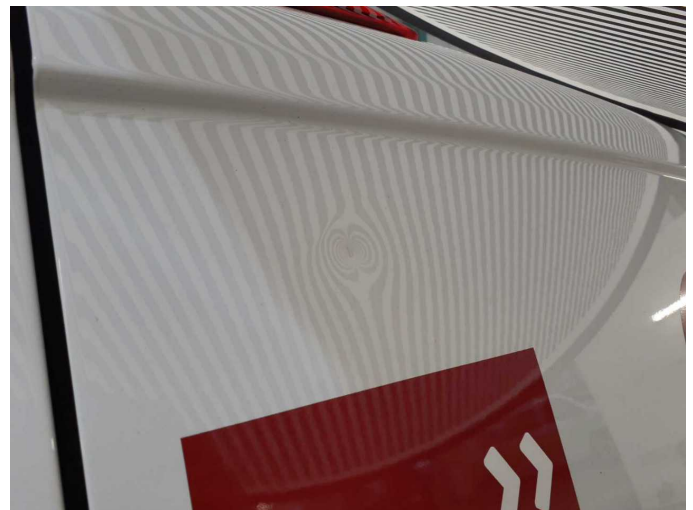
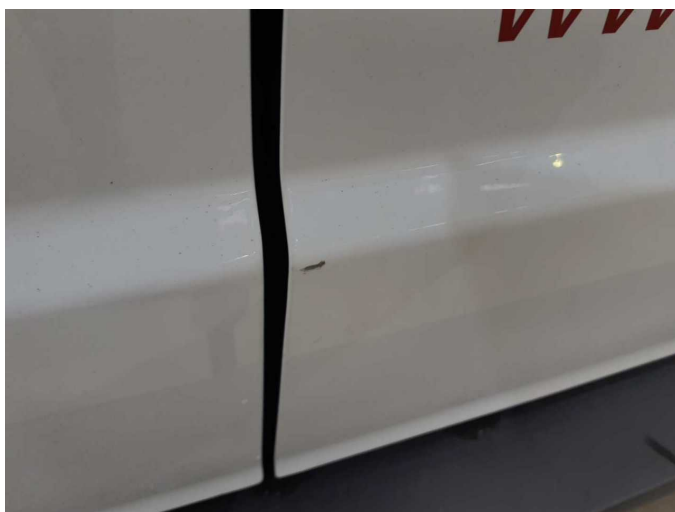
Damage 3: Boot lid / rear door: Rear door - right side - Dent / paintcoat damage - Repair and paint

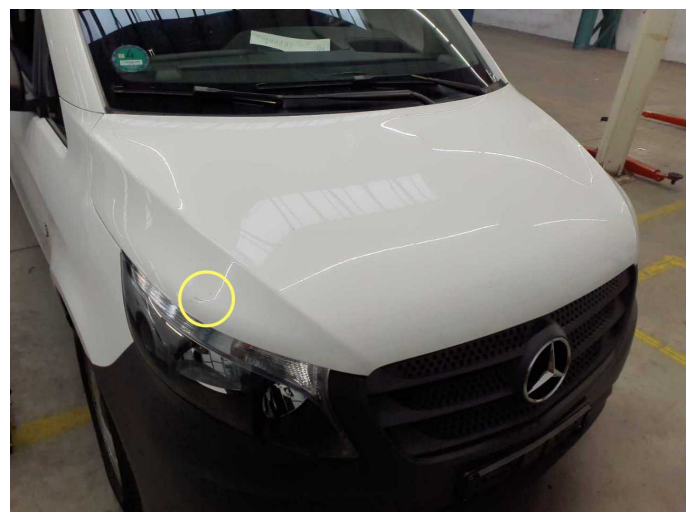
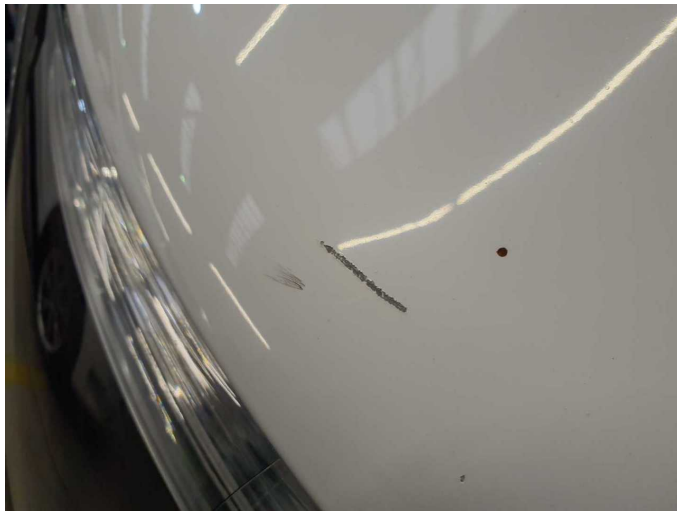
Damage 4: Bonnet: Bonnet - Scratch(es) - Paint

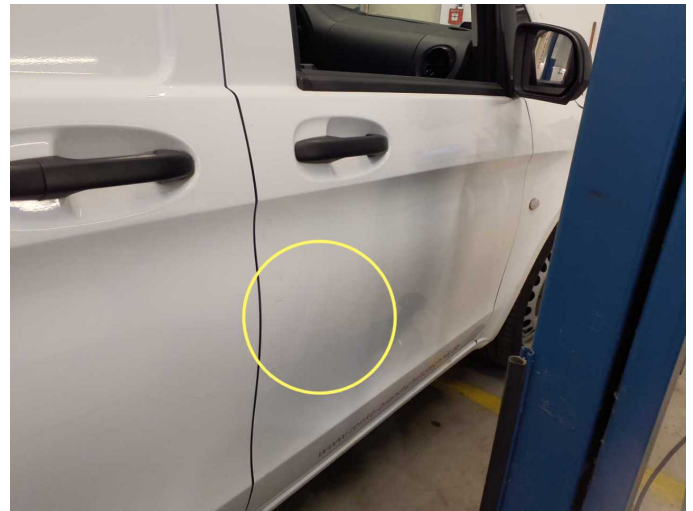
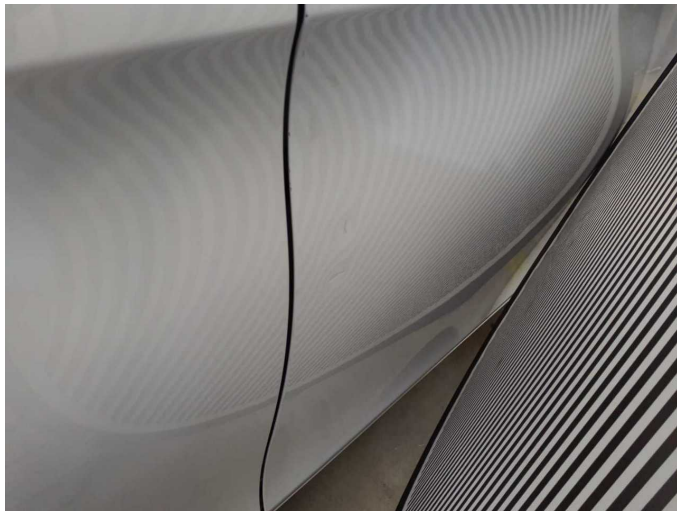
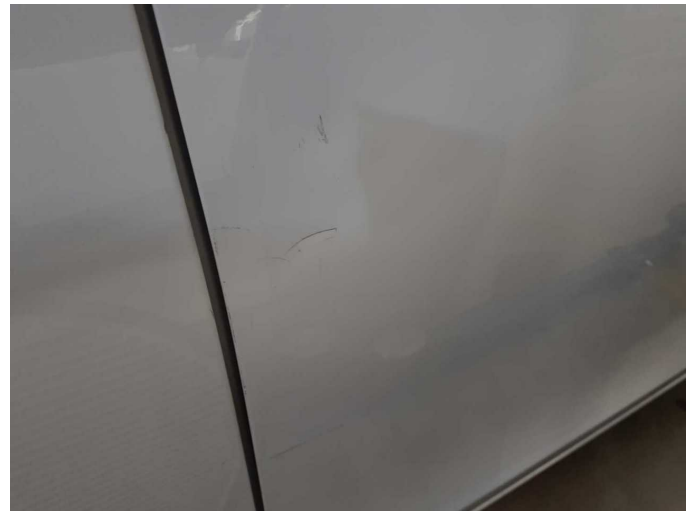
Damage 5: Door - front right side: Door - Dent / paintcoat damage - Repair and paint

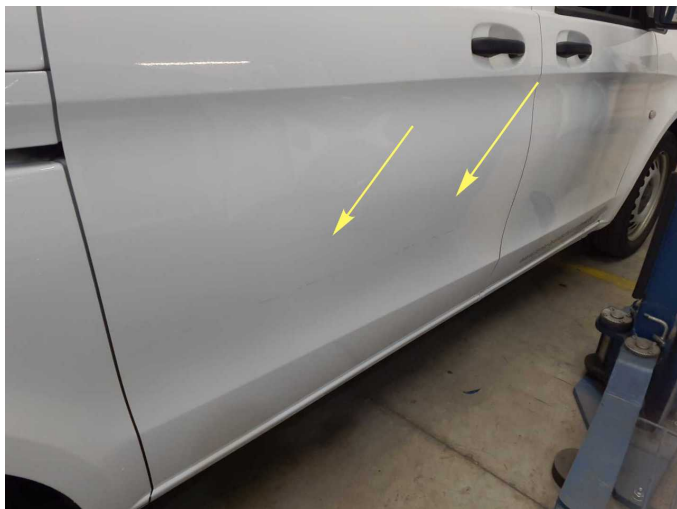
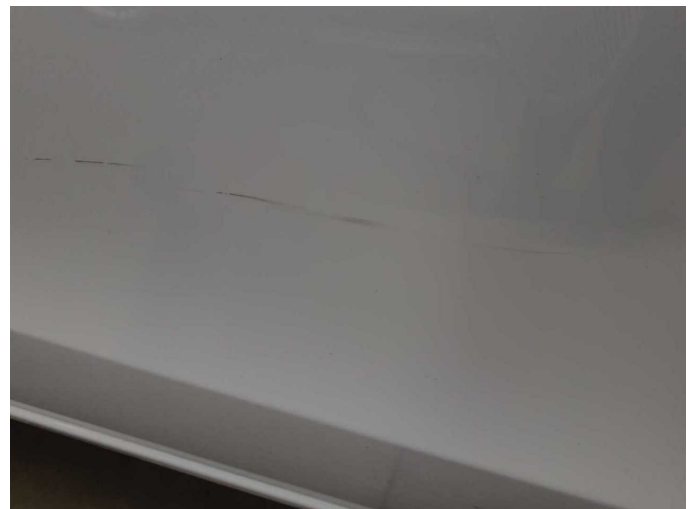
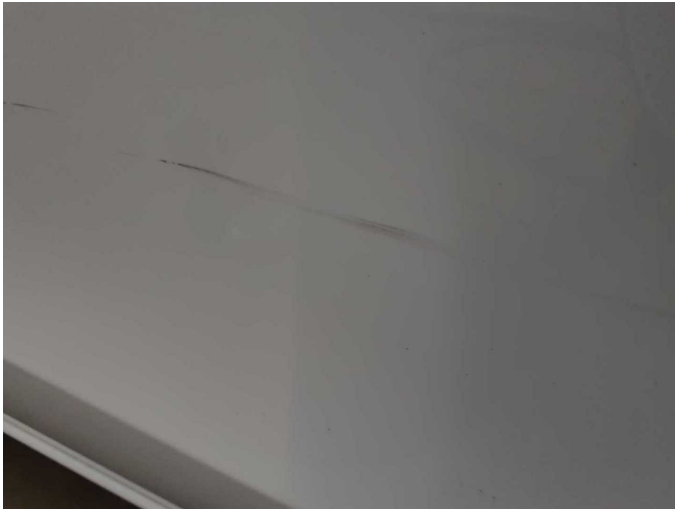
Damage 6: Sliding door, right: Sliding door - Scratch(es) - Paint

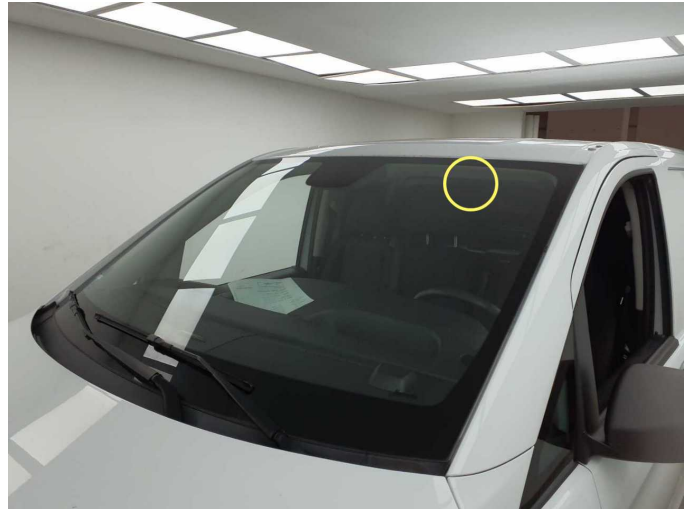
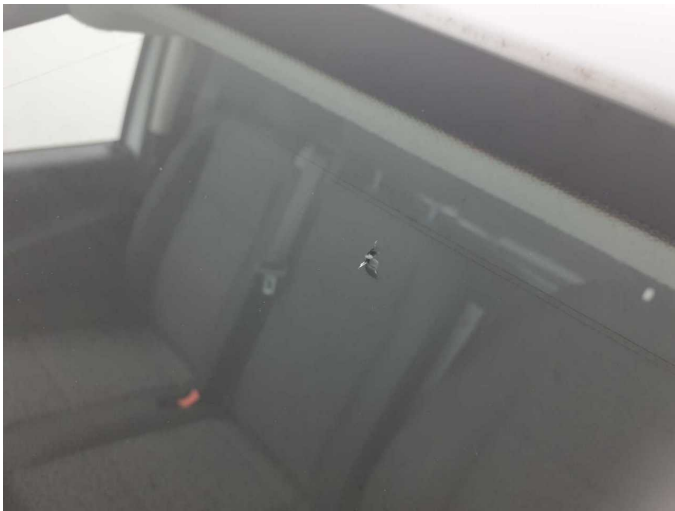
Damage 7: Vehicle glazing: Windscreen (Mit Rissbildung) - Stone chips - Replace

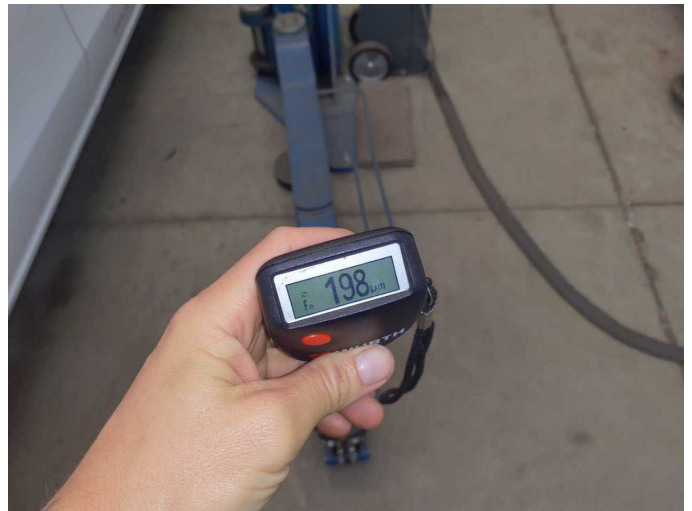
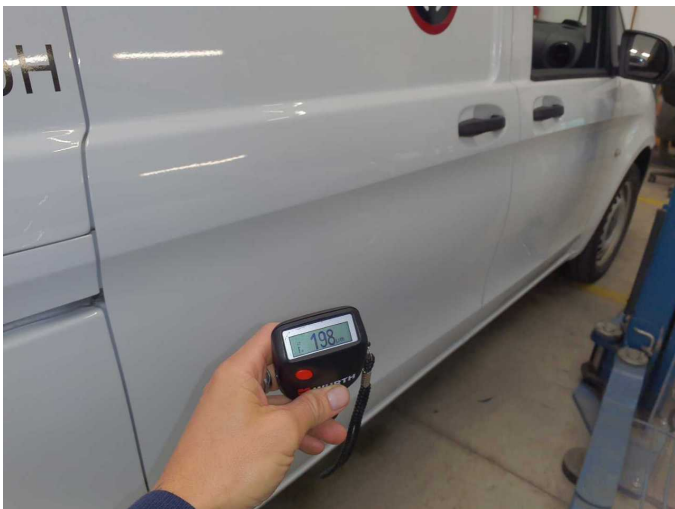
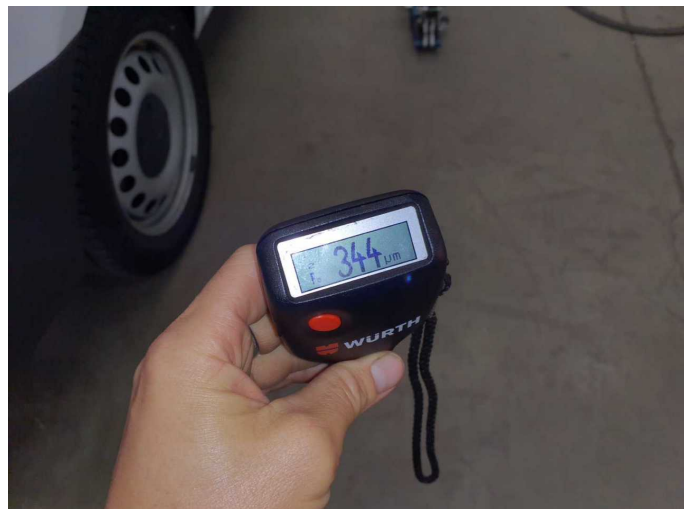
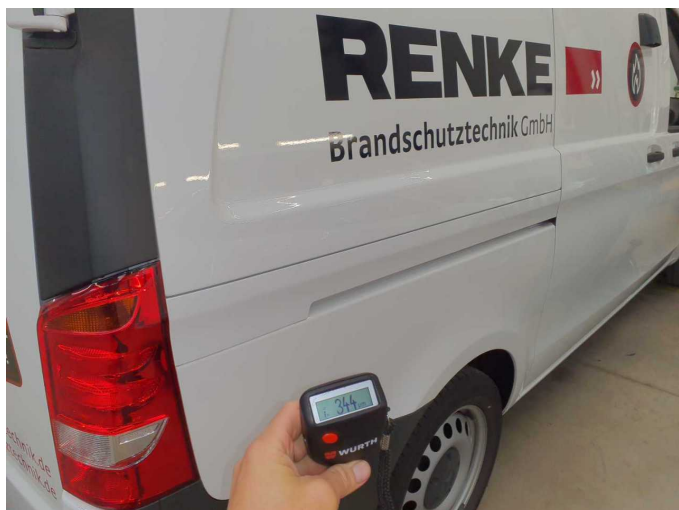
No.	Repainting
1	Side panel - rear right side, Door - rear right side, Professionally carried out, Invoice of repair done Non-existent

Side panel - rear right side	344 µm	Door - rear right side	198 µm
------------------------------	--------	------------------------	--------

Repainting 1: Side panel - rear right side, Door - rear right side
