Expertise

Protocol number: 41581782
Order No. / Reference: 25214353
Inspection date: 18 Sept 2025

Model: Vito 114 CDI Lang HA Aut. PRO

VIN: W1V44760314136721

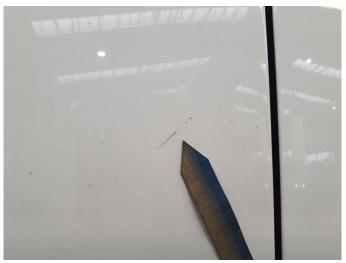
No.	Component group	Description
1	Door - front right side	Door edge - Scratch(es) - Smart repair
2	Boot lid / rear door	Boot lid - Scratch(es) - Smart repair
3	Body	Body - Glued / labelled - De-glue / neutralise

Damage 1: Door - front right side: Door edge - Scratch(es) - Smart repair

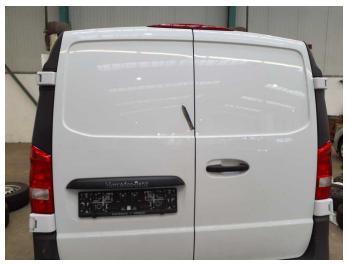
Damage 2: Boot lid / rear door: Boot lid - Scratch(es) - Smart repair

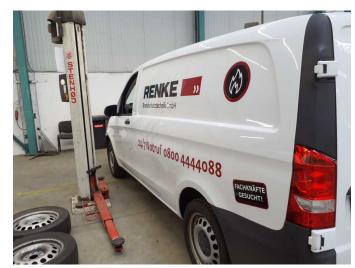
Damage 3: Body: Body - Glued / labelled - De-glue / neutralise

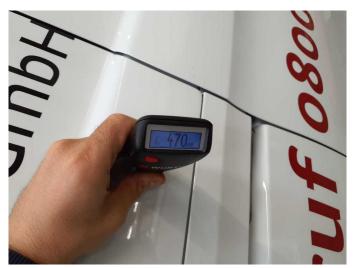
Damage 3: Body: Body - Glued / labelled - De-glue / neutralise

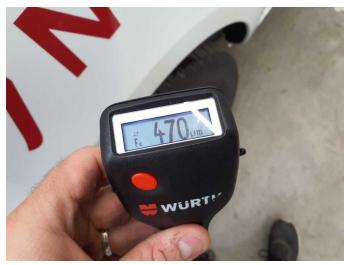
- 1 Side panel rear right side, Professionally carried out, Invoice of repair done Non-existent
- 2 Door rear right side, Professionally carried out, Invoice of repair done Non-existent

Side panel - rear right side 470 μm Door - rear right side 200 μm

Repainting 1: Side panel - rear right side

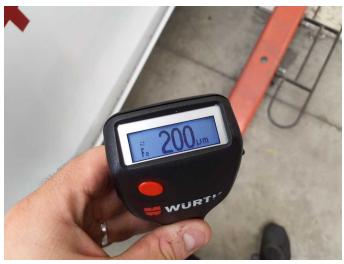
Repainting 2: Door - rear right side
