Expertise

Protocol number: 41617679
Order No. / Reference: 25227373
Inspection date: 19 Sept 2025

Manufacturer: Mercedes-Benz

Model: Vito 114 CDI Kastenwagen Lang HA Aut. PRO

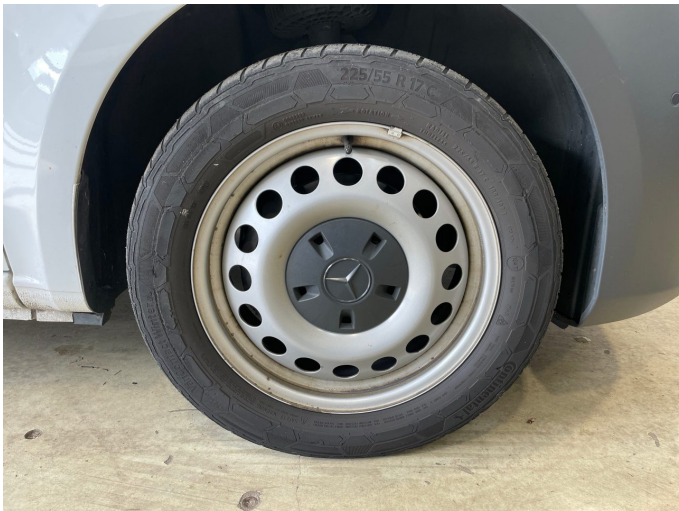
Figure 12: Mounted tyres

#	Tyre size	Type of tyre	Manufacturer	Tread depth
1)	225/55 R17 109T	Winter tyres on Steel	Continental	4mm / 2mm
2)	225/55 R17 109T	Winter tyres on Steel	Continental	5mm / 5mm

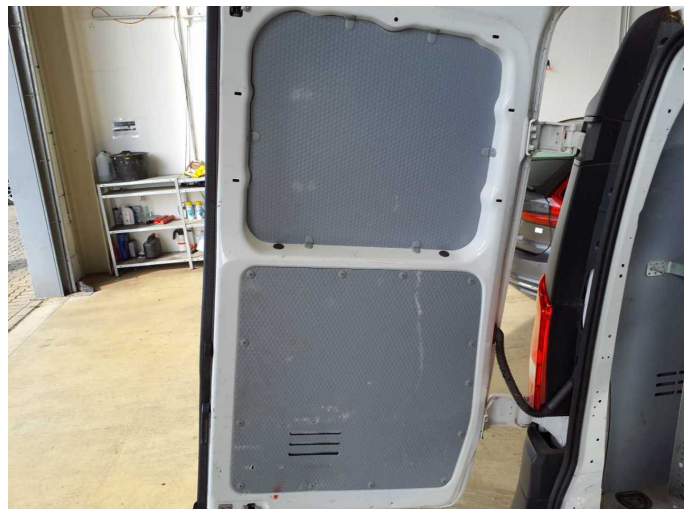
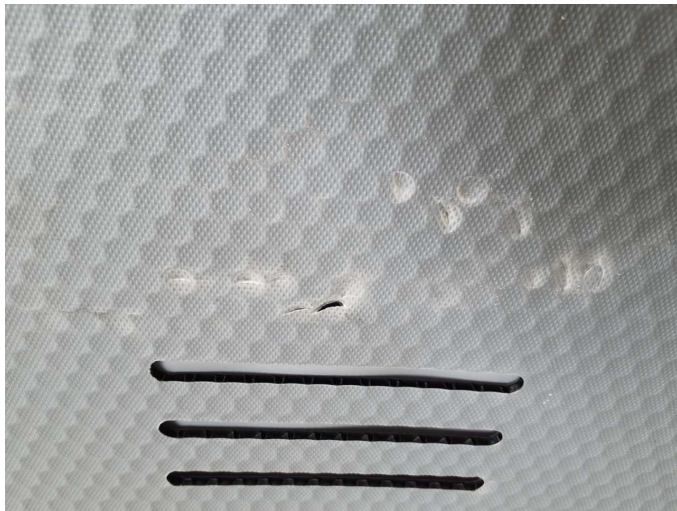
Damage 1: Boot lid / rear door: Rear door - left side (Innenverkleidung) - Damaged - Replace

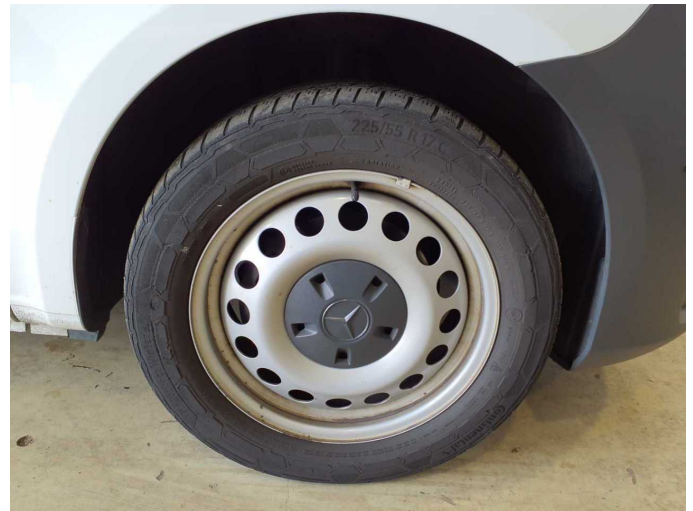
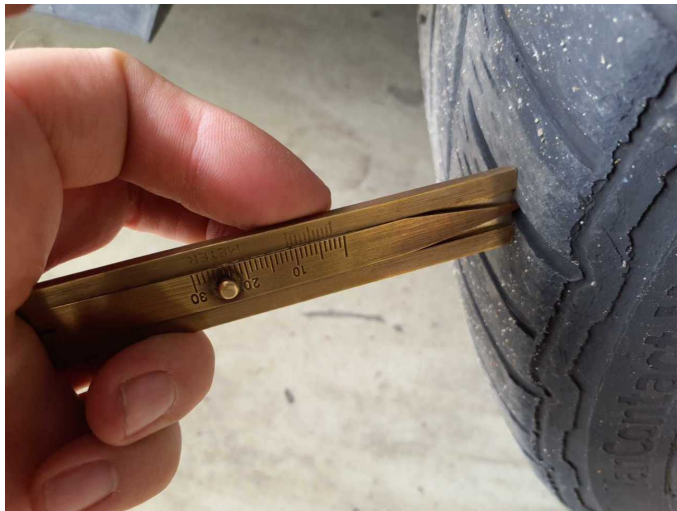
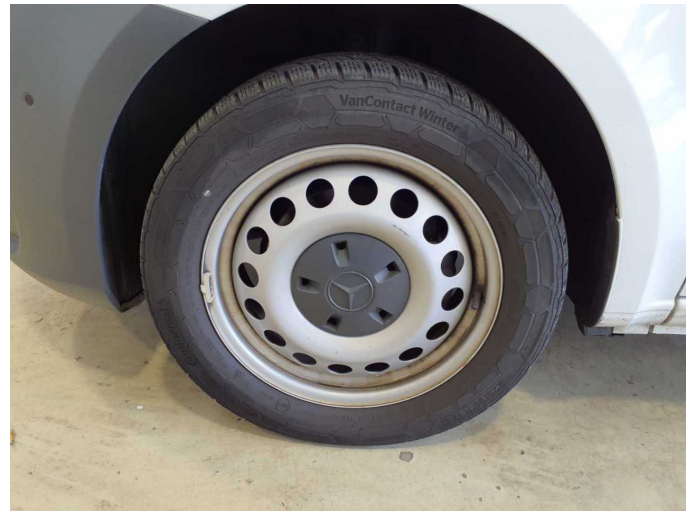
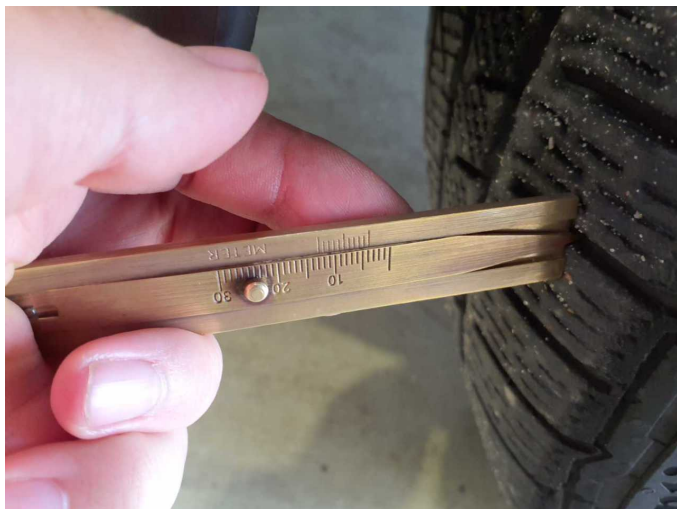
Damage 2: Wheel / tyres: Tyre - front - Does not meet the leasing specifications - Replace

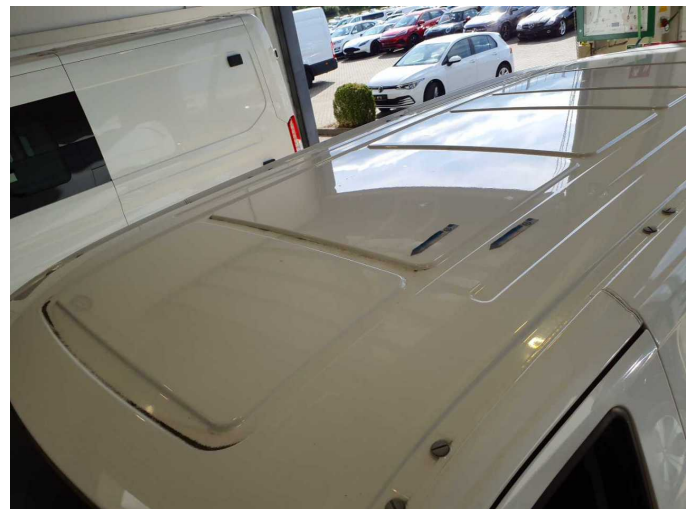
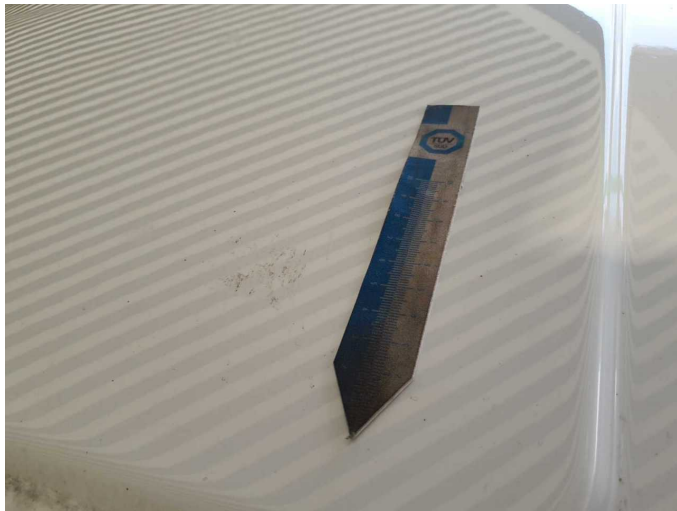
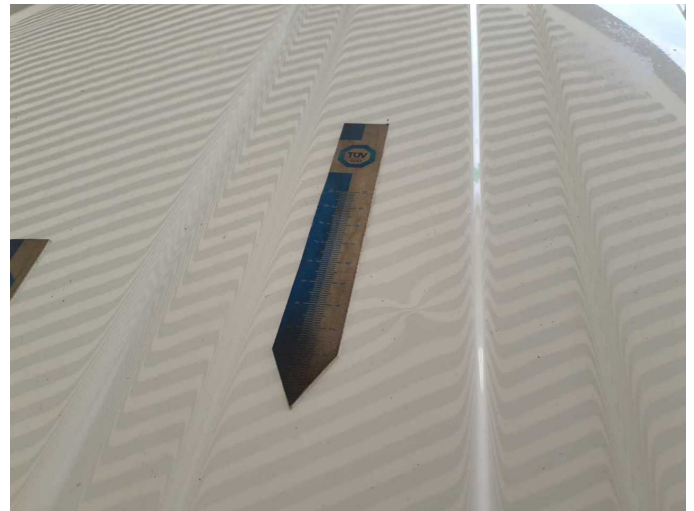
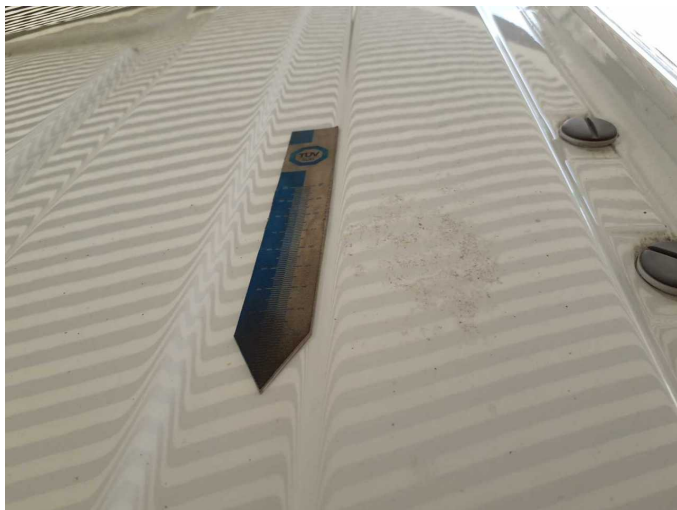
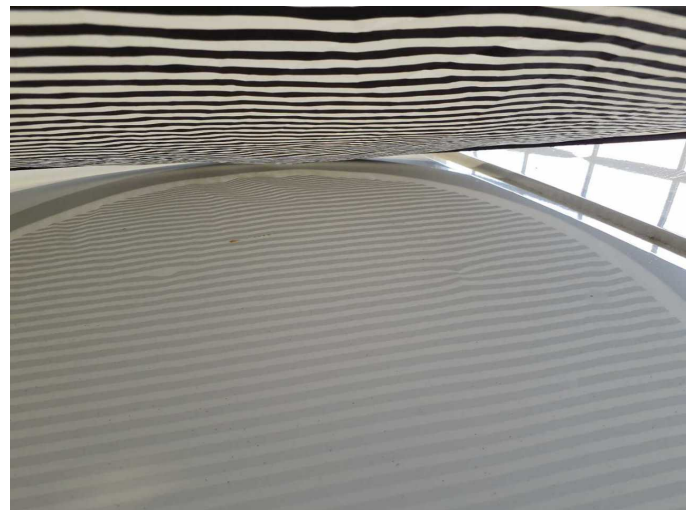
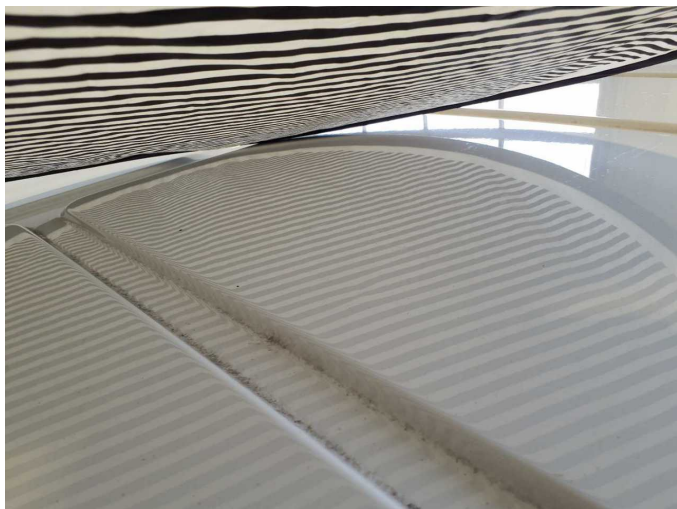
Damage 3: Roof: Roof - Dent / paintcoat damage - Loss in value

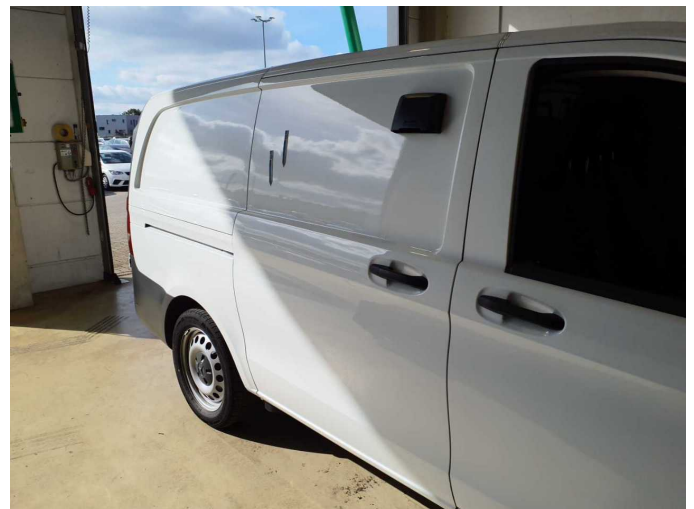
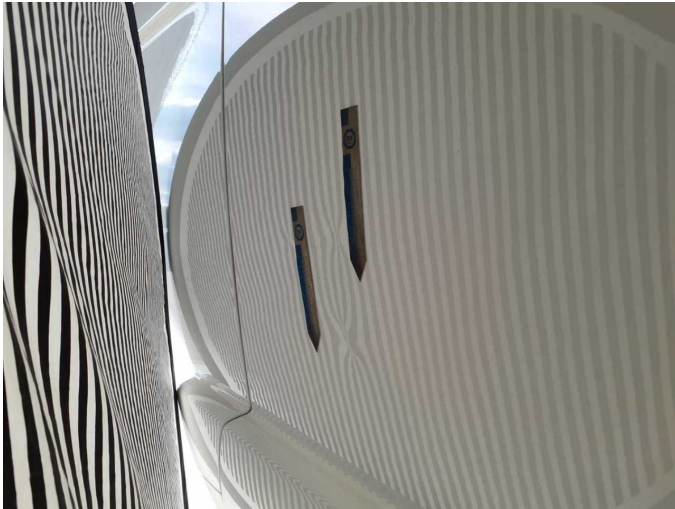
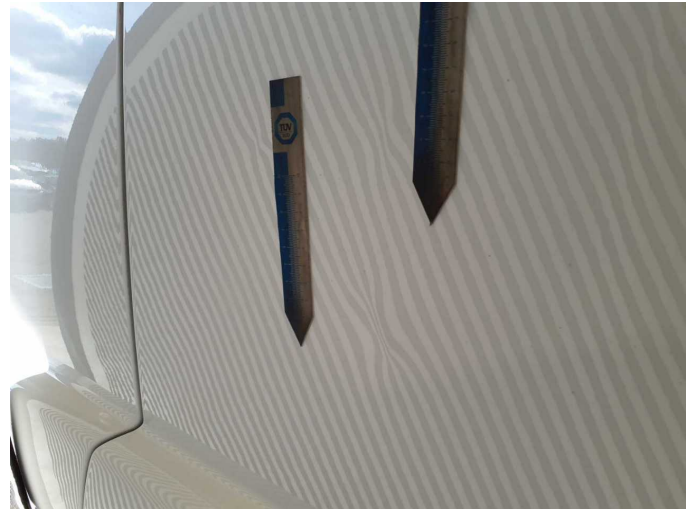
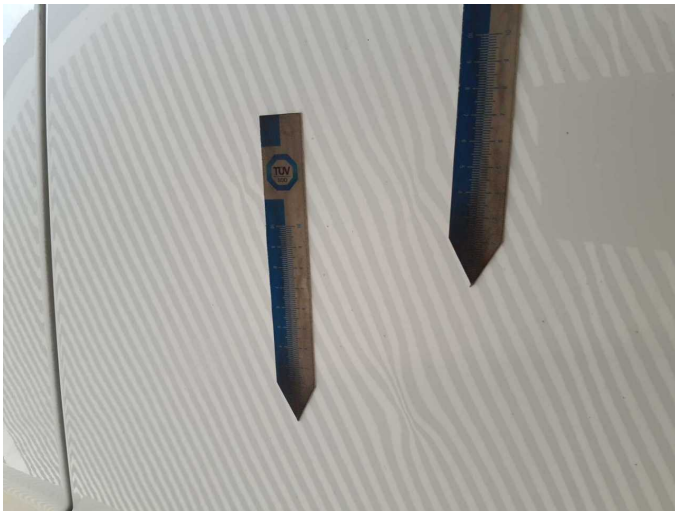
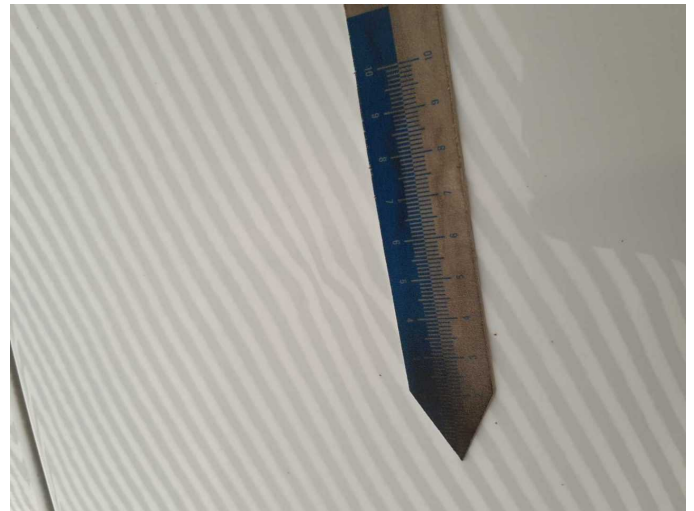
Damage 4: Sliding door, right: Sliding door - Deformed - Repair and paint

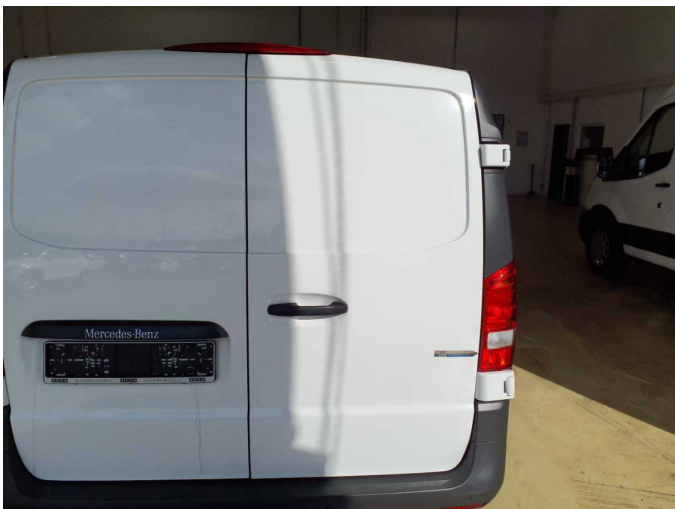
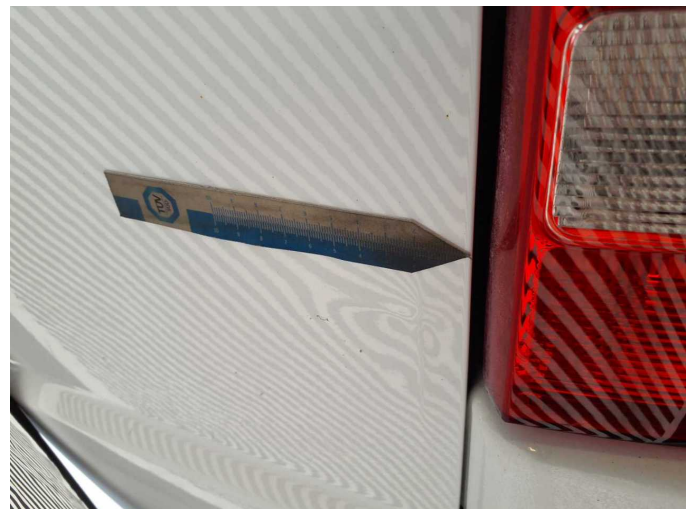
Damage 5: Boot lid / rear door: Rear door - right side - Deformed - Repair and paint

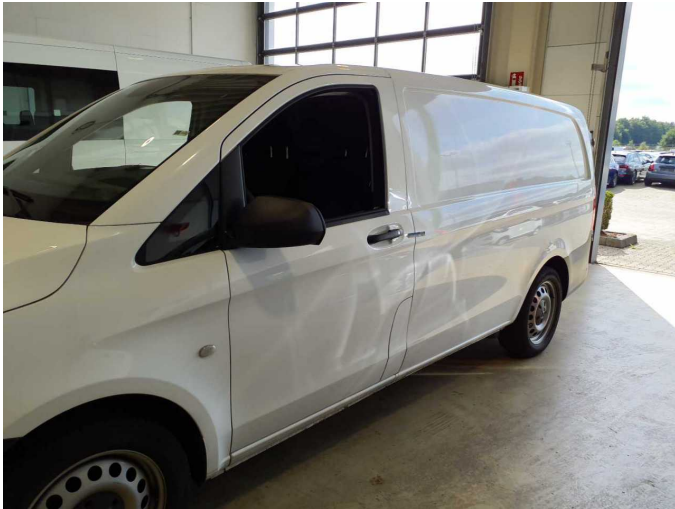
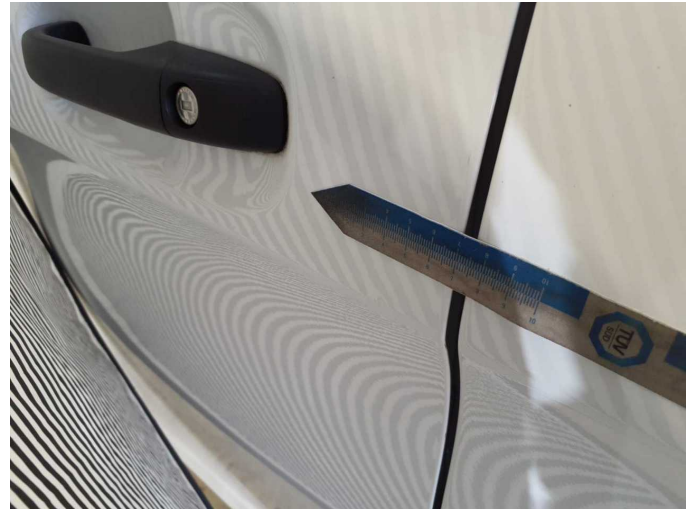
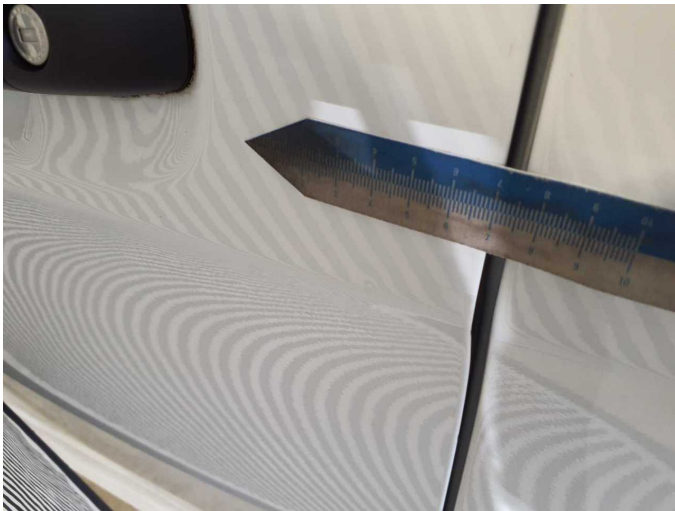
Wear and tear 5: Door - front left side: Door - dent(s) - No deduction

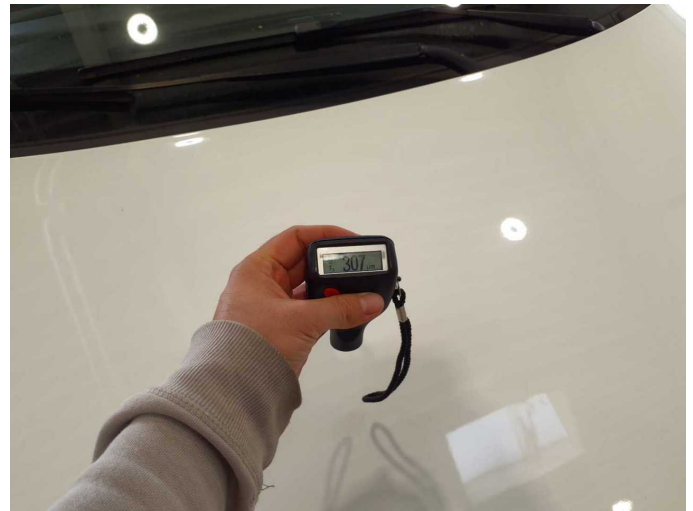
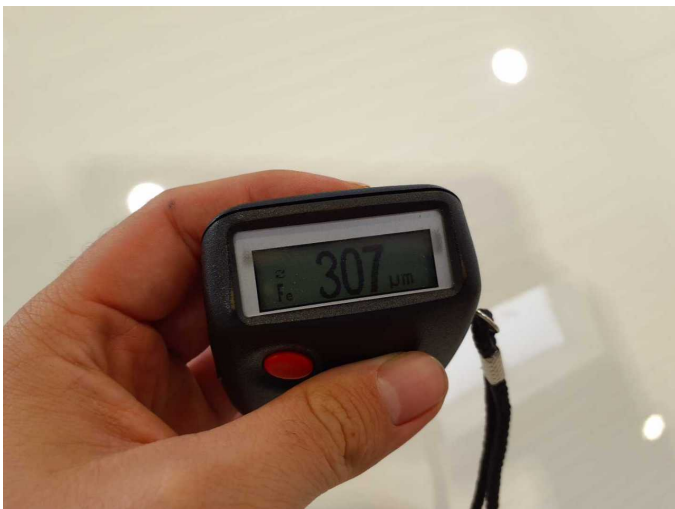
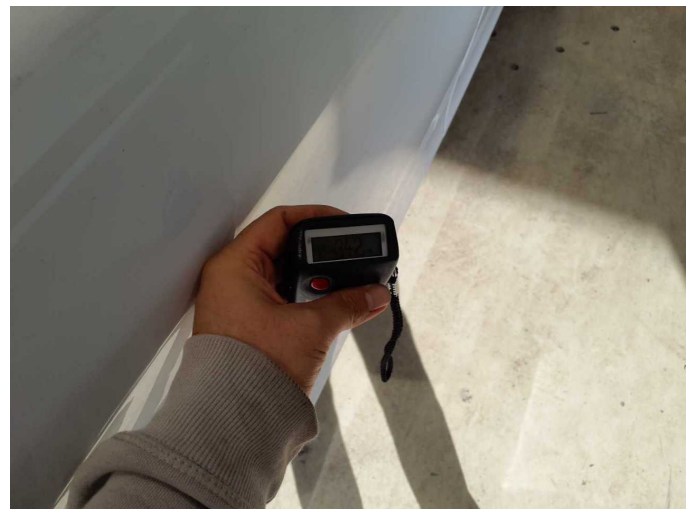
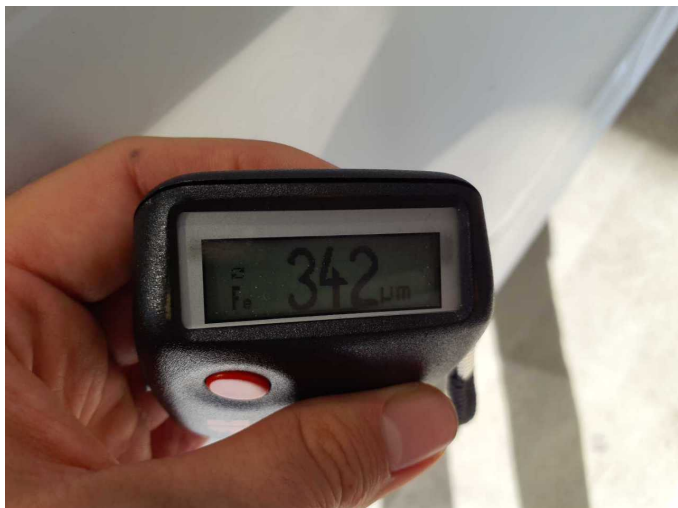
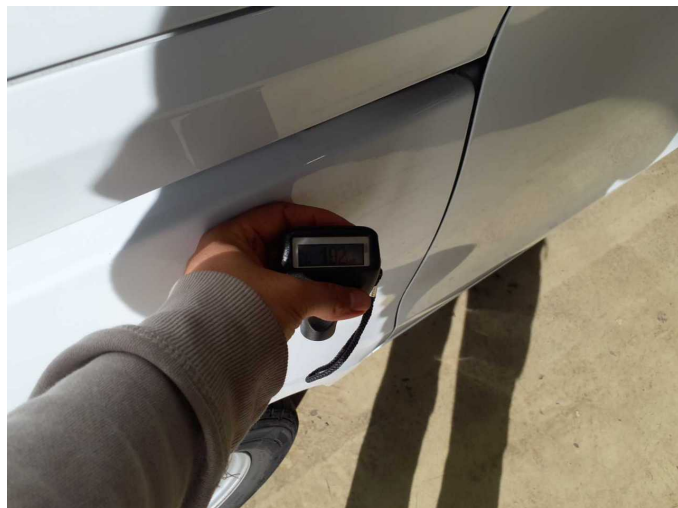
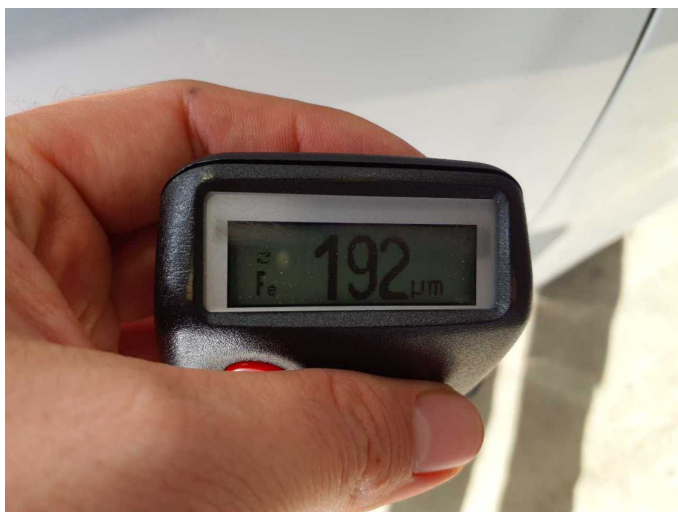
Bonnet	307 µm	Side panel - rear right side	192 µm
Door - rear right side	342 µm

Repainting 1: Bonnet, Side panel - rear right side, Door - rear right side
