Expertise

Protocol number: 41593647
Order No. / Reference: 25139980
Inspection date: 17 Sept 2025

Manufacturer: Mercedes-Benz
VIN: W1V44760513978638

Model: Vito 116 CDI Kasten Extralang HA PRO

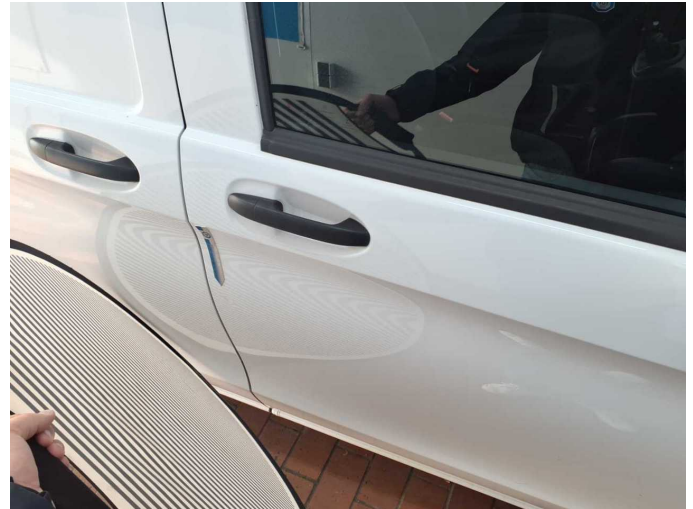
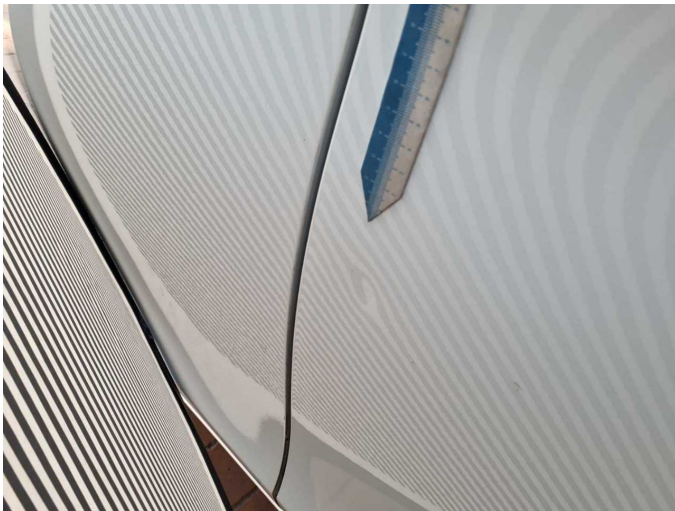
Damage 1: Door - front right side: Door - dent(s) - Smart repair

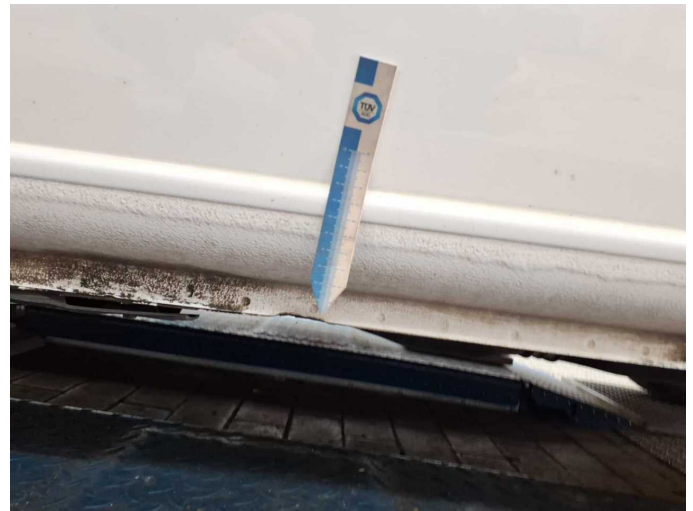
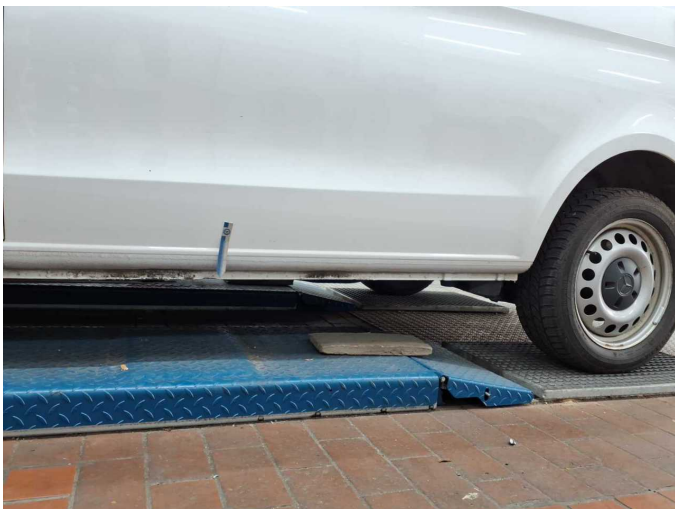
Damage 2: Sill - left side: Sill - Deformed - Loss in value

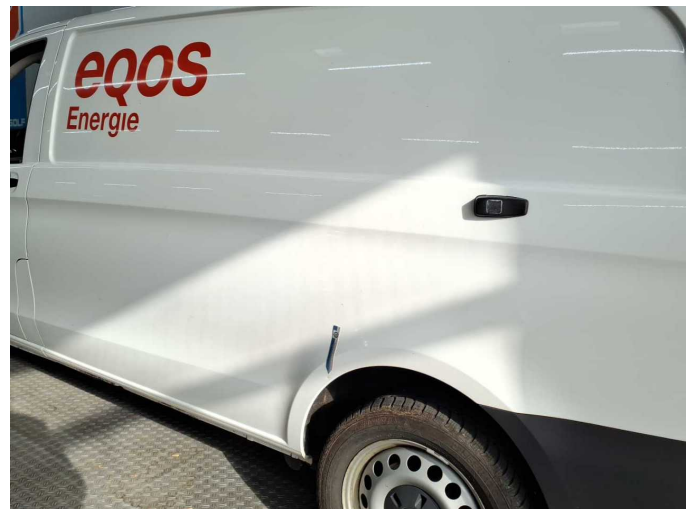
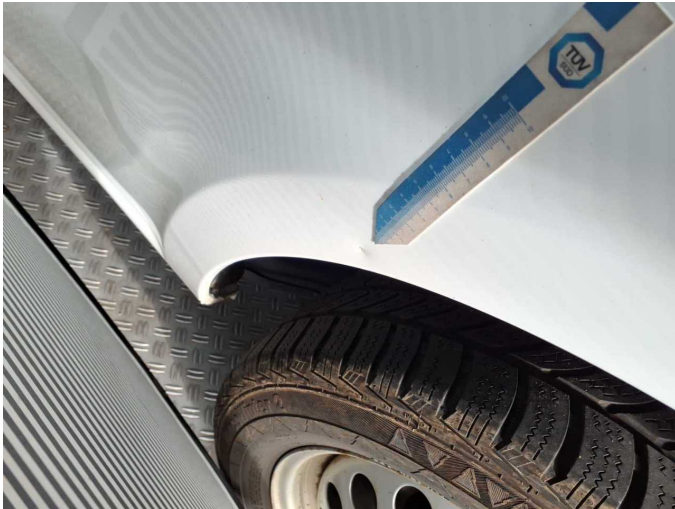
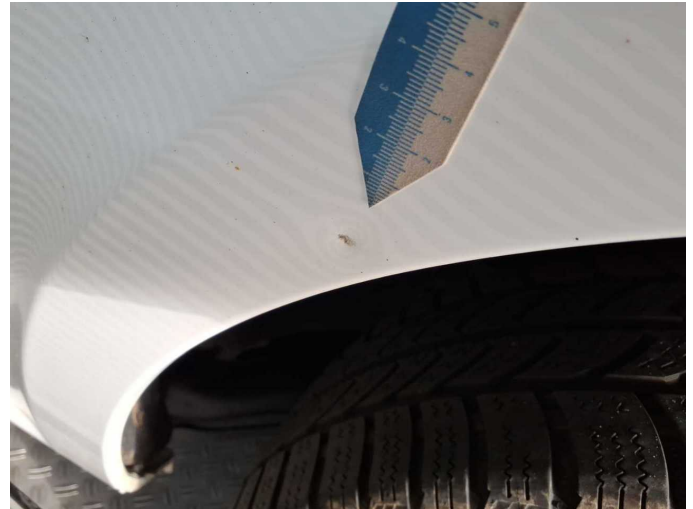
Damage 3: Side panel - rear left side: Side panel - Dent / paintcoat damage - Smart repair

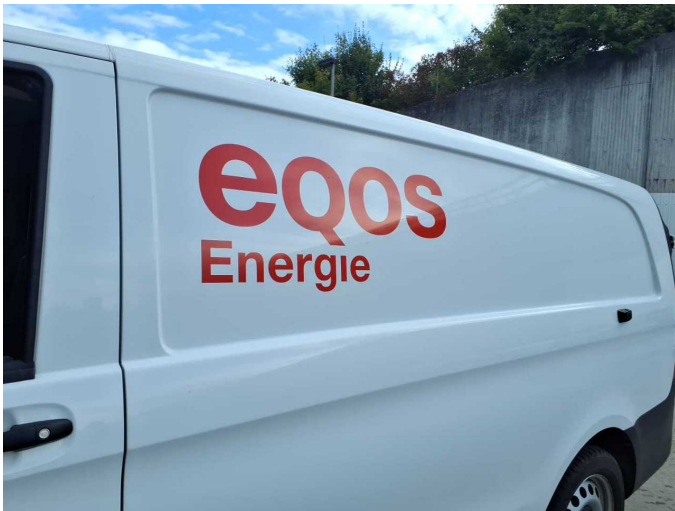
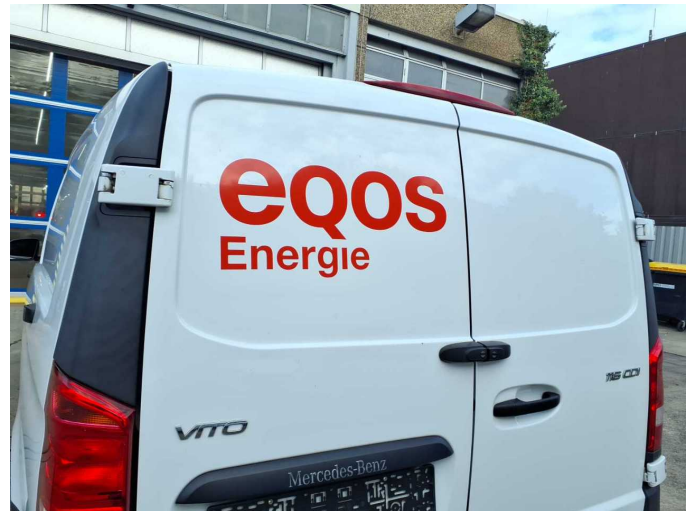
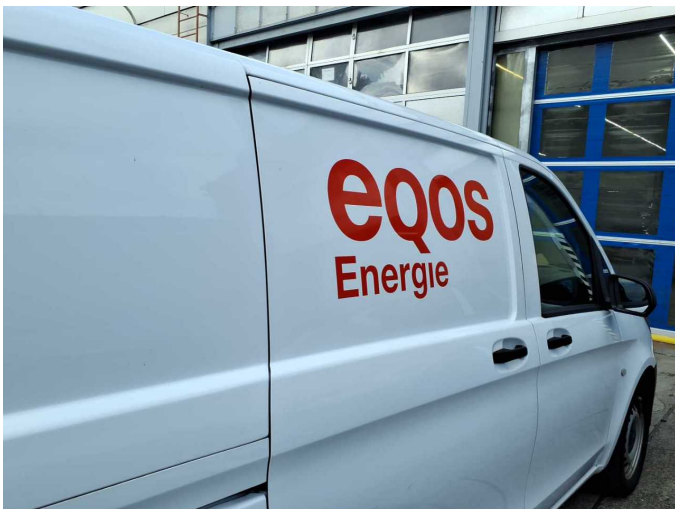
Damage 4: Body: Body - Glued / labelled - De-glue / neutralise

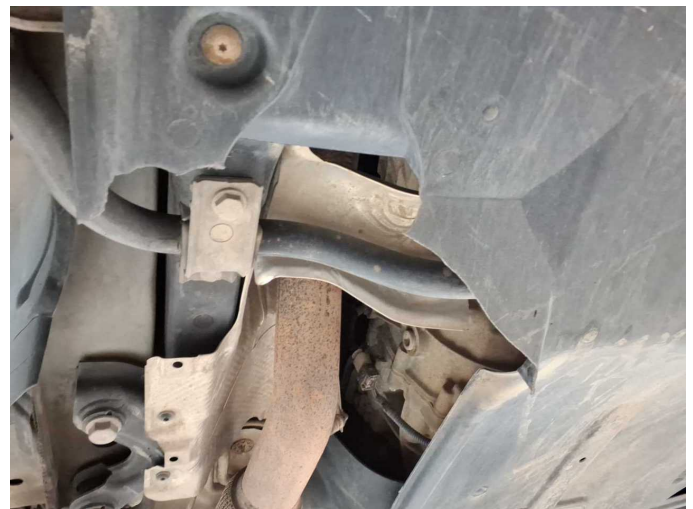
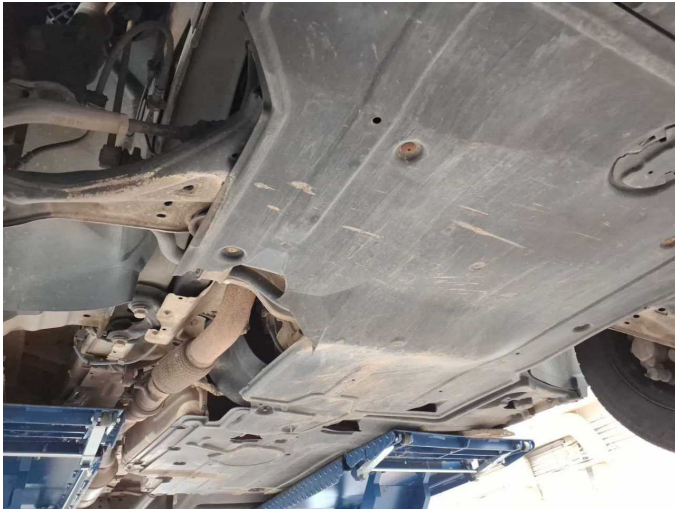
Damage 5: Body: Underbody panelling - Broken / torn - Replace

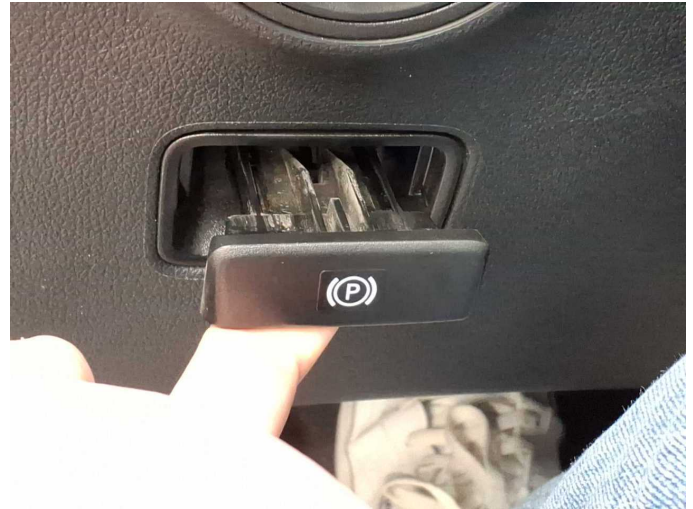
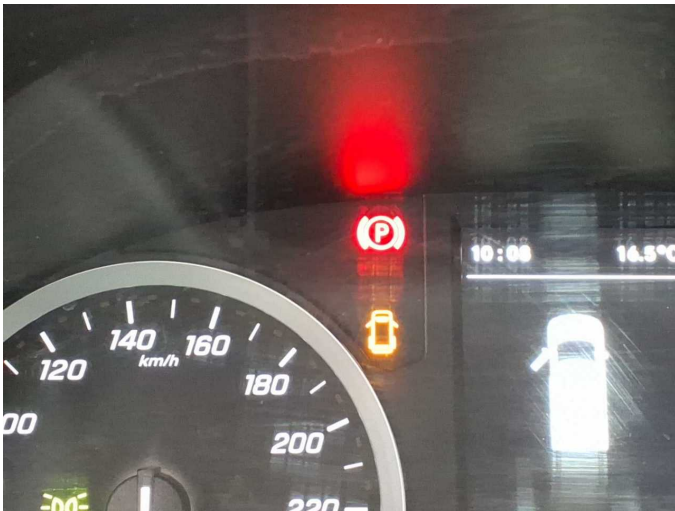
Damage 6: Braking system: Braking system (Handbremse ohne Funktion) - Specify findings - Perform diagnosis

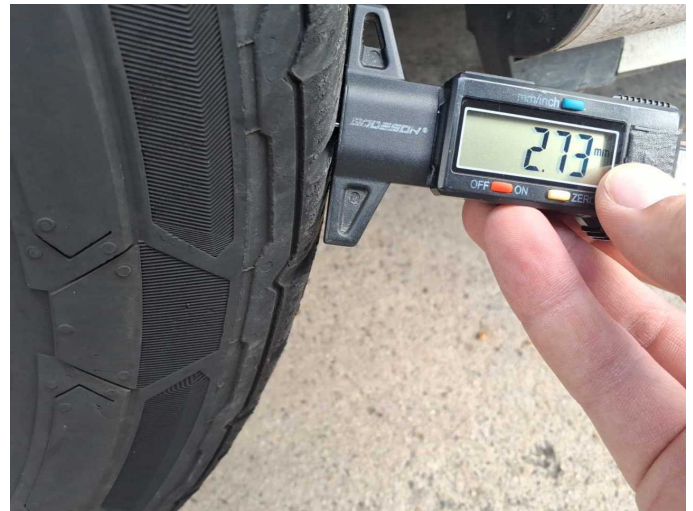
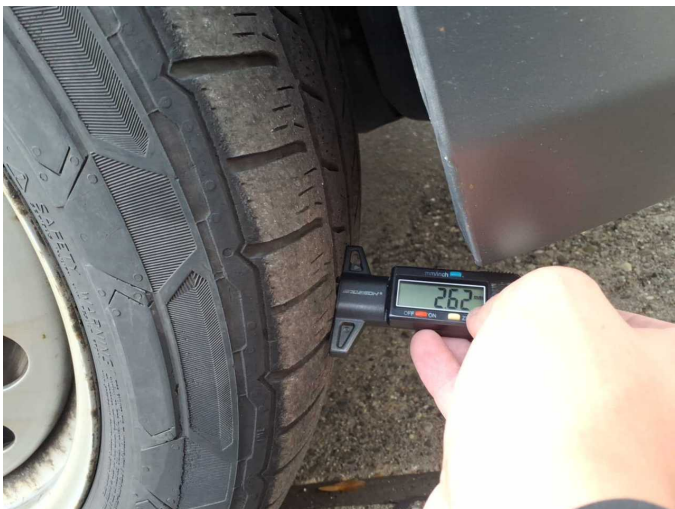
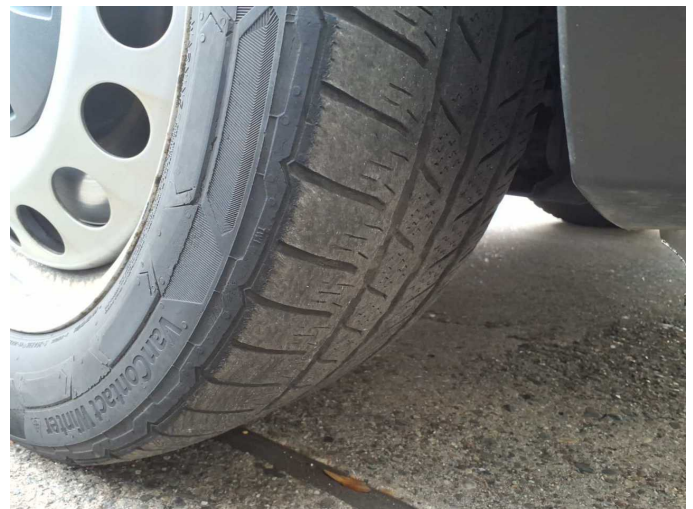
#	Tyre size	Type of tyre	Manufacturer	Tread depth
1)	225/55 R17 109T	Winter tyres on Steel rim with wheel cover	Continental	2mm / 2mm
2)	225/55 R17 109T	Winter tyres on Steel rim with wheel cover	Continental	5mm / 5mm

Damage 7: Wheel / tyres: Tyre - front - Does not meet the leasing specifications - Replace

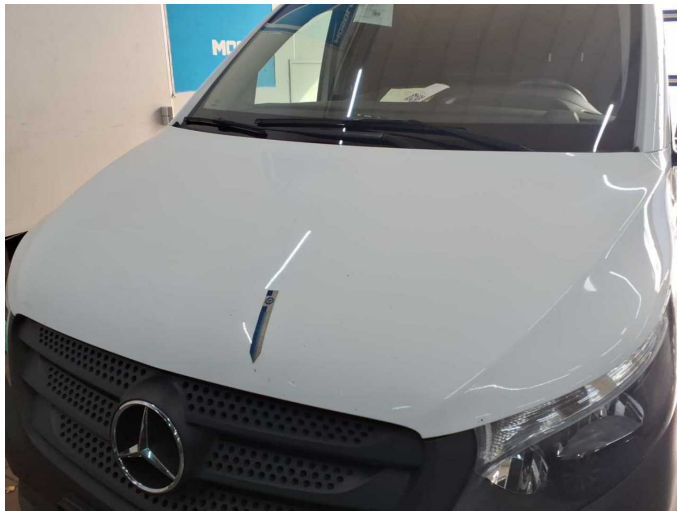
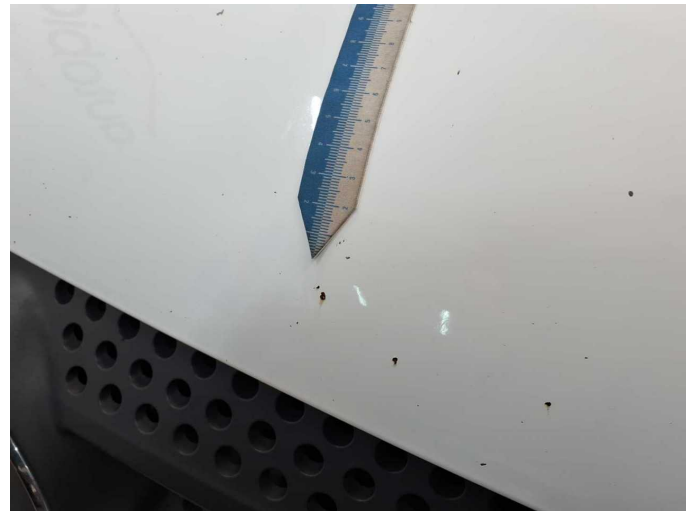
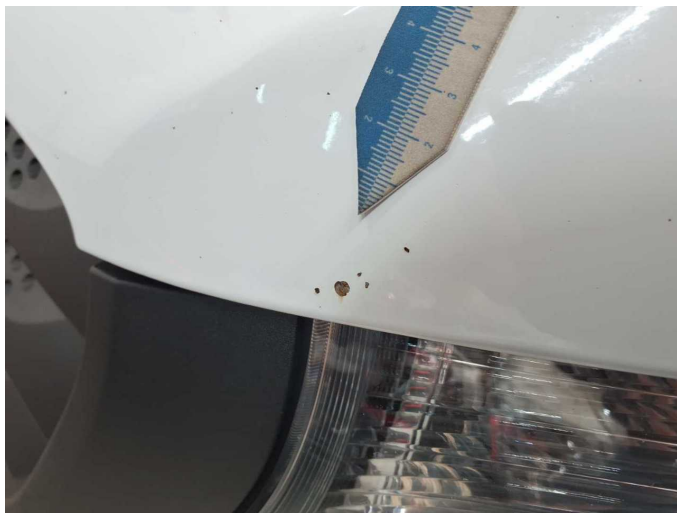
Damage 8: Bonnet: Bonnet (+Korrosion) - Stone chips - Paint

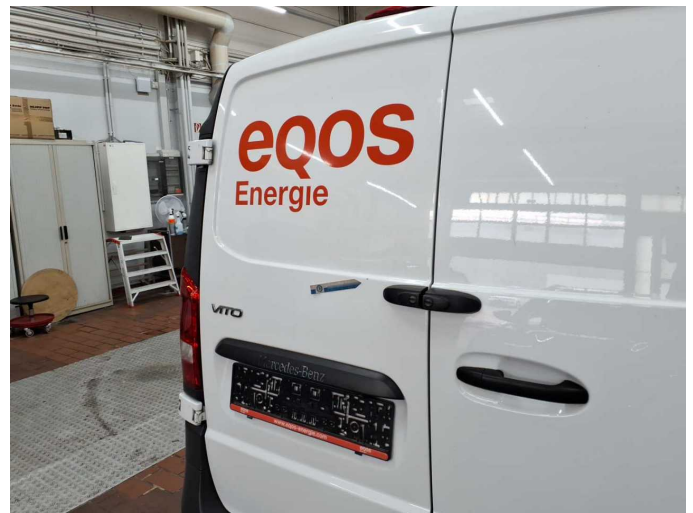
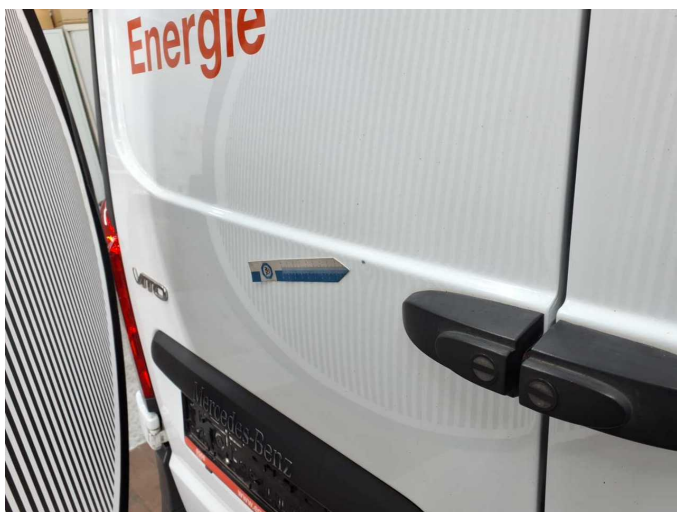
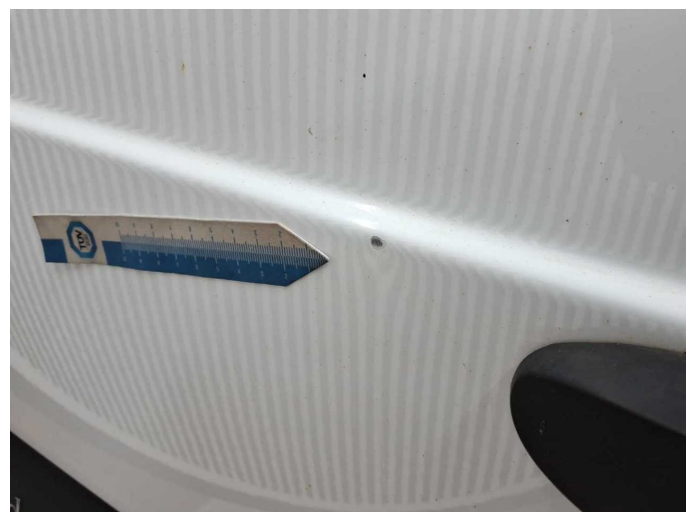
Wear and tear 5: Boot lid / rear door: Rear door - left side - Dent / paintcoat damage - No deduction
