## status report

| <b>customer:</b> | <b>Bank 11, Neuss</b> |
| <b>contract number:</b> | <b>1267206851-AKR</b> |

| vehicle data | | | |
|---|---|---|---|
| <b>Mercedes-Benz V -Klasse V 220/250/300 d AVANTGARDE EDITION 4MATIC lang</b> | | | |

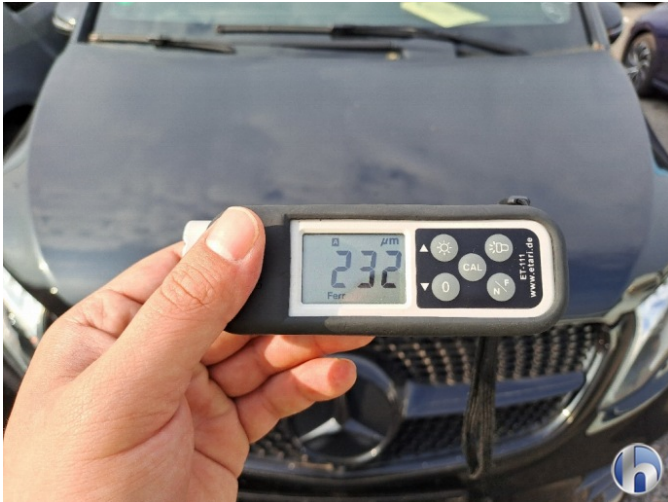
| component | Damage | Rep kind |
|---|---|---|
| 1. hood | Subsequently painted | acceptable |

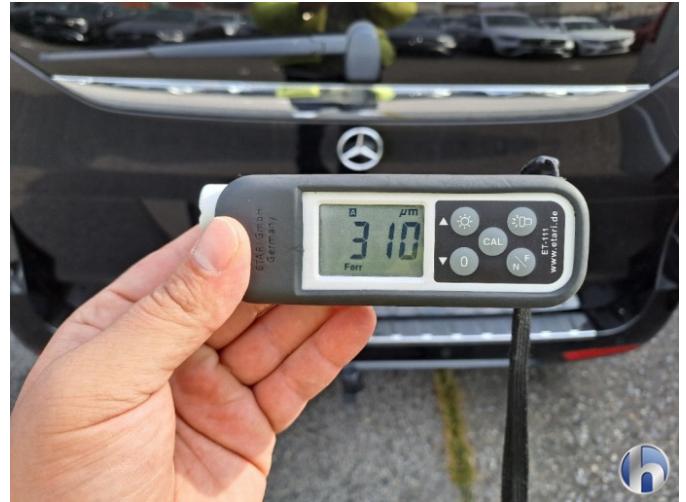
| component | Damage | Rep kind |
|---|---|---|
| 2. tailgate | Subsequently painted | acceptable |

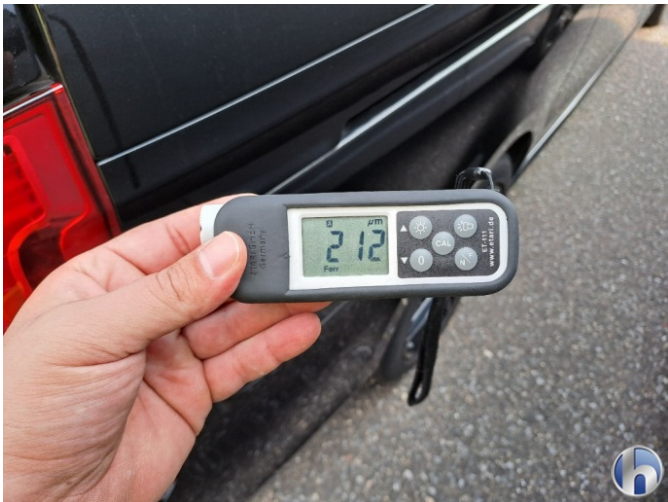
| component | Damage | Rep kind |
|---|---|---|
| 3. Sidewall - Rear - right | Subsequently painted | acceptable |

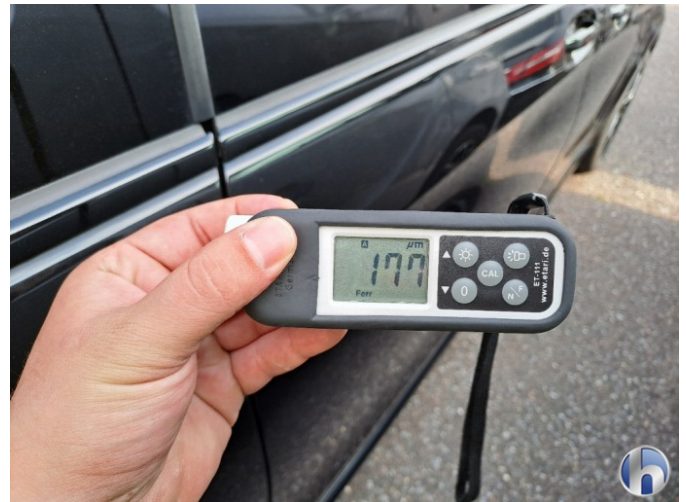
| component | Damage | Rep kind |
|---|---|---|
| 4. Door Rear - right | Subsequently painted | acceptable |

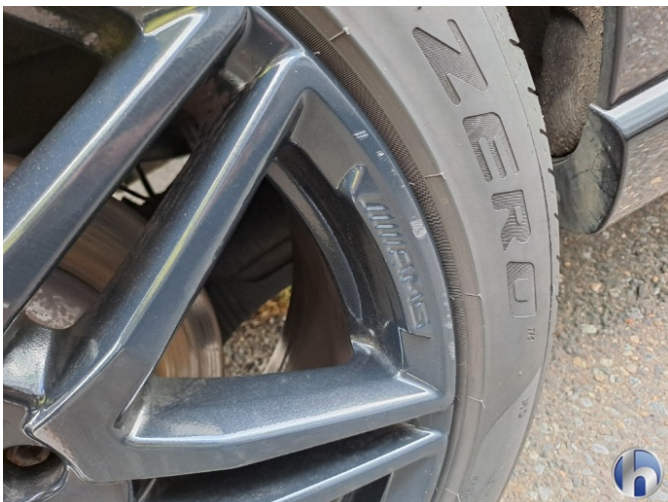
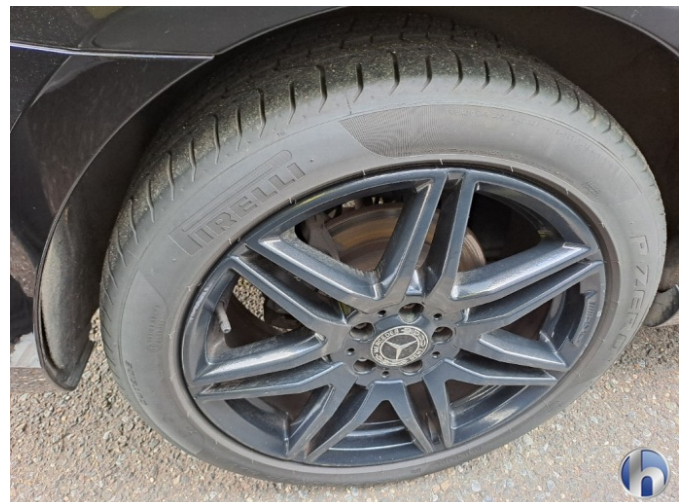
| component | Damage | Rep kind |
|---|---|---|
| 5. Rim rear - right | Scratch(es) | Smart repair |

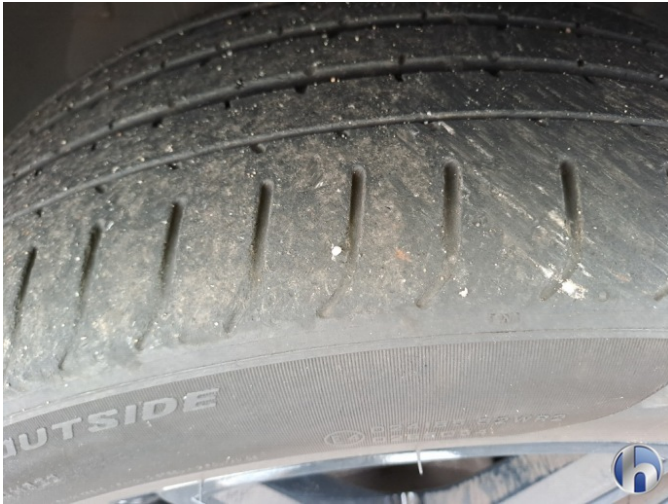
| mounted tires | | |
|---|---|---|
| 1st axis - Left / states . | <b>Pirelli</b> | <b>245/45/R19/102Y 1 mm</b> |

| component | Damage | Rep kind |
|---|---|---|
| 6. tire front - left | Worn | Replace |

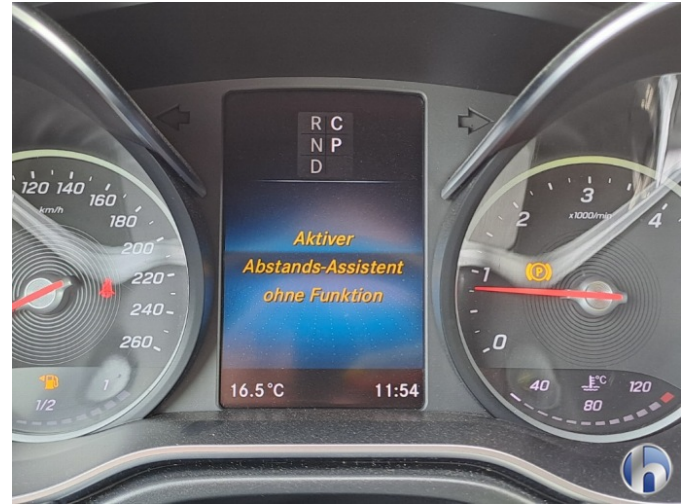
| component | Damage | Rep kind |
|---|---|---|
| 8. Abstandsassistent | Error message | Carry out a fault diagnosis |

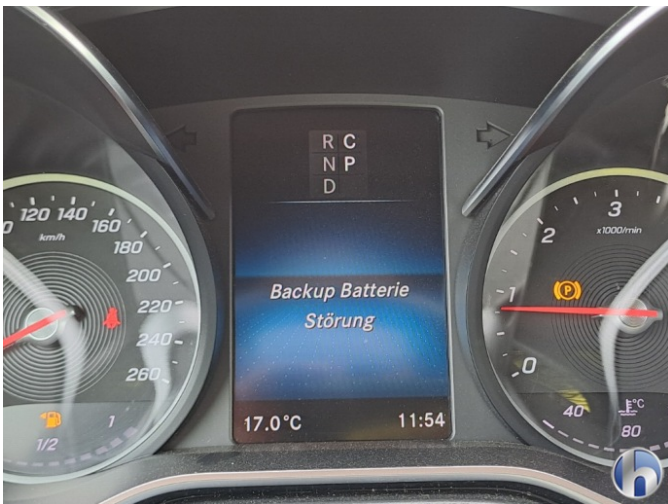
| Performed testing technology | |
|---|---|
| <b>Battery / accumulator:</b> | The battery (accumulator) was discharged for visiting time . |
| <b>oil loss:</b> | **Battery deep discharge. Vehicle was bridged with a jumper. |

| component | Damage | Rep kind |
|---|---|---|
| 9. battery | Error message | Carry out a fault diagnosis |

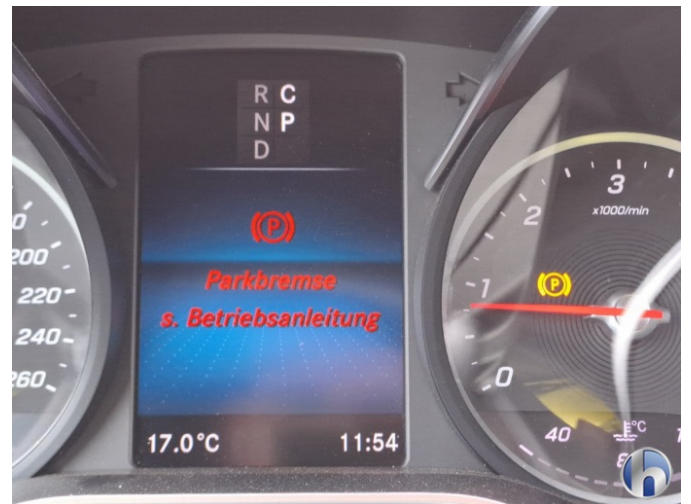
| component | Damage | Rep kind |
|---|---|---|
| 10. Parkbremse | Error message | Carry out a fault diagnosis |

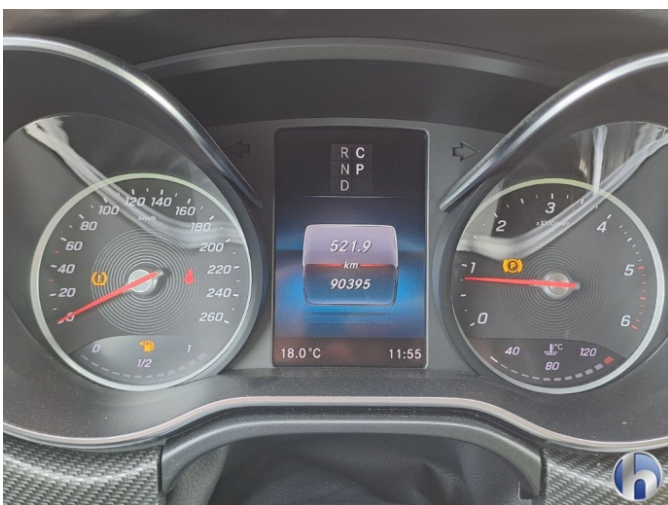
| component | Damage | Rep kind |
|---|---|---|
| 11. Warnleuchte Reifendruck | Error message | Carry out a fault diagnosis |

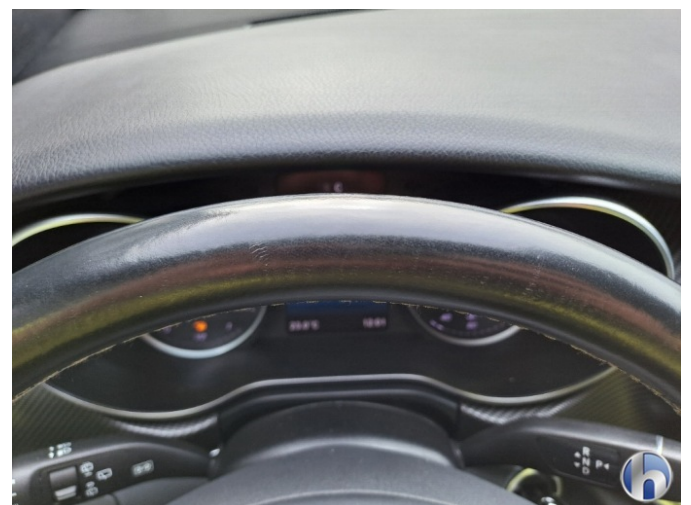
| component | Damage | Rep kind |
|---|---|---|
| 12. steering wheel | Scratch(es) | Replace |

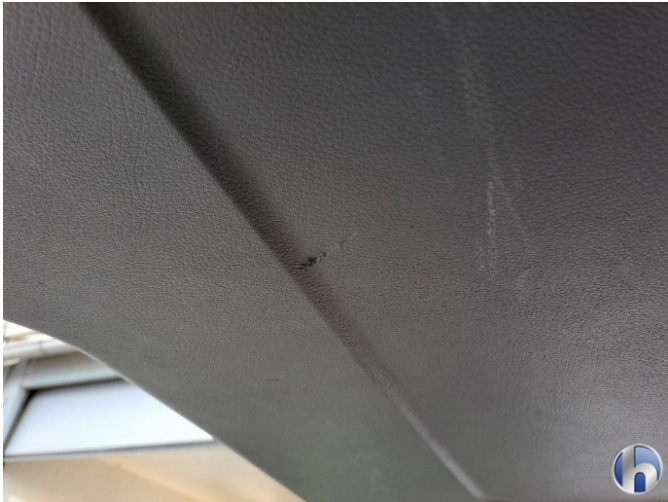
| component | Damage | Rep kind |
|---|---|---|
| 13. tailgate trim | Scrape | Replace |

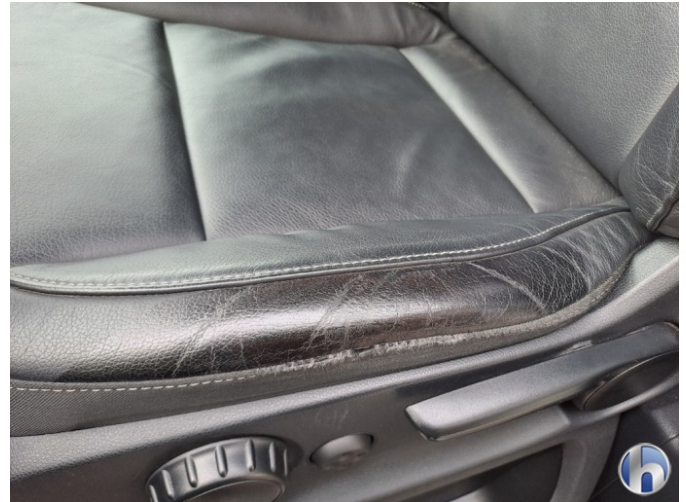
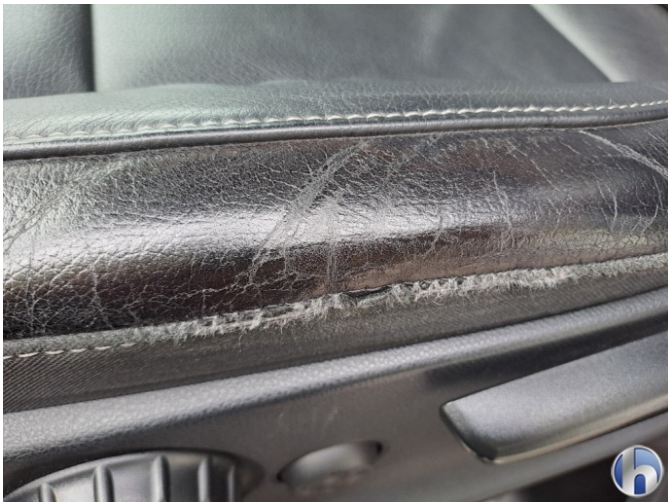
| component | Damage | Rep kind |
|---|---|---|
| 15. | Wear and tear | acceptable |

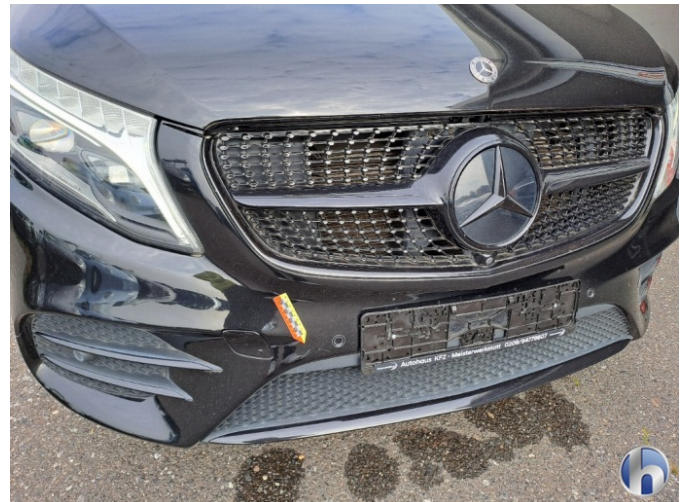
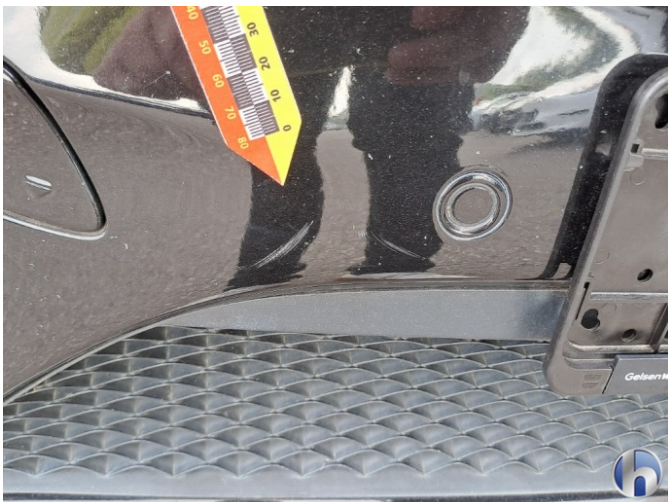
| component | Damage | Rep kind |
|---|---|---|
| 16. Front bumper | Scratch(es) | Paint |

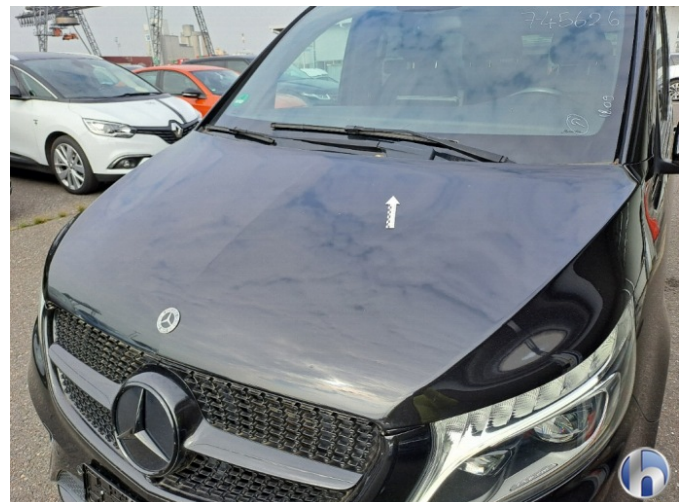
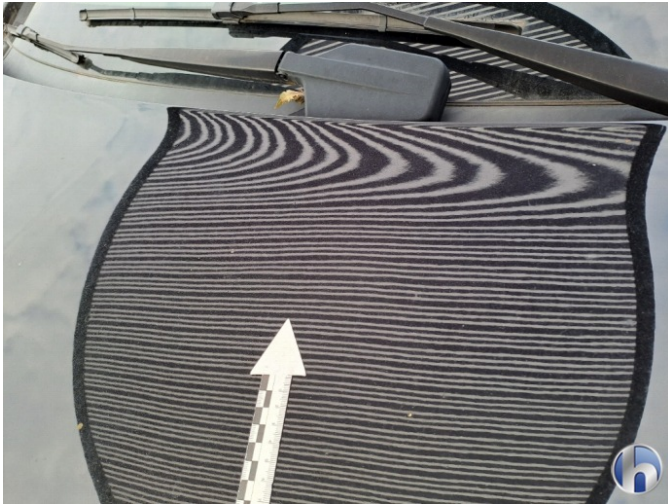
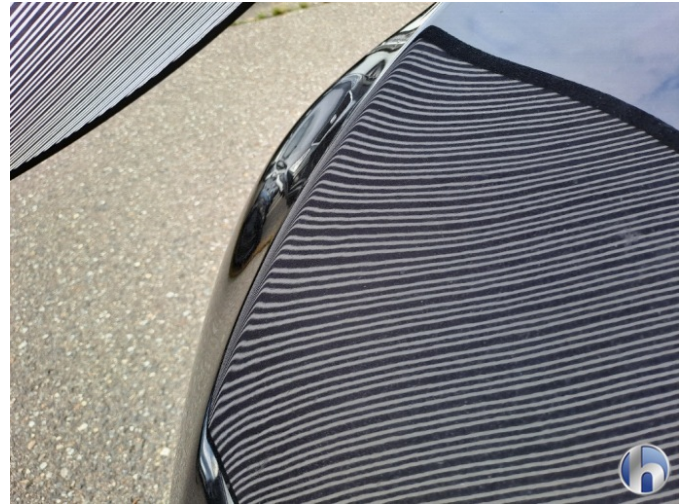
| component | Damage | Rep kind |
|---|---|---|
| 17. hood | Execution defect | Paint |

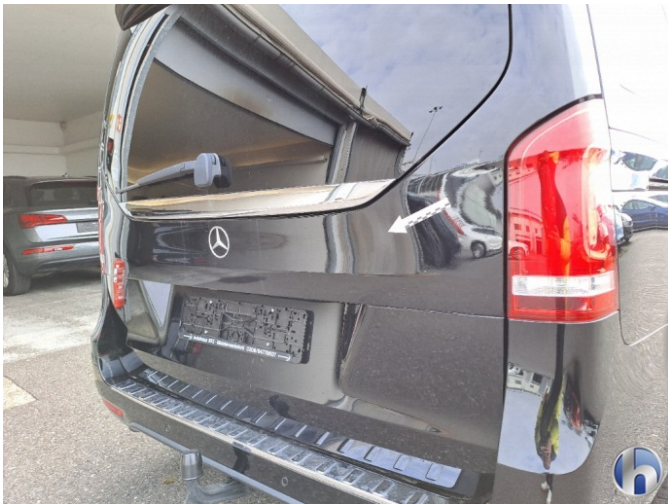
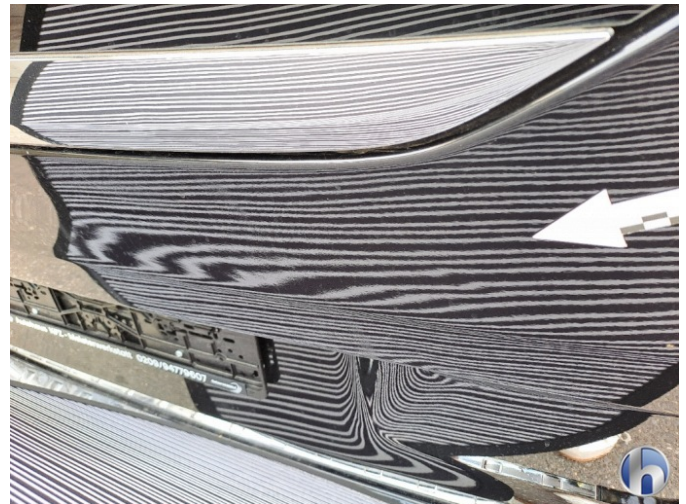
| component | Damage | Rep kind |
|---|---|---|
| 18. tailgate | Execution defect | Refurbish and paint |

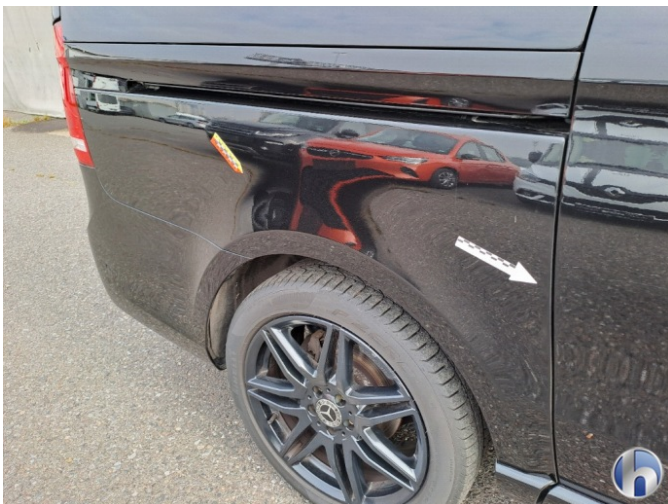
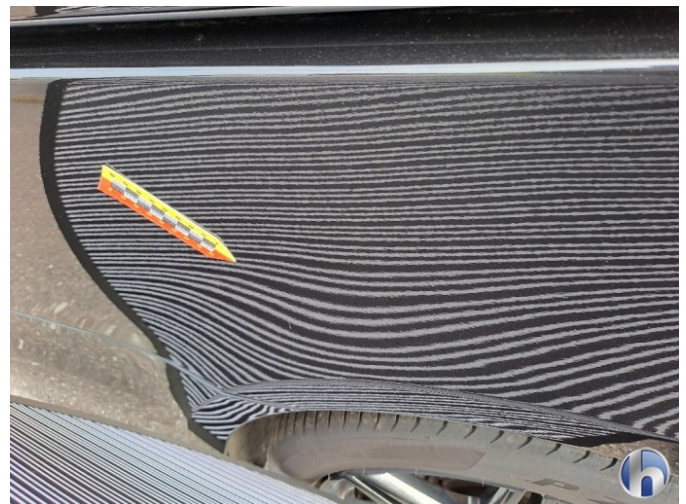
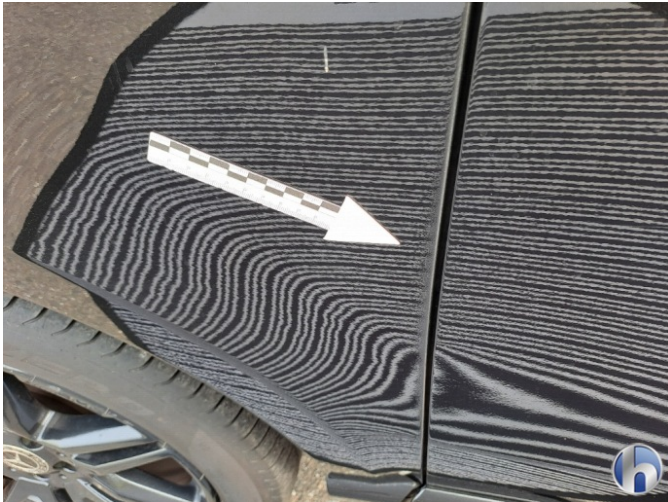
| component | Damage | Rep kind |
|---|---|---|
| 19. Sidewall - Rear - right | Execution defect | Refurbish and paint |

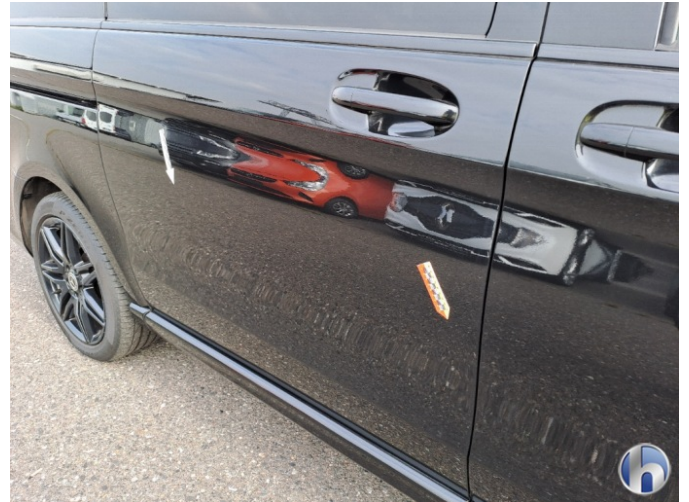
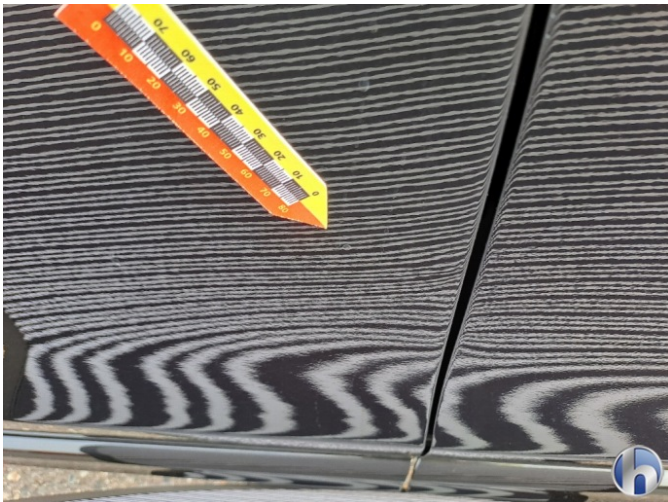
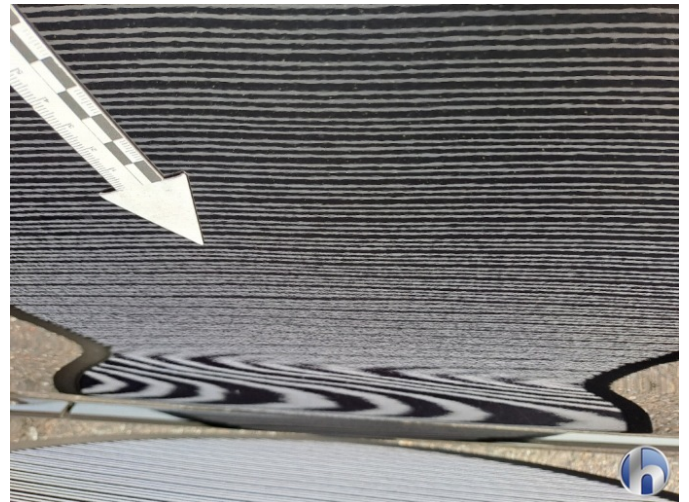
| component | Damage | Rep kind |
|---|---|---|
| 20. Door Rear - right | Execution defect | Refurbish and paint |

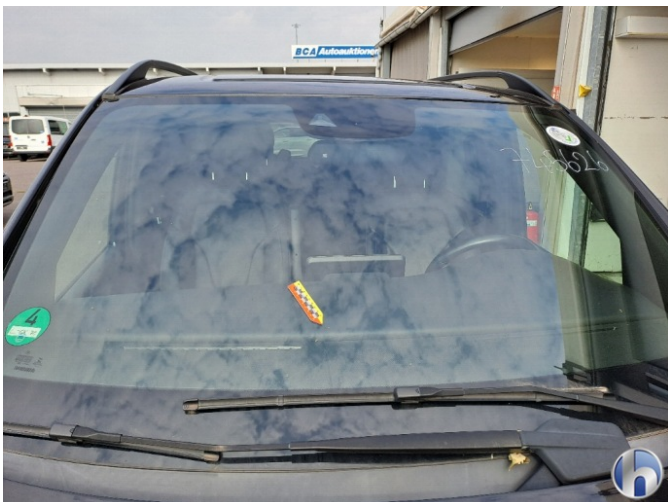
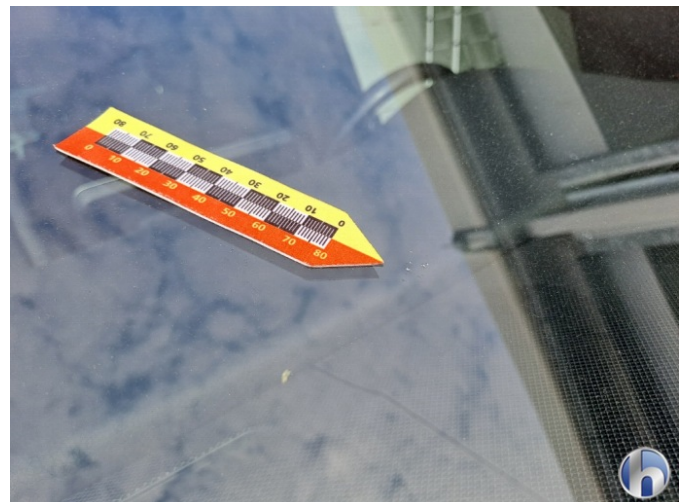
| component | Damage | Rep kind |
|---|---|---|
| 21. Windshield | Chipping from stones | Replace |

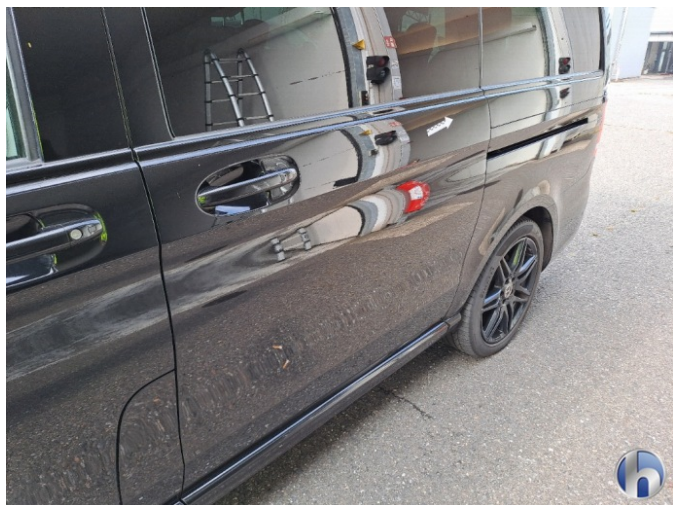
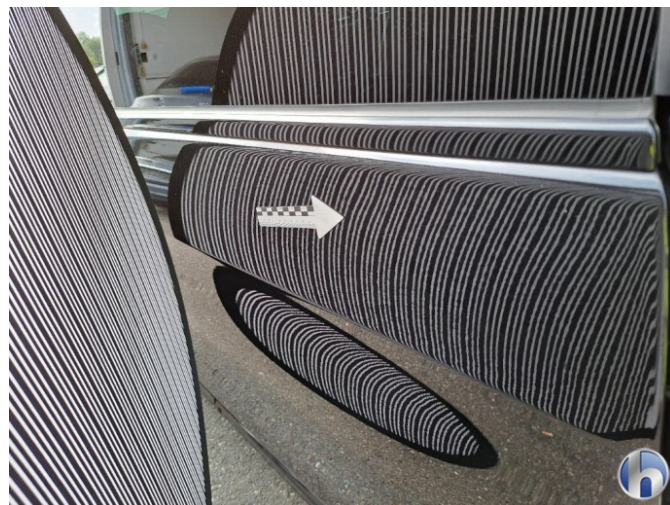
| component | Damage | Rep kind |
|---|---|---|
| 22. Rear door - left | Delle | Smart repair |

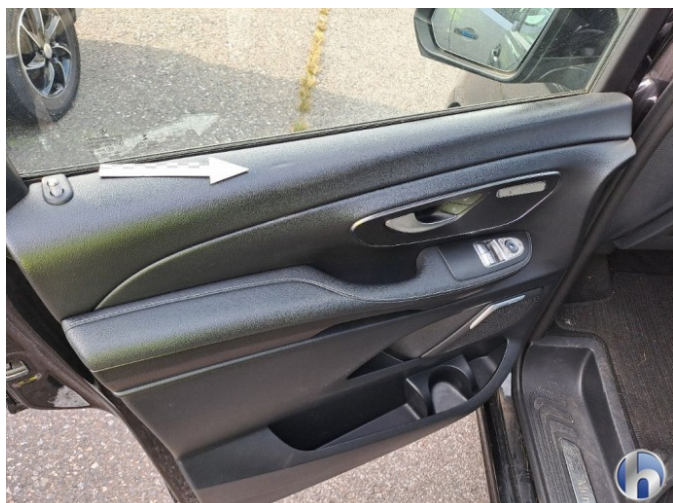
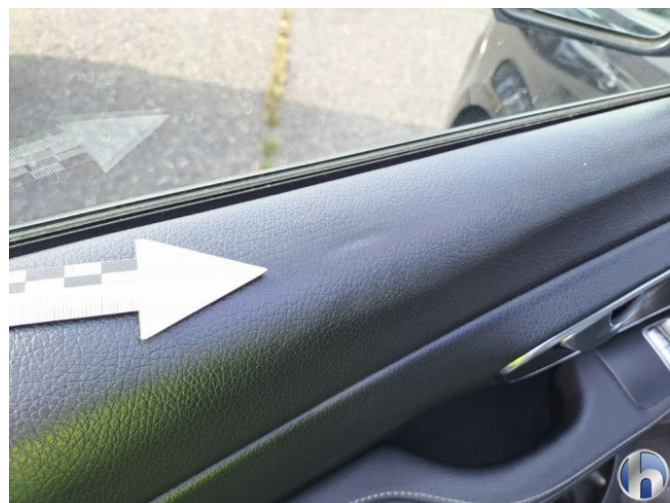
| component | Damage | Rep kind |
|---|---|---|
| 23. Front door trim - left | Deformed (slightly) | Replace |
