Expertise

Protocol number: 41567253
Order No. / Reference: 25232949
Inspection date: 15 Sept 2025

Manufacturer: Mercedes-Benz
VIN: W1V9076331P268061

Model: 319 CDI Sprinter Standard HA

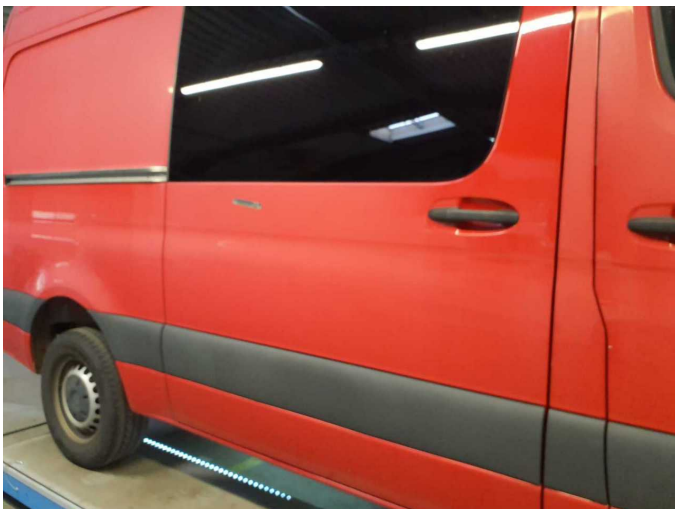
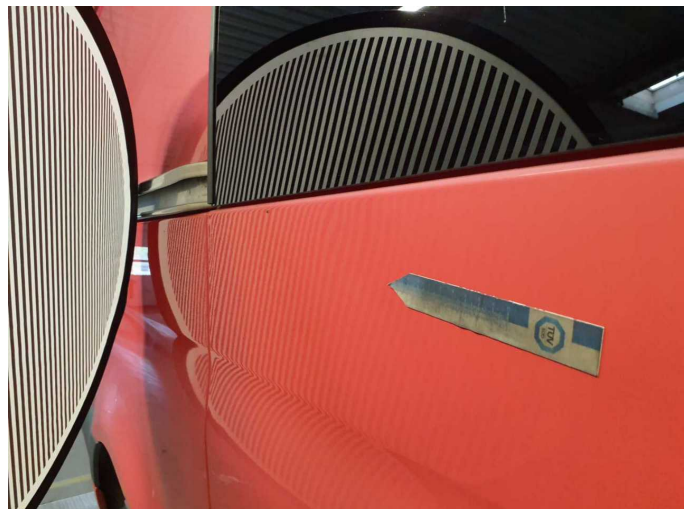
No.	Component group	Description
1	Misc.	Main inspection - No evidence - No deduction
2	Sliding door, right	Sliding door with glass panel - dent(s) - Smooth repair work
3	Mudguard - right side	Mudguard - right side - dent(s) - Smooth repair work
4	Door - front right side	Door - Scratched - Smart repair
5	Body	Body (Ausgeblichen) - Paint defect - Conditioning

Damage 2: Sliding door, right: Sliding door with glass panel - dent(s) - Smooth repair work

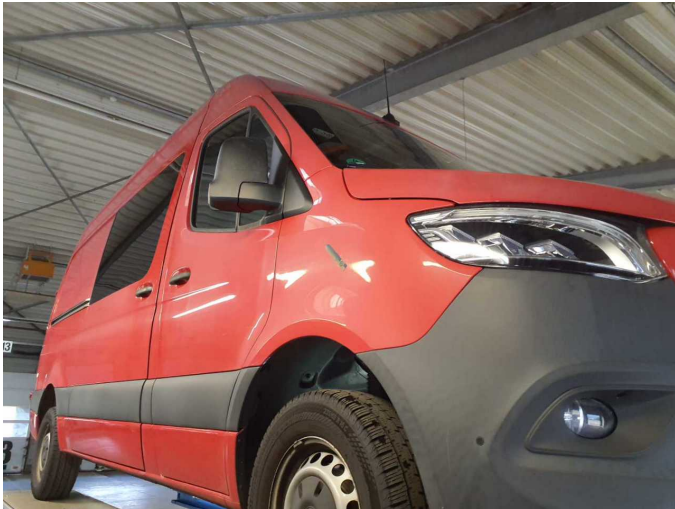
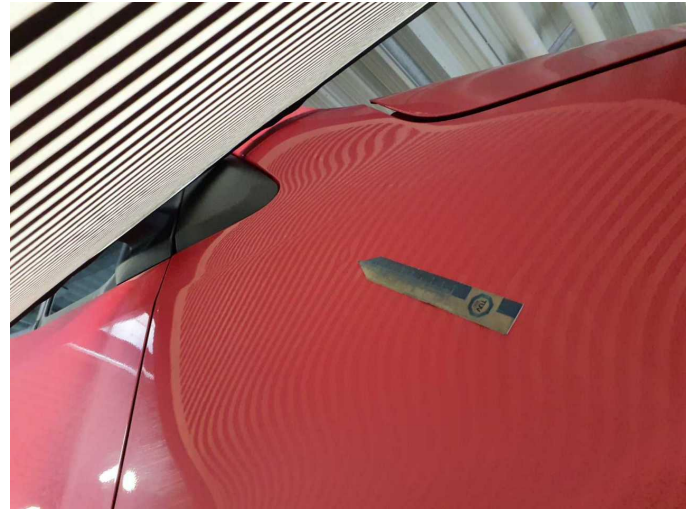
Damage 3: Mudguard - right side: Mudguard - right side - dent(s) - Smooth repair work

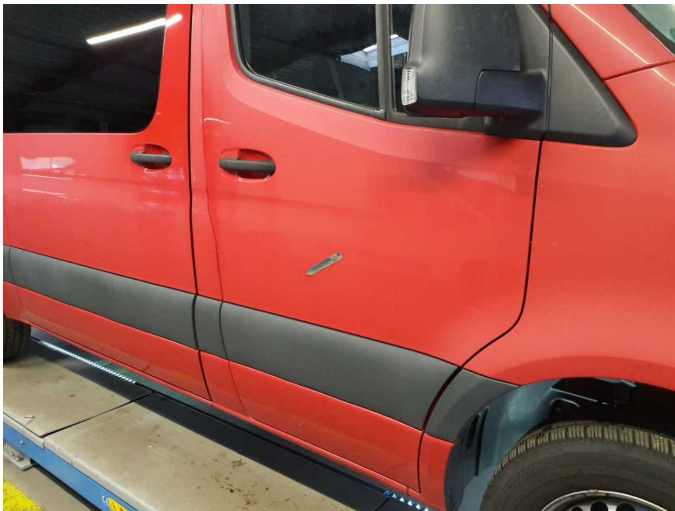
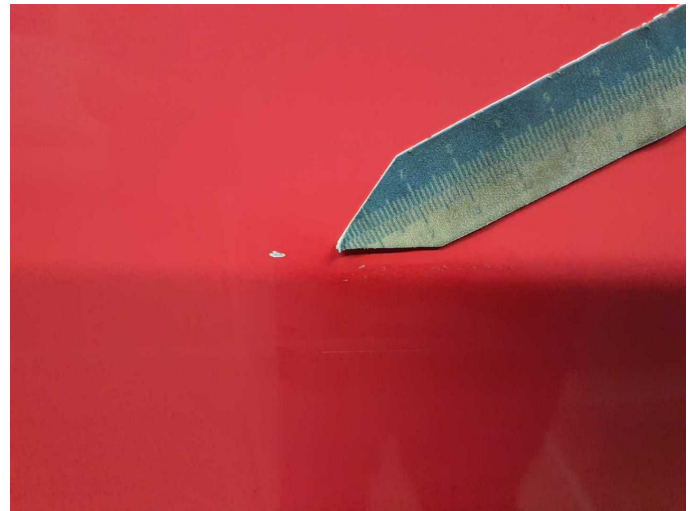
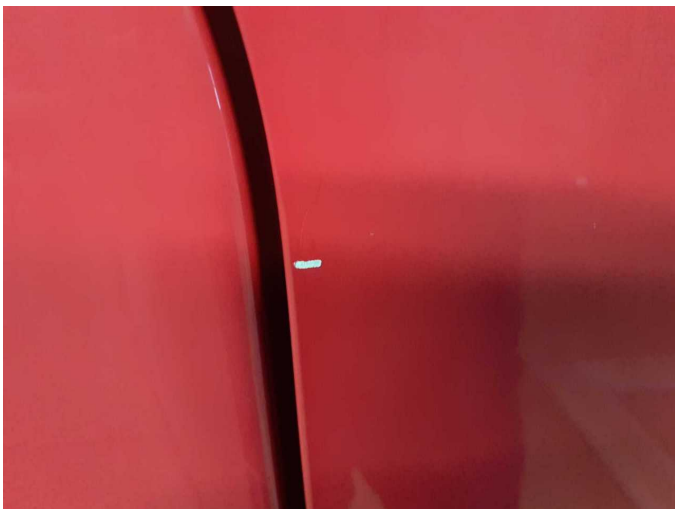
Damage 4: Door - front right side: Door - Scratched - Smart repair

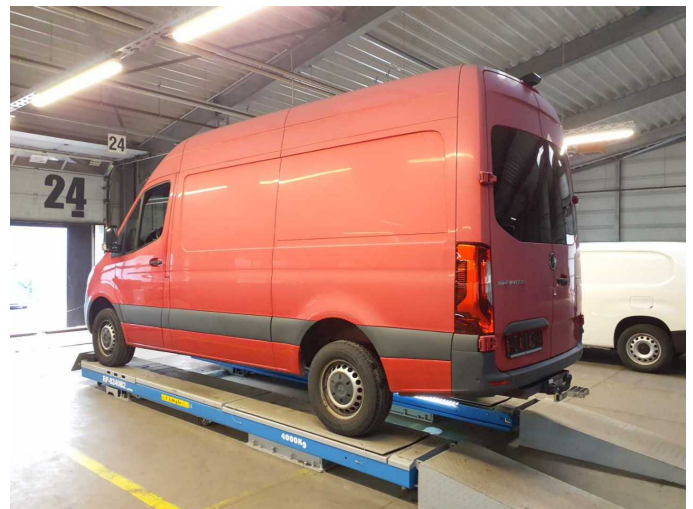
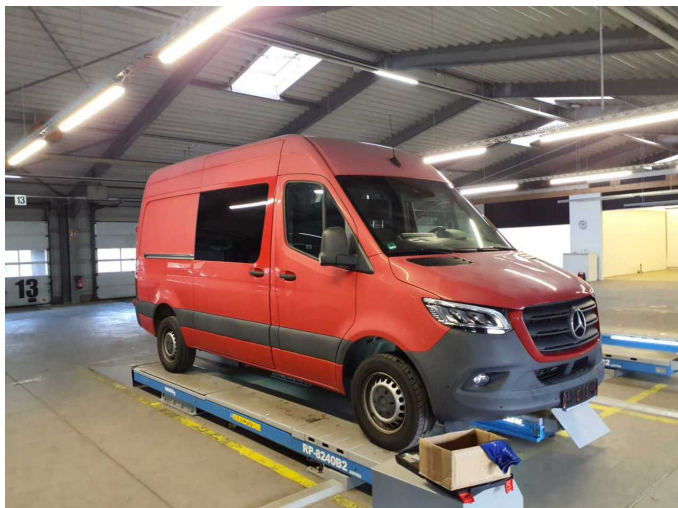
Damage 5: Body: Body (Ausgeblichen) - Paint defect - Conditioning

Sollte beim aufbereiten der Lack keinen Glanz bekommen-können Mehrkosten entstehen.
