Expertise

Protocol number: 41596730
Order No. / Reference: 25218718
Inspection date: 18 Sept 2025

Manufacturer: Mercedes-Benz	Model: 317 CDI Sprinter Standard HA 9G-TRONIC
VIN: W1V9076331P437645

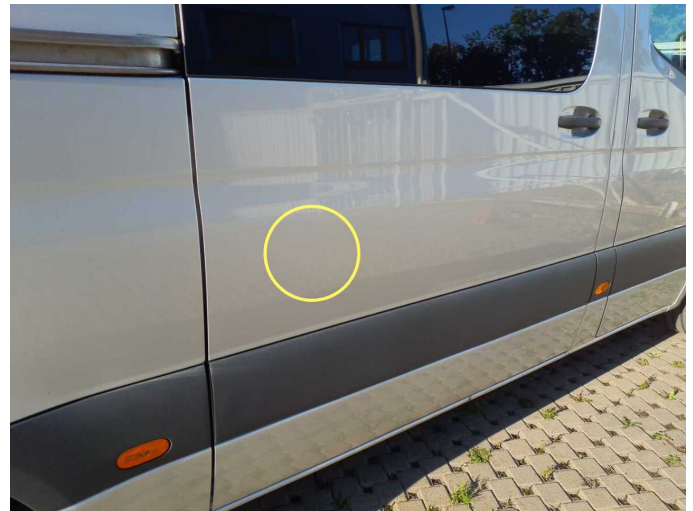
Damage 1: Sliding door, right: Sliding door - dent(s) - Smooth repair work

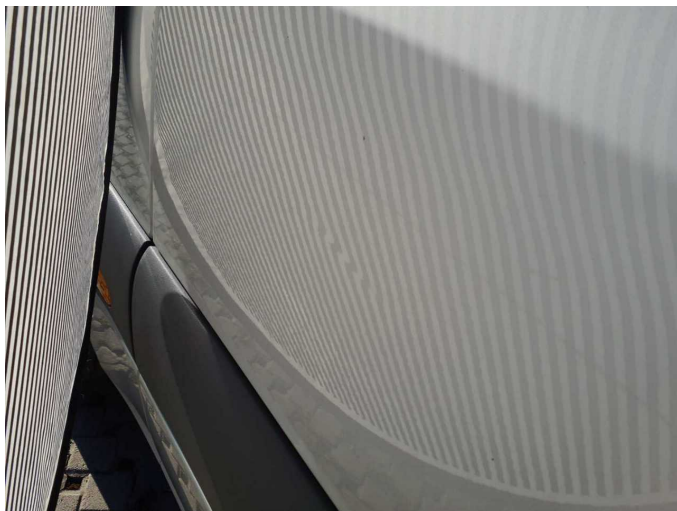
Damage 1: Sliding door, right: Sliding door - dent(s) - Smooth repair work

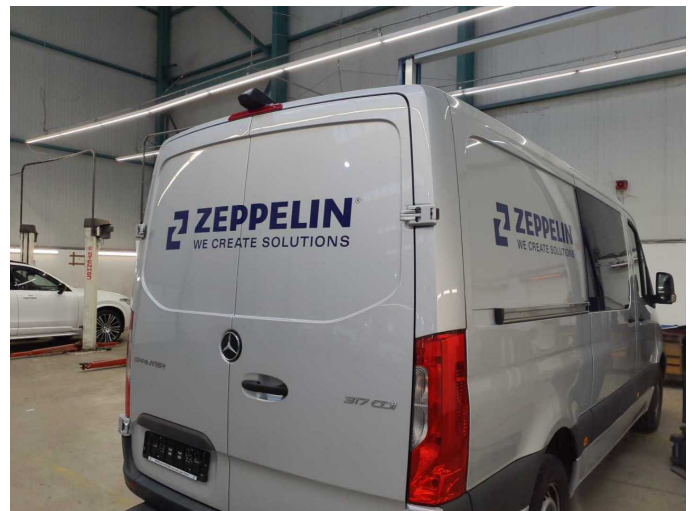
Damage 2: Body: Body - Glued / labelled - De-glue / neutralise

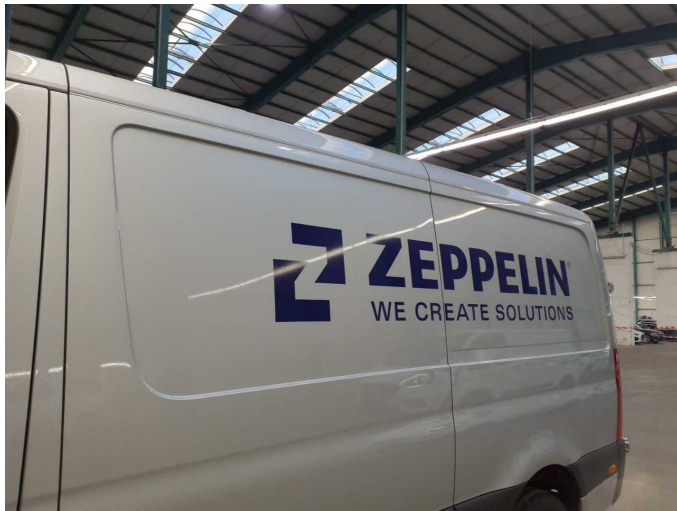
Damage 2: Body: Body - Glued / labelled - De-glue / neutralise

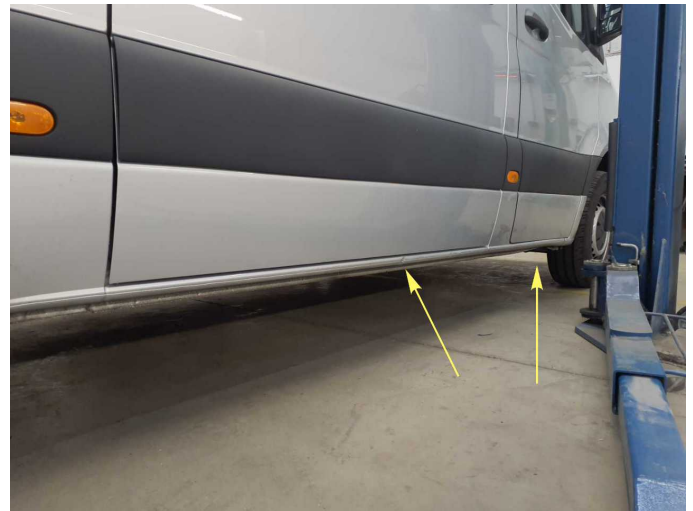
Damage 3: Sill - right side: Sill - Damaged - Repair and paint

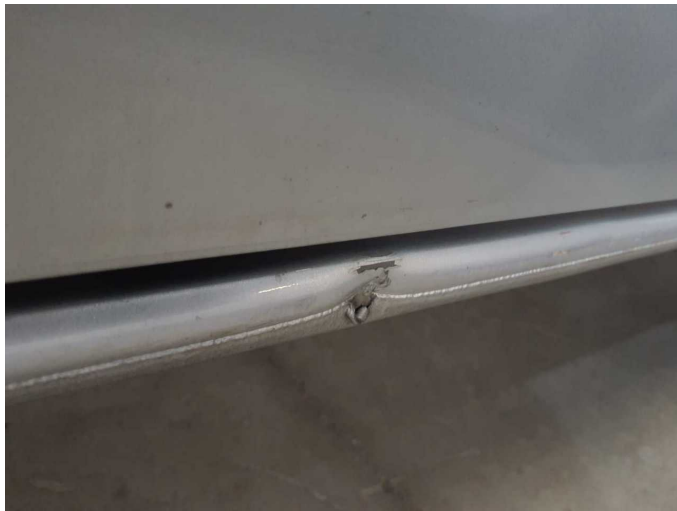
Damage 3: Sill - right side: Sill - Damaged - Repair and paint

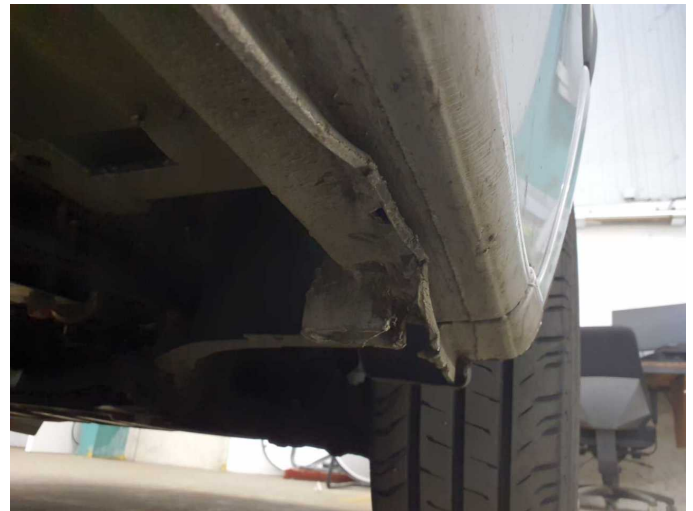
Damage 3: Sill - right side: Sill - Damaged - Repair and paint

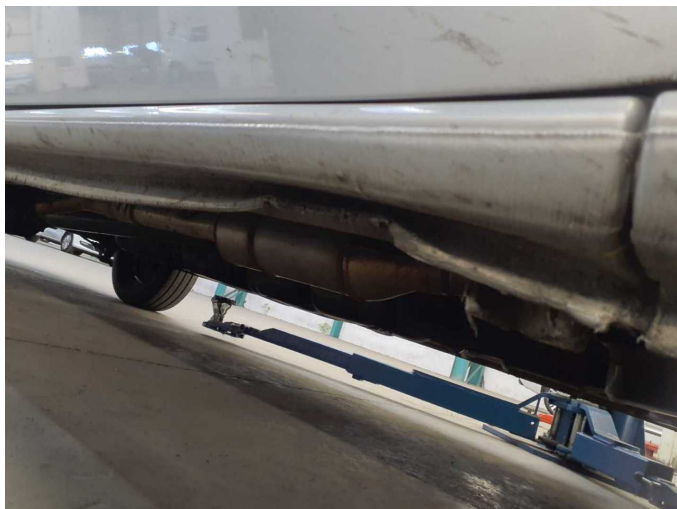
Damage 3: Sill - right side: Sill - Damaged - Repair and paint

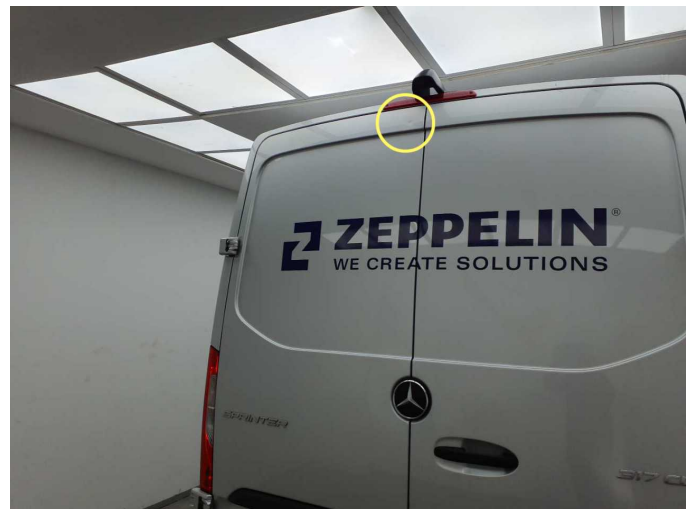
Damage 4: Boot lid / rear door: Rear door - left side - Dent / paintcoat damage - Repair and paint

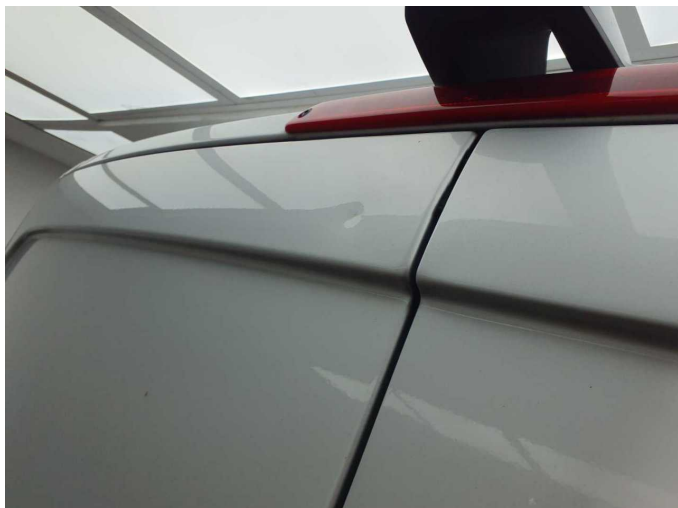
Damage 4: Boot lid / rear door: Rear door - left side - Dent / paintcoat damage - Repair and paint

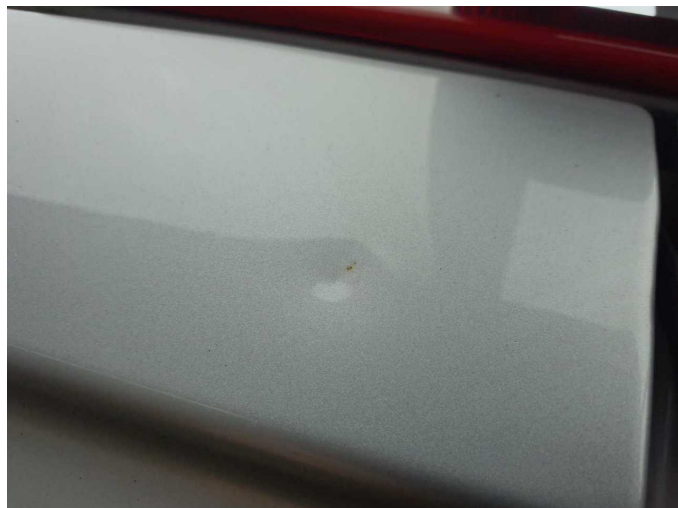
Damage 4: Boot lid / rear door: Rear door - left side - Dent / paintcoat damage - Repair and paint
