## status report

**customer:** BCA Autoauktionen GmbH

#### Audi Q5 Quattro

| Vehicle identification number | <b>WA1D7AFPXGA040382</b> | mileage read: | <b>141605 km</b> |

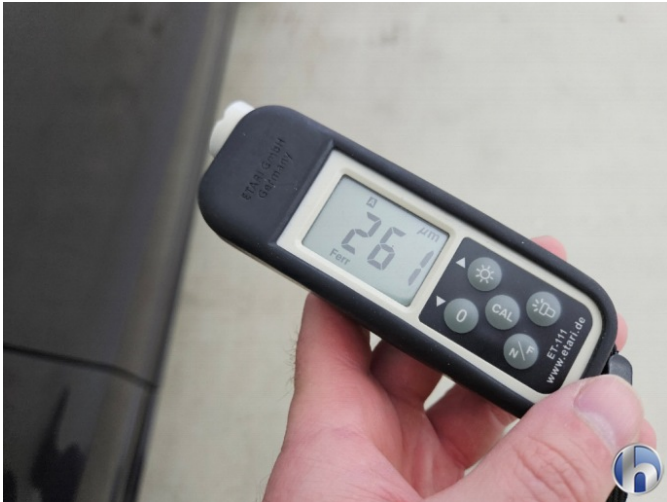
| component | Damage | Rep kind |
|---|---|---|
| 1. Door Rear - right | Subsequently painted | acceptable |

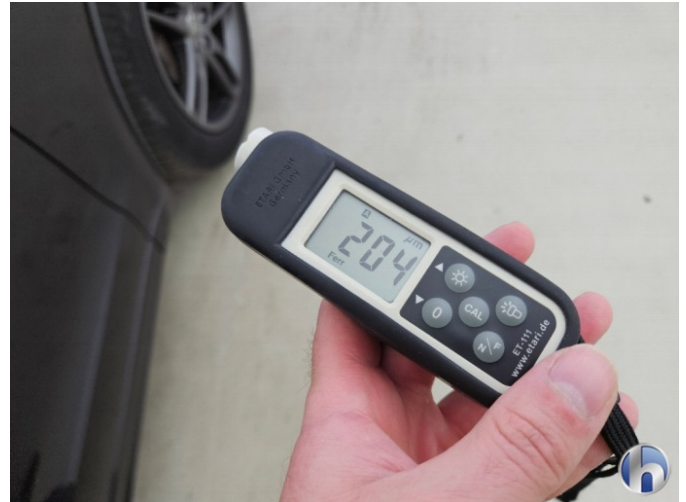
| component | Damage | Rep kind |
|---|---|---|
| 2. Front door - right | Subsequently painted | acceptable |

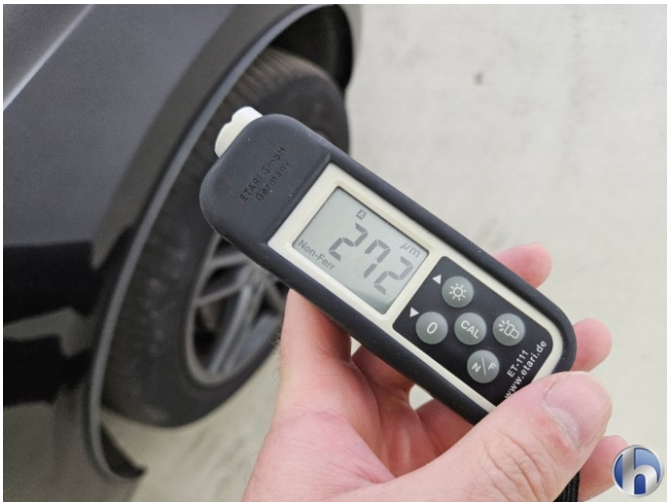
| component | Damage | Rep kind |
|---|---|---|
| 3. hood | Subsequently painted | acceptable |

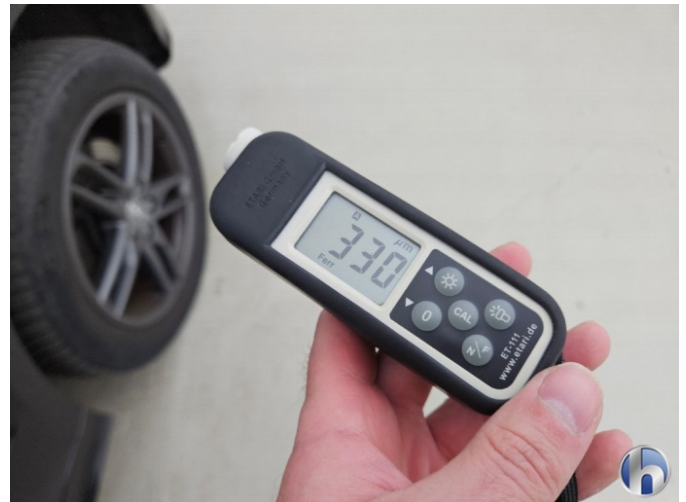
| component | Damage | Rep kind |
|---|---|---|
| 4. Front door - left | Subsequently painted | acceptable |

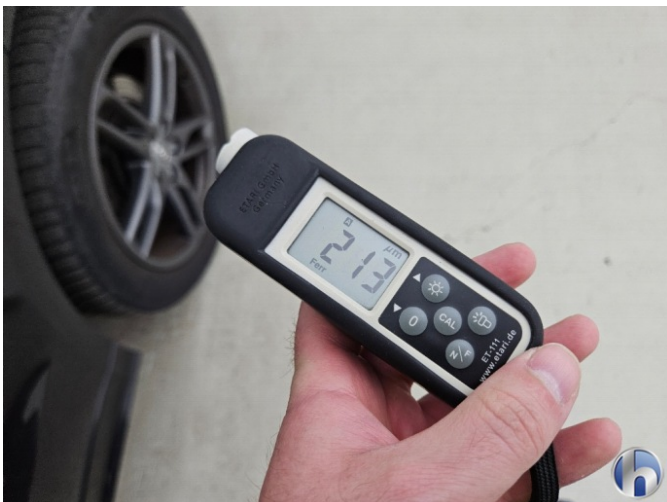
| component | Damage | Rep kind |
|---|---|---|
| 5. Rear door - left | Subsequently painted | acceptable |

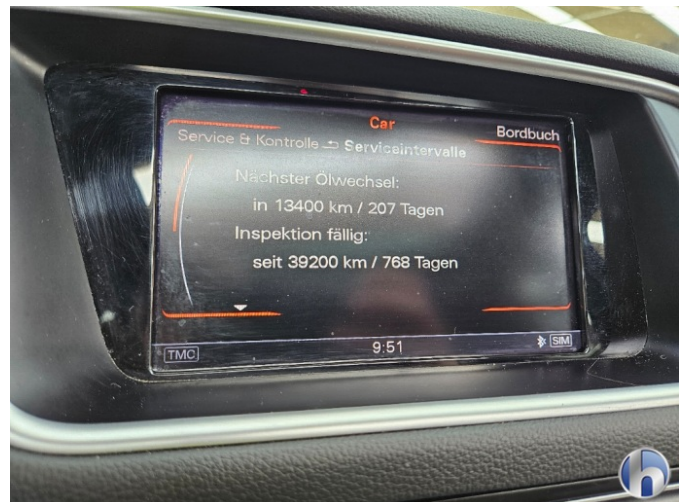
| component | Damage | Rep kind |
|---|---|---|
| 7. Wartung | Due | Replace |

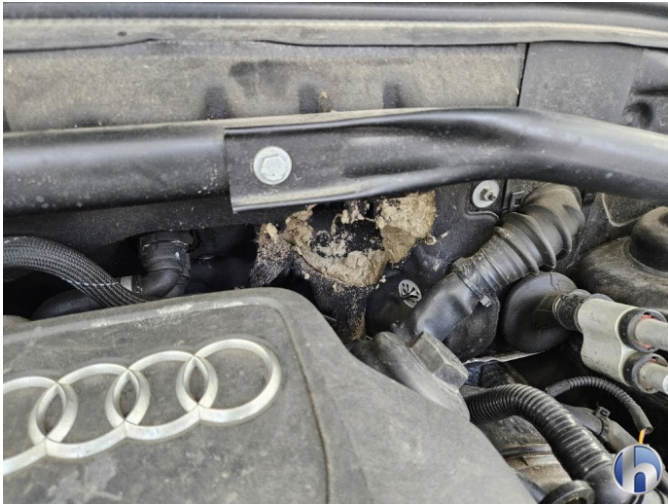
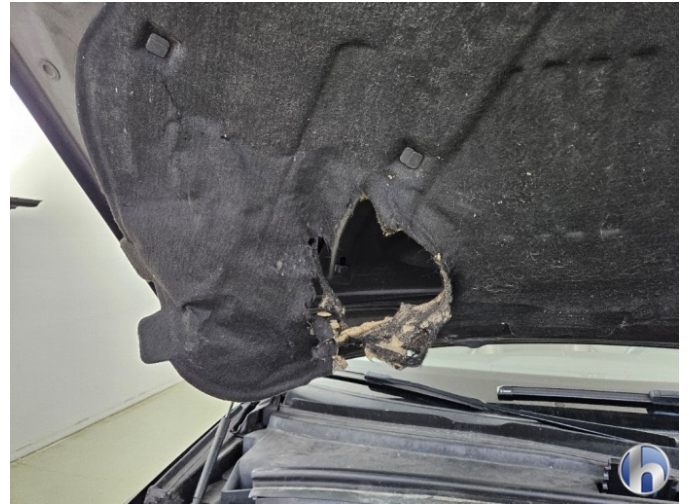
| component | Damage | Rep kind |
|---|---|---|
| 8. Motordämmmaterial | Damaged | Replace |

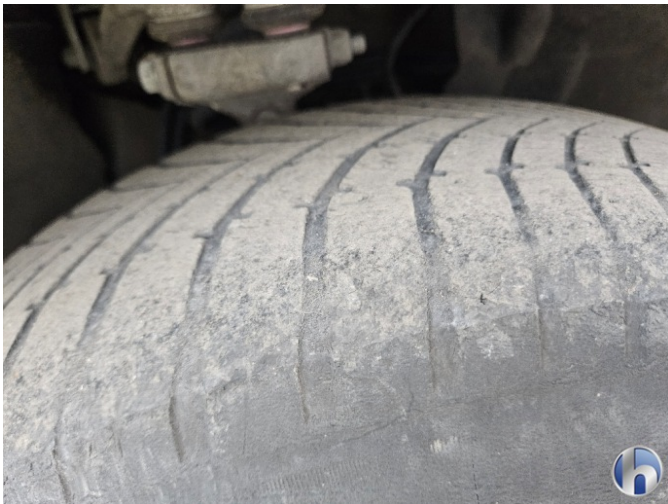
| 1st axis - Left / states . | <b>Bridgestone</b> | <b>235/55/R19/105W 2 mm</b> |
| 1st axis - right / states . | <b>Bridgestone</b> | <b>235/55/R19/105W 2 mm</b> |
| traffic Safety: | <b>not roadworthy</b> | |

| component | Damage | Rep kind |
|---|---|---|
| 9. Reifen v.l./v.r. | Not safe for road traffic | Replace |

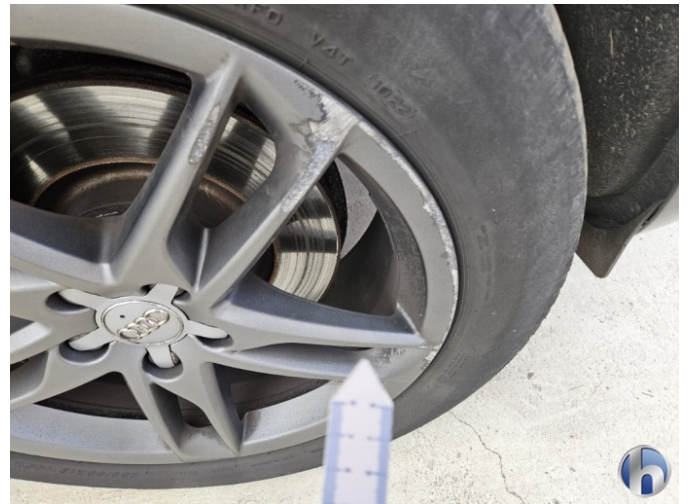
| component | Damage | Rep kind |
|---|---|---|
| 10. Felge v.r. | Scratch(es) | Paint |

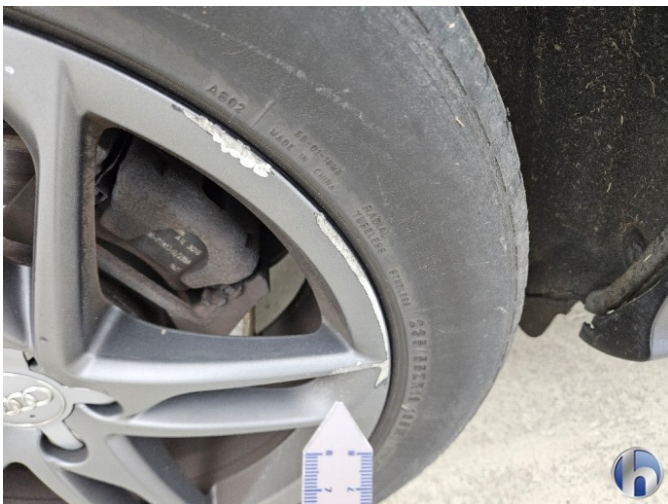
| component | Damage | Rep kind |
|---|---|---|
| 11. Felge h.r. | Scratch(es) | Paint |

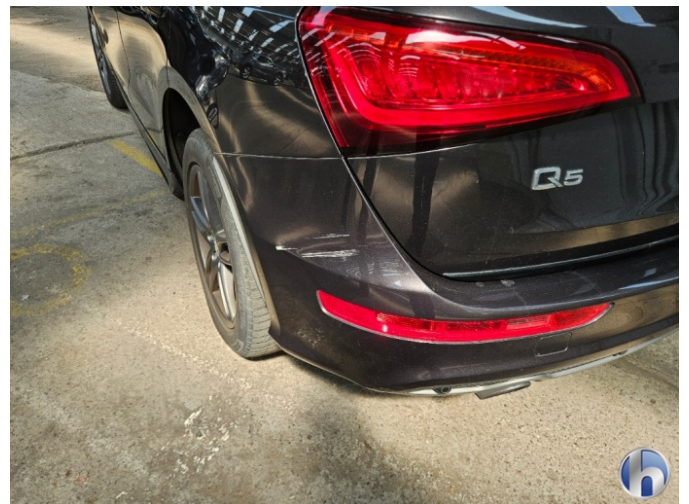
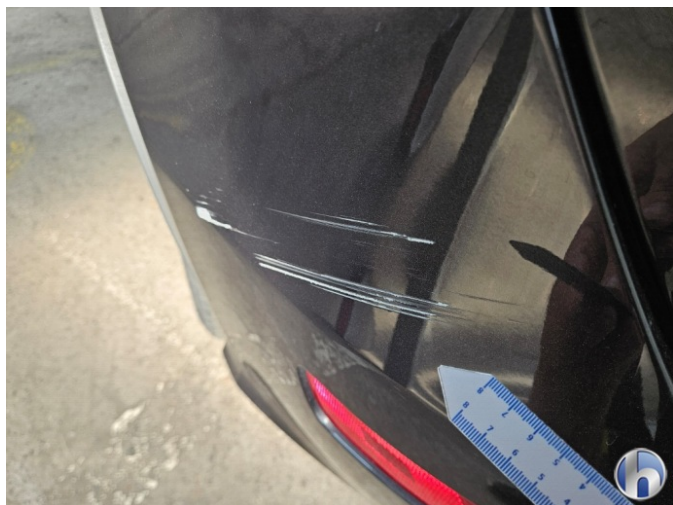
| component | Damage | Rep kind |
|---|---|---|
| 12. Rear bumper | Scratch(es) | Paint |

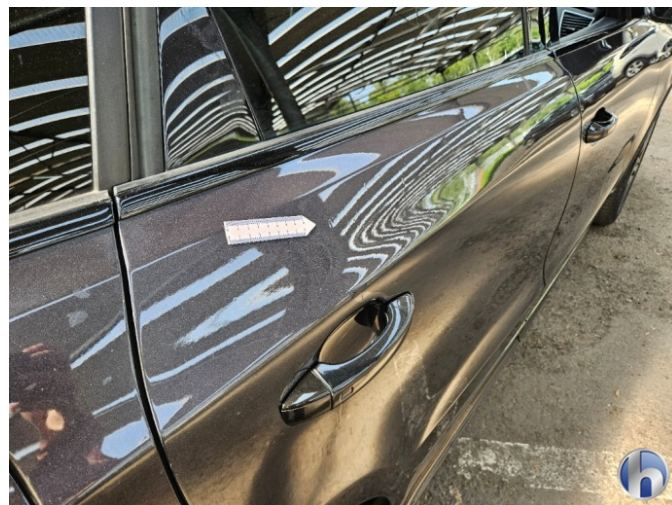
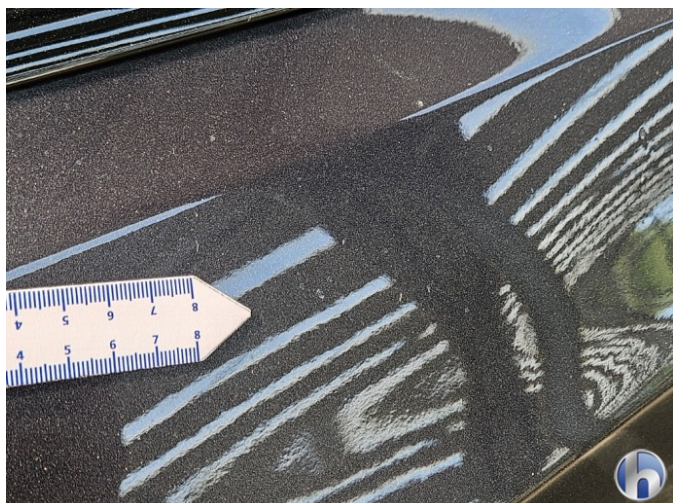
| component | Damage | Rep kind |
|---|---|---|
| 13. Door Rear - right | Execution defect | Paint |

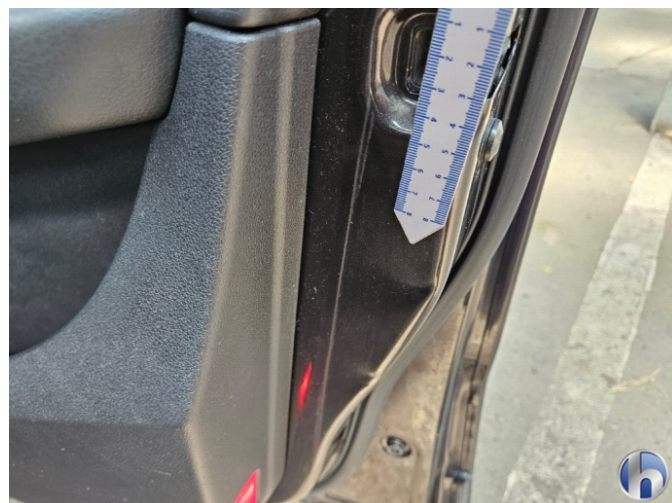
| component | Damage | Rep kind |
|---|---|---|
| 14. Front door - right | Wear and tear | acceptable |

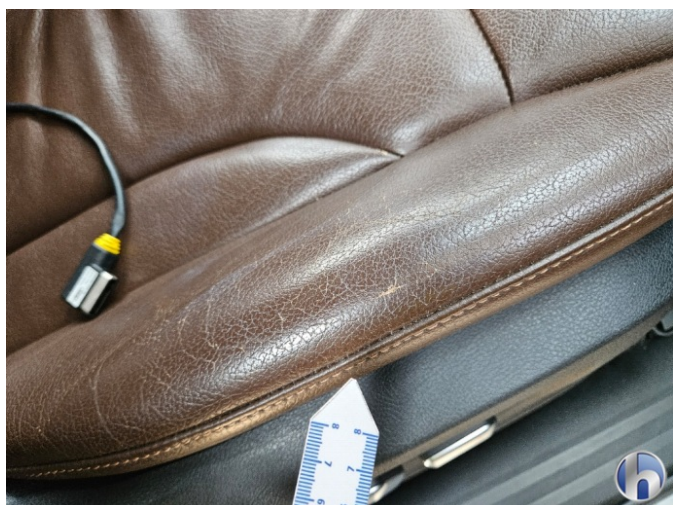
| component | Damage | Rep kind |
|---|---|---|
| 15. Sitz v.r. | Wear and tear | acceptable |

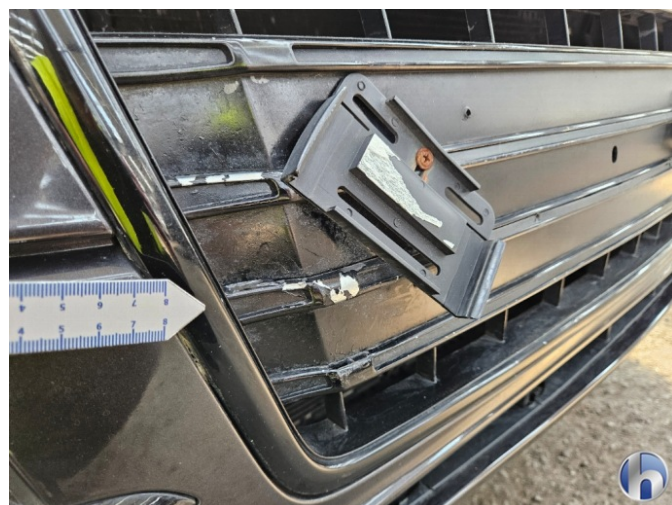
| component | Damage | Rep kind |
|---|---|---|
| 16. Front grille top | Damaged | Replace |

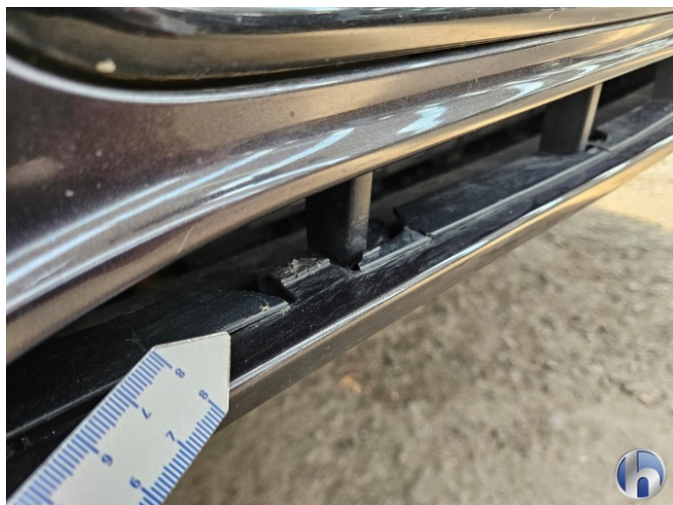
| component | Damage | Rep kind |
|---|---|---|
| 17. Frontgrill Stoßfänger Unten | Damaged | Replace |

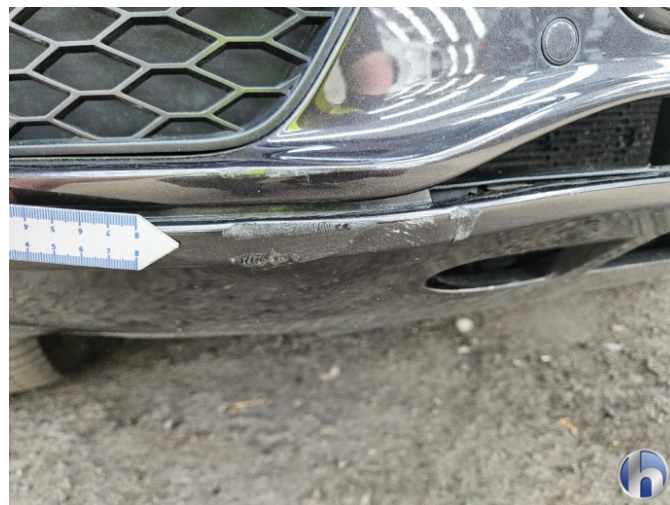
| component | Damage | Rep kind |
|---|---|---|
| 18. Front bumper | Damaged | Refurbish and paint |

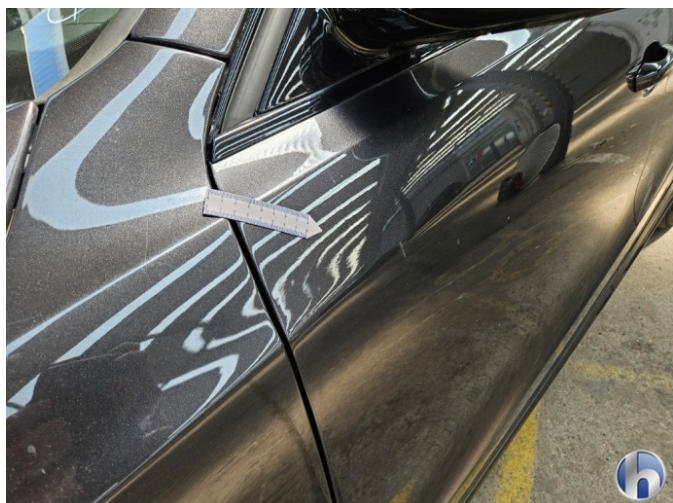
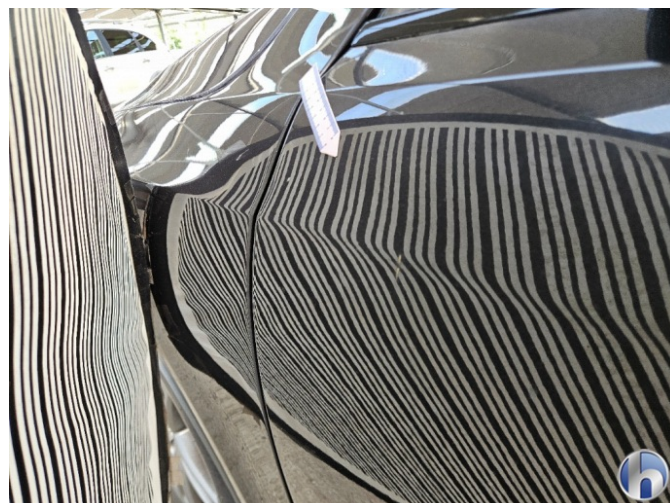
| component | Damage | Rep kind |
|---|---|---|
| 19. Front door - left | Execution defect | Paint |

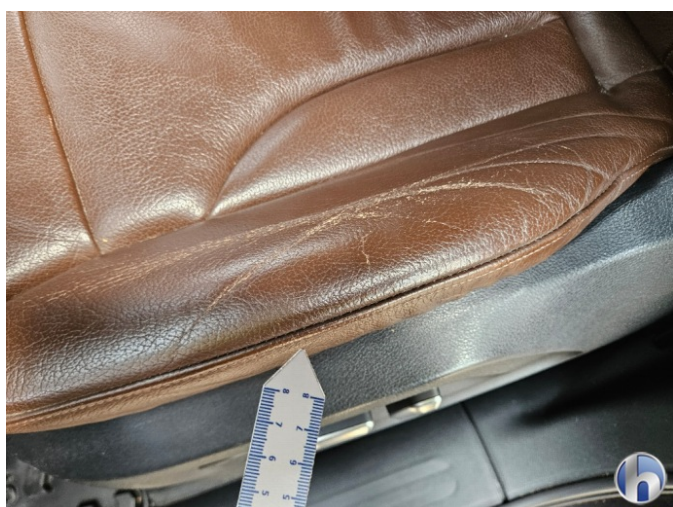
| component | Damage | Rep kind |
|---|---|---|
| 20. Sitz v.l. | Wear and tear | acceptable |
