## status report

#### Audi A6 Avant 2.0 TDI quattro

| Vehicle identification number | <b>WAUZZZ4G5JN118183</b> | mileage read: | <b>173940 km</b> |

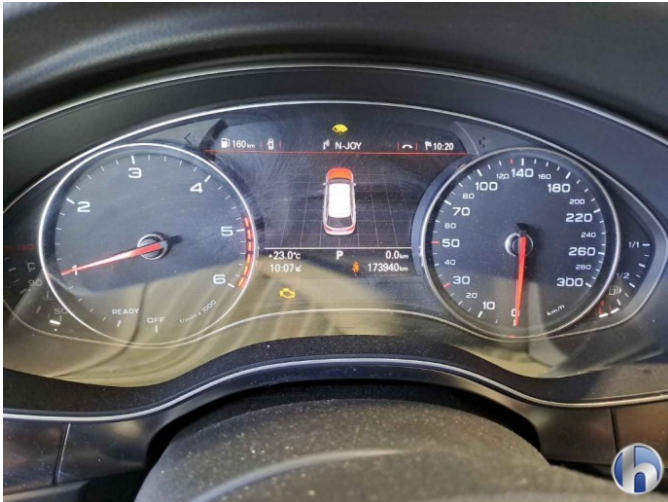
6. MIL

| General examination | |
|---|---|
| <b>Note Road Safe:</b> | MIL Fehlermeldung, Batterie Tiefentladen |

| Performed testing technology | |
|---|---|
| <b>engine running:</b> | A field test of the engine had to acoustic or visual defects for visiting time .<br>**Engine warning light. |
| <b>reference:</b> | *Fahrzeug hat Alter und Laufleistungs bedingte Gebrauchsspuren innen und außen MIL<br>Fehlermeldung Fehlerdiagnose durchführen lassen Schaden und Kosten Erweiterung möglich |

| | <b>component</b> | <b>Damage</b> | <b>Rep kind</b> |
|---|---|---|---|
| 6. | MIL | Error message | Carry out a fault diagnosis |

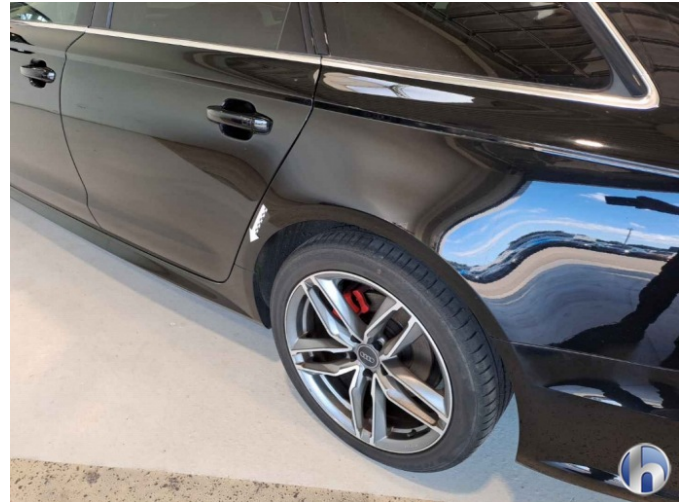
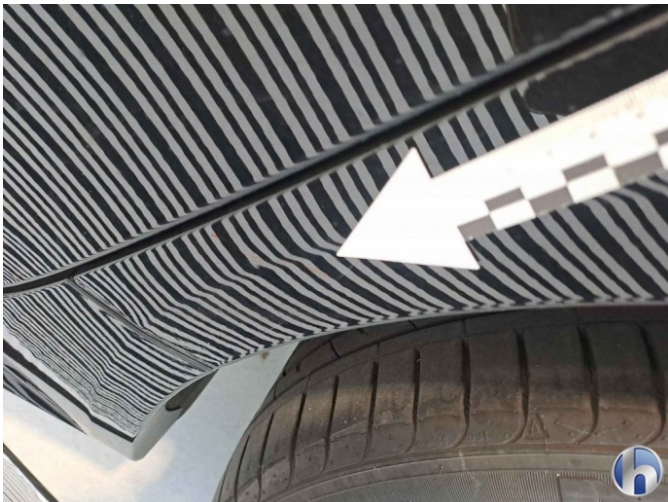
7. Sidewall - Rear - Left

| | <b>component</b> | <b>Damage</b> | <b>Rep kind</b> |
|---|---|---|---|
| 7. | Sidewall - Rear - Left | Delle | Smart repair |

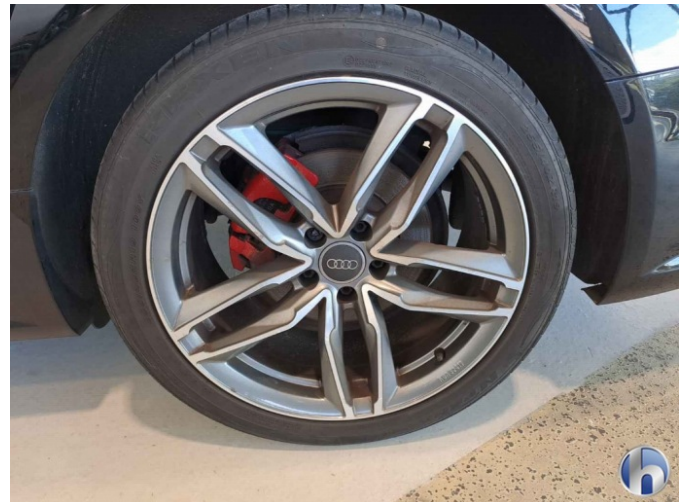
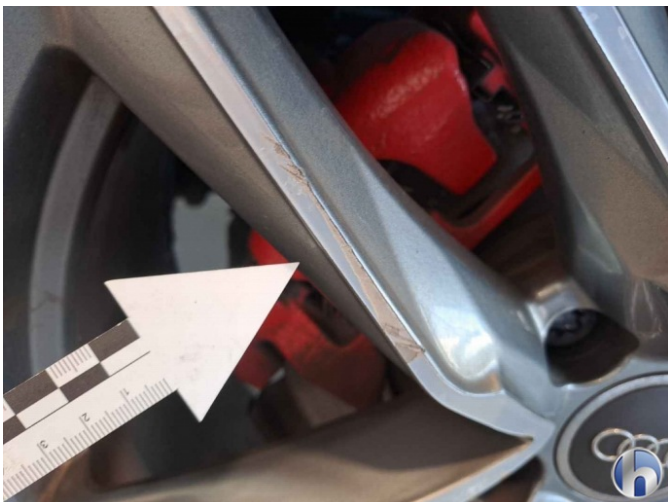
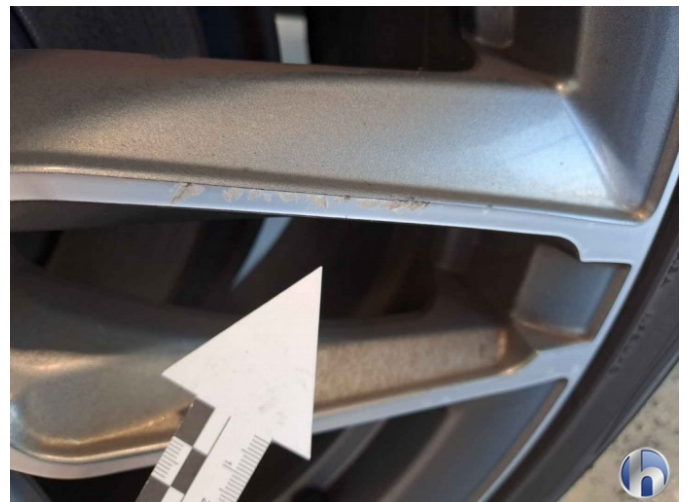
8. Rim rear - left

| | <b>component</b> | <b>Damage</b> | <b>Rep kind</b> |
|---|---|---|---|
| 8. | Rim rear - left | Scratch(es) | Replace |

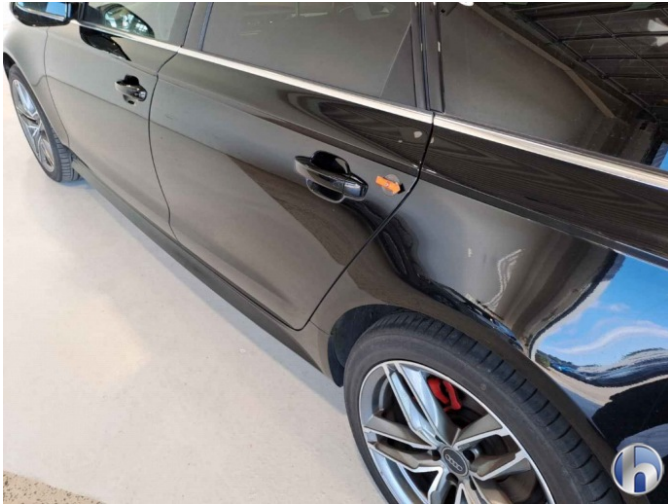
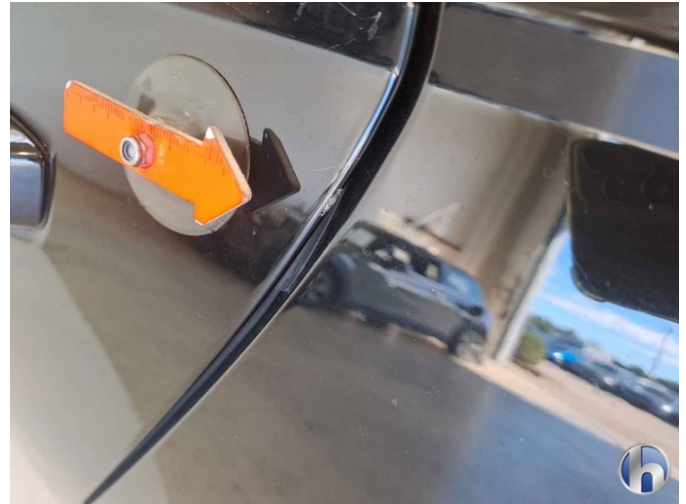
9. Rear door - left

| | <b>component</b> | <b>Damage</b> | <b>Rep kind</b> |
|---|---|---|---|
| 9. | Rear door - left | Scrape | Smart repair |

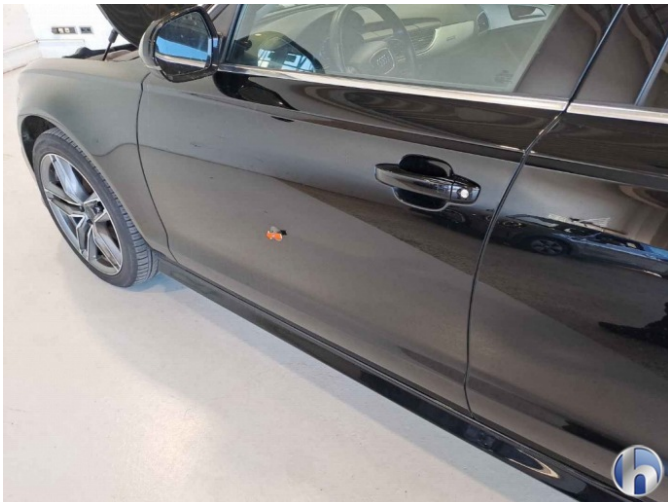
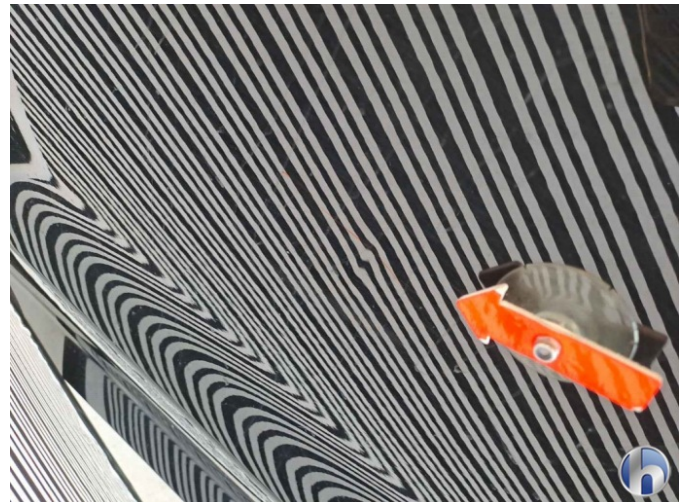
10. Front door - left

| | <b>component</b> | <b>Damage</b> | <b>Rep kind</b> |
|---|---|---|---|
| 10. | Front door - left | Delle | Smart repair |

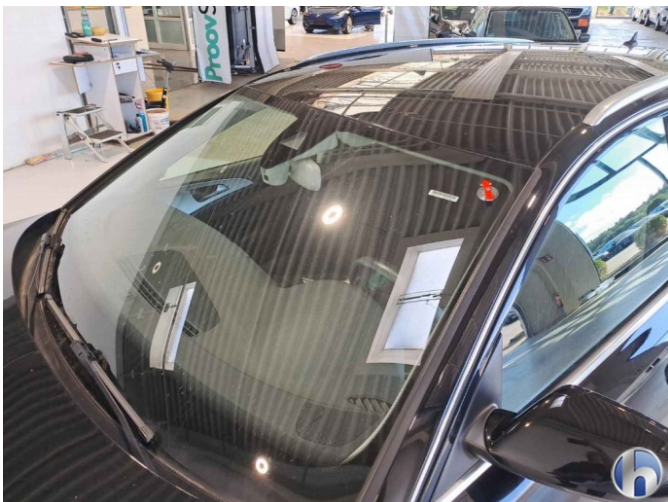
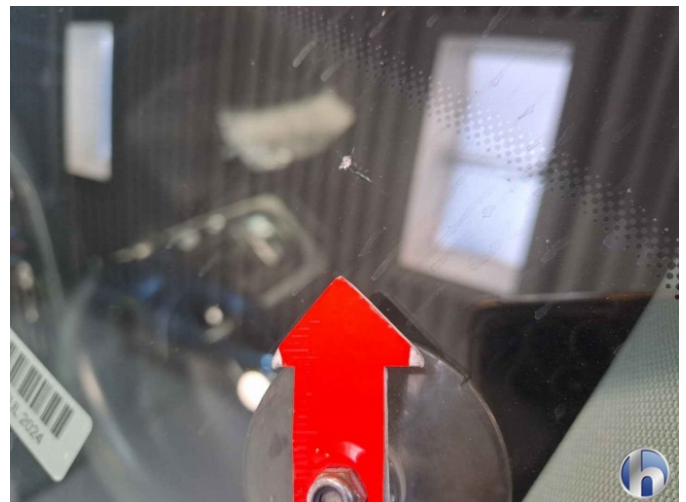
11. Windshield

| | <b>component</b> | <b>Damage</b> | <b>Rep kind</b> |
|---|---|---|---|
| 11. | Windshield | Chipping from stones | Smart repair |

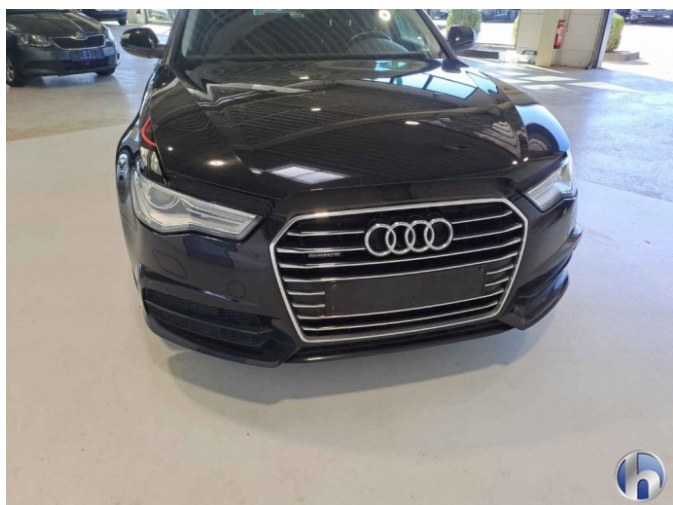
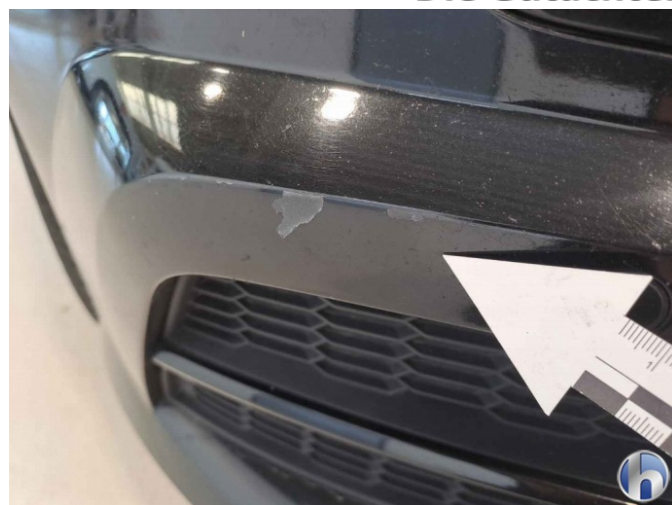
12. Front bumper

| | <b>component</b> | <b>Damage</b> | <b>Rep kind</b> |
|---|---|---|---|
| 12. | Front bumper | chipped paint | Smart repair |

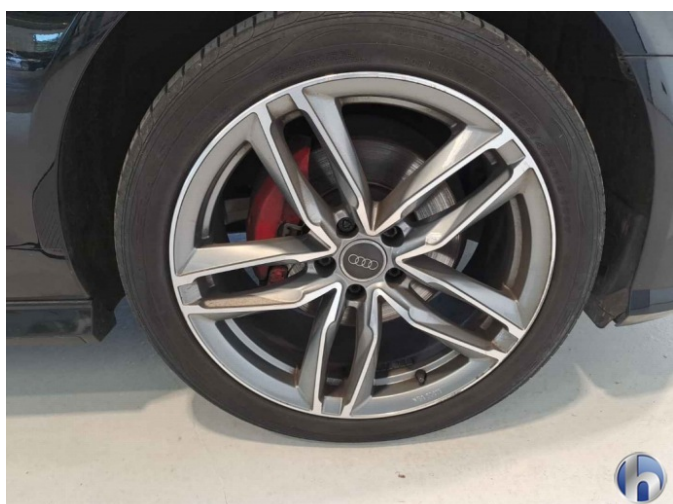
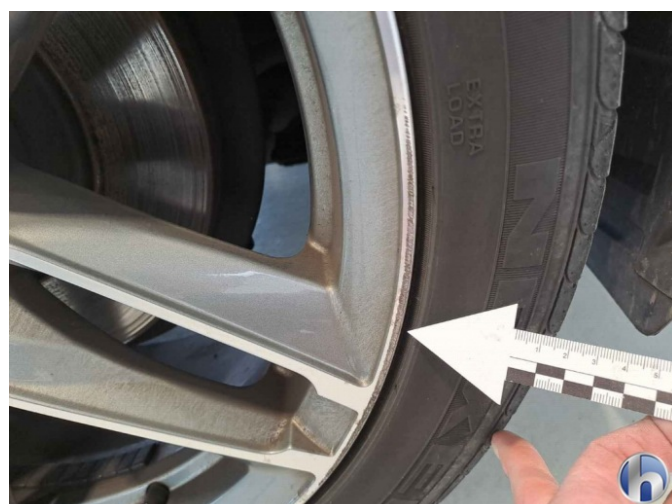
13. Rim front - right

| | <b>component</b> | <b>Damage</b> | <b>Rep kind</b> |
|---|---|---|---|
| 13. | Rim front - right | Scratch(es) | Replace |

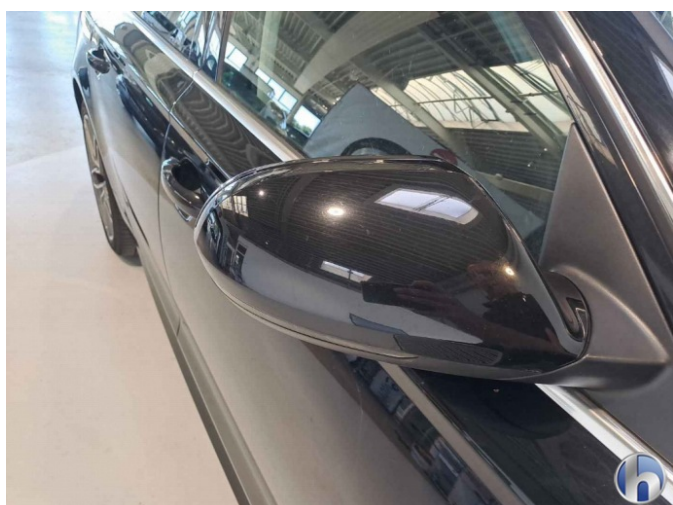
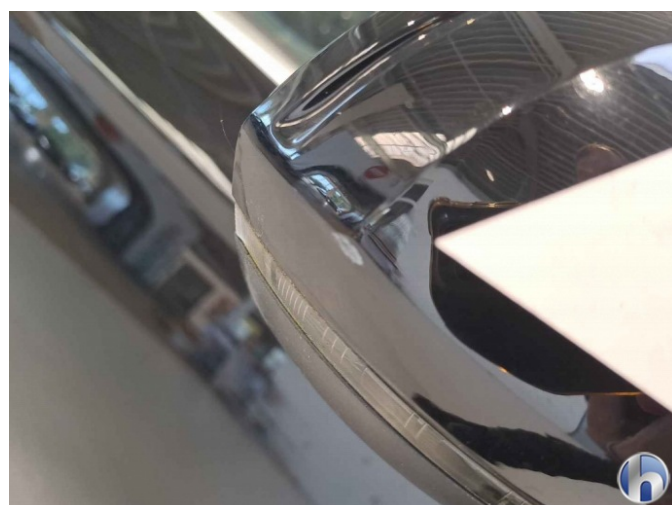
| | <b>component</b> | <b>Damage</b> | <b>Rep kind</b> |
|---|---|---|---|
| 14. | | Scrape | Smart repair |

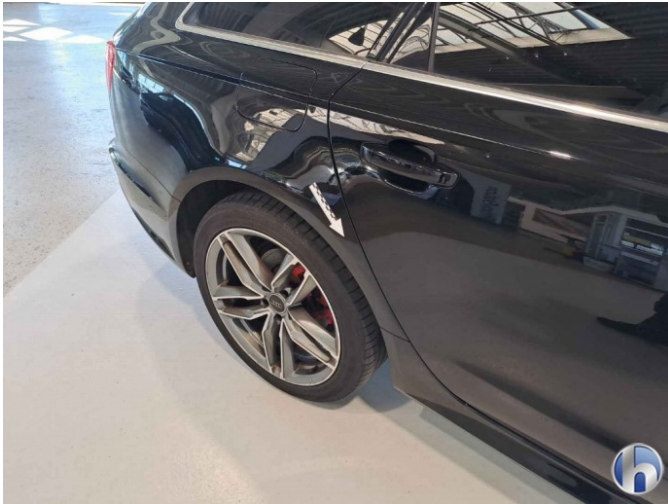
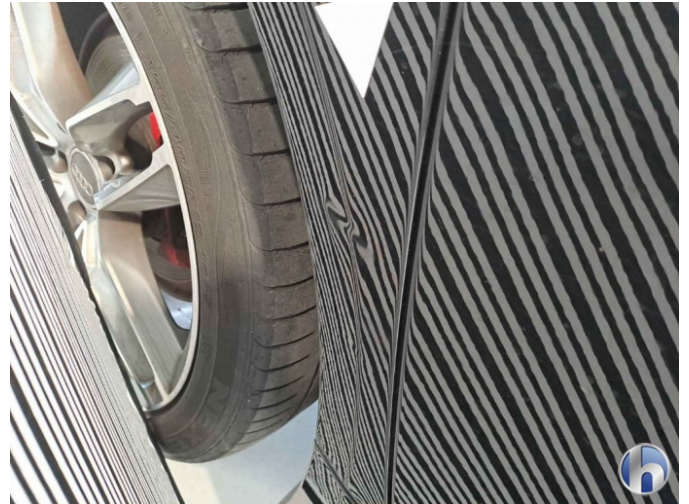
15. Sidewall - Rear - right

| | <b>component</b> | <b>Damage</b> | <b>Rep kind</b> |
|---|---|---|---|
| 15. | Sidewall - Rear - right | Deformed (slightly) | Refurbish and paint |

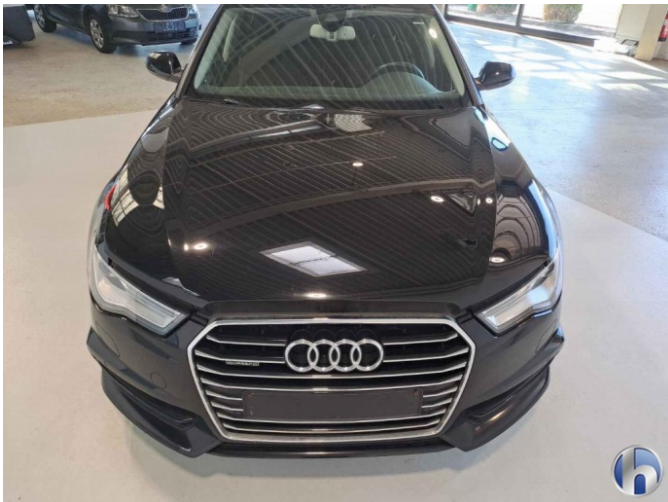
16. exterior body

| | <b>component</b> | <b>Damage</b> | <b>Rep kind</b> |
|---|---|---|---|
| 16. | exterior body | Surface scratch(es) | |

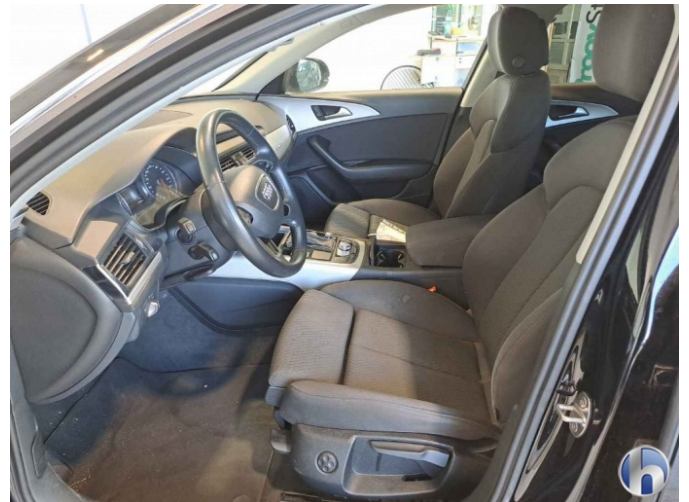
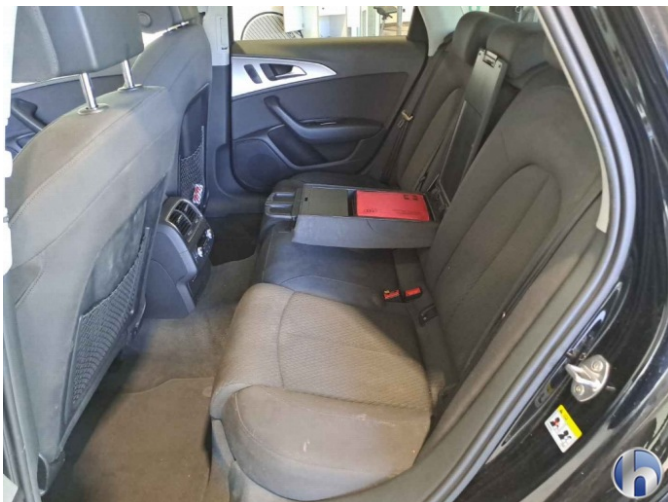
| | <b>component</b> | <b>Damage</b> | <b>Rep kind</b> |
|---|---|---|---|
| 17. | | Wear and tear | acceptable |

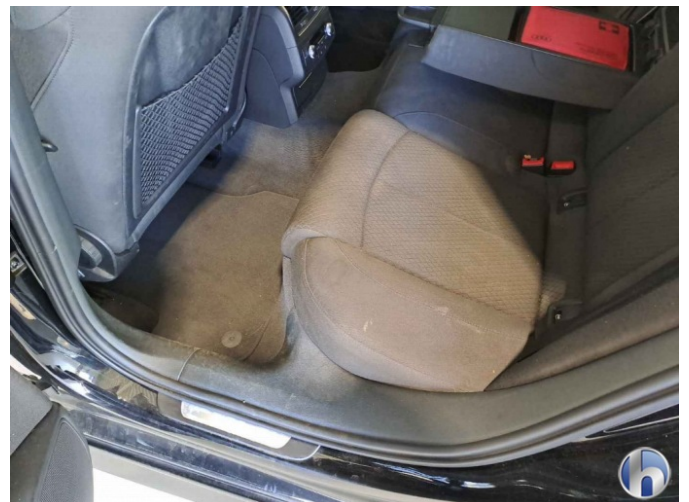
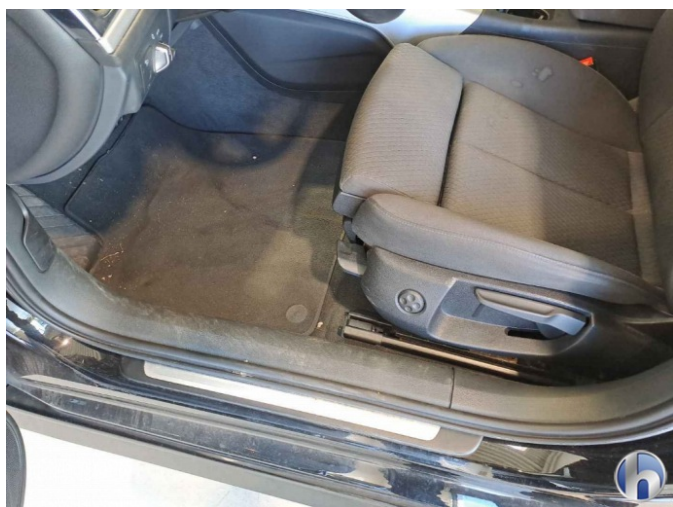
| | <b>component</b> | <b>Damage</b> | <b>Rep kind</b> |
|---|---|---|---|
| 18. | | Dirty | |

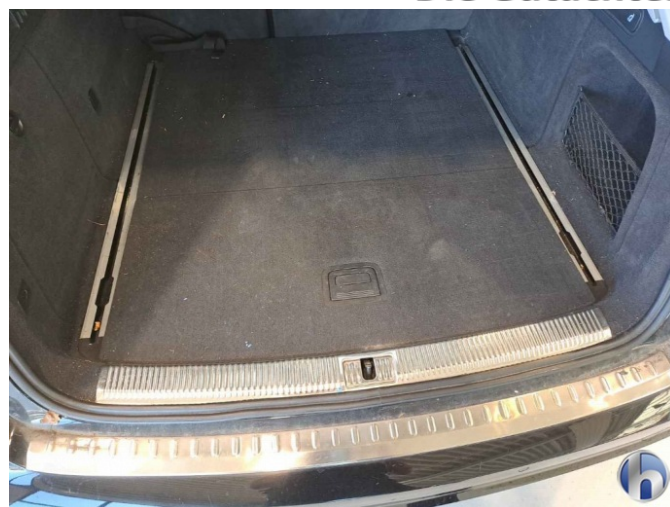
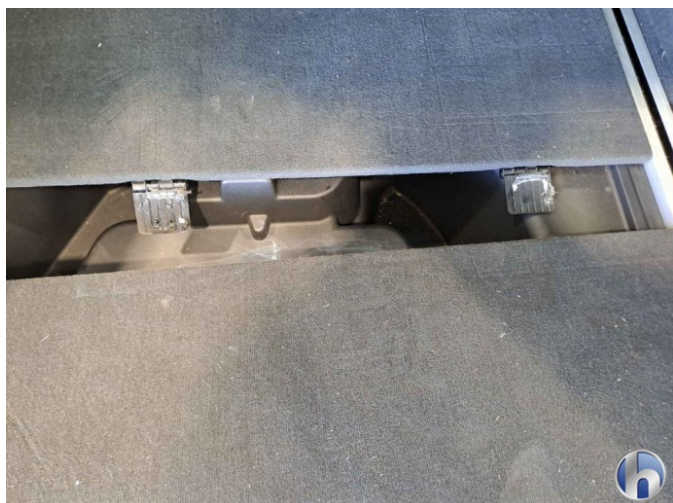
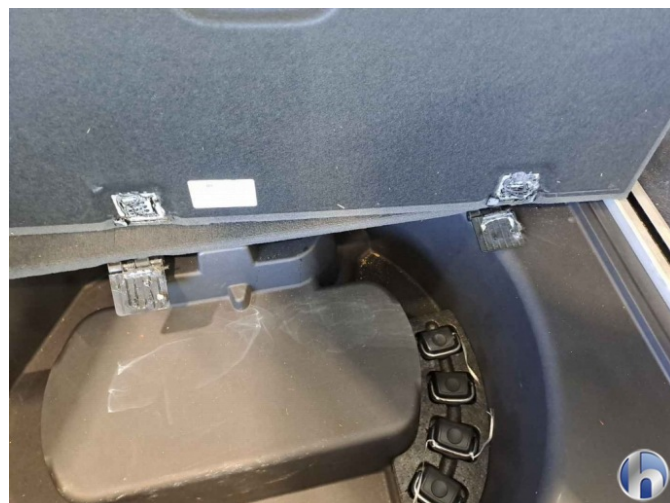
20. Trunk Flooring

| | <b>component</b> | <b>Damage</b> | <b>Rep kind</b> |
|---|---|---|---|
| 20. | Trunk Flooring | Damaged | Replace |

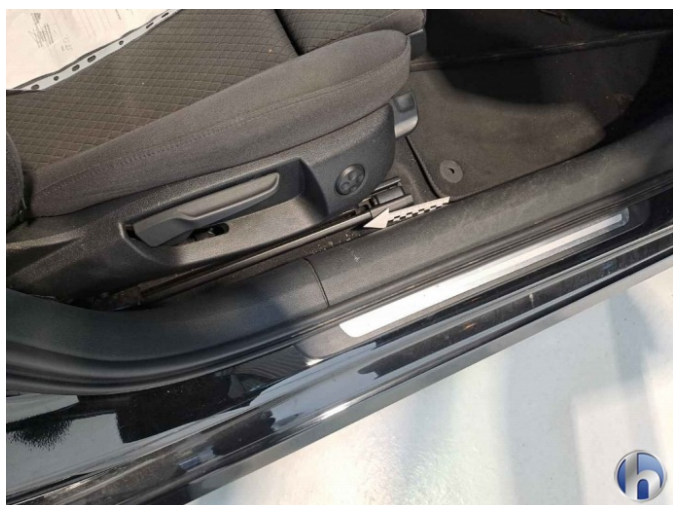
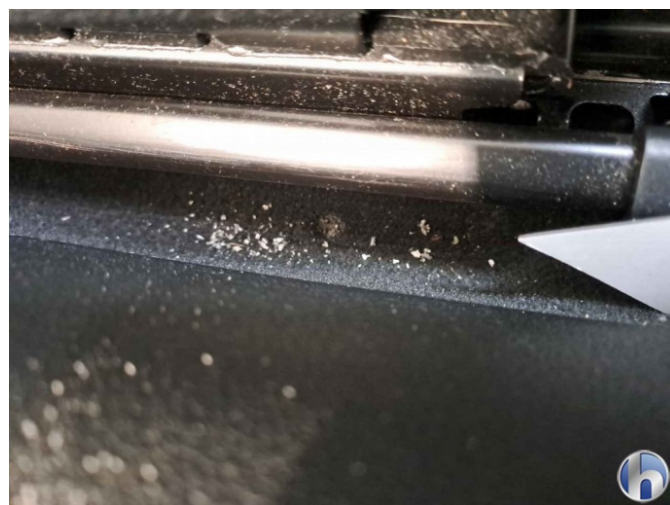
21. flooring

| | <b>component</b> | <b>Damage</b> | <b>Rep kind</b> |
|---|---|---|---|
| 21. | flooring | Burn hole | Smart repair |
