## status report

#### Audi A6 Allroad quattro 3.0 TDI

| Vehicle identification number | <b>WAUZZZ4G6JN034826</b> | mileage read: | <b>161570 km</b> |

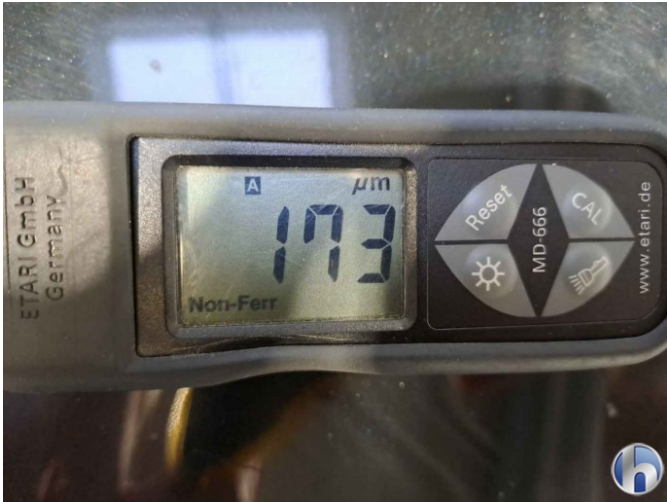
| component | Damage | Rep kind |
|---|---|---|
| 1. hood | Subsequently painted | acceptable |

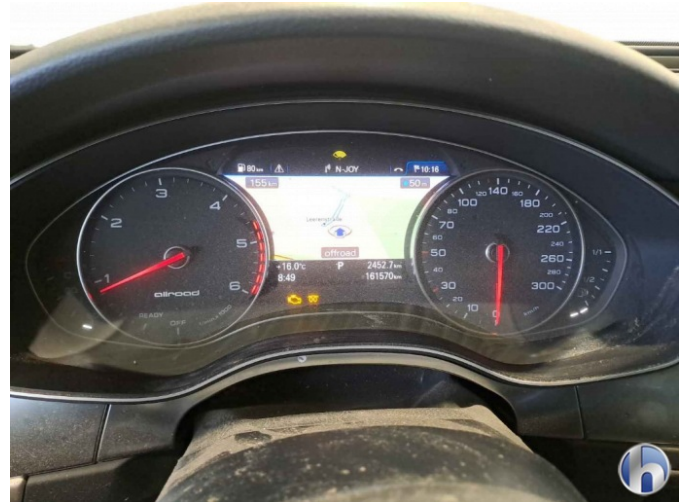
| General examination | |
|---|---|
| <b>Note Road Safe:</b> | MIL Fehlermeldung, Motor unnormale Geräusche |

| component | Damage | Rep kind |
|---|---|---|
| 4. MIL | Error message | Carry out a fault diagnosis |

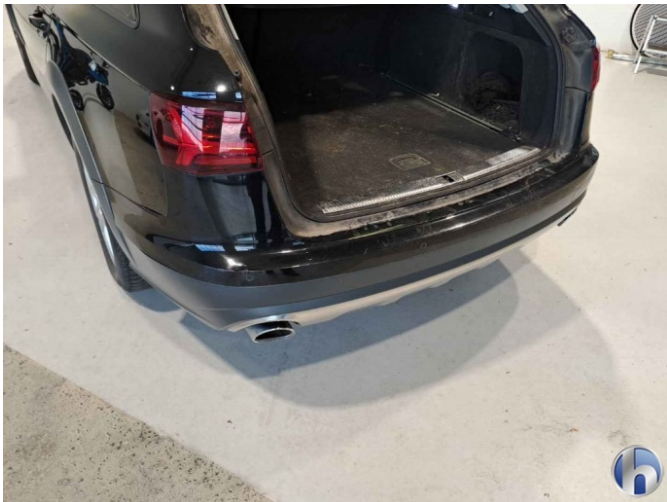
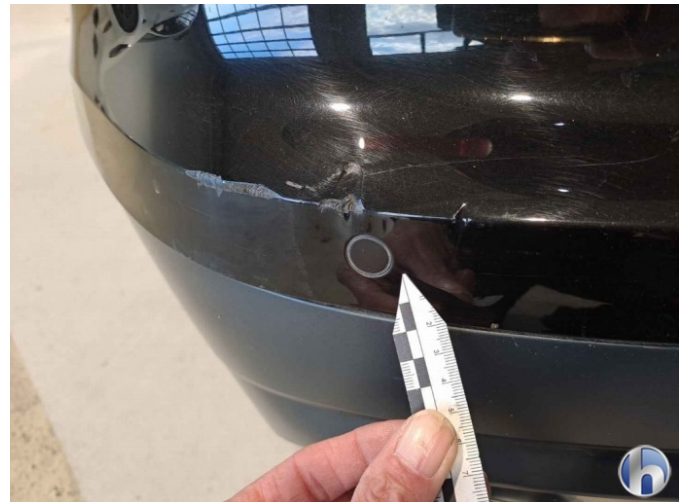
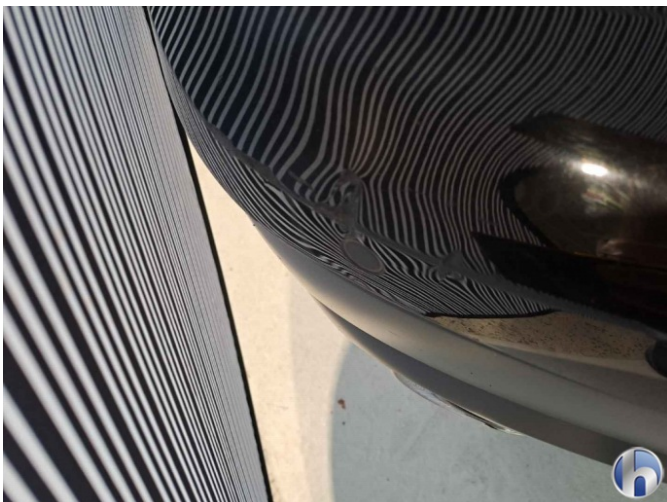
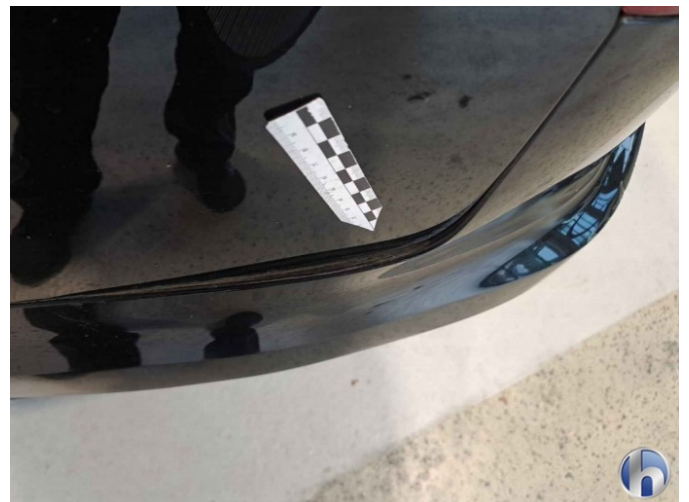
| component | Damage | Rep kind |
|---|---|---|
| 6. Rear bumper | Damaged | Replace |

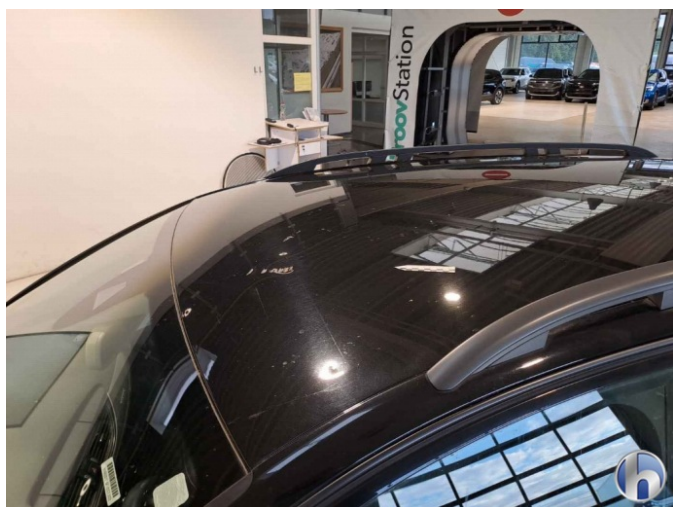
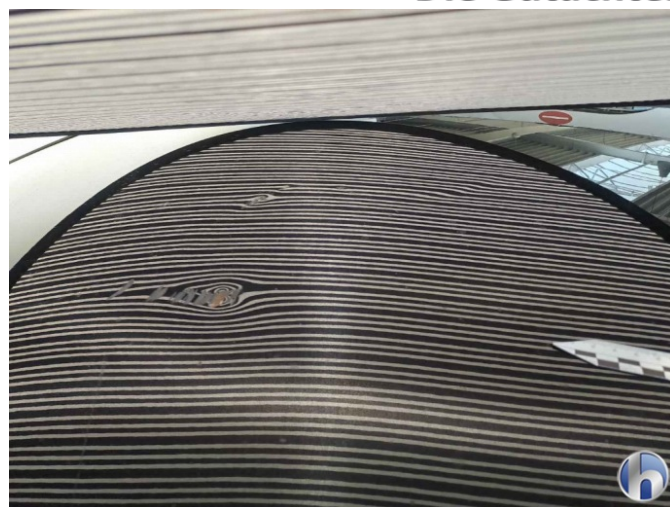
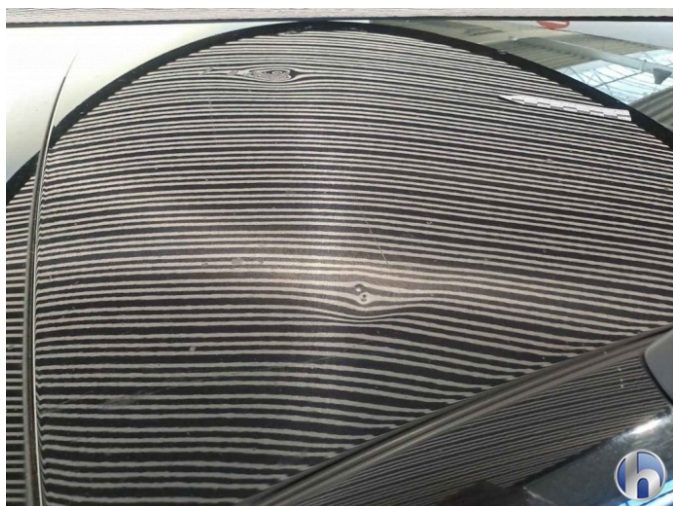
| component | Damage | Rep kind |
|---|---|---|
| 7. roof | Deformed | Refurbish and paint |

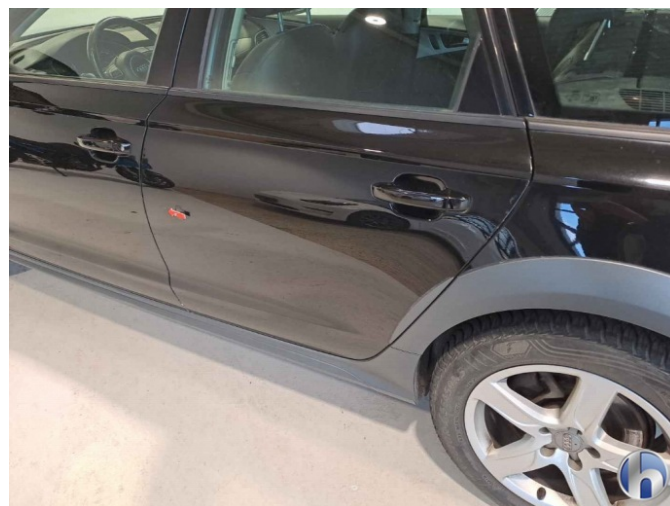
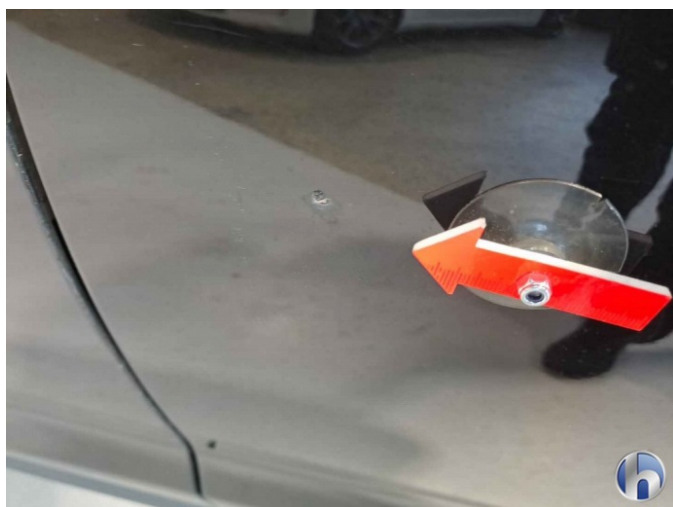
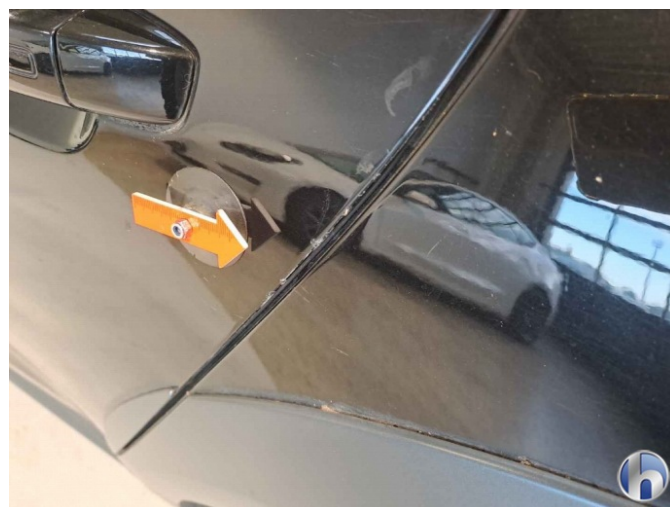
| component | Damage | Rep kind |
|---|---|---|
| 8. Rear door - left | Scrape | Paint |

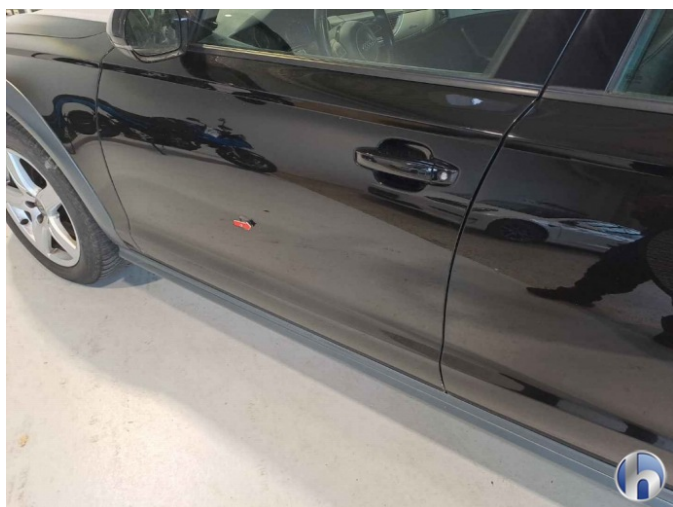
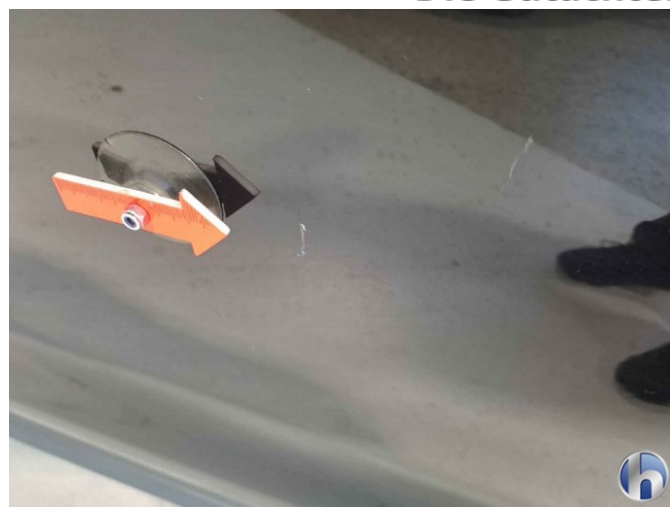
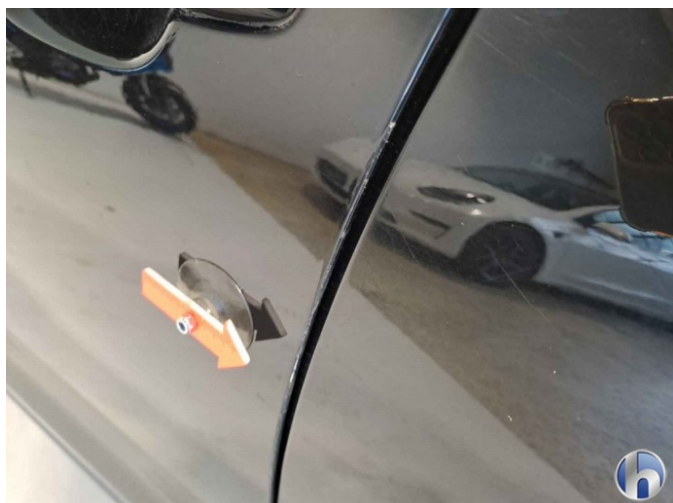
| component | Damage | Rep kind |
|---|---|---|
| 9. Front door - left | Scrape | Paint |

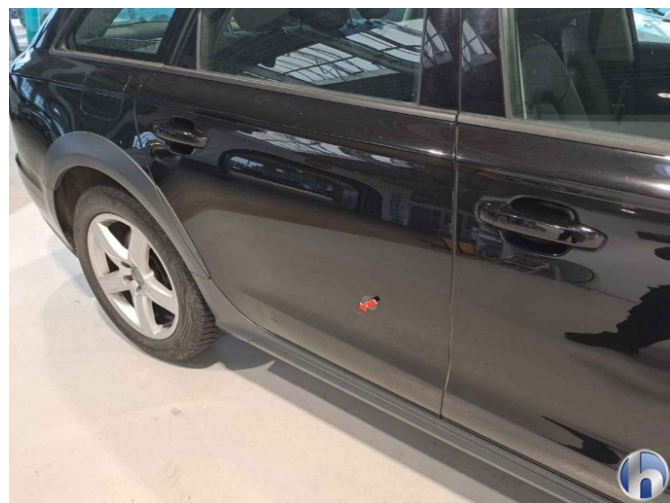
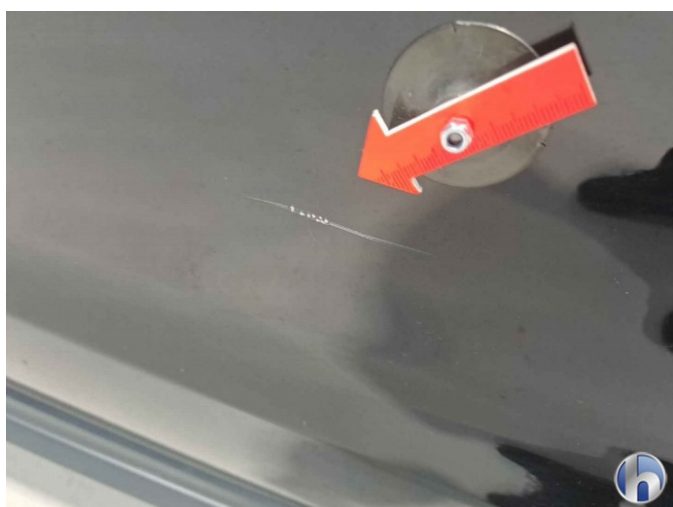
| component | Damage | Rep kind |
|---|---|---|
| 10. Door Rear - right | Scratch(es) | Paint |

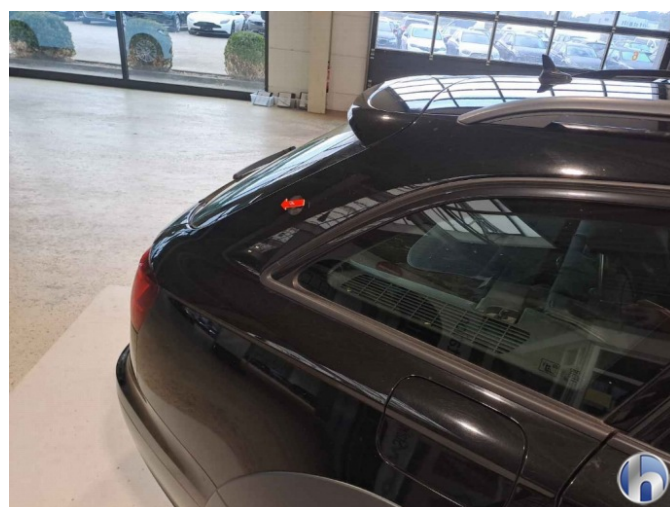
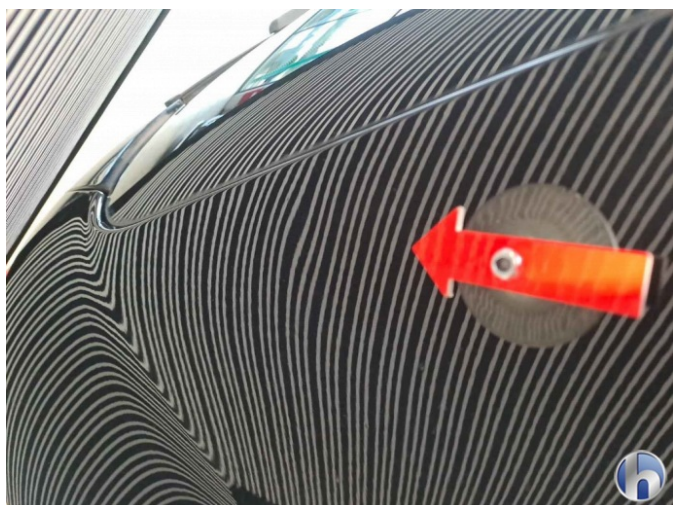
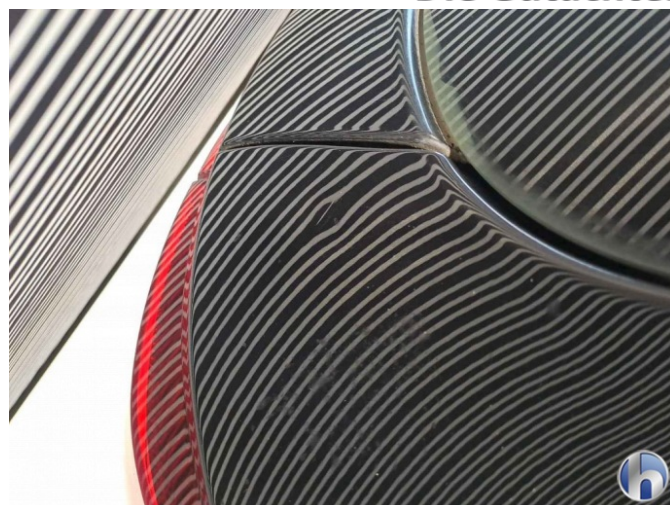
| component | Damage | Rep kind |
|---|---|---|
| 11. Sidewall - Rear - right | Deformed (slightly) | Smart repair |

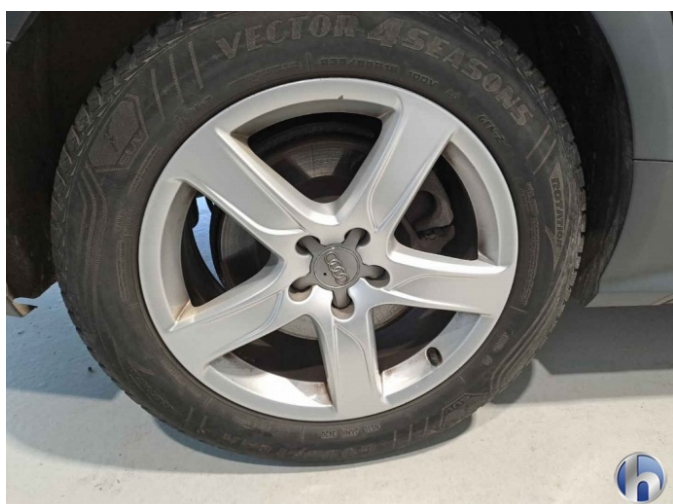
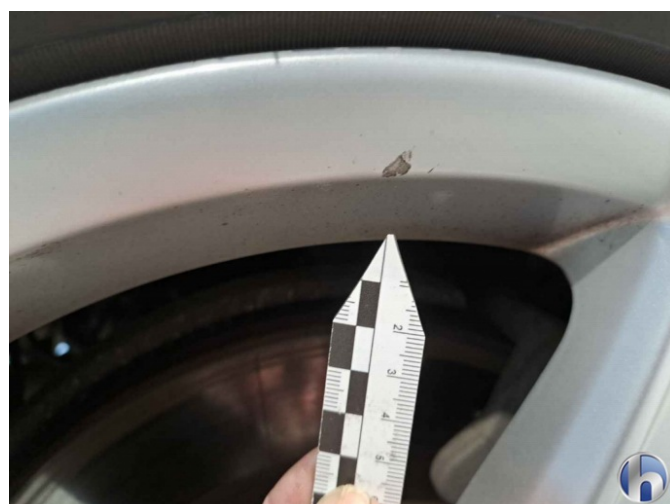
| component | Damage | Rep kind |
|---|---|---|
| 12. Rim rear - right | Scratch(es) | Paint |

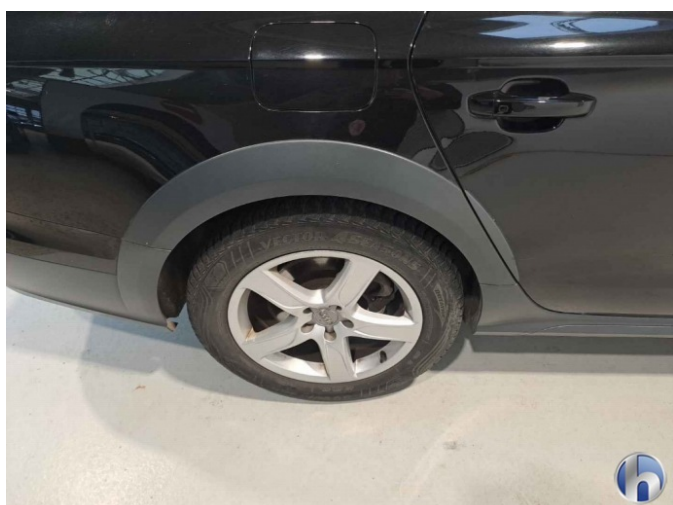
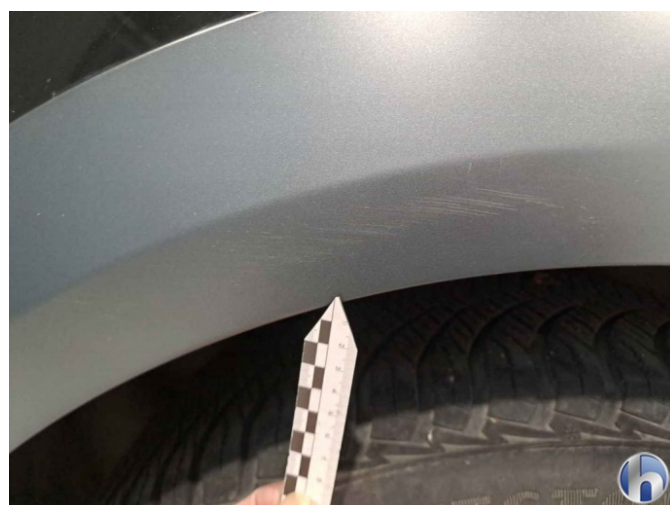
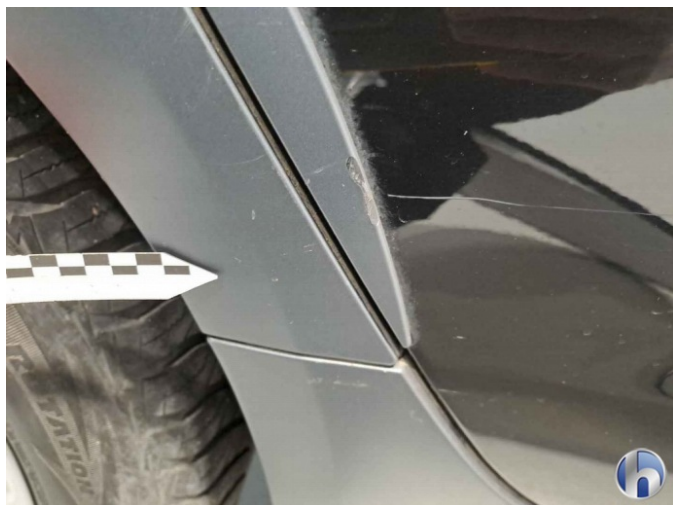
| component | Damage | Rep kind |
|---|---|---|
| 13. | Scrape | Replace |

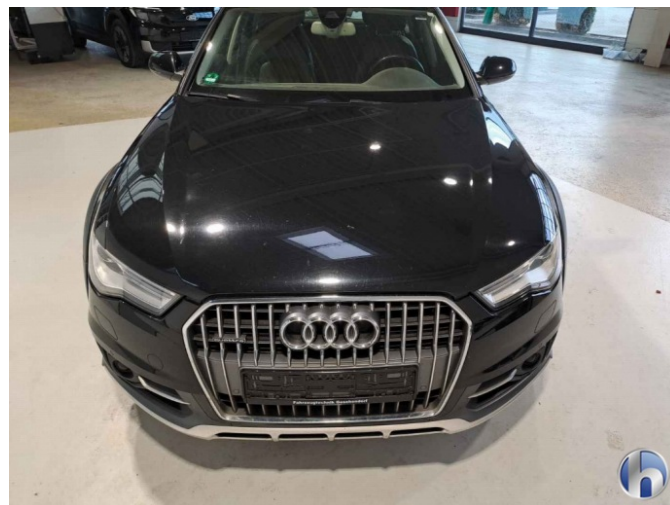
| component | Damage | Rep kind |
|---|---|---|
| 14. exterior body | Surface scratch(es) | |

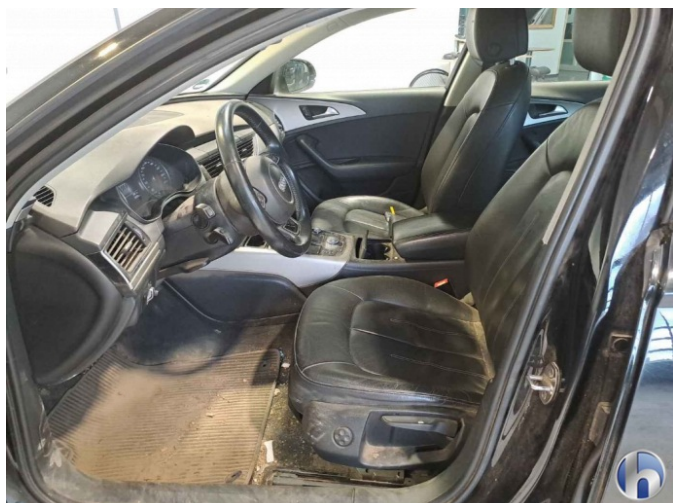
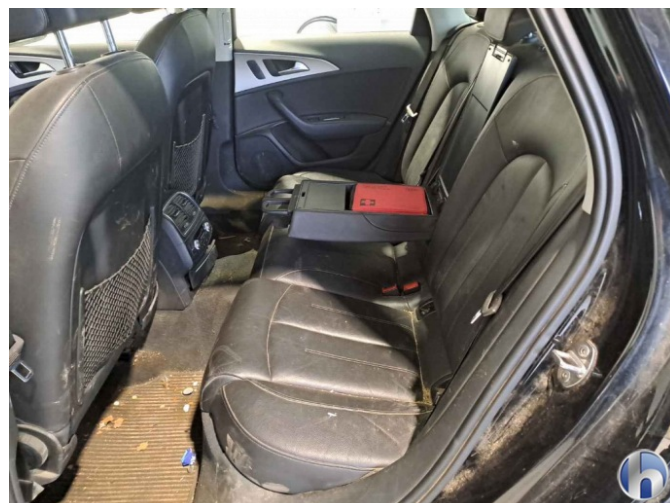
| component | Damage | Rep kind |
|---|---|---|
| 15. | Wear and tear | acceptable |

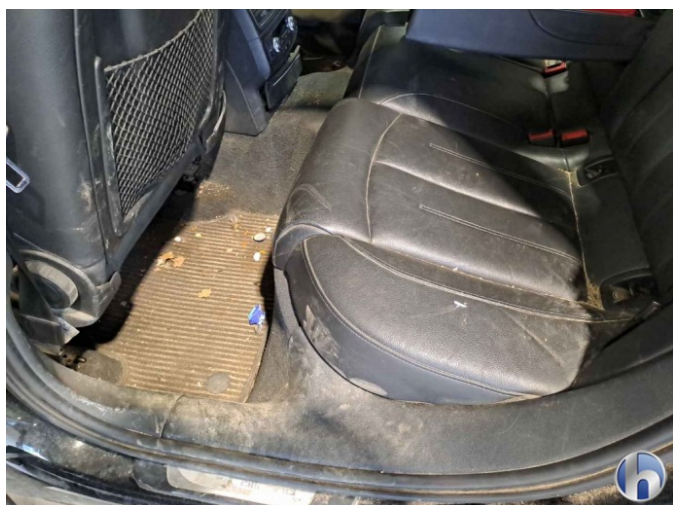
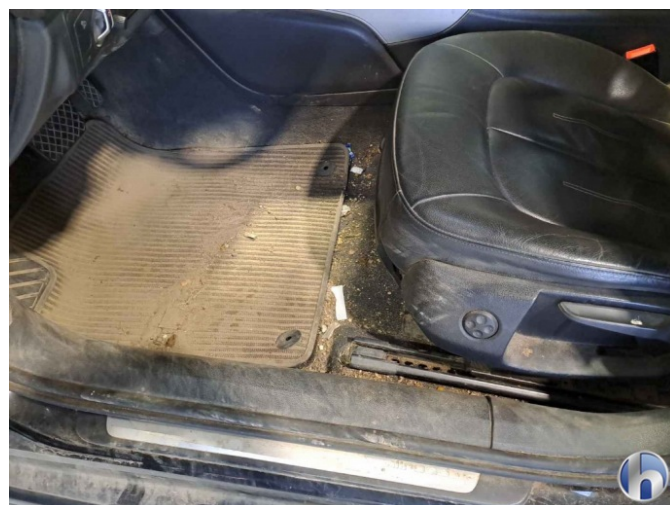
| component | Damage | Rep kind |
|---|---|---|
| 16. | Dirty (strong) | |

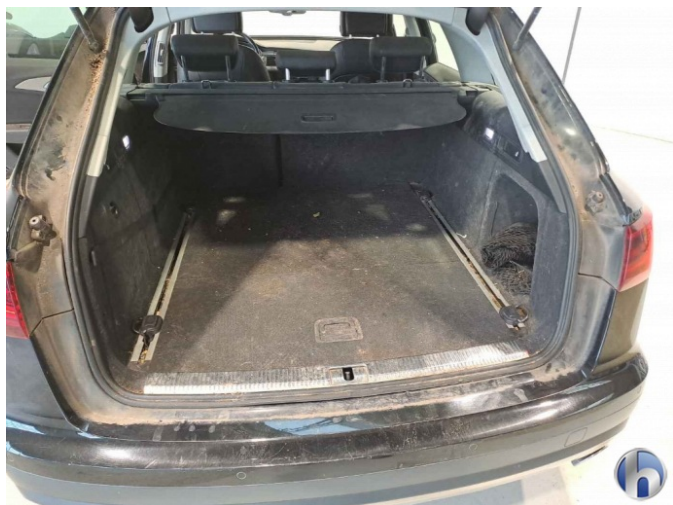
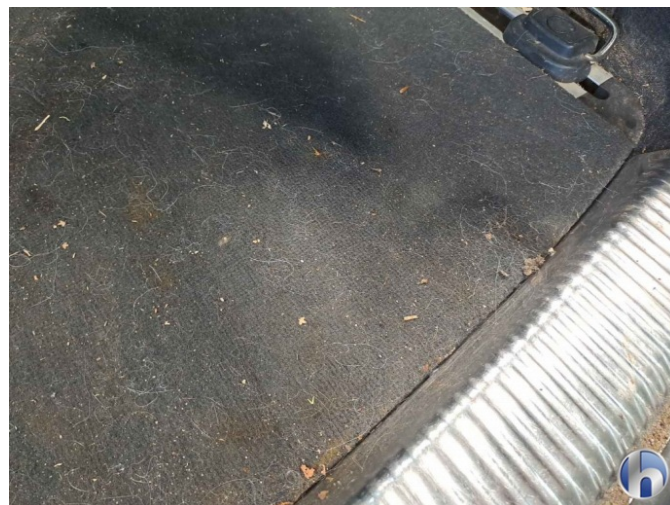
| component | Damage | Rep kind |
|---|---|---|
| 17. | Dirty (animal hair) | |

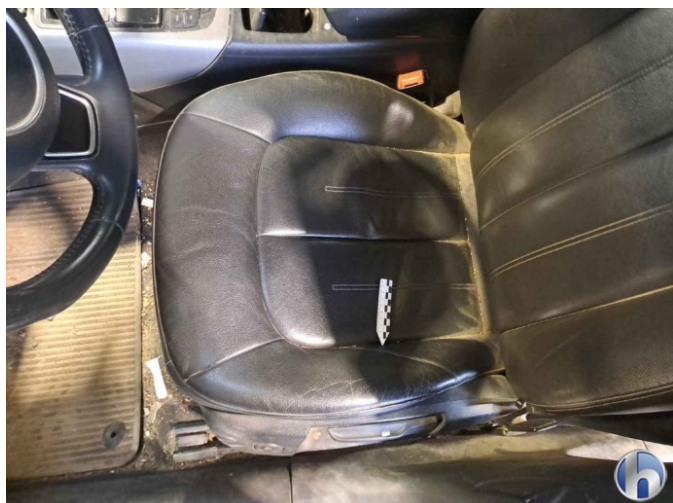
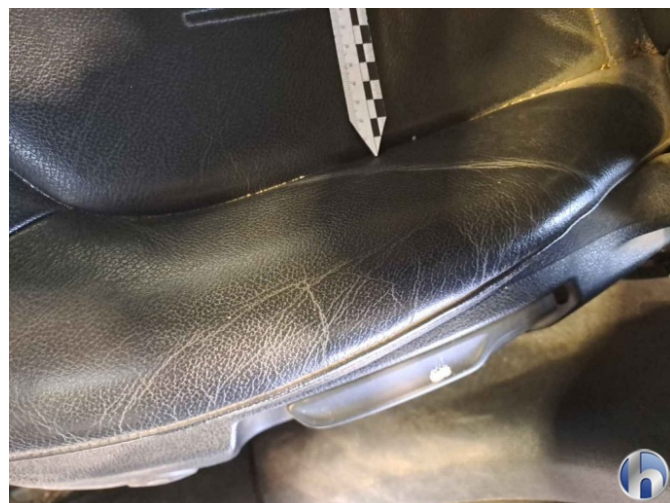
| component | Damage | Rep kind |
|---|---|---|
| 19. | Damaged | Replace |

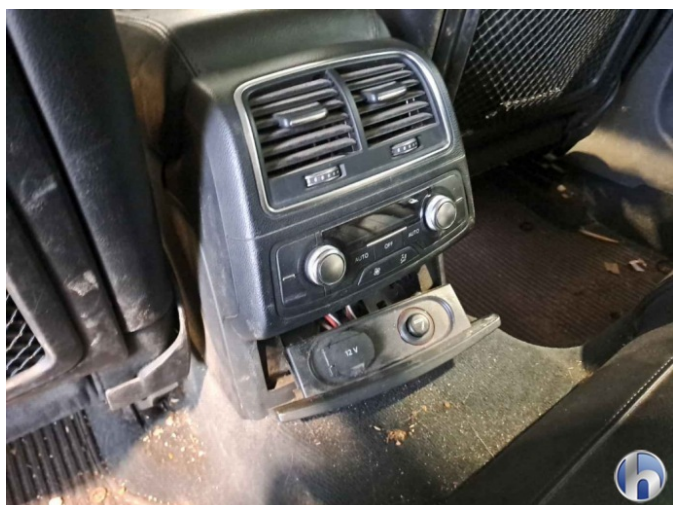
| component | Damage | Rep kind |
|---|---|---|
| 20. Bedieneinheit Hinten | Damaged | Replace |

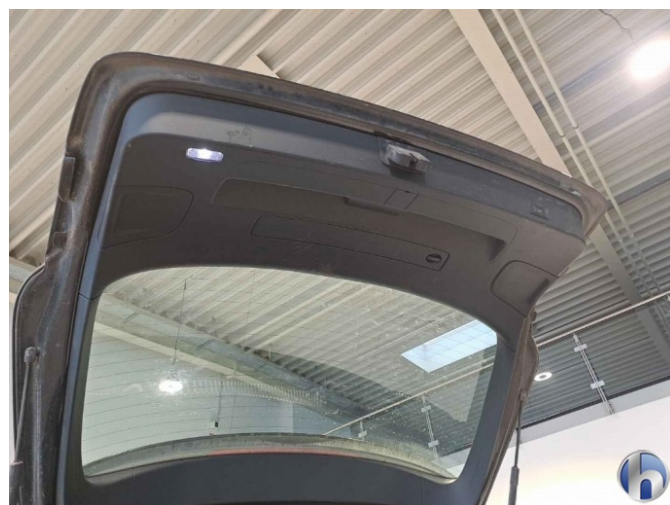
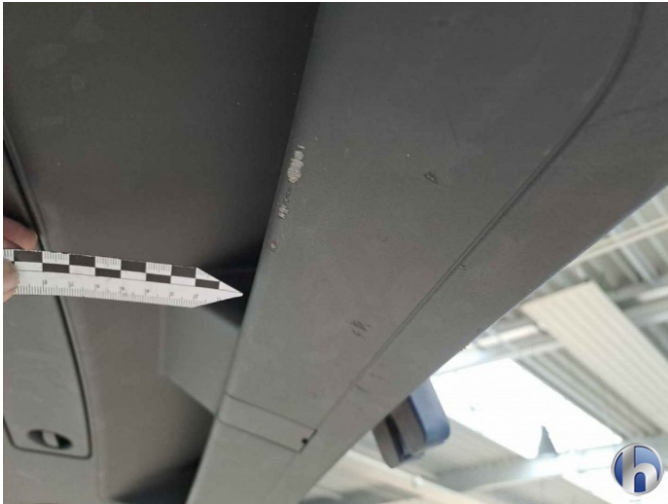
| component | Damage | Rep kind |
|---|---|---|
| 21. tailgate trim | Scrape | Replace |
