## status report

#### Audi A6 Lim. 3.0 TDI quattro

| Vehicle identification number | <b>WAUZZZ4G9JN106716</b> | mileage read: | <b>163011 km</b> |

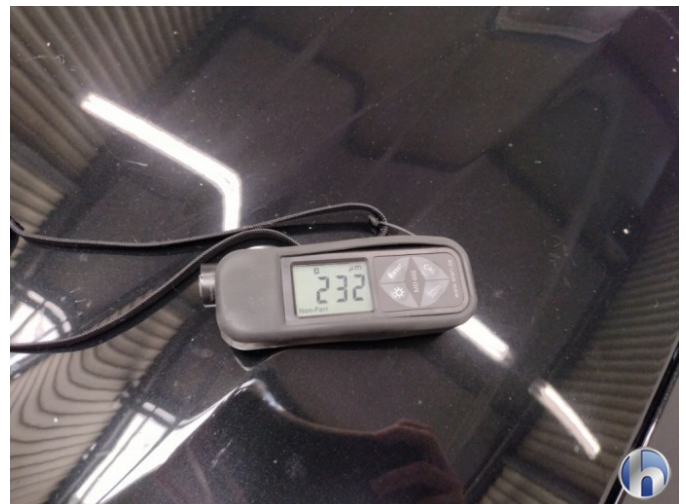
| component | Damage | Rep kind |
|---|---|---|
| 1. hood | Subsequently painted | acceptable |

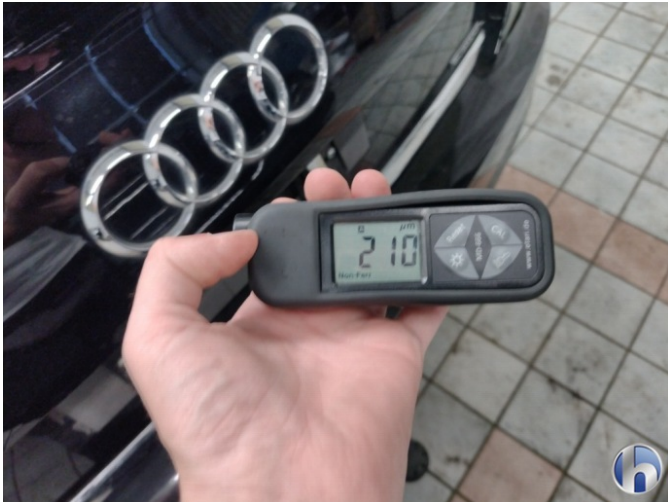
| component | Damage | Rep kind |
|---|---|---|
| 2. tailgate | Subsequently painted | acceptable |

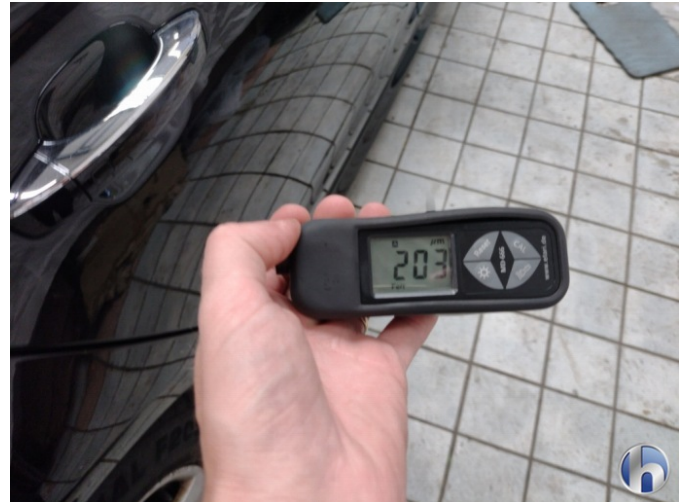
| component | Damage | Rep kind |
|---|---|---|
| 3. Sidewall - Rear - right | Subsequently painted | acceptable |

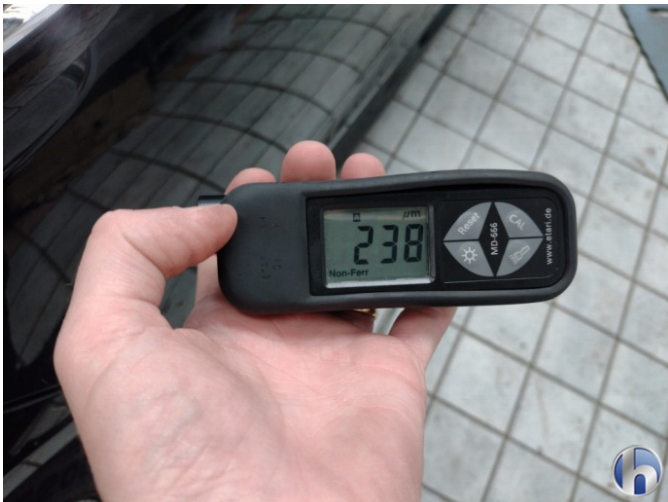
| component | Damage | Rep kind |
|---|---|---|
| 4. Door Rear - right | Subsequently painted | acceptable |

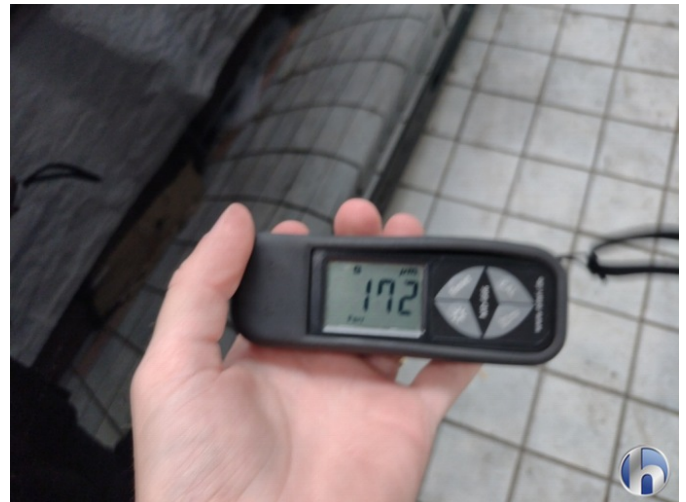
| component | Damage | Rep kind |
|---|---|---|
| 5. Roof frame - right | Subsequently painted | acceptable |

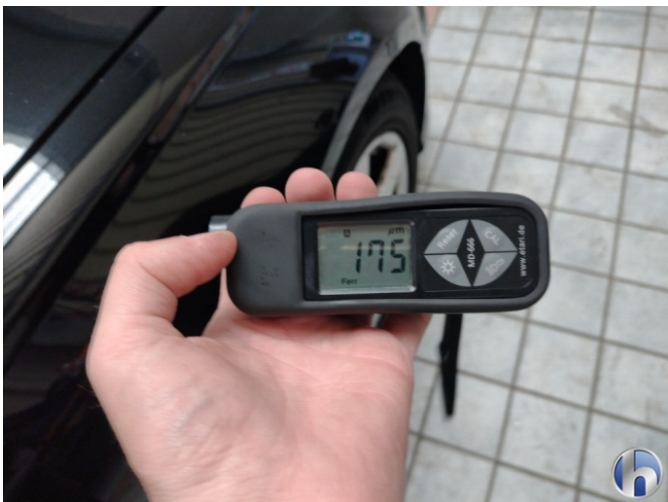
| component | Damage | Rep kind |
|---|---|---|
| 6. A-pillar Front - right | Subsequently painted | acceptable |

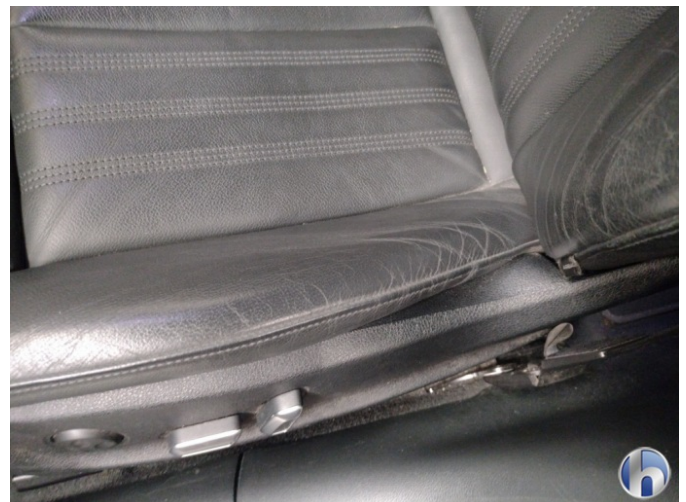
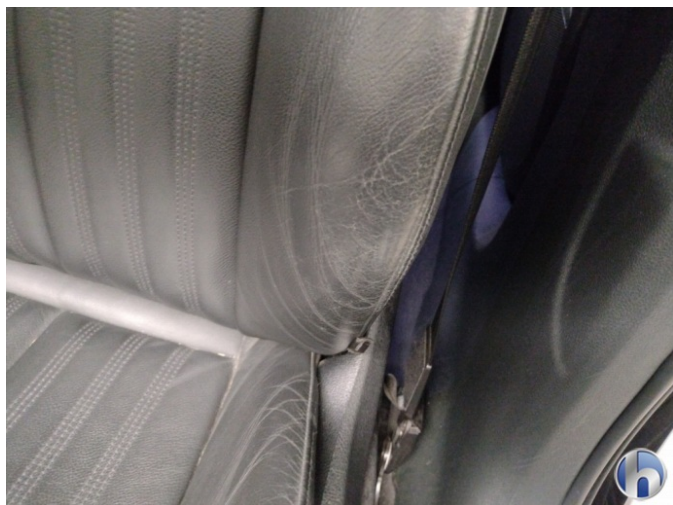
| component | Damage | Rep kind |
|---|---|---|
| 7. Sitz Vorne Links | Damaged | Smart repair |

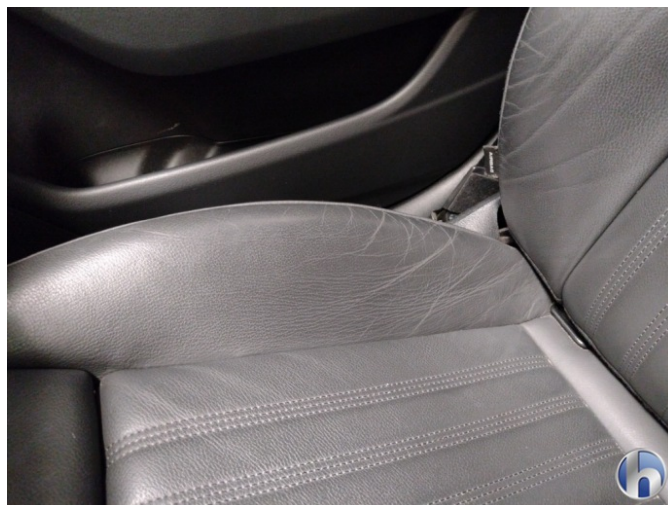
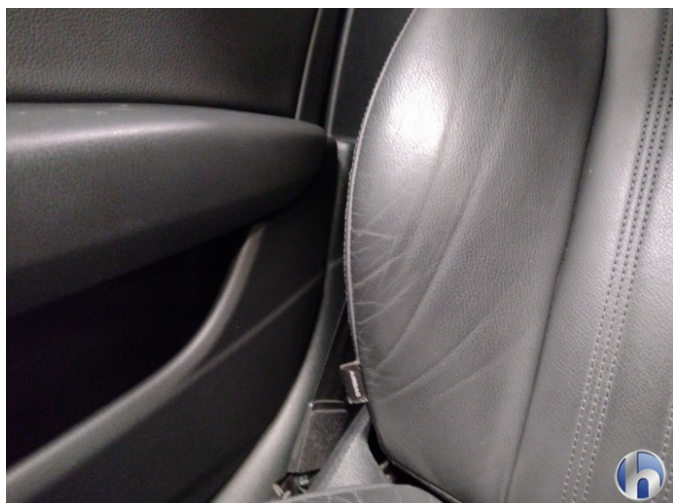
| component | Damage | Rep kind |
|---|---|---|
| 8. Sitz Vorne Rechts | Damaged | Smart repair |

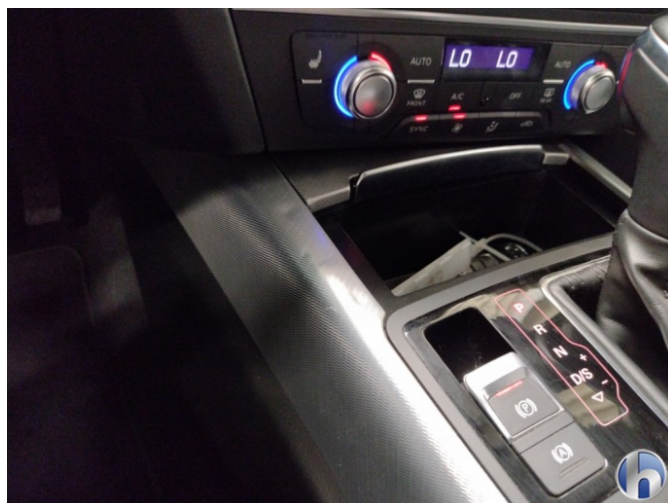
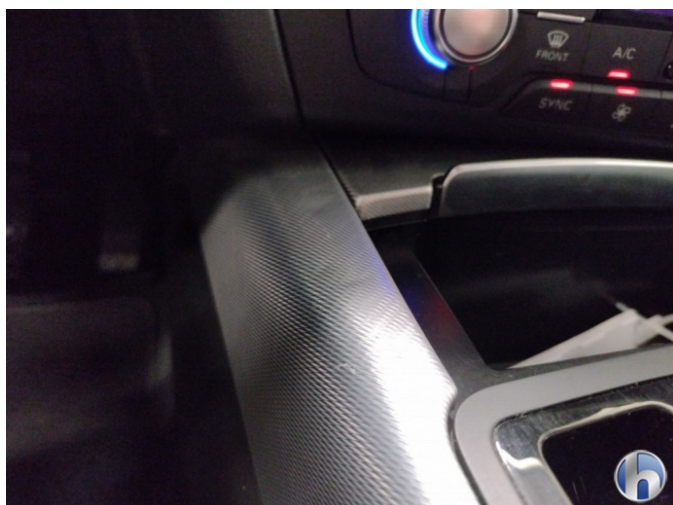
| component | Damage | Rep kind |
|---|---|---|
| 9. Mittelkonsole Blende | Damaged | Replace |

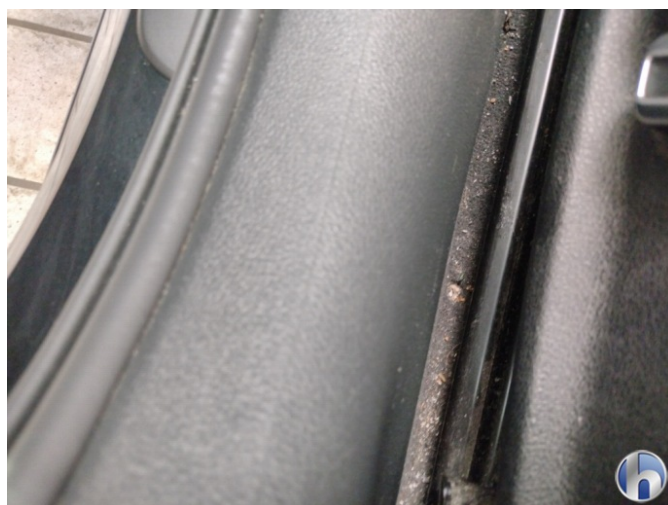
| component | Damage | Rep kind |
|---|---|---|
| 12. Bodenbelag Fahrerseite | Burn hole | Smart repair |

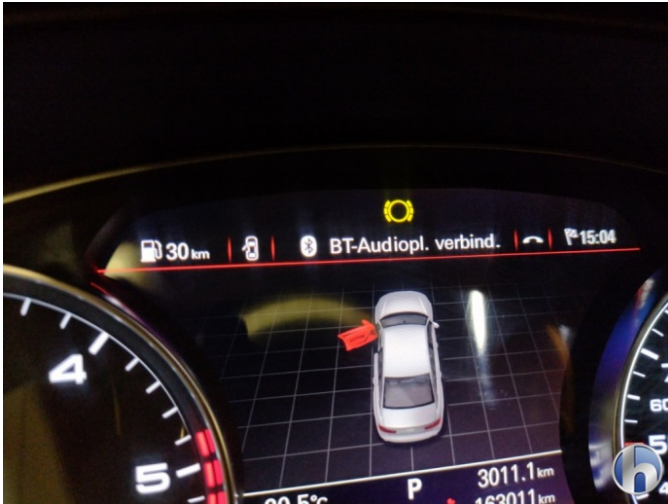
| component | Damage | Rep kind |
|---|---|---|
| 13. Bremsen | Worn | Replace |

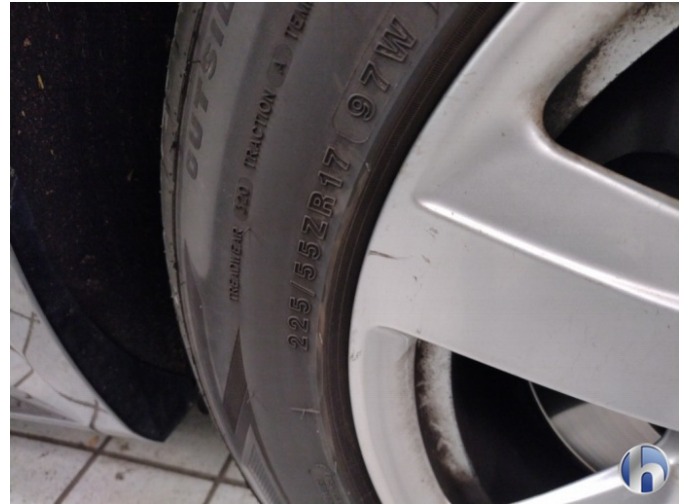
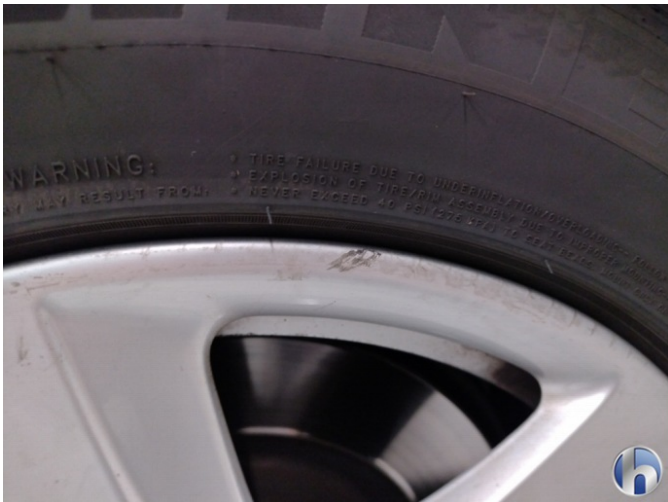
| component | Damage | Rep kind |
|---|---|---|
| 14. Rim rear - left | Scratch(es) | Smart repair |

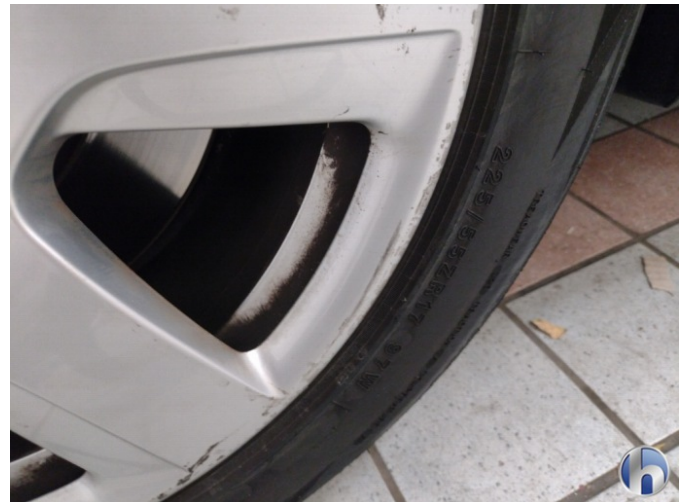
| component | Damage | Rep kind |
|---|---|---|
| 15. Rim rear - right | Scratch(es) | Smart repair |

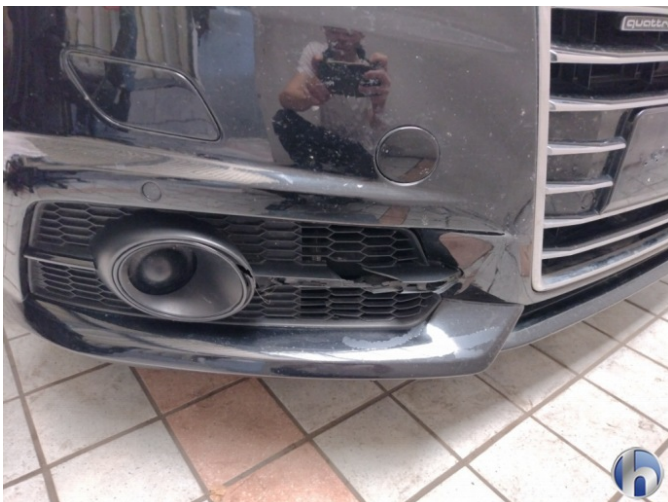
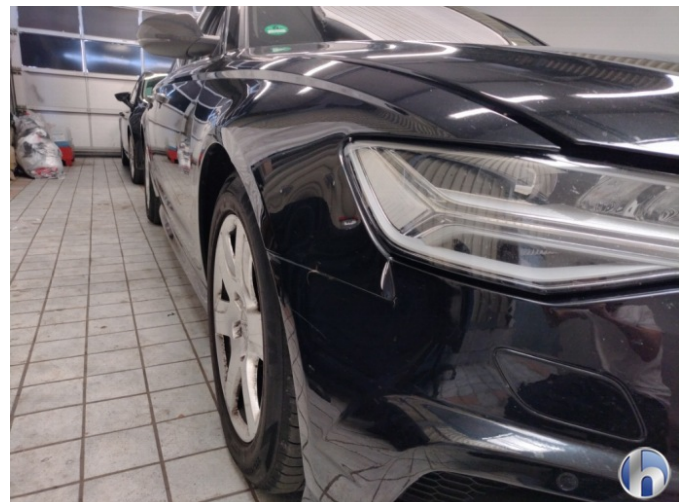
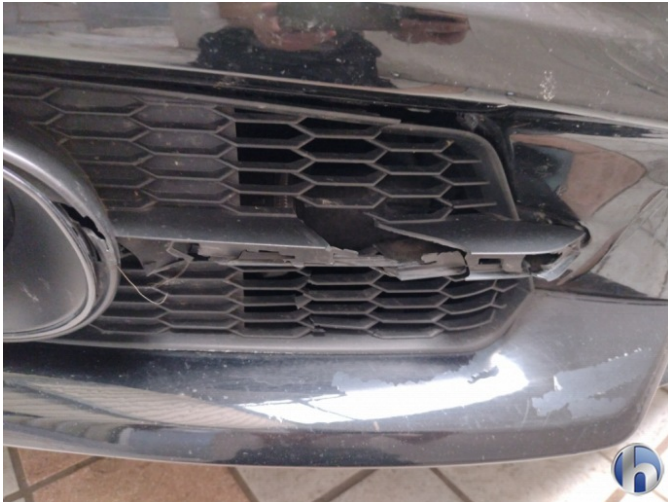
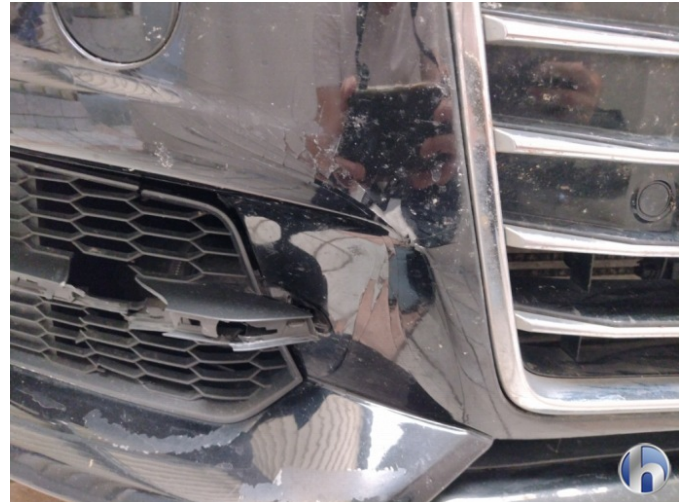
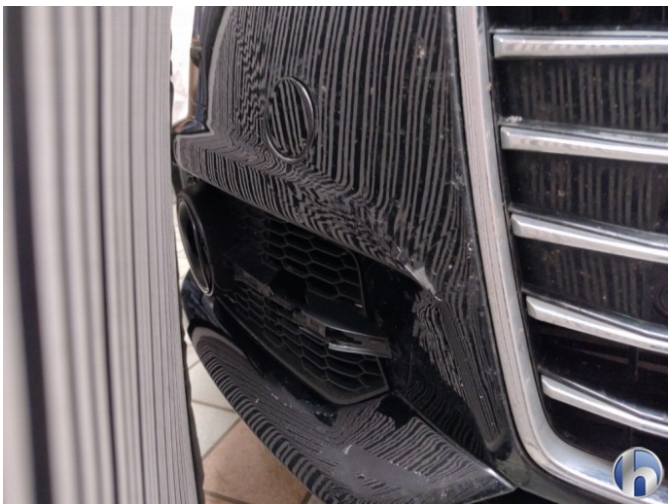
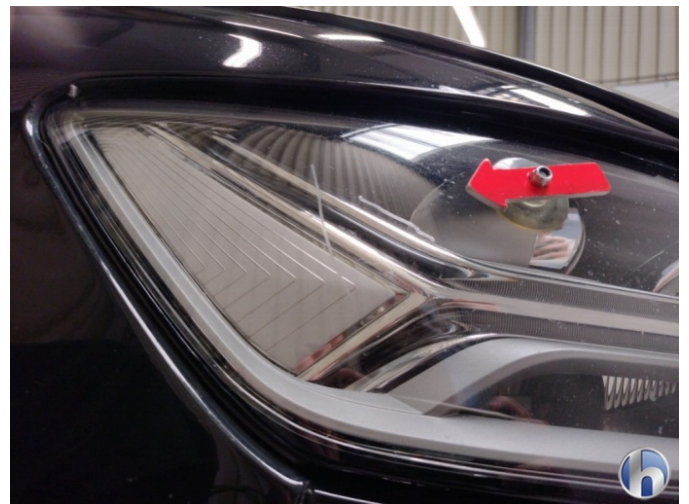
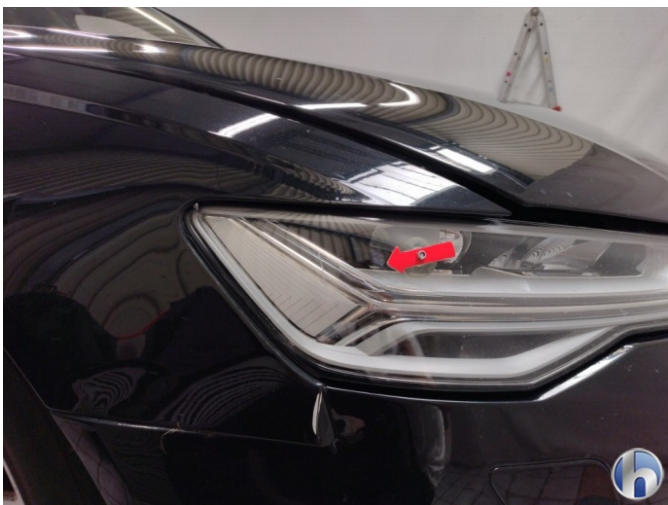
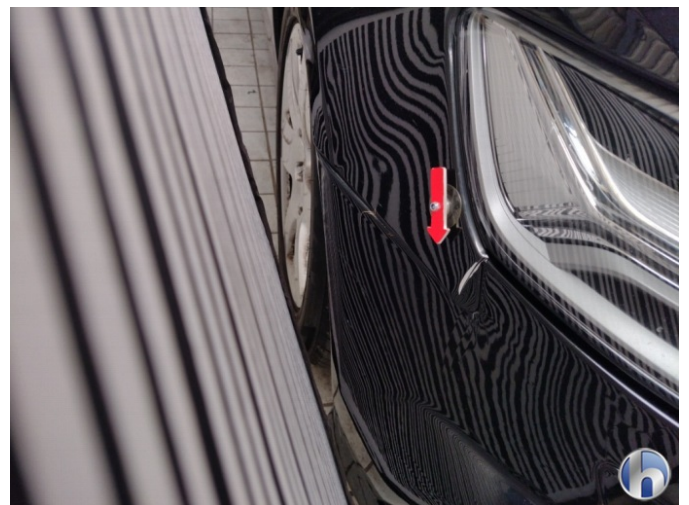
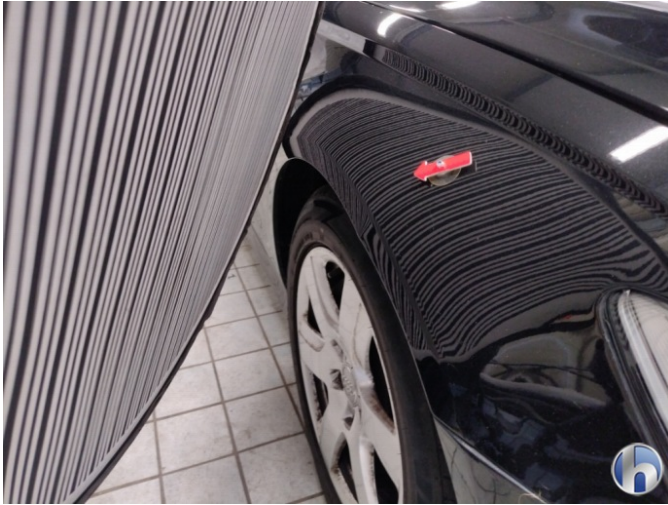
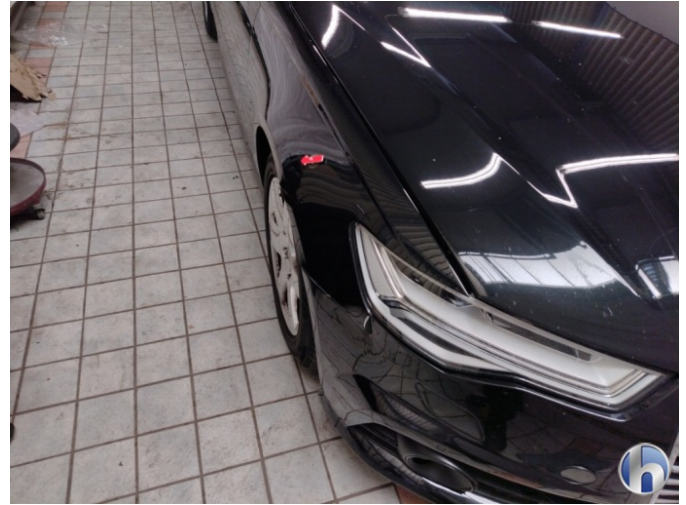
16. Unfallschaden Vorne Rechts Schadenserweiterung möglich

| General examination | |
|---|---|
| <b>Note Road Safe:</b> | Steinschlag im Sichtfeld, Unfallschaden Vorne Rechts |

| <b>Existing collision damage:</b> | <b>found</b><br>At the unrepaired vehicle accident damage were observed on visual examination on the body skin . |
| <b>reference:</b> | Fahrzeug mit bestehenden Unfallschaden, zur Schadensermittlung wurden keine Demontearbeiten durchgeführt, verborgen gebliebene Schäden können nicht ausgeschlossen werden. Unfallschaden Kosten wurden überschlägig Kalkuliert, Kostenerweiterung möglich. |

| component | Damage | Rep kind |
|---|---|---|
| 16. Unfallschaden Vorne Rechts<br>Schadenserweiterung möglich | Accident damage | Replace |

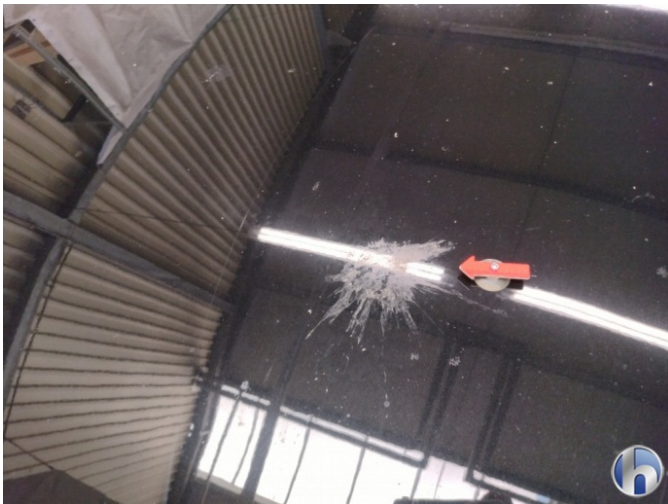
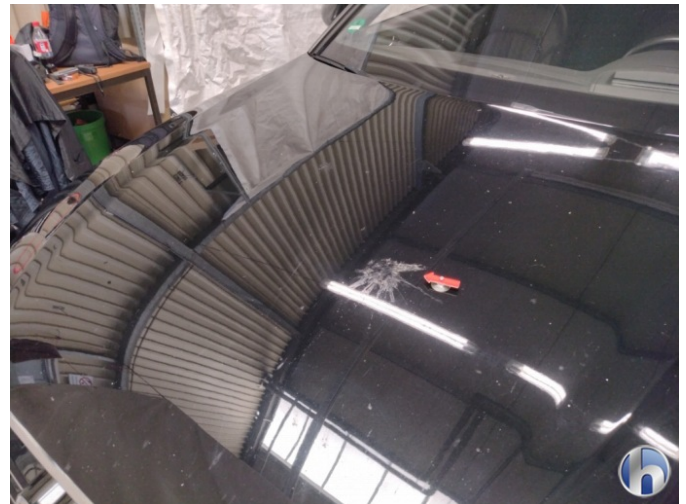
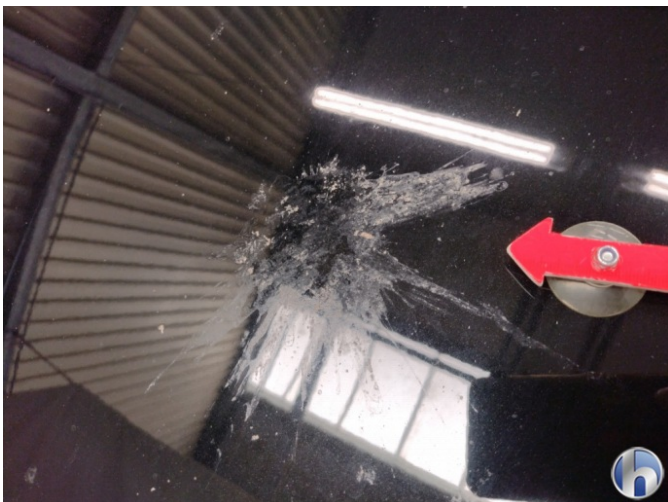
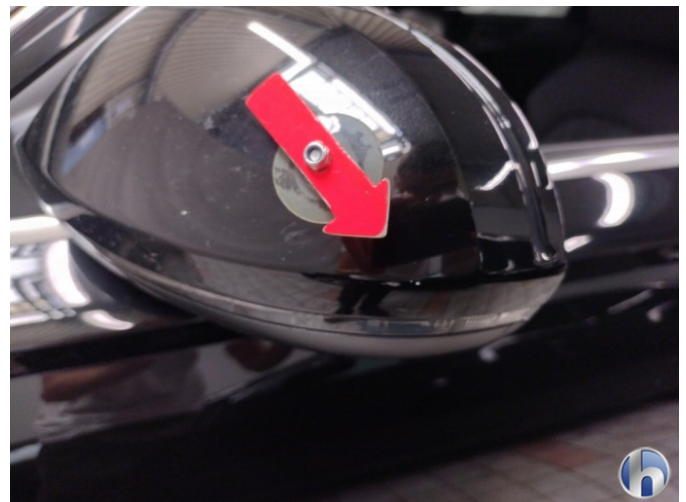
| component | Damage | Rep kind |
|---|---|---|
| 17. hood | | Paint |

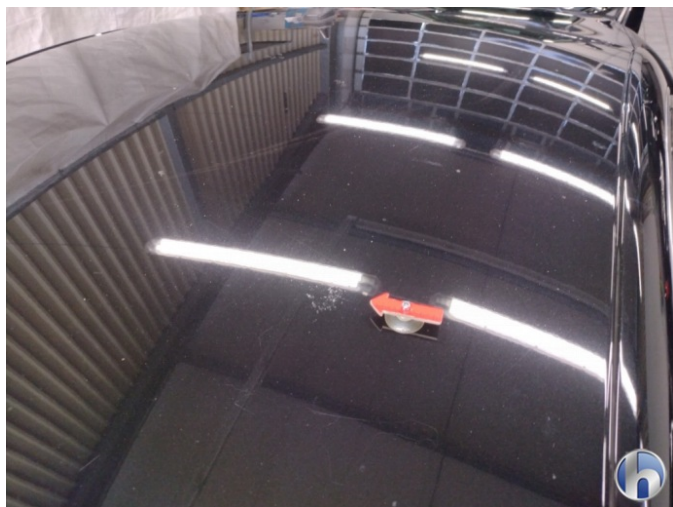
| component | Damage | Rep kind |
|---|---|---|
| 18. | Scratch(es) | Paint |

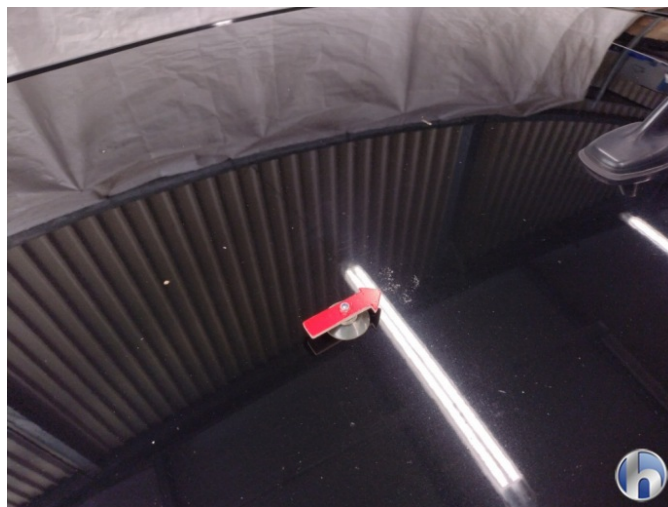
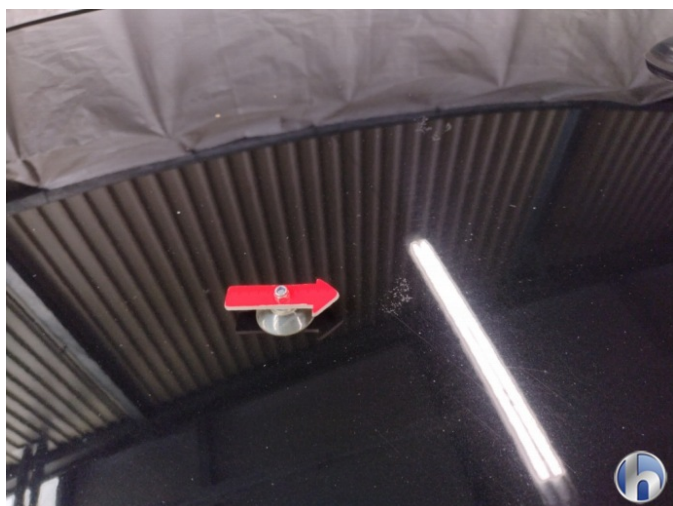
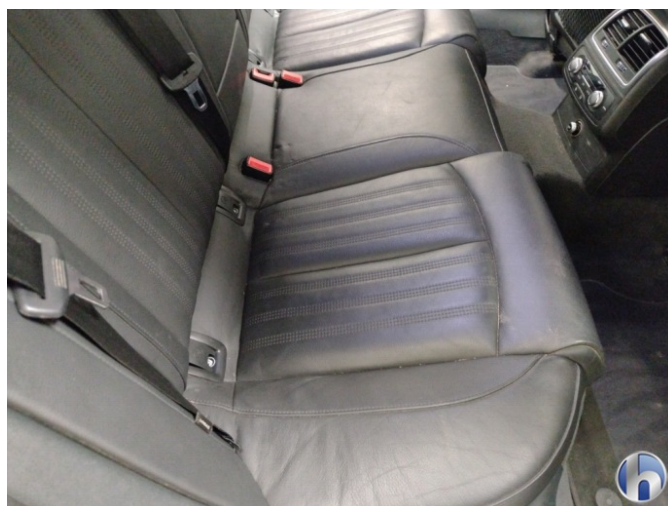
| component | Damage | Rep kind |
|---|---|---|
| 19. roof | | Paint |

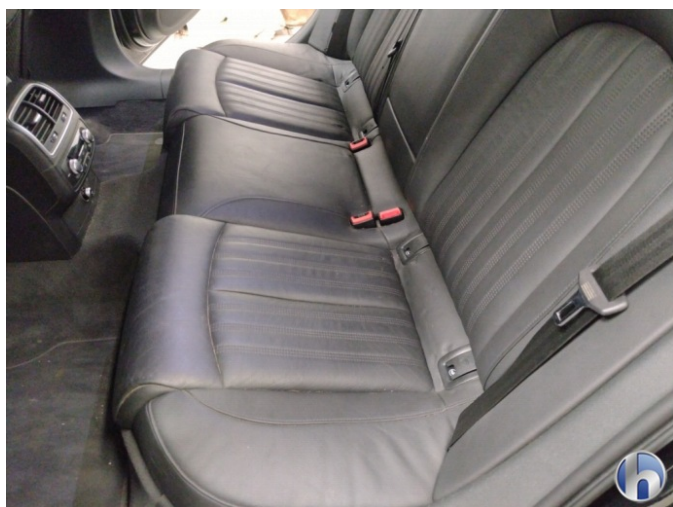
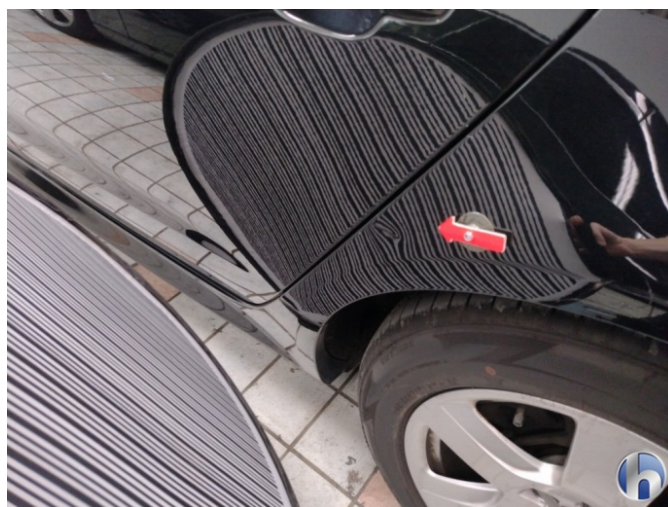
| component | Damage | Rep kind |
|---|---|---|
| 20. Sitzreihe Hinten | Damaged | Smart repair |

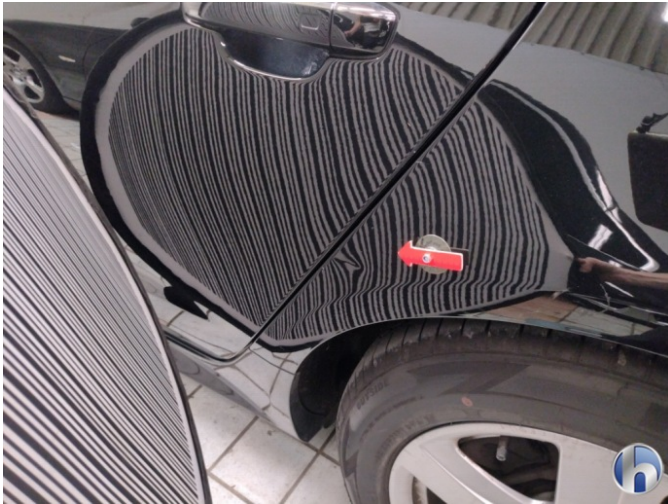
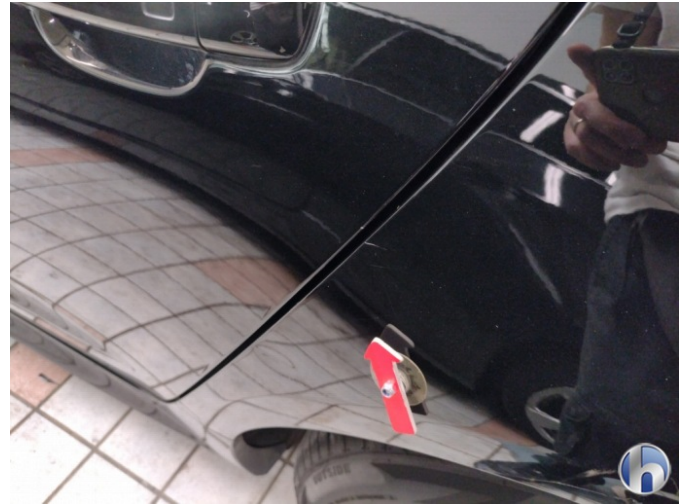
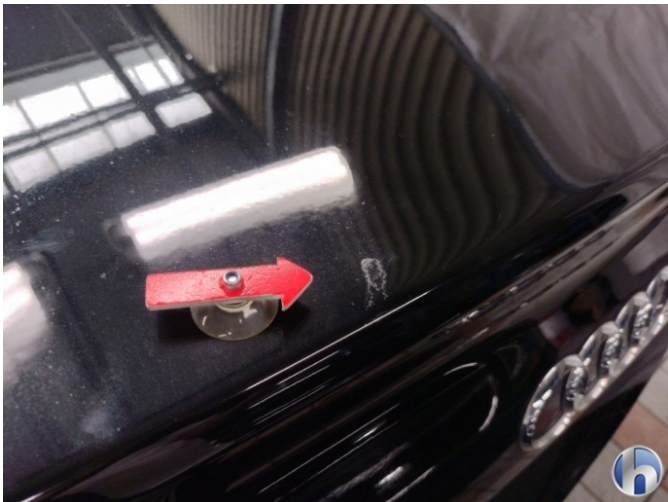
| component | Damage | Rep kind |
|---|---|---|
| 21. Sidewall - Rear - Left | Deformed | Refurbish and paint |

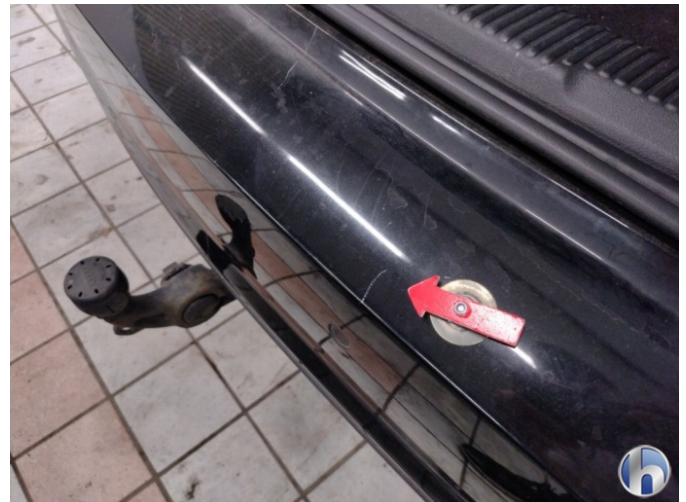
| component | Damage | Rep kind |
|---|---|---|
| 22. tailgate | | Smart repair |

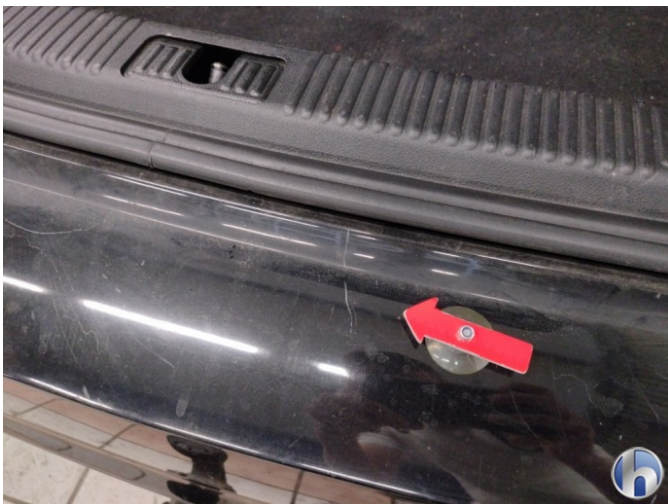
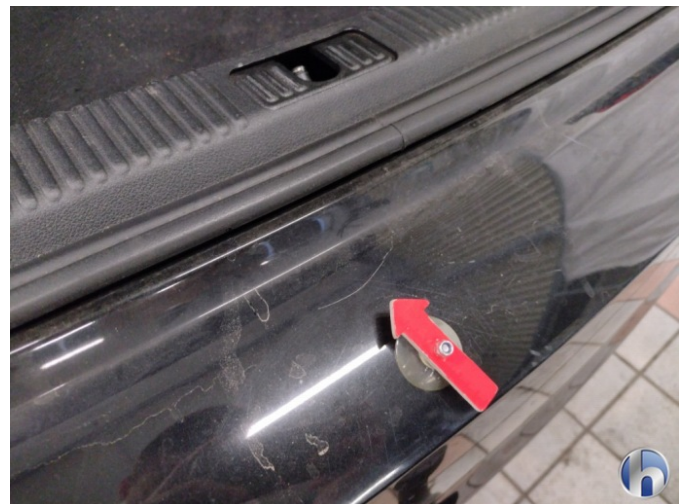
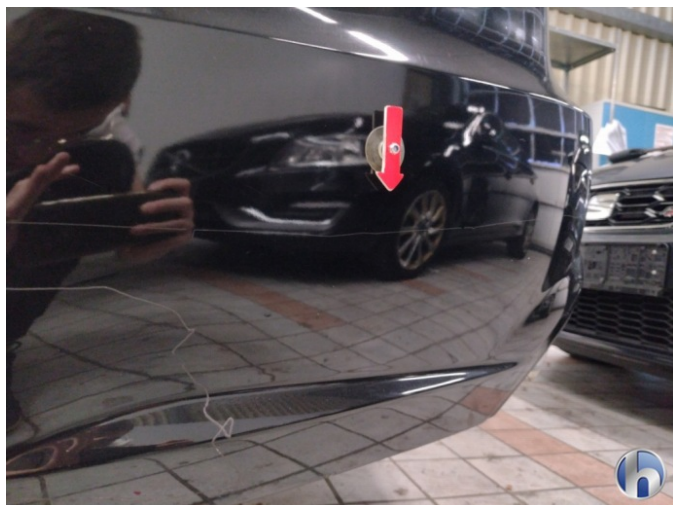
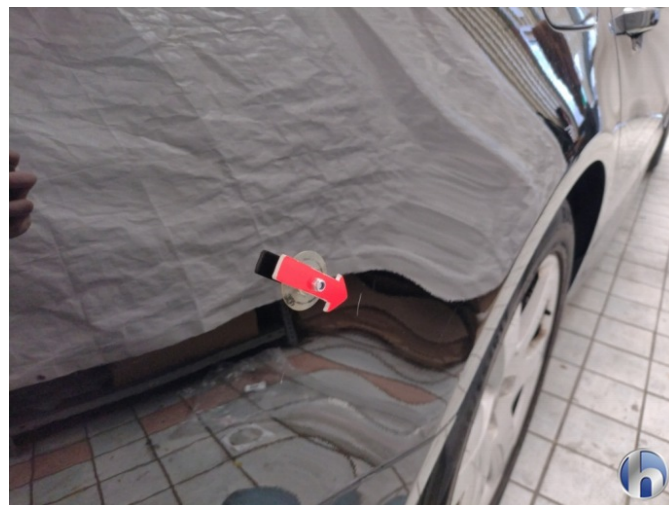
| component | Damage | Rep kind |
|---|---|---|
| 23. Rear bumper | Scratch(es) | Paint |

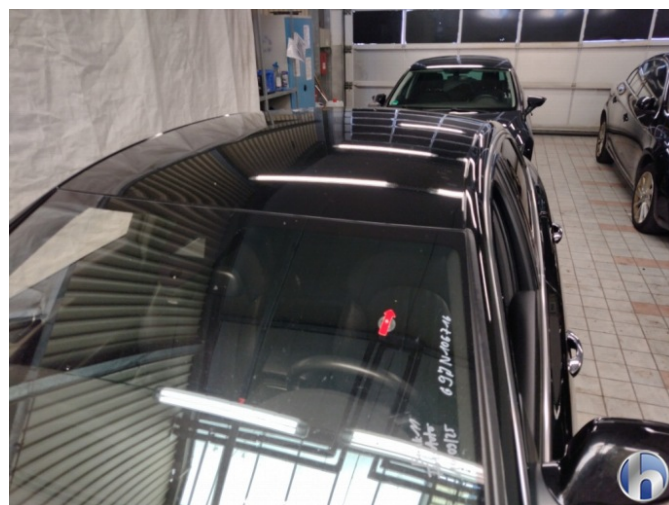
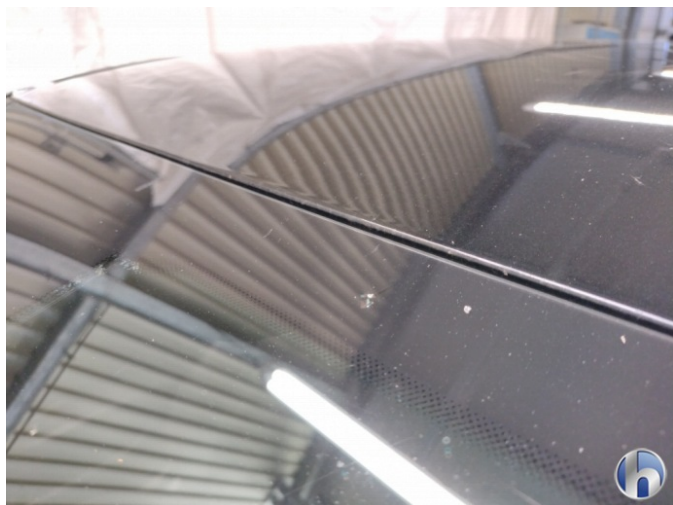
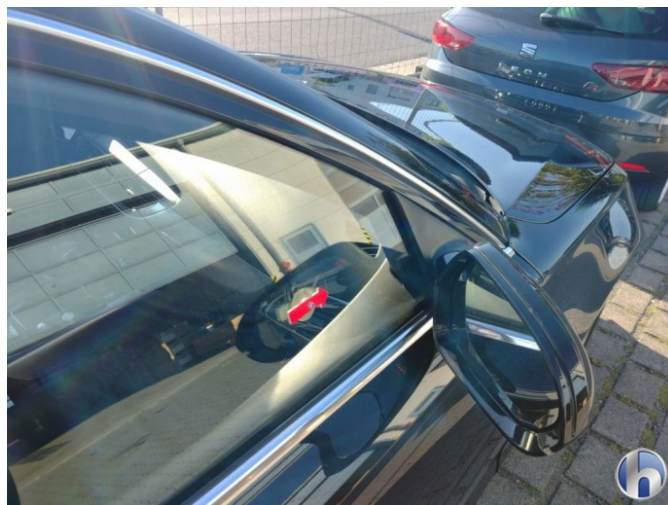
| component | Damage | Rep kind |
|---|---|---|
| 27. Windshield | Damaged | Replace |

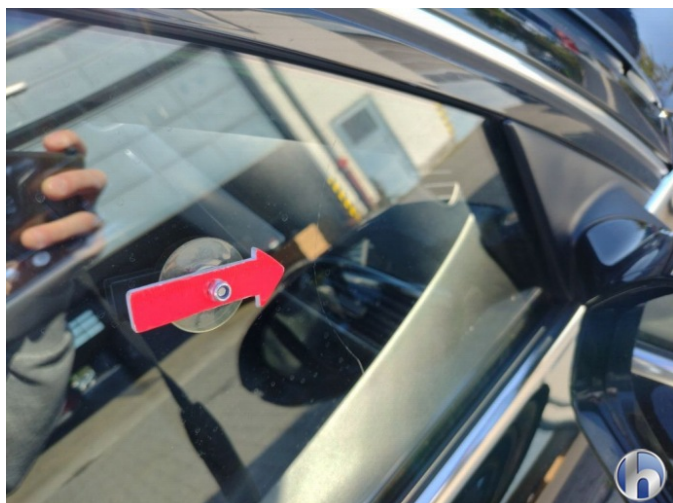
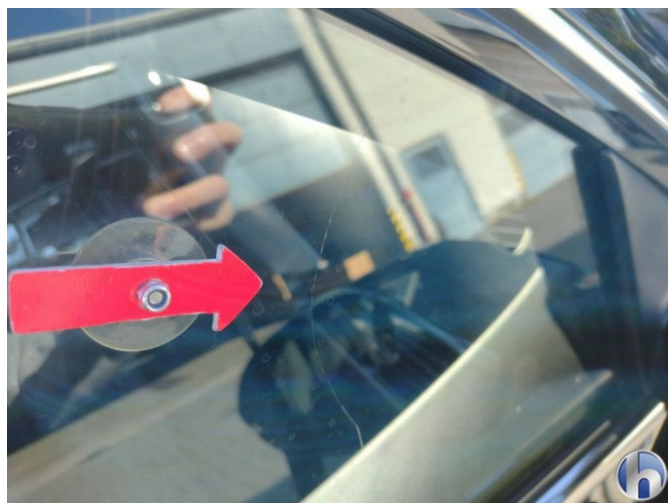
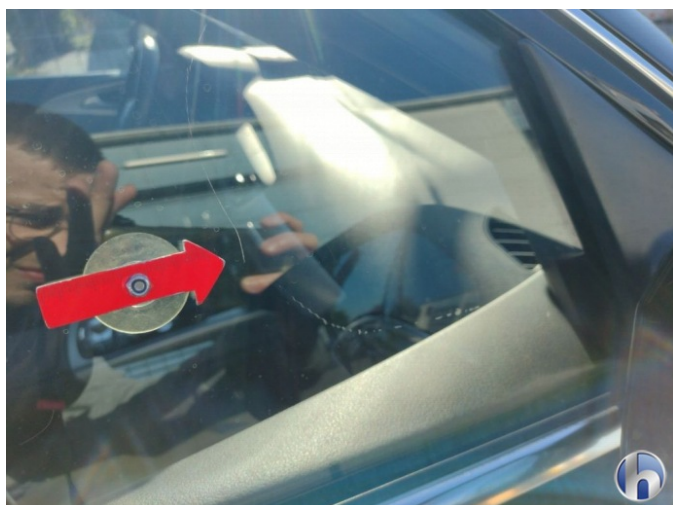
| component | Damage | Rep kind |
|---|---|---|
| 28. Side window - Front - right | Scratch(es) | Replace |
