## status report

#### Audi Q7 4.2 TDI quattro

| Vehicle identification number | <b>WAUZZZ4L8AD021742</b> | mileage read: | <b>123734 km</b> |

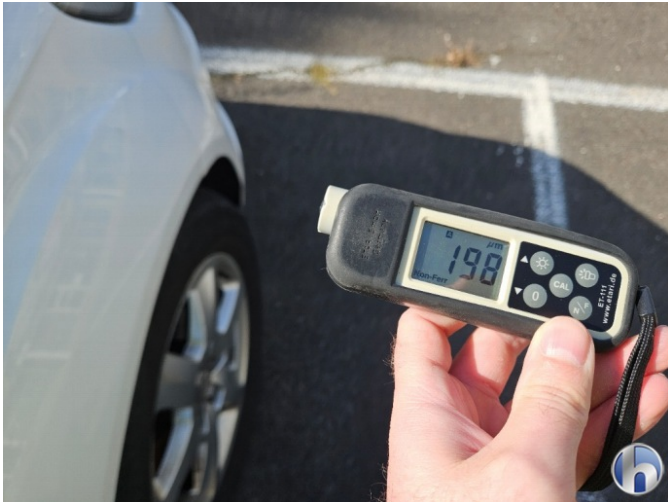
| component | Damage | Rep kind |
|---|---|---|
| 1. Front fender - right | Subsequently painted | acceptable |

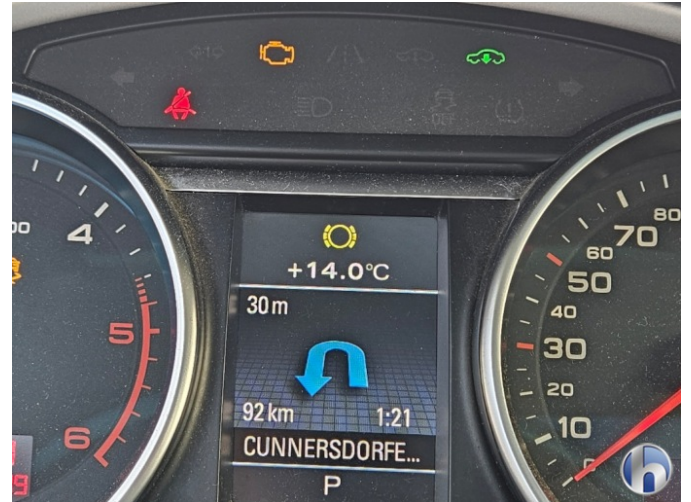
| General examination | |
|---|---|
| <b>Note Road Safe:</b> | Fehlermeldung Bremsanlage |

| component | Damage | Rep kind |
|---|---|---|
| 4. brake system | Error message | Carry out a fault diagnosis |

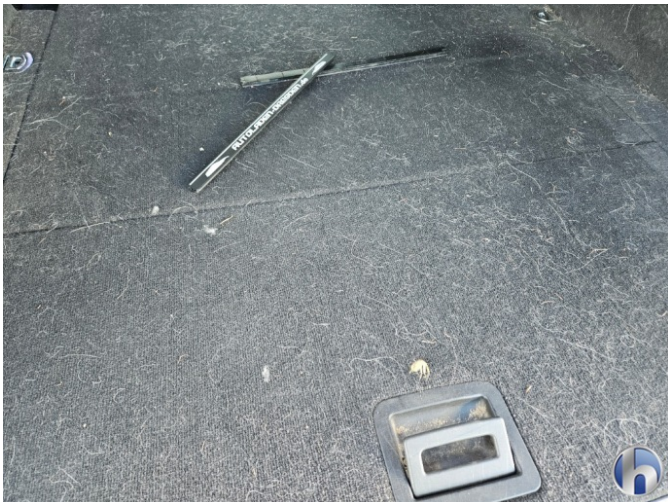
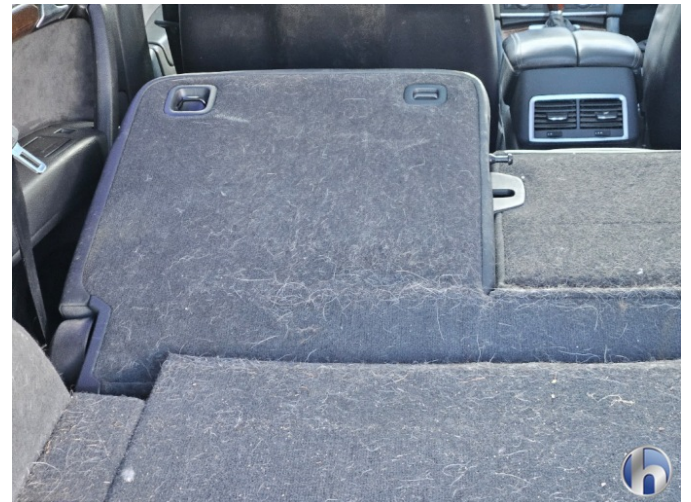
| component | Damage | Rep kind |
|---|---|---|
| 6. | Dirty (animal hair) | |

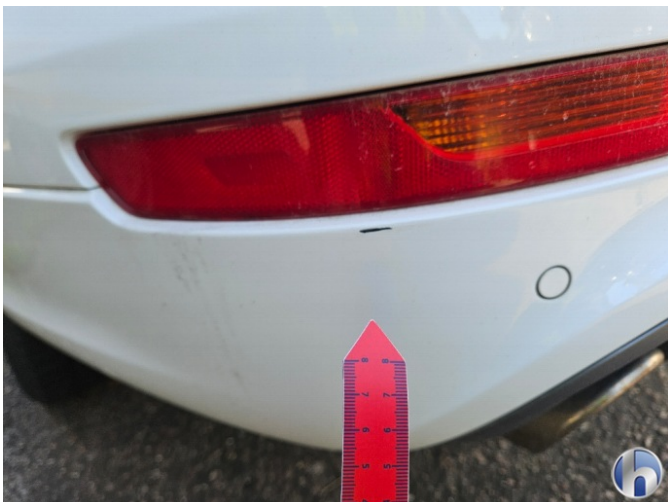
| component | Damage | Rep kind |
|---|---|---|
| 9. Rear bumper | Scratch(es) | Paint |

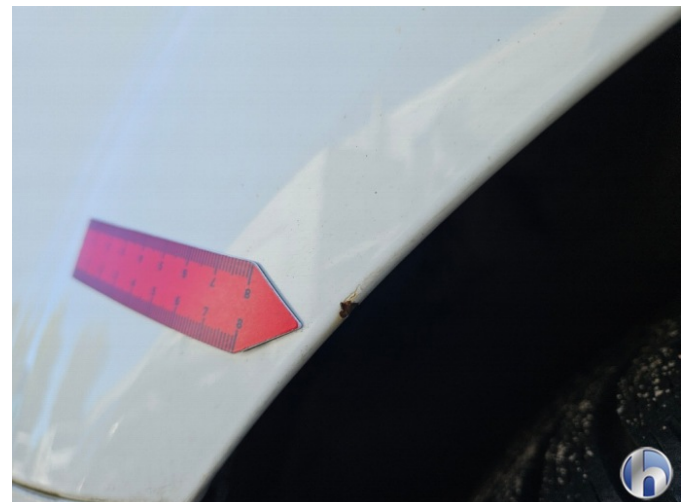
| component | Damage | Rep kind |
|---|---|---|
| 10. Sidewall - Rear - right | Corroded | Paint |

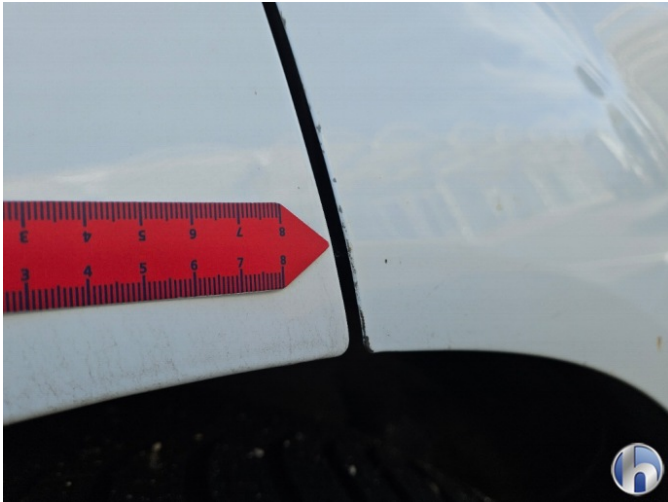
| component | Damage | Rep kind |
|---|---|---|
| 11. Door Rear - right | Wear and tear | acceptable |

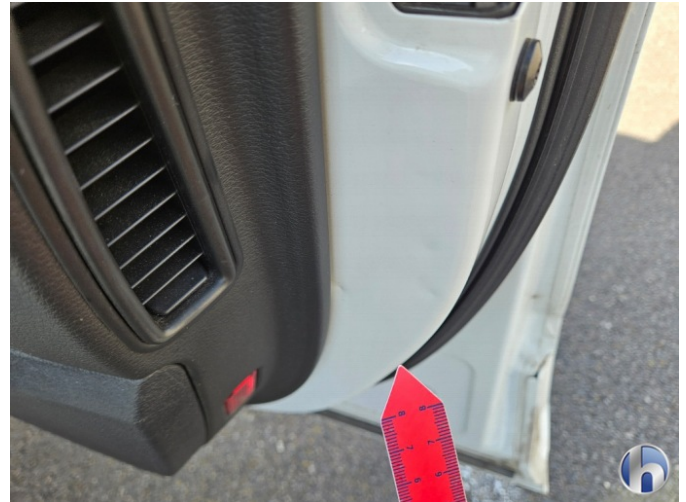
| component | Damage | Rep kind |
|---|---|---|
| 12. Front door - right | Wear and tear | acceptable |

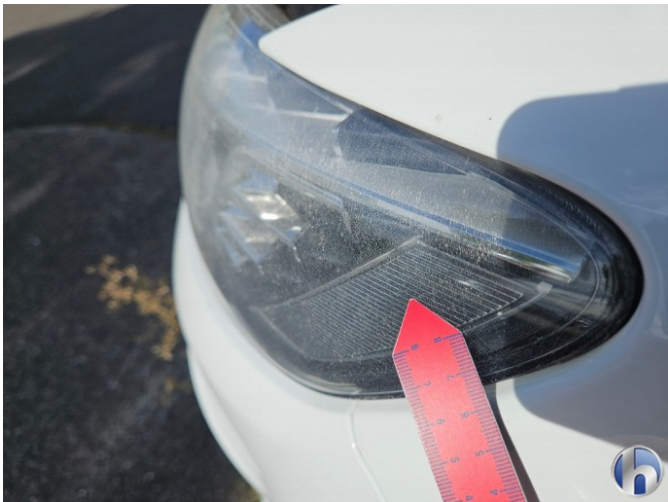
| component | Damage | Rep kind |
|---|---|---|
| 13. Bi xenon headlights - left | Wear and tear | acceptable |

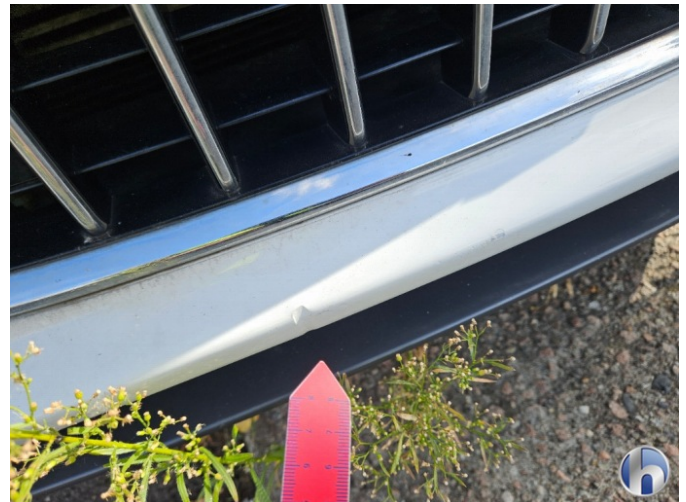
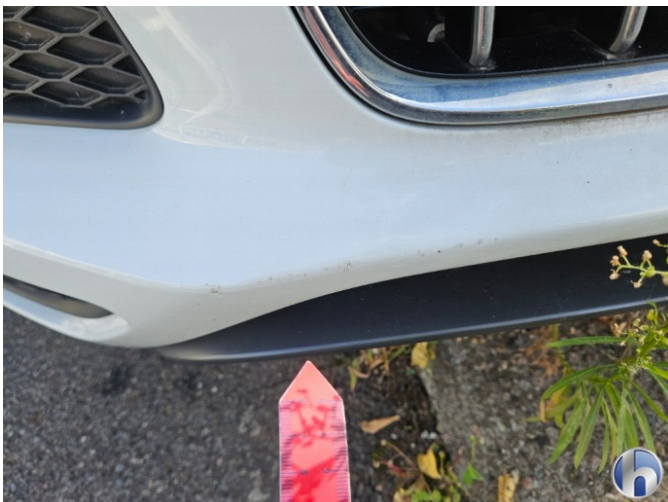
| component | Damage | Rep kind |
|---|---|---|
| 14. Front bumper | Scratch(es) | Smart repair |

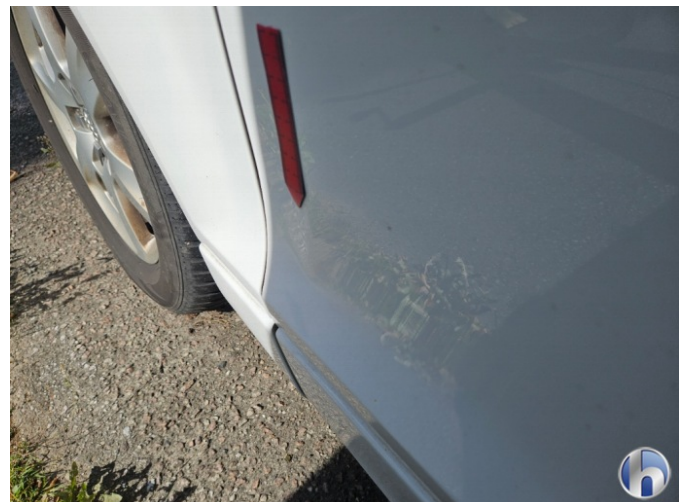
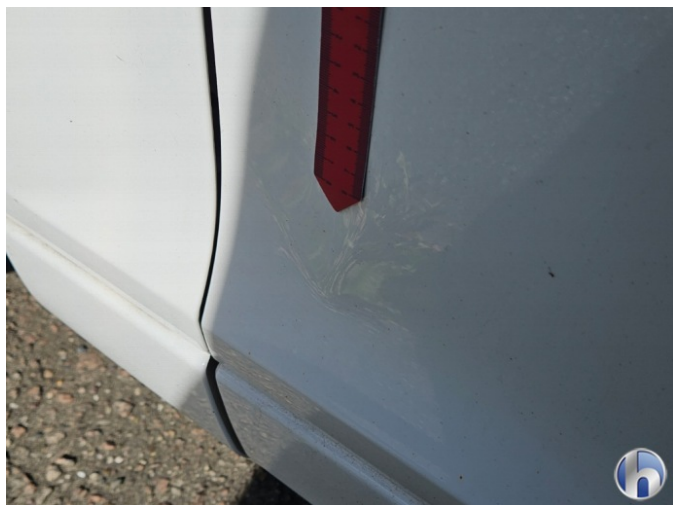
| component | Damage | Rep kind |
|---|---|---|
| 15. Front door - left | Deformed (slightly) | Refurbish and paint |

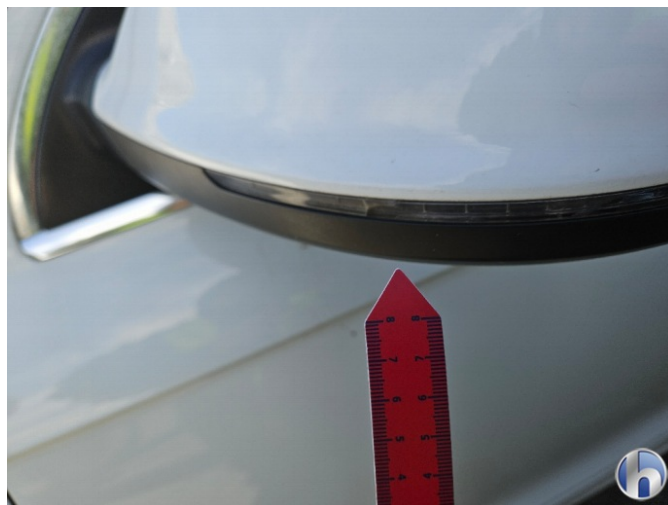
| component | Damage | Rep kind |
|---|---|---|
| 16. Spiegelblinker li. | Damaged | Replace |

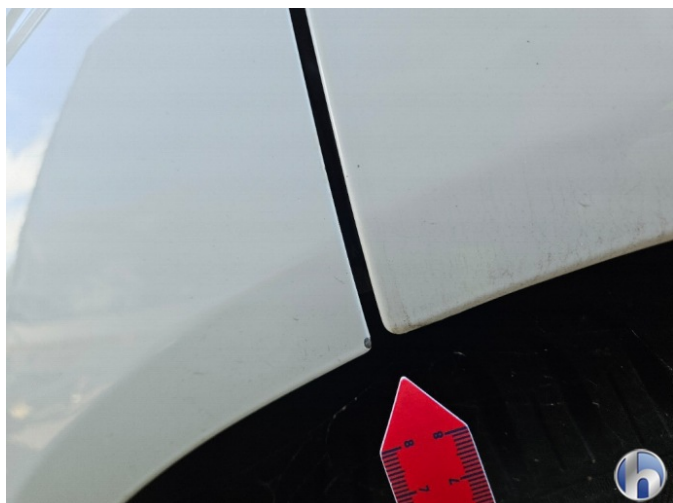
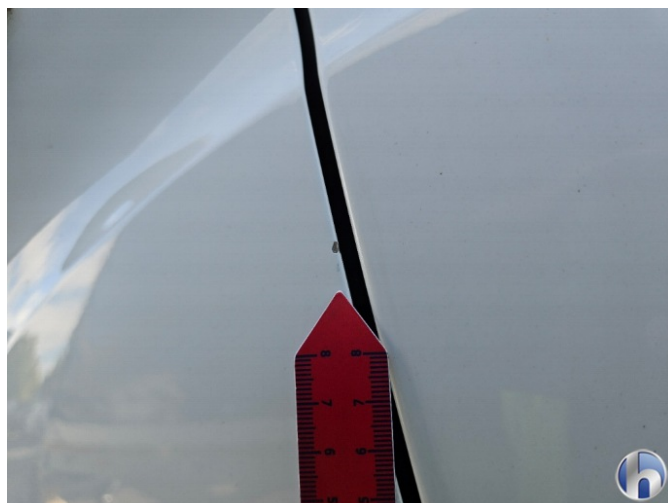
| component | Damage | Rep kind |
|---|---|---|
| 17. Rear door - left | Wear and tear | acceptable |

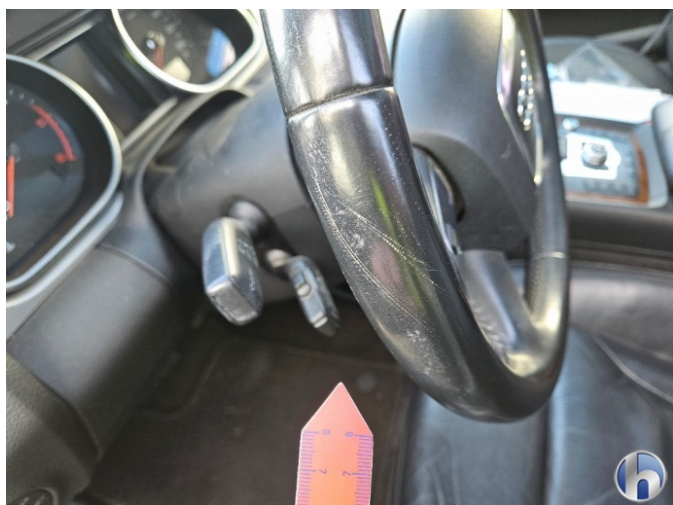
| component | Damage | Rep kind |
|---|---|---|
| 18. Steering wheel (leather) | Damaged | Replace |

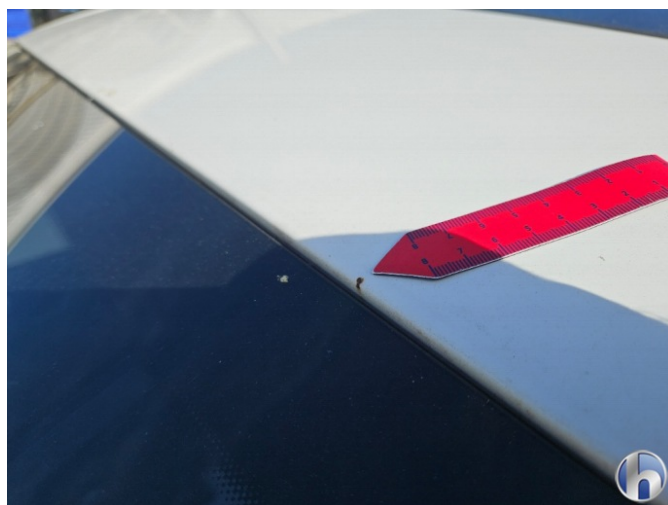
| component | Damage | Rep kind |
|---|---|---|
| 19. roof | Corroded | Paint |
