AUDI A5 I 2011 Cabriolet Diesel
A5 Cabrio 2.0 tdi Advanced 177cv
multitronic

VIN NO WAUZZZ8F3EN006134
Registration Number EY205HV

Inspection Report Summary

Customer	BCA Lodi	Report Number	P20250919120853
Inspection Date / Place	2025-09-19 / BCA Lodi	Cosmetic Grade	3

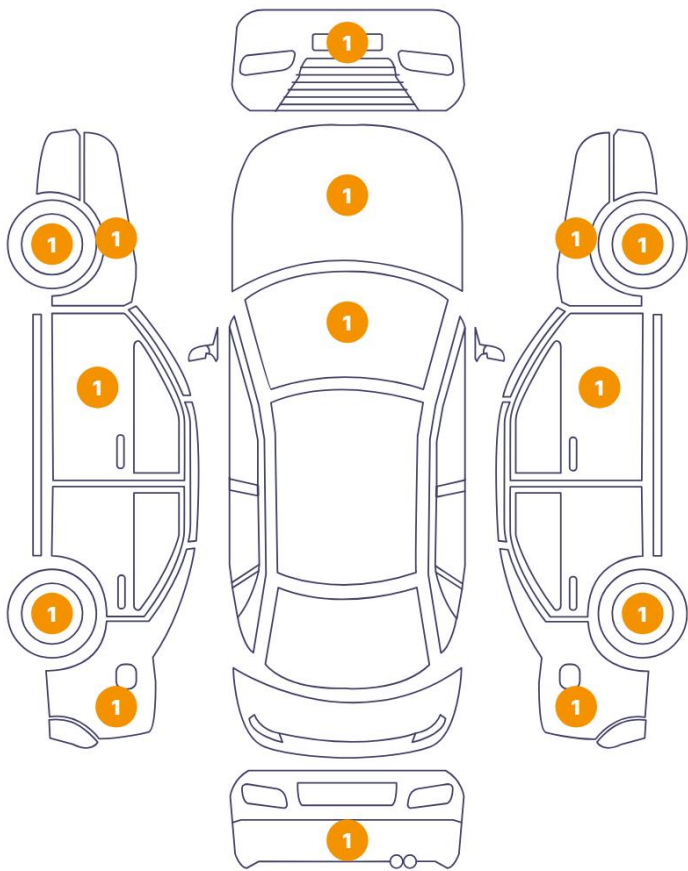
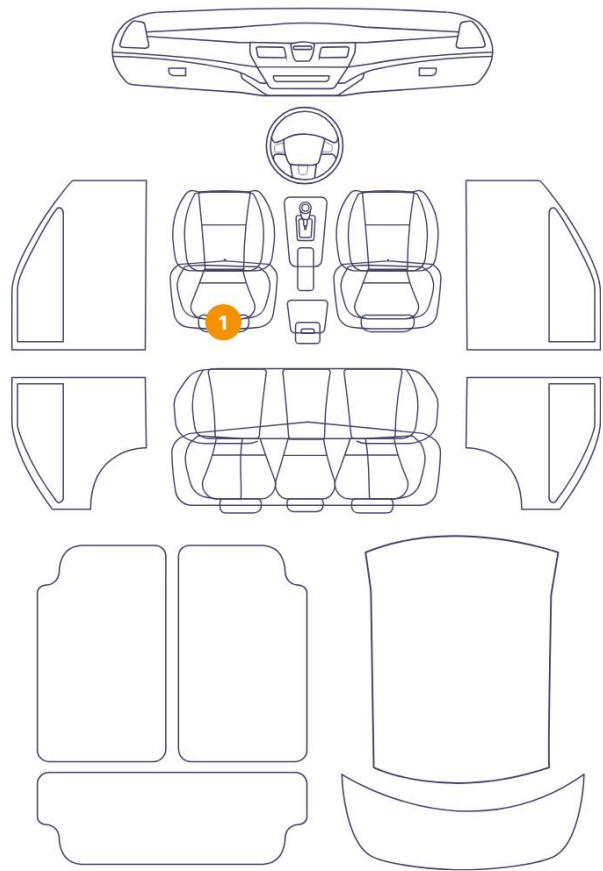
Component		Damage	Comments
1	Seat / Front Left	Interior / Worn - out	
2	Rim / Front Right	Out of Bodywork / Scratch	
3	Fender / Front Right	Bodywork / Poor Previous Repair	
4	Hood	Bodywork / Poor Previous Repair	
5	Fender / Front Left	Paint / Scratch / Line	
6	Rim / Front Left	Out of Bodywork / Scratch	
7	Door / Front Left	Paint / Scratch / Line	
8	Windshield / Front	Glass Break	
9	Rim / Back Left	Out of Bodywork / Scratch	
10	Fender / Back Left	Paint / Scratch / Line	
11	Rim / Back Right	Out of Bodywork / Scratch	
12	Fender / Back Right	Bodywork / Poor Previous Repair

13	Bumper / Back	Paint / Scratch / Line
14	Door / Front Right	Paint / Scratch / Line
15	Bumper / Front	Paint / Scratch / Line

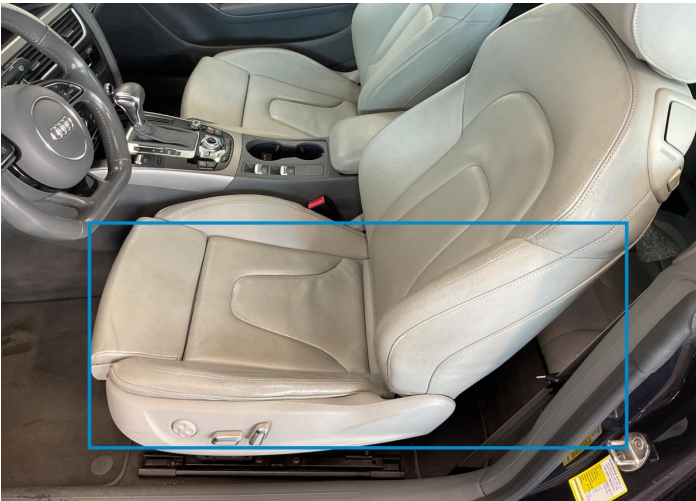
1. Seat / Front Left
Interior / Worn - out -

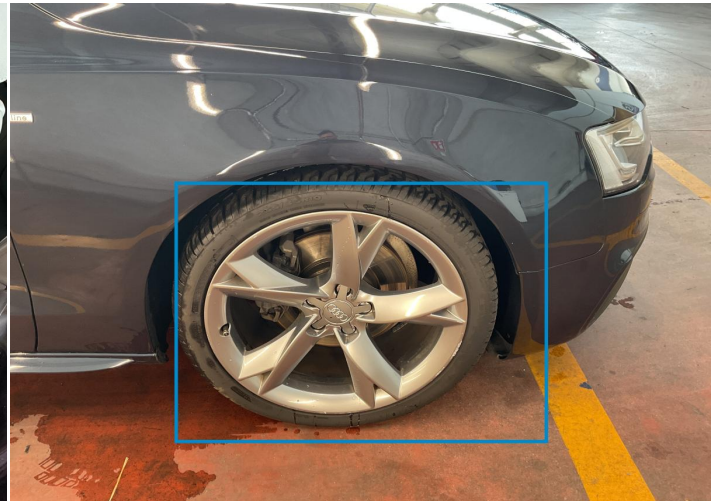
2. Rim / Front Right
Out of Bodywork / Scratch -

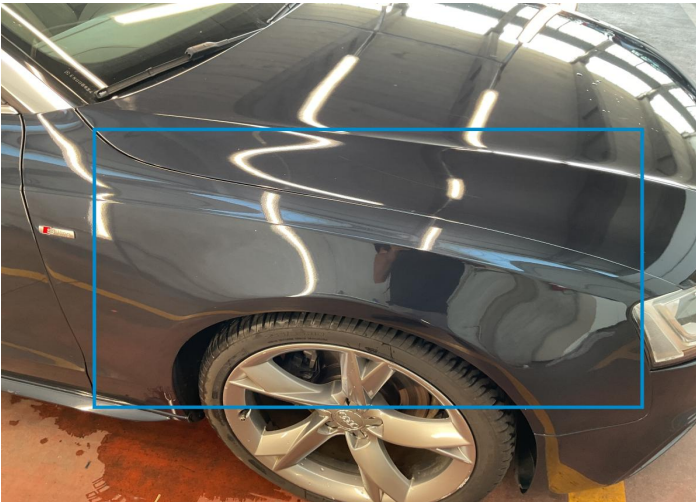
3. Fender / Front Right
Bodywork / Poor Previous Repair -

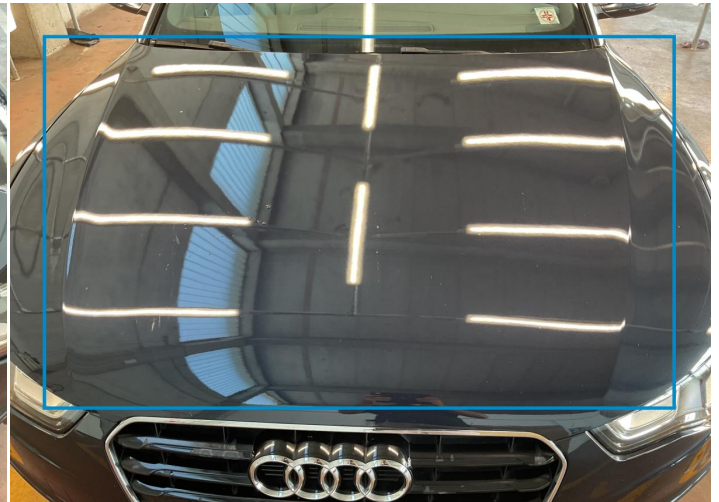
4. Hood
Bodywork / Poor Previous Repair -

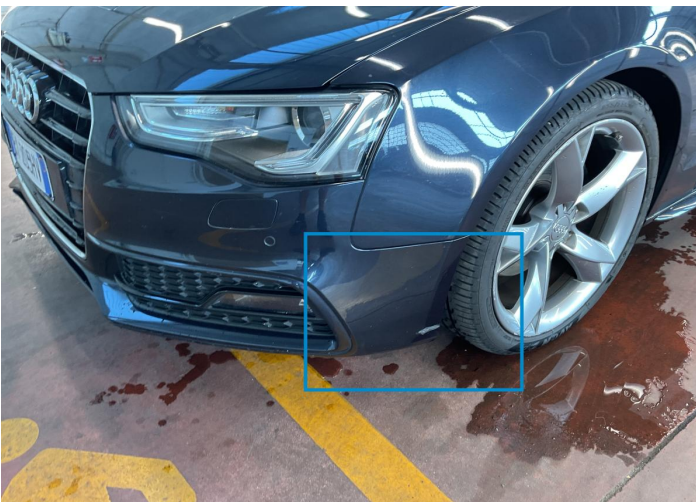
5. Fender / Front Left
Paint / Scratch / Line -

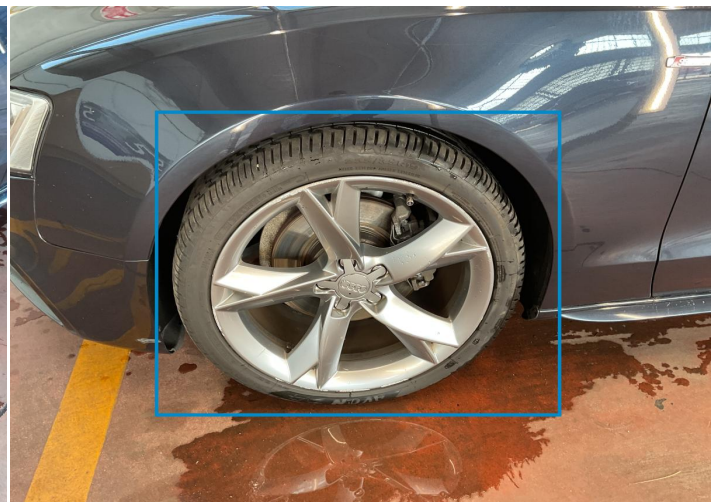
6. Rim / Front Left
Out of Bodywork / Scratch -

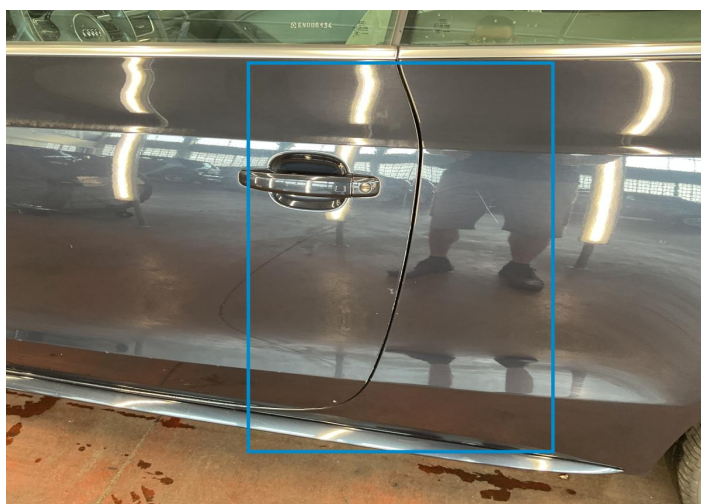
7. Door / Front Left
Paint / Scratch / Line -

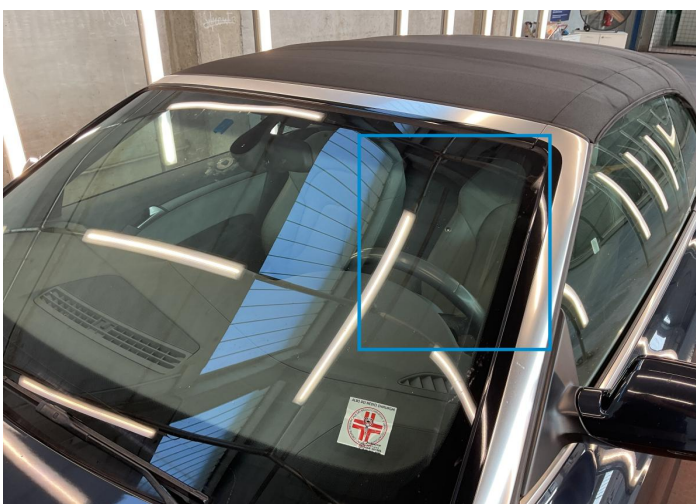
8. Windshield / Front
Glass Break -

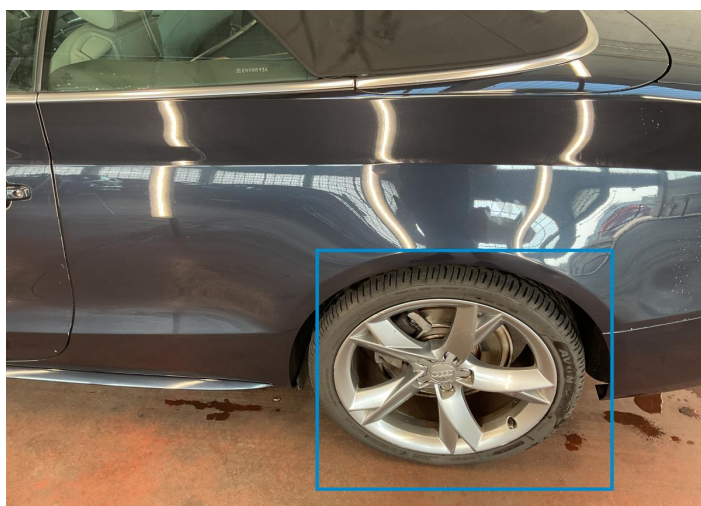
9. Rim / Back Left
Out of Bodywork / Scratch -

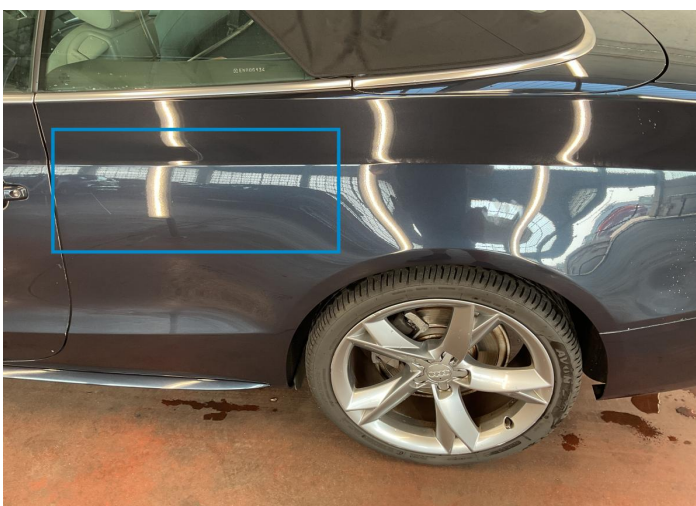
10. Fender / Back Left
Paint / Scratch / Line -

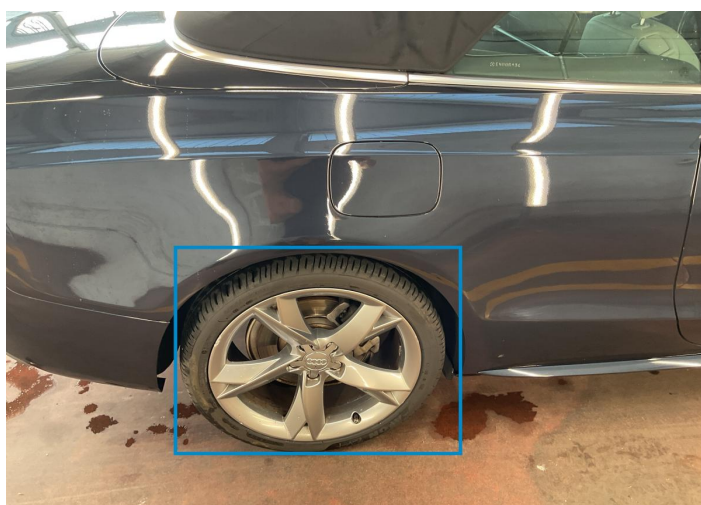
11. Rim / Back Right
Out of Bodywork / Scratch -

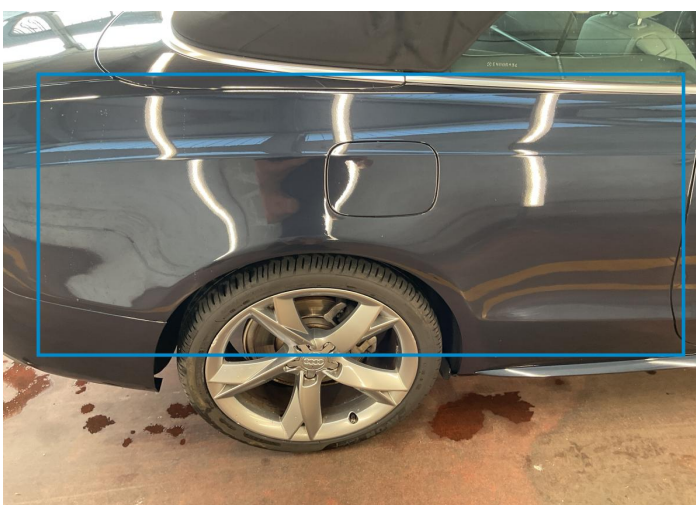
12. Fender / Back Right
Bodywork / Poor Previous Repair -

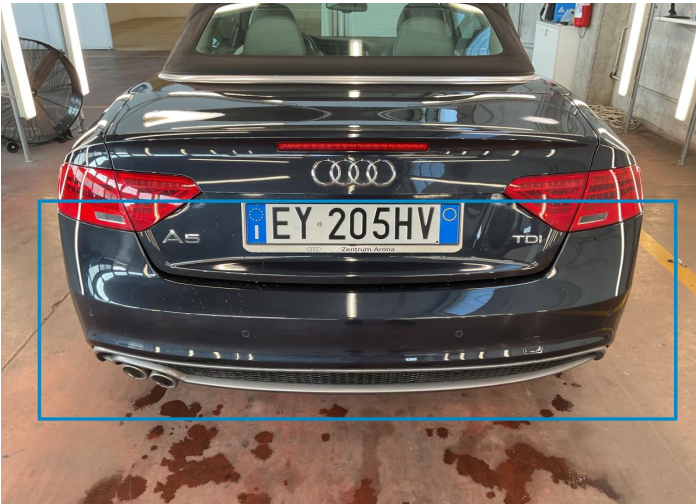
13. Bumper / Back
Paint / Scratch / Line -

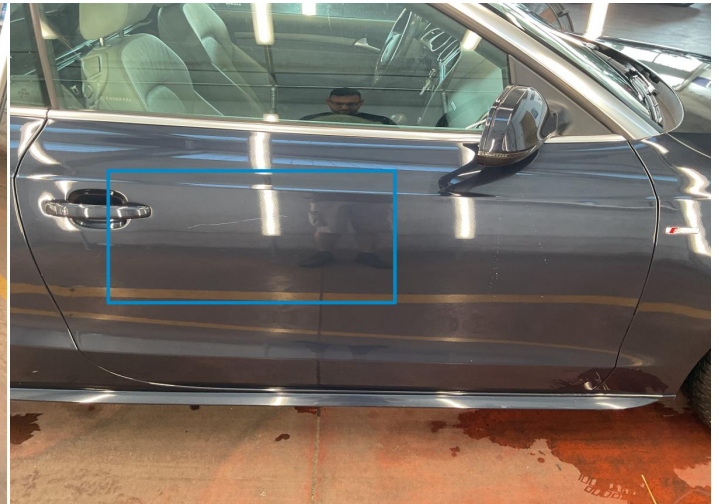
14. Door / Front Right
Paint / Scratch / Line -

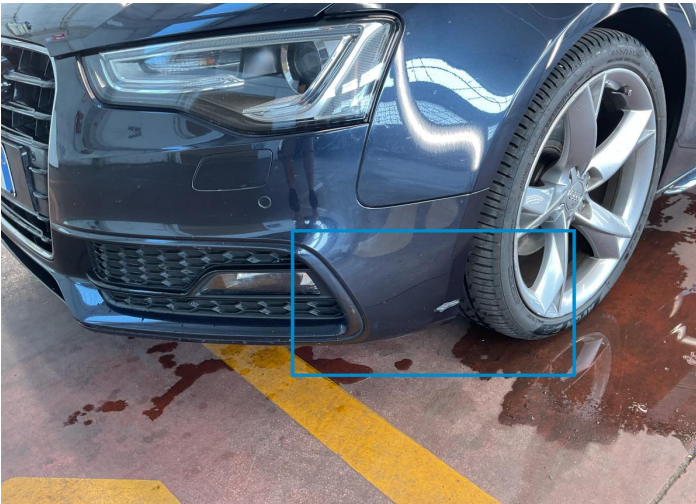
15. Bumper / Front
Paint / Scratch / Line -
