AUDI A4
A4 Avant 2.0 TDI DPF

VIN NO WAUZZZ8KX9A005315
Registration Number KX9A005315

Inspection Report Summary

Customer	BCA Online	Report Number	P20250605114608
Inspection Date / Place	2025-06-05 / BCA Neuss	Cosmetic Grade	5

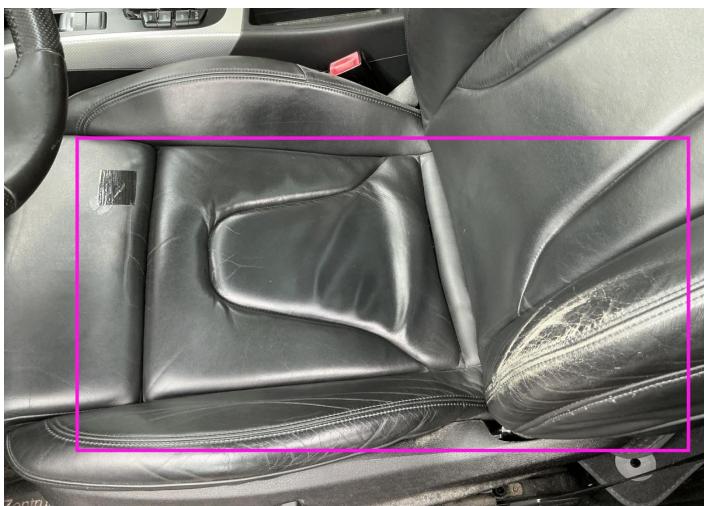
1. Seat / Front Left
Interior / Non - compliant -

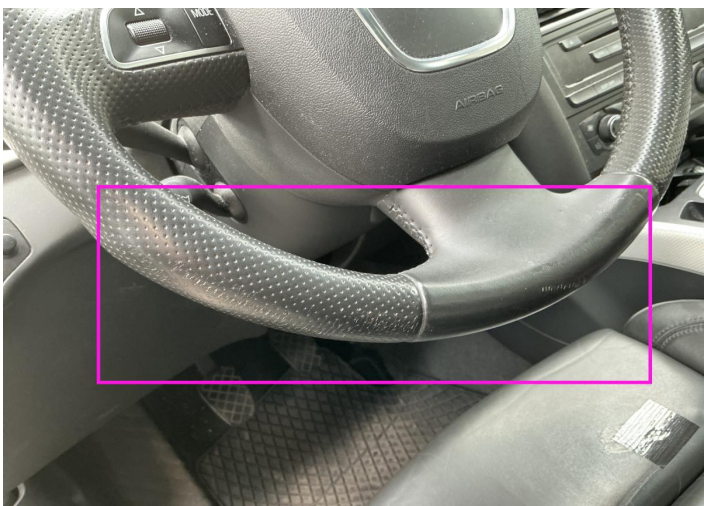
2. Steering Wheel / Front
Interior / Worn - out -

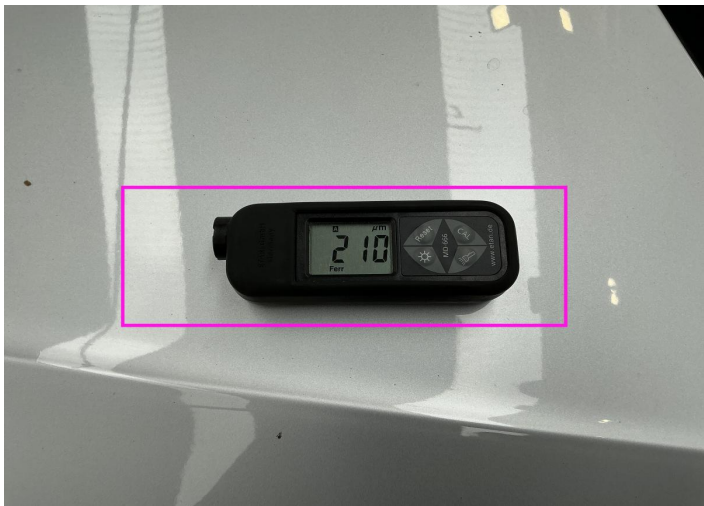
3.
Paint / Poor Previous Repair -

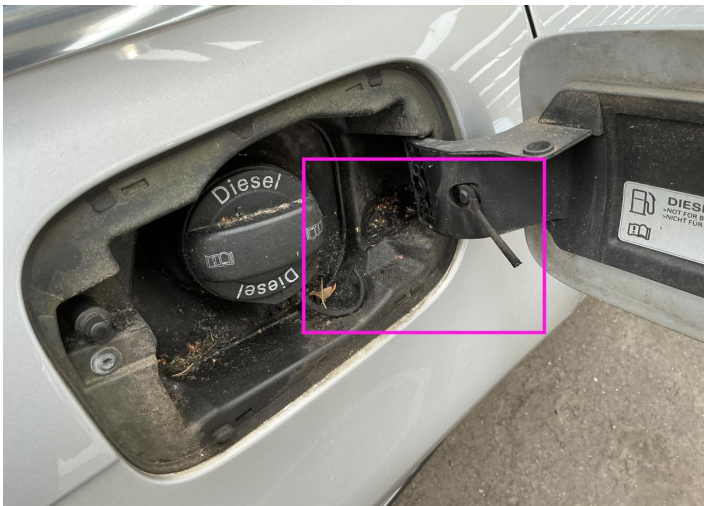
4. Fuel Door / Back Right
Bodywork / Breakage -

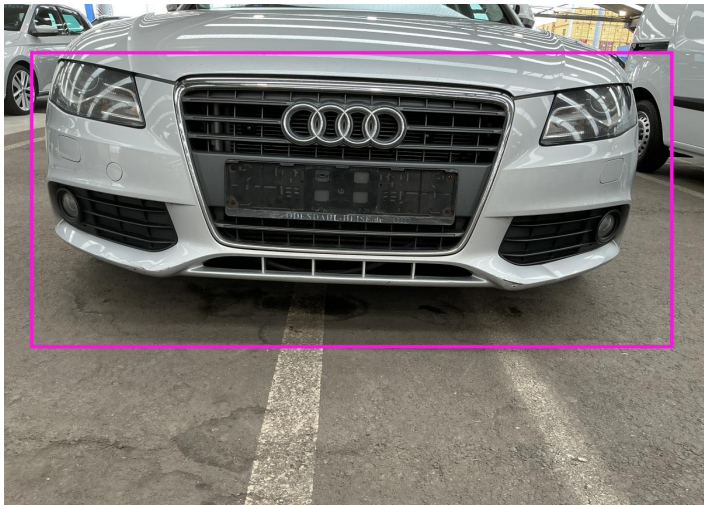
5. Bumper / Front
Bodywork / Breakage / Crack -

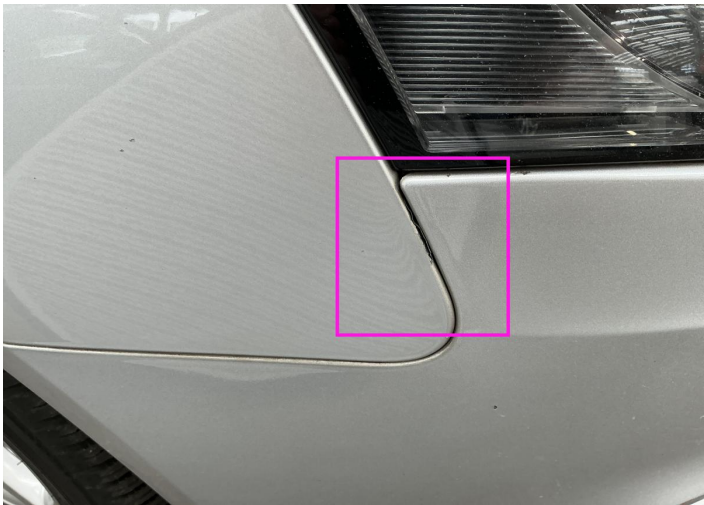
6. Fender / Front Right
Paint / Poor Previous Repair -

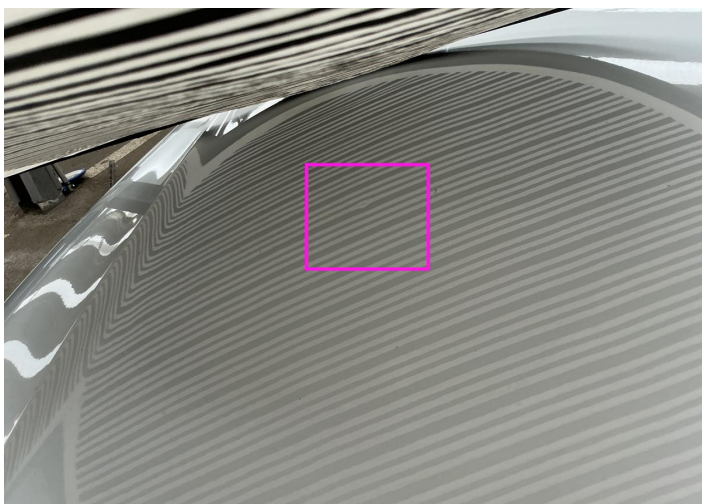
7. Hood
Bodywork / Dent / Dent -

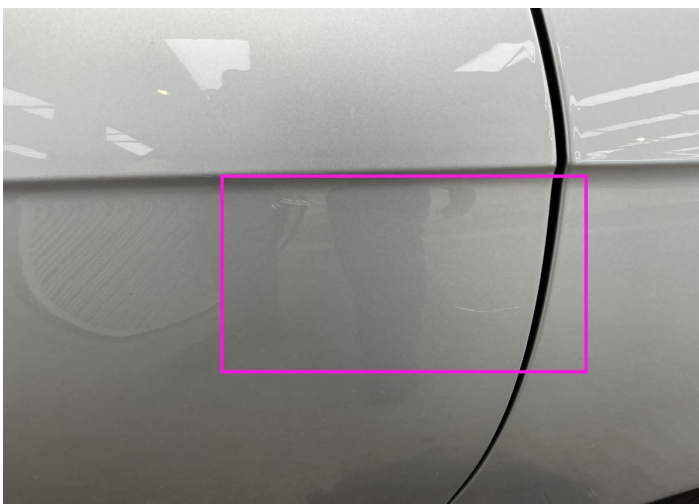
8. Door / Front Right
Paint / Scratch / Scuff -

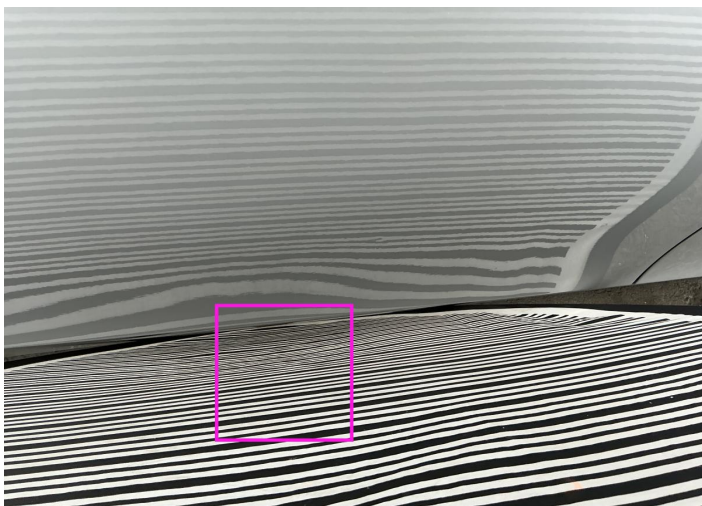
9. Door / Back Right
Bodywork / Dent / Dent -

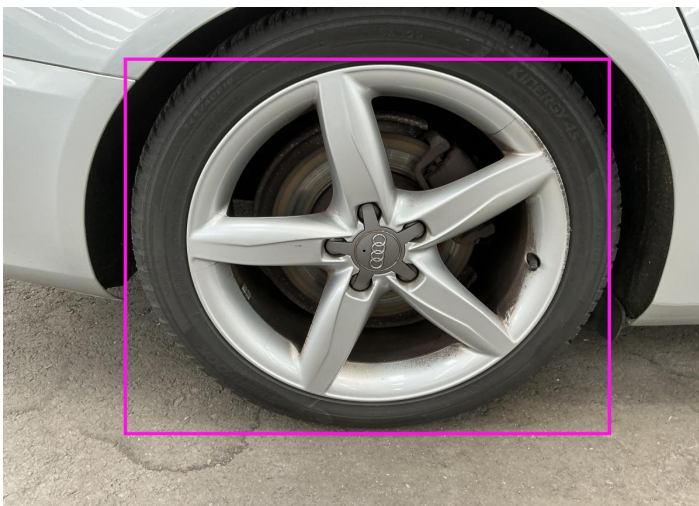
10. Rim / Back Right
Out of Bodywork / Scratch -

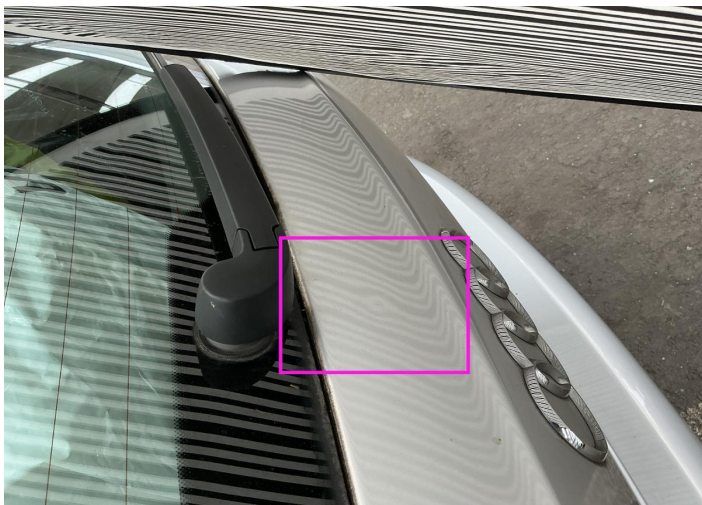
11. Tailgate
Bodywork / Dent / Dent -

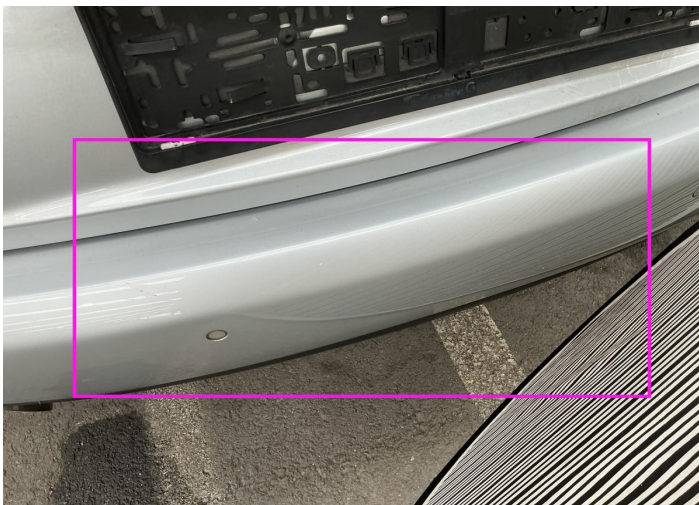
12. Bumper / Back
Bodywork / Dent / Dent -

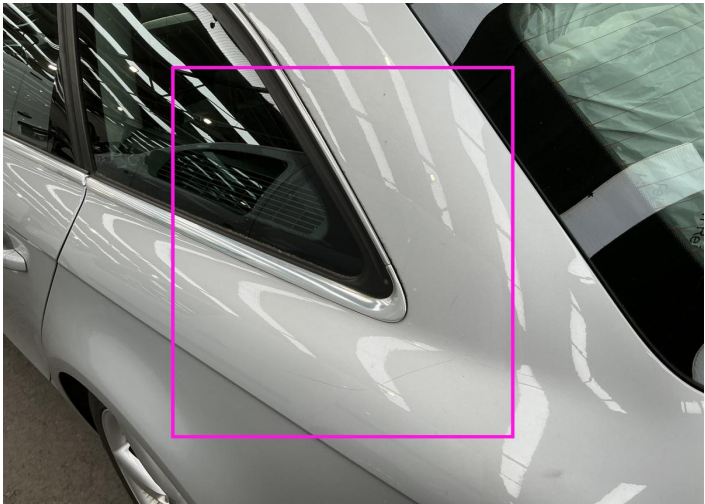
13. Side Panel / Back Left
Paint / Scratch / Scuff -

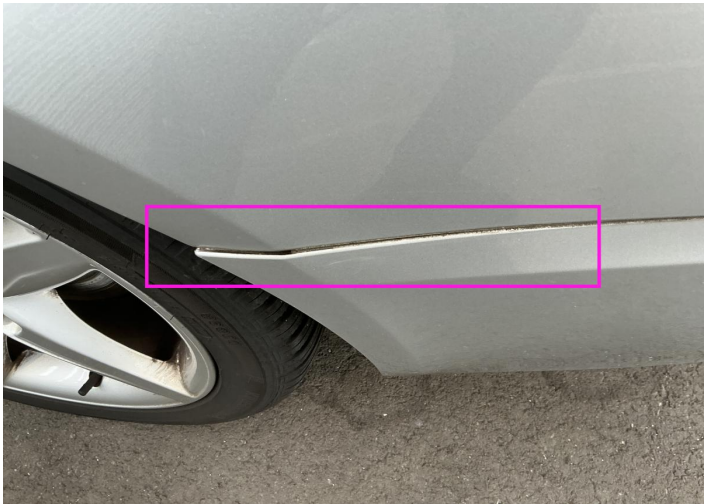
14. Bumper / Back
Bodywork / Breakage -
