## status report

#### Audi S4 Lim. 3.0 TFSI quattro

| Vehicle identification number | <b>WAUZZZ8KXEA027101</b> | mileage read: | <b>73131 km</b> |

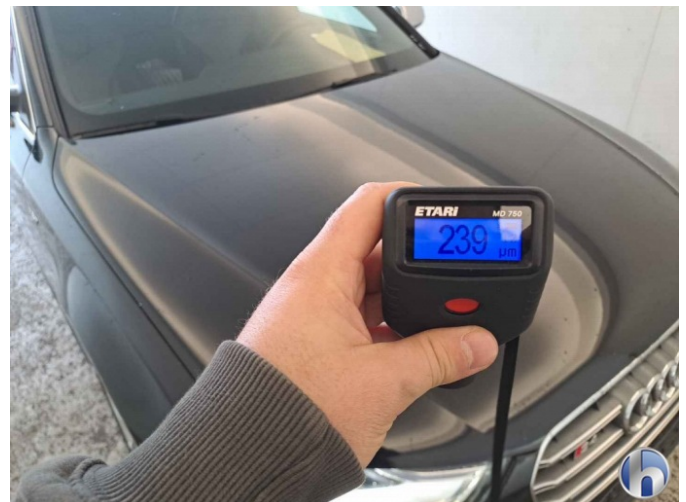
| component | Damage | Rep kind |
|---|---|---|
| 1. hood | Subsequently painted | acceptable |

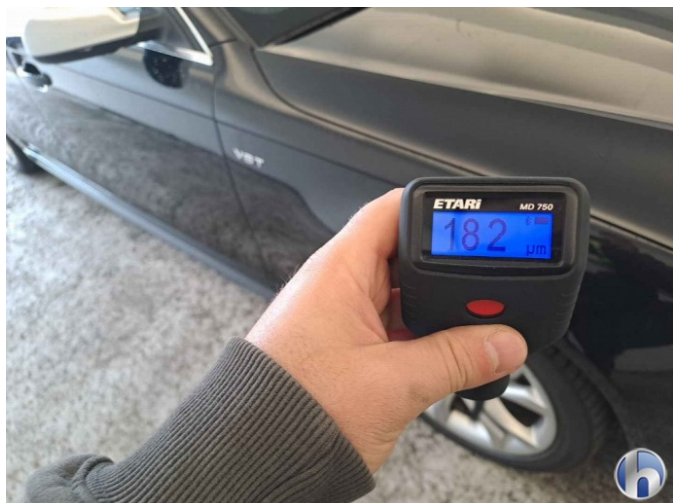
| component | Damage | Rep kind |
|---|---|---|
| 2. Front fender - right | Subsequently painted | acceptable |

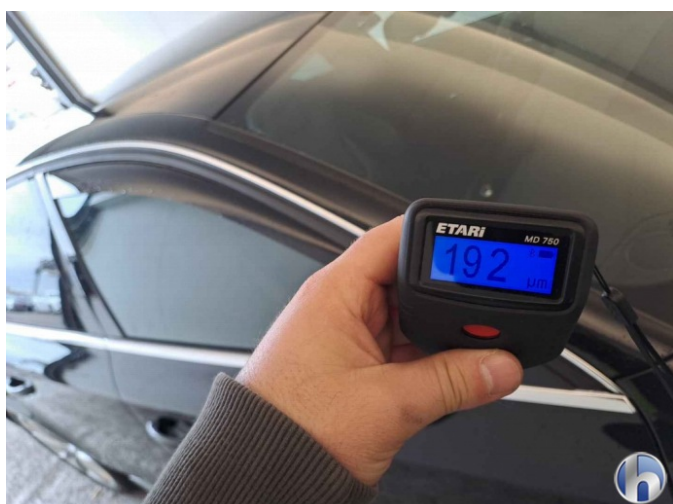
| component | Damage | Rep kind |
|---|---|---|
| 4. A-pillar Front - right | Subsequently painted | acceptable |

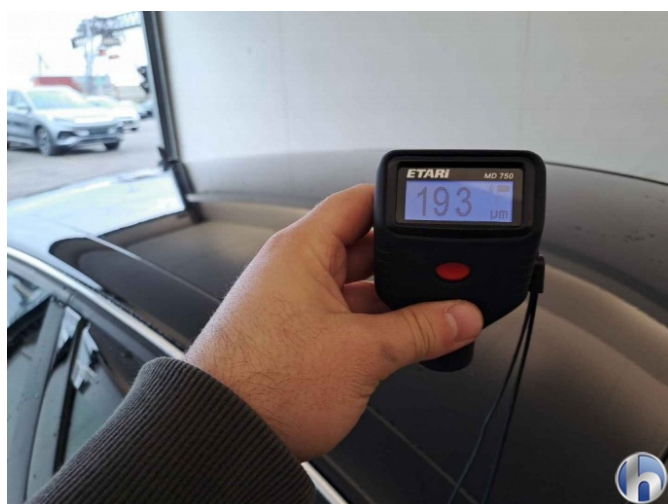
| component | Damage | Rep kind |
|---|---|---|
| 5. roof | Subsequently painted | acceptable |

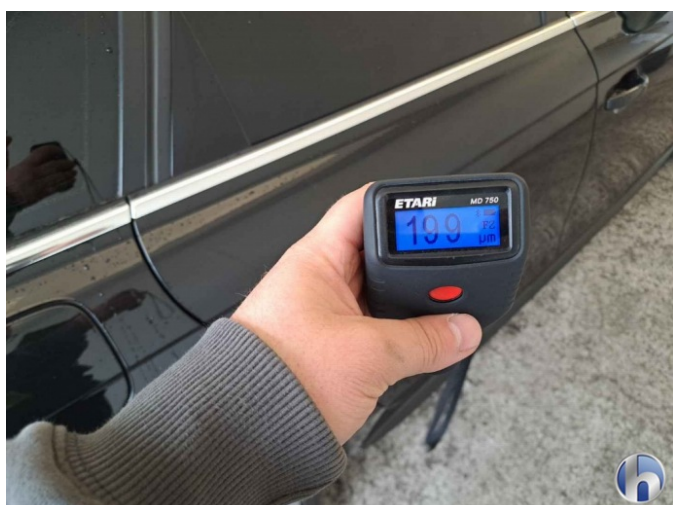
| component | Damage | Rep kind |
|---|---|---|
| 6. Door Rear - right | Subsequently painted | acceptable |

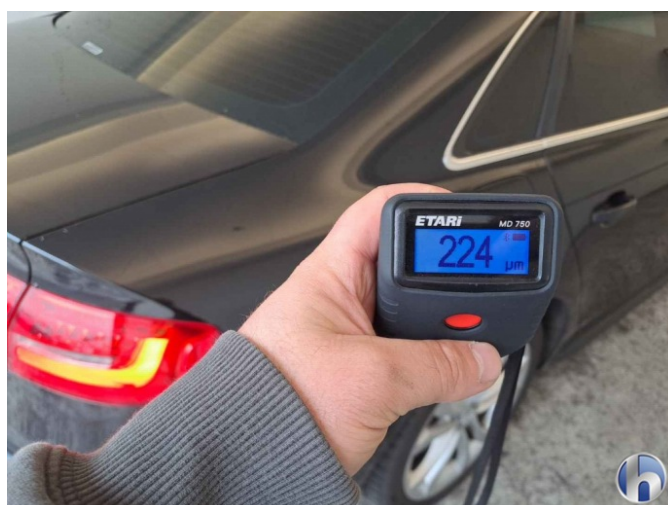
| component | Damage | Rep kind |
|---|---|---|
| 7. Sidewall - Rear - right | Subsequently painted | acceptable |

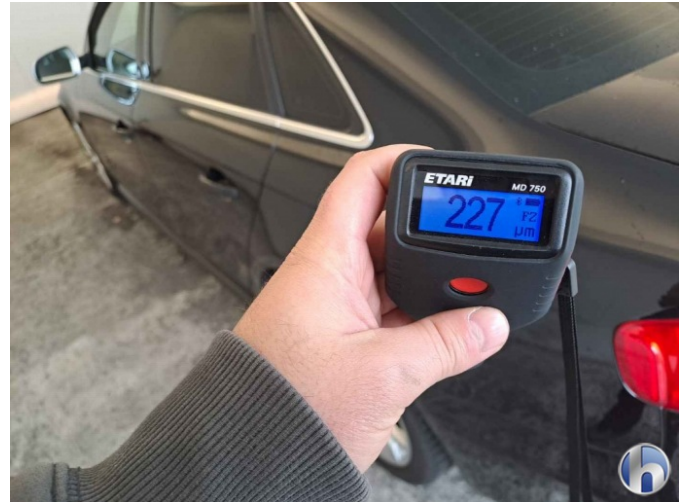
| component | Damage | Rep kind |
|---|---|---|
| 9. Sidewall - Rear - Left | Subsequently painted | acceptable |

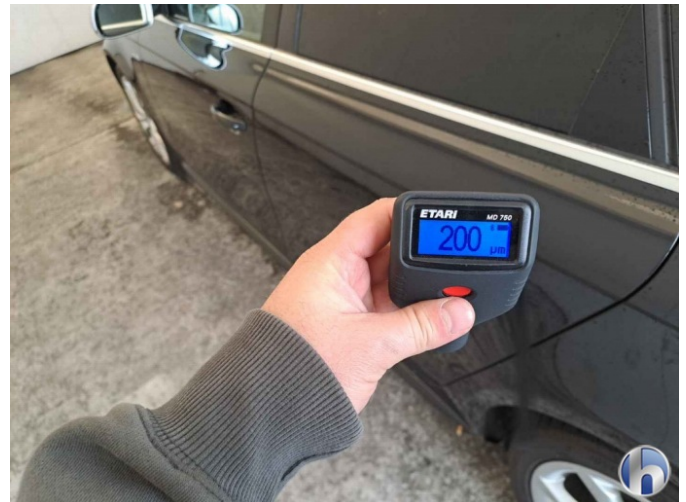
| component | Damage | Rep kind |
|---|---|---|
| 11. Rear door - left | Subsequently painted | acceptable |

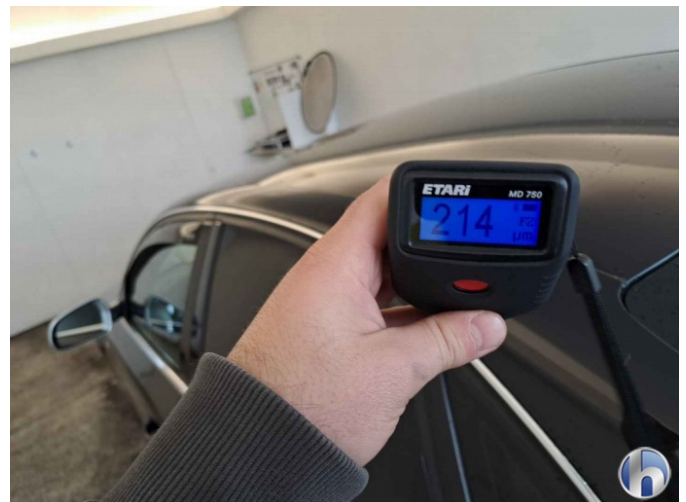
| component | Damage | Rep kind |
|---|---|---|
| 13. Roof frame - left | Subsequently painted | acceptable |

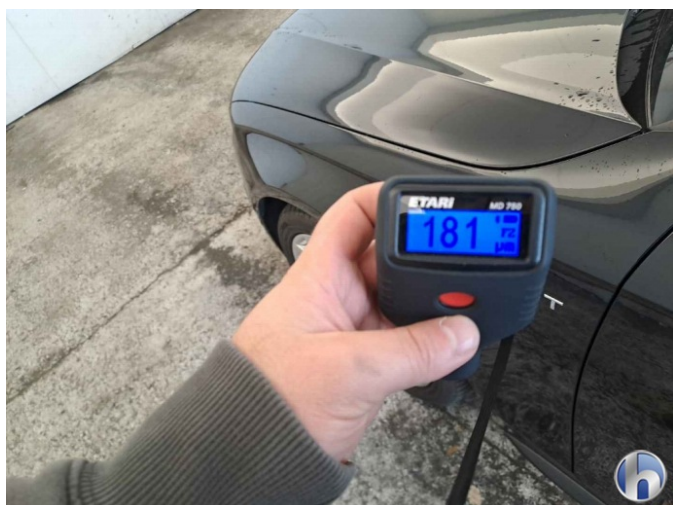
| component | Damage | Rep kind |
|---|---|---|
| 14. Front fender - left | Subsequently painted | acceptable |

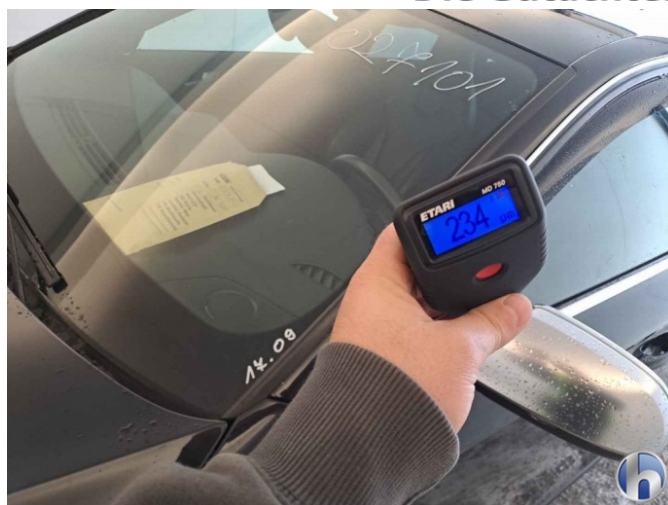
| component | Damage | Rep kind |
|---|---|---|
| 15. A-pillar Front - Left | Subsequently painted | acceptable |

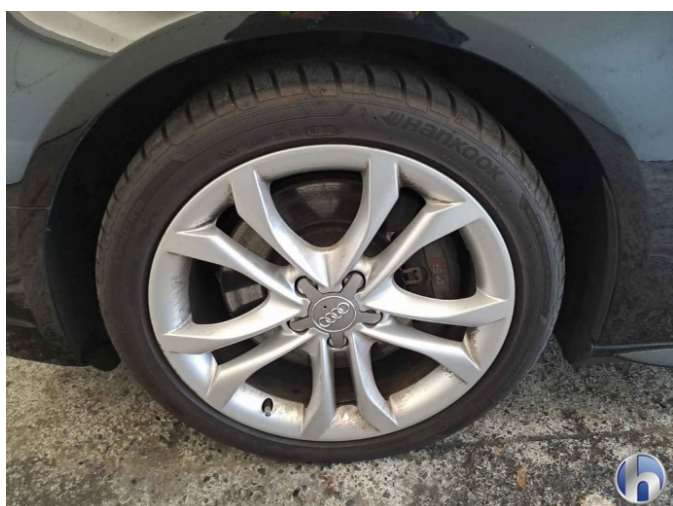
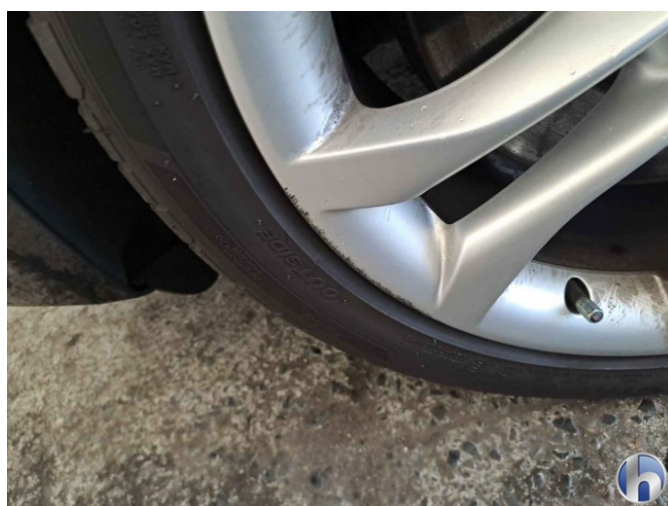
| component | Damage | Rep kind |
|---|---|---|
| 16. Rim front - left | Scratch(es) | Smart repair |

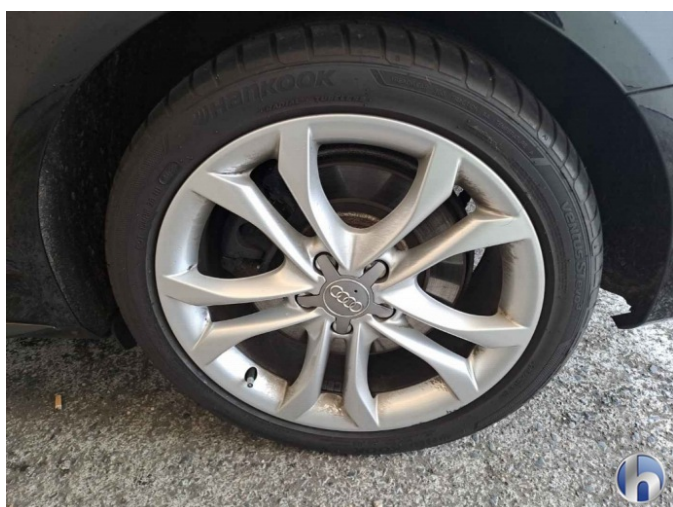
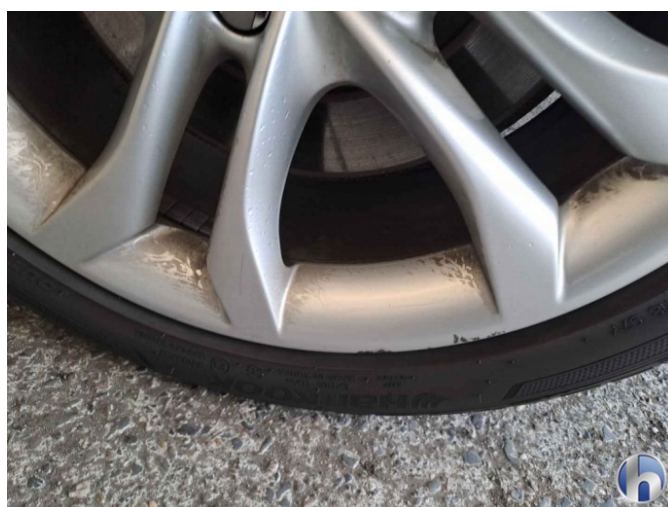
| component | Damage | Rep kind |
|---|---|---|
| 18. Rim rear - left | Scratch(es) | Smart repair |

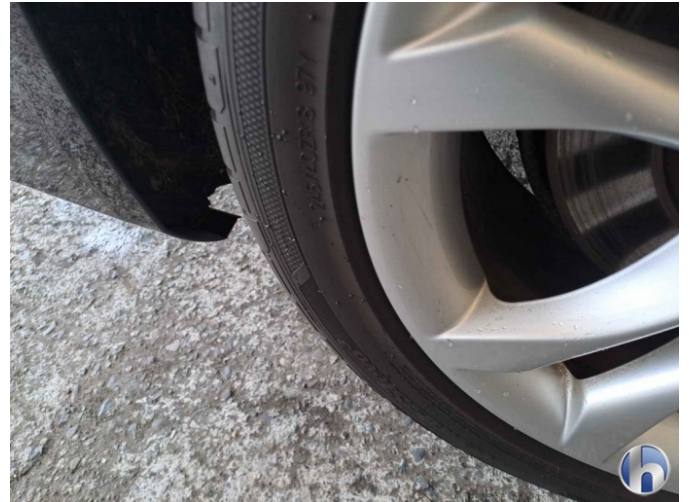
| component | Damage | Rep kind |
|---|---|---|
| 19. Rim rear - right | Scratch(es) | Smart repair |

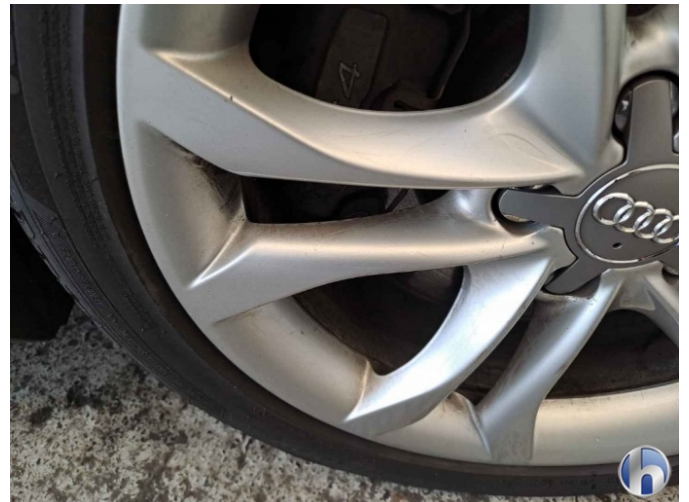
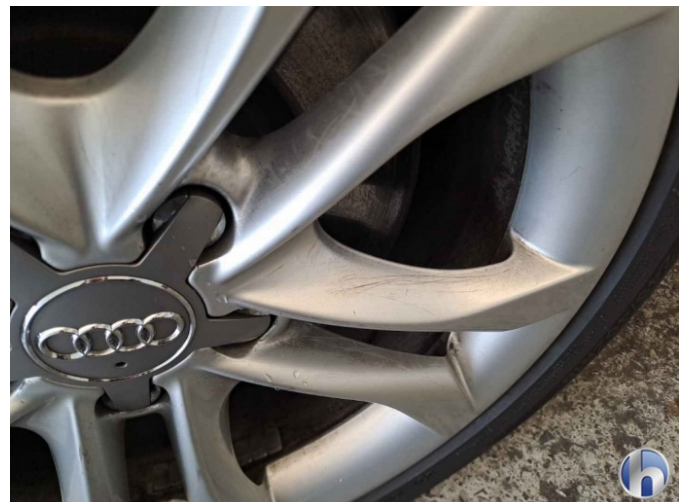
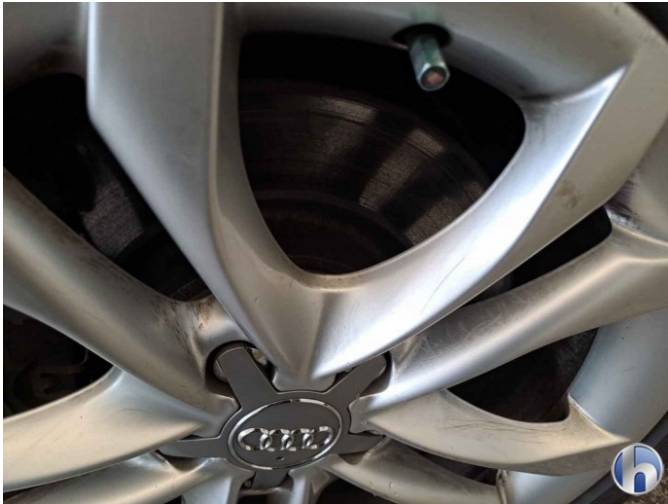
| component | Damage | Rep kind |
|---|---|---|
| 20. Rim front - right | Scratch(es) | Paint |

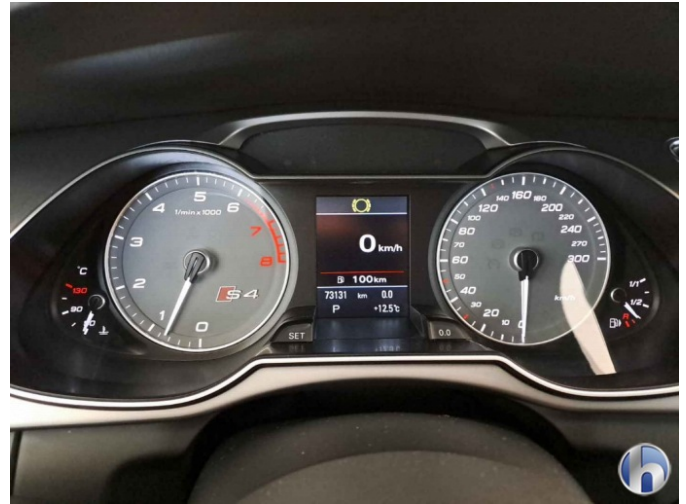
| component | Damage | Rep kind |
|---|---|---|
| 21. warning light | Error message | Carry out a fault diagnosis |

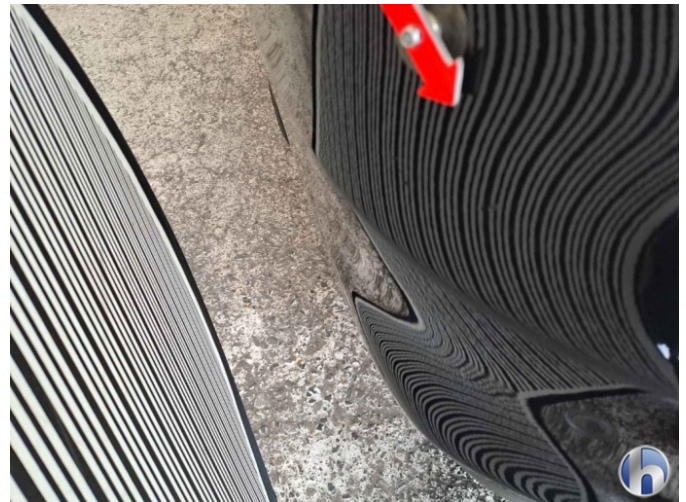
| component | Damage | Rep kind |
|---|---|---|
| 22. Rear bumper | Scratch(es) | Paint |

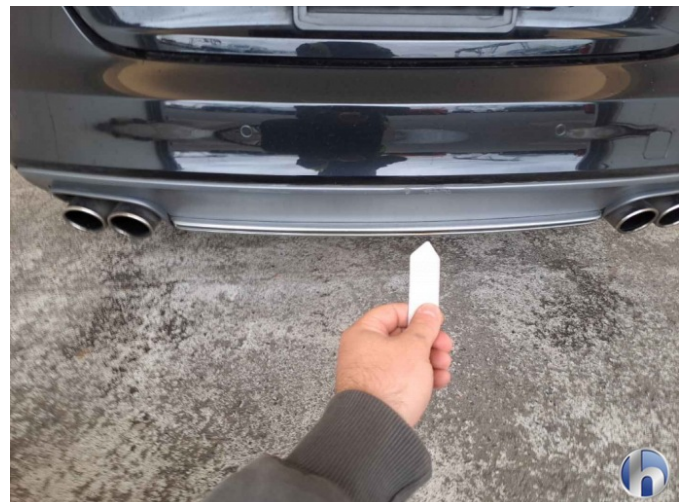
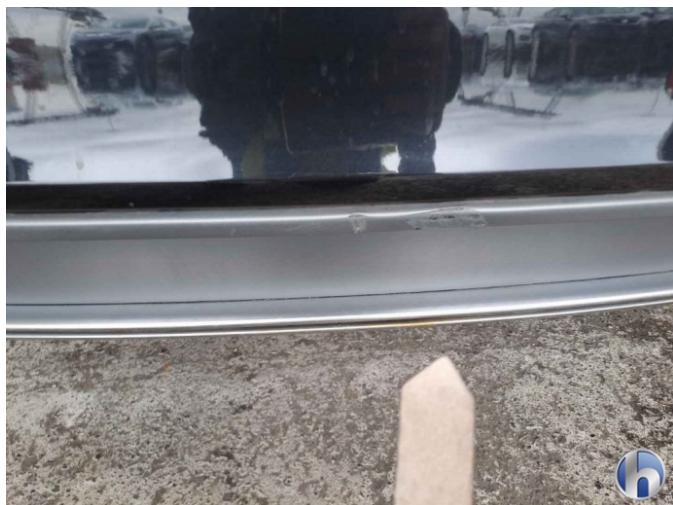
| component | Damage | Rep kind |
|---|---|---|
| 23. Diffusor | Damaged | Replace |

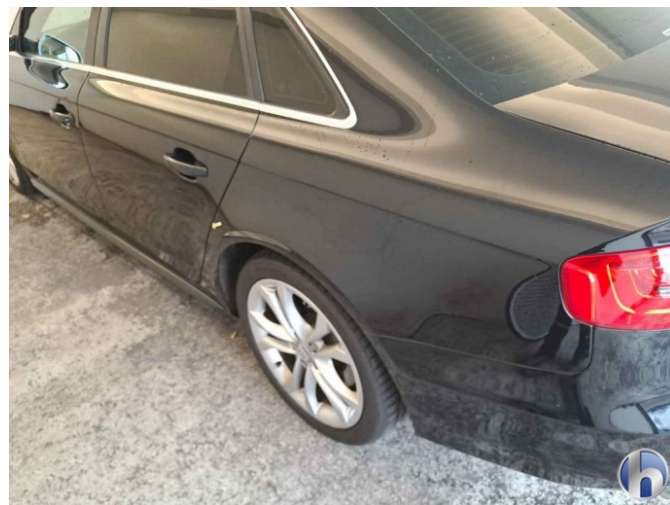
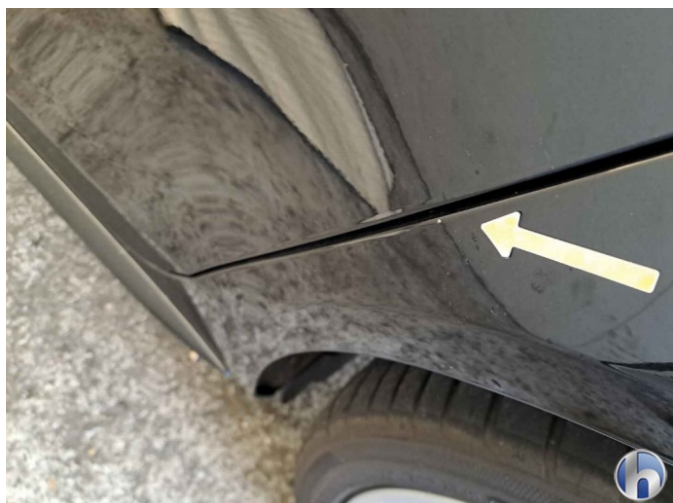
| component | Damage | Rep kind |
|---|---|---|
| 24. Sidewall - Rear - Left | Scratch(es) | Paint |

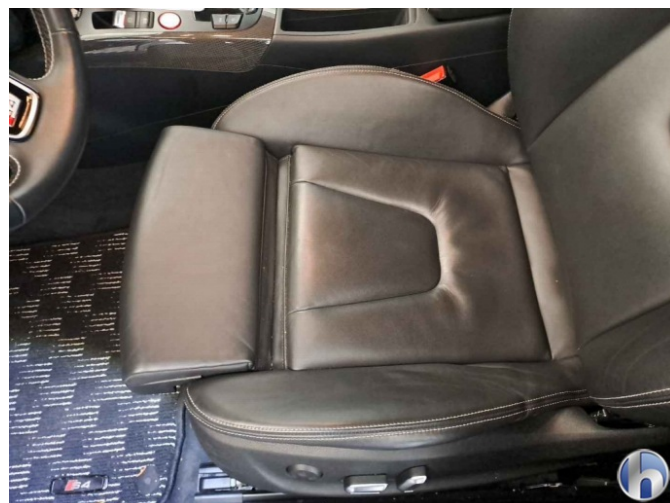
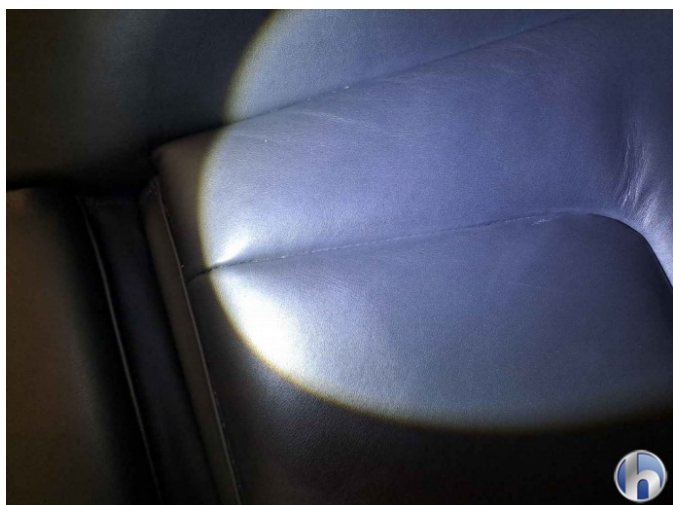
| component | Damage | Rep kind |
|---|---|---|
| 25. | Scratch(es) | Replace |

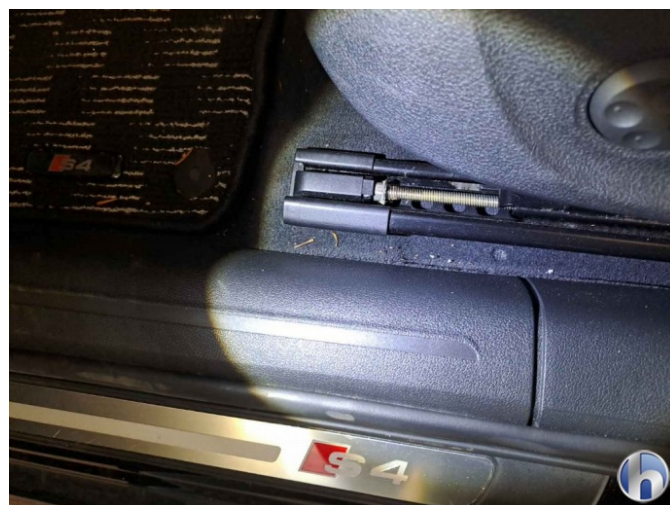
| component | Damage | Rep kind |
|---|---|---|
| 26. flooring | Burn hole | Smart repair |

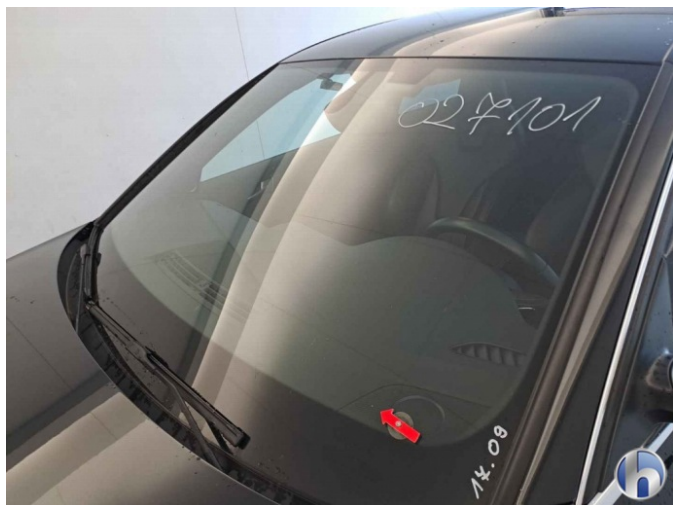
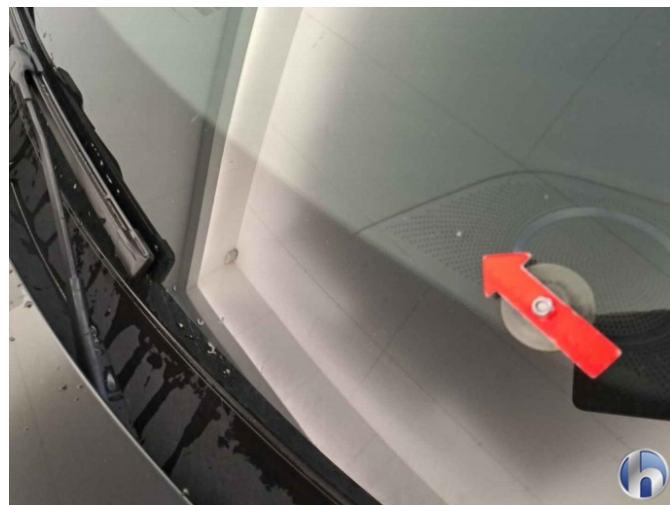
| component | Damage | Rep kind |
|---|---|---|
| 28. Windshield | Chipping from stones in field of view | Replace |

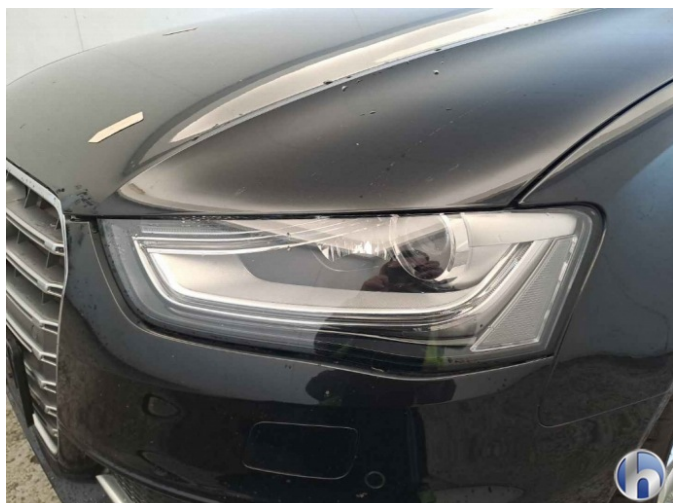
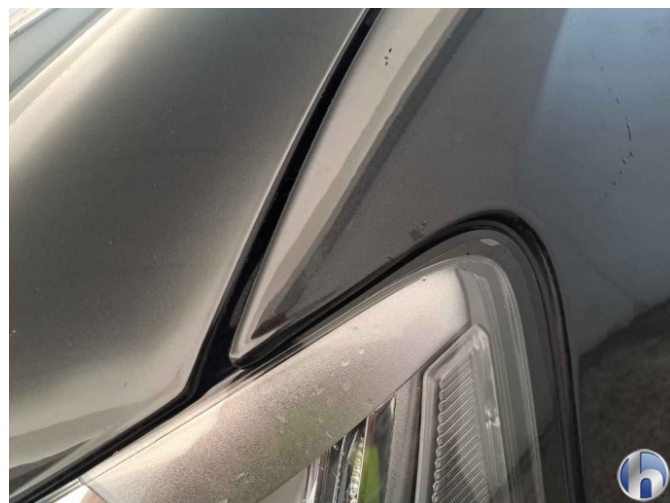
| component | Damage | Rep kind |
|---|---|---|
| 29. Bi xenon headlights - left | Sticker | |

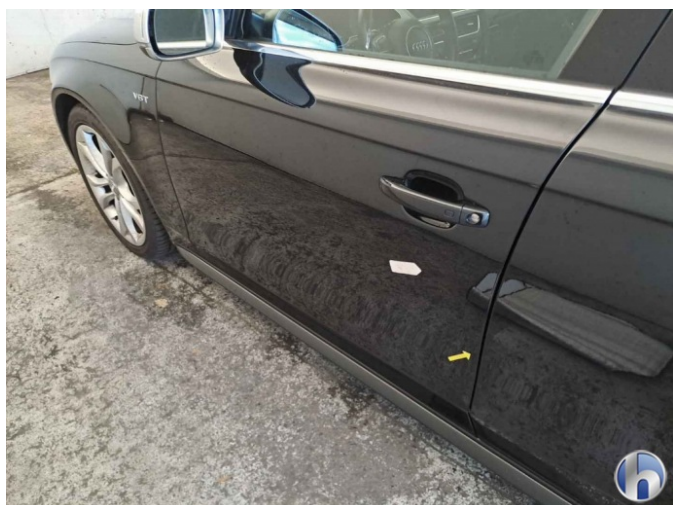
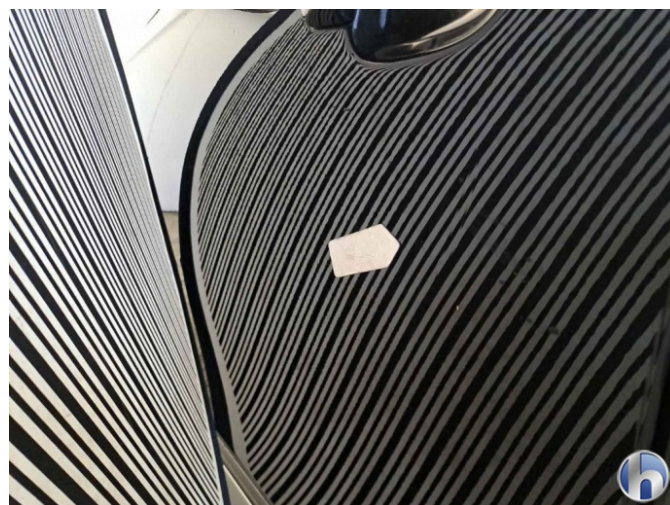
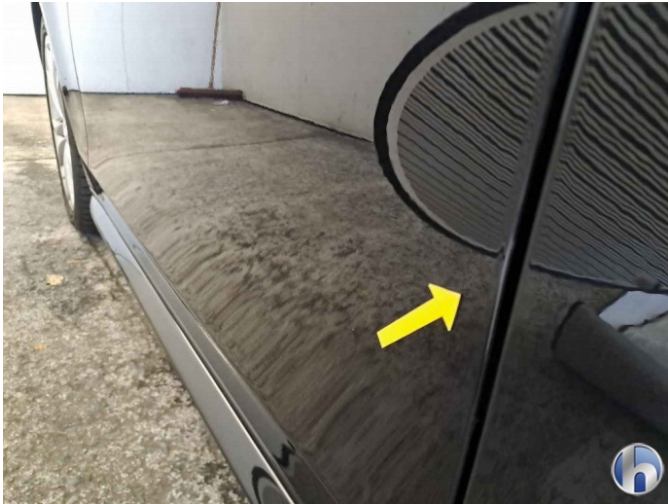
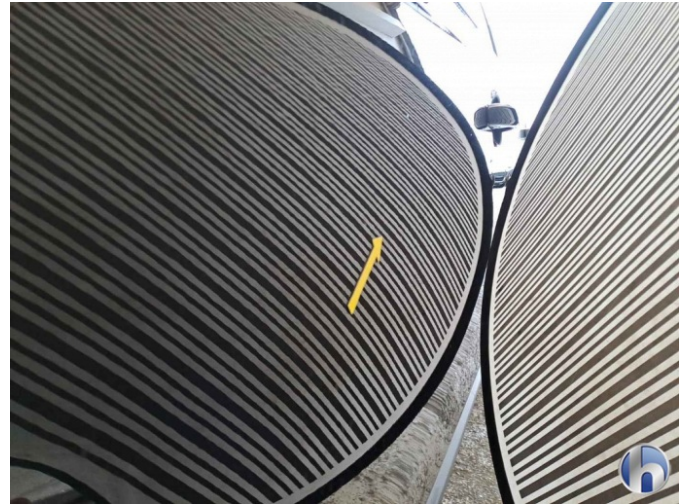
| component | Damage | Rep kind |
|---|---|---|
| 30. Front door - left | Execution defect | Paint |

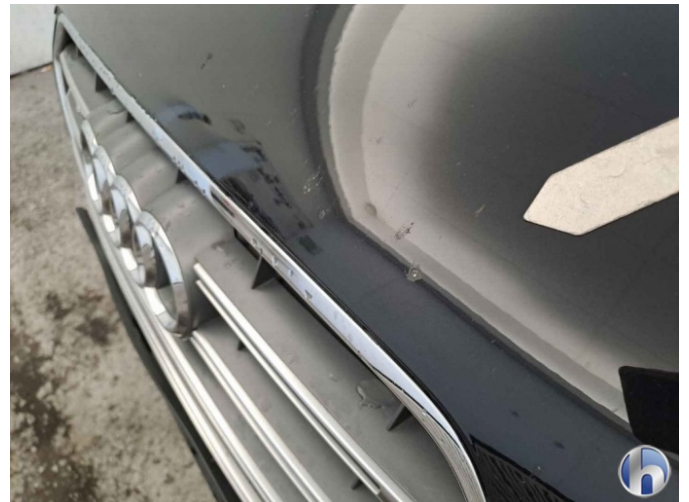
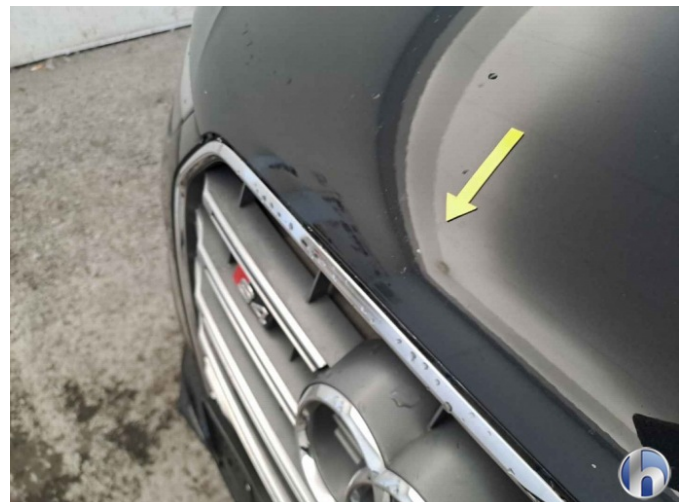
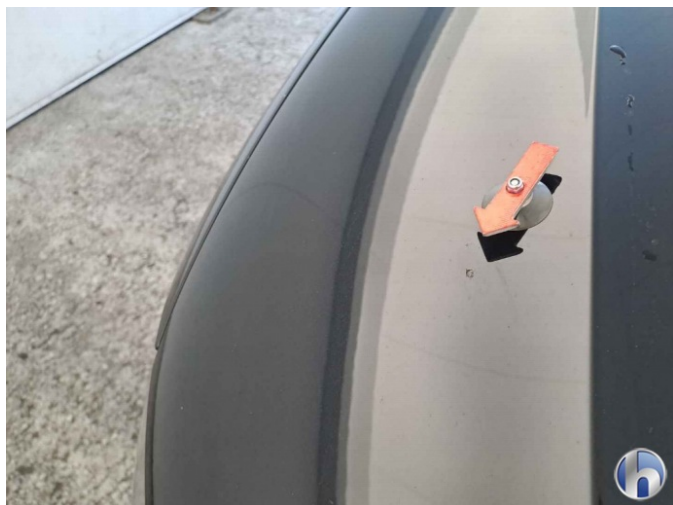
| component | Damage | Rep kind |
|---|---|---|
| 31. hood | Execution defect | Refurbish and paint |

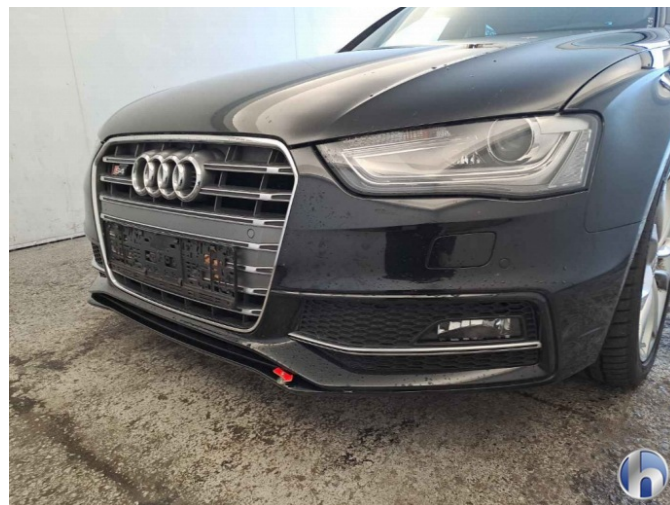
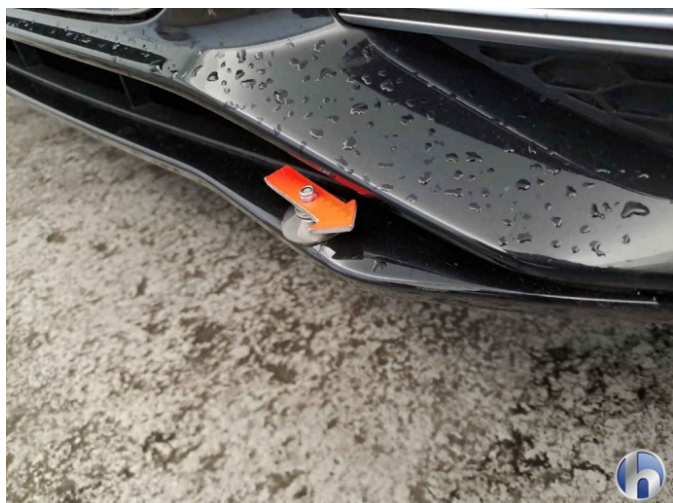
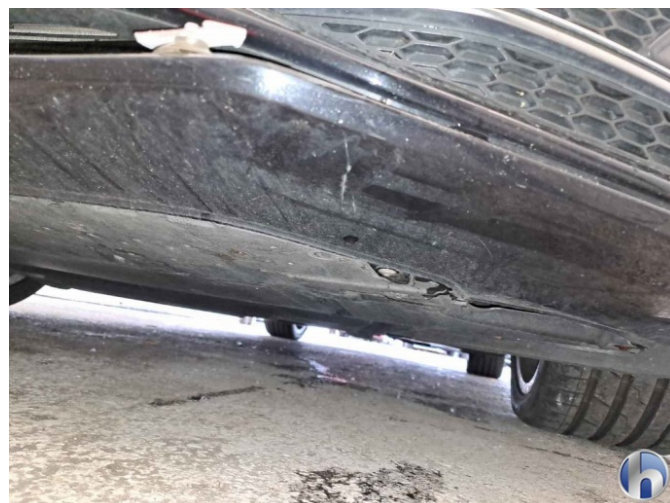
| component | Damage | Rep kind |
|---|---|---|
| 32. Front bumper | Scrape | Refurbish and paint |

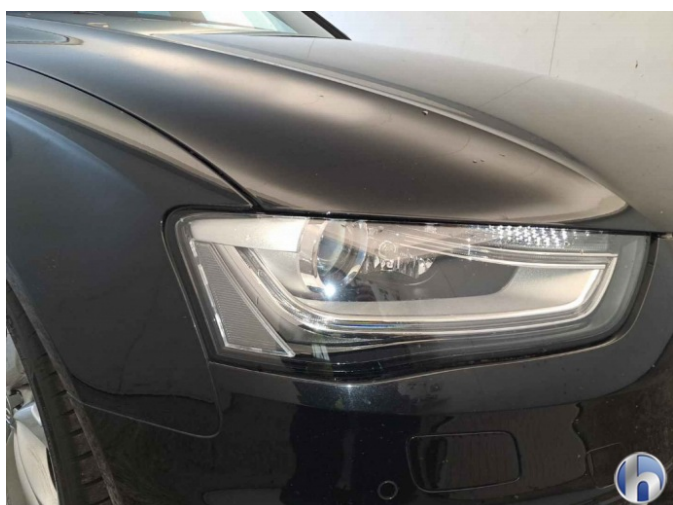
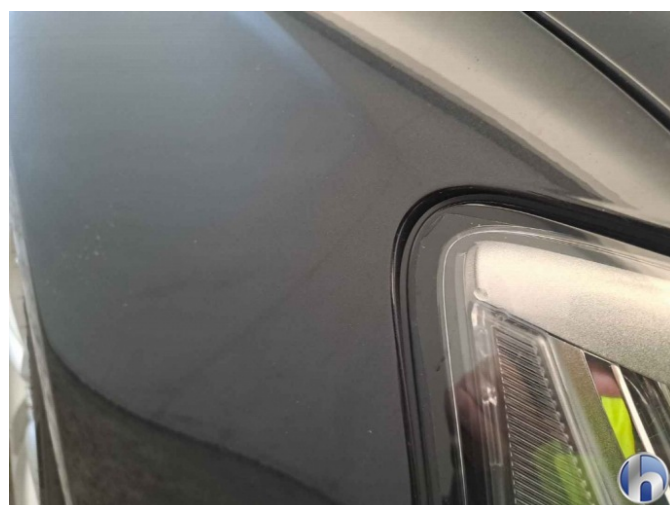
| component | Damage | Rep kind |
|---|---|---|
| 33. Bi xenon headlights - Right | Sticker | |

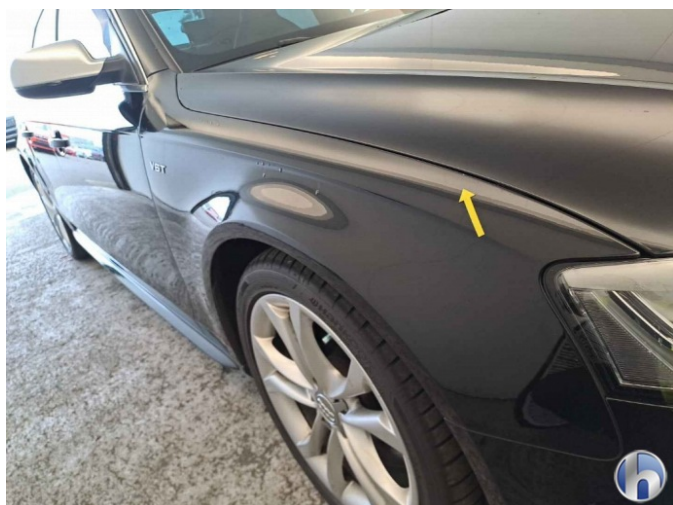
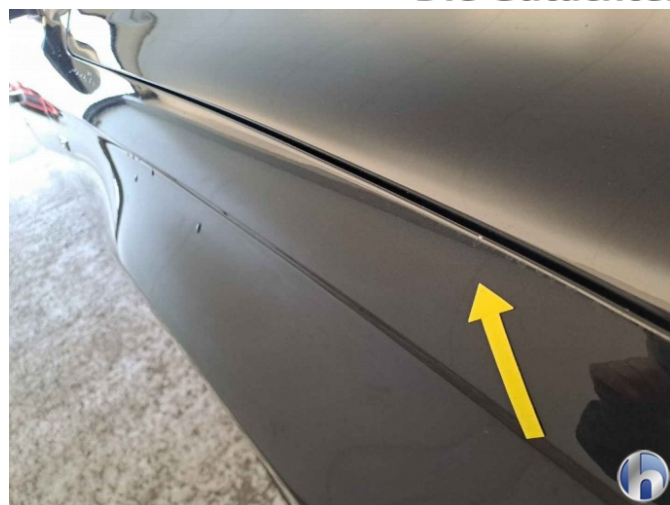
| component | Damage | Rep kind |
|---|---|---|
| 34. Front fender - right | Wear and tear | acceptable |

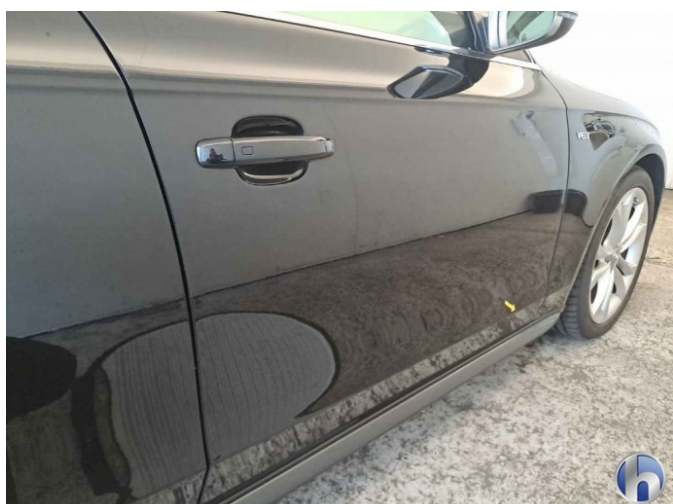
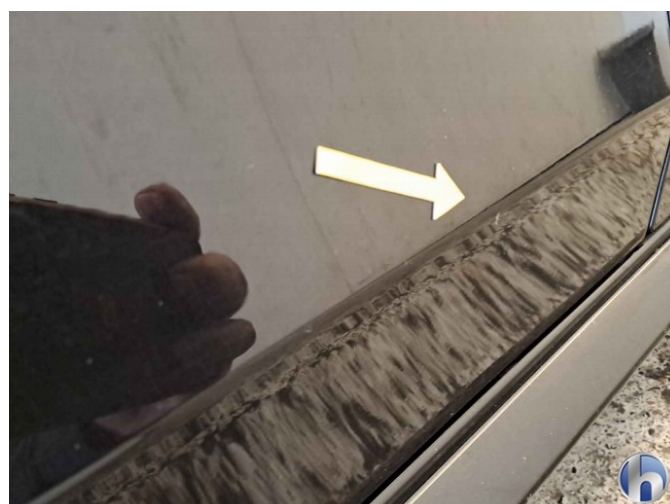
| component | Damage | Rep kind |
|---|---|---|
| 35. Front door - right | Scratch(es) | Paint |

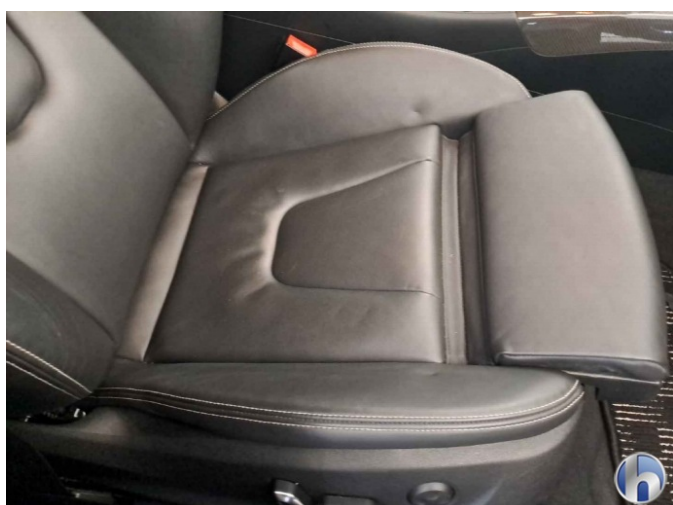
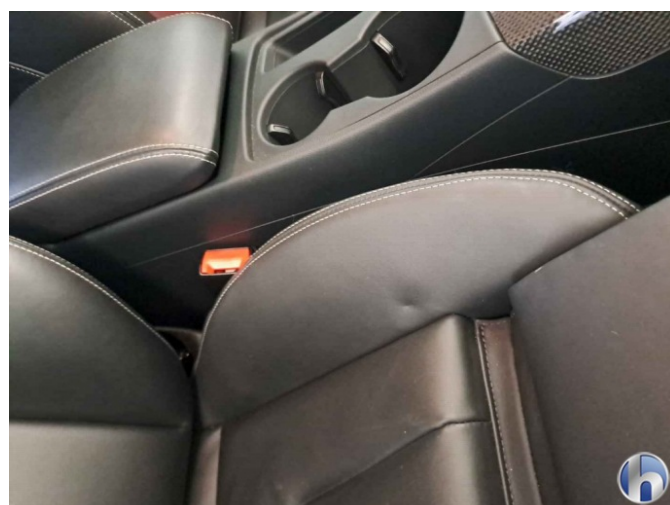
| component | Damage | Rep kind |
|---|---|---|
| 36. Sitz - Vorne - Rechts: Kissen | Damaged | Smart repair |

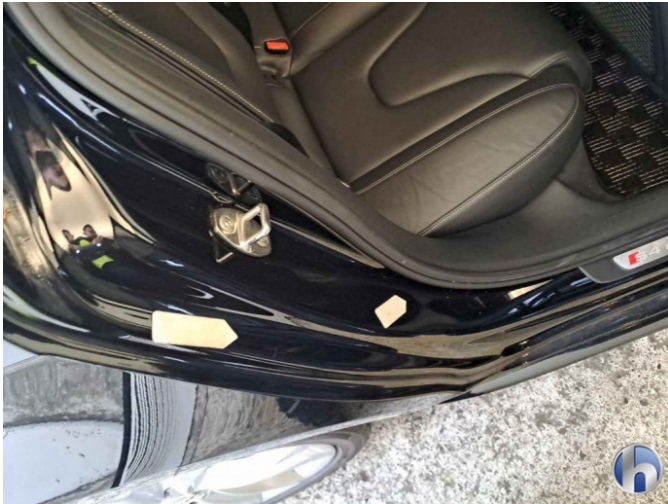
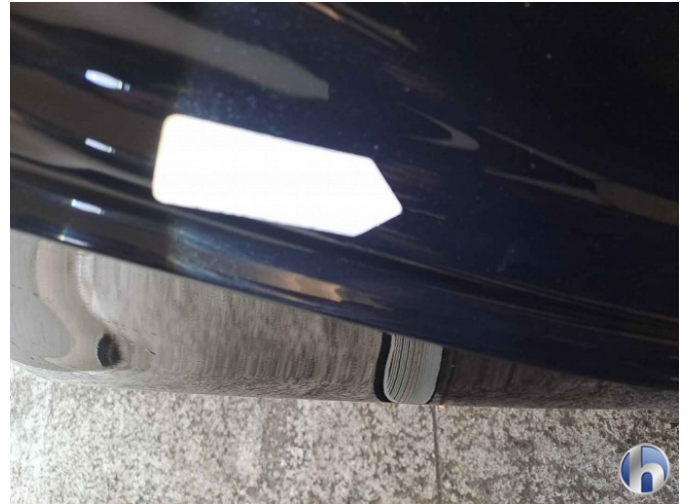
| component | Damage | Rep kind |
|---|---|---|
| 37. Türeinstieg Hinten - Rechts | Damaged | Paint |

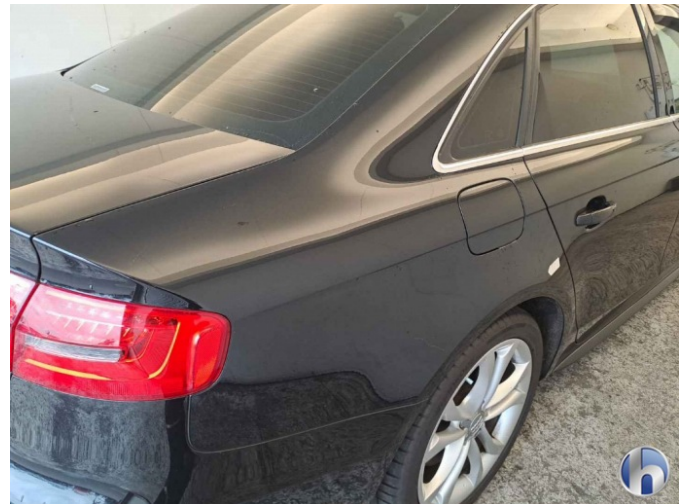
| component | Damage | Rep kind |
|---|---|---|
| 38. Sidewall - Rear - right | Deformed | Refurbish and paint |

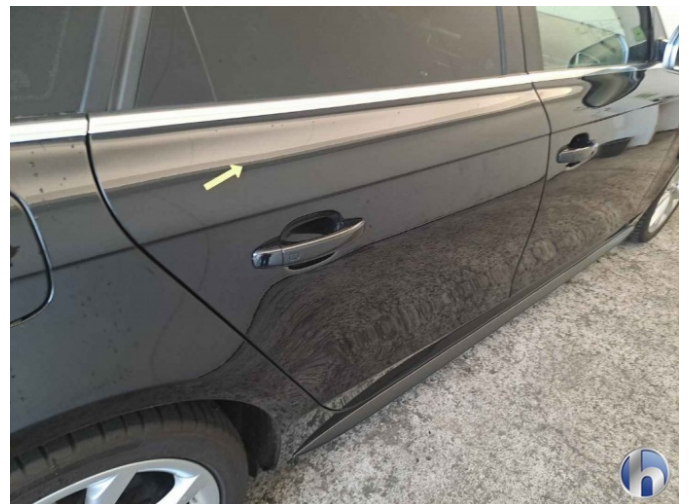
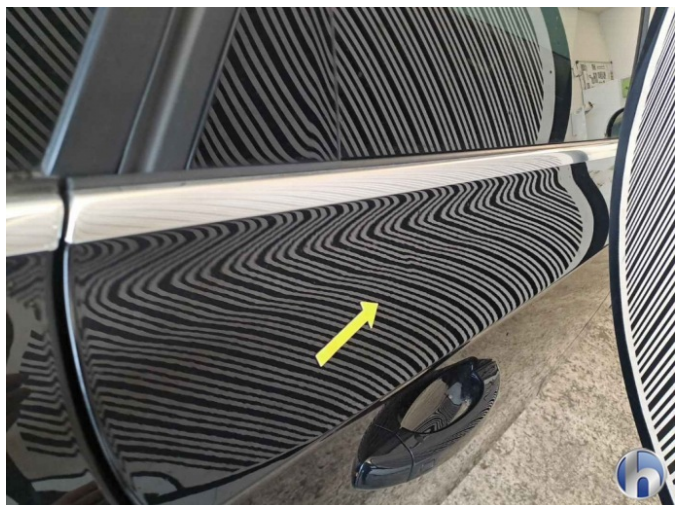
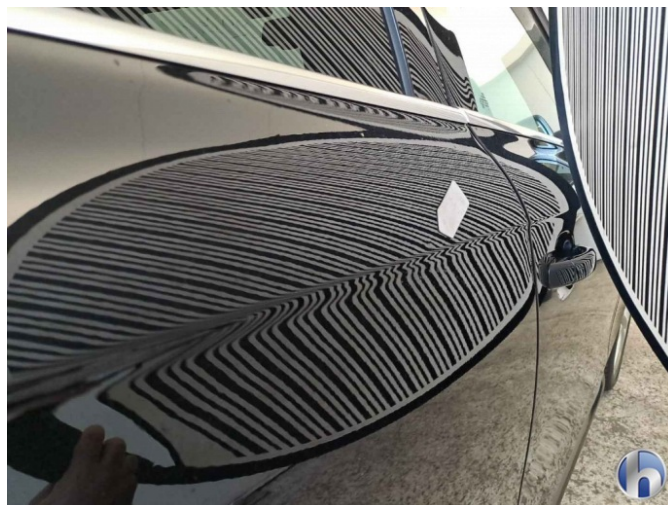
39. Door Rear - right

| 39. | Door Rear - right | Deformed | Refurbish and paint |

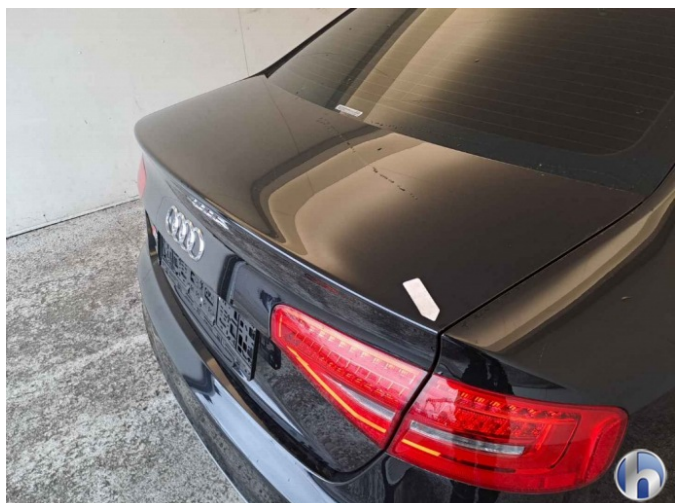
40. tailgate

| 40. | tailgate | Scratch(es) | Paint |

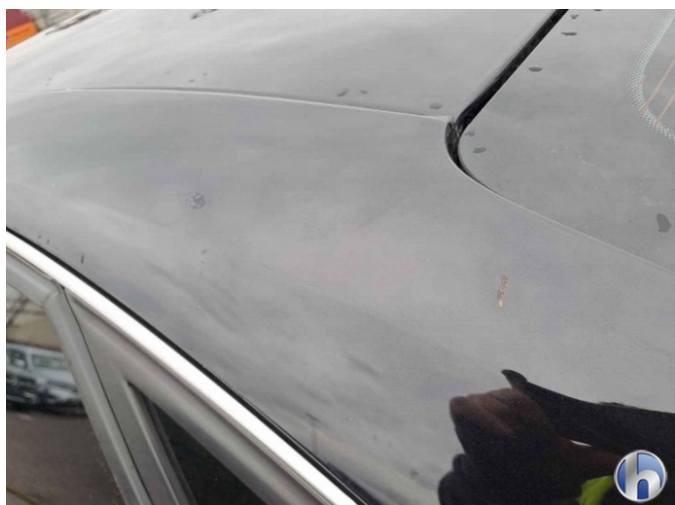
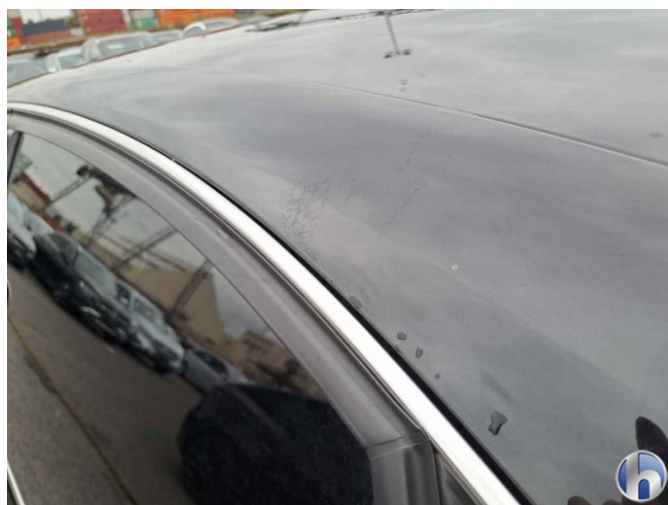
42. exterior body

| 42. | exterior body | Damaged | |
